LAKE SURVEY MAP

TRILBY LAKE
VILAS COUNTY
SEC. 11, 12, 13, 14 T. 40 N. R. 6 E.

Source: Wisconsin Department of Natural Resources 608-266-2621
Trilby Lake - Vilas County, Wisconsin DNR Lake Map
Date – Jun 1970 - Historical Lake Map - Not for Navigation
A Public Document - Please Identify the Source when using it.

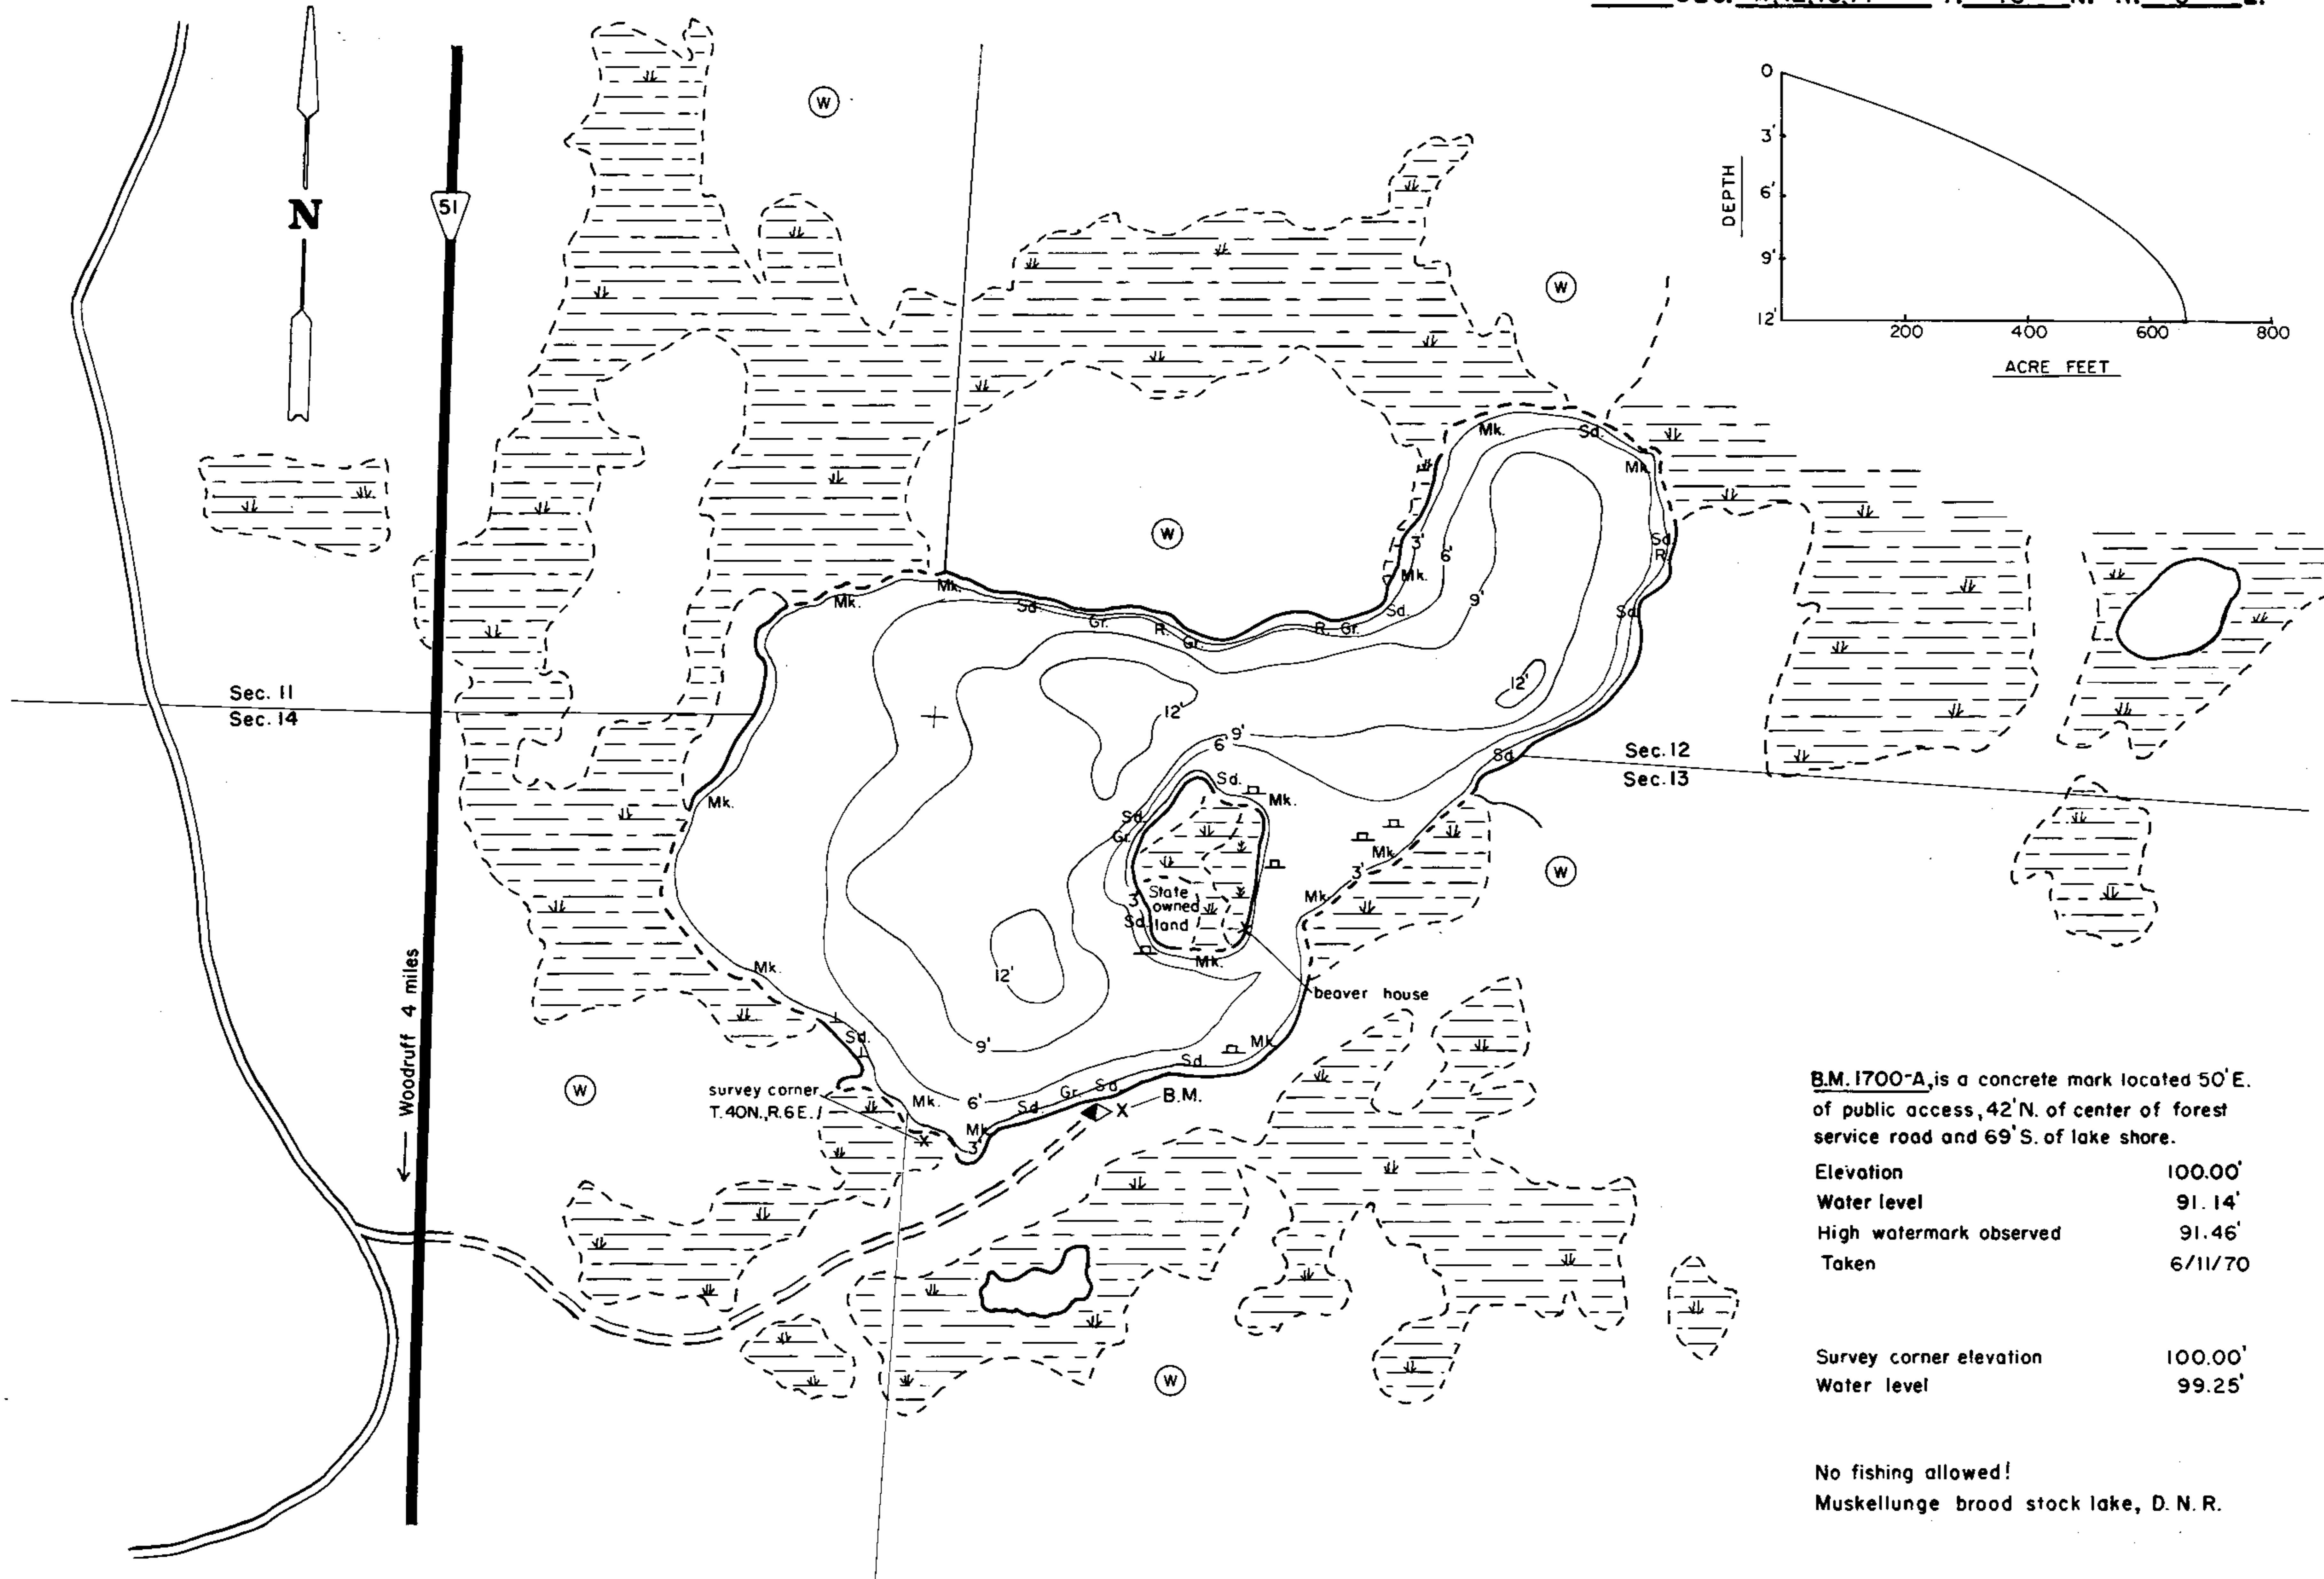
B.M. 1700-A, is a concrete mark located 50' E. of public access, 42' N. of center of forest service road and 69' S. of lake shore.

Elevation	100.00'
Water level	91.14'
High watermark observed	91.46'
Taken	6/11/70
Survey corner elevation	100.00'
Water level	99.25'

WATER AREA	91.71	ACRES
UNDER 3 FT.	8	%
OVER 20 FT.	0	%
MAX. DEPTH	12	FEET.
TOTAL ALK.	3	P.P.M.
VOLUME	657.72	ACRE FT.
SHORELINE	1.70	MILES
WITH ISLAND	2.07	MILES

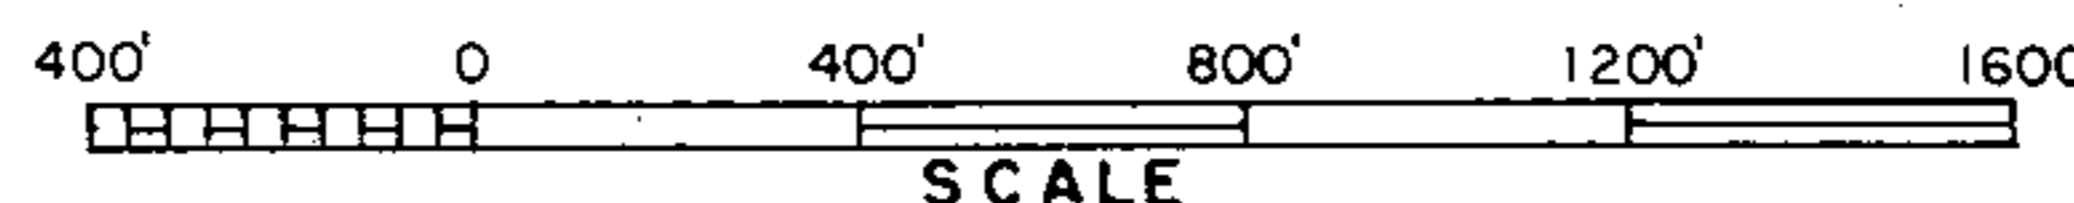
EQUIPMENT RECORDING		SONAR MAPPED		JUNE 1970	
TOPOGRAPHIC SYMBOLS		MONTH	YEAR	LAKE BOTTOM SYMBOLS	
(B) Brush	Steep slope	P. Peat	B Boulders	Mk. Muck	⊙ Stumps & Snags
(PW) Partially wooded	Indefinite shoreline	C. Clay	⊙ Rock danger to navigation	M. Marl	T Submergent vegetation
(W) Wooded	Marsh	Sd. Sand	⊥ Emergent vegetation	St. Silt	⊥ Floating vegetation
(C) Cleared	Spring	Gr. Gravel	⊕ Brush shelters	R. Rubble	
(P) Pastured	Intermittent stream	Bc. Bedrock			
(A) Agricultural	Permanent inlet				
B.M. Bench Mark	Permanent outlet				
■ Dwelling	Dam				
■ Resort	D.N.R. State owned land				
⊙ Camp
