LAKE SURVEY MAP

SILVER LAKE
VILAS COUNTY
SEC. 27, 28 T. -40- N. R. -10- E.

Source: Wisconsin Department of Natural Resources 608-266-2621
Silver Lake – Vilas County, Wisconsin DNR Lake Map
Date – Aug 1978 - Historical Lake Map - Not for Navigation
A Public Document - Please Identify the Source when using it.

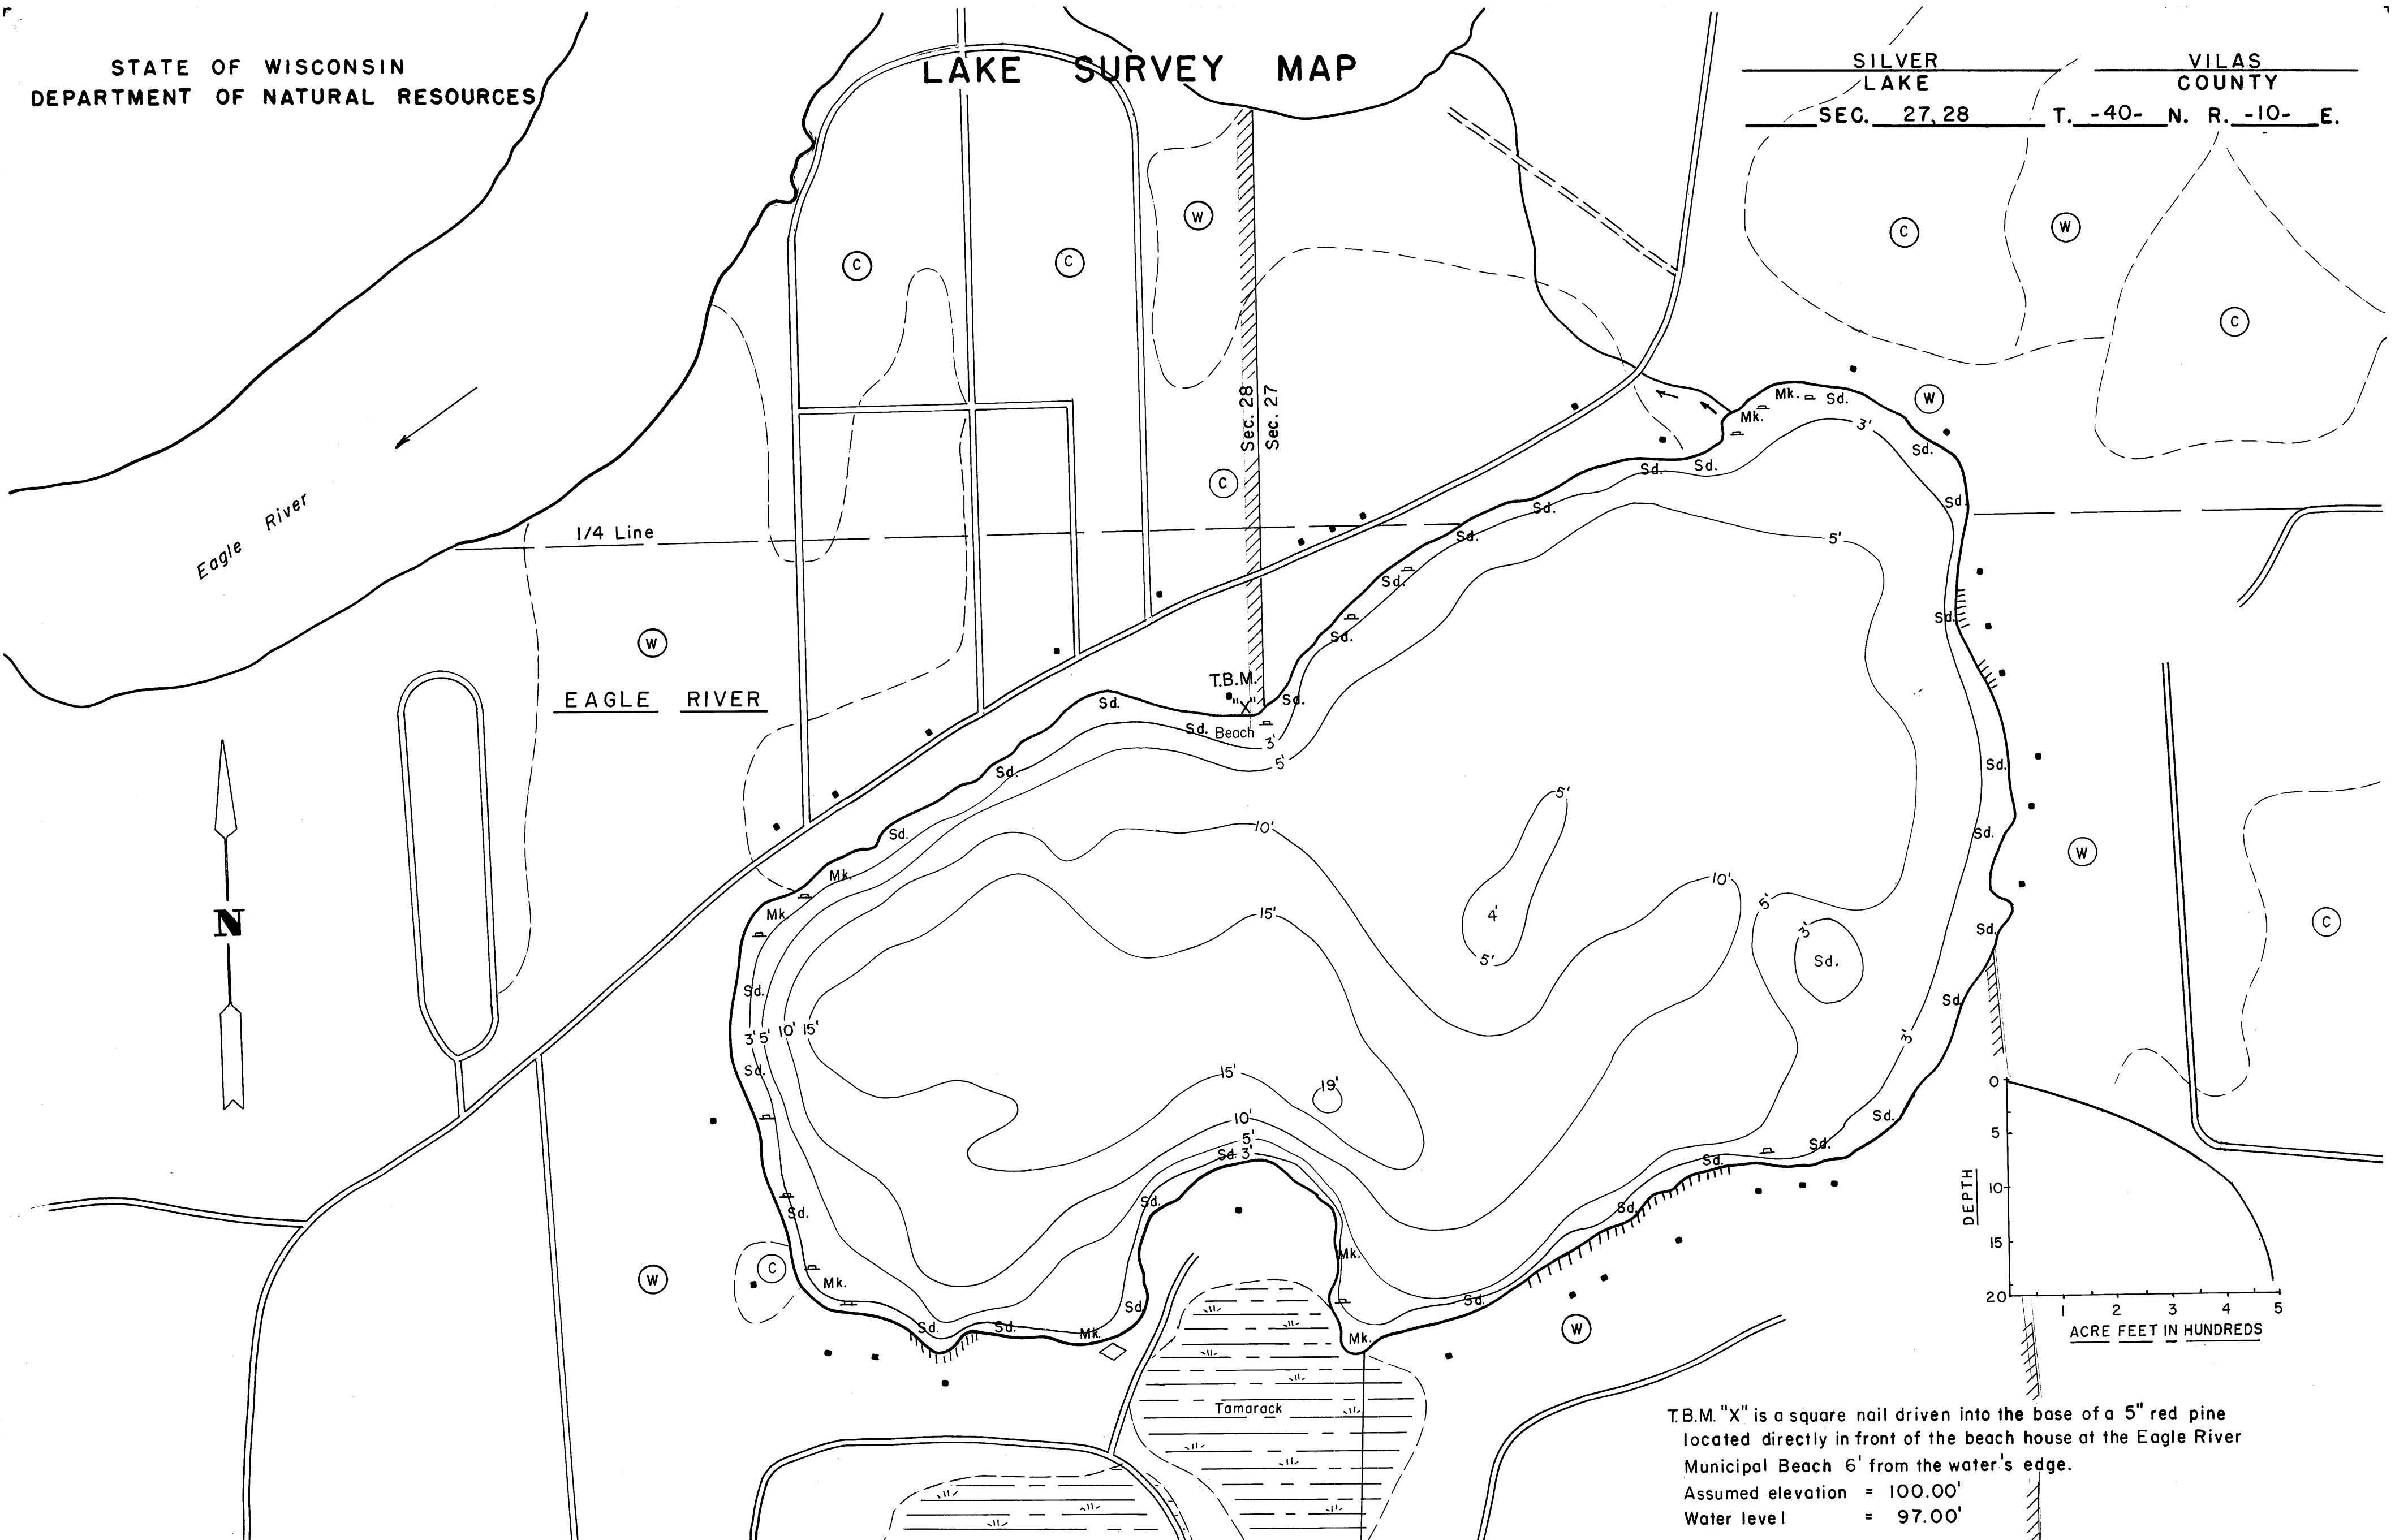
T.B.M. "X" is a square nail driven into the base of a 5" red pine located directly in front of the beach house at the Eagle River Municipal Beach 6' from the water's edge.
Assumed elevation = 100.00'
Water level = 97.00'

EQUIPMENT RECORDING SONAR MAPPED AUGUST 1978

WATER AREA 60.9 ACRES
UNDER 3 FT. 10 %
OVER 20 FT. 0 %
MAX. DEPTH 19 FEET.
TOTAL ALK. 11 P.P.M.
VOLUME 483.82 ACRE FT.
MAIN SHORELINE 1.37 MI.
ISLAND SHORELINE 0 MI.
