AREA 32.5 ACRES
UNDER 3 FT. 36.6 %
OVER 20 FT. 0 %
VOLUME 126.8 ACRE FT.
TOTAL ALK. 18 P.P.M.
SHORELINE 1.2 MILES
MAX. DEPTH 8 FEET

Source: Wisconsin Department of Natural Resources 608-266-2621
Emerson Lake – Clark County, Wisconsin DNR Lake Map
Date – Jun 1967 - Historical Lake Map - Not for Navigation
A Public Document - Please Identify the Source when using it.

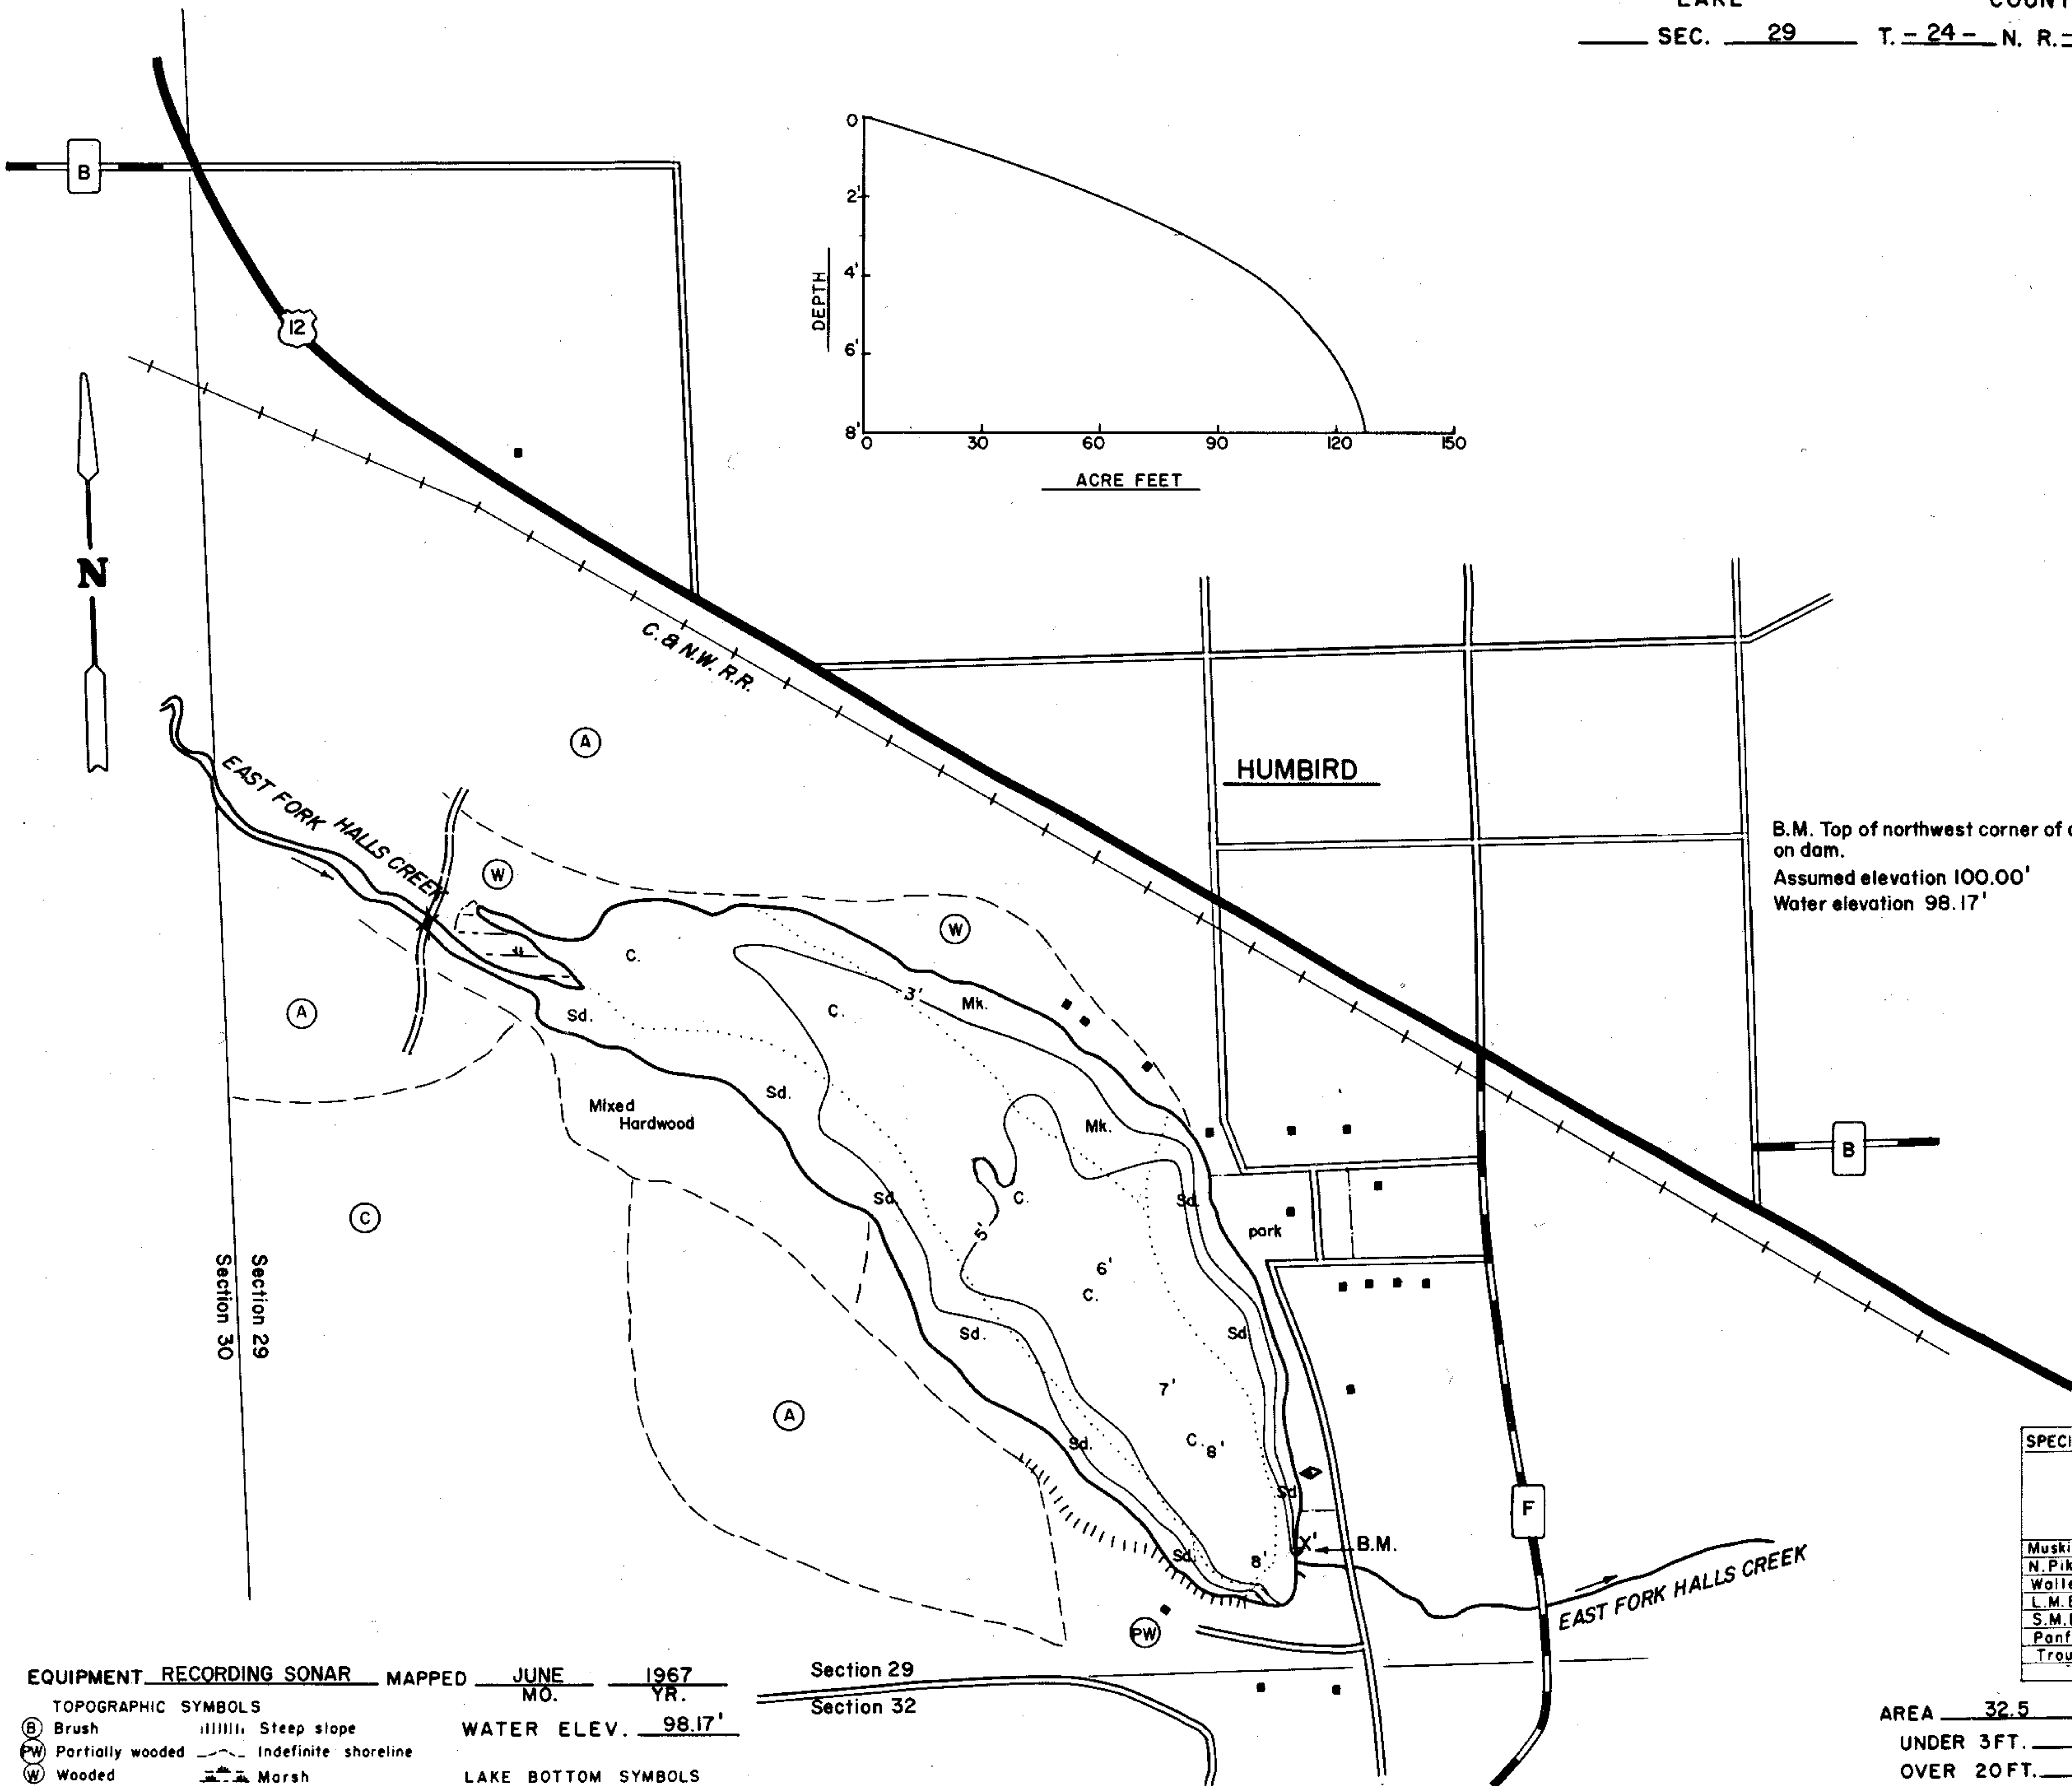
B.M. Top of northwest corner of concrete walk on dam.
Assumed elevation 100.00'
Water elevation 98.17'

EQUIPMENT RECORDING SONAR MAPPED JUNE 1967
MO. YR.
