EQUIPMENT RECORDING SONAR MAPPED JULY 1966 MO. YR.

Source: Wisconsin Department of Natural Resources 608-266-2621
Butternut Lake – Barron County, Wisconsin DNR Lake Map
Date – Jul 1966 - Historical Lake Map - Not for Navigation
A Public Document - Please Identify the Source when using it.

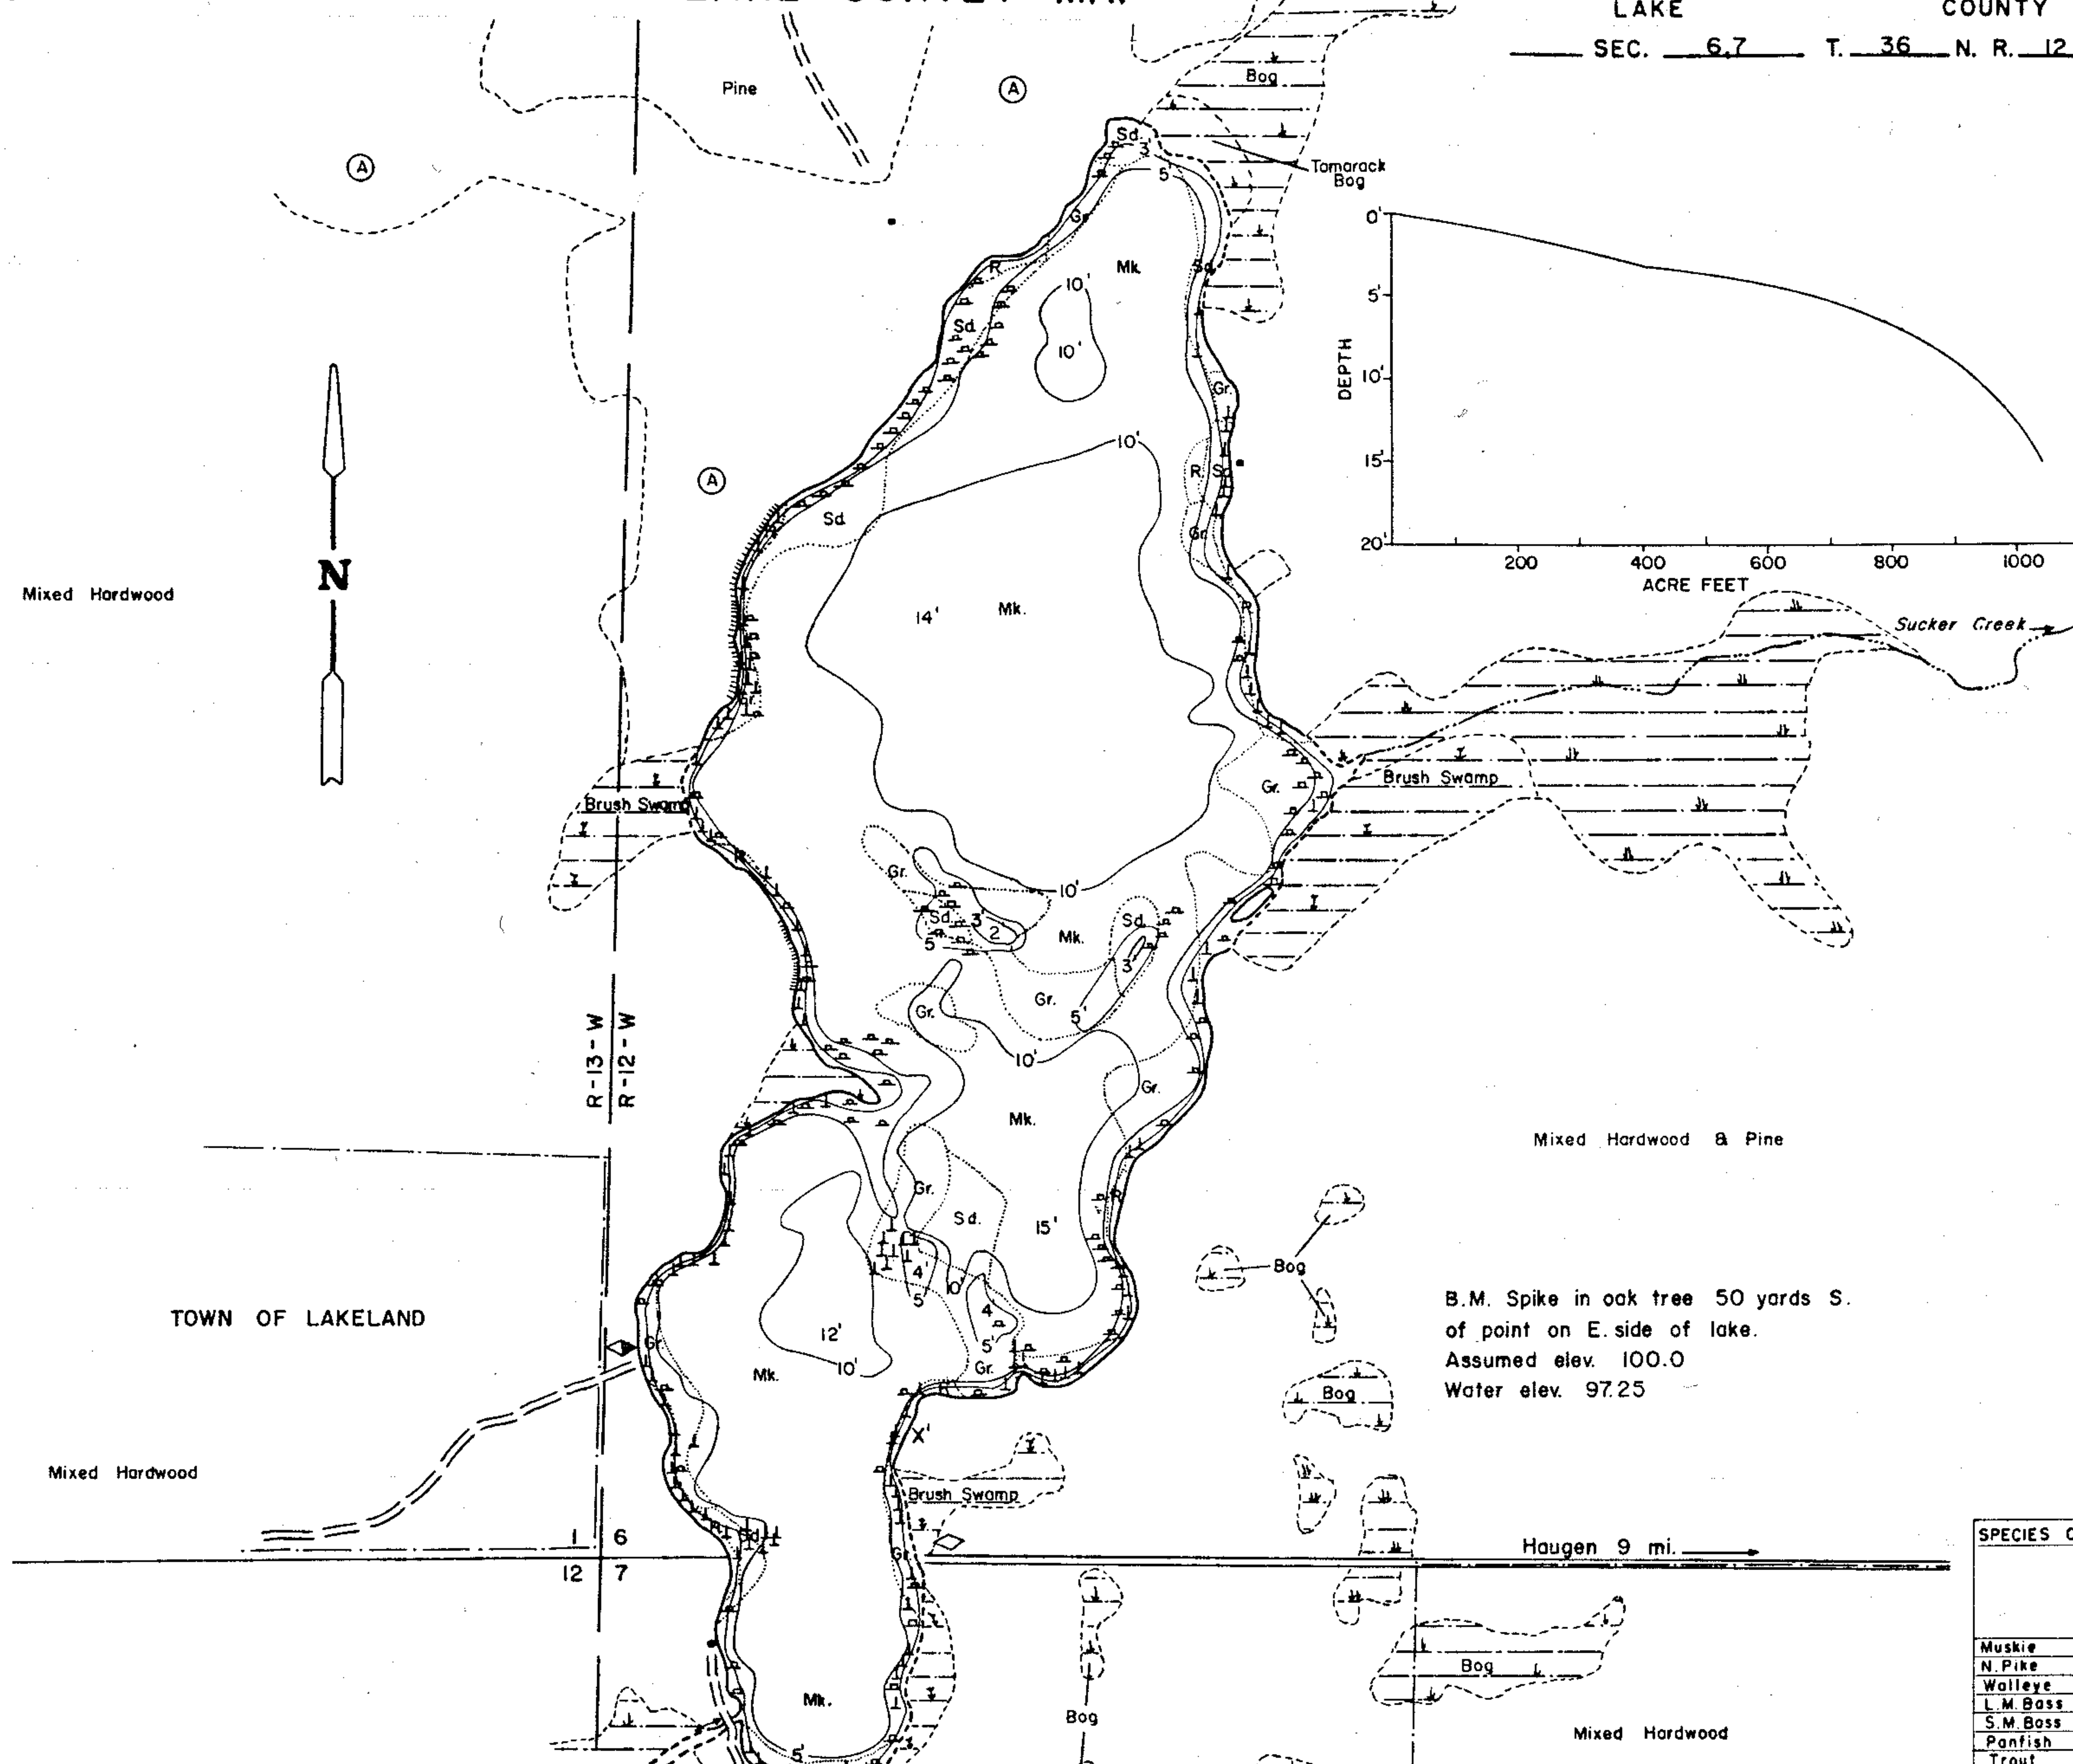
B.M. Spike in oak tree 50 yards S. of point on E. side of lake. Assumed elev. 100.0 Water elev. 97.25

AREA 140.6 ACRES
 UNDER 3FT. 5.8 %
 OVER 20FT. 0 %
 VOLUME 1039 ACRE FT.
 TOTAL ALK. 15 P.P.M.
 SHORELINE 2.6 MILES
 MAX. DEPTH 15 FEET

WATER ELEV. 97.25
