EQUIPMENT RECORDING SONAR MAPPED JULY 1968

Source: Wisconsin Department of Natural Resources 608-266-2621
Big Crooked Lake - Vilas County, Wisconsin DNR Lake Map
Date – Jul 1968 - Historical Lake Map - Not for Navigation
A Public Document - Please Identify the Source when using it.

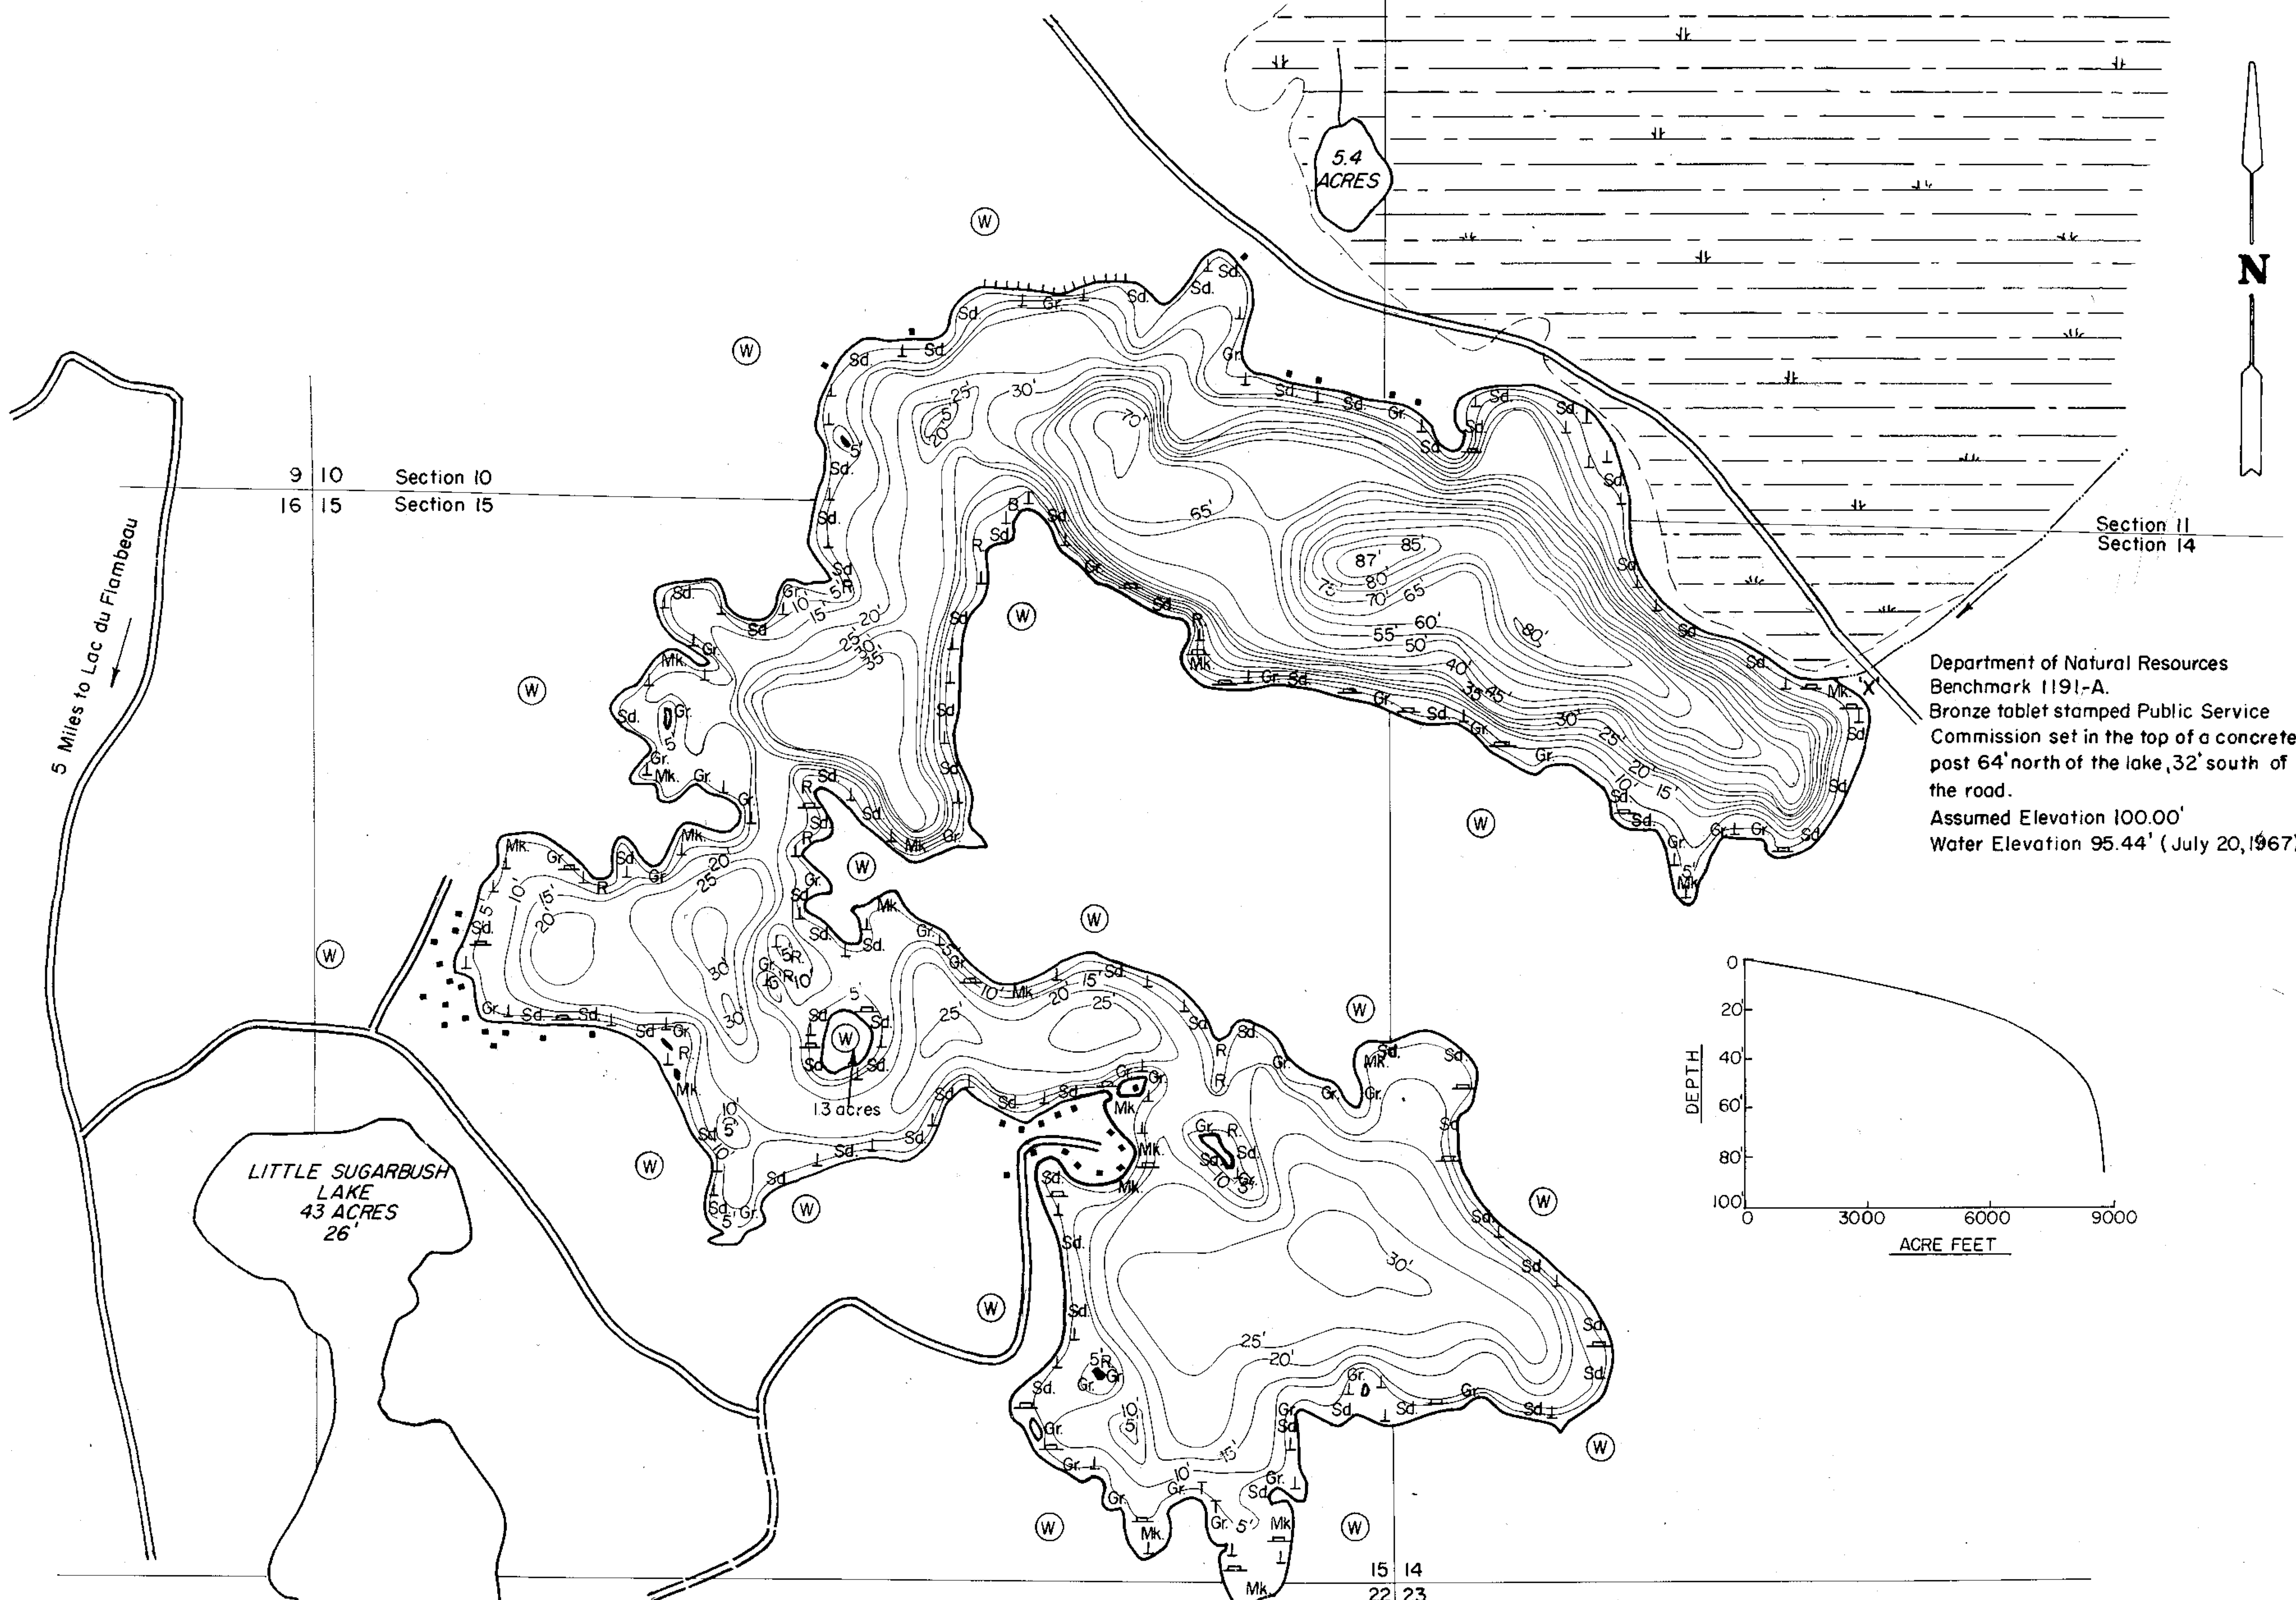
Department of Natural Resources
Benchmark 1191-A.
Bronze tablet stamped Public Service
Commission set in the top of a concrete
post 64' north of the lake, 32' south of
the road.
Assumed Elevation 100.00'
Water Elevation 95.44' (July 20, 1967)

WATER AREA 384.2 ACRES
UNDER 3 FT. 8 %
OVER 20 FT. 47 %
MAX. DEPTH 87 FEET.
TOTAL ALK. 13 P.P.M.
VOLUME 8,822.4 ACRE FT.
SHORELINE 8.0 MILES
7.6 MILES SHORELINE
EXCLUDING ISLANDS
