EQUIPMENT RECORDING SONAR MAPPED AUGUST 1967 MO. YR.

Source: Wisconsin Department of Natural Resources 608-266-2621  
Crooked Lake – Burnett County, Wisconsin DNR Lake Map  
Date – Aug 1967 - Historical Lake Map - Not for Navigation  
A Public Document - Please Identify the Source when using it.

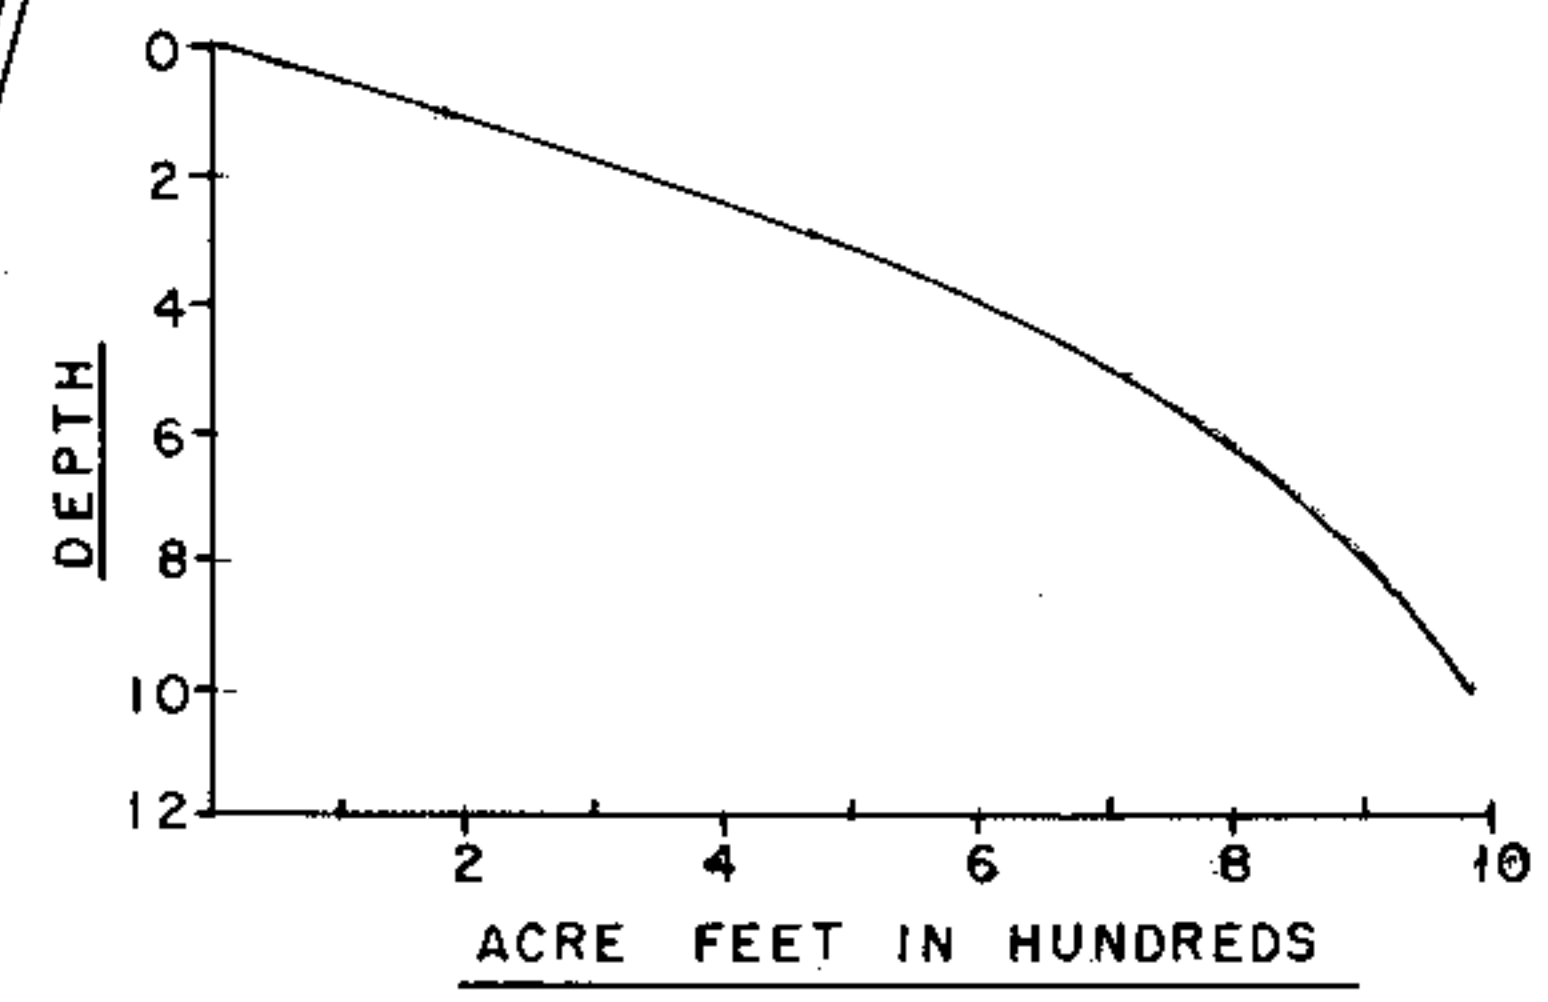
P.S.C. B.M. 1157-A Bronze Tablet set in top of concrete post north of shelter house, level taken 8/18/67 Assumed Elev. 100.00' Water Elev. 89.65'

WATER ELEV. 89.65

AREA 180 ACRES  
 UNDER 3FT. 18 %  
 OVER 20FT. 0 %  
 VOLUME 987.2 ACRE FT.  
 TOTAL ALK. 9 P.P.M.  
 SHORELINE 4.3 MILES  
 MAX. DEPTH 10 FEET
