EQUIPMENT RECORDING SONAR MAPPED JUNE 1966
 MO. YR.

Source: Wisconsin Department of Natural Resources 608-266-2621
Squaw Lake – St. Croix County, Wisconsin DNR Lake Map
Date – Jun 1966 - Historical Lake Map - Not for Navigation
A Public Document - Please Identify the Source when using it.

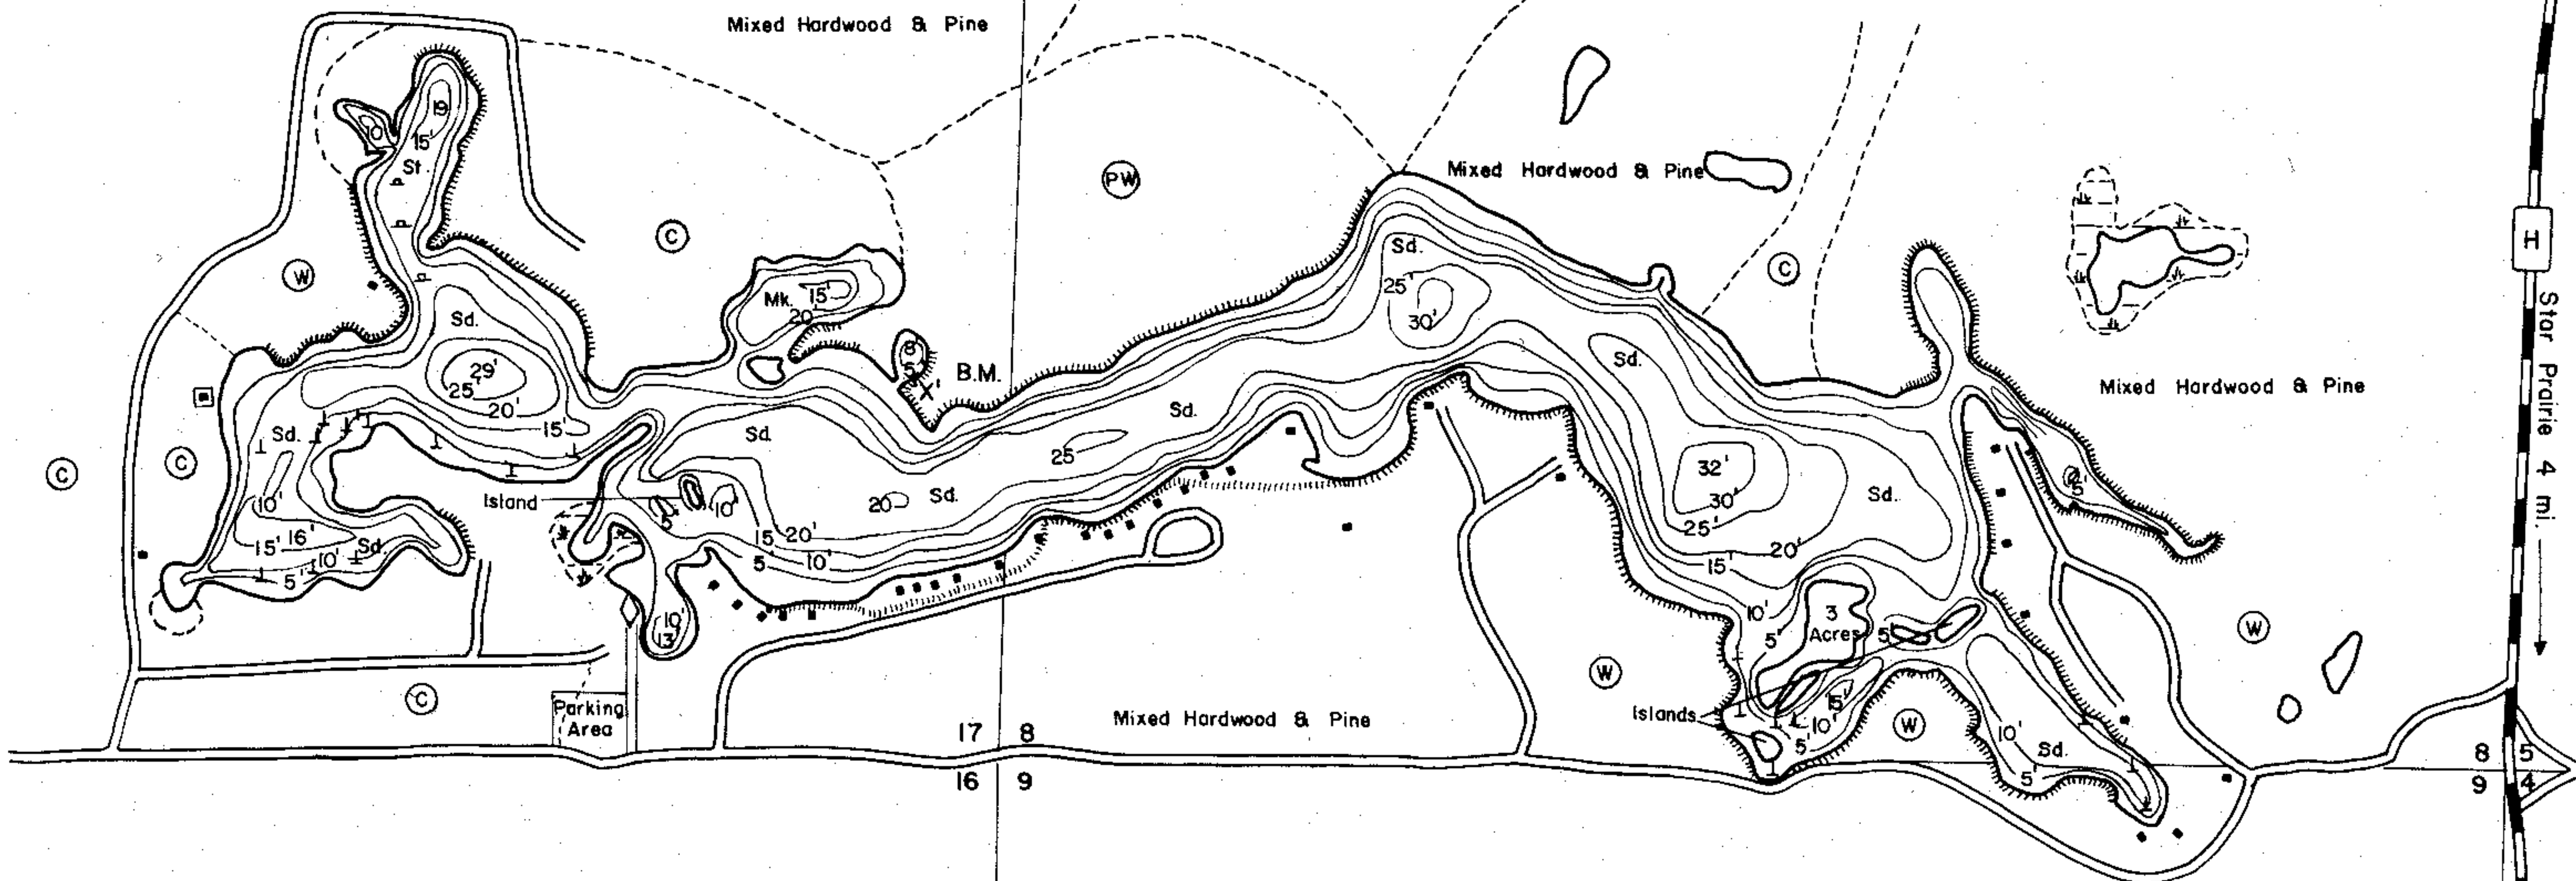
B.M. 'X' Spike in base of oak tree at
 waters edge
 Assumed elev. 100.0'
 Water elev 96.0'

This body of water subject to widely
 fluctuating water levels and at time of
 survey was at a high level

WATER ELEV. 96.0

133.2 WITH IS.
 AREA 129.2 ACRES
 UNDER 3FT. 21 %
 OVER 20FT. 22.4 %
 VOLUME 1625.9 ACRE FT.
 TOTAL ALK. 25 P.P.M.
 SHORELINE 5.6 MILES
 MAX. DEPTH 32 FEET
