Source: Wisconsin Department of Natural Resources 608-266-2621  
Lamont Lake – Polk County, Wisconsin DNR Lake Map  
Date – Sep 1969 - Historical Lake Map - Not for Navigation  
A Public Document - Please Identify the Source when using it.

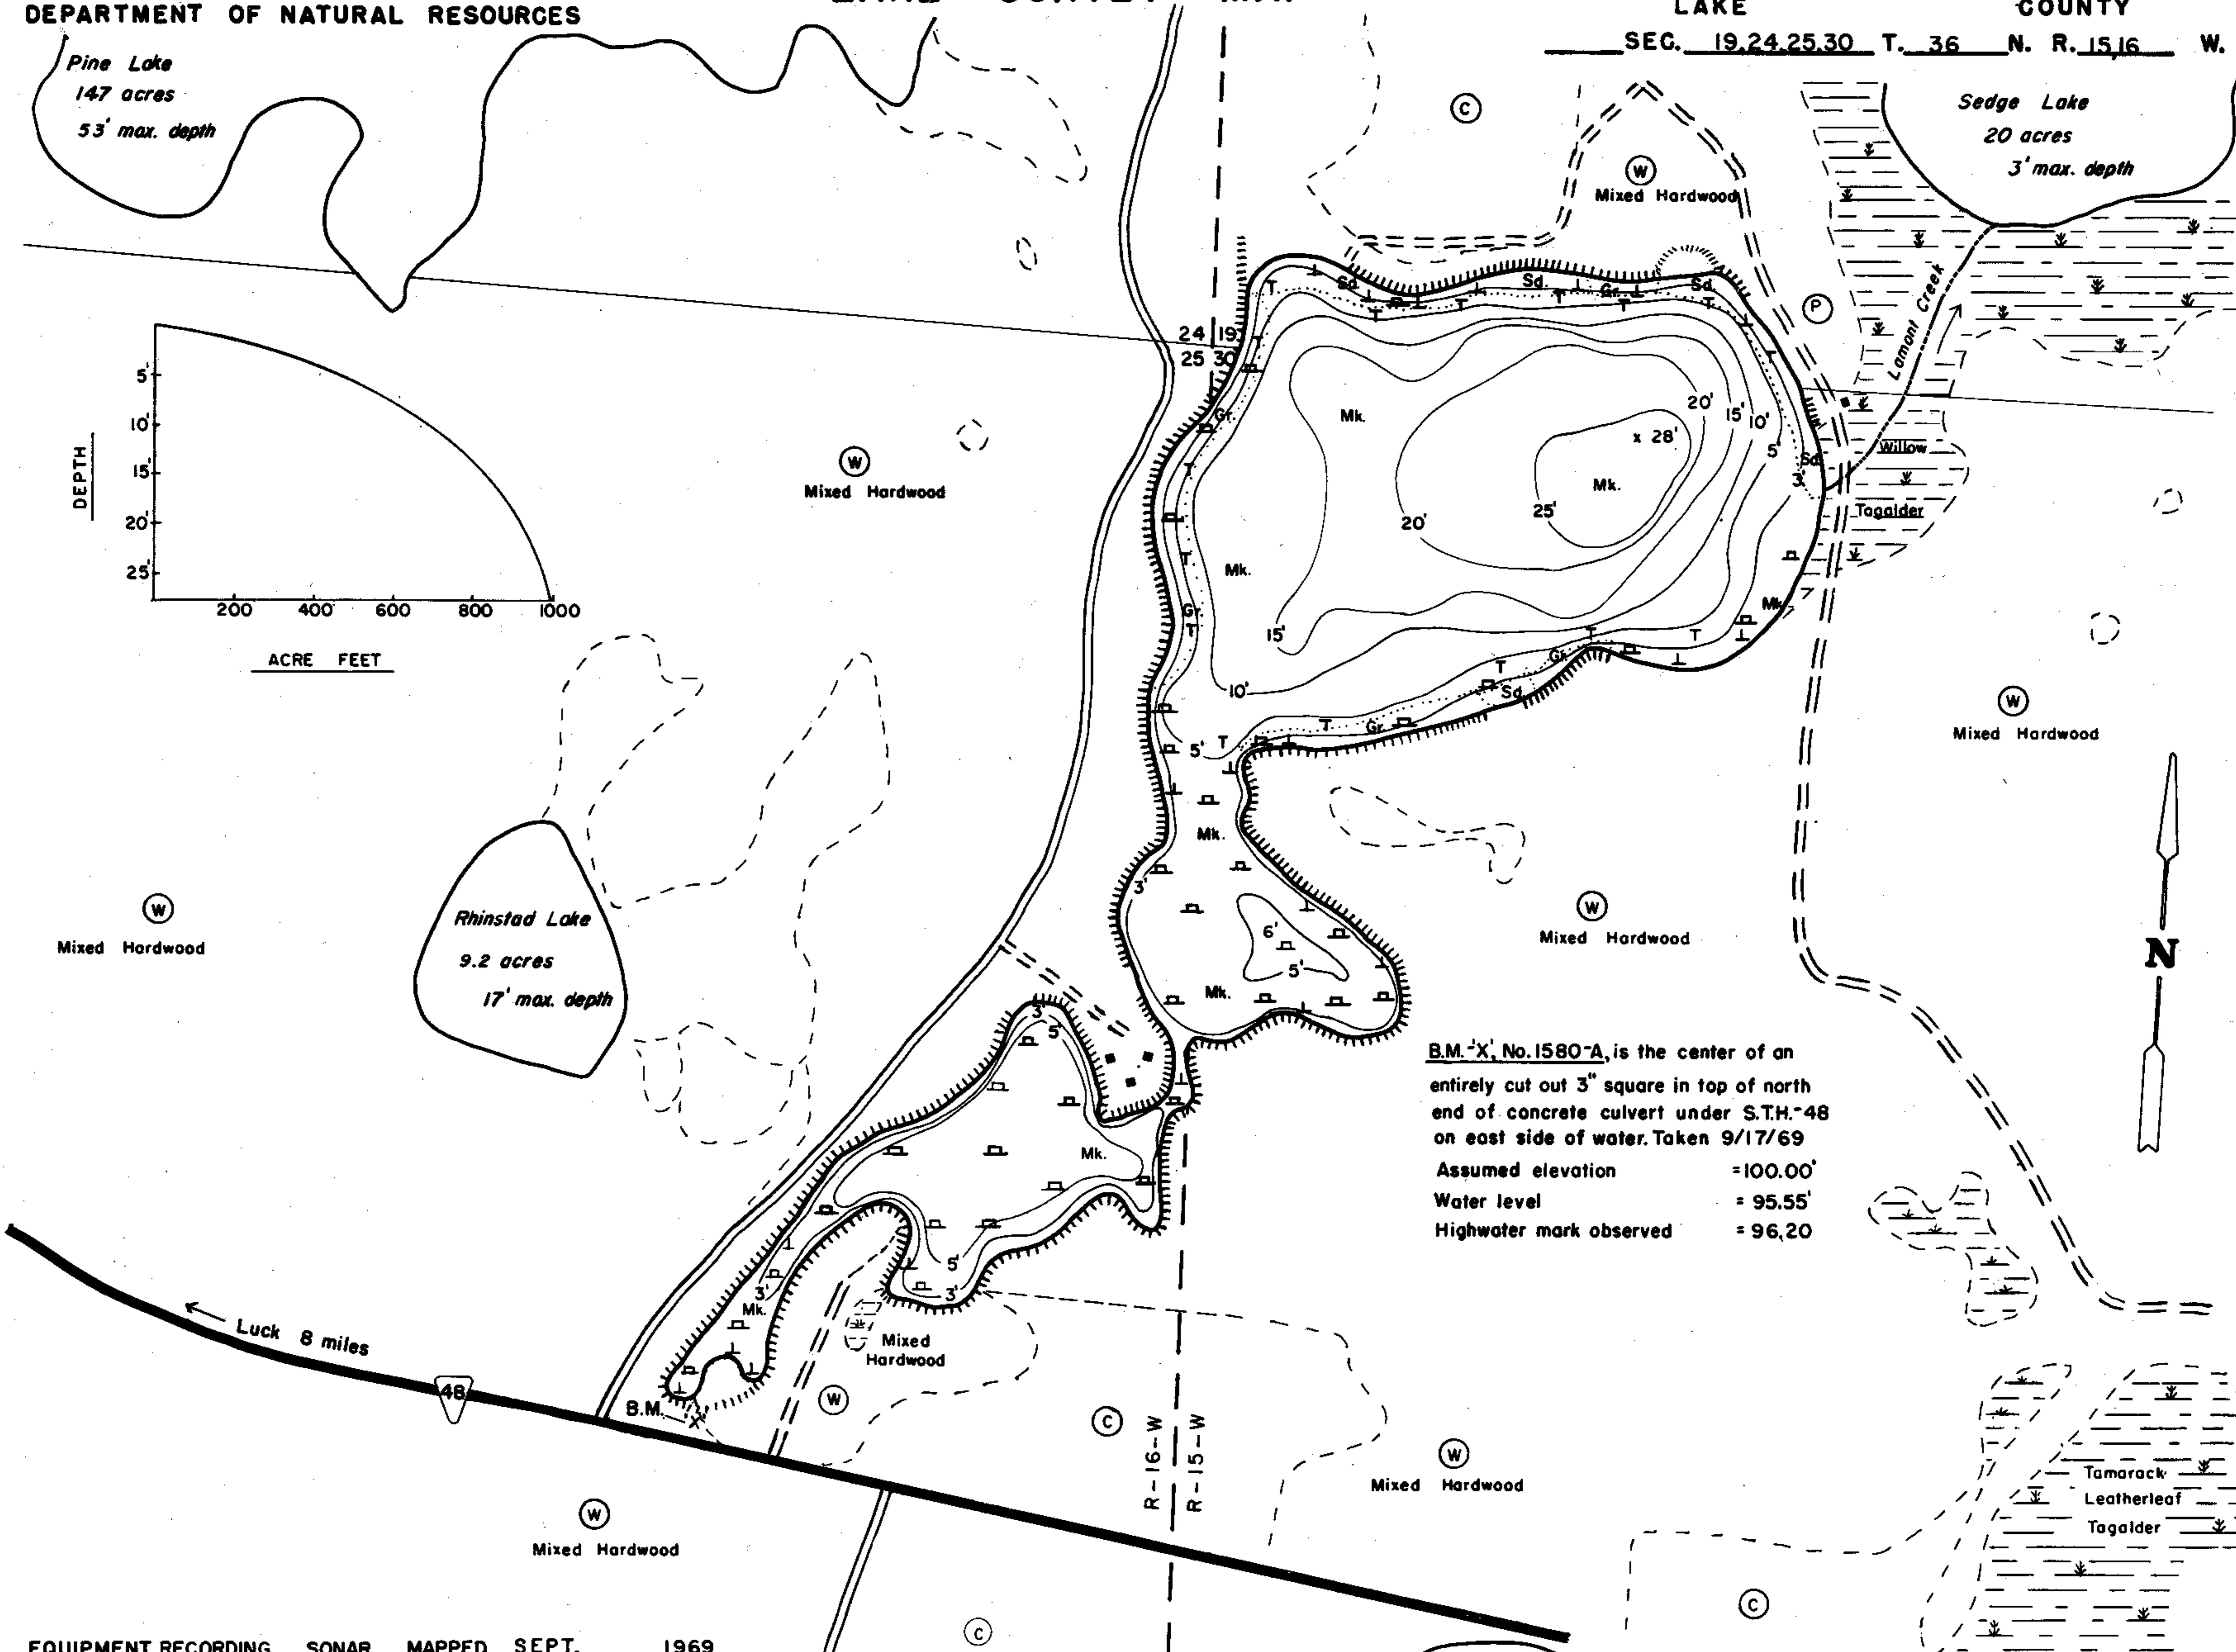
B.M. 'X', No. 1580-A, is the center of an entirely cut out 3" square in top of north end of concrete culvert under S.T.H.-48 on east side of water. Taken 9/17/69  
Assumed elevation = 100.00'  
Water level = 95.55'  
Highwater mark observed = 96.20

WATER AREA 96.3 ACRES  
UNDER 3 FT. 13 %  
OVER 20 FT. 14 %  
MAX. DEPTH 28 FEET.  
TOTAL ALK. 27 P.P.M.  
VOLUME 992.3 ACRE FT.  
SHORELINE 2.93 MILES
