Marion Pond – Waupaca County, Wisconsin DNR Lake Map

Date – May 1964 - Historical Lake Map - Not for Navigation

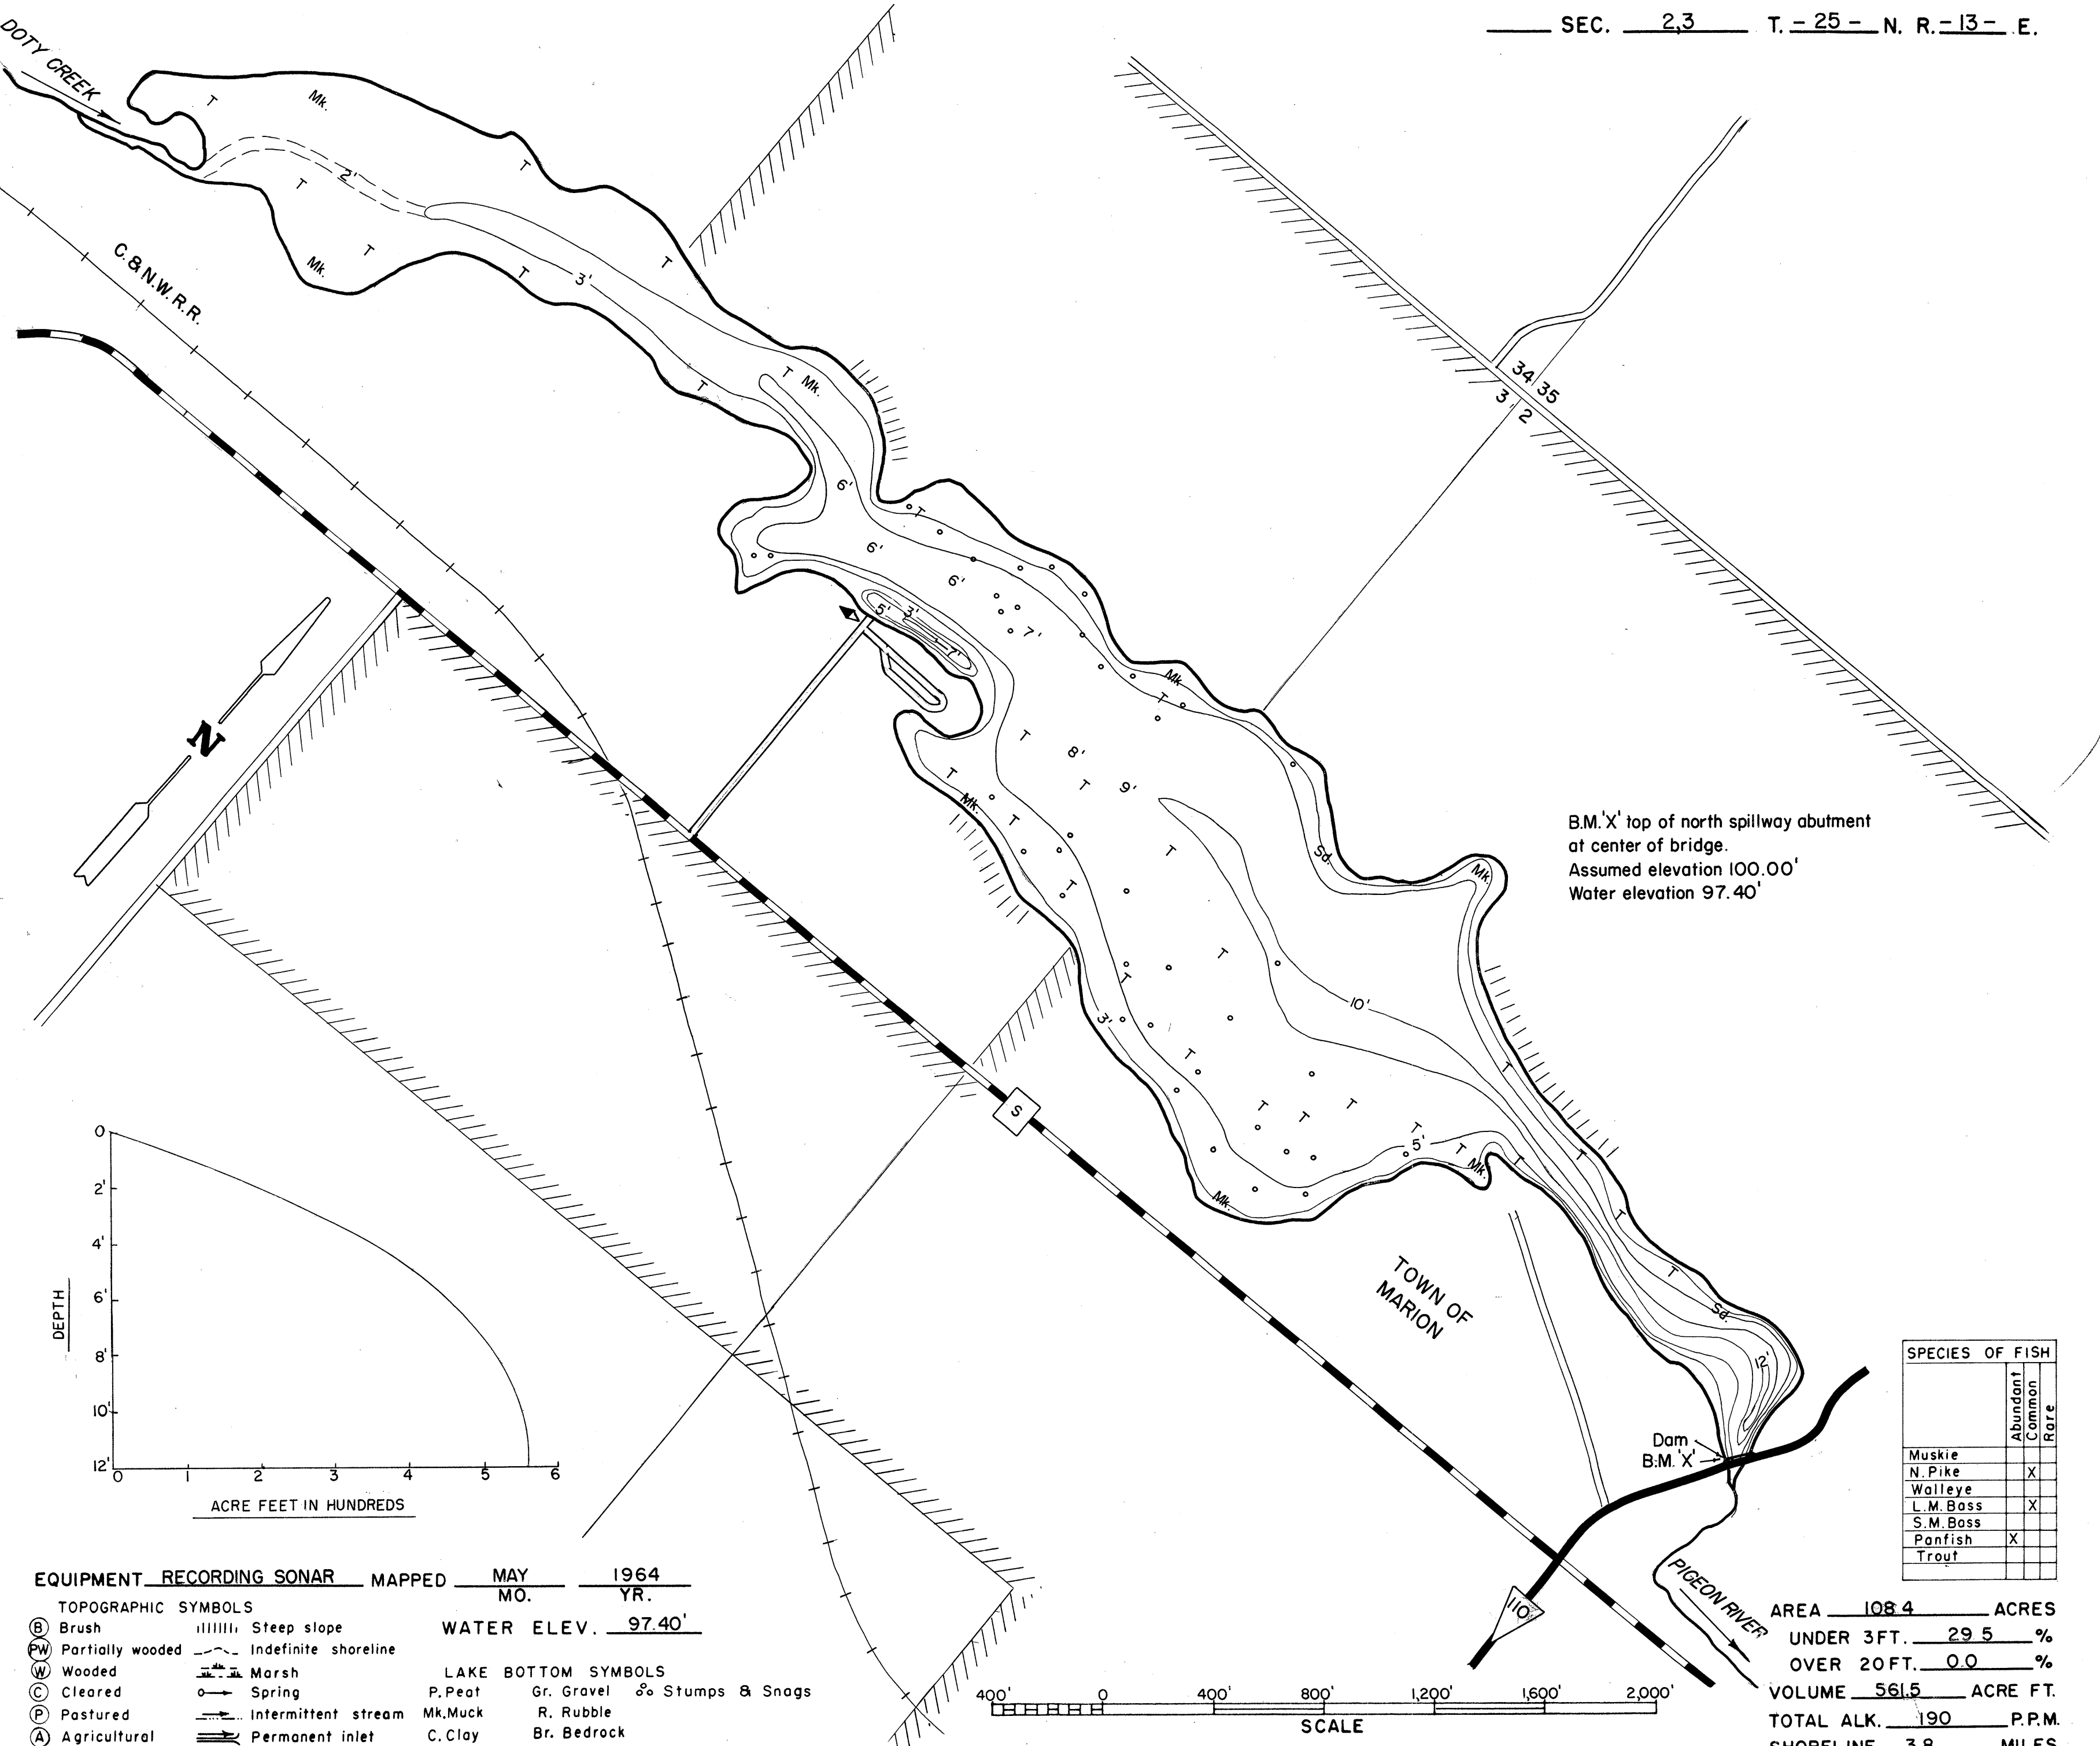
B.M. 'X' top of north spillway abutment
 at center of bridge.
 Assumed elevation 100.00'
 Water elevation 97.40'

AREA 108.4 ACRES
 UNDER 3 FT. 29.5 %
 OVER 20 FT. 0.0 %
 VOLUME 561.5 ACRE FT.
 TOTAL ALK. 190 P.P.M.
 SHORELINE 3.8 MILES
 MAX. DEPTH 12 FEET
