# Presque Isle Wilderness Waters Program

## Aquatic Plant Management Plan – Red Bass Lake

**Date: 2021**

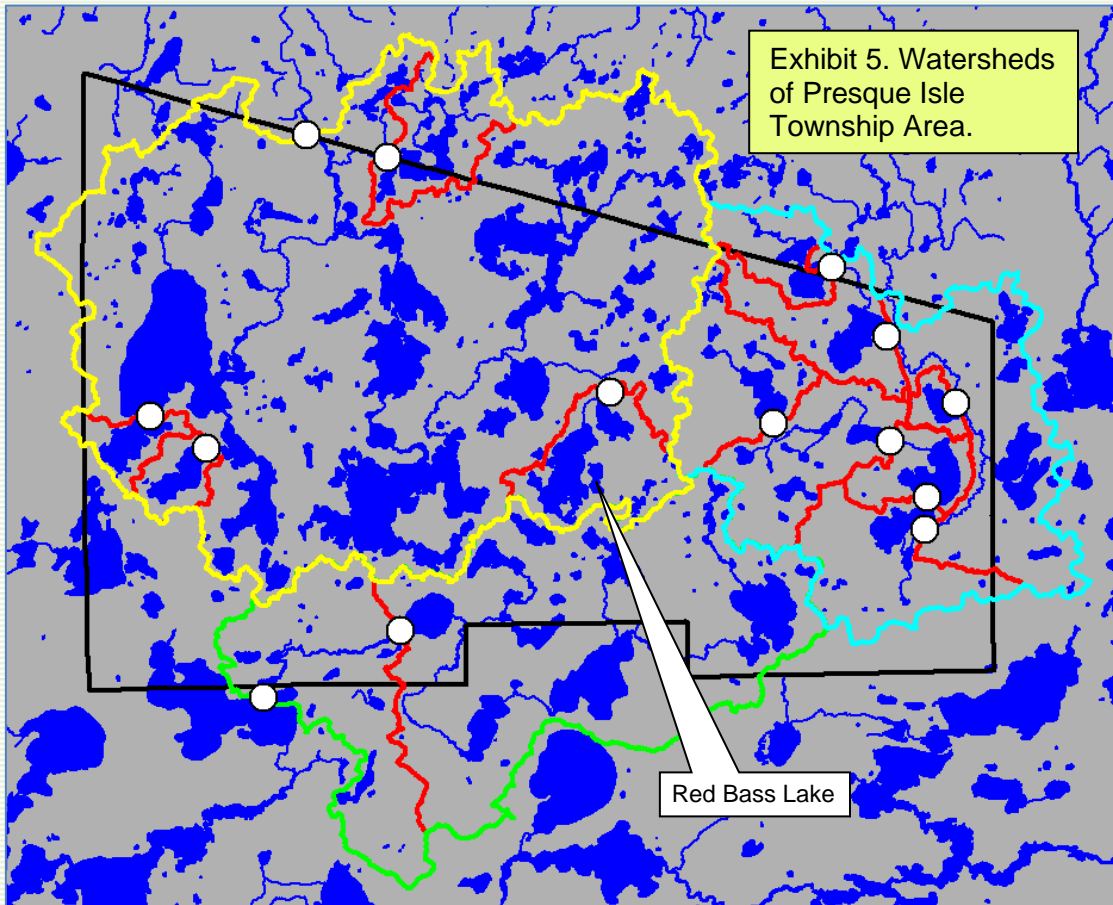
Description: Portions of 3 federal hydrologic sub-watersheds are illustrated: (1) S.Br. Presque Isle River (bounded by yellow), (2) Pomeroy Cr-E.Br. Presque Isle River (bounded by blue and yellow), and (3) Rice Cr. (bounded by green, yellow, and blue). Also shown are the smaller watersheds of individual water bodies subject to the Wilderness Waters studies (bounded by red). White dots show outlet points for the smaller watersheds.

The Presque Isle Township waterscape sits on a large-scale watershed divide. Some of the water drains north through the Presque Isle River system and eventually enters Lake Superior. Some of the water drains into the Flambeau River system to the Mississippi River and to the Gulf of Mexico. In fact there are two federal hydrologic sub-basins (designated by 8-digit HUC codes) that include Presque Isle Township. The Black-Presque Isle Rivers sub-basin (HUC#04020101) drains north to Lake Superior and the Flambeau River sub-basin (HUC#0705002) drains southwesterly to the Mississippi River. The Black-Presque Isle Rivers sub-basin contains two federal hydrologic sub-watersheds within Presque Isle Township: the South Branch Presque Isle River sub-watershed (HUC#040201010303) and the Pomeroy Creek-East Branch Presque Isle River sub-watershed (HUC#040201010301). Exhibit 5 illustrates these watersheds and the watersheds of the water bodies subject to the Wilderness Waters Program studies. Red Bass Lake is contained within the South Branch Presque Isle River sub-watershed (Exhibit 5).

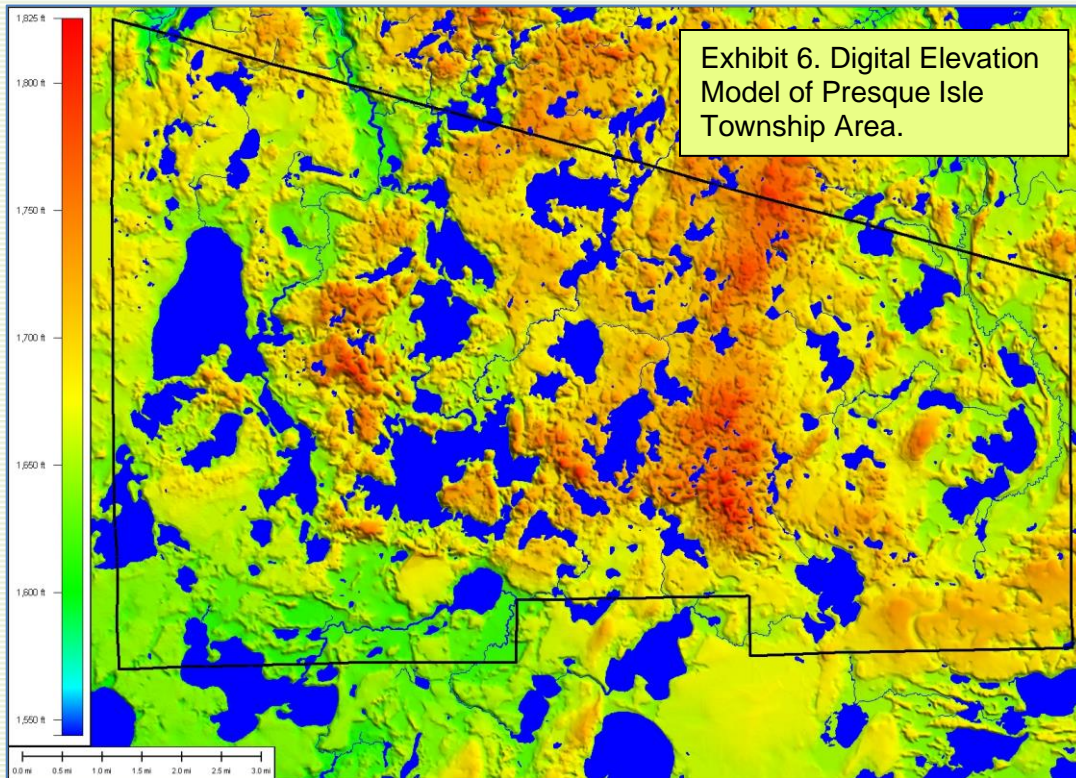
The elevation in Presque Isle Township ranges from around 1,550 feet above sea level to 1,750 feet above sea level. A digital elevation model is provided as Exhibit 6 and shows the relative elevations for the area with orange areas of the landscape being the highest elevations and greens and blues being the lowest elevations.

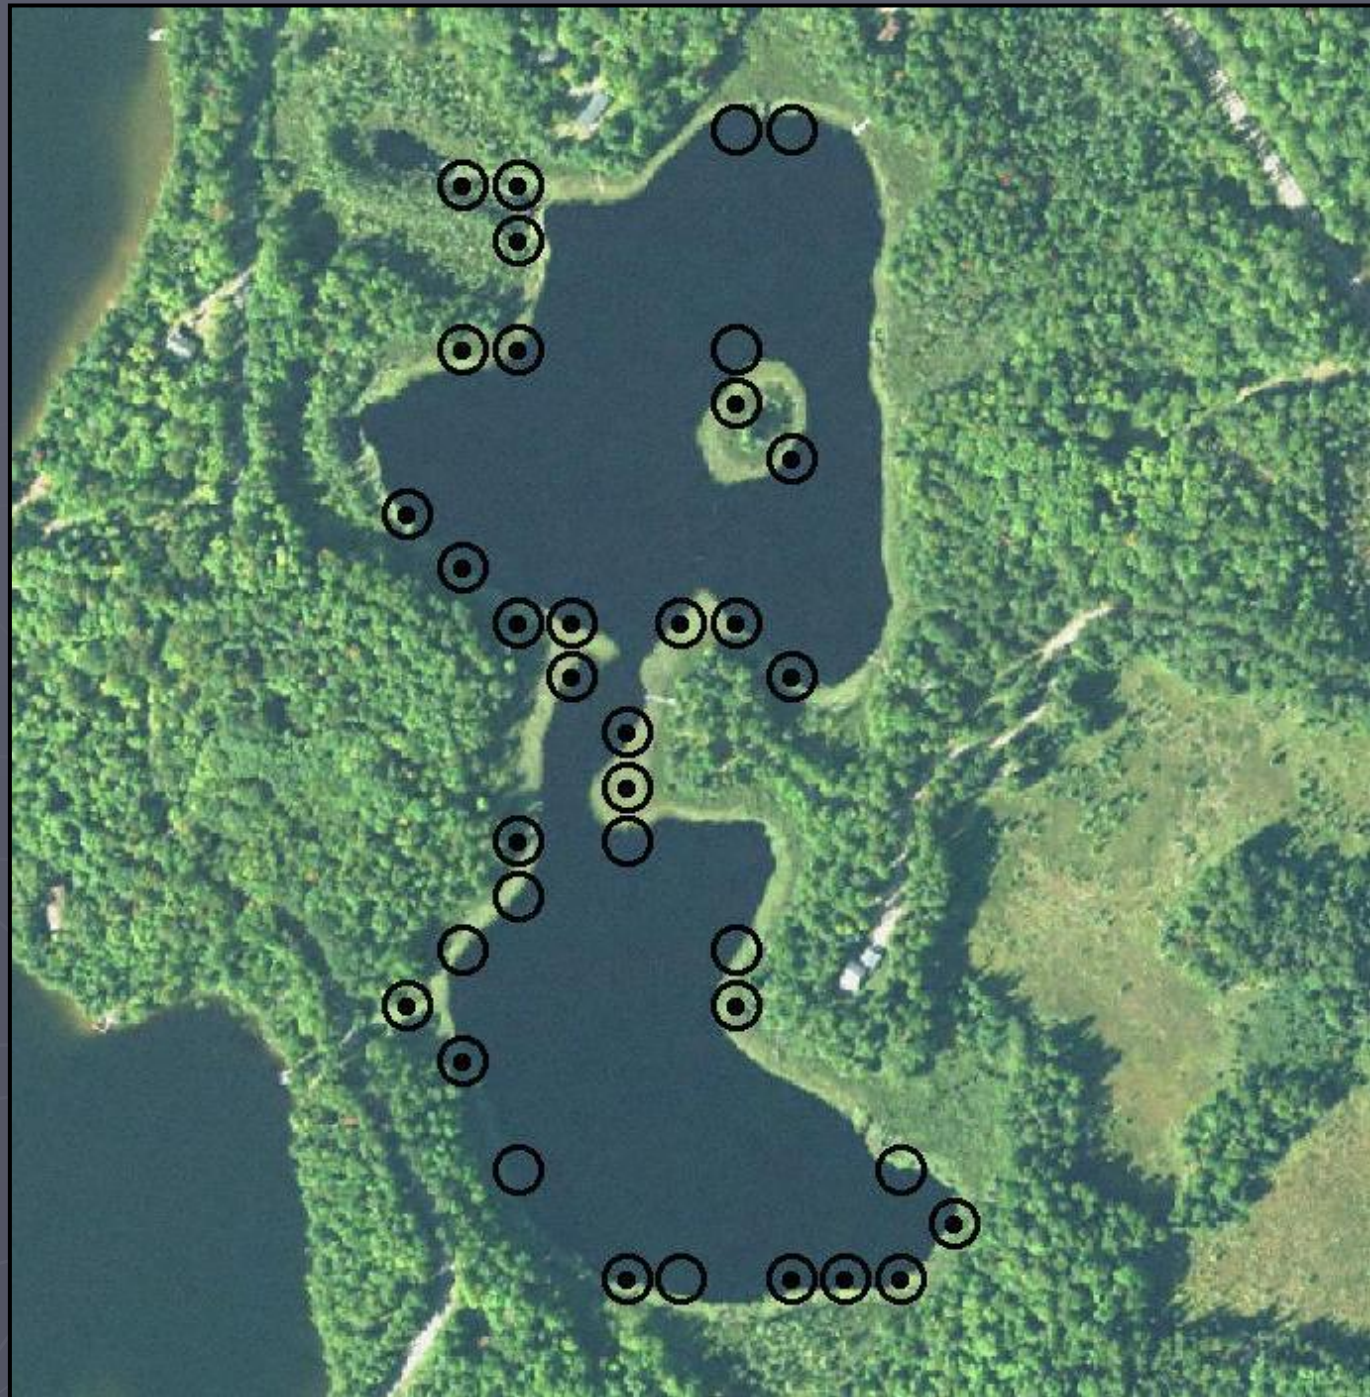
Figure 4. Red Bass Lake sampling sites less than or equal to maximum depth of rooted vegetation (2019).

- Site less than or equal to maximum depth of plant colonization (MDC).
- Plant find(s) at site less than or equal to MDC.

The maximum depth of plant colonization is 7 feet (Table 1 and Figure 3). Rooted vegetation was found at 26 of the 36 sample sites with depth  $\leq$  the maximum depth of plant colonization (72.22% of sites). These sites are displayed as a black dot within a circle on Figure 4. This indicates that although availability of appropriate depth may limit the distribution of plants, it is not the only habitat factor involved. Substrate is another feature that influences plant

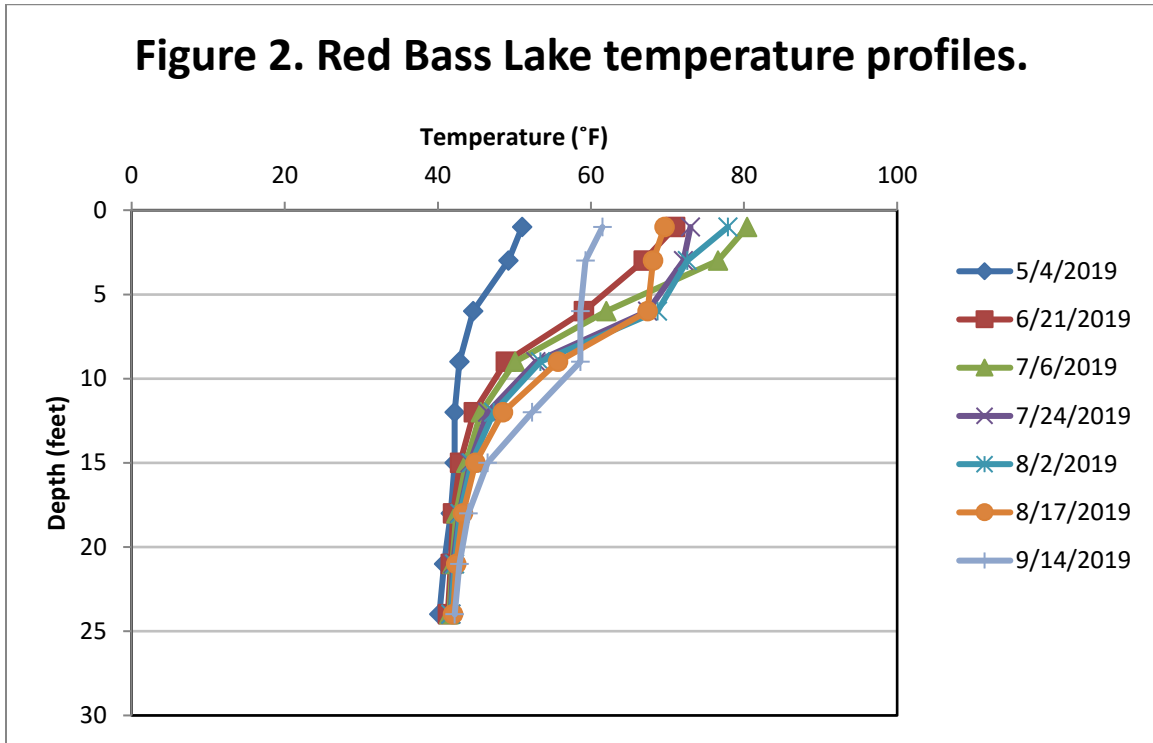
affect the distribution of fish species throughout a lake. A temperature profile was conducted in May, June, July, August and September of 2019 (Figure 2).

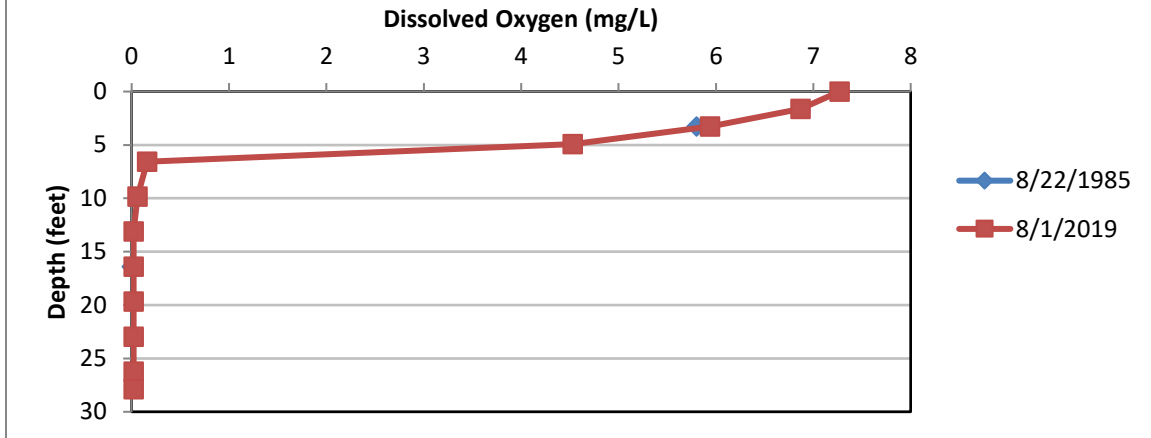
**Figure 3. Red Bass Lake dissolved oxygen profiles.**

The dissolved oxygen (D.O.) content of lake water is vital in determining presence of fish species and other aquatic organisms. Dissolved oxygen also has a strong influence on the chemical and physical conditions of a lake. The amount of dissolved oxygen is dependent on the water temperature, atmospheric pressure, and biological activity. Oxygen levels are increased by aquatic plant photosynthesis, but reduced by respiration of plants, decomposer organisms, fish, and invertebrates. The amount of dissolved oxygen available in a lake, particularly in the deeper parts of a lake, is critical to overall health. In August, 1985, D.O. was 5.8 mg/L at 3 feet. A D.O. profile was also conducted August 1, 2019 with a surface D.O. of 7.27 mg/L which drops off at approximately 5-6 feet.

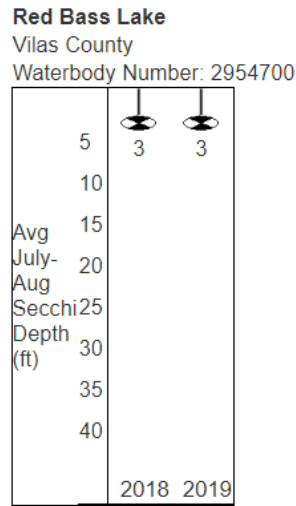
**Figure 4. Red Bass Lake Secchi depth averages (July and August only) (WDNR, 2021).**

Water clarity	Secchi depth (ft.)
Very poor	3
Poor	5
Fair	7
Good	10
Very good	20
Excellent	32

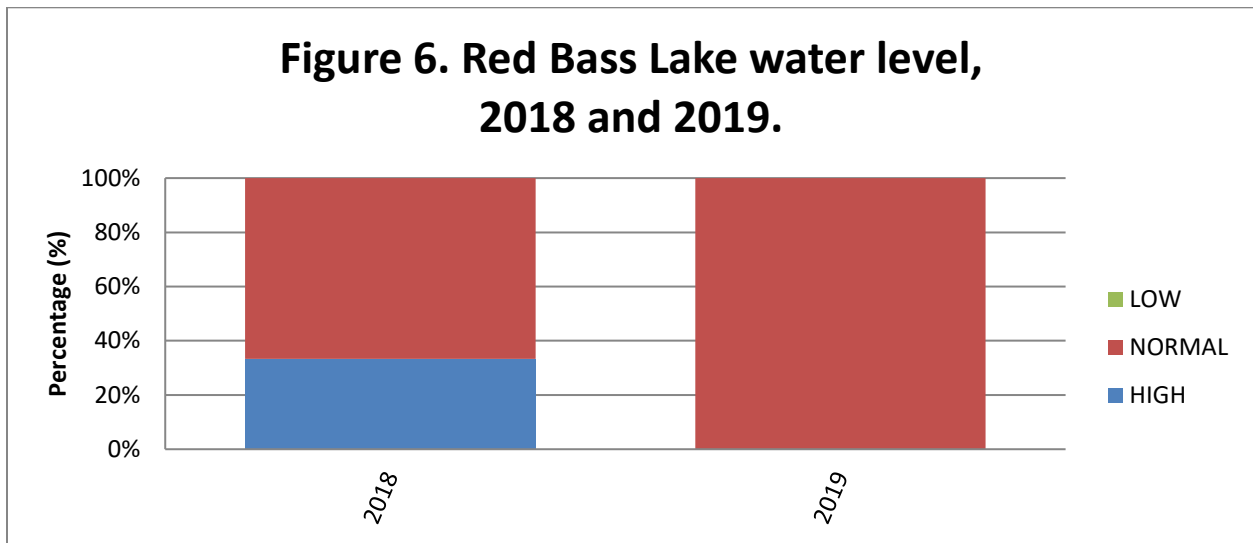
When CLMN volunteers collect Secchi depth readings, they also record their opinion of lake level as “high,” “normal,” or “low.” Water level was monitored by a Citizen Lake volunteer in 2018 and 2019. Figure 6 indicates that in 2019 the water level was normal.

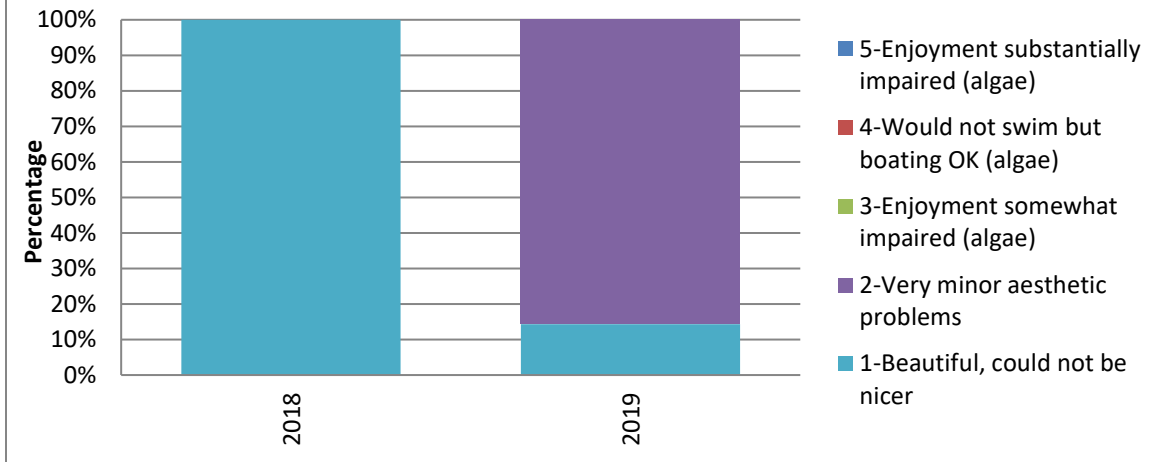
**Figure 7. Red Bass Lake aesthetic value, 2018-2019.**

When Secchi depth readings are collected, the CLMN record their perceptions of the water, based on the physical appearance and the recreational suitability. These perceptions can be compared to water quality parameters to see how the lake user would experience the lake at that time. When interpreting the transparency data, we see that when the Secchi depth decreases, the rating of the lake’s physical appearance also decreases. A Citizen Lake Monitor looked at Red Bass Lakes’s aesthetic value in 2018 and 2019 (Figure 7).

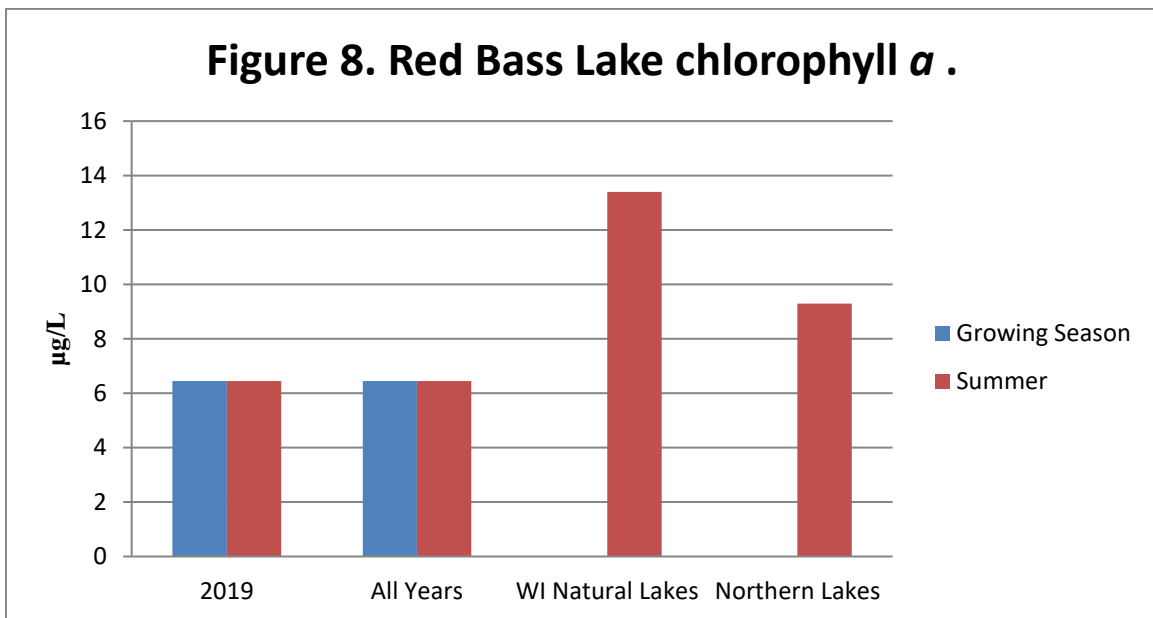
**Figure 8. Red Bass Lake chlorophyll *a* .**

Chlorophyll *a* is the photosynthetic pigment that makes plants and algae green. Chlorophyll *a* in lake water is therefore an indicator of the amount of algae. Chlorophyll *a* concentration greater than 10 µg/L are perceived as a mild algae bloom, while concentrations greater than 20 µg/L are perceived as a nuisance. Chlorophyll *a* values were below nuisance levels and well below the average levels for Wisconsin natural lakes for the summer months. Chlorophyll *a* was analyzed on Red Bass Lake in August, 2019 (Figure 8). Long term monitoring should be conducted to show any trends in chlorophyll *a* data.

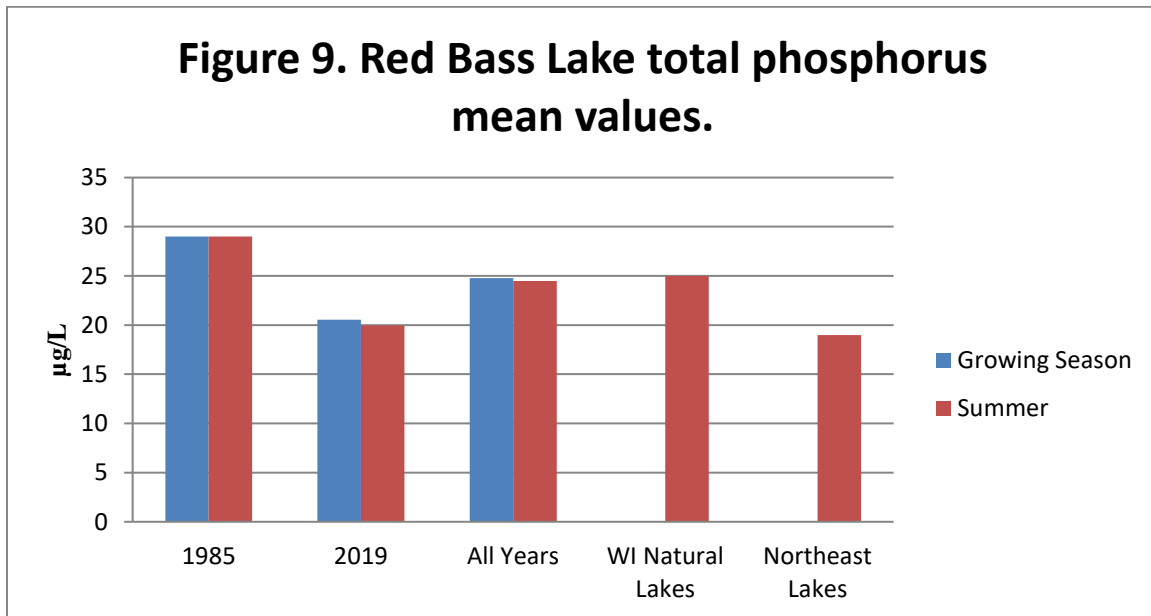
Total phosphorus was analyzed in August, 1985 and was 12  $\mu\text{g/L}$  and on August, 2019 (Figure 9). Based on these values, Red Bass Lake's total phosphorus can be classified as "good" (Figure 3). Long term monitoring should be conducted to determine any trends in total phosphorus.

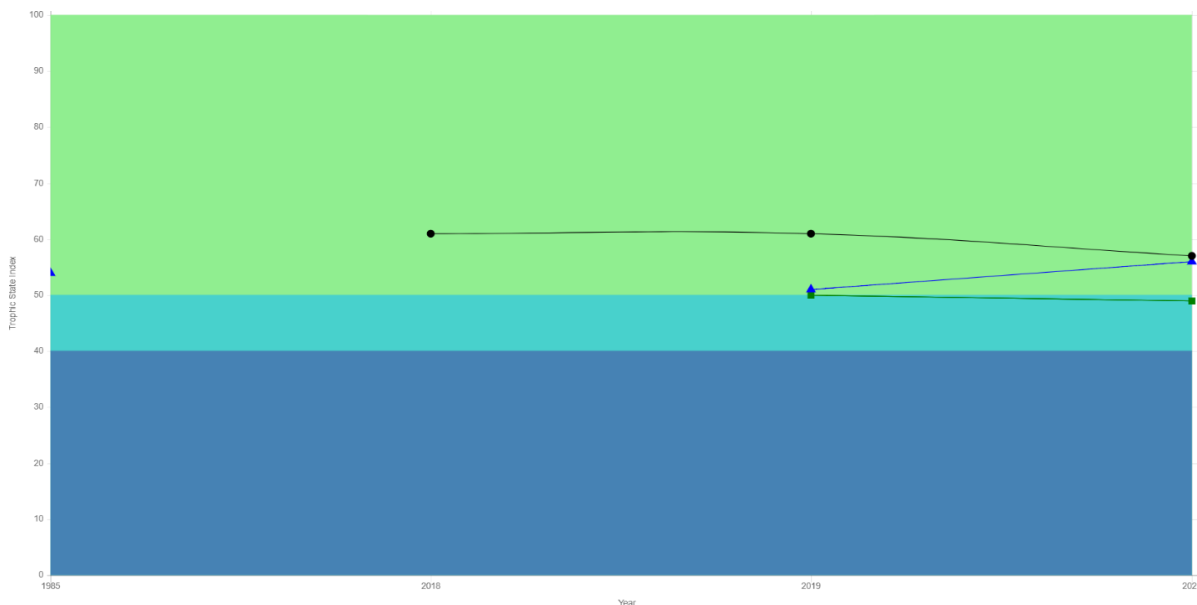
**Figure 11. Red Bass Lake Trophic State Index, 1985, 2018, 2019, and 2021.**

Trophic state is another indicator of water quality (Carlson, 1977). Lakes can be divided into three categories based on trophic state – oligotrophic, mesotrophic, and eutrophic. These categories reflect a lake’s nutrient and clarity levels (Shaw et al., 2004).

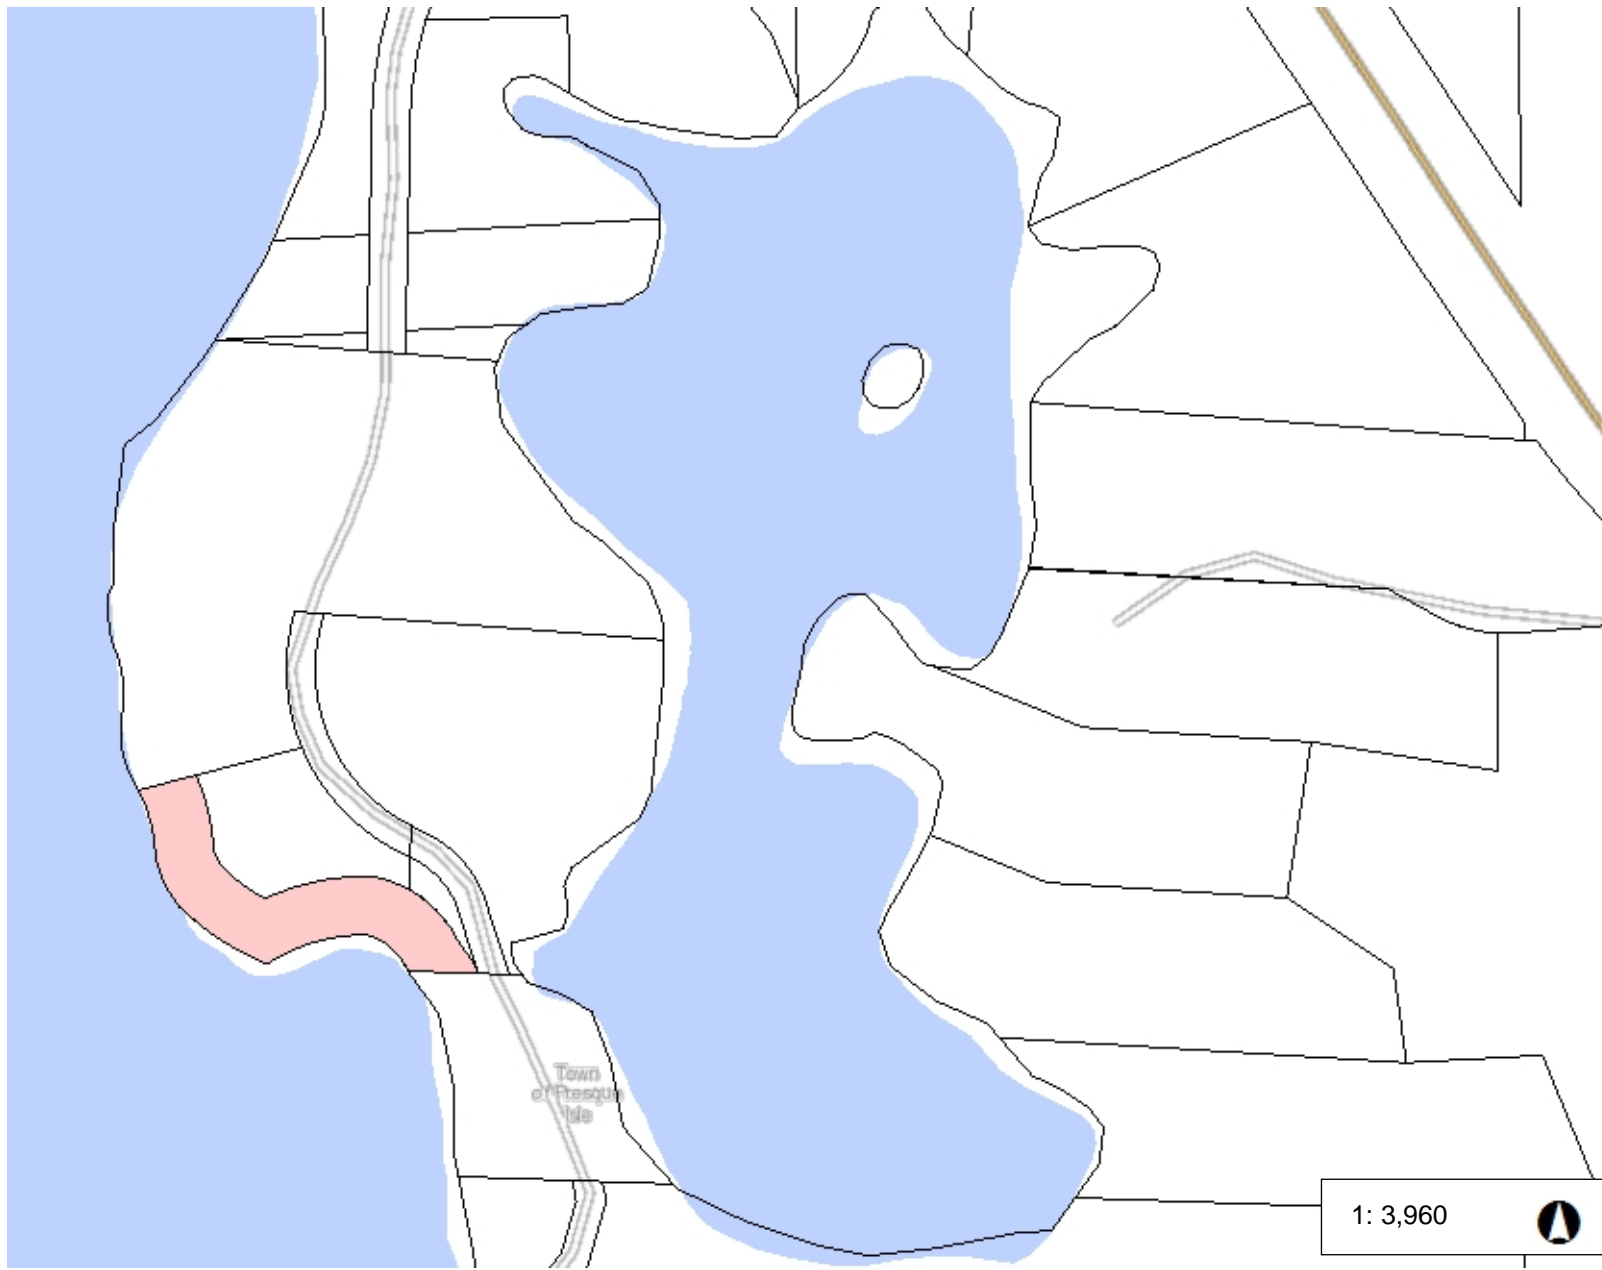
# Exhibit 9. Red Bass Lake Bank Erosion and Modifications - 2019

- Bank Erosion >1ft
- Bank Erosion <1ft
- Vertical Sea Wall**
  - 1 - 50 ft
  - 51 - 100 ft
  - 101 - 200 ft
  - 200 + ft
- Rip Rap**
  - 1 - 50 ft
  - 51 - 100 ft
  - 101 - 200 ft
  - 200+ ft
- Other Bank Modifications**
  - 10 - 50 ft
  - 51 - 100 ft
  - 101 - 200 ft
  - 200+ ft
- Artificial Beach**
  - 0 - 50 ft
  - 51 - 100 ft
  - 101 - 200 ft
  - 200+ ft
- Shoreland Parcels
- County Boundary
- Municipality
- State Boundaries

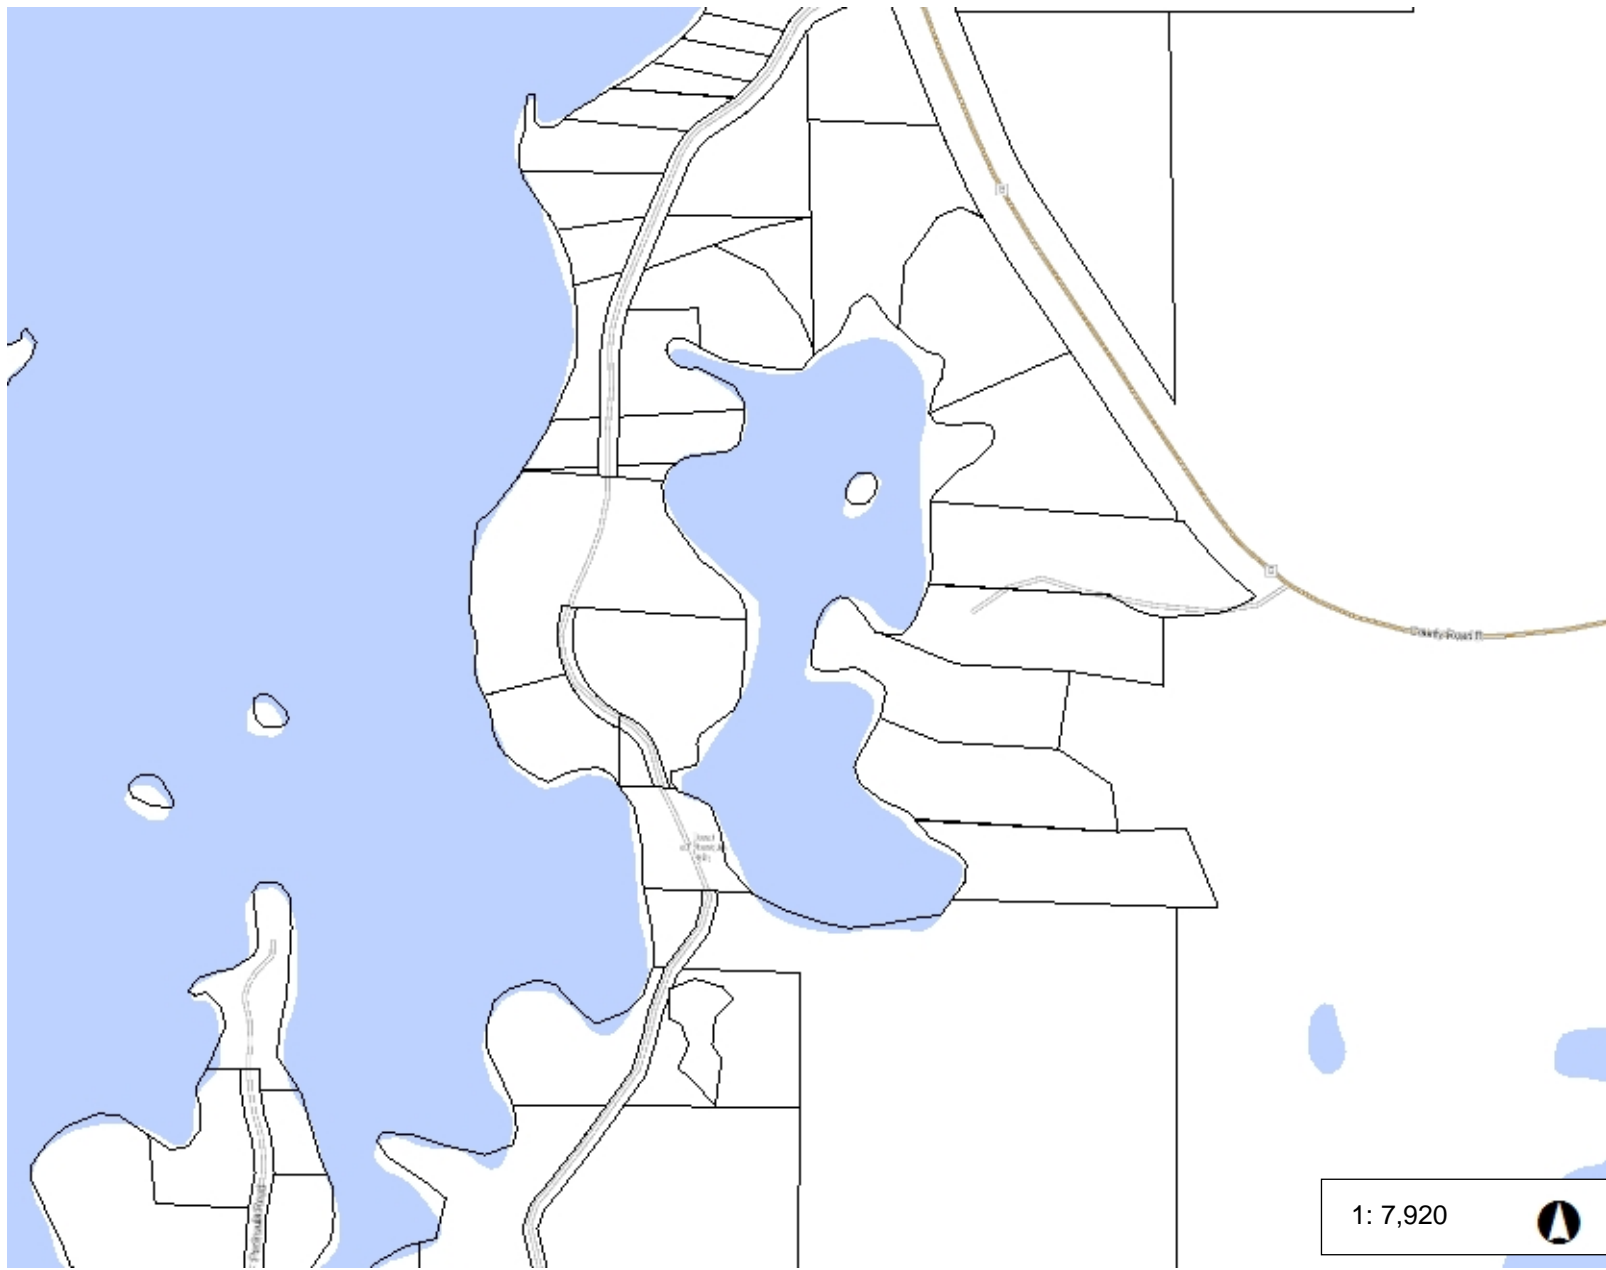
# Exhibit 10. Red Bass Lake Runoff Concerns - 2019

- Channelized Flow
- Point Source
- Shoreland Parcels
- County Boundary
- Municipality
- State Boundaries
- County Boundaries

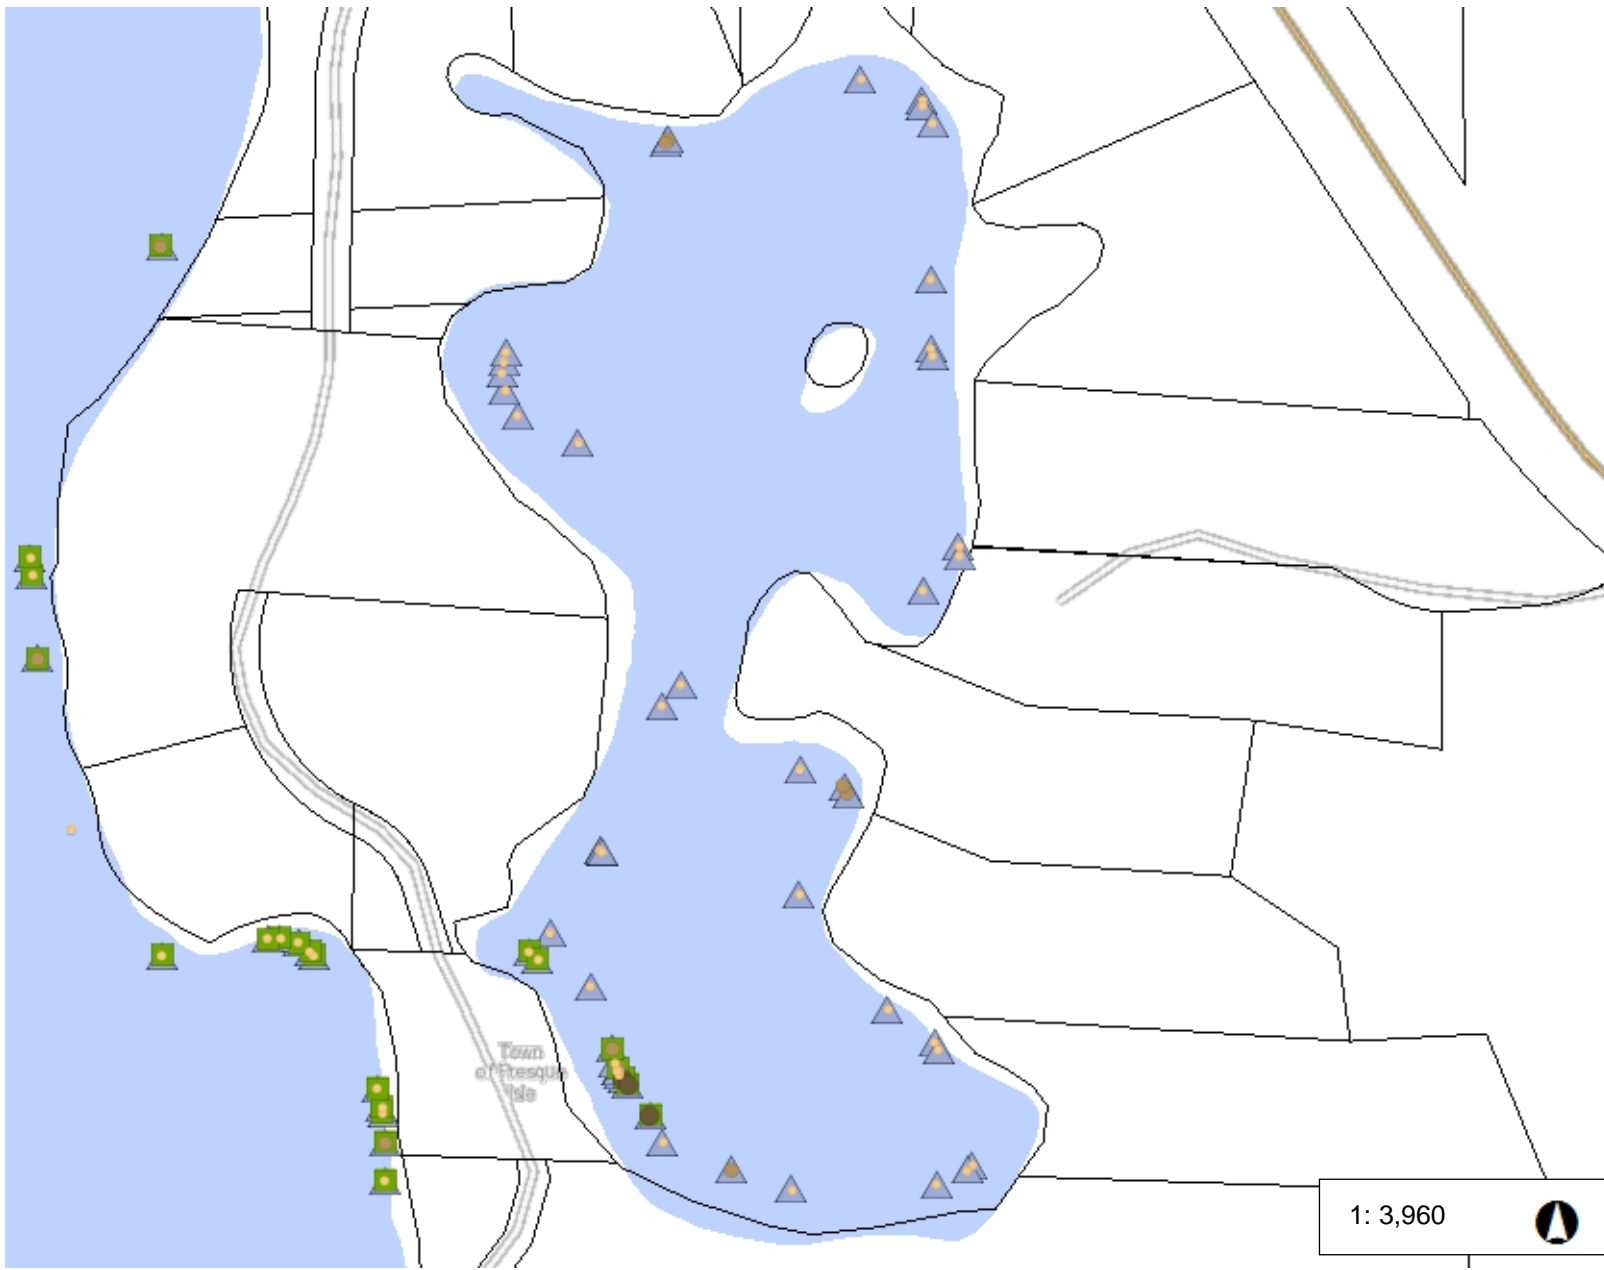
# Exhibit 13. Red Bass Lake Woody Habitat - 2019

- WH Branchiness**
  - No branches (orange circle)
  - Few branches (brown circle)
  - Full tree crown (dark brown circle)
- WH Touching Shore** (green square)
- WH In Water** (blue triangle)
- Shoreland Parcels (black outline)
- County Boundary (thin black line)
- Municipality (yellow outline)
- State Boundaries (dashed black line)
- County Boundaries (yellow outline)
- Major Roads**
  - Interstate Highway (thick orange line)
  - State Highway (orange line)
  - US Highway (red line)
- County and Local Roads**
  - County HWY (thin orange line)
  - Local Road (grey line)
- Railroads (black line with cross-ticks)
- Tribal Lands (tan shaded area)
- Rivers and Streams (blue line)
- Intermittent Streams (dashed blue line)
- Open Water (light blue fill)
- Great Lakes (medium blue fill)

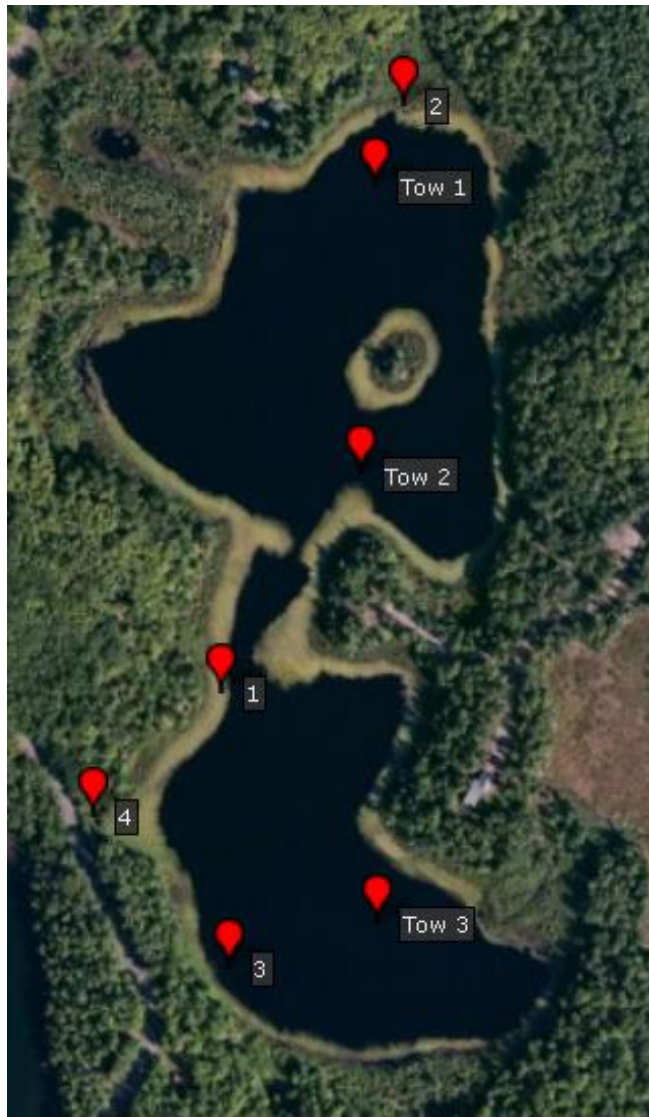
Exhibit 1. Red Bass Lake AIS survey sites 1-4 and locations of zooplankton tows.

There were no known AIS that were established in Red Bass Lake prior to this survey. During the survey there were no AIS found.
