Presque Isle Wilderness Waters Program

Aquatic Plant Management Plan – Van Vliet Lake

White Water Associates, Inc.
Dean Premo, Ph.D.
429 River Lane, P.O. Box 27
Amasa, Michigan 49903

Date: 2021

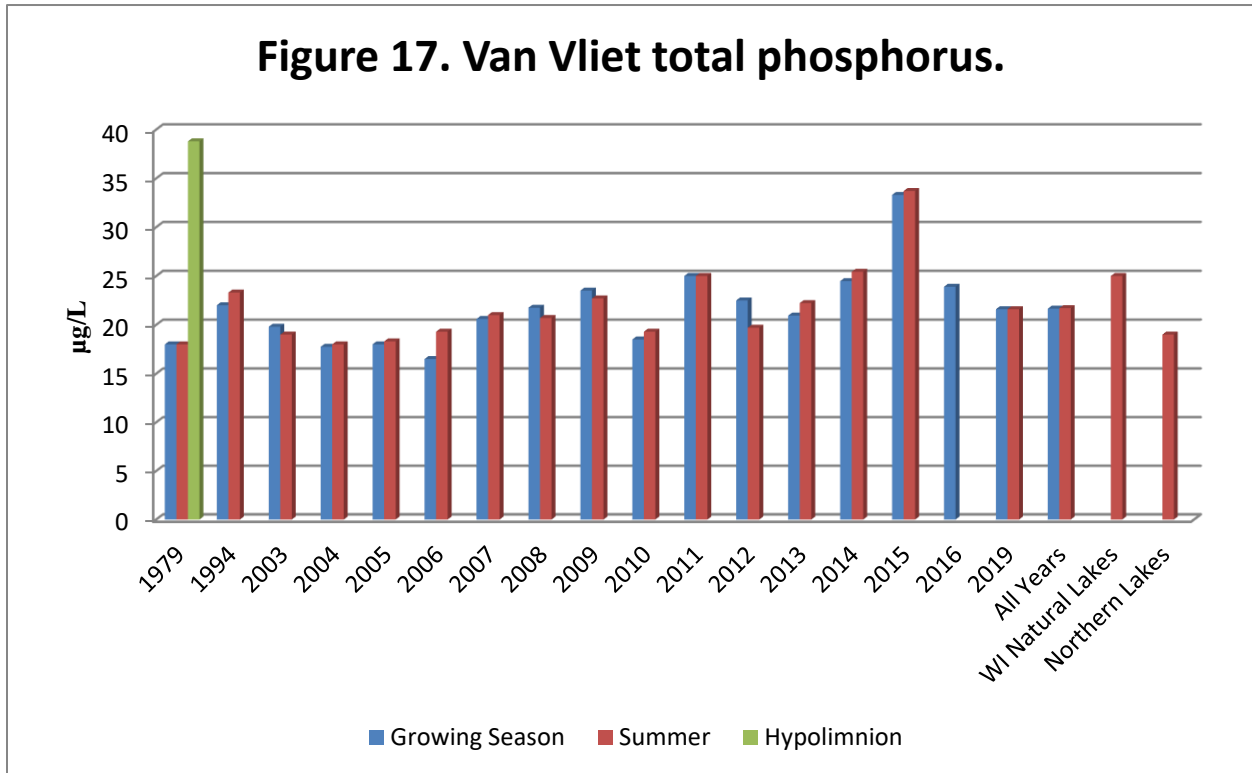
Van Vliet Lake total phosphorus fluctuated near the nuisance threshold of 20 µg/L in sampled years (Figure 17). Van Vliet’s average total phosphorus is 21.7 µg/L. According to Figure 18, Van Vliet Lake’s average total phosphorus is classified as “good.”
