Mississippi River Climate Change: Status, Challenges and Adaptations

EGAD # 3900-2023-02

Shawn Giblin, Sara Strassman, and Jeremy King
Wisconsin Department of Natural Resources
Office of Great Waters

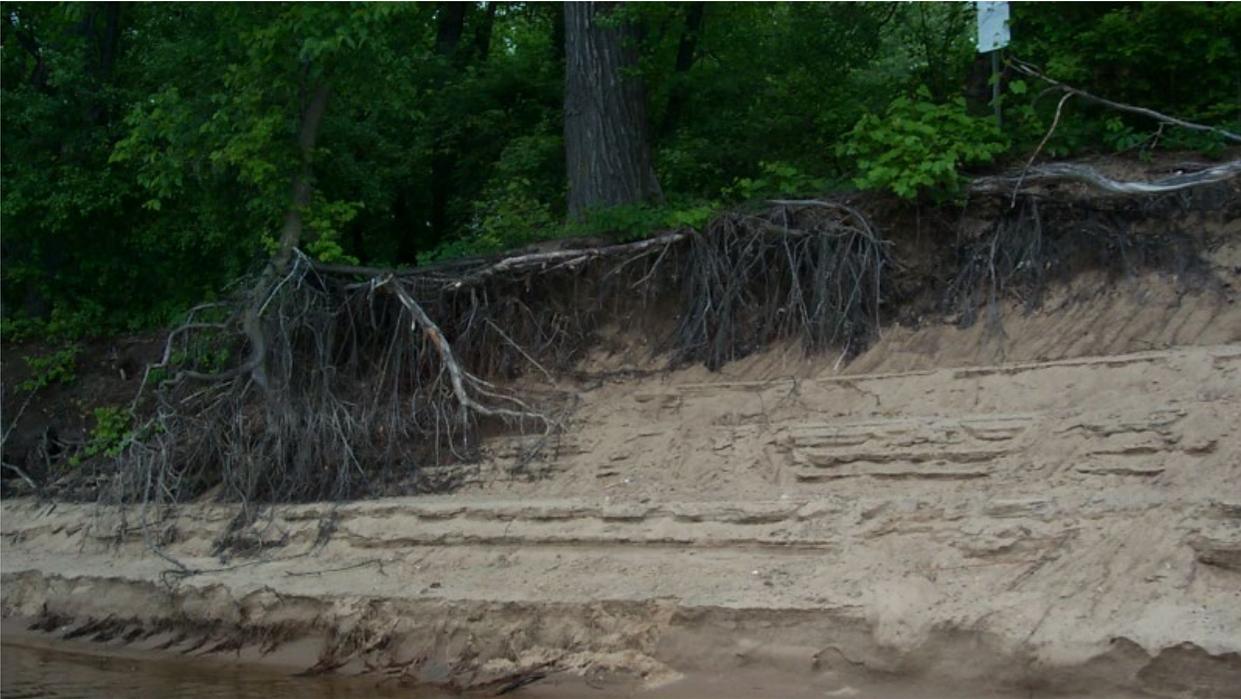
Figure 2: Mississippi River island exhibiting significant erosion as a result of increasing river discharge. Note the forest loss that is occurring as trees are about to fall into the river due to bank erosion.

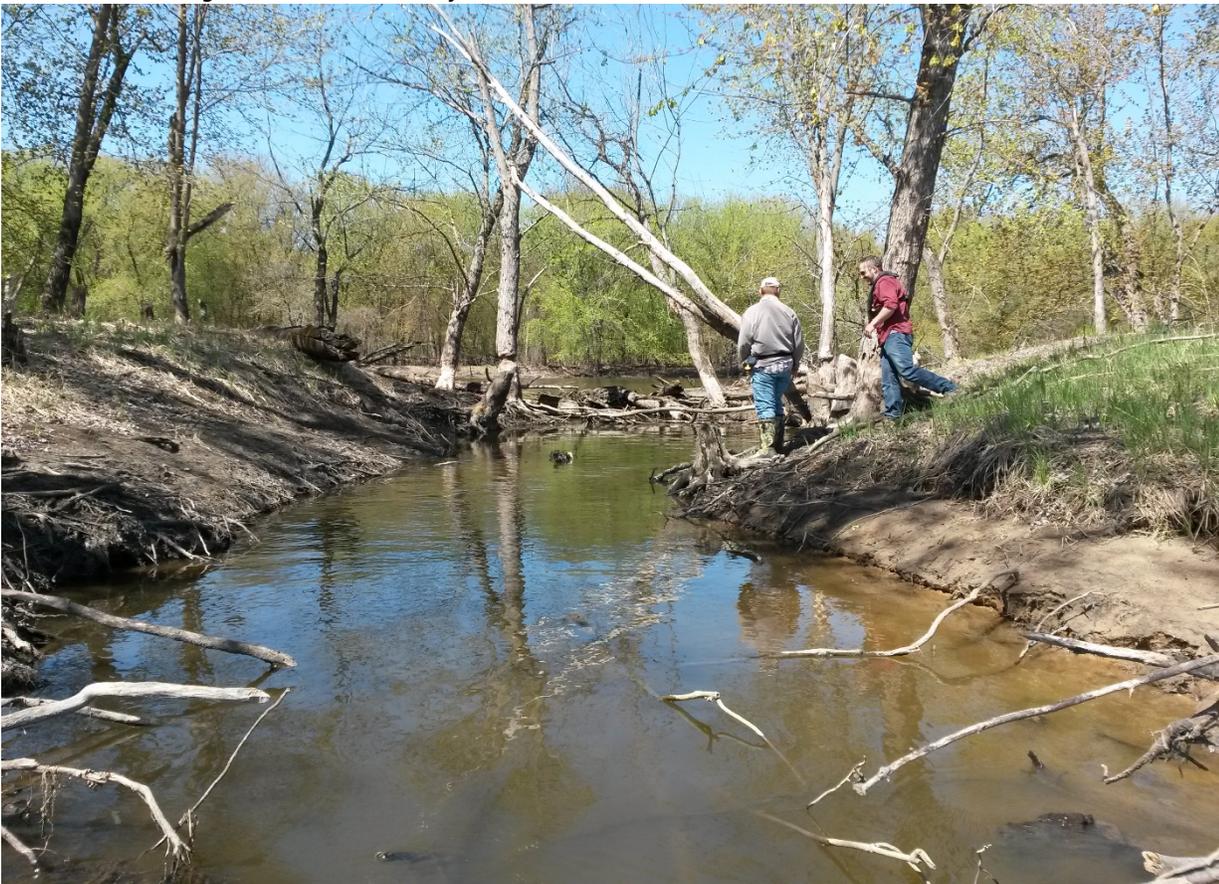
Figure 3: Natural levee breach on Mississippi River island as result of increasing river discharge and stage that has occurred over recent decades.

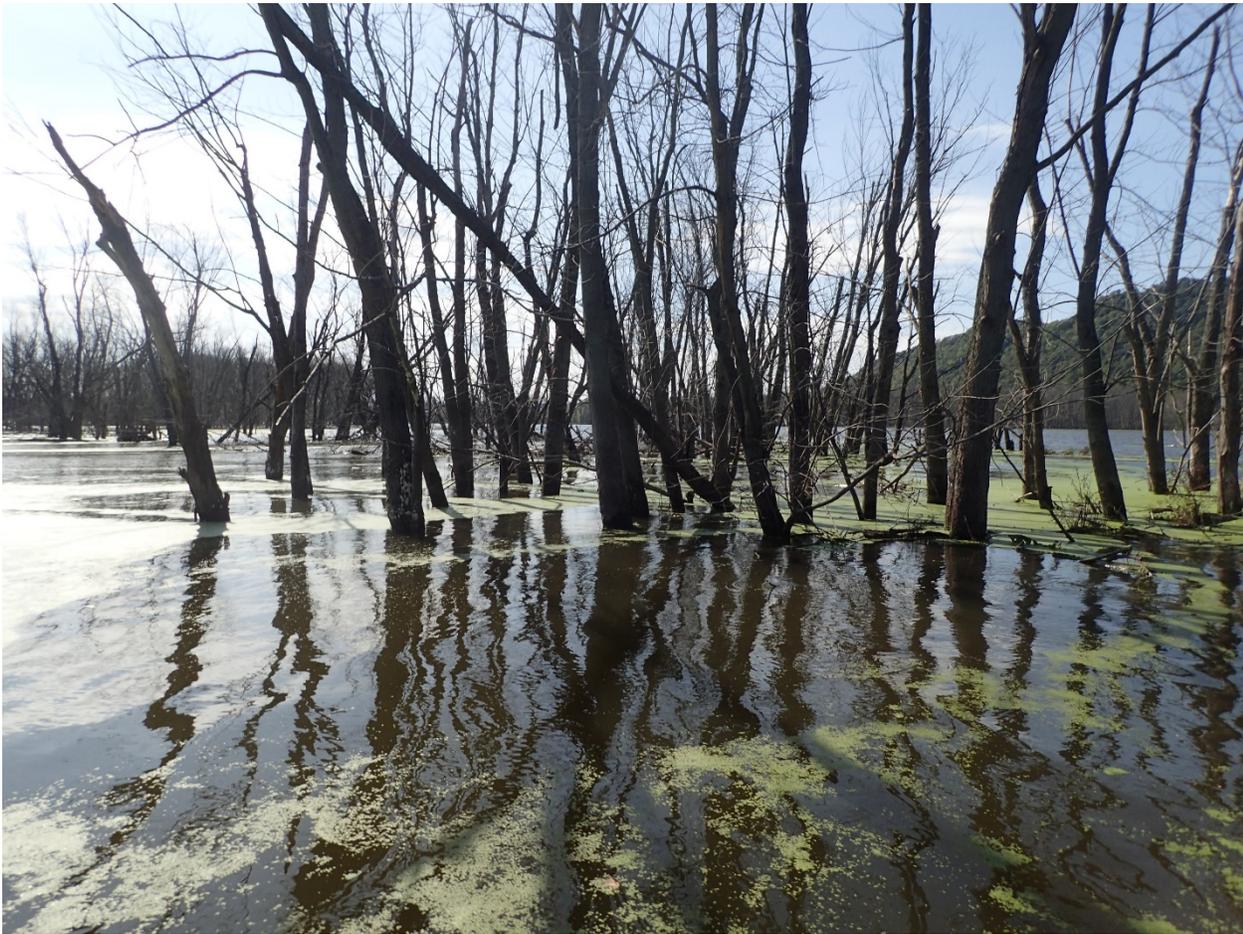
Figure 4: The loss of floodplain forest is a symptom of climate change. Extended periods of high river stage result in forest loss.

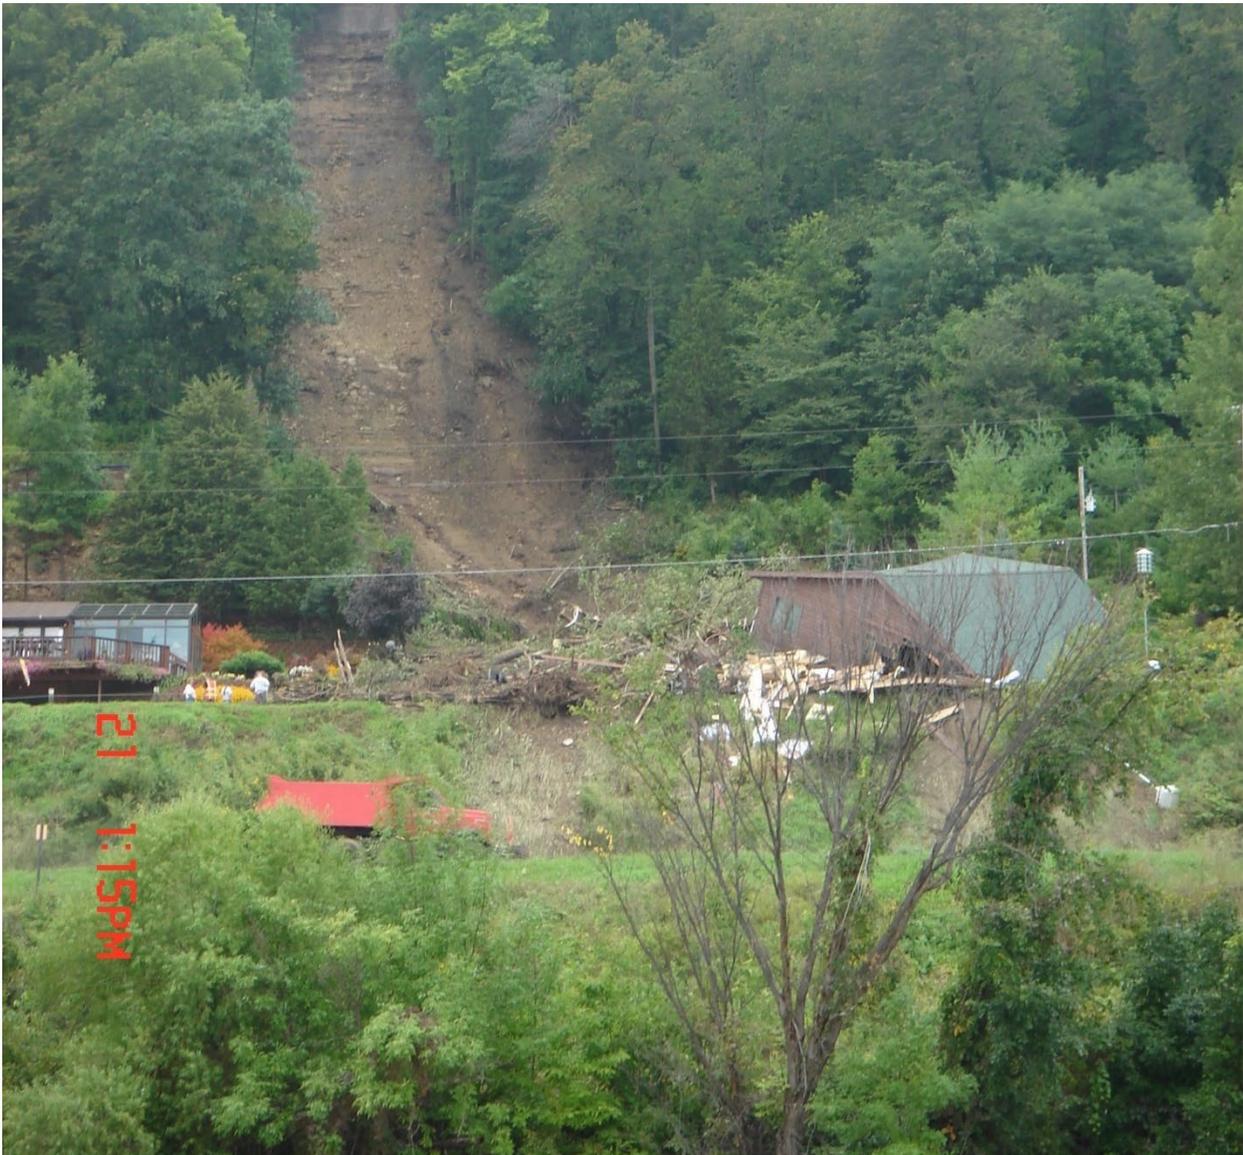
Figure 5: Mudslide to Mississippi River and consequent property loss. Fifteen inches of rainfall over a 24-hour period triggered the slide.

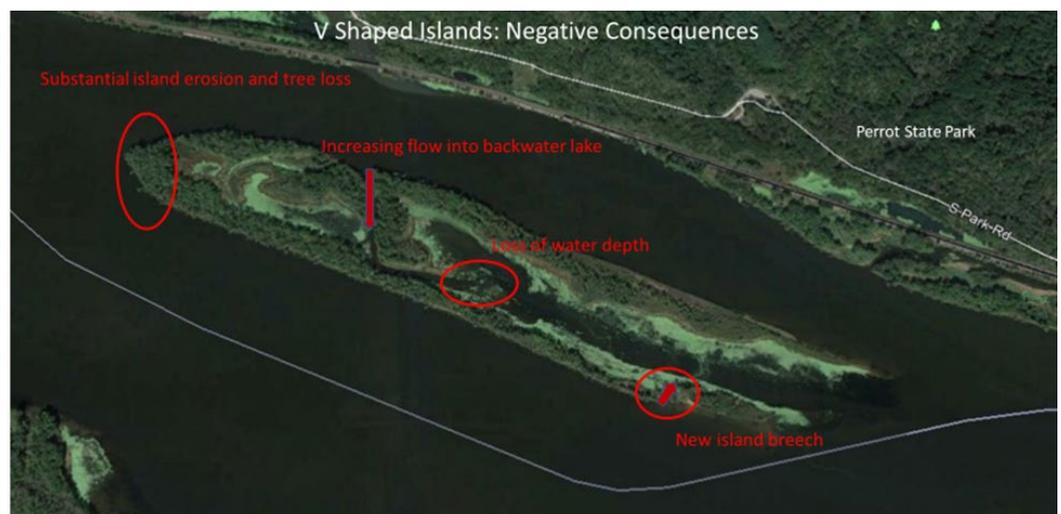
Figure 10: Negative ecosystem consequences observed in the Johnson Island Complex in Trempealeau County since 2015.

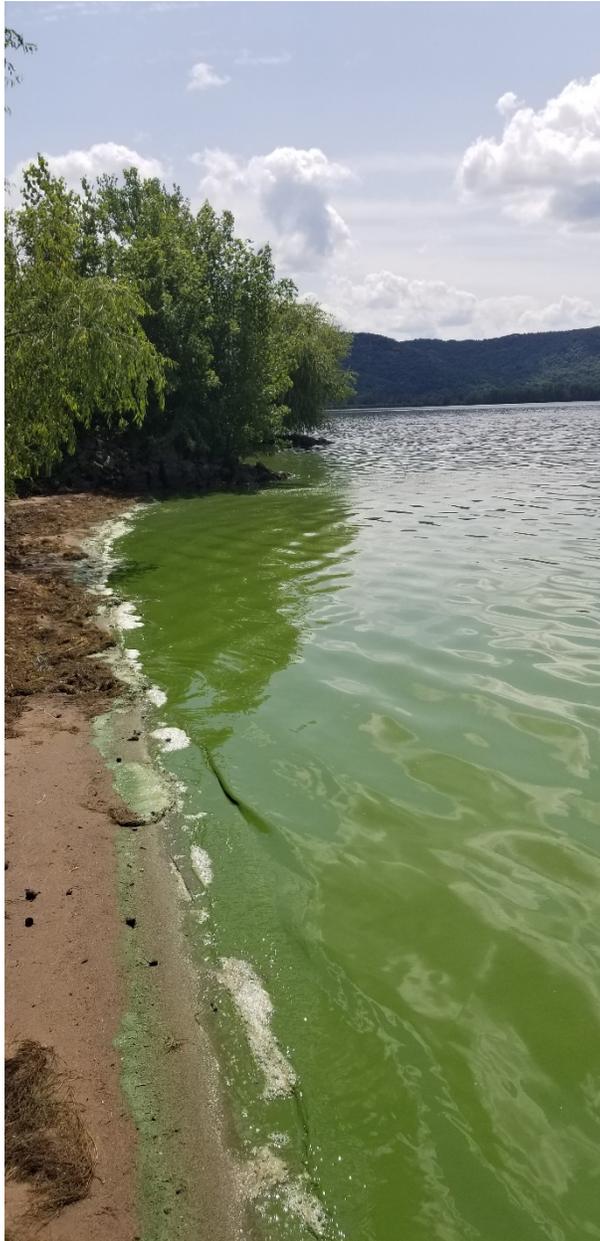
Figure 19: A summer cyanobacteria bloom within the Trempealeau National Wildlife Refuge.

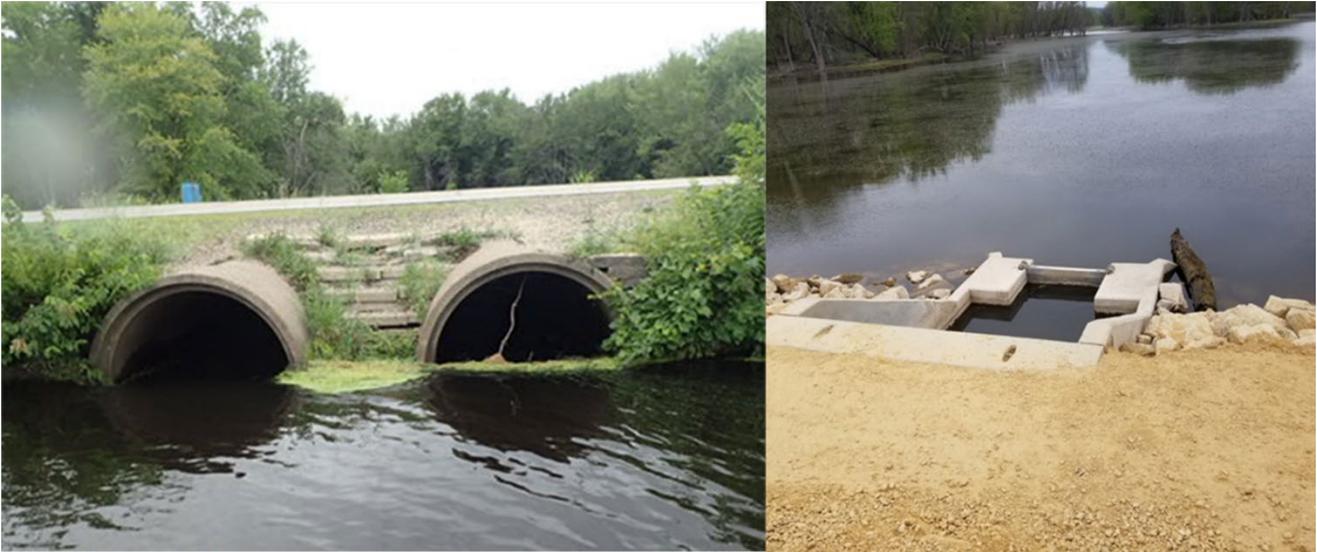
Figure 22: Photo on left shows uncontrolled culverts. Photo on right shows the climate adaptation design with water control via stoplogs up to river elevation of 632 feet. At water surface elevation greater than 632 feet, water is uncontrolled.

Infrastructure retrofits are another approach to adapt to changing climatic conditions and are exemplified on Wing Lake in La Crosse County. One such retrofit occurred during a construction project in La Crosse County. The water in Wing Lake was conveyed under County Highway GI through uncontrolled culverts for many years. The culverts were resulting in water quality problems. Under low river stage, the culverts would perch (conveying no flow through Wing Lake) and low oxygen conditions would rapidly develop. Under high discharge winters, high volume of cold, channel water was conveyed through Wing Lake resulting in water too cold for overwintering organisms. The solution was to replace the uncontrolled culverts with a water control structure that would regulate winter flow rates while still allowing for increased flood conveyance. This was achieved by designing a control structure with stoplogs that would allow for flow control during even very high winter discharge (Figure 22). This system is now being managed with the slotted stoplog method which has improved water quality during multiple seasons with minimal stoplog modifications (Figures 23-24). Solutions such as this require incorporating the input and expertise of biologists, hydrologists and water quality experts to develop optimal conditions for natural resources that are altered by infrastructure. As climate drives an increase in storm intensity and frequency, there will continue to be infrastructure damages that offer opportunities for upgrading infrastructure to be more resilient to future conditions. Ensuring good communications between the grey and the green infrastructure experts will optimize investments.

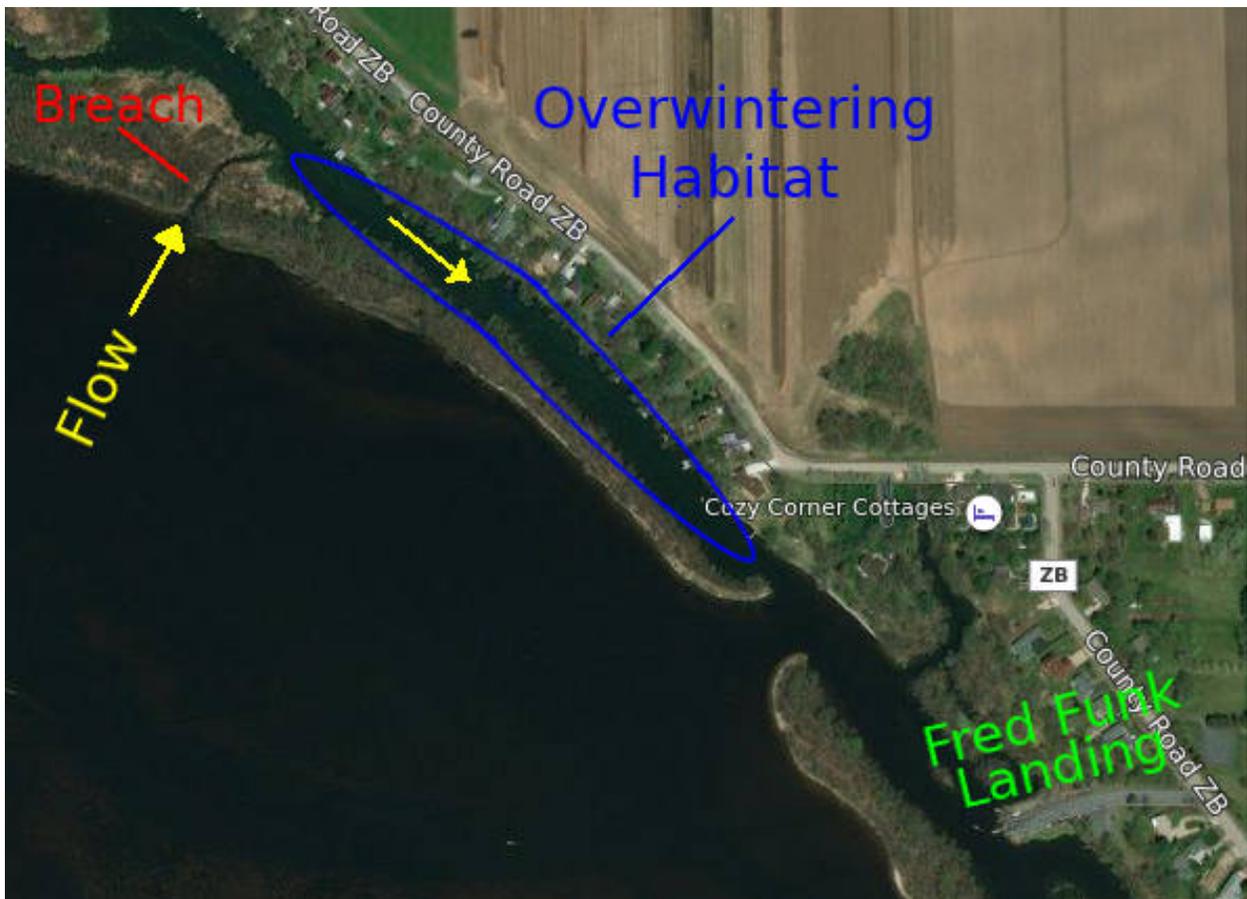
Figure 25: Location of the Blackdeer Channel levee breach upstream of a critical overwintering area in Lake Onalaska.

The Mississippi River has a rich history of community engagement, advocacy and stewardship of its recreational and ecological assets. One community-led, low-cost climate adaptation example occurred in Blackdeer Channel in Lake Onalaska. A floodplain island breach upstream of a critical fish overwintering area opened up during recent high discharge years (Figure 25). Water quality and fish habitat declined with the influx of cold, low oxygen water into the complex. WI DNR coordinated with the Fish and Wildlife Service and the Brice Prairie Conservation Association to

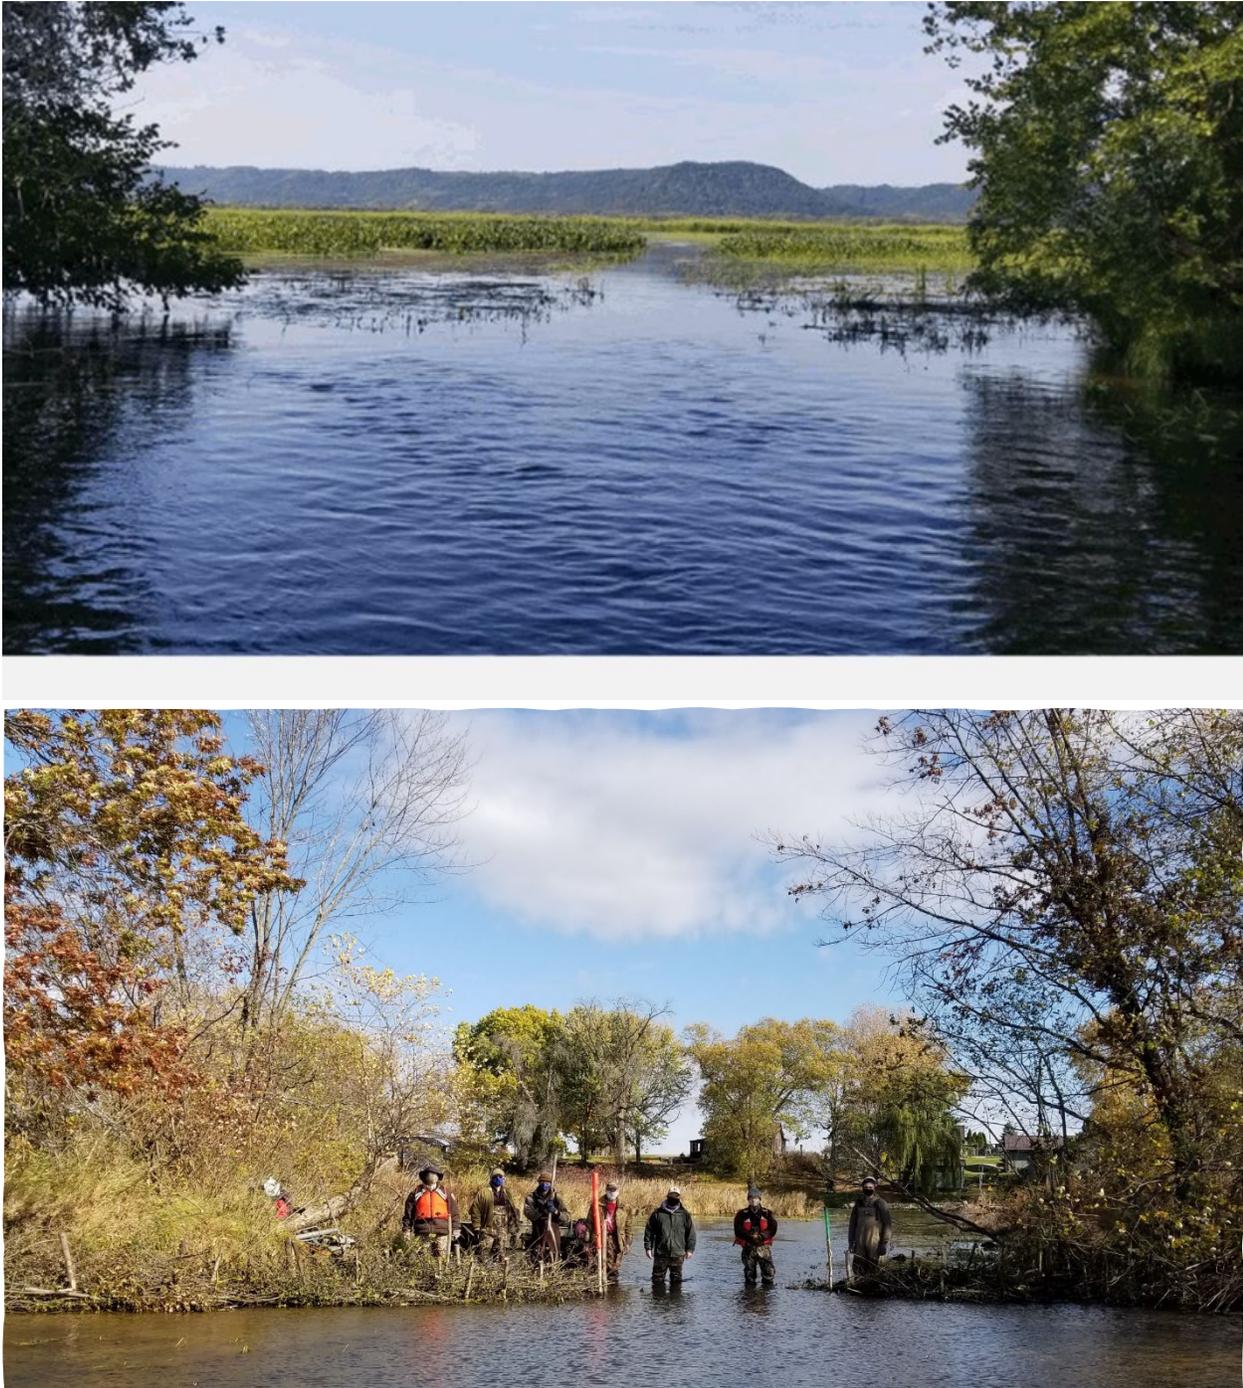
Figure 26: Top panel: Levee breach prior to buckthorn bundling project. Bottom panel: Post-project breach reduction using the buckthorn brush bundling technique.

improve winter habitat conditions. A local project to control invasive buckthorn was utilized to implement a solution. The invasive buckthorn was cut and constructed into brush bundles, which were staked in the breach opening to limit the influx of cold, low oxygen water into the overwintering site (Figure 26). Post-project monitoring documented warmer water with adequate dissolved oxygen during the winter months. Further refinements are planned for 2021 and beyond. This project represents a creative ecosystem improvement solution that provides dual benefits for invasive species control and aquatic water quality improvement that was implemented at very low-cost utilizing citizen leadership for project implementation.
