# **Bony Lake Critical Habitat Designation Report**

*Bayfield County, WI*

April 2013

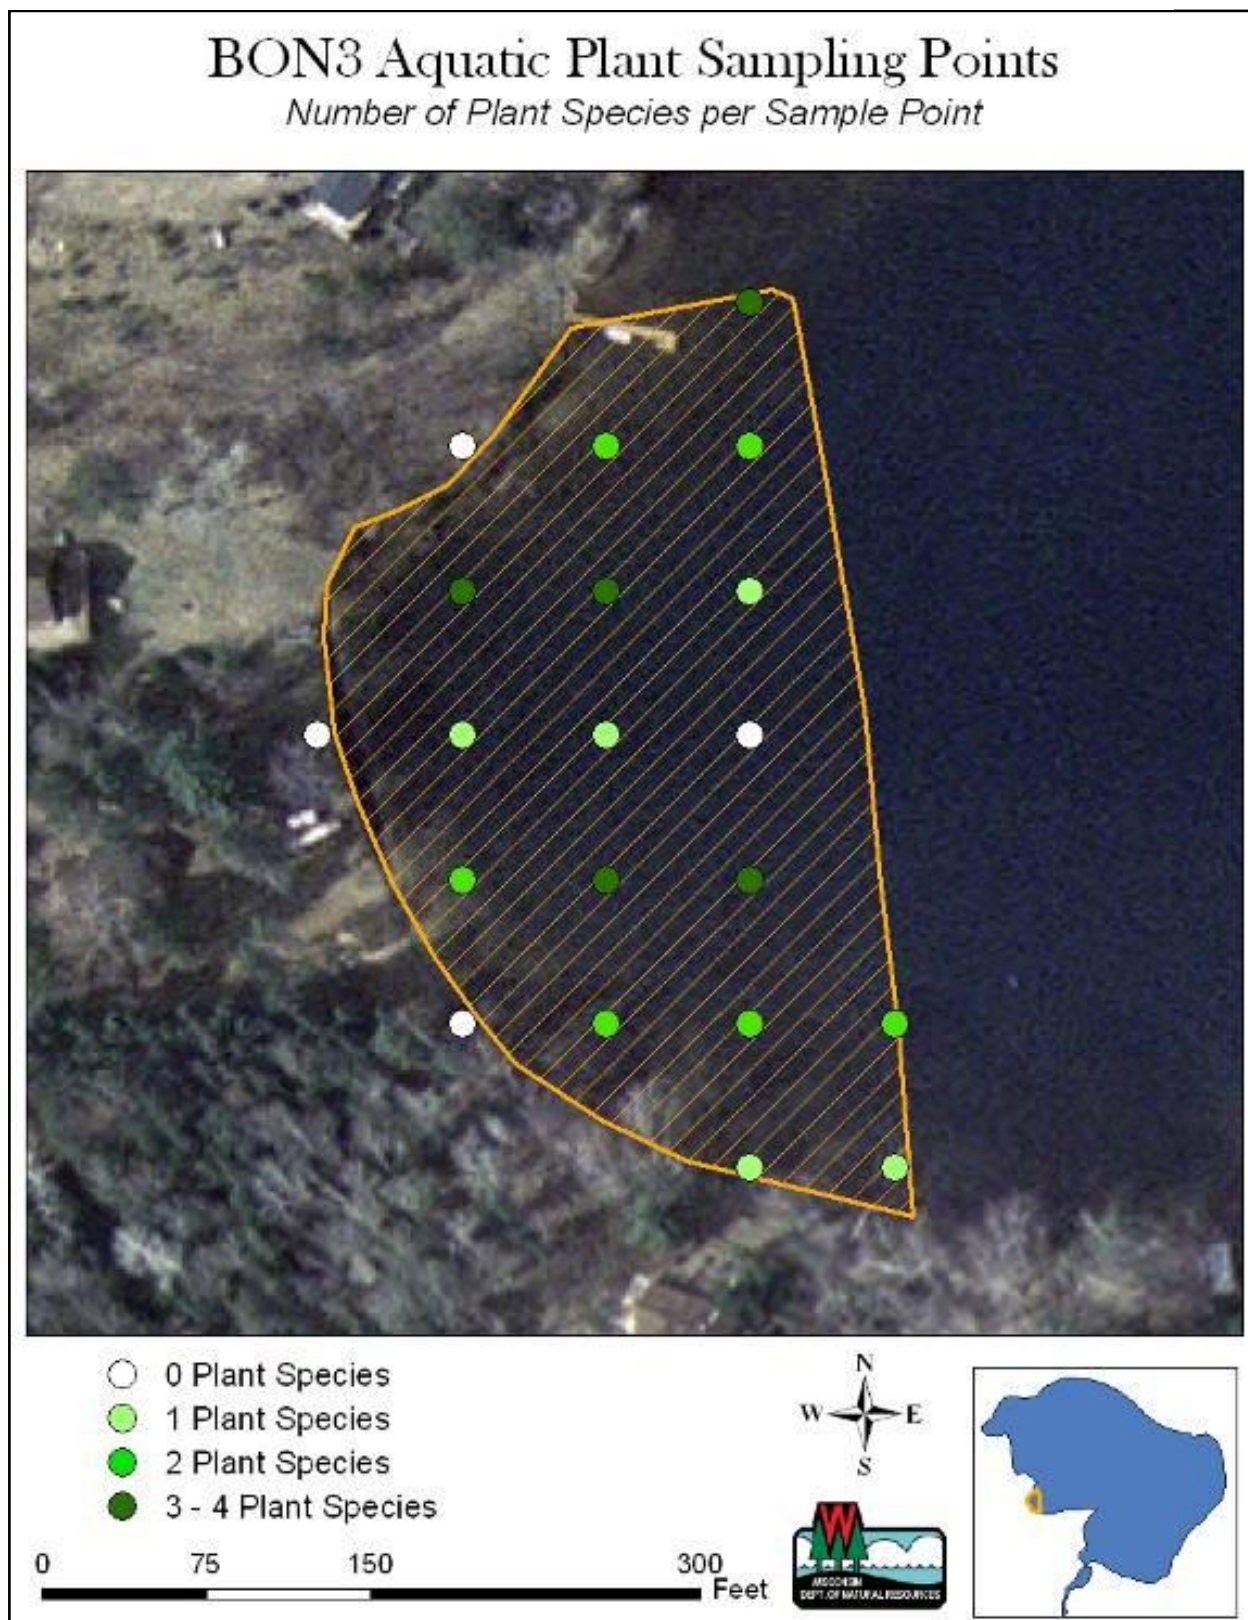
Figure 9. BON3 Aquatic Plant Diversity Map

Critical Habitat site BON3 was designated a Sensitive Area for its Emergent and Floating Leaf Vegetation and its Bio-Diverse Submerged Aquatic Vegetation. It is 1.8 acres in size and is located in a bay on the West side of Bony Lake.

Scientific Name	Common Name	Plant Type	FQI Coefficient	Relative Frequency
<i>Nuphar variegata</i>	Spatterdock	Floating Leaf	6	3.1
<i>Nymphaea odorata</i>	White water lily	Floating Leaf	6	6.3
<i>Polygonum amphibium</i>	Water smartweed	Floating Leaf	5	6.3
<i>Ceratophyllum demersum</i>	Coontail	Submergent	3	3.1
<i>Chara</i>	Muskgrasses	Submergent	7	21.9
<i>Elatine minima</i>	Waterwort	Submergent	9	Visual
<i>Eleocharis acicularis</i>	Needle spikerush	Submergent	5	6.3
<i>Najas flexilis</i>	Bushy pondweed	Submergent	6	25
<i>Potamogeton zosteriformis</i>	Flat-stem pondweed	Submergent	6	6.3
<i>Vallisneria americana</i>	Wild celery	Submergent	6	21.9

SUMMARY STATISTICS	BON3
Total number of points sampled	20
Total number of sites with vegetation	16
Total number of sites shallower than maximum depth of plants	19
Frequency of occurrence at sites shallower than maximum depth of plants	84.21
Simpson Diversity Index	0.82
Maximum depth of plants (Feet)	16.5
Number of sites sampled using rake on Rope (R)	0
Number of sites sampled using rake on Pole (P)	20
Average number of all species per site (shallower than max depth)	1.68
Average number of all species per site (veg. sites only)	2.00
Average number of native species per site (shallower than max depth)	1.68
Average number of native species per site (veg. sites only)	2.00
Species Richness	9
Species Richness (including visuals)	10
Floristic Quality Index	18.70

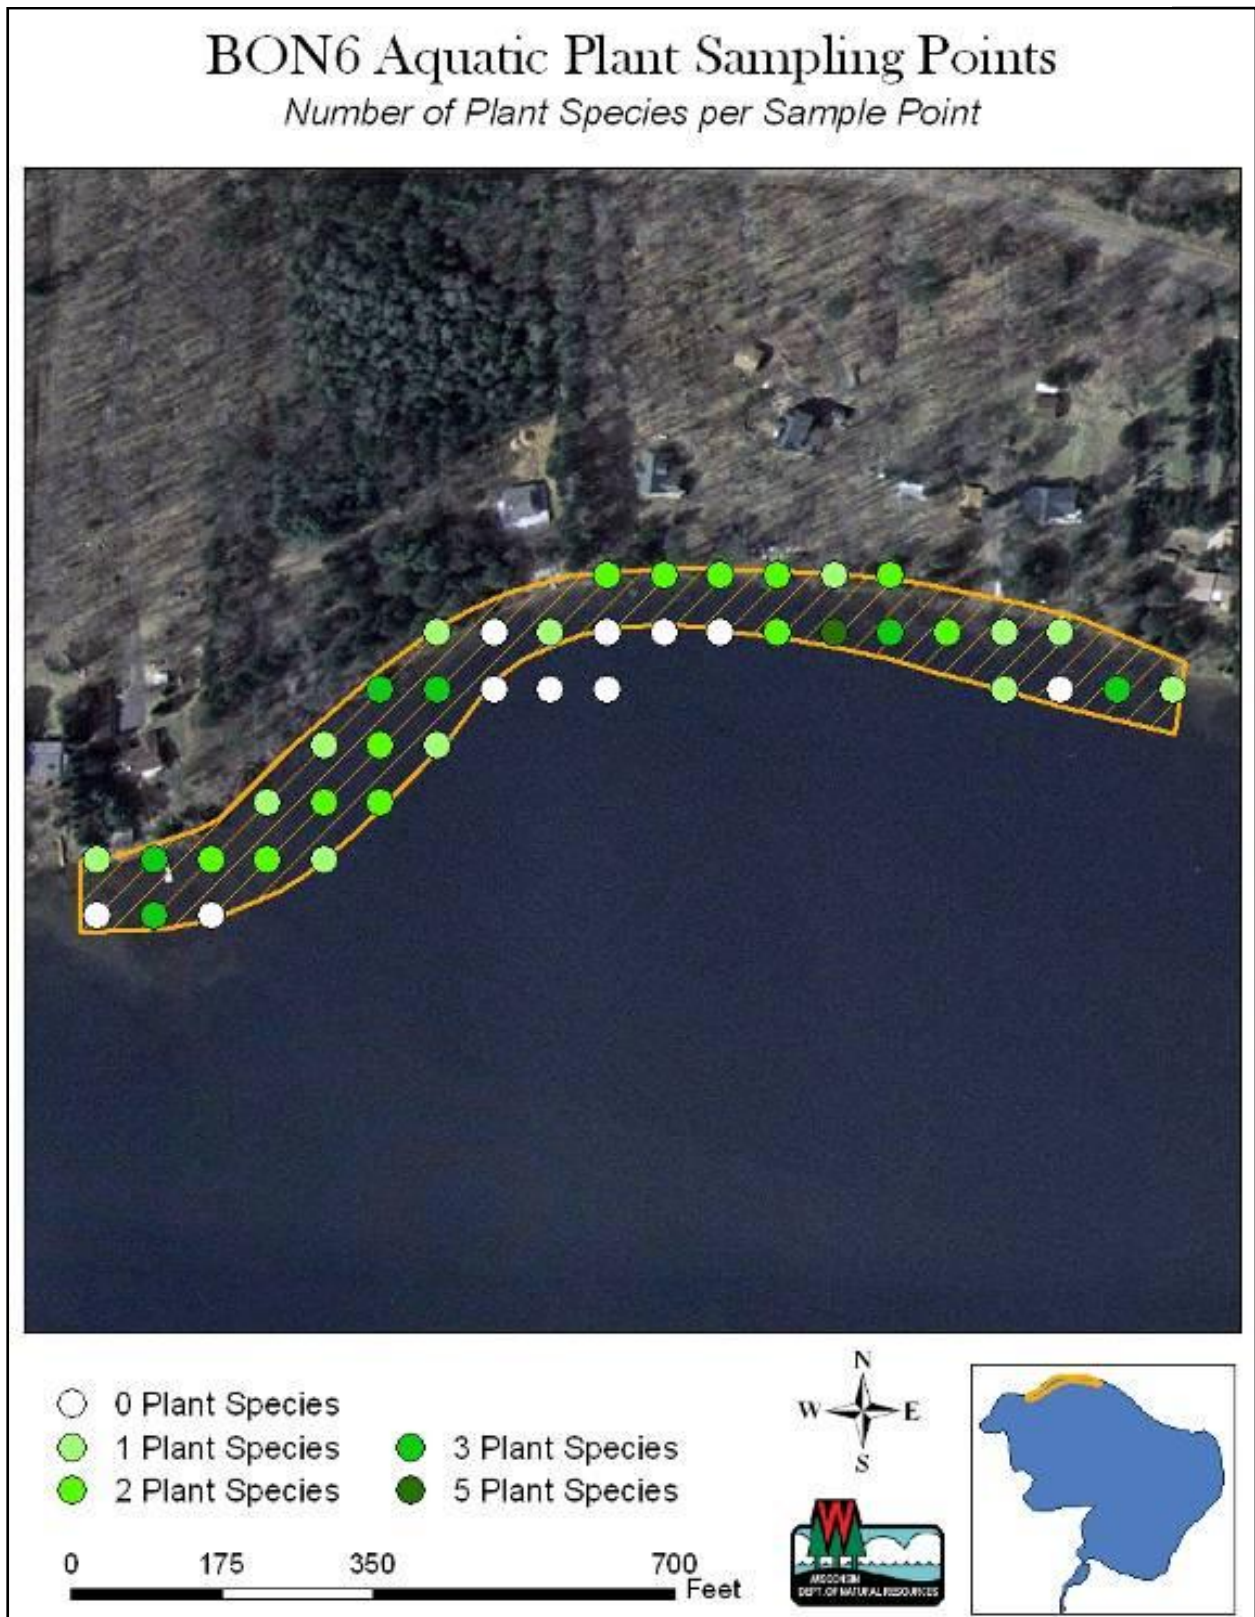
Figure 12. BON6 Aquatic Plant Diversity Map

Table 20. BON6 Aquatic Plant Sampling Summary Statistics	
<b>SUMMARY STATISTICS</b>	<b>BON6</b>
Total number of points sampled	41
Total number of sites with vegetation	27
Total number of sites shallower than maximum depth of plants	37
Frequency of occurrence at sites shallower than maximum depth of plants	72.97
Simpson Diversity Index	0.91
Maximum depth of plants (Feet)	16
Number of sites sampled using rake on Rope (R)	0
Number of sites sampled using rake on Pole (P)	0
Average number of all species per site (shallower than max depth)	1.41
Average number of all species per site (veg. sites only)	1.93
Average number of native species per site (shallower than max depth)	1.41
Average number of native species per site (veg. sites only)	1.93
Species Richness	18
Species Richness (including visuals)	18
Floristic Quality Index	26.40

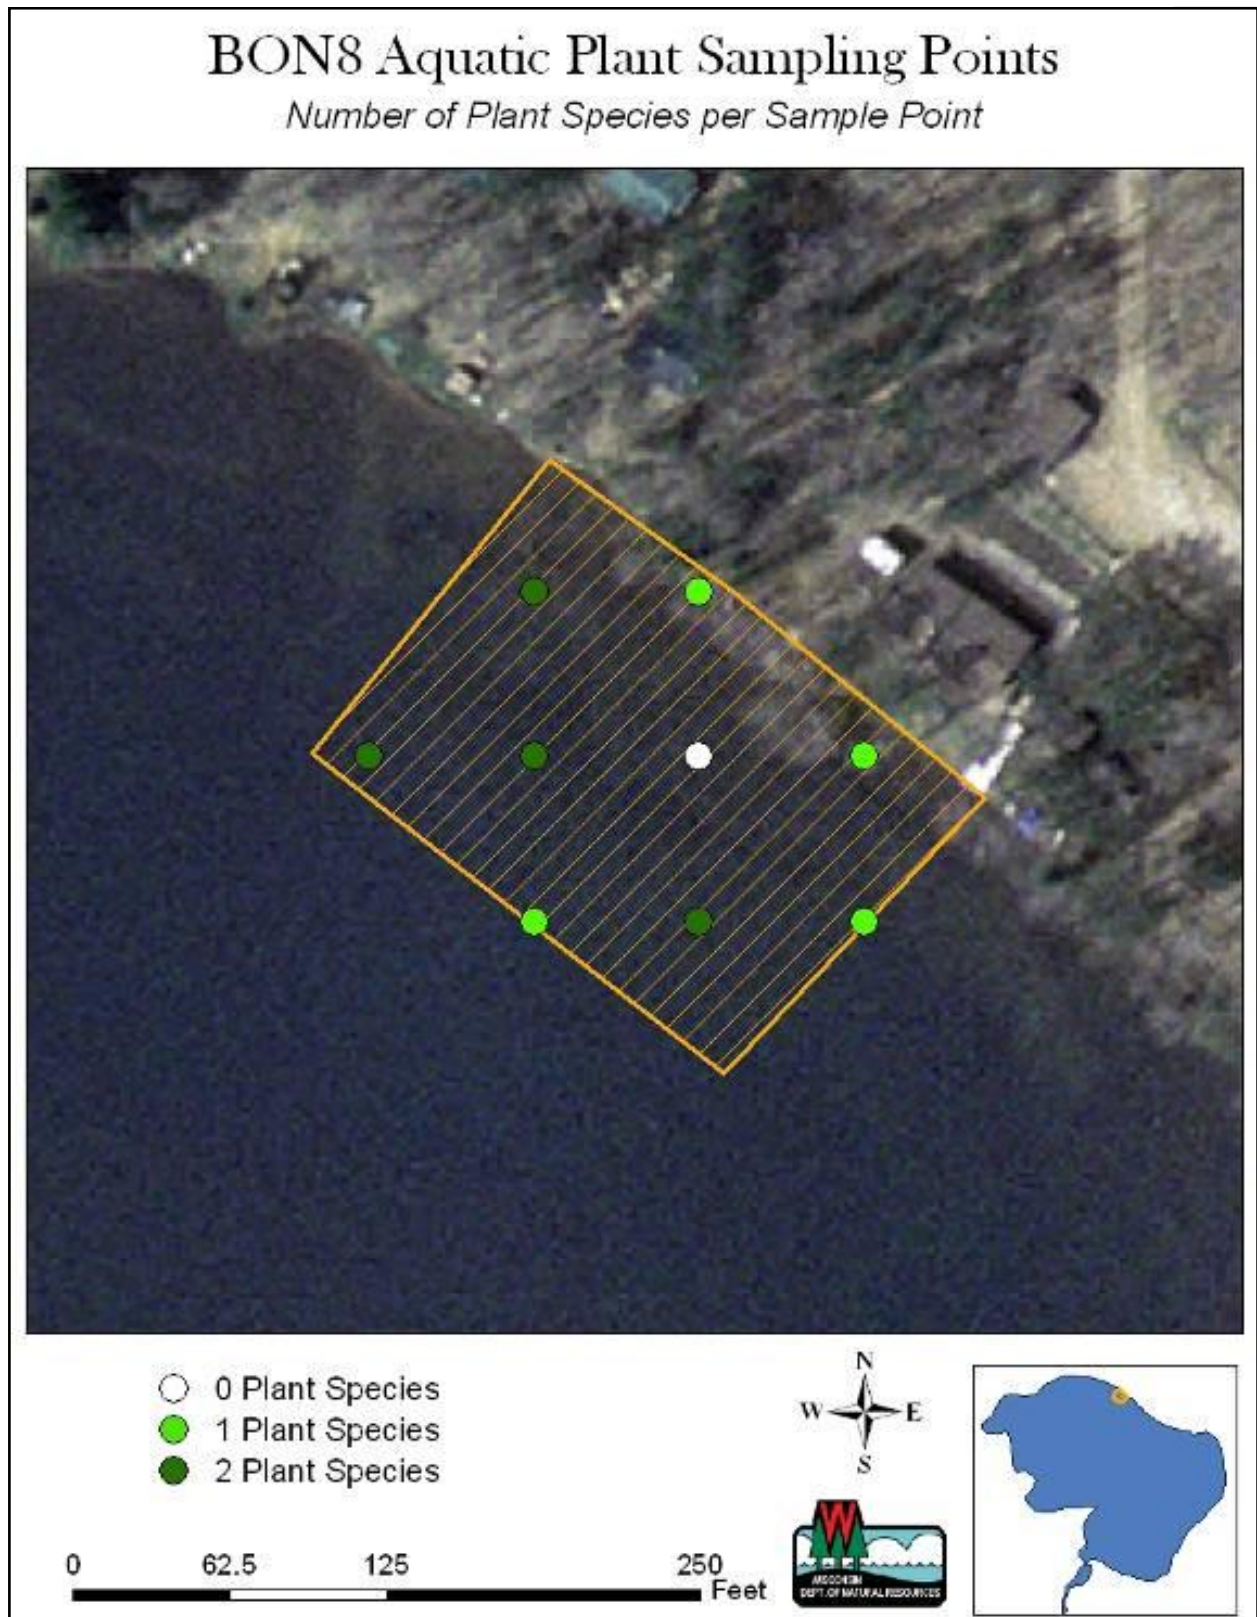
Figure 15. BON8 Aquatic Plant Diversity

SUMMARY STATISTICS	BON8
Total number of points sampled	9
Total number of sites with vegetation	8
Total number of sites shallower than maximum depth of plants	9
Frequency of occurrence at sites shallower than maximum depth of plants	88.89
Simpson Diversity Index	0.78
Maximum depth of plants (Feet)	8
Number of sites sampled using rake on Rope (R)	0
Number of sites sampled using rake on Pole (P)	9
Average number of all species per site (shallower than max depth)	1.33
Average number of all species per site (veg. sites only)	1.50
Average number of native species per site (shallower than max depth)	1.33
Average number of native species per site (veg. sites only)	1.50
Species Richness	6
Species Richness (including visuals)	6
Floristic Quality Index	15.50

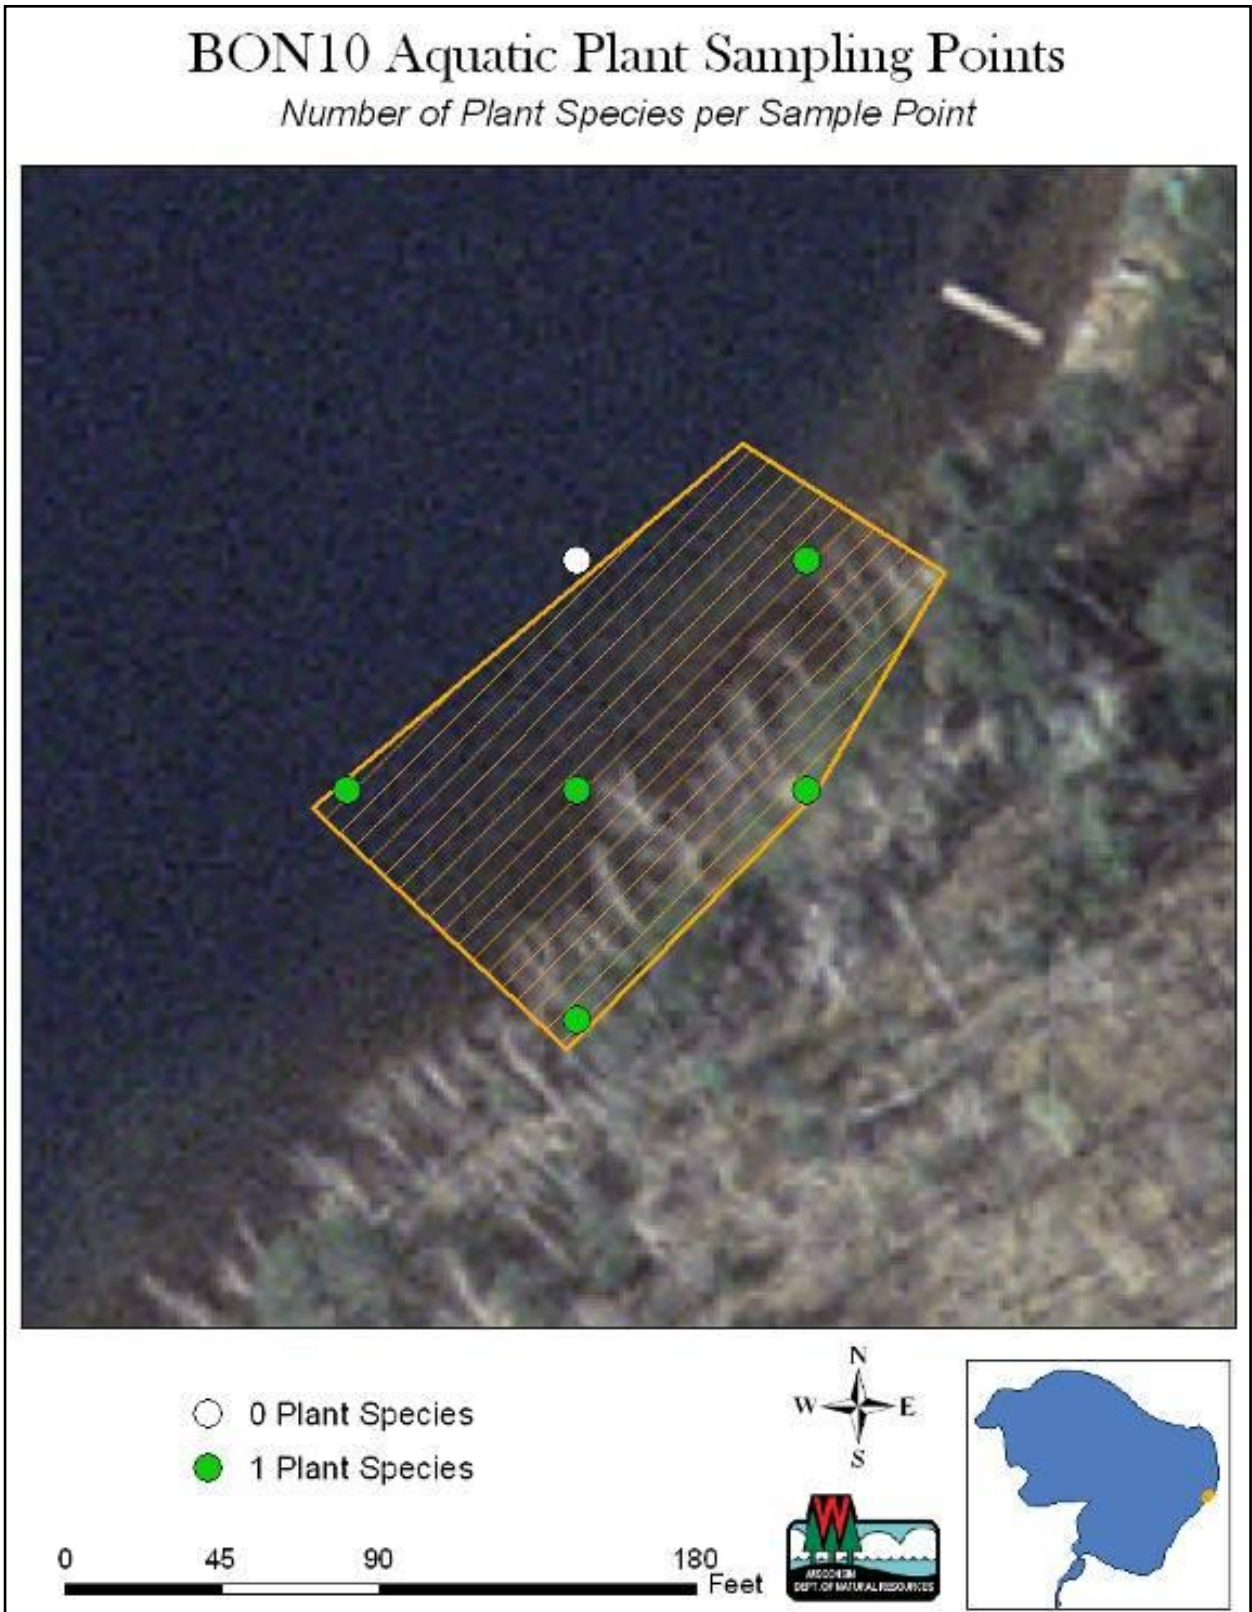
Figure 19. BON10 Aquatic Plant Diversity

SUMMARY STATISTICS	BON10
Total number of points sampled	6
Total number of sites with vegetation	5
Total number of sites shallower than maximum depth of plants	5
Frequency of occurrence at sites shallower than maximum depth of plants	100
Simpson Diversity Index	0.32
Maximum depth of plants (Feet)	8
Number of sites sampled using rake on Rope (R)	0
Number of sites sampled using rake on Pole (P)	6
Average number of all species per site (shallower than max depth)	1.00
Average number of all species per site (veg. sites only)	1.00
Average number of native species per site (shallower than max depth)	1.00
Average number of native species per site (veg. sites only)	1.00
Species Richness	2
Species Richness (including visuals)	2
Floristic Quality Index	7.10

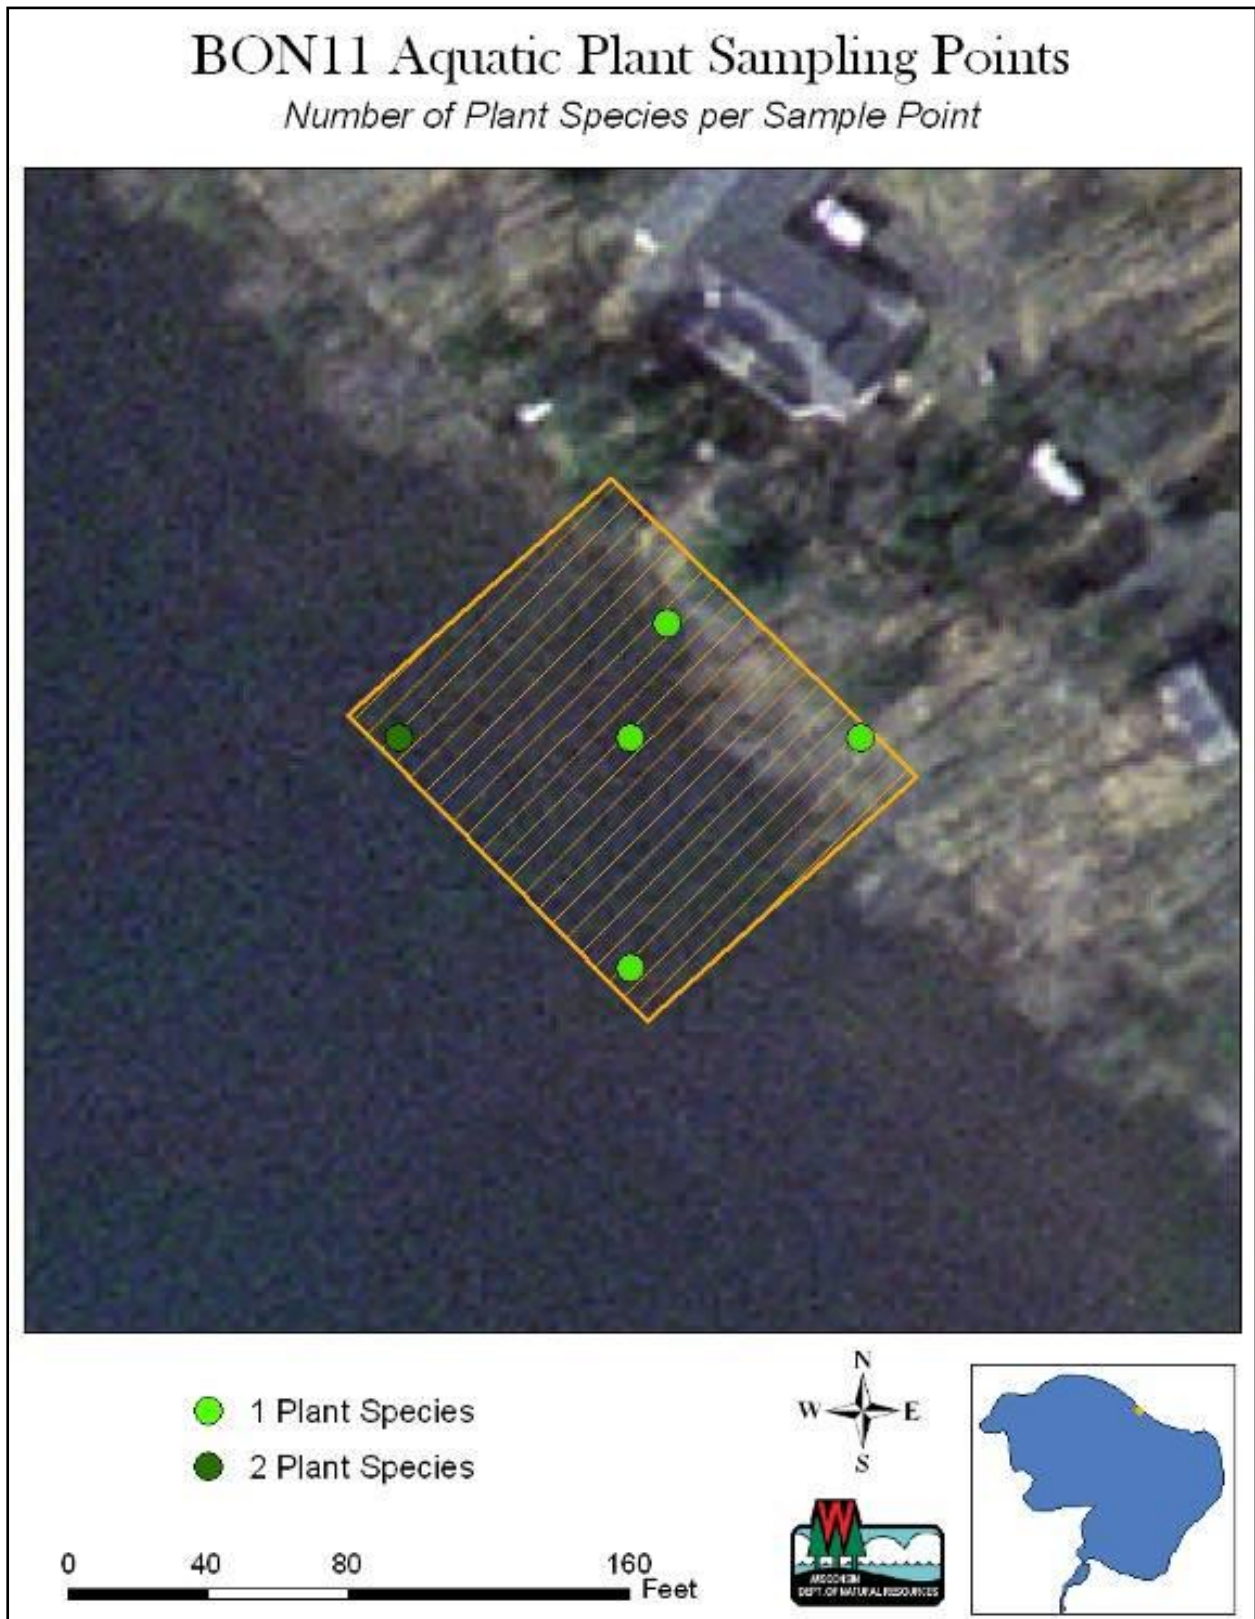
Figure 21. BON11 Aquatic Plant Diversity

SUMMARY STATISTICS	BON11
Total number of points sampled	5
Total number of sites with vegetation	3
Total number of sites shallower than maximum depth of plants	5
Frequency of occurrence at sites shallower than maximum depth of plants	60
Simpson Diversity Index	0.625
Maximum depth of plants (Feet)	3
Number of sites sampled using rake on Rope (R)	0
Number of sites sampled using rake on Pole (P)	5
Average number of all species per site (shallower than max depth)	0.80
Average number of all species per site (veg. sites only)	1.33
Average number of native species per site (shallower than max depth)	0.80
Average number of native species per site (veg. sites only)	1.33
Species Richness	3
Species Richness (including visuals)	3
Floristic Quality Index	11.00
