Random Lake Management Plan 2023

Sheboygan County, Wisconsin

Prepared by Aquatic Biologists, Inc. Fond du Lac, WI

5/26/2023

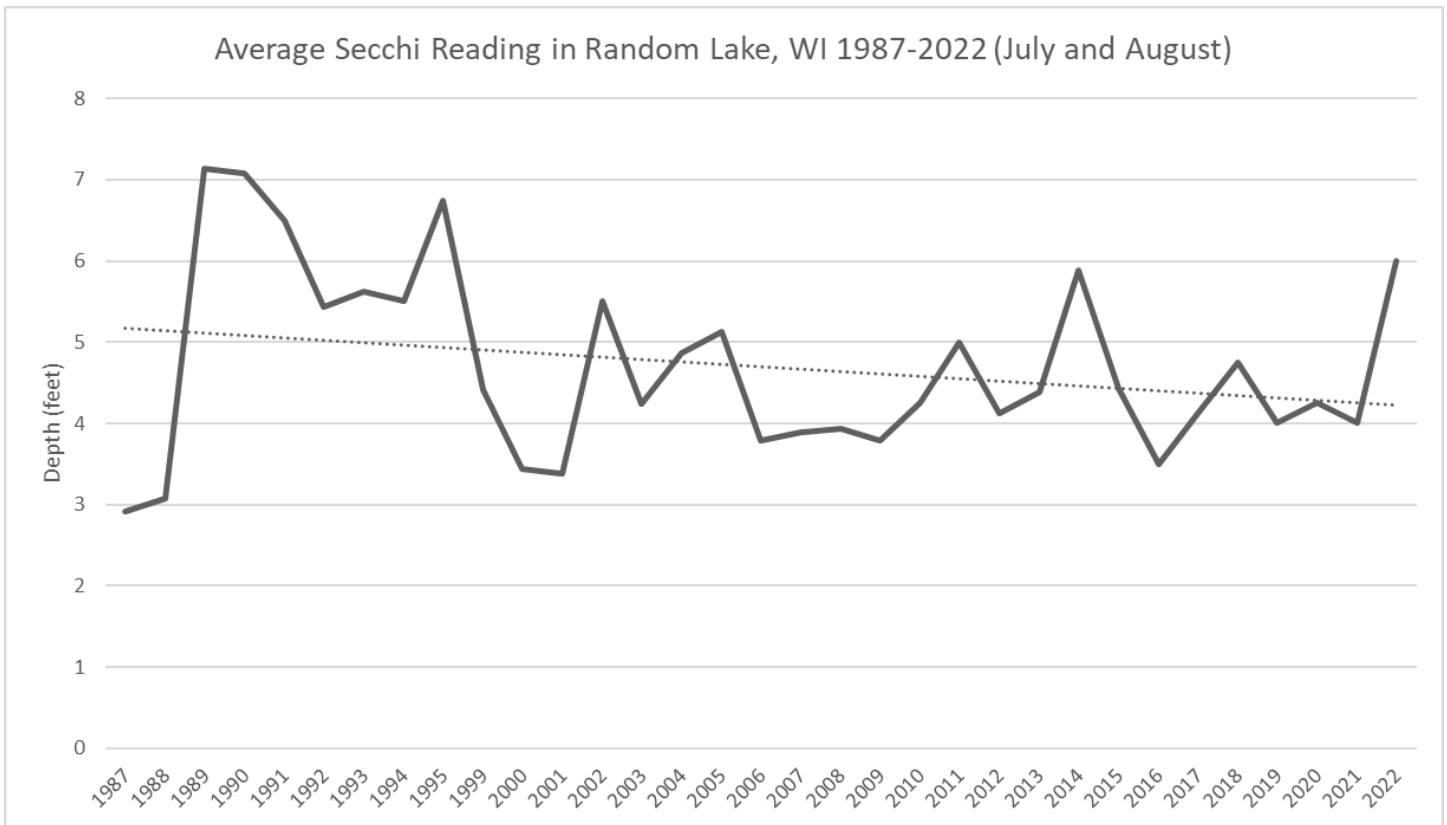
Secchi depth has trended downwards on average during July and August from 1987 until 2022. Comments from the volunteers conducting the lake monitoring, most often marked the color of the lake as “green.” This decrease in water clarity is probably a combination of many factors. As development in the watershed increases, runoff and the nutrient carried increases and as a result, the number and severity of algal blooms increases.

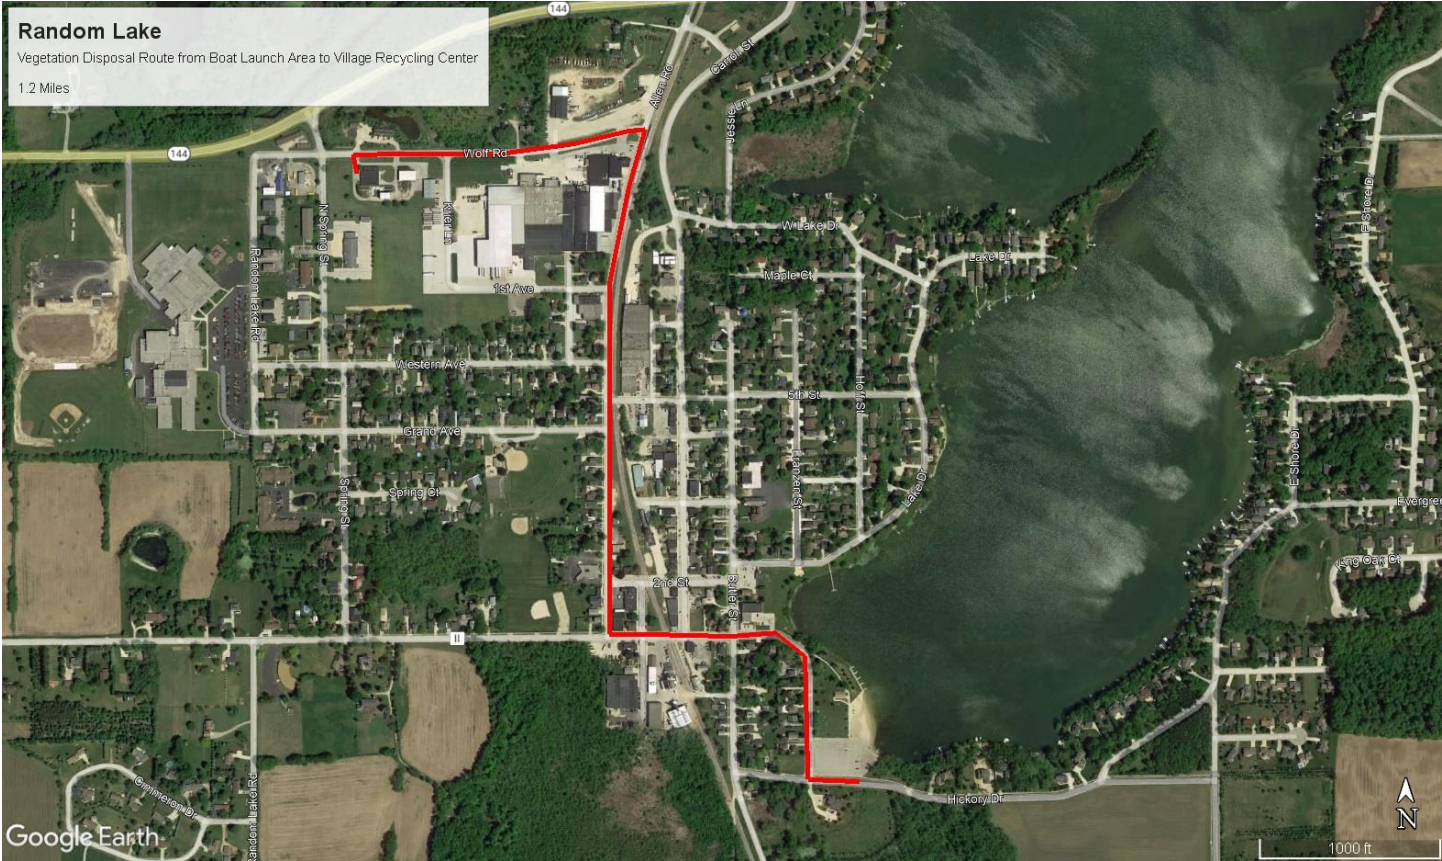
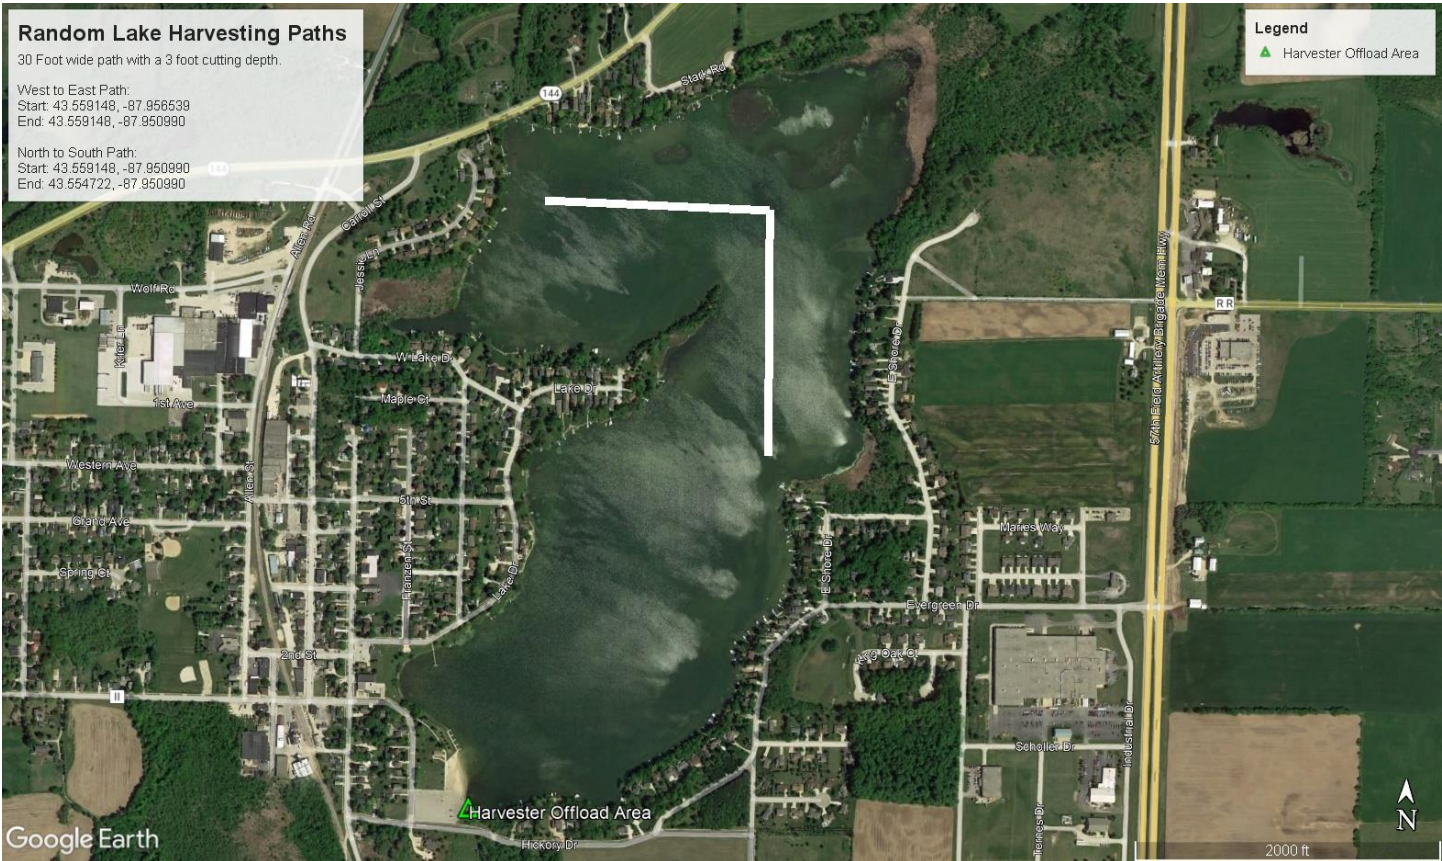
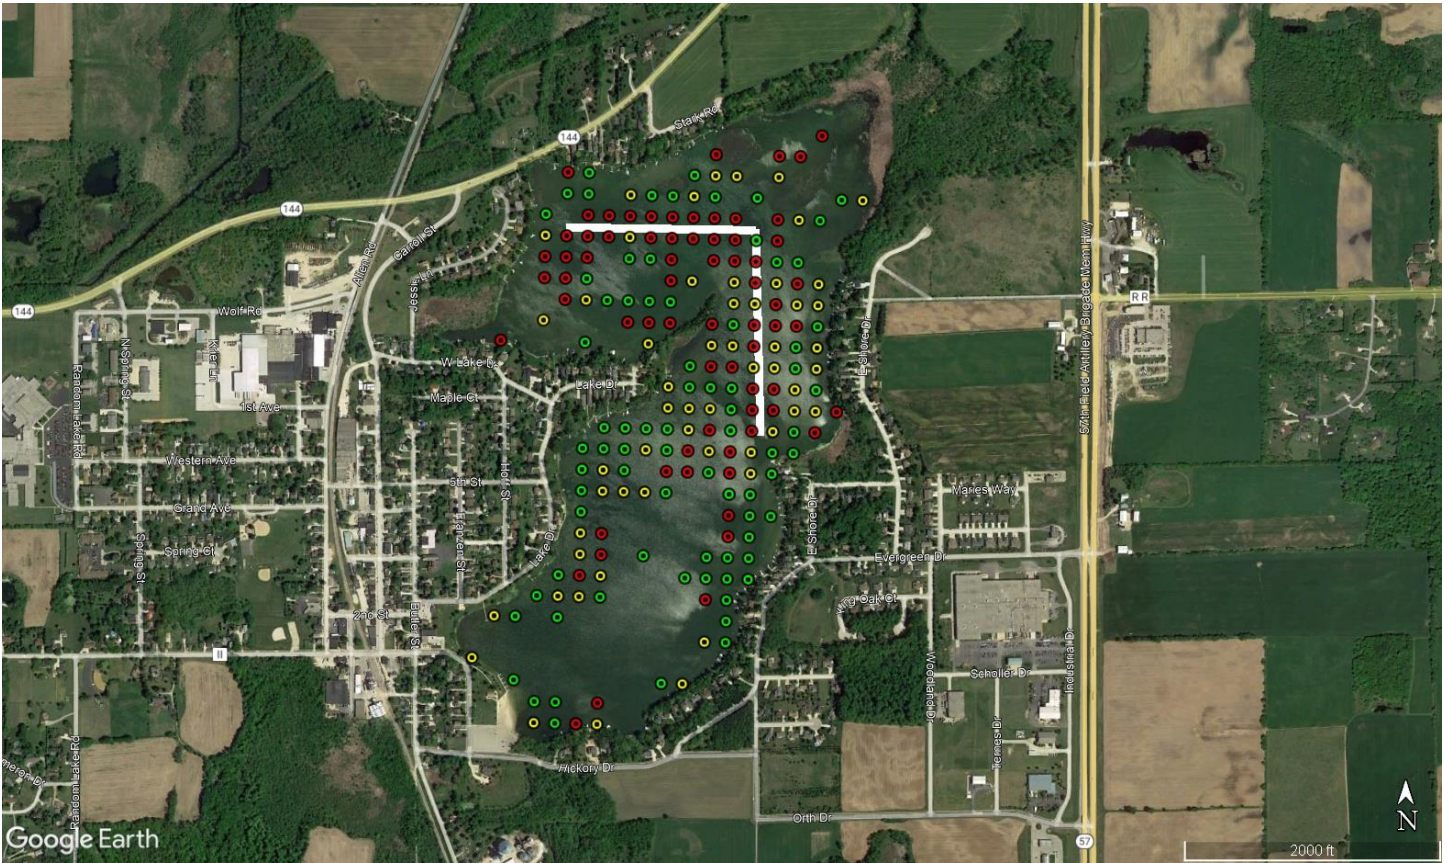
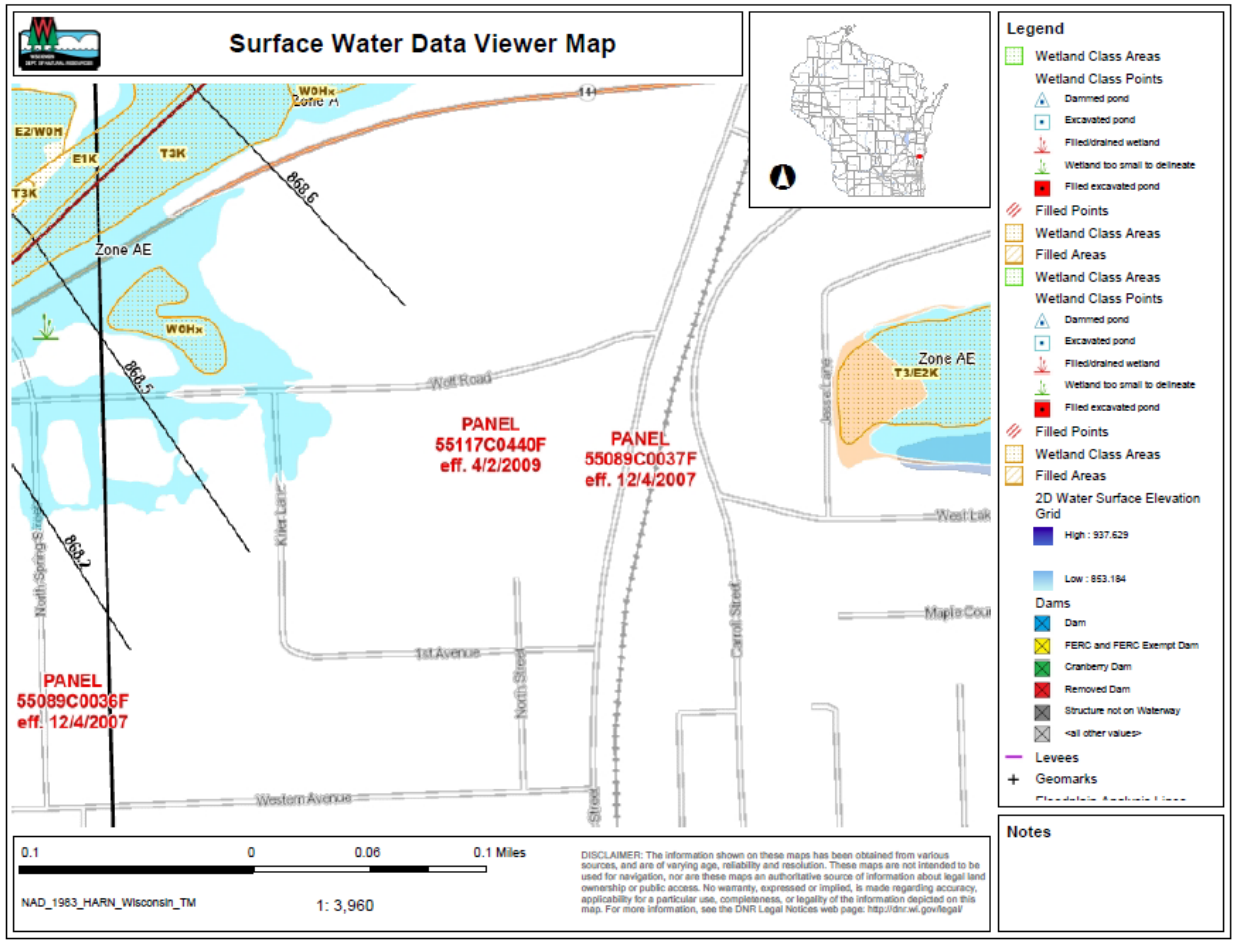
During a year of high growth, mechanical harvesting is encouraged to allow fish passage lanes in dense vegetation. See maps at the ends of this report for a detailed harvesting plan in the event vegetation is dense. Lanes should be 30 feet wide with a cutting depth no more than half the water column up to a 3 foot cutting depth. Vegetation harvested must be collected to the best of the machines ability with careful attention to detail when cutting through milfoil patches. Cut vegetation to be deposited on shore near boat launch area in a manner not to interfere with the launch lanes and swim area. Vegetation will be disposed of at the Village of Random Lake Recycling Center.

Harvesting paths to start and end at GPS coordinates described on the map below.
