# SAND LAKE BARRON COUNTY

2021 AQUATIC PLANT MANAGEMENT  
SUMMARY REPORT  
WDNR WBIC: 2661100

Prepared by: Megan Mader, Aquatic Biologist & Dave Blumer, Lake  
Educator

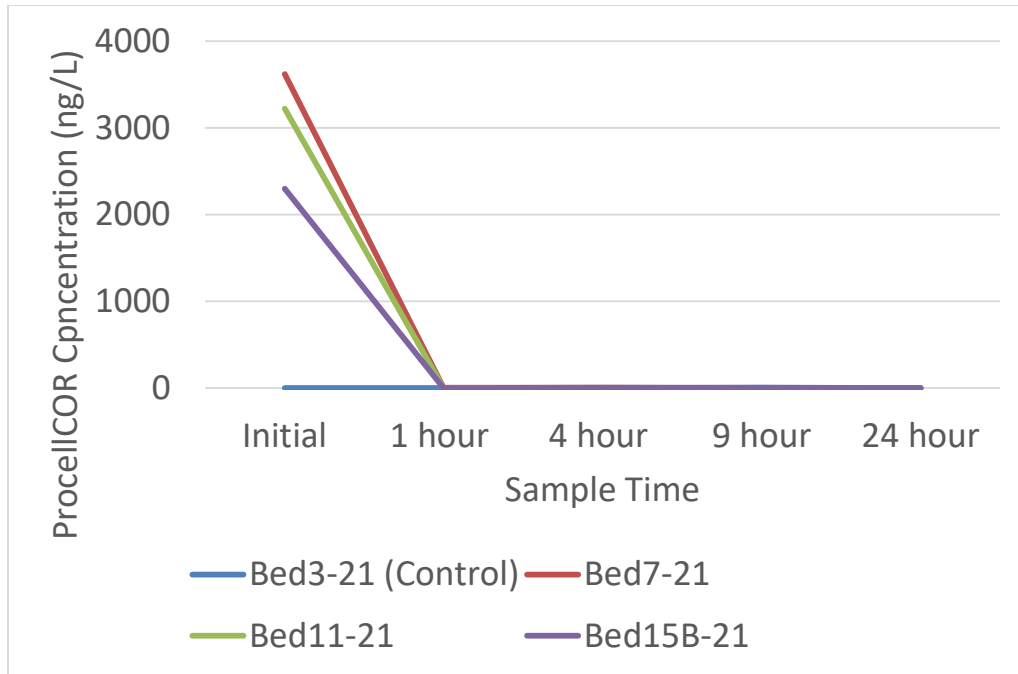
**Figure 3: Sand Lake ProcellaCOR concentration – Application to 24 hours after treatment (HAT)**

The samples were sent to the EPL Bio Analytical Services Lab in Niantic, Illinois where they were tested for the concentration of ProcellaCOR. From the results, it can be inferred that the ProcellaCOR herbicide was quickly taken up by the plants in the treatment beds. Within 1 hour, the concentration decreased significantly in all beds to virtually zero ( $p < 0.001$ ; Figure Concentration).

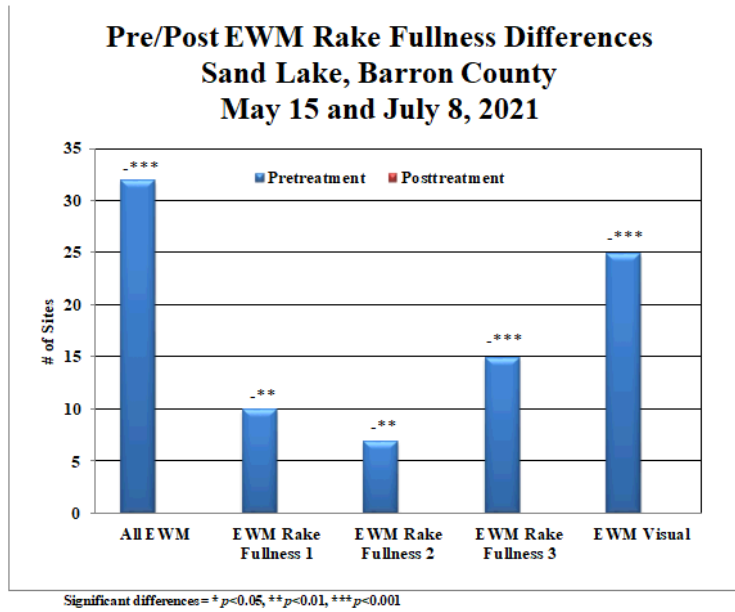
Figure 6: Pre and post-treatment rake fullness differences

ERS found significant changes in the distribution and density of EWM after the treatment. EWM was found in clusters and small beds throughout the treatment and control areas in the pretreatment survey. ERS estimated that 13.9% of the study areas had a significant infestation of EWM with rake fullness ratings of 2 or 3. Posttreatment, no EWM was found in the study areas. These results indicate a highly significant decline in EWM total density and distribution ( $p < 0.001$ ; Figure Rake Fullness; Berg, 2021)

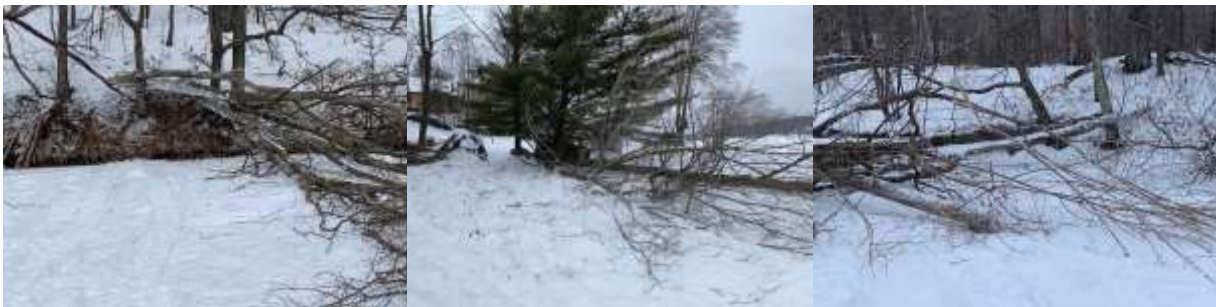
Figure 8: February 2021 Fishsticks Installations – Tinker (left), Held (center), and Janka (right)

In 2020, a Healthy Lakes Grant for Fishsticks was granted for three properties around Sand Lake. In January, a meeting was held about the installation of the fishsticks. In February, the fishsticks were installed at the Tinker, Held, and Janka properties (Figure Fishsticks). LEAPS assisted in the grant application process, as well as the installation.
