**Herbicide Treatment Analysis for *Potamogeton crispus*-
Curly-leaf pondweed (CLP)**

Bone Lake, Polk County WI (WBIC: 2628100)

June, 2021

**Surveys, mapping, and analysis provided by Ecological Integrity Service Amery, Wisconsin
Herbicide Application provided by Lake Restoration, Inc. Rogers, Minnesota**

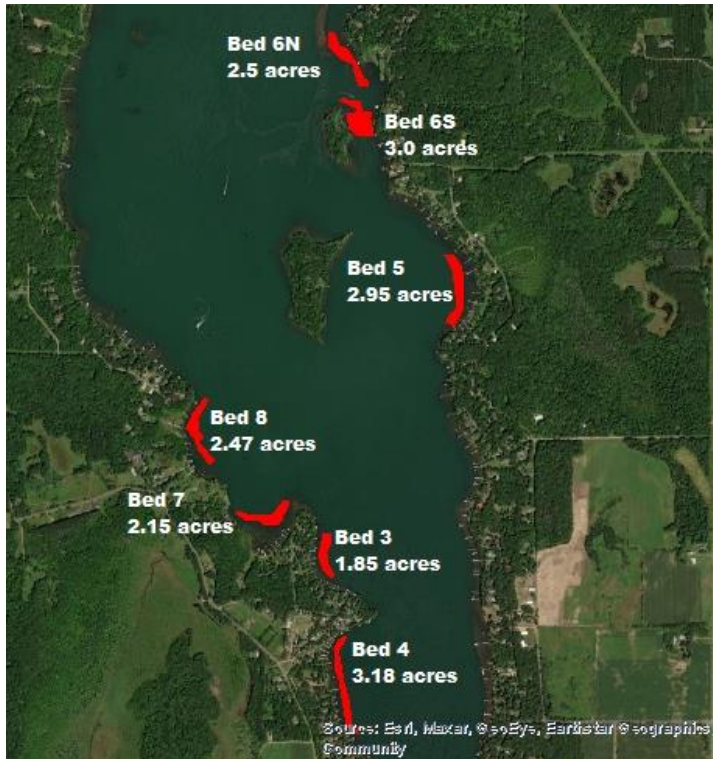
Figure 1: Map showing Bone Lake 2021 treatment beds.

On May 17 and May 24, 2021, a total of 13.07 acres of curly-leaf pondweed beds (five different beds) were treated with endothall. The permit was to treat 18.1 acres, but two beds (beds 3 and 4) were not treated because treatment couldn't be completed prior to warm water temperatures and substantial growth of native plant species. These beds were changed from 2020 due to changes in the management plan.

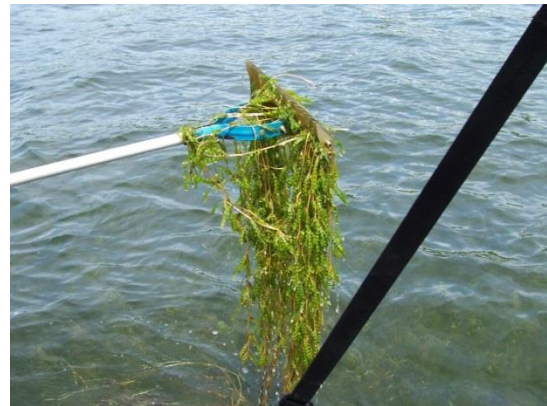
Figure 2: Density rating system and example CLP rake sample.

The second survey is referred to as the post-treatment survey. This survey involves going to the same GPS coordinates as the pre-treatment survey and doing a rake sample at the point. If any CLP is on the rake, the density of the CLP is recorded (see Figure 2 for reference). All other species are also recorded from the rake sample to assess potential damage to the native plants.

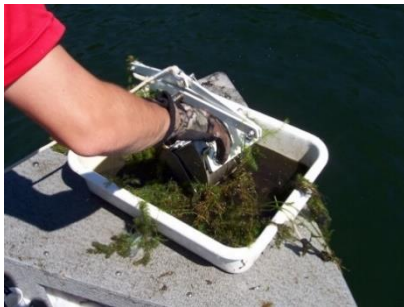
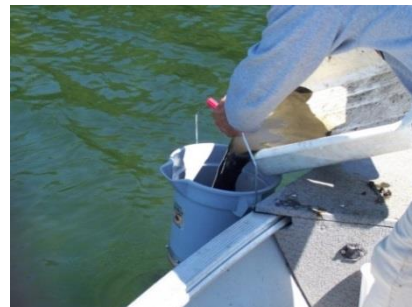
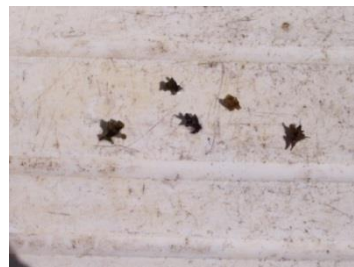
Figure 3: Pictures showing turion density methods. a shows sediment sample; b shows separation; c shows separated turions.

To reflect potential future growth and the cumulative success of treatments, a turion analysis is conducted in the fall following treatment. This analysis involves going to sample points near the middle of the CLP bed (assuming this will reflect the highest density). At each sample point, a sediment sampler is lowered to the lake sediment and a sediment sample is obtained. Two samples are obtained from each side of the boat at each location. The samples are then sifted with a screened bucket to isolate the turions. The turions are then counted and the density of turions is calculated in turions/square meter. Consistently successful treatments should show a trend of reduced turion density each year. This way we know the treatments are killing plants before turion production, resulting in an overall reduction in CLP in those beds.

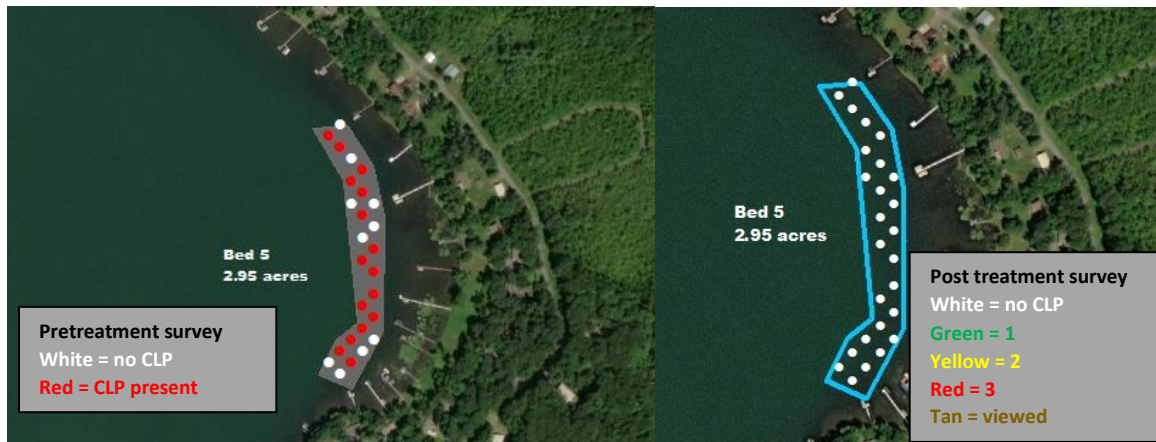
Figure 6: Pretreatment and post treatment CLP growth in Bed 5, 2021.

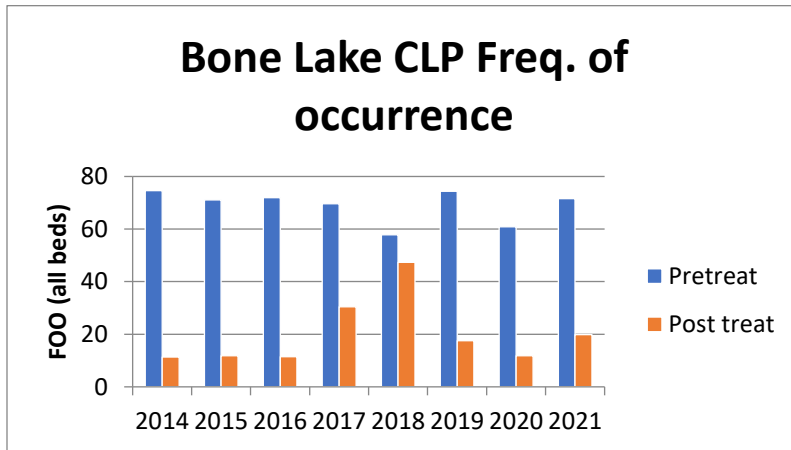
Figure 10: Graph showing FOO of pretreatment and post treatment surveys from 2014-2021.

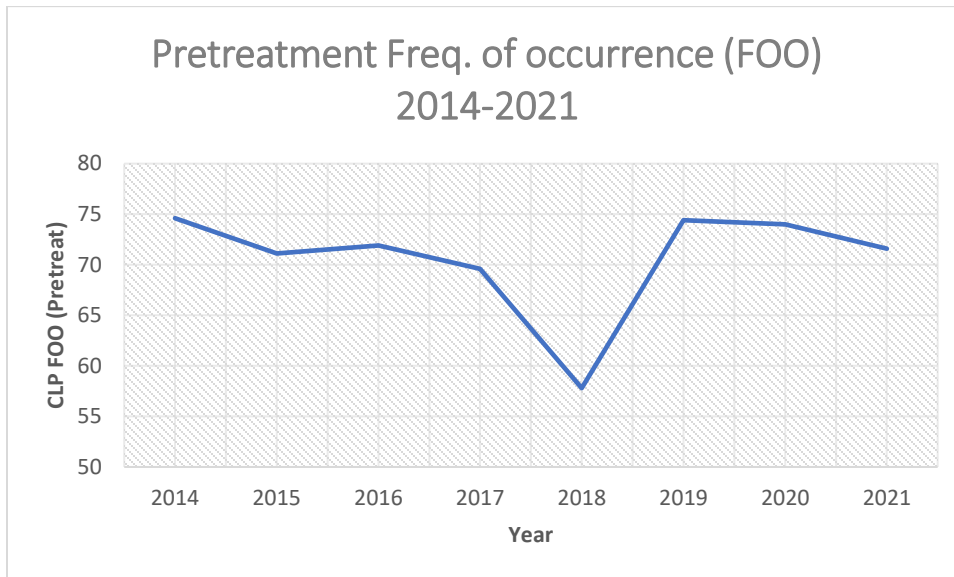
Figure 12: Graph showing long-term pretreatment frequency of CLP (all beds).

Figure 12 shows that the FOO in pretreatment surveys increased in 2019 due to no treatment in 2018. It is slightly decreasing in 2020 and 2021, but not immensely. The 2014 to 2020 comparison using a chi-square analysis shows the change is not statistically significant.

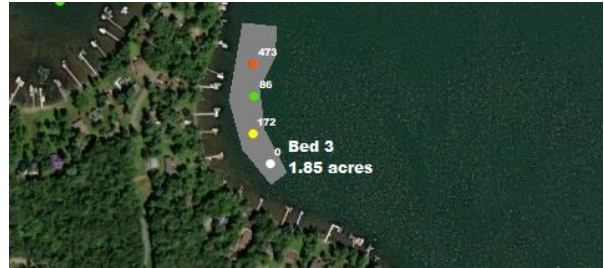
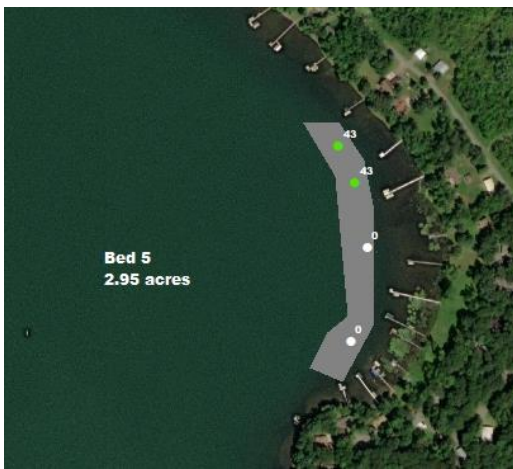
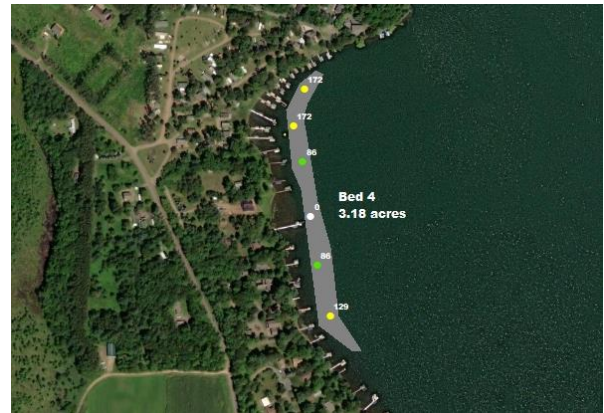
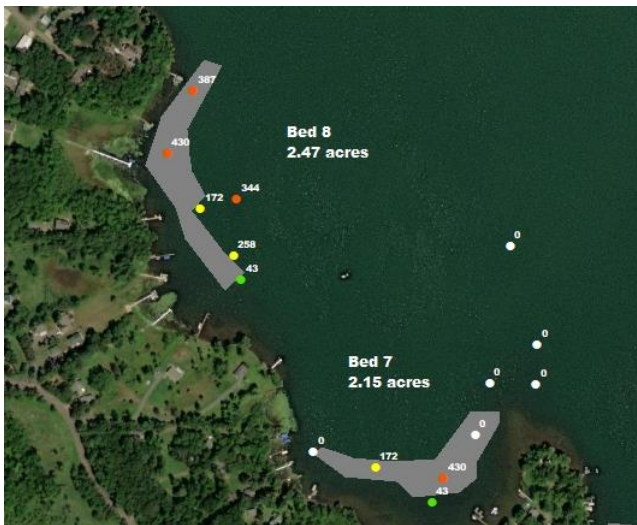
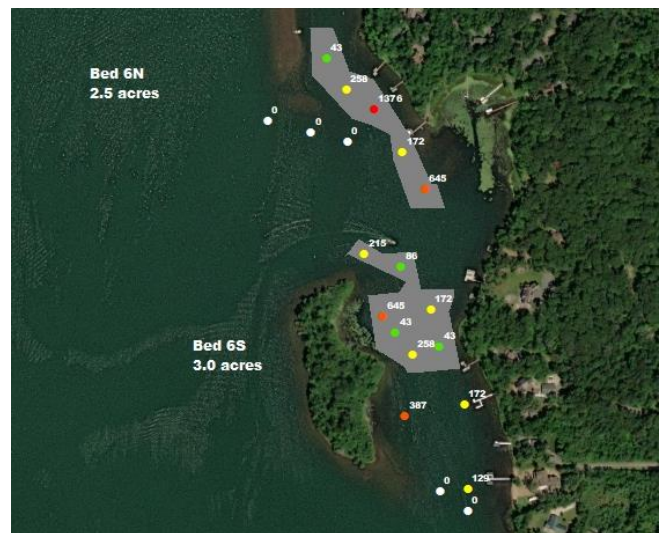
Figure 14: Maps of turion density within beds 2-8, from the Oct. 2021 turion analysis. White shows no turions, green up to 100, yellow up to 300, orange up to 700 and red more than 700. The density is listed near the sample point.

The analysis shows that bed 8 has the highest mean turion density of 272 turions per square meter (in sediment). This is followed closely by bed 6 with 232. The lowest was in a bed that has not been treated for a few years (bed 2). Bed 7 was quite low at just under 72 turions/square meter, which has not been treated as many years as beds 3-5 (figure 13). The turions density is shown in maps that follow (figure 14).

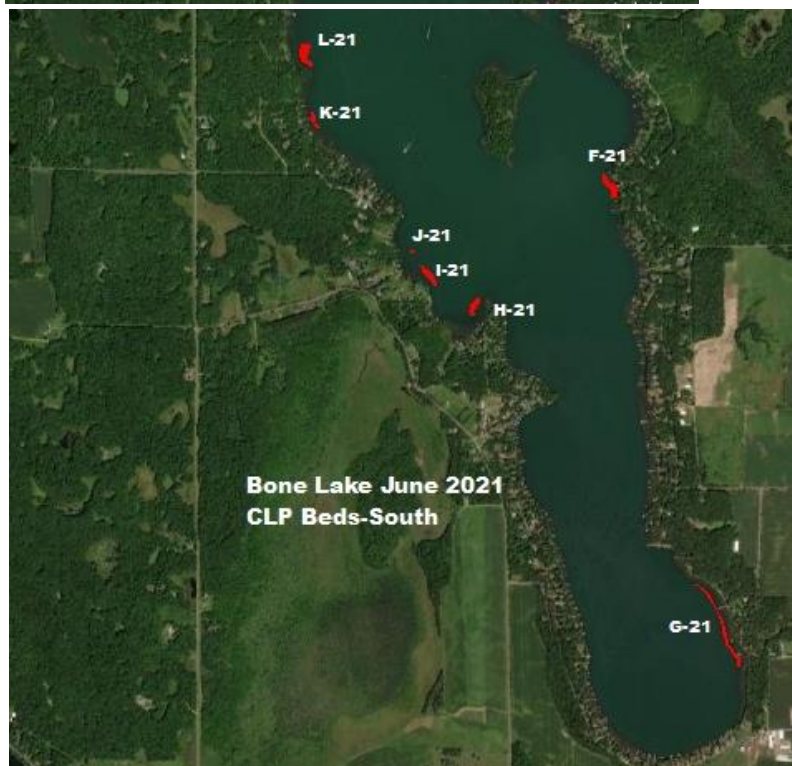
Figure 16: Bone Lake CLP bed map from June 2021.

Table 5 shows the area of each bed mapped and Figure 16 is a map showing the location of each bed. The bed sizes ranged from a high of 16.3 acres (Bed A in northern most bay of Bone Lake) to low of 0.05 acres. Nineteen total beds were mapped, four of which occurred within or just adjacent to treatment beds from 2021 (Beds E, H, I and J which were within or adjacent to treatment beds 6S, 7 and 8 respectively). This increased growth adjacent to treatment beds is due to stopping treatment in portions of these beds that were historically treated. This increase in growth shows the result of
