**Eurasian Water-milfoil (*Myriophyllum spicatum*)
Boat Landing and Meandering Littoral Zone Surveys
Pipe/North Pipe Lakes - WBIC: 2490500 and 2485700
Polk County, Wisconsin**

Endangered Resource Services, LLC
Matthew S. Berg, Research Biologist
St. Croix Falls, Wisconsin
June-October, 2020

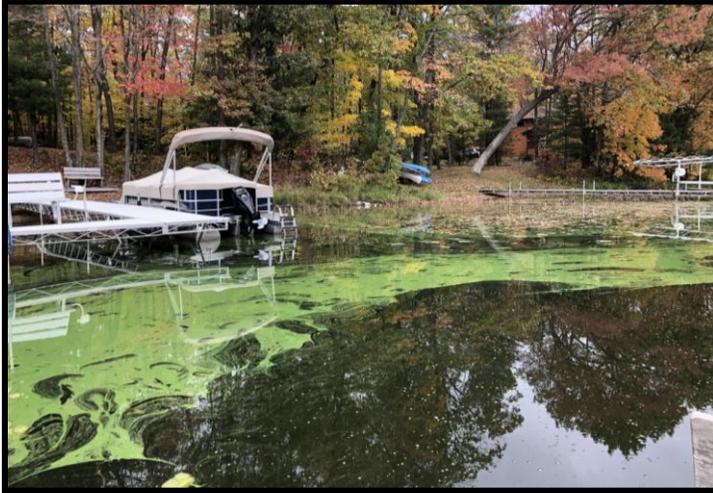
Blue-green algae bloom during the October 3rd survey – North Pipe Lake (Berg 2020)

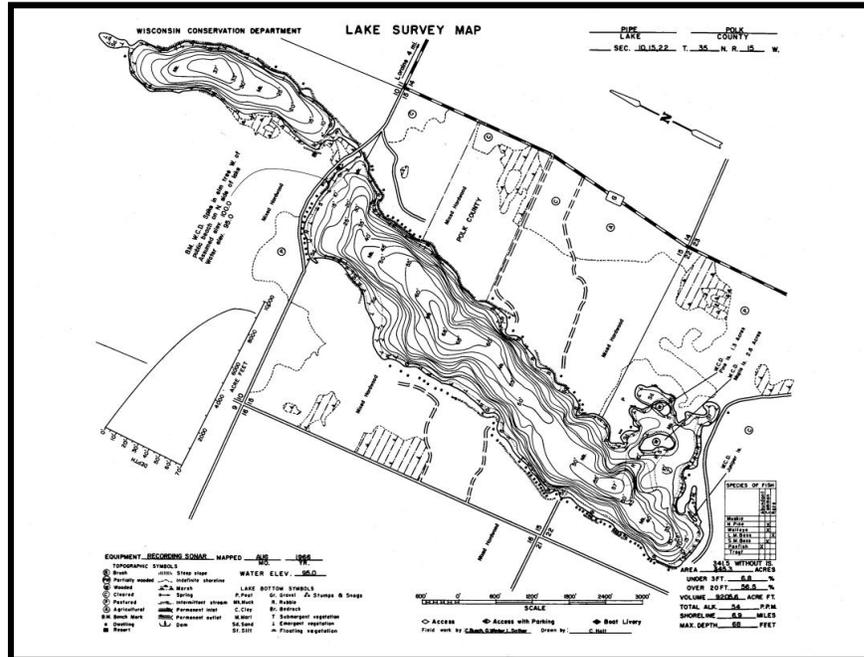
Figure 1: Pipe and North Pipe Lakes Bathymetric Map

Pipe Lake (WBIC 2490500- 293 acre seepage lake) and North Pipe Lake (WBIC 2485700 - 64 acre drainage lake) are located in east-central Polk County, Wisconsin in the Town of Johnstown (T35N R15W). Pipe reaches a maximum depth of 68ft in the north basin and has an average depth of approximately 27ft (WDNR 2020). The lake is mesotrophic in nature with 2020 Secchi readings averaging 10.3ft – down from a cumulative historical average of 14.7ft and the lowest yearly average of any year from 1994-2020 (WDNR 2020). The bottom substrate is predominately sand and rock along the shoreline, but this gradually transitions to sandy muck in most deep areas (Figure 1) (Busch et al. 1966).

North Pipe reaches a maximum depth of 37ft in the central basin and has an average depth of approximately 18ft (WDNR 2020). The lake is eutrophic in nature with Secchi readings in 2020 averaging 3.3ft – down from a cumulative historical average of 5.6ft and the second lowest yearly average (2014 was 2.3ft) of any year from 1999-2020(WDNR 2020). The bottom substrate is predominately sand and rock along the east/west shorelines and a nutrient rich organic muck in the north and south bays (Figure 1) (Busch et al. 1966).

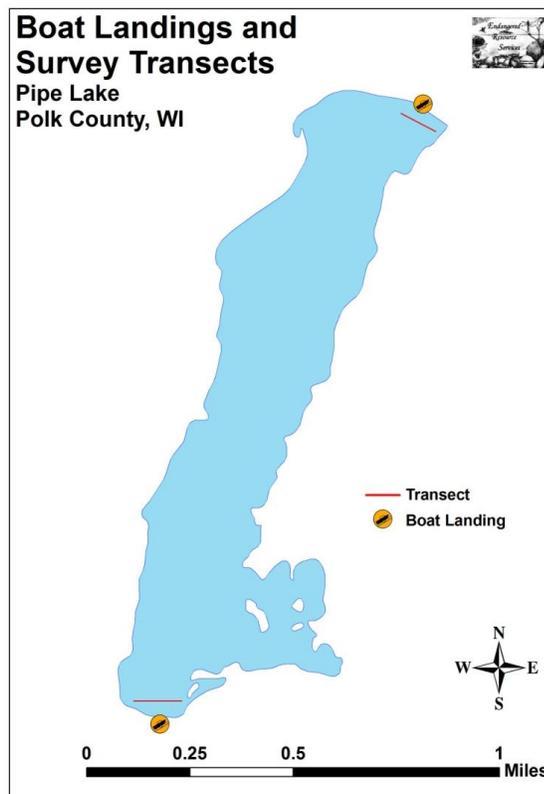
Figure 2: Boat Landings and 2020 Survey Transects

During the growing season from June-October 2020, we conducted landing inspections approximately once a month at the north boat landing and along the old southern landing on Pipe Lake (Figure 2). Using three 100-150m parallel transects approximately 15, 30 and 45m from shore; we motored at idle speed looking for any evidence of EWM's characteristic red growth top. Once we had finished the three transects, we returned to our starting point using a stitch pattern that crossed back and forth over all three lines to look for any plants we may have missed between the transects. As Eurasian water-milfoil primarily reproduces by shedding numerous vegetative fragments, we also walked along the north landing shoreline to look for pieces of EWM that would likely wash up if plants were present.

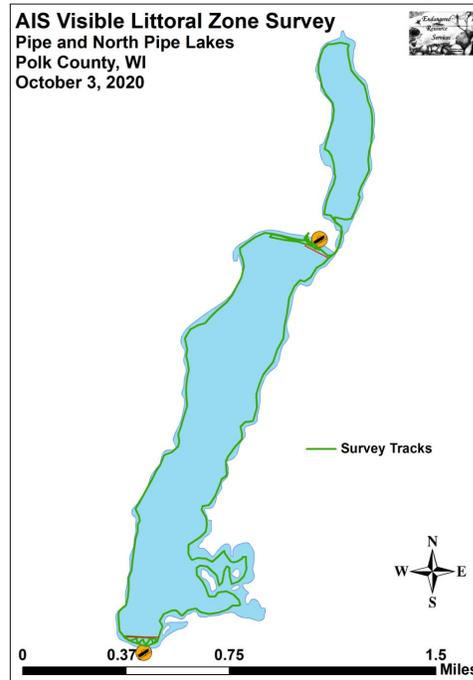
Figure 3: October 3, 2020 Visible Littoral Zone AIS Survey Tracks

We conducted whole-lake aquatic invasive species (AIS) shoreline surveys on both Pipe and North Pipe on June 3rd and October 3rd (Figure 3) (Appendix I). We also completed transect surveys at just the landings on July 2nd, August 9th, August 30th. Fortunately, we did **NOT** find any evidence of CLP, EWM or any other AIS in or adjacent to the lakes other than the previously reported Reed canary grass (*Phalaris arundinacea*). Despite concern about expansion during low water years, this species has experienced a notable decline since 2016 in the wake of rising water levels.

With Eurasian water-milfoil growing in nine other nearby Barron and Polk County Lakes (Sand, Beaver Dam, Kidney, Duck, Horseshoe, Echo, Lower Vermillion, Shallow, and Pike), we continue to recommend that landing inspections occur on a regular basis into the foreseeable future. Early detection of EWM provides the best chance to economically contain the plant once an infestation has occurred. As always, if lake residents or boaters discover a plant they even suspect may be Curly-leaf pondweed or Eurasian water-milfoil, we encourage them to immediately contact us (Matthew Berg, ERS, LLC Research Biologist) at 715-338-7502 saintcroixdfly@gmail.com. Ideally, a fresh specimen, JPG photograph, and GPS coordinates of where the specimen was obtained would aid in the identification and location of any suspect plant(s). However, even a texted picture of the plant in question held in hand is often enough to confirm identification. Likewise, we are happy to identify ANY plant a lake resident finds that they may want identified. ☺

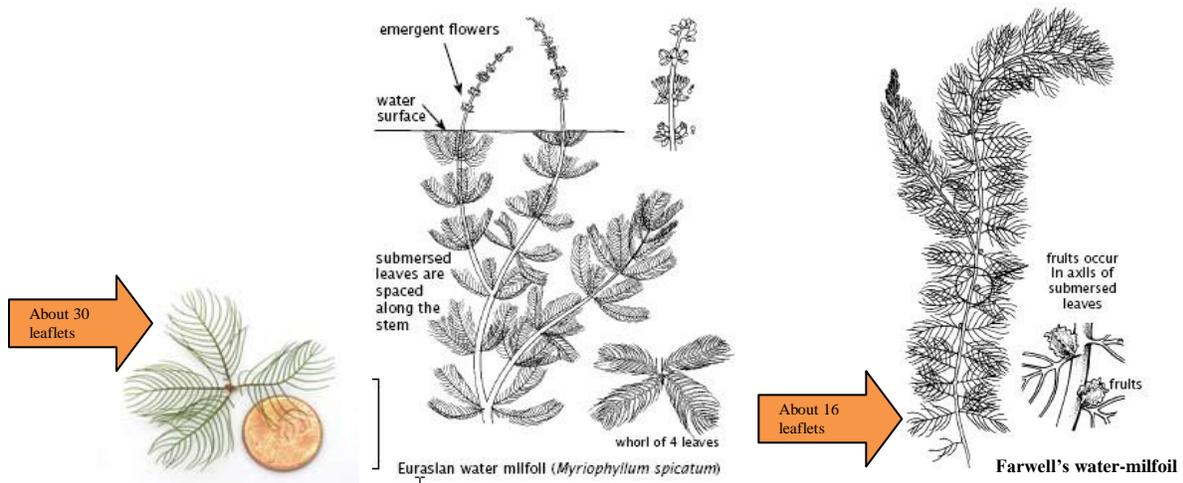
Figure 4: Eurasian and Farwell's Water-milfoil Identification
 (Hill et al. in Maine's Field Guide to Aquatic Invasive Species and Crow and Hellquist 2006)

As in the past, the only native milfoil we found that resembles EWM was Farwell's water-milfoil (*Myriophyllum farwellii*) – a valuable habitat producing native plant that is relatively uncommon in the state. In Pipe Lake, it grows in dense beds in the sheltered bays of the southeast corner in shallow water over thick organic muck (especially near the beaver lodge on the east side of the northeast island). Farwell's is also found scattered through North Pipe Lake, but here it is uncommon and never bed forming. Farwell's water-milfoil can be told from Eurasian water-milfoil in that it has leaves with leaflets numbering <16 whereas EWM normally has >26 leaflets (Figure 4). EWM also has an emergent flower stalk where Farwell's flowers are scattered along the stem and look like tiny nuts (Figure 5).

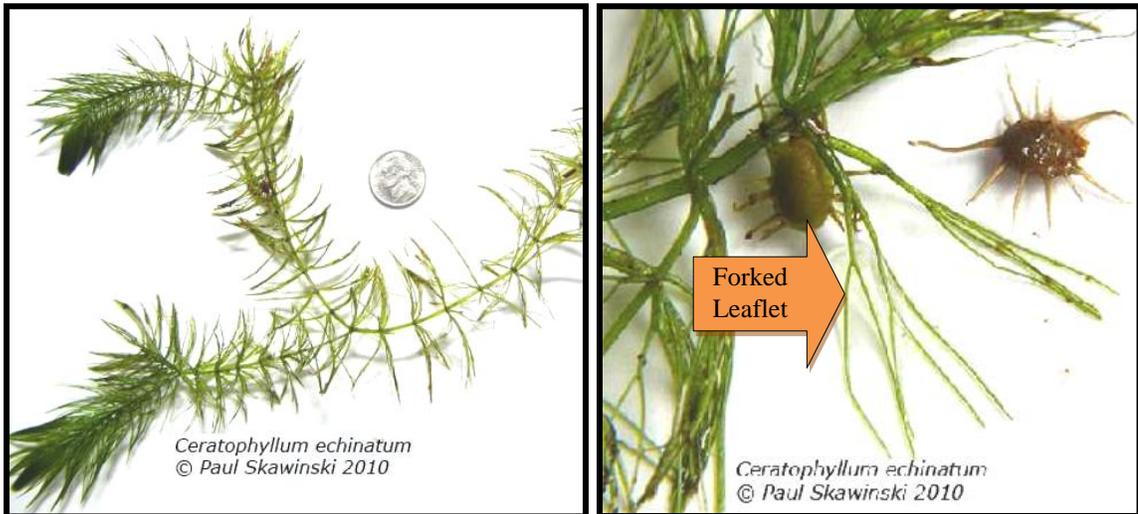
Figure 6: Spiny Hornwort Identification (Skawinski 2010)

We also noted two other beneficial native species that could potentially be confused with Eurasian water-milfoil: Spiny hornwort (*Ceratophyllum echinatum*) (Figure 6) and Common bladderwort (*Utricularia vulgaris*) (Figure 7). Both species are relatively common in the lakes' bays where they primarily occur in water <1.5m over organic muck substrates. Hornwort can be told from the milfoils as it has leaflets that fork repeatedly, while bladderworts have tiny "bladders" along their forked leaflets where these carnivorous plants trap and digest minute aquatic animals like mosquito larvae.

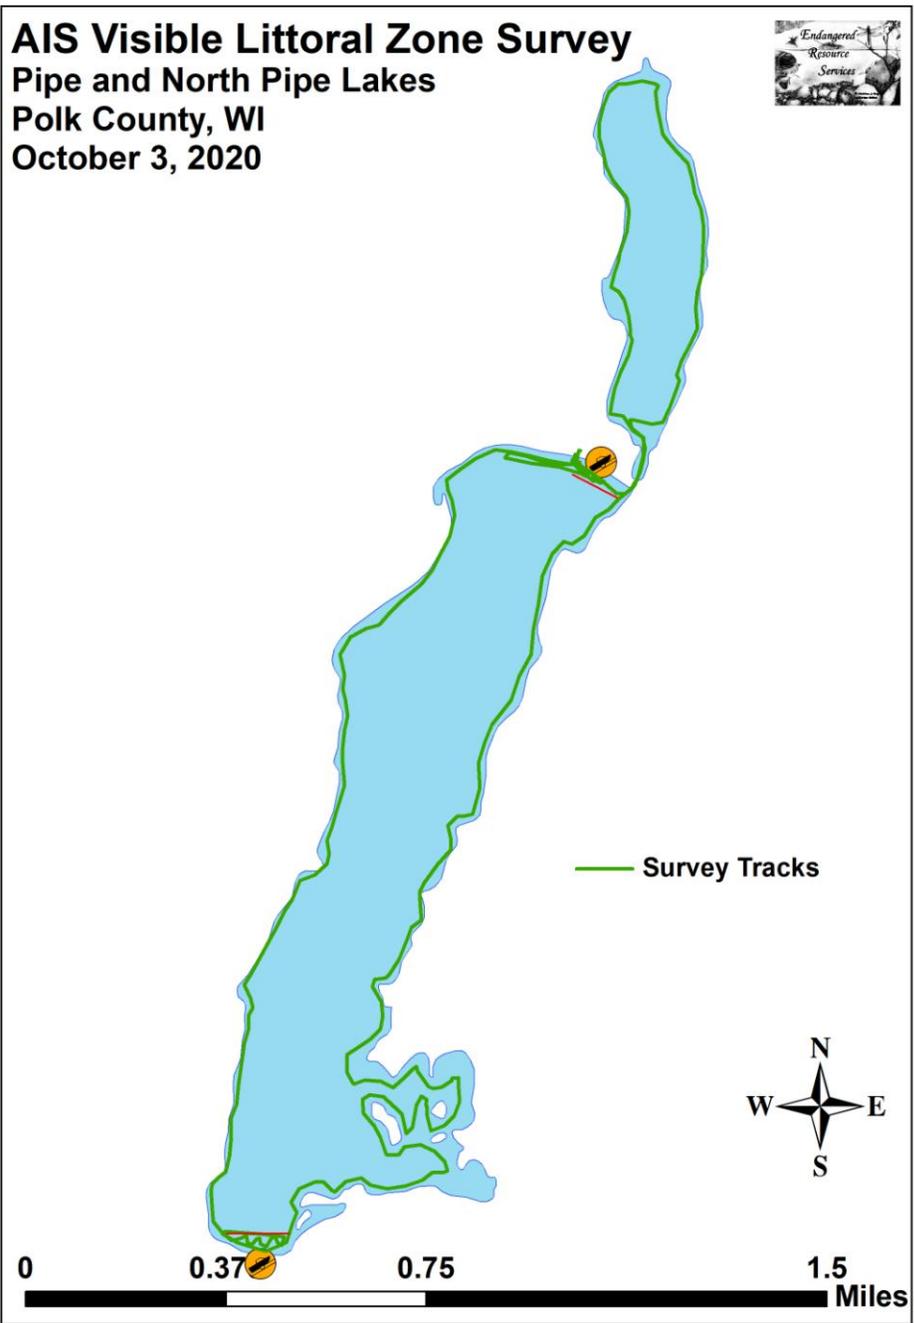
Appendix I: Pipe Lakes Fall Survey Tracks

AIS Visible Littoral Zone Survey
Pipe and North Pipe Lakes
Polk County, WI
October 3, 2020
