Wisconsin Department of Natural Resources
Aquatic Invasive Species Grant Program
Grant # AIRR23319

Smoky Lake Eurasian Watermilfoil Control Project

Smoky Lake - Vilas County, WI and Iron County, MI

Final Reporting 2018-2019

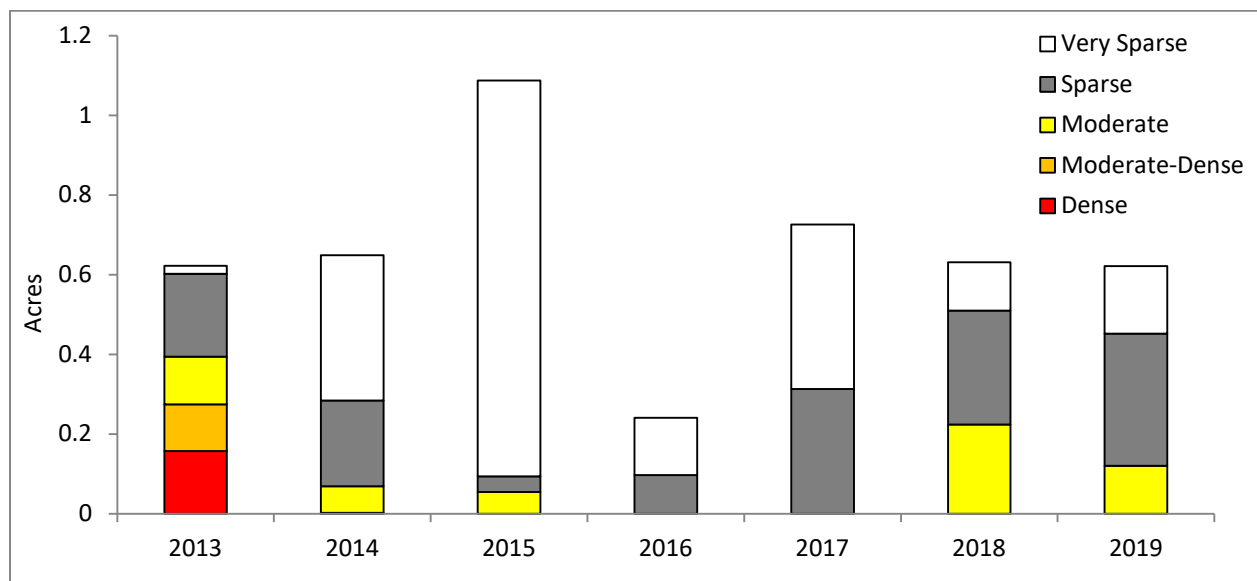
Figure 1: EWM abundance and acreage estimate 2013 to 2019 – Smoky Lake.

Currently EWM makes up very small portion of the aquatic plant community on Smoky Lake. Between 2013 to 2019, EWM lake-wide ranged from .24 acres in 2016 to 1.09 acres in 2015, with an average of .65 acres since monitoring began in 2013 (Figure 1 & Table 2). Total acreage fell slightly below the 6-year average at 0.62 acres in 2019. Since seasonal monitoring began in 2013, the greatest increase in EWM acreage occurred from 2016 to 2017, and the greatest decrease in acreage occurred from 2015 to 2016. Level of hand removal efforts, seasonal weather patterns, and water levels may all contribute to the historical ebb and flow of EWM documented to date on Smoky Lake. Maintaining EWM at current low levels may require continued seasonal control with hand removal using a blend of snorkeling, diving, and DASH. With increases in water levels, it may become less and less practical to use snorkel pulling as a feasible option in the near future.

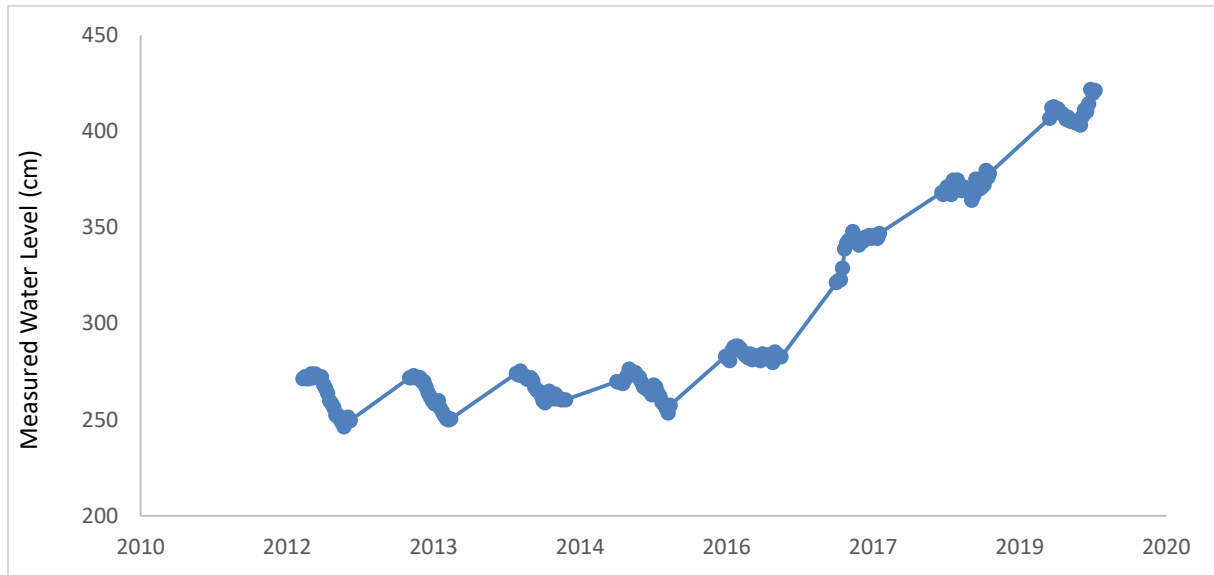
Figure 2: Smoky Lake Water Level Monitoring, 2012-2019.

Water levels on Smoky have steadily risen over the past several years (Figure 2). Being a seepage lake, this is an expected pattern over time. Since volunteer lake level monitoring began, from October 2012 to October 2019, Smoky Lake has recorded a change (+) in 172.9 cm, which is 5.67 feet. From 2016 to 2019, average depth of EWM plants detected rose from 5 feet in 2016 to 11.25 feet in 2019. Since most monitoring is done visually, increasing depths does make visual monitoring more challenging, even with Smoky's exceptionally clear water. Underwater cameras are a good tool to supplement visual observations; however, they do have their limitations, even for those that use them regularly to map EWM. The view from the

Lake levels rose close to 2.5 feet between the winter of 2016 and the fall of 2017. Lake levels continued to rise by 9 inches in both 2018 and again in 2019. Early survey work found far less milfoil at shallow depths and more at deeper depths in the summers of 2017, 2018, and 2019. This made volunteer removal sessions less feasible, and so reliance on professional remediation through hand removal was essential.

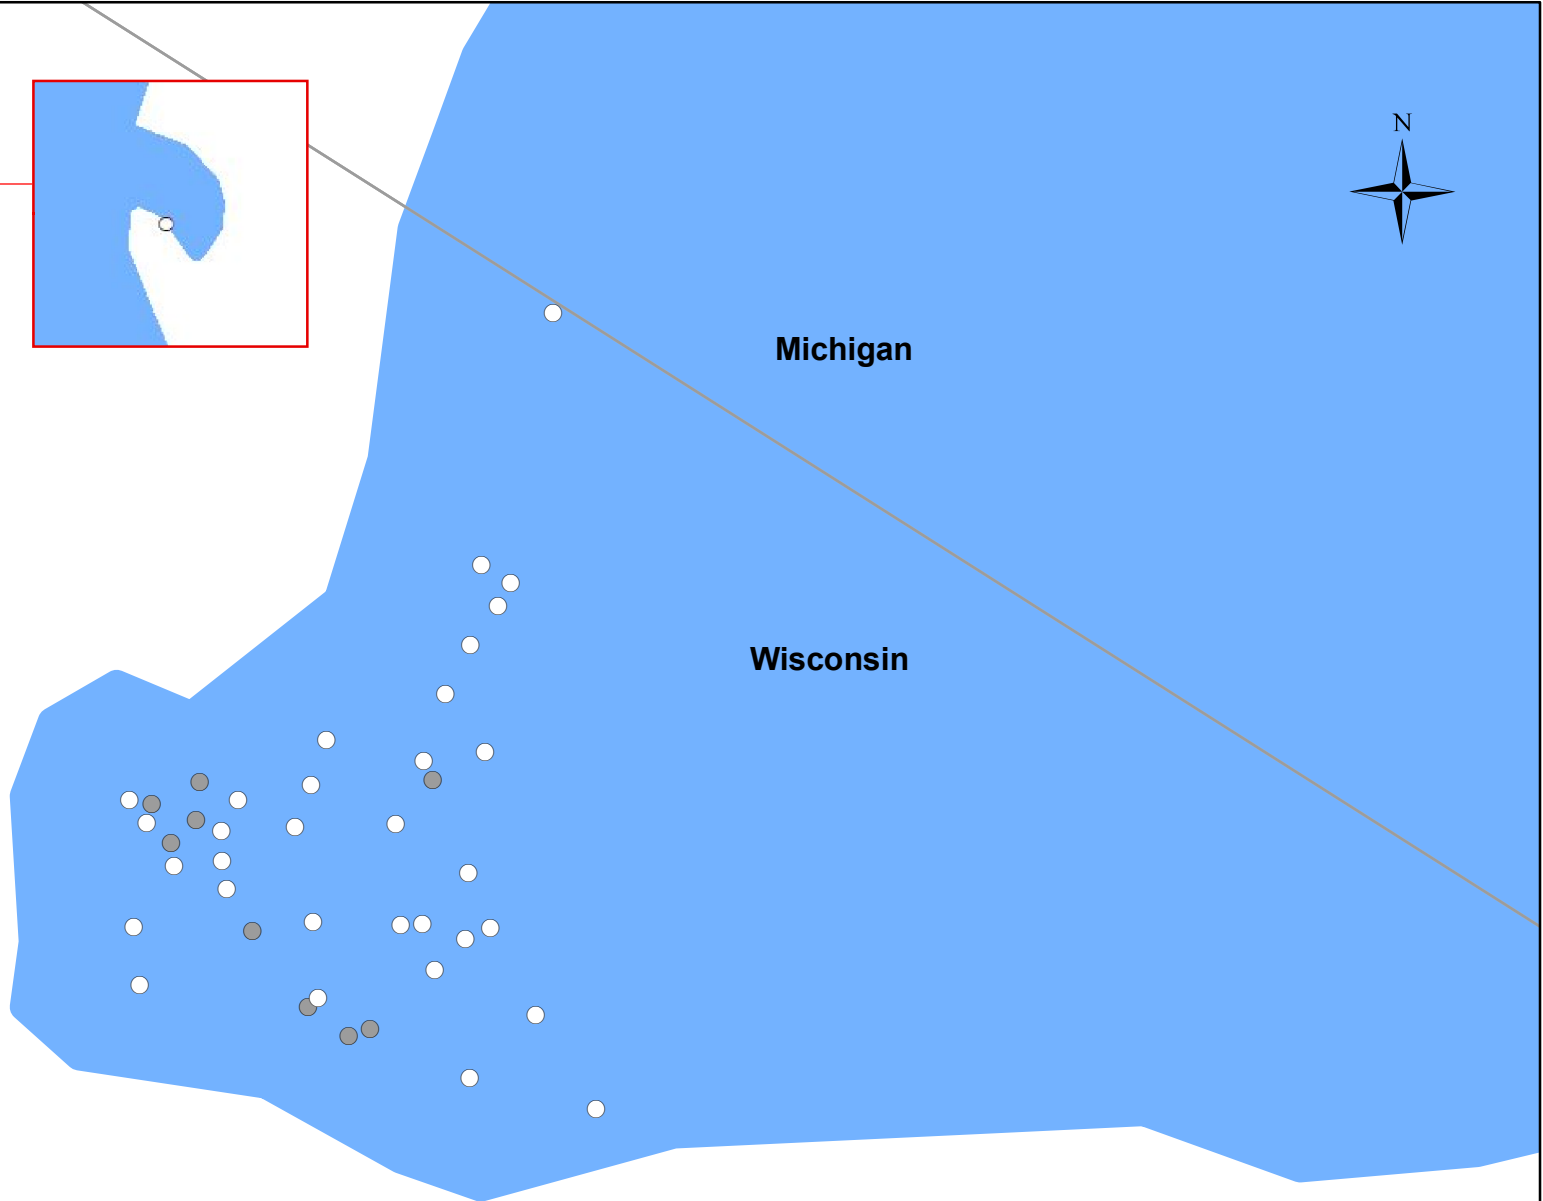
**Early Season EWM Survey
Smoky Lake - Vilas County, WI
& Iron County, MI
2018**

Early season monitoring took place on June 22nd 2018 (Appendix A). Mainly sparse to very sparse point based locations of EWM were detected within the far southwest bay, along with one single plant found within a private cove located along the far northeastern portion of the lake. Mid-late season monitoring took place on September 6th 2018. These surveys detected several deep-water colonies along the west shore between depths of 10 to 13 feet. Most colonies detected were sparse to very sparse, but a few small yet moderate density EWM colonies were observed. All locations of EWM occurred within the southwest bay and the southwestern shore. One small colony of about five plants was detected along the west shore about a half mile north of Wisconsin/Michigan boarder.

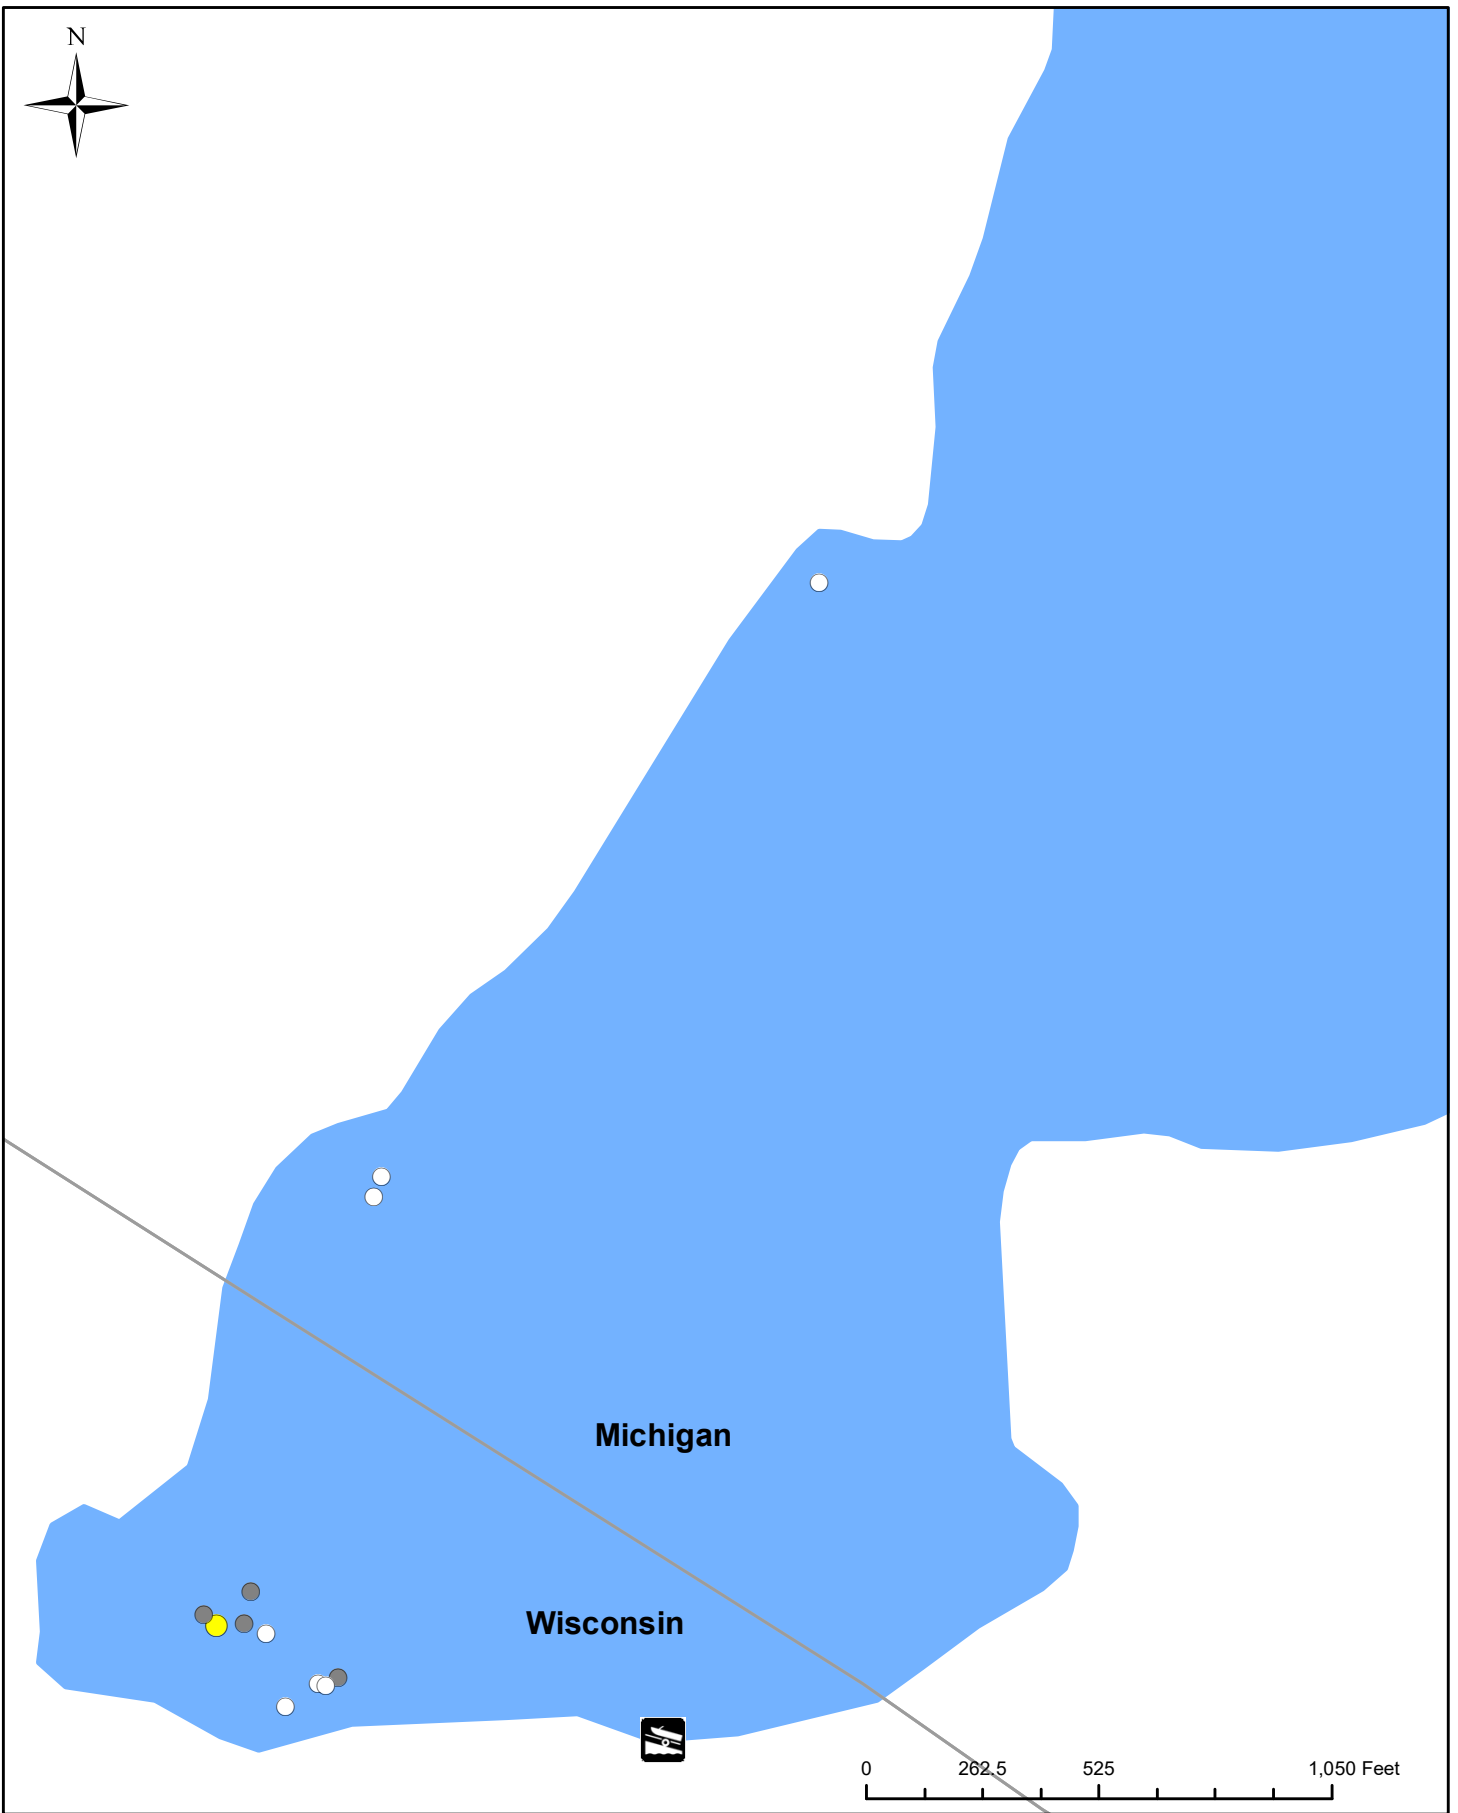
**Mid/Late Season AIS/EWM Survey
 Smoky Lake - Vilas County, WI
 & Iron County, MI
 2019**

Lake Name: Smoky Lake
Map Date & Creator: 1.9.20, Many Water, LLC
Survey Dates: 10.7.2019
Source: EWM-Many Waters, Mi_GDL Lake_polygons_200403
File: Smoky_EOY_2019

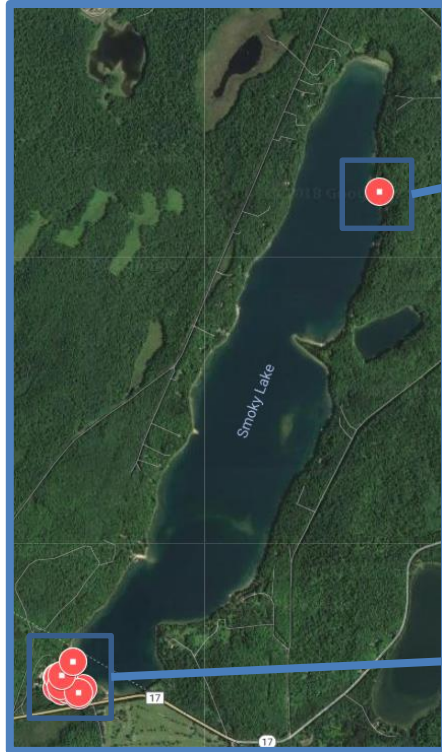
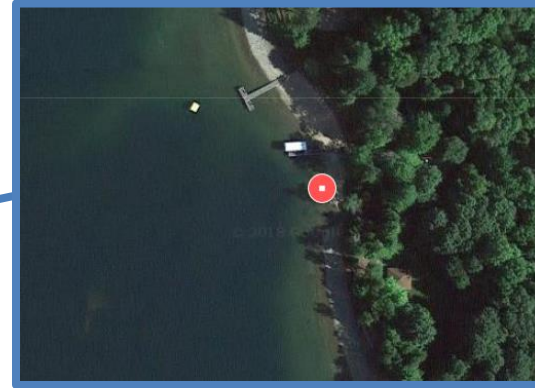
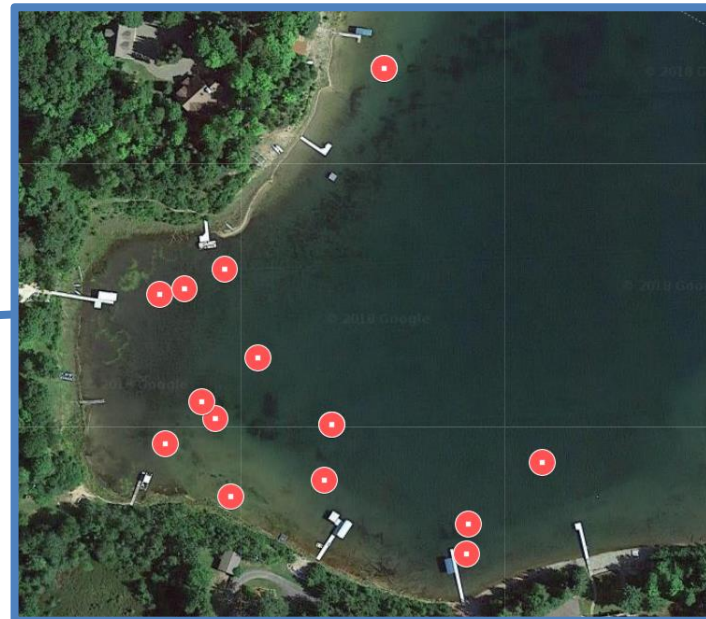
Map of Smoky Lake Dive Sites

Summary: On July 16th, 17th, 18th, and 19th, Aquatic Plant Management LLC (APM) Conducted hand-harvesting services of Eurasian Watermilfoil (EWM) on Smoky Lake in Vilas County, WI. Our divers were able to successfully remove 64.3 cubic feet of EWM from the lake. On July 16th and 17th, we focused our efforts on the EWM along the shoreline of the southwest bay. We also were able to remove the few EWM occurrences from the northeastern shoreline of the lake. On July 18th and 19th, we then focused on removal of EWM growing at depths between 6' and 12' along the same shoreline.

Recommendations: While we were able to remove all visible EWM from the 2018 control area, continued monitoring and management efforts are vital to preventing proliferation of EWM throughout Smoky Lake.

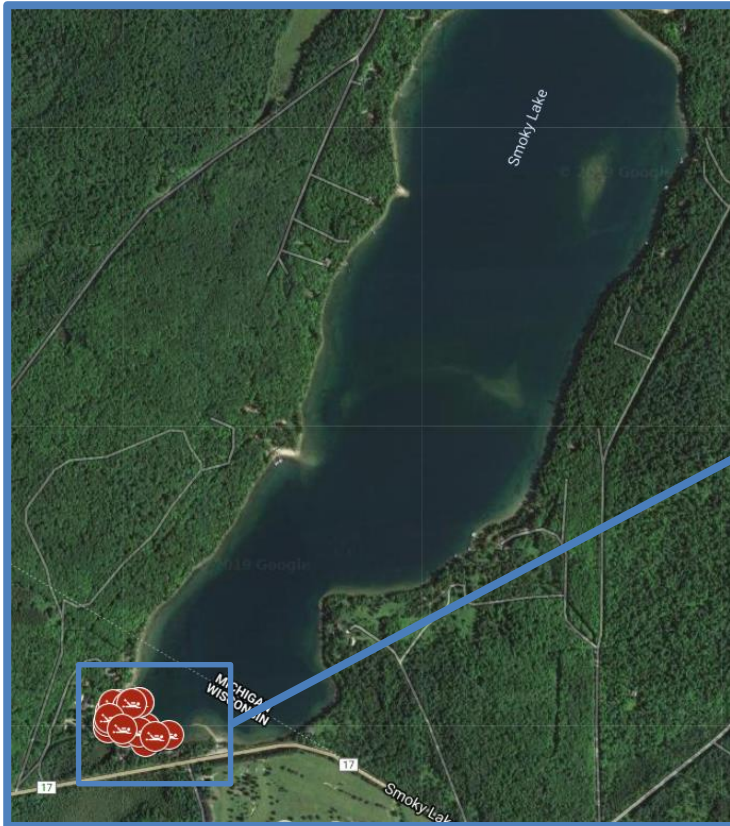
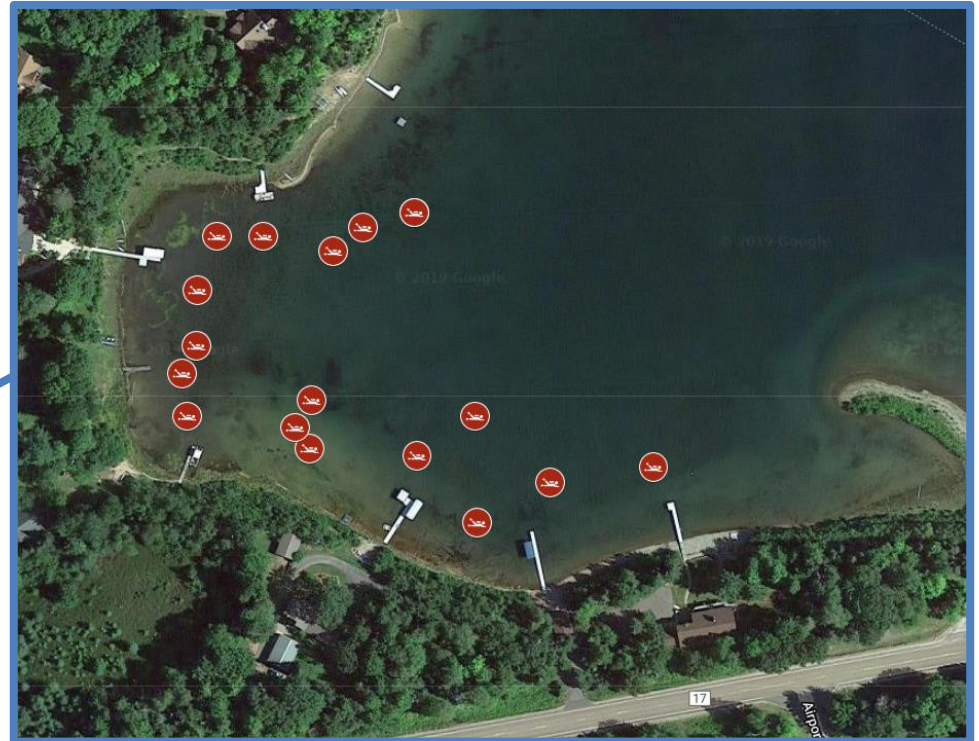
Map of Smoky Lake Dive Sites

Summary: On August 8th, 9th and 14th Aquatic Plant Management LLC (APM) conducted traditional Hand Harvesting of Eurasian Watermilfoil (EWM) on Smoky Lake in Vilas County, WI. Utilizing GPS coordinates provided by Many Waters LLC, the dive team focused their efforts on the scattered plants in the southeastern end of the lake. There were some scattered plants along the shoreline under some downed trees that were targeted, but not included on the original map. In total, the dive team was able to remove **43.5 cubic feet of EWM** from the lake over the course of 3 days.

Recommendations: The EWM on the southern end of Smoky Lake was scattered and hand harvesting was an effective method of removal. However, the dive location on the eastern end of the bay at a depth of over 15 would a good area for Diver Assisted Suction Harvesting (DASH) due to the depth and density of the EWM. The Smoky Lake Association should continue to closely monitor the EWM population in order to evaluate the effectiveness of the removal efforts.
