# Vilas County 2020 Healthy Lakes Report

**Grant Number:** LPT65920

**Grant Sponsor:** Vilas County Land & Water Conservation

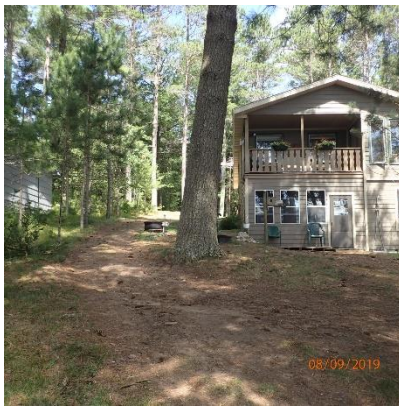
Photo 1: Aug 9, 2019. Driveway around home had ruts from use and erosion.

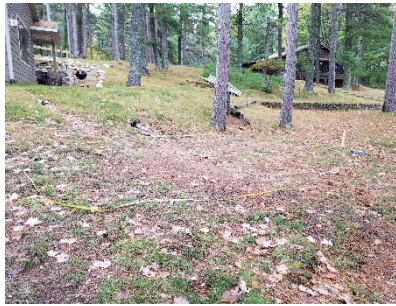
Photo 2: Oct 4, 2019. Gutters directed roof runoff and was creating some erosion issues.

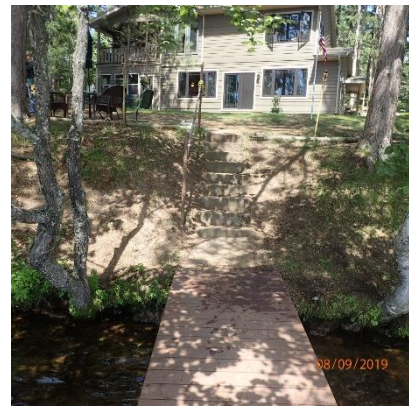
Photo 3: Aug 9, 2019. Home is at the 75 ft. setback, so erosion concerns were close to the lake.

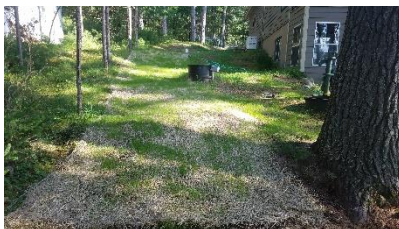
Photo 4: Sep 9, 2020. Two broad-based dips were installed and seeded along driveway.

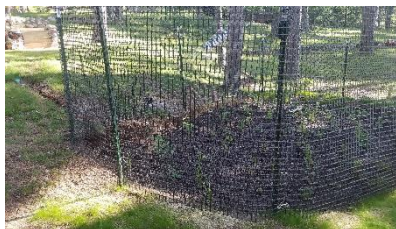
Photo 5: Sep 3, 2020 Rain garden installed near 2 of gutter outlets.

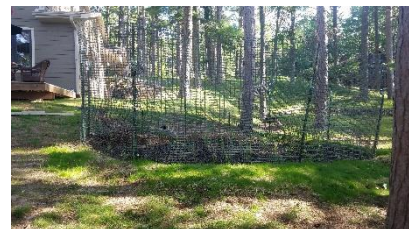
Photo 6: Sep 3, 2020. Rain garden installed.

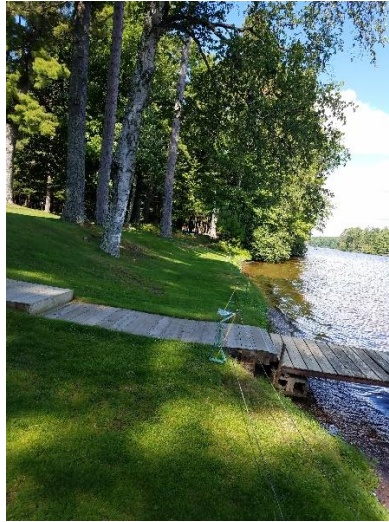
Photo 8: Aug 5, 2019. The golf course's sloped lawn was mowed to the lake's edge.

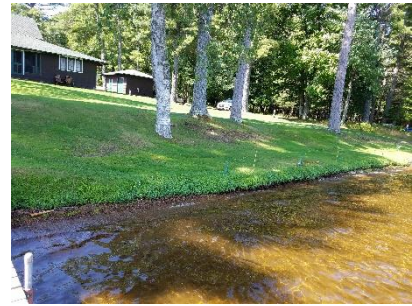
Photo 9: Aug 5, 2019. This is the area slated for the native planting.

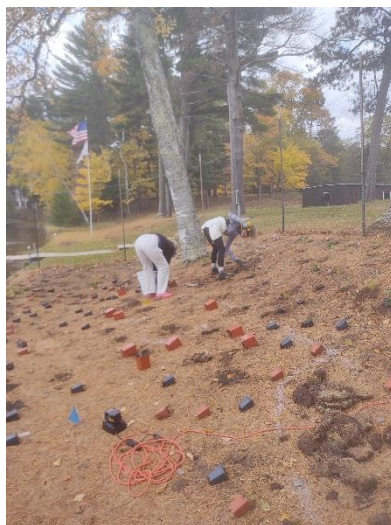
Photo 10: Oct 6, 2020. The volunteers started installing the plants.

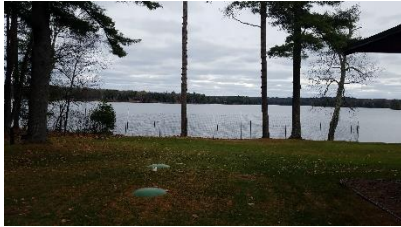
Photo 12: Oct 19, 2020. 1,250 sq. ft. native plantings fenced and installed.

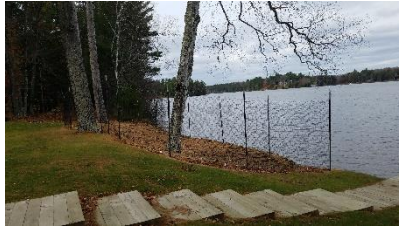
Photo 13: The shoreland buffer in this area is now 50 ft. long and 25 ft. deep.

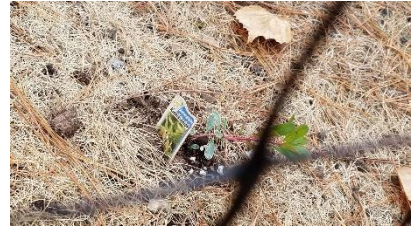
Photo 14: Native plants like kinnikinnick were used.

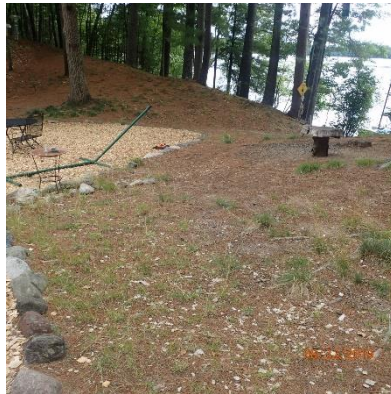
Photo 15: Aug 22, 2019. The landscape naturally funnels towards the lake access path.

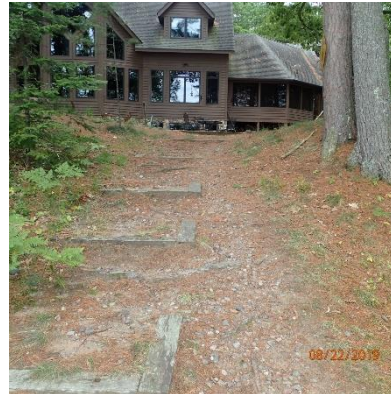
Photo 16: Aug 22, 2019. The access path had timber framed steps.

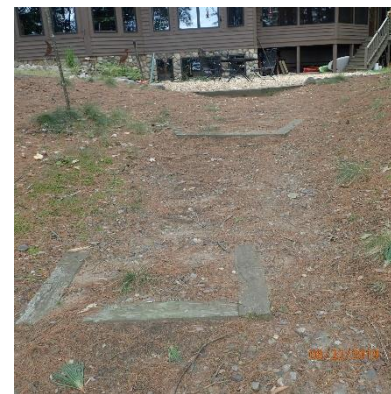
Photo 17: Aug 22, 2019. Deposits of sand & pine needles are evident on the steps.

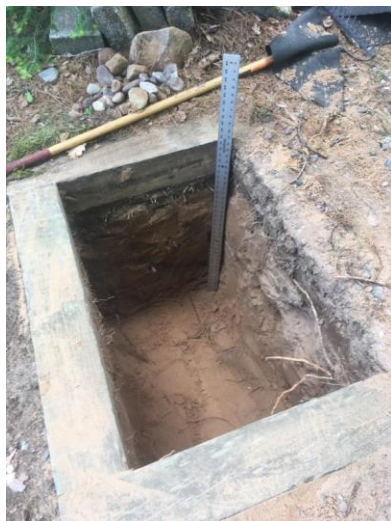
Photo 18: June 9, 2020. The owner dug 3 ft. deep holes for the infiltration pit in the steps.

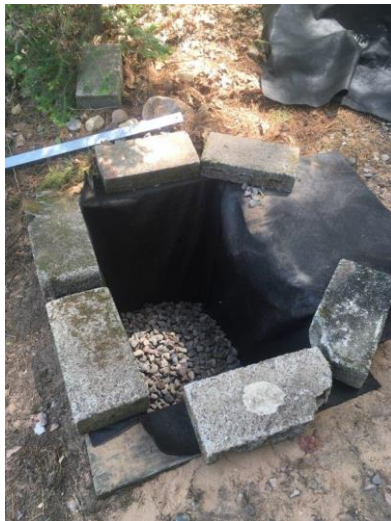
Photo 19: June 9, 2020. Pit is lined with filter fabric on all sides and filled with rock.

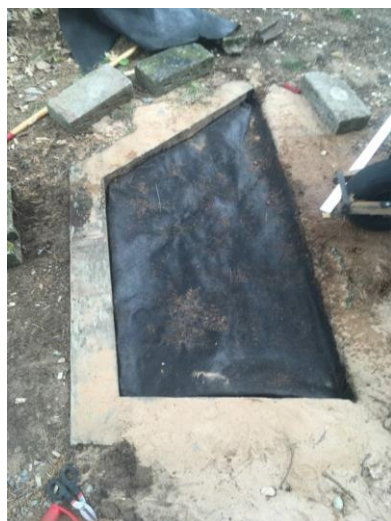
Photo 20: June 9, 2020. Filter fabric folded over top of pit. Rock layer will be added on top.

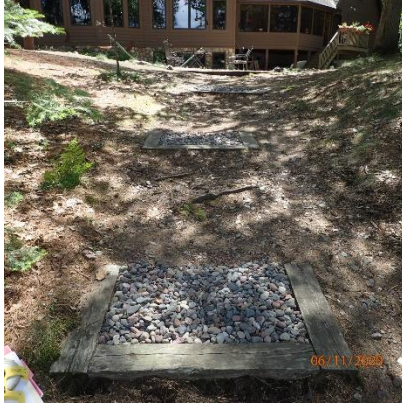
Photo 21: June 11, 2020. Three infiltration pits are installed.

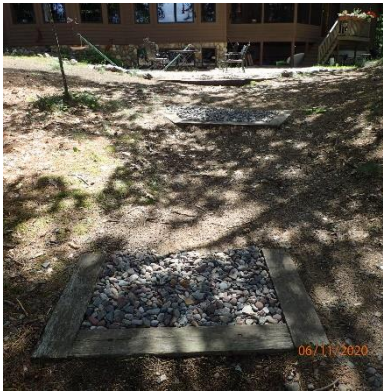
Photo 22: Top 2 infiltration pits.

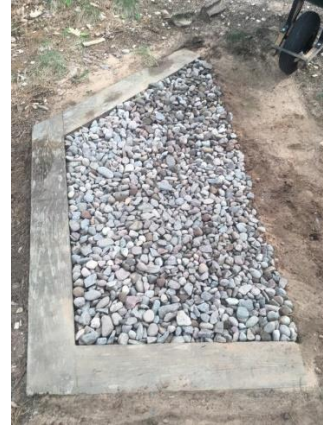
Photo 23: June 11, 2020. Top infiltration pit with 3 inches of rock over filter fabric.

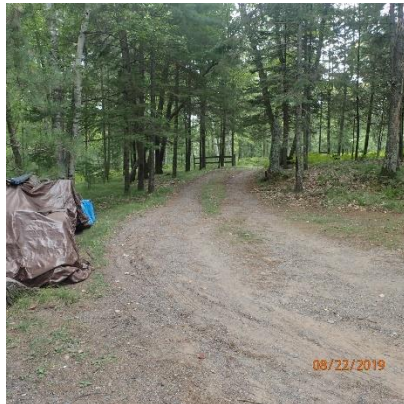
Photo 24: Aug 22, 2019. The driveway angles towards Boulder Lake.

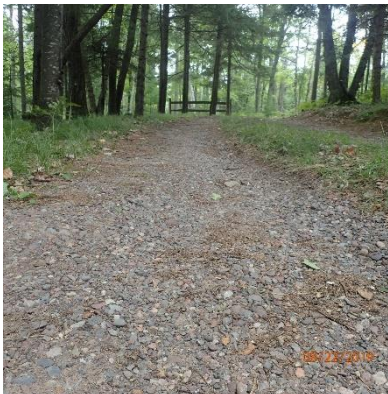
Photo 25: Aug 22, 2019. Some erosion on driveway is evident.

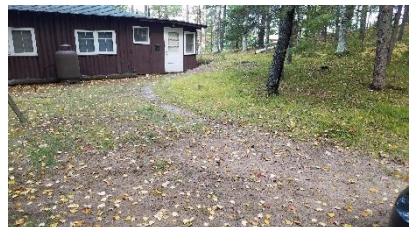
Photo 26: Sep 21, 2019. Runoff from the driveway runs around the house and towards the lake.

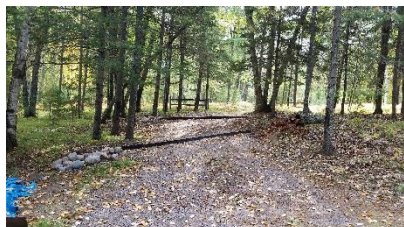
Photo 27: Sep 21, 2020. Two conveyor belt diversions with rock outlets installed.

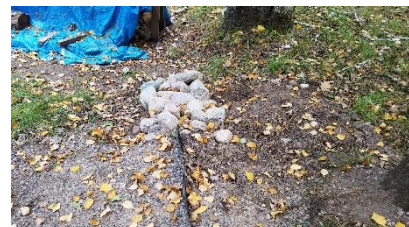
Photo 29: Sep 21, 2020. Rock outlet at end of diversion.

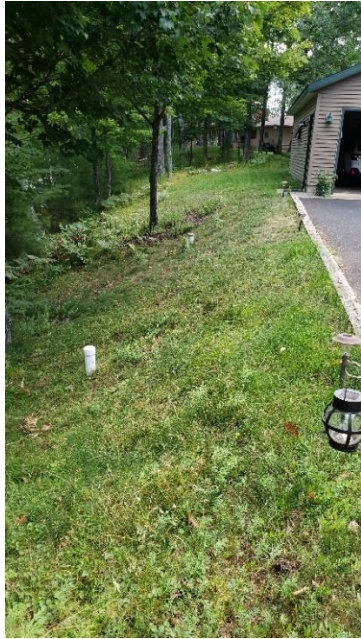
Photo 30: Sep 5, 2019. The very steep grassy area near the garage.

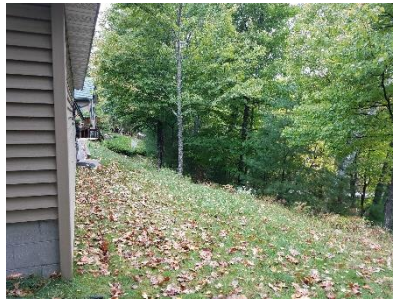
Photo 31: Sep 5, 2019. The slope goes toward the lake – the pier is visible behind the trees.

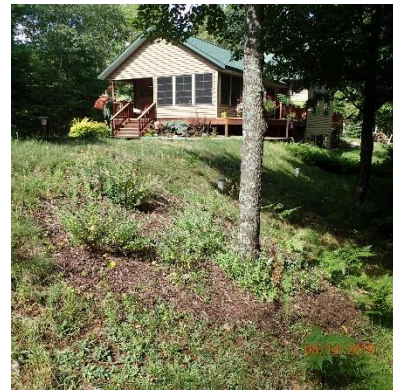
Photo 32: Aug 14, 2019. There is some erosion on the slope face near the lake.

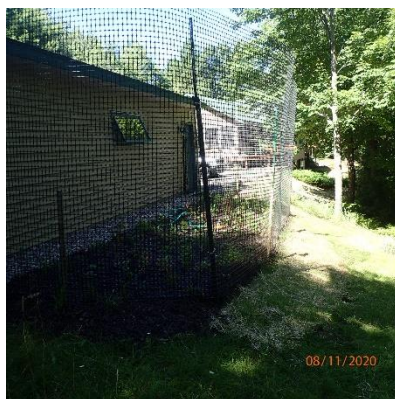
Photo 33: Aug 11, 2020. A rain garden and deer fencing were installed to manage stormwater from the garage.

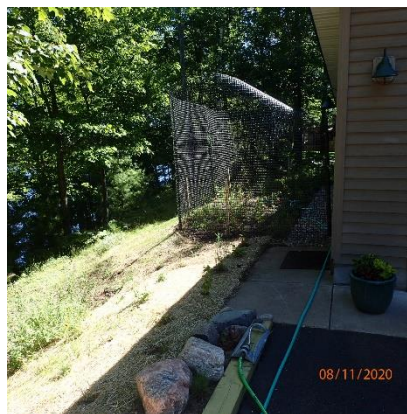
Photo 35: Aug 11, 2020. Rain garden area is contained on flat area before slope.

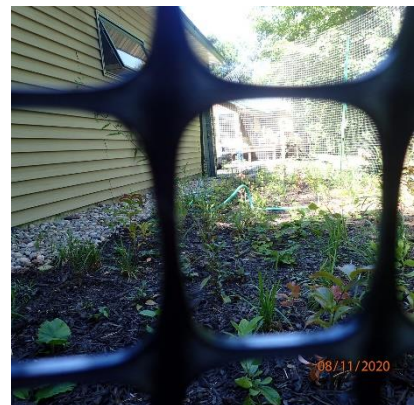
Photo 36: Aug 11, 2020. Native plants were planted, and landowner is watering and weeding as needed.

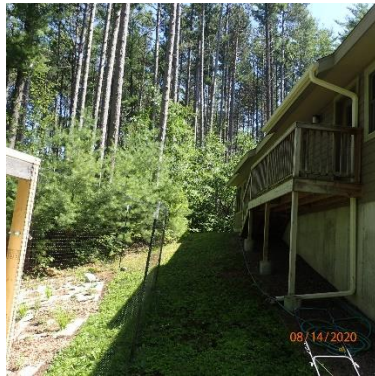
Photo 37: Aug 14, 2020. While this photo shows the rain garden on the right, it shows the roof runoff, gutter, and slope of the site.

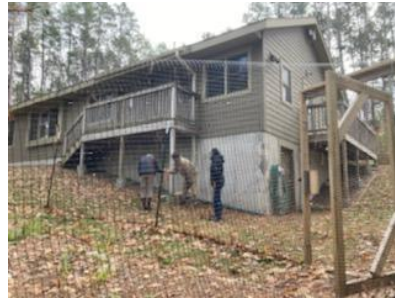
Photo 38: Oct 21, 2020. The photo shows the steep grassed area to the side of the dorm.

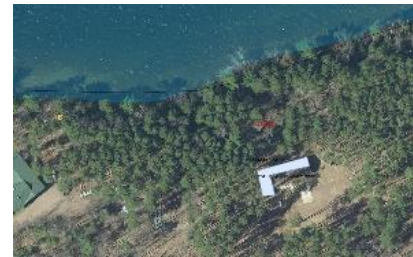
Photo 39: 2015 air photo. Trout Lake's shore is about 180 ft from the runoff area.

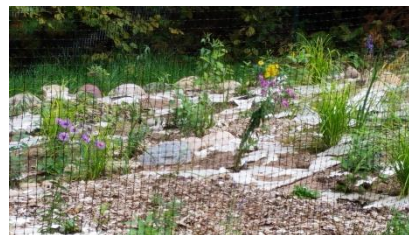
Photo 41: Sep 21, 2020. Native plants were used. Terracing was used to help slow down water on the slope.

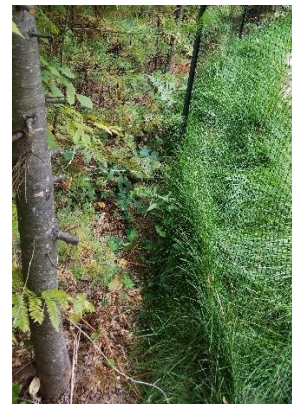
Photo 42: Sep 21, 2020. Even after several heavy rain events, the berm and outside area show no signs of runoff/erosion.
