*Iron County LWCD
Lake Protection Grant
Grant Reimbursement Report
LPT70721
December 10, 2021*

BURNS PROJECT

FLORENCE PROJECT

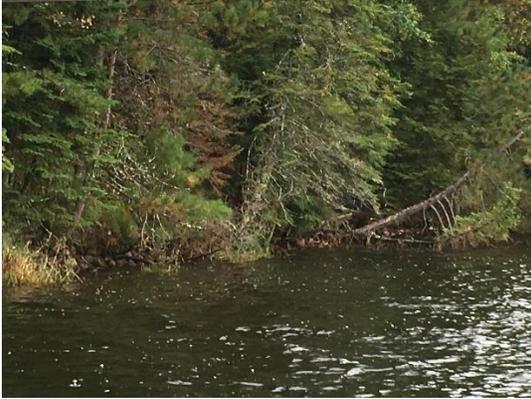
Toe erosion causing loss of trees.

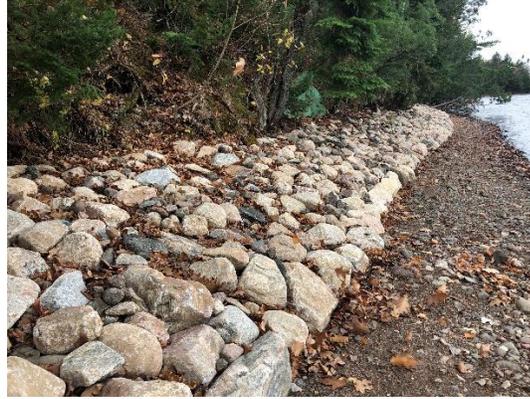
Riprap installed to protect the shoreline.

Project Summary - 140 linear feet of rock riprap was installed at the toe of the bank with a geo-bag installed within the riprap which was planted with a native plant. The planted riprap will provide further stabilization as the roots will make their way to the bank. It will also provide added benefit to wildlife and provide more natural aesthetics. In addition to the riprap, areas of the bank that had sparse vegetation were addressed with supplemental plantings to restore the shoreline. Any area of disturbance from construction was seeded, had erosion mat installed and was planted with native plants to revegetate and stabilize. In total on this property, 154 cubic yards of rock was used to protect the shoreline, every 6 feet there was a geo-bag installed within the riprap and planted with a forb or shrub for a total of 24 planted bags. In addition, there was 10 shrubs and 50 grass plugs planted in areas in need of additional vegetation.

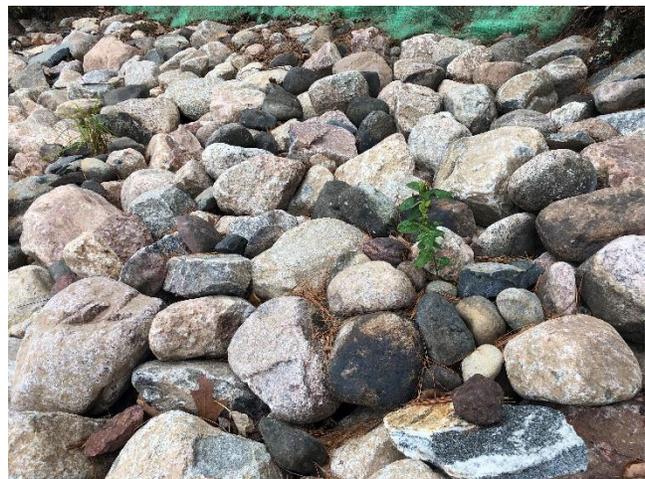
Shrubs planted in geo-bags within the riprap.

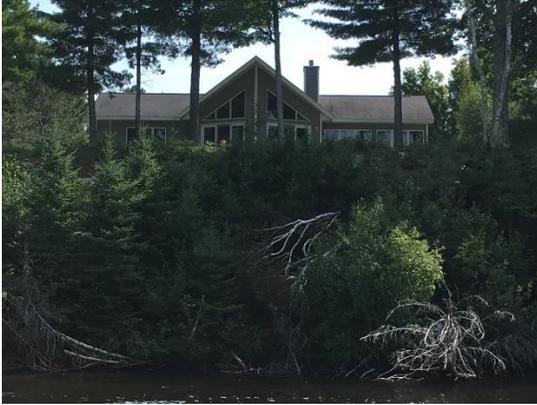
Mature trees lost from failing bank.

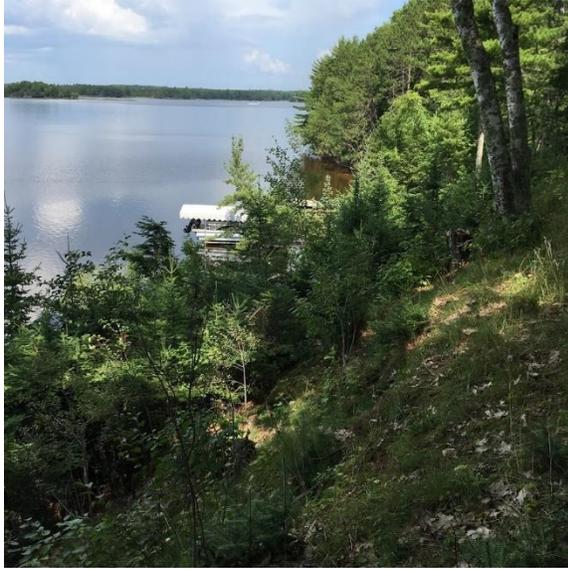
Bank failure at the top of the vegetated slope.

Project Summary - The Florence site was the more extensive project. There was toe erosion on this site along with severe bank failure in several areas on the steep slope where the bank would slough. The area of greatest concern was 65 linear feet of shoreline. This plan consisted of riprap along the toe of the slope with vegetated geo-bag walls being constructed from the top of the rock to the area of the slope that would be stable. Additional vegetated geo-bag walls installed towards the top of the slope to protect the failure point pictured above on the right. Geo-bags were chosen over geo-grids to protect as much existing vegetation on this slope as possible. At the time of the grant application geogrids were planned, however, at the pre-bid meeting geo-bags were discussed and agreed up by all parties. This decision was made as it was easier to save some of the existing vegetation and was the preferred method of labor. The walls were built to an elevation where the natural slope behind is a stable 3:1 slope so vegetation can be reestablished if needed, or natural existing vegetation is be protected. As each bag is placed, a spike is placed at each end of the bag, along with a handful of compost, and a native plant.

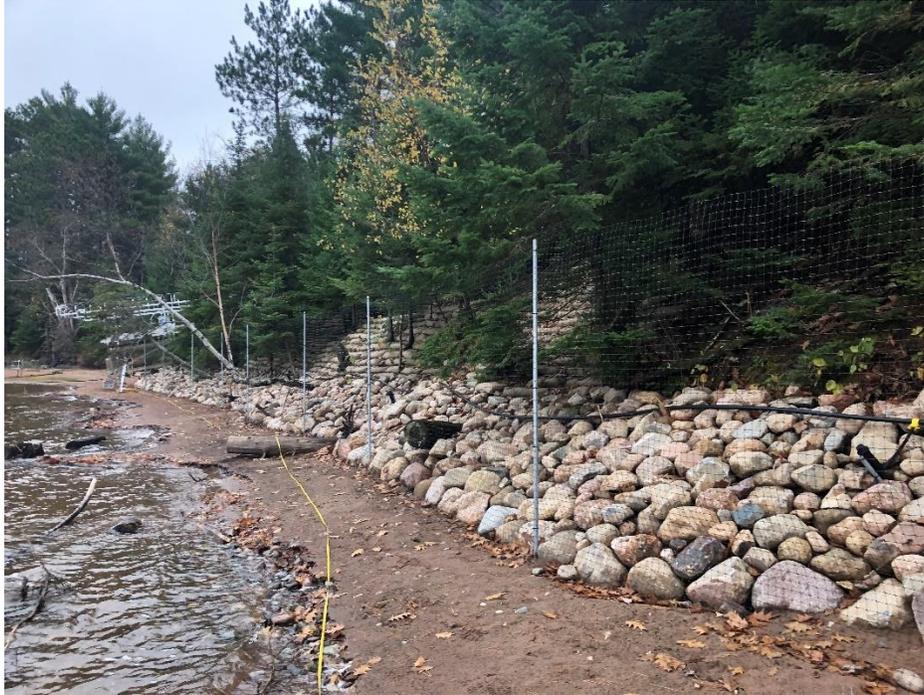
Riprap protecting the toe of the bank and creating a stable foundation to build the vegetated geo-bag walls on. The riprap was installed to incorporate the existing trees that had fallen but were still rooted in the bank.

Construction took place in September, wrapping up in early October with low water levels to access the toe of the bottom of the bank and work upland on the vegetated walls. In total, this project required 120 cubic yards of rock, 1,150 filled geo-bags, 1,534 forbs for the geo-bags, 766 shrubs for the geo-bags, 400 forbs for additional planting and 24 shrubs for additional planting areas. Once the riprap and the walls were constructed a watering system was installed and finally a deer proof fence was put up to protect the plants from any deer browse.

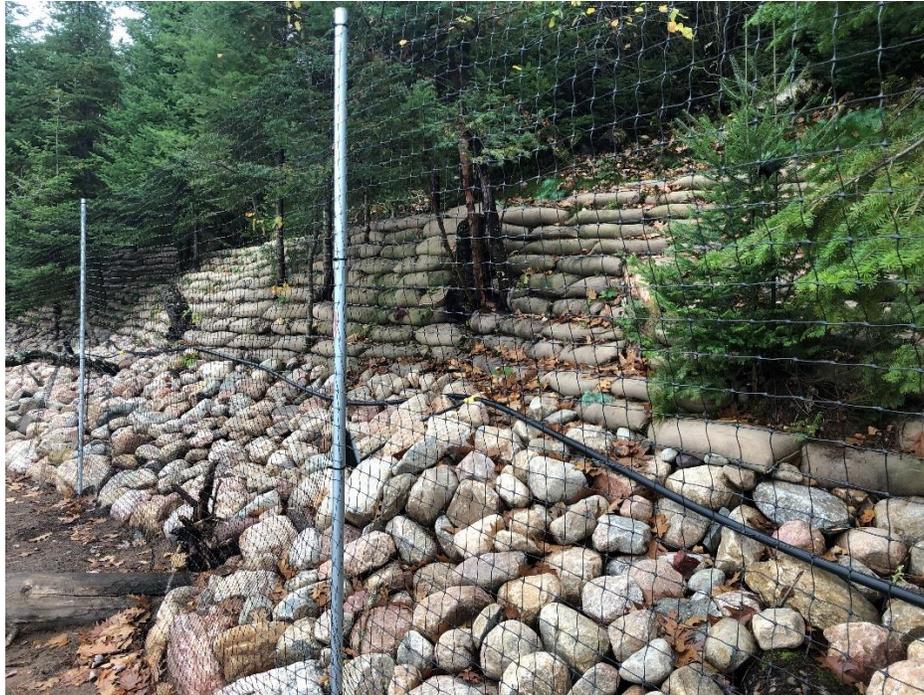
Vegetated walls above the riprap incorporating the existing vegetation, each bag has two plants installed between each row. The black plastic pipe along the rock is the irrigation system and deer fencing was installed to protect the plants.
