Wisconsin Department of Natural Resources  
Surface Water Grants Program  
Aquatic Invasive Species  
Grant # AIRR-23419

## **Buckatabon Lakes Eurasian Watermilfoil Control and Prevention Rapid Response Project**

Upper and Lower Buckatabon Lakes - Vilas County, WI

### **Final Reporting**

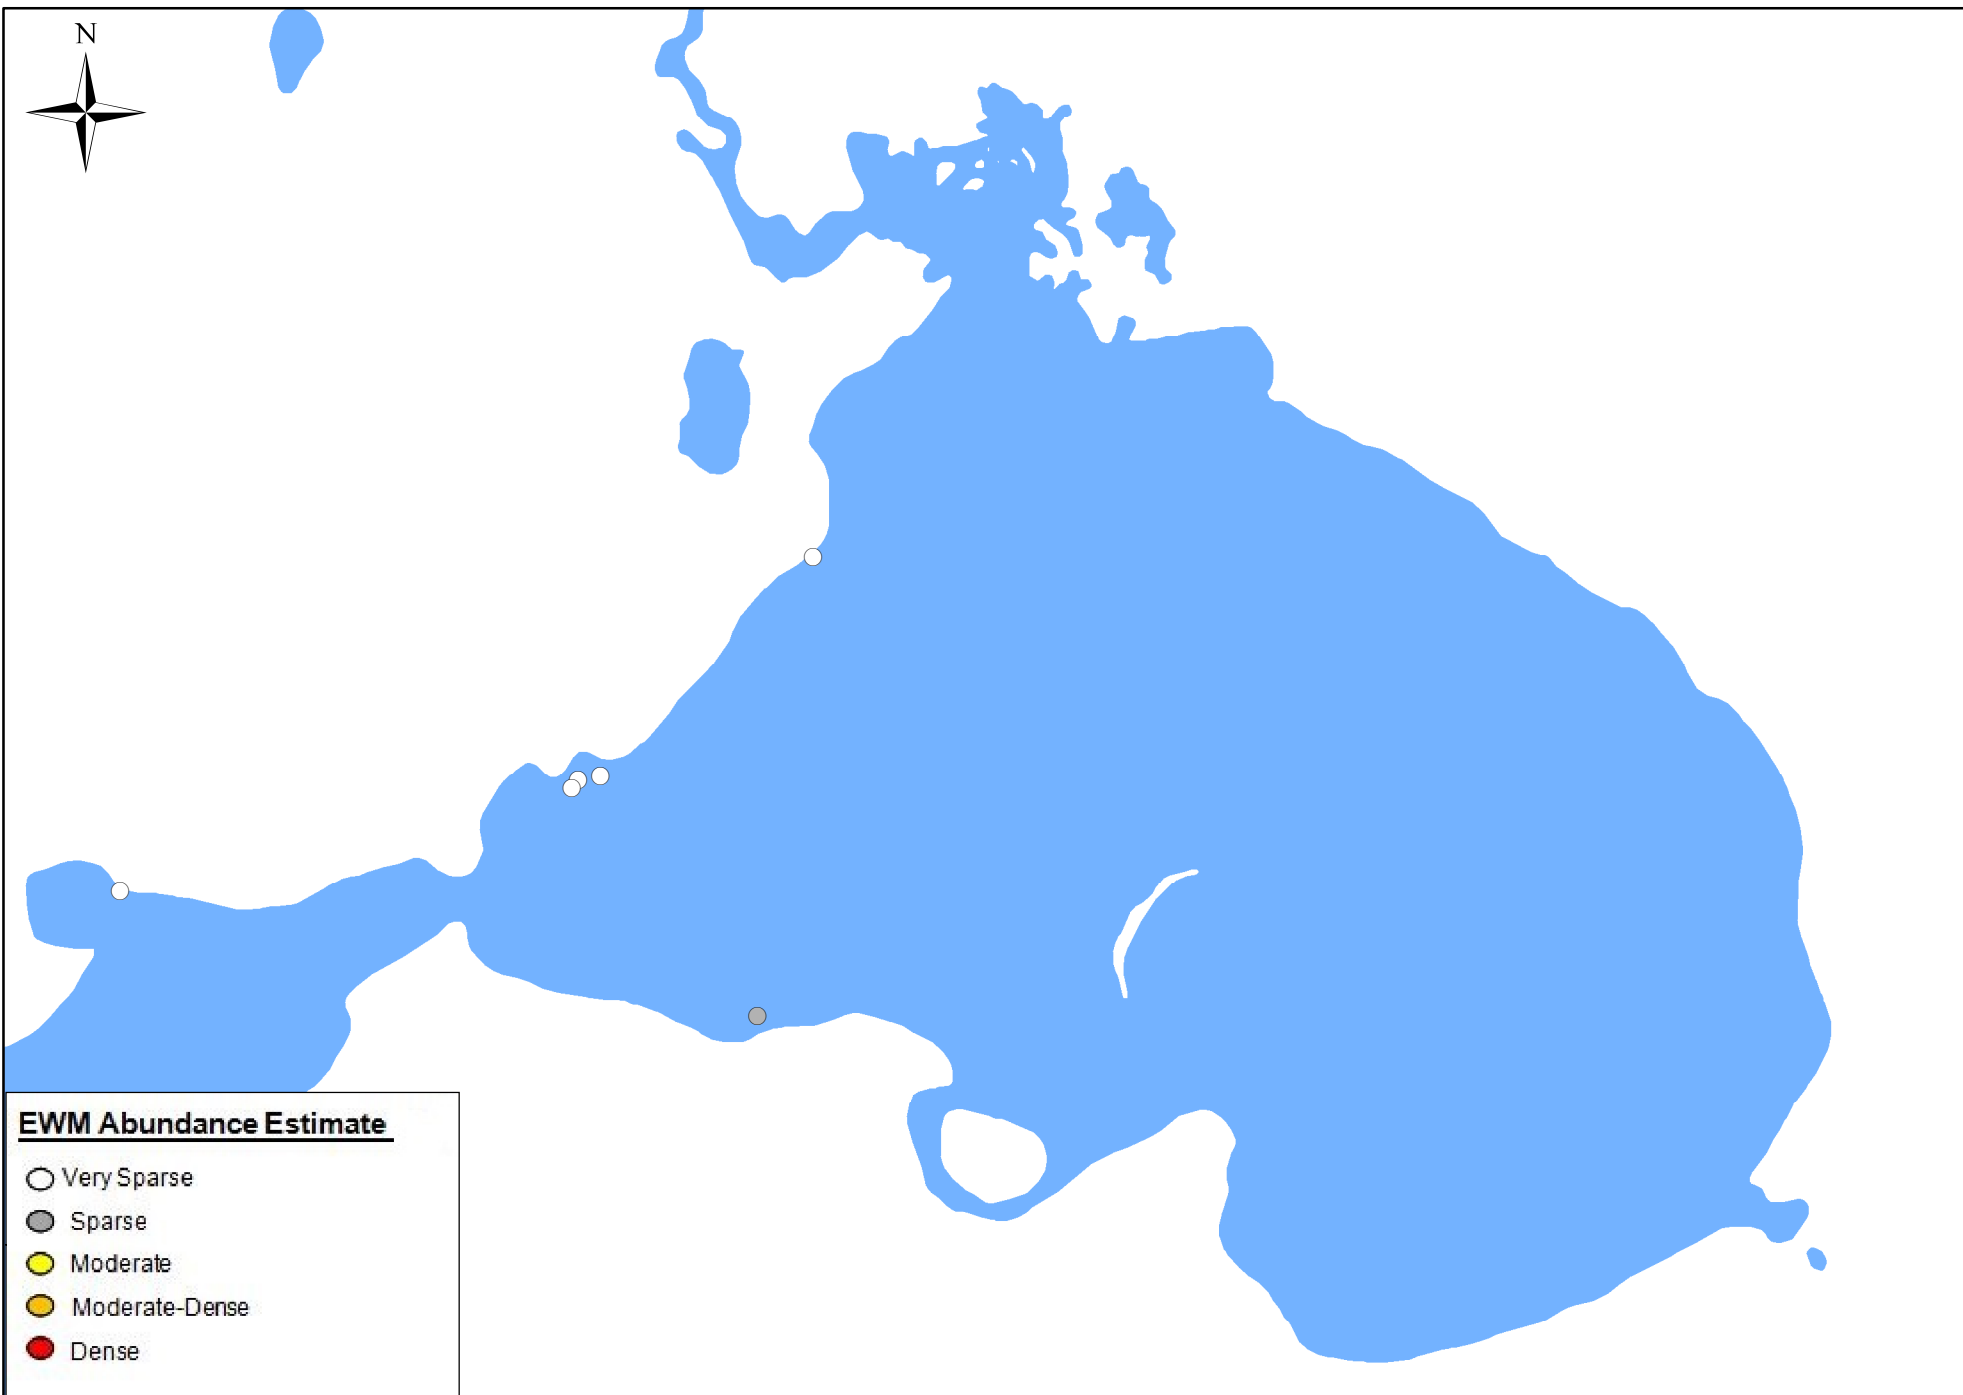
**Early Season EWM Survey  
Lower Buckatabon  
2018**

Lake: Lower Buckatabon, Vilas County, WI  
Map Date & Creator: 4.24.2019 Many Waters, LLC  
Source: WDNR hydro, EWM-Many Waters  
File: Buckatabon\_ES\_2018

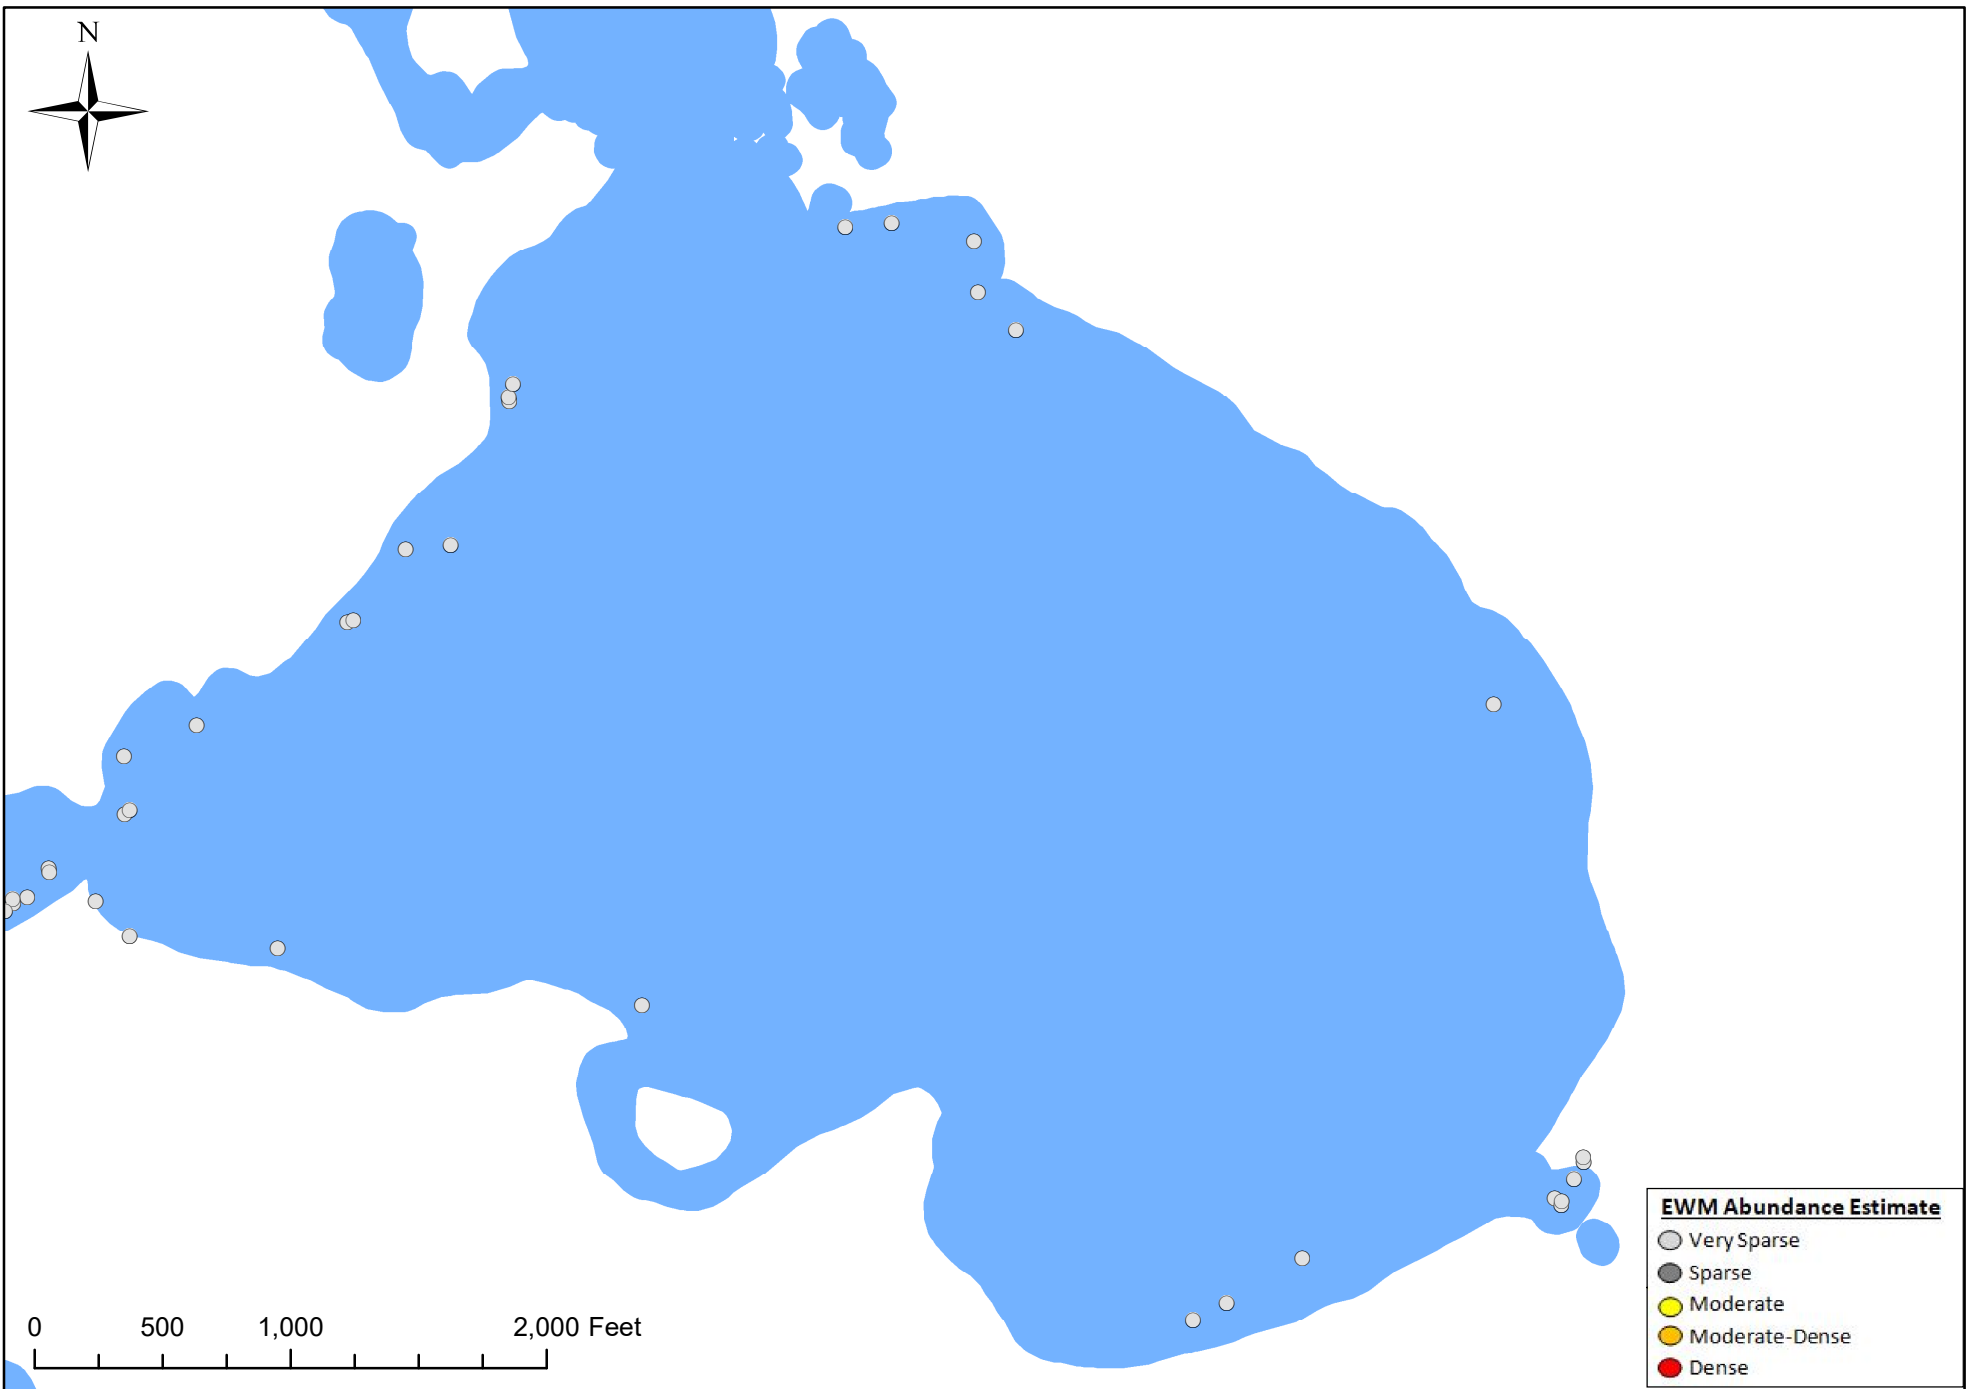
**Lower Buckatabon Lake**  
**Mid/Late Season EWM Survey**  
**2020**

Lake: Lower Buckatabon, Vilas County, WI  
 Map Date & Creator: 10.14.2020, Many Waters, LLC  
 Survey Date: 7.30.2020-8.12.2020  
 Source: WDNR hydro, EWM-Many Waters  
 File: Buckatabon\_MLSS\_2020
