Planning for Protection in the Balsam Lake Watershed  
Final Report for County Lake Grant LPL-1791-21

Prepared by  
Katelin Anderson and Colton Sorensen  
Polk County Land and Water Resources Department  
100 Polk County Plaza, Ste 120  
Balsam Lake, WI 54810

Funded by  
Wisconsin Department of Natural Resources Surface Water Grant Program

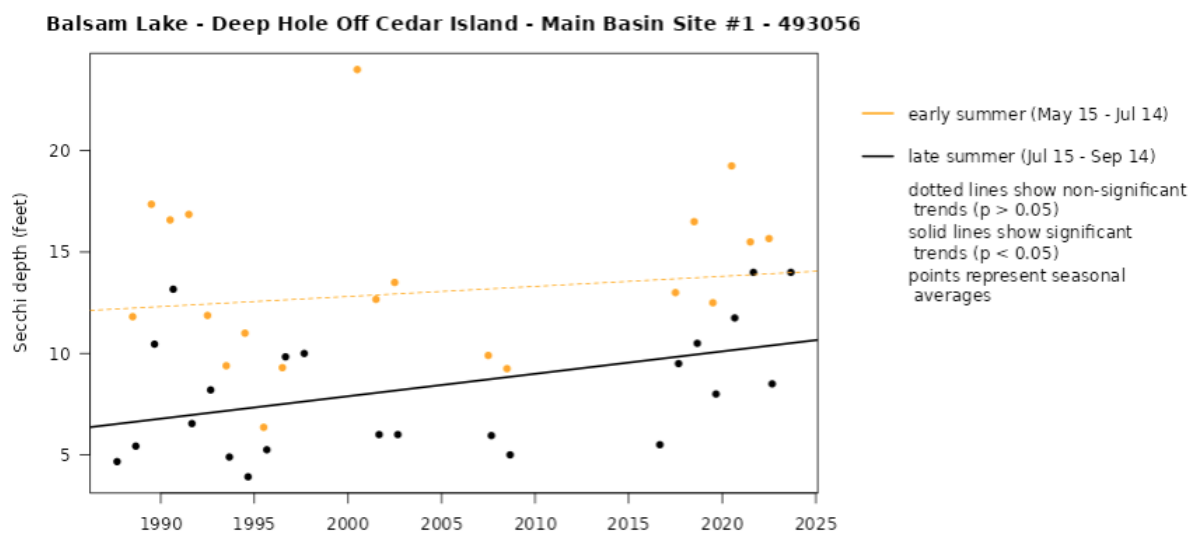
### Trends in Secchi depth

Legend notes: dotted lines show non-significant trends ( $p > 0.05$ ), solid lines show significant trends ( $p < 0.05$ ), and points represent seasonal averages

Balsam Lake has been monitored by volunteers since 1987. The average summer trophic state for the last five years based on secchi depth determined the lake is mesotrophic. Averages for the last ten years for secchi, total phosphorus, and chlorophyll *a* indicate that Balsam Lake has greater water clarity and lower nutrient and algal levels as compared to other shallow lowland lakes. Since 1987, early summer secchi has increased and late summer secchi has significantly increased ( $p < 0.05$ ). Since 1993, late summer total phosphorus has decreased and since 2008 late summer total chlorophyll *a* has decreased.

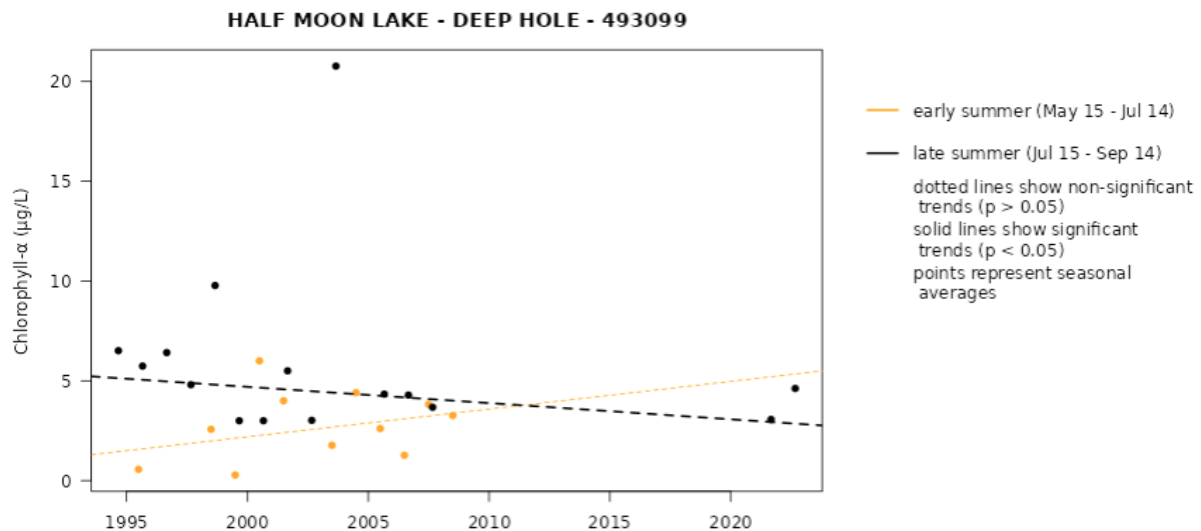
## Trends in chlorophyll- $\alpha$

Legend notes: dotted lines show non-significant trends ( $p > 0.05$ ), solid lines show significant trends ( $p < 0.05$ ), and points represent seasonal averages

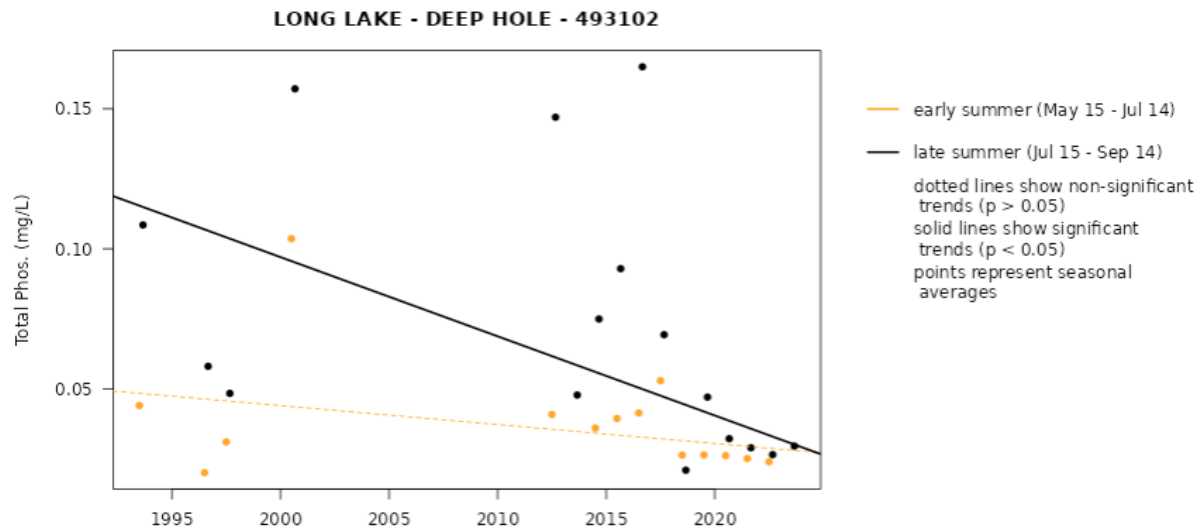
## Trends in total phosphorus

Legend notes: dotted lines show non-significant trends ( $p > 0.05$ ), solid lines show significant trends ( $p < 0.05$ ), and points represent seasonal averages

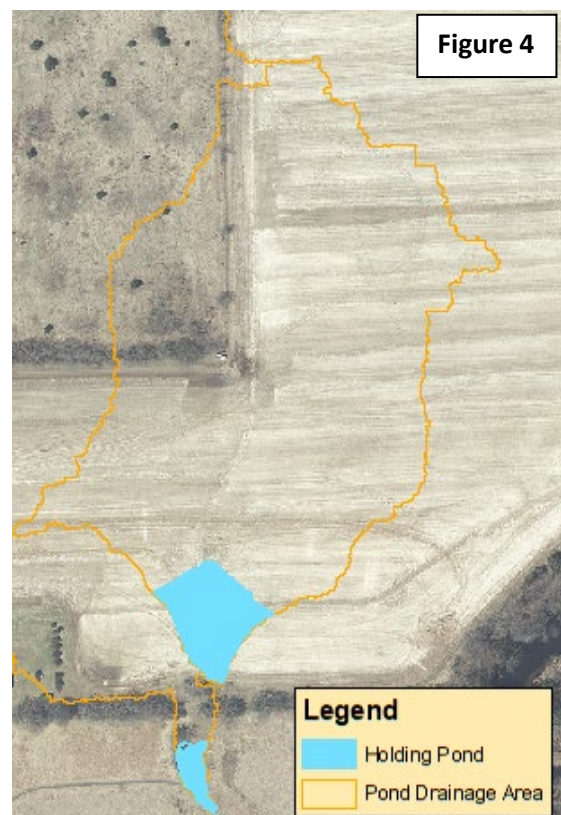
There were 166 areas in the Balsam Lake Watershed that ACPF identified as suitable for a sediment pond. In figure 4 the blue area is the pond, and the orange line is the drainage area for the pond. If overland flow occurs during a rainfall event, any

rainwater that falls within the orange area will drain to the pond. When ponds are prescribed by ACPF, the pond follows the contours of the land in its current state. When the pond is constructed, the landscape will be reshaped so that the project benefits water quality while minimizing the impact to the production of the field and minimizing the loss of tillable ground. The example in figure 4 is a desirable location because much of the drainage area includes agricultural land. However, to reduce the amount of farmable ground lost to the pond itself, shifting the holding area closer to the edge of the field or combining the two ponds may be ideal for this location. Implementing a sediment pond in this location would keep nutrients and sediment from entering surface water and reduce the overall impact from the agricultural practices occurring in this field.

Sediment ponds are depressions that are created in areas of higher slopes where other practices are not suitable. They are designed to catch runoff, reduce erosion, and allow for sediment and nutrients to settle out before entering surface waters. The outlet of the pond is reinforced to ensure no erosion occurs when the pond reaches maximum capacity and outlets to surface water. Sediment ponds are designed to catch runoff from five to one hundred acres of contributing area (drainage area).

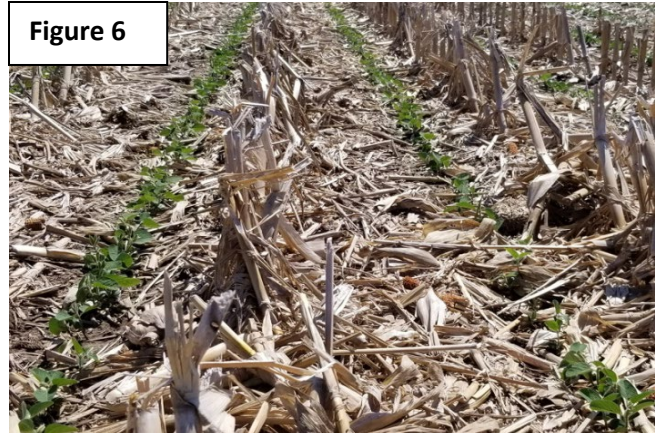
Fields classified as having high runoff risk potential would be excellent candidates for the implementation of no-till or cover crops. No-till planting is a conservation practice where crops are grown without the use of tillage. Soil tillage is a common agricultural practice used to loosen soil, incorporate crop residue and plant nutrients (fertilizer and manure), and prepare a suitable seed bed for planting the crop. However, tillage increases the potential of soil erosion and nutrient runoff. Tillage breaks the soil structure, inhibits the process of soil aggregation, and reduces surface crop residue. Soil is left exposed and more susceptible to the erosive forces of wind and water. An example of no-till can be seen in figure 6.

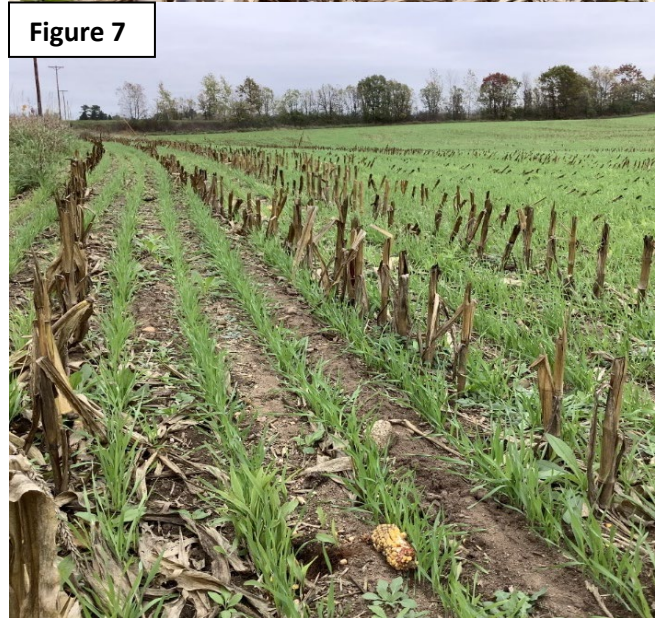
Planting cover crops (as seen in figure 7) is another conservation practice that can reduce agriculture's impact on water quality. Cover crops are plants that are grown outside of the main production crop specifically for their benefits to the soil or main crop. The primary benefit of cover crops is the reduction of erosion. Cover crops reduce erosion because the vegetation and roots protect the soil from early spring and late fall rains when the primary crop is not growing. Cover crops can increase infiltration, capture unused nutrients, build soil structure, promote soil bacteria and fungi growth, break

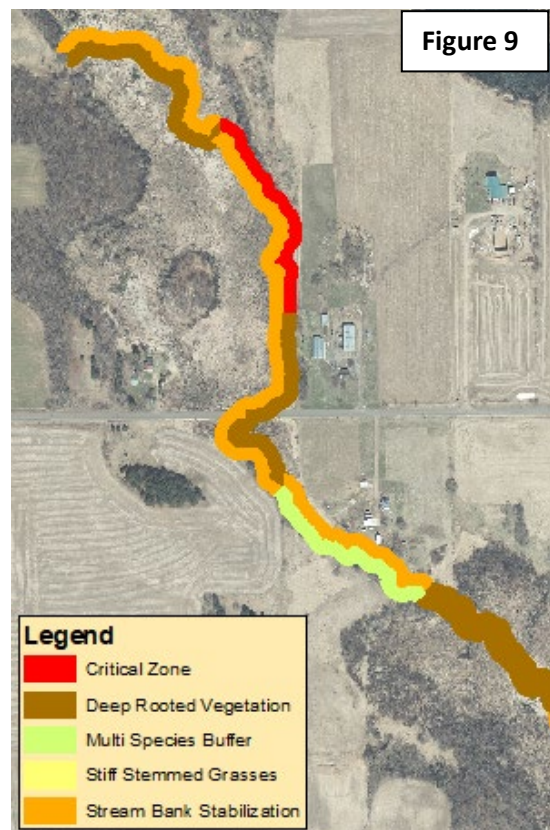
The Balsam Lake Watershed has a diverse network of streams varying in depth, width, flow, substrate, and shoreline condition. There was only one area in the watershed that was identified as a critical zone, with the remainder of the shoreline split between stream bank stabilization (59%), deep rooted vegetation

(20%), stiff stemmed grasses (12%), and multispecies buffer (8%). In areas where deep-rooted vegetation, multispecies buffer, and stiff steamed grasses are prescribed by ACPF, the program believes there is an opportunity for the buffer to intercept surface runoff and/or shallow ground water. When none of these opportunities are possible the critical zone and stream bank stabilization designation is given. Site visits will still need to be conducted to address site suitability and identify the best practice or buffer for the specific site.

The preferred buffer type is determined using slope, land use, and soils. The three main buffer types include deep rooted vegetation, multiple species vegetation, and stiff stemmed grasses. In areas where the three buffer types are inadequate, the tool classifies areas as either critical zones or those requiring additional bank stabilization.
