Towanda Lake

Vilas County, Wisconsin

Comprehensive Management Plan

June 2021

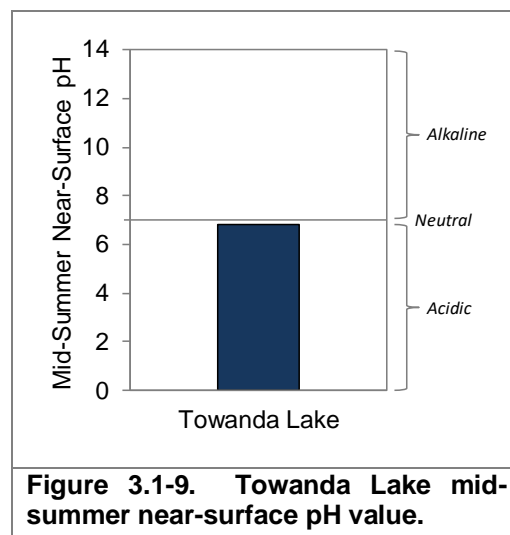
The pH scale ranges from 0 to 14 and indicates the concentration of hydrogen ions (H^+) within the lake's water and is an index of the lake's acidity. Water with a pH value of 7 has equal amounts of hydrogen ions and hydroxide ions (OH^-), and is considered to be neutral. Water with a pH of less than 7 has higher concentrations of hydrogen ions and is considered to be acidic, while values greater than 7 have lower hydrogen ion concentrations and are considered basic or alkaline. The pH scale is logarithmic; meaning that for every 1.0 pH unit the hydrogen ion concentration changes tenfold. The normal range for lake water pH in Wisconsin is about 5.2 to 8.4, though values lower than 5.2 can be observed in some acid bog lakes and higher than 8.4 in some marl lakes. In lakes with a pH of 6.5 and lower, the spawning of certain fish species such as walleye becomes inhibited (Shaw and Nimphius 1985). The pH of the water in Towanda Lake was found to be near neutral with a value of 6.8, and falls within the normal range for Wisconsin Lakes (Figure 3.1-9).

Figure 3.1-9. Towanda Lake mid-summer near-surface pH value.

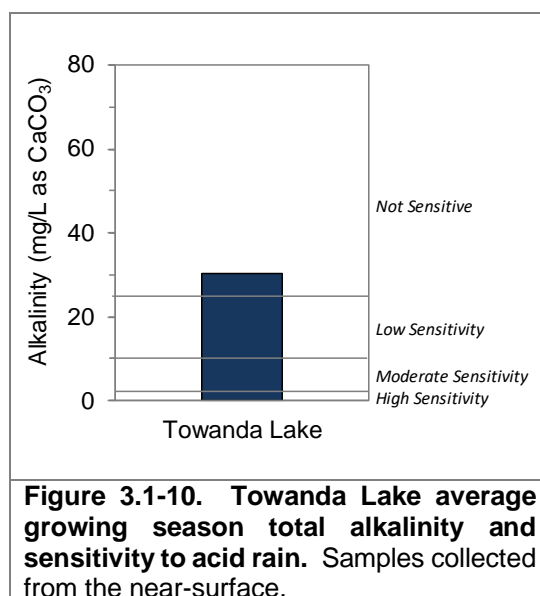
Alkalinity is a lake's capacity to resist fluctuations in pH by neutralizing or buffering against inputs such as acid rain. The main compounds that contribute to a lake's alkalinity in Wisconsin are bicarbonate (HCO_3^-) and carbonate (CO_3^{2-}), which neutralize hydrogen ions from acidic inputs. These compounds are present in a lake if the groundwater entering it comes into contact with minerals such as calcite ($CaCO_3$) and/or dolomite ($CaMgCO_3$). A lake's pH is primarily determined by the amount of alkalinity. Rainwater in northern Wisconsin is slightly acidic naturally due to dissolved carbon dioxide from the atmosphere with a pH of around 5.0. Consequently, lakes with low alkalinity have lower pH due to their inability to buffer against acid inputs. The alkalinity in Towanda Lake was measured at 30 (mg/L as $CaCO_3$), indicating that the lake has a substantial capacity to resist fluctuations in pH and has a low sensitivity to acid rain (Figure 3.1-10).

Figure 3.1-10. Towanda Lake average growing season total alkalinity and sensitivity to acid rain. Samples collected from the near-surface.

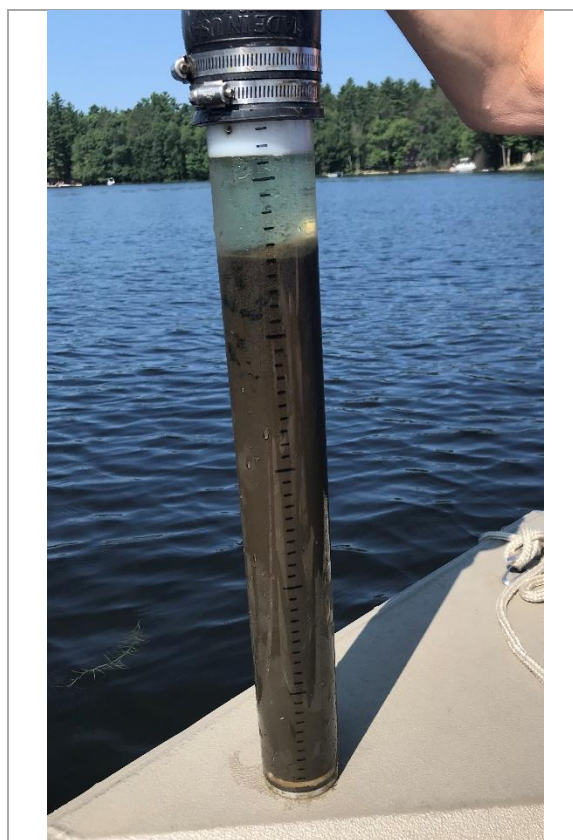
A sediment core was collected from the deep area in Towanda Lake by Onterra staff on July 30, 2018. The total length of the core was 45 cm. The top 20 cm of the core was dark brown in color. From 20 to 45 cm the sediment was medium gray in color (Photo 3.2-2). The color change in the lower part of the core likely indicates this sediment was deposited prior to the twentieth century. The top 1 cm was kept for analysis and it is assumed this represents present day water quality conditions in the lake. A bottom sample, 42-44 cm, was analyzed and this is assumed to represent conditions before the arrival Euroamerican settlers in the nineteenth century.

Photo 3.2-2. Photo of sediment core collected from Towanda Lake. Below 15 cm the color changed from dark brown to lighter brown which likely signifies when logging occurred.

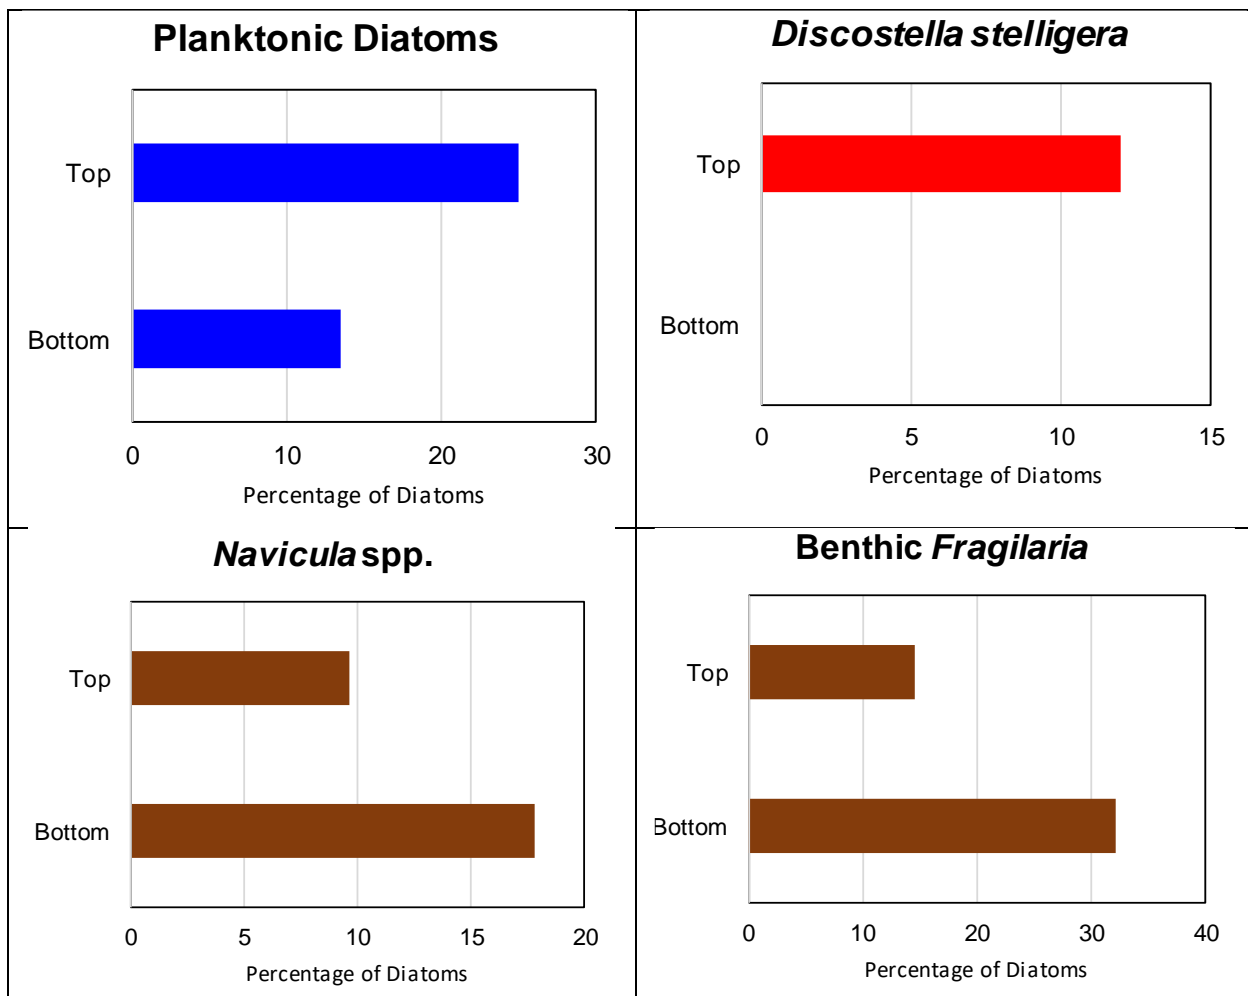
Figure 3.2-2. Changes in abundance of important diatoms found in the top and bottom of the sediment core from Towanda Lake. The diatom community at the bottom of the core was dominated by benthic diatoms, esp. benthic *Fragilaria*. The decline in these taxa as well as the increase in planktonic diatoms indicates a small increase in the lake's productivity.

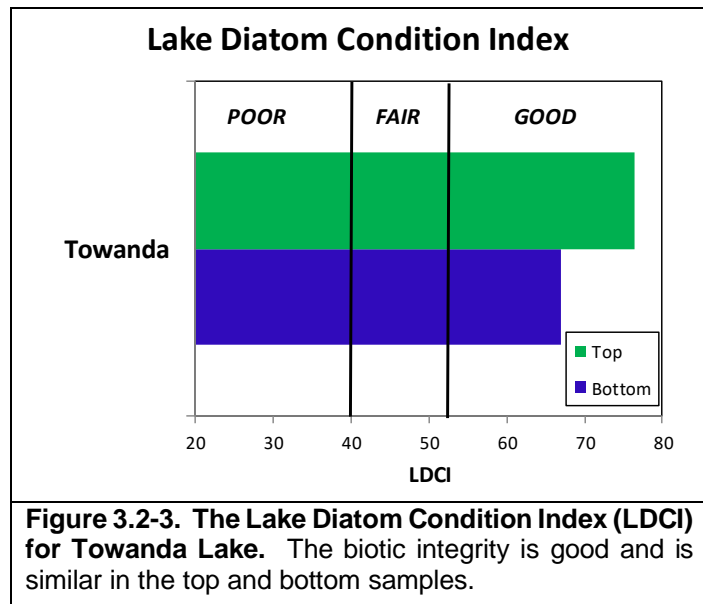
Figure 3.2-3. The Lake Diatom Condition Index (LDCI) for Towanda Lake. The biotic integrity is good and is similar in the top and bottom samples.

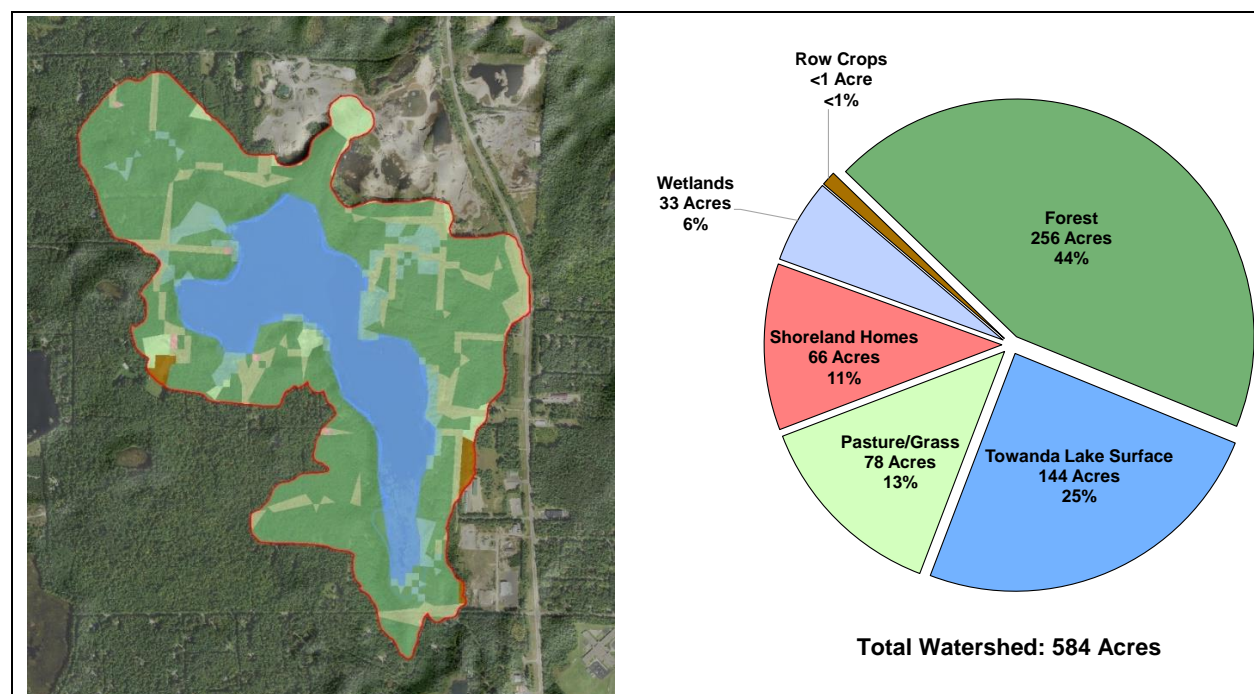
Figure 3.3-1. Towanda Lake watershed boundary (red line) and proportion of land cover types. Based upon National Land Cover Database (NLCD – Fry et. al 2011).

Wisconsin Lakes Modeling Suite (WiLMS) modeling indicates that Towanda Lake's residence time is approximately 1.1 year, or the water within the lake is completely replaced 0.9 times per year.

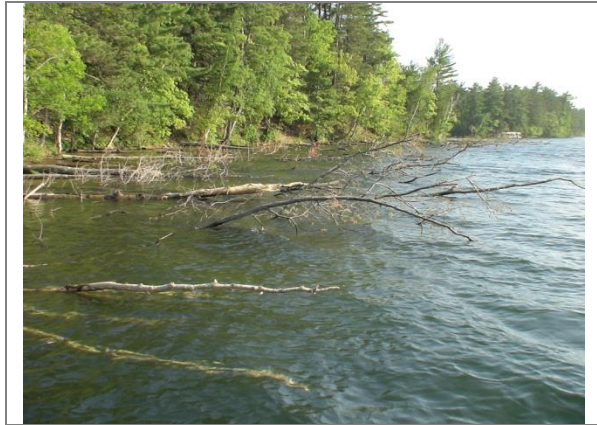
Photograph 3.4-1. Example of coarse woody habitat in a lake.

Emerging research in Wisconsin has shown that coarse woody habitat (sometimes called “coarse woody debris”), often stemming from natural or undeveloped shorelands, provides many ecosystem benefits in a lake. Coarse woody habitat describes habitat consisting of trees, limbs, branches, roots and wood fragments at least four inches in diameter that enter a lake by natural or human means. Coarse woody habitat provides shoreland erosion control, a carbon source for the lake, prevents suspension of sediments and provides a surface for algal growth which important for aquatic macroinvertebrates (Sass 2009). While it impacts these aspects considerably, one of the greatest benefits coarse woody habitat provides is habitat for fish species.

Coarse woody habitat has shown to be advantageous for fisheries in terms of providing refuge, foraging area, as well as spawning habitat (Hanchin et al 2003). In one study, researchers observed 16 different species occupying coarse woody habitat areas in a Wisconsin lake (Newbrey et al. 2005). Bluegill and bass species in particular are attracted to this habitat type; largemouth bass stalk bluegill in these areas while the bluegill hide amongst the debris and often feed upon many macroinvertebrates found in these areas, who themselves are feeding upon algae and periphyton growing on the wood surface. Newbrey et al. (2005) found that some fish species prefer different complexity of branching on coarse woody habitat, though in general some degree of branching is preferred over coarse woody habitat that has no branching.

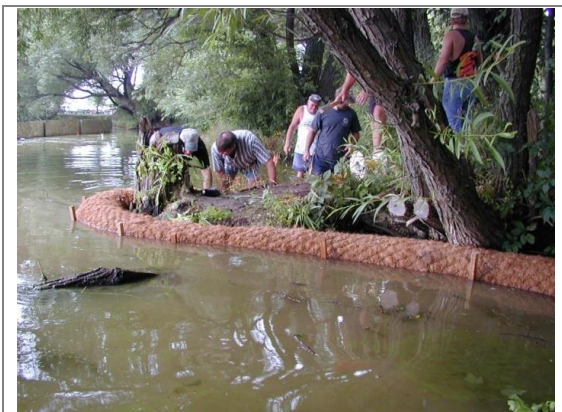
Photograph 3.4-2. Example of a biolog restoration site.

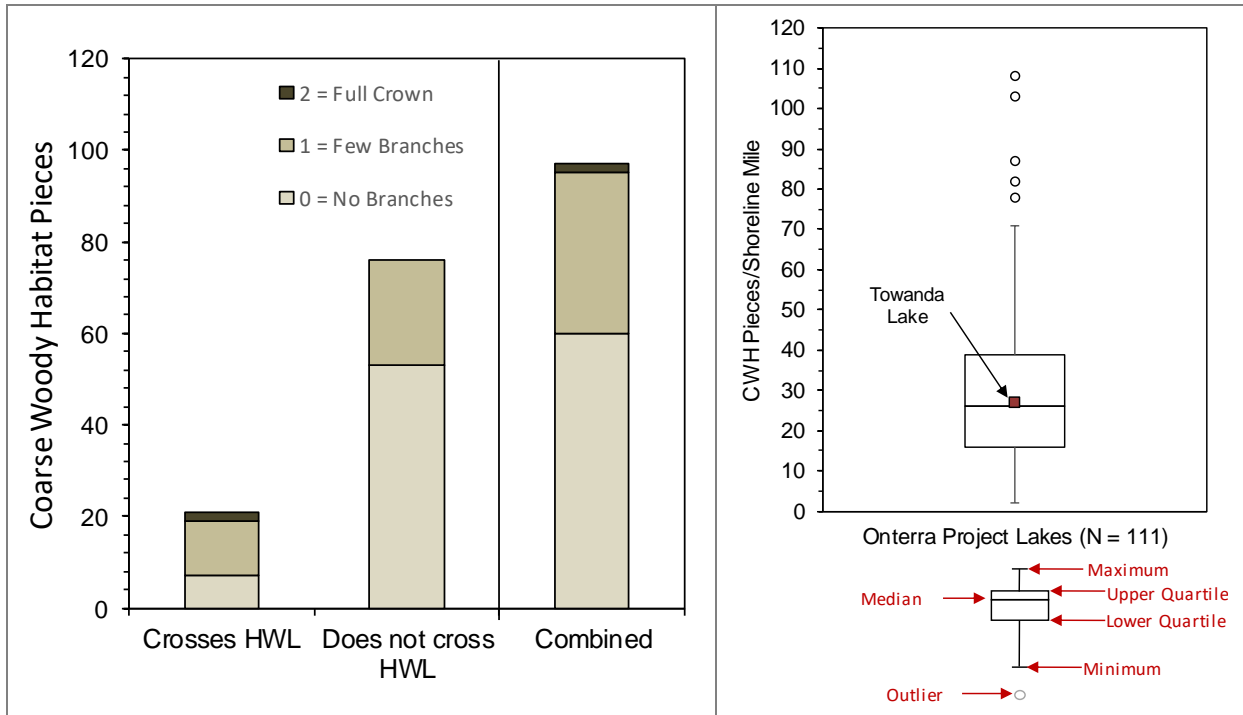
Figure 3.4-1. Towanda Lake coarse woody habitat survey results. Based upon a summer 2019 survey. Locations of Towanda Lake coarse woody habitat can be found on Map 6.

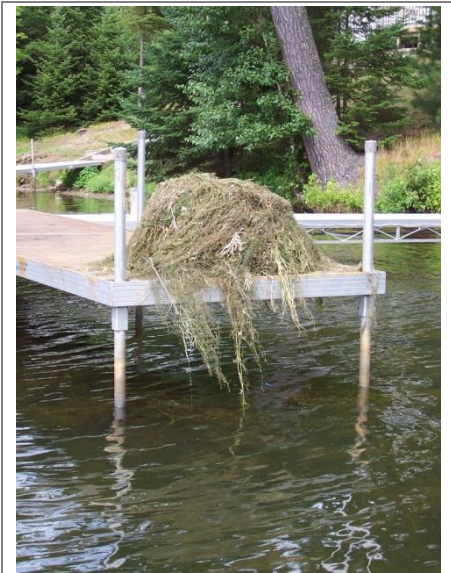
Photograph 3.5-2. Example of aquatic plants that have been removed manually.

Manual removal methods include hand-pulling, raking, and hand-cutting. Hand-pulling involves the manual removal of whole plants, including roots, from the area of concern and disposing them out of the waterbody. Raking entails the removal of partial and whole plants from the lake by dragging a rake with a rope tied to it through plant beds. Specially designed rakes are available from commercial sources or an asphalt rake can be used. Hand-cutting differs from the other two manual methods because the entire plant is not removed, rather the plants are cut similar to mowing a lawn; however, Wisconsin law states that all plant fragments must be removed. One manual cutting technique involves throwing a specialized “V” shaped cutter into the plant bed and retrieving it with a rope. The raking method entails the use of a two-sided straight blade on a telescoping pole that is swiped back and forth at the base of the undesired plants.

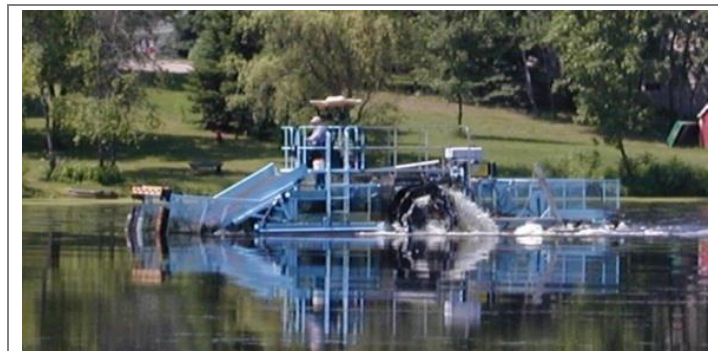
Photograph 3.5-3. Mechanical harvester.

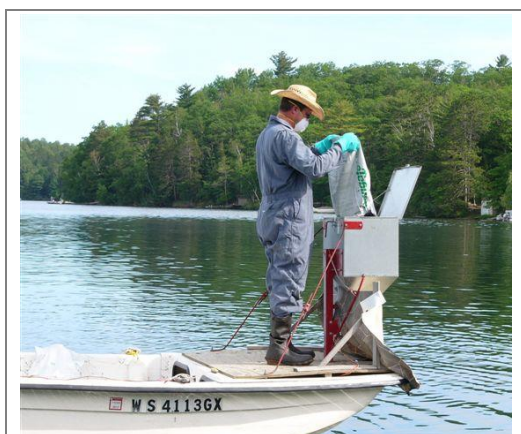
Photograph 3.5-4. Granular herbicide application.

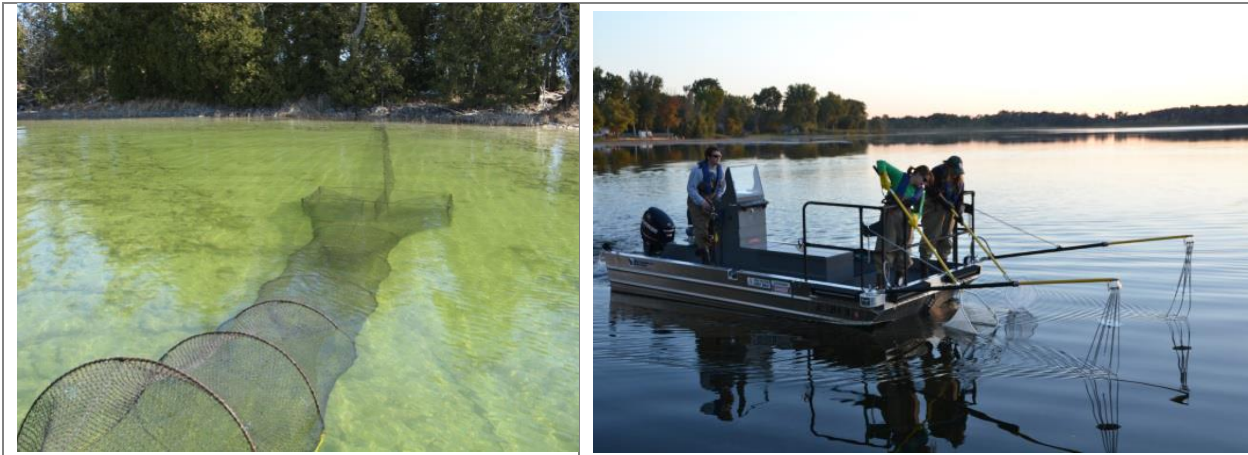
Photograph 3.7-1. Fyke net positioned in the littoral zone of a Wisconsin Lake (left) and an electroshocking boat (right).

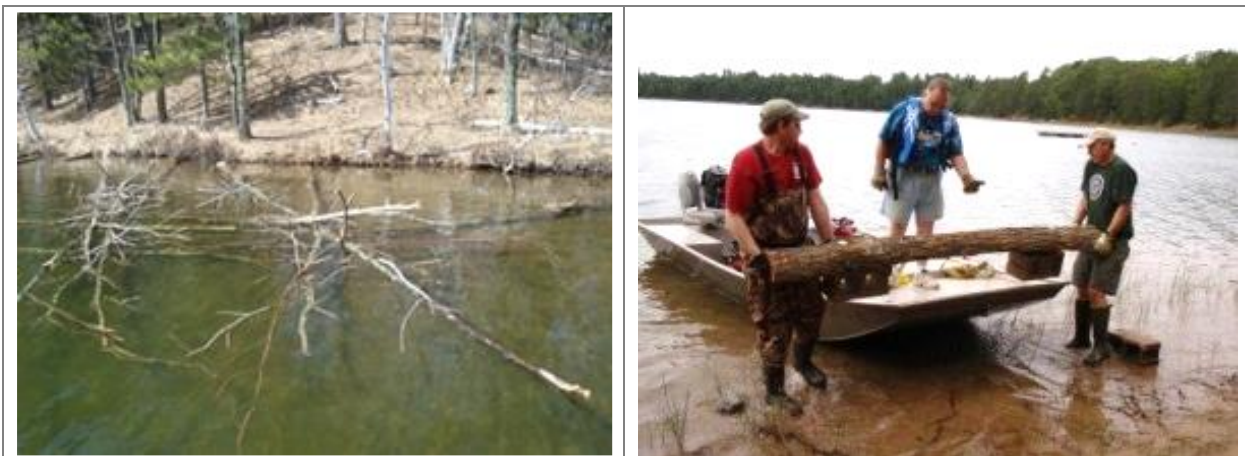
Photograph 3.7-3. Examples of fish sticks (left) and half-log habitat structures. (Photos by WDNR)
