Aquatic Plant Survey of Beaver Lake

Washburn County, Wisconsin
July 2021

Survey and report completed by:
Aquatic Plant & Habitat Services, LLC
Sara Hatleli
715-299-4604, Sarahatleli97@gmail.com
With field survey assistance from AEM Consulting

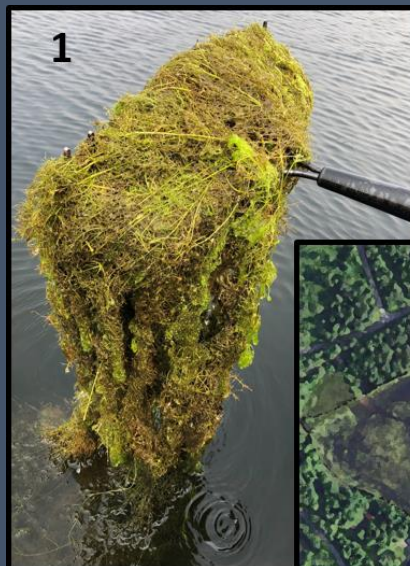
Photos from Cover Page

1. Rake sample of large purple bladderwort from Beaver Lake in 2021.
2. Northwest bay and boggy shoreline of Beaver Lake.
3. Large purple bladderwort was the most commonly occurring plant in Beaver Lake.
4. Aerial imagery and shoreline illustration of Beaver Lake.

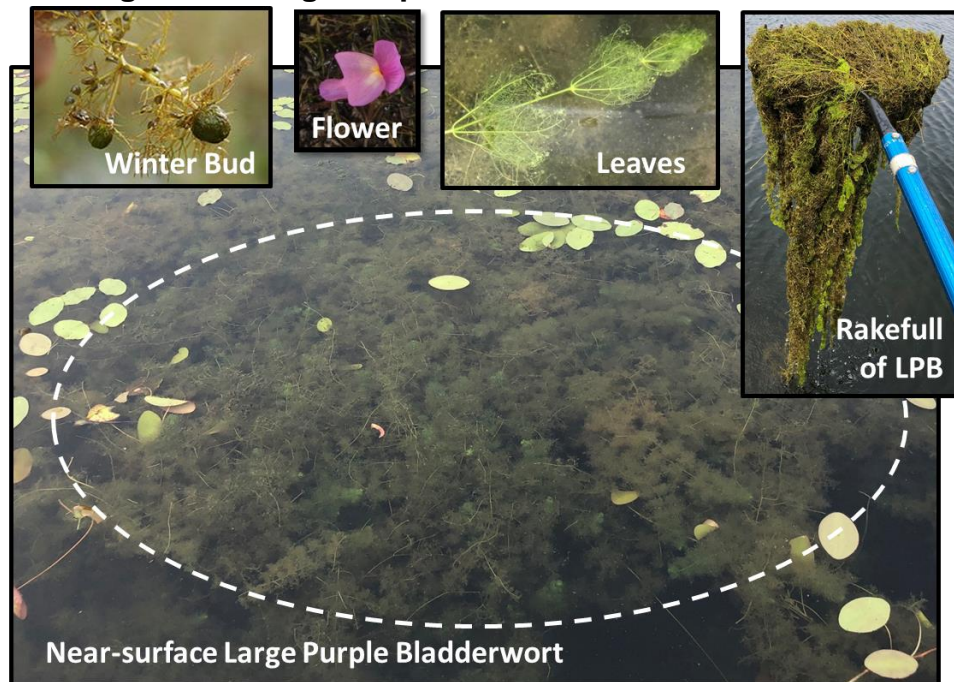
Figure 8 – Large Purple Bladderwort Photos

Although LPB is a native plant species with a high conservatism value of 9 and generally thought of as a desirable plant, it can sometimes grow abundantly and cause frustration for lake residents. Populations can often fluctuate from one year to the next. High abundance and subsequent nuisance conditions created by LPB is a relatively new phenomenon (15 years) in northwest Wisconsin in seepage lakes similar to Beaver Lake. As a member of the bladderwort family, LPB lacks roots and is generally free-floating but is sometimes anchored to the bottom sediment by plant parts. The finely divided leaves have bladder-like carnivorous traps, believed to be for capturing and digesting microorganisms that provide the plant with nutrients. Recent information suggests that bladders are more often observed to contain bacteria, algae, and diatoms living in the bladders, not as prey, suggesting that the bladders perform mutually beneficial relationships with some organisms¹. If the plant flowers, purple flowers are held on stalks above the lake surface. LPB reproduces by seed and winter buds (turions), which are structures that forms at the tip of each branch at the end of summer, drop to the lake bottom, and grow the following spring. A single "stem" of bladderwort has a growing end where new growth and branching occurs. The opposite end of that "stem" is the dying end where decay occurs. This suggests the plant does not necessarily fragment but one "stem" (actually a stolon) can branch many times yielding many plants as the stolon decays from the dying end.
