Chilton Millpond

Comprehensive Management Plan

November 2023

Created by: Tim Hoyman, Josephine Barlament, Kelsey Wilcox, and Andrew Senderhauf
Onterra, LLC
De Pere, WI

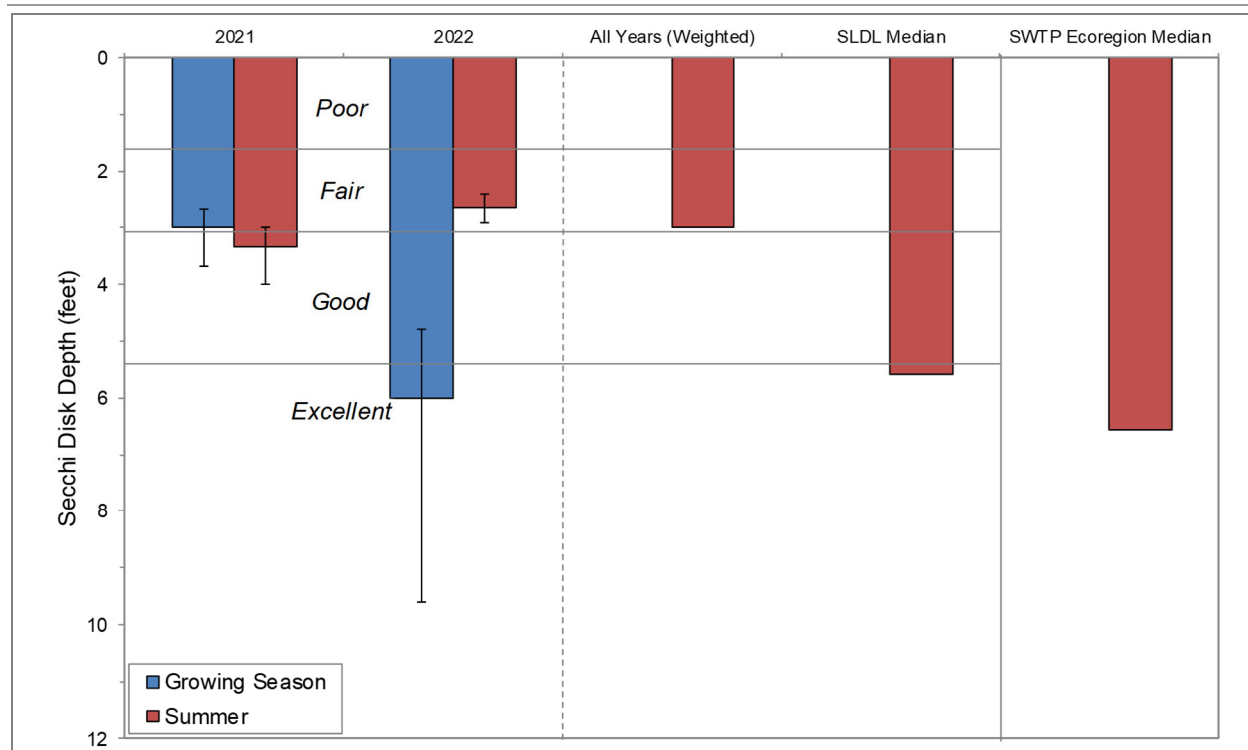
Figure 3.1-5. Chilton Millpond, statewide class 4 lakes, and regional Secchi disk clarity values. Mean values calculated with summer month surface sample data. Water Quality Index values adapted from WDNR PUB WT-913.

Water clarity is controlled by suspended particles in the water column (turbidity) and light absorption due to color. In the Chilton Millpond, the primary factor controlling water clarity is color. As detailed below, the millpond has tea-colored water, which limits light penetration. Suspended sediment likely also plays a role at times, as well.

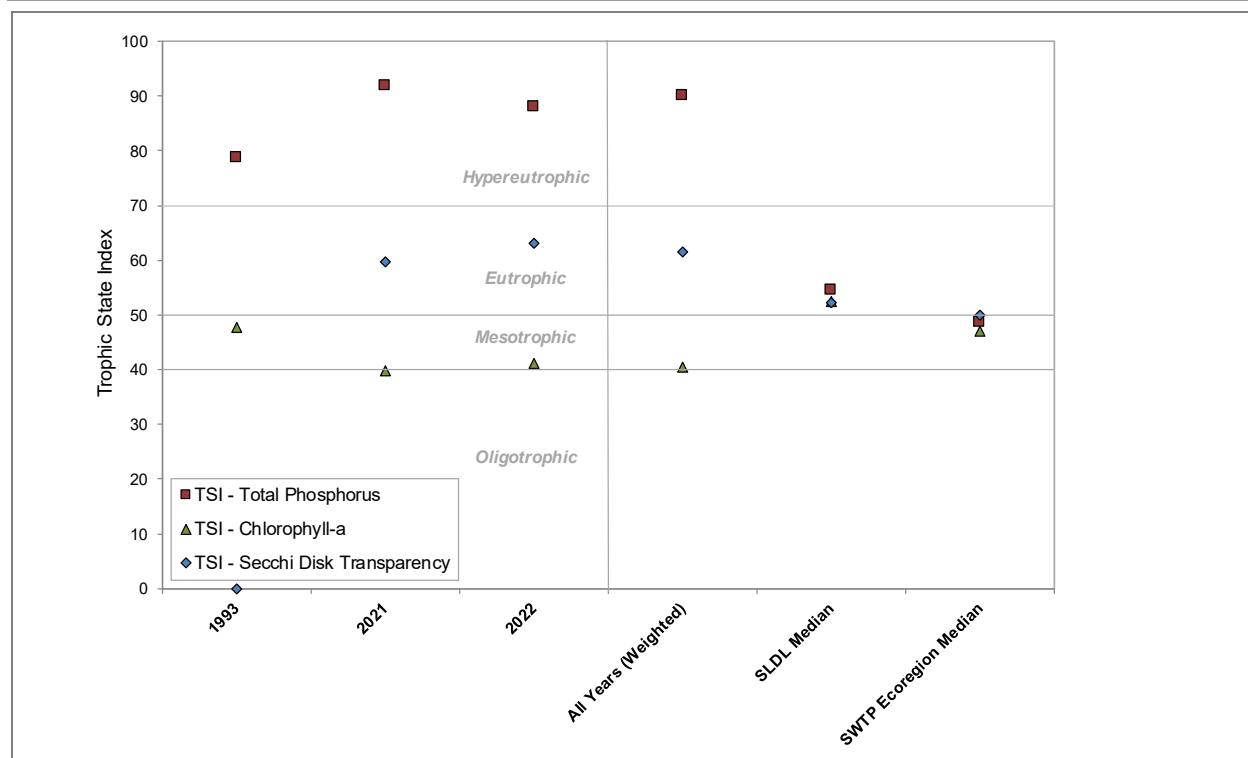
Figure 3.1-6. Chilton Millpond, statewide class 4 lakes, and regional Trophic State Index values. Values calculated with summer month surface sample data using WDNR PUB-WT-193.

Figure 3.1-5 contains the Trophic State Index (TSI) values for Chilton Millpond. The TSI values are calculated with average Secchi disk, chlorophyll-*a*, and total phosphorus values. Typically, the values are similar between the three parameters because of the relationship of the three trophic parameters. This can be seen with the TSI values calculated for the median values from the Southeastern Wisconsin Till Plains ecoregion and statewide shallow headwater drainage lakes. The trophic level of a lake is an indicator of nutrification and productivity within the lake. Phosphorus values in Chilton Millpond are quite high, so using those values to calculate TSI indicates the lake has unhealthy (hypereutrophic) levels of nutrients; however, the lake’s very low chlorophyll-*a* values produce TSI values within the low mesotrophic range. The millpond’s Secchi disk values are high impacted by water color, which is not related to its trophic state; therefore, the TSI values produced with Secchi disk values are unrepresentative in this analysis (Figure 3.1-6). To approximate the trophic level of Chilton Millpond, we need to consider its macrophyte population, which is quite dense in much of the lake. That high level of plant production indicates that the lake is likely eutrophic.

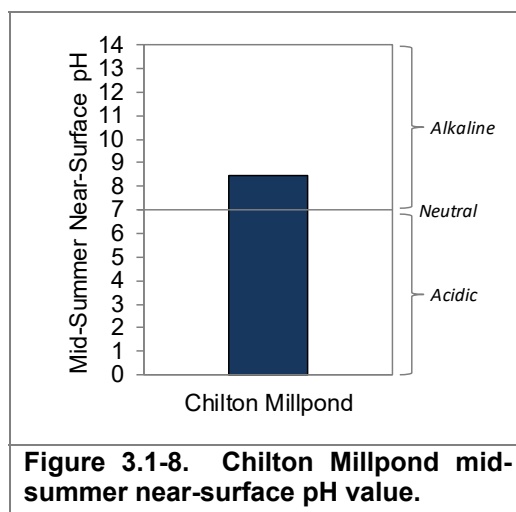
Figure 3.1-8. Chilton Millpond mid-summer near-surface pH value.

The pH scale ranges from 0 to 14 and indicates the concentration of hydrogen ions (H^+) within the lake's water and is an index of the lake's acidity. Water with a pH value of 7 has equal amounts of hydrogen ions and hydroxide ions (OH^-), and is considered to be neutral. Water with a pH of less than 7 has higher concentrations of hydrogen ions and is considered to be acidic, while values greater than 7 have lower hydrogen ion concentrations and are considered basic or alkaline. The pH scale is logarithmic; meaning that for every 1.0 pH unit the hydrogen ion concentration changes tenfold. The normal range for lake water pH in Wisconsin is about 5.2 to 8.4, though values lower than 5.2 can be observed in some acid bog lakes and higher than 8.4 in some marl lakes. In lakes with a pH of 6.5 and lower, the spawning of certain fish species such as walleye becomes inhibited (Shaw & Nimphius, 1985). The pH of the water in Chilton Millpond was found to be slightly alkaline with a value of 8.4, and falls within the normal range for Wisconsin Lakes (Figure 3.1-8).

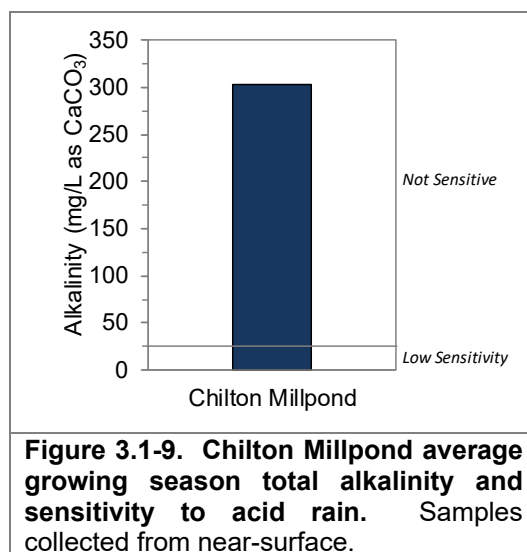
Figure 3.1-9. Chilton Millpond average growing season total alkalinity and sensitivity to acid rain. Samples collected from near-surface.

Alkalinity is a lake's capacity to resist fluctuations in pH by neutralizing or buffering against inputs such as acid rain. The main compounds that contribute to a lake's alkalinity in Wisconsin are bicarbonate (HCO_3^-) and carbonate (CO_3^{2-}), which neutralize hydrogen ions from acidic inputs. These compounds are present in a lake if the groundwater entering it comes into contact with minerals such as calcite ($CaCO_3$) and/or dolomite ($CaMgCO_3$)₂. A lake's pH is primarily determined by the amount of alkalinity. Rainwater in northern Wisconsin is slightly acidic naturally due to dissolved carbon dioxide from the atmosphere with a pH of around 5.0. Consequently, lakes with low alkalinity have lower pH due to their inability to buffer against acid inputs. The alkalinity in Chilton Millpond was measured at 303 mg/L as $CaCO_3$, indicating that the lake has a substantial capacity to resist fluctuations in pH and has a low sensitivity to acid rain (Figure 3.1-9).

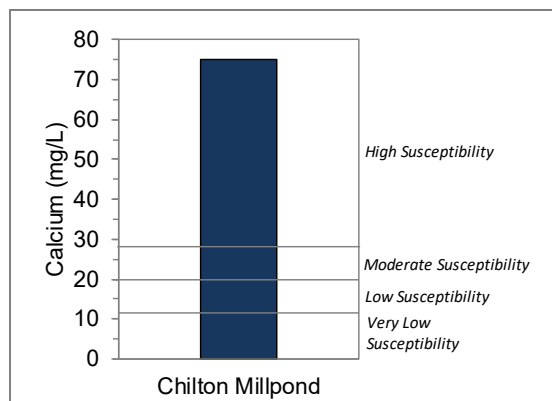
Figure 3.1-10. Chilton Millpond spring calcium concentration and zebra mussel susceptibility. Samples collected from the near-surface.

has been used to determine what lakes can support zebra mussel populations if they are introduced. The commonly accepted pH range for zebra mussels is 7.0 to 9.0, so Chilton Millpond’s pH of 8.4 falls inside of this range. Lakes with calcium concentrations of less than 12 mg/L are considered to have very low susceptibility to zebra mussel establishment. The calcium concentration of Chilton Millpond was found to be 75.1 mg/L, falling well within the optimal range for zebra mussels (Figure 3.1-10).

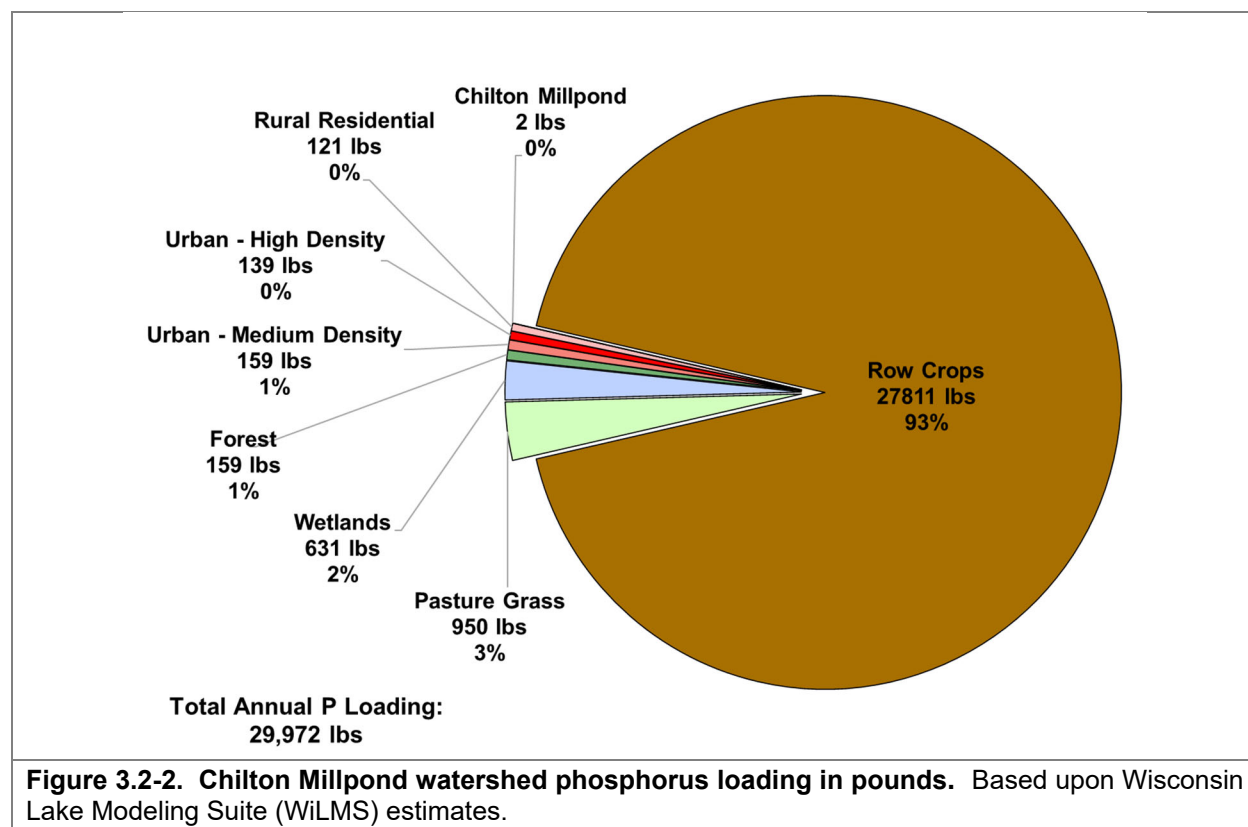
WiLMS is a screening-level model and its accuracy wains with very large watersheds like that of Chilton Millpond. Utilizing an annual phosphorus load of 29,972 lbs, the model predicted an average growing season phosphorus concentration of 161-745 $\mu\text{g/L}$, with the most likely concentration being 299 $\mu\text{g/L}$. Considering the limited amount of historical phosphorus data, the wide fluctuations of the available data, and the fact that the growing season and summer month measured averages are 302 and 358 $\mu\text{g/L}$, respectively, the predicted value indicates the model is reasonably reflecting phosphorus loading to Chilton Millpond. As shown in Figure 3.2-2, the largest phosphorus contributing land cover type is row crop agriculture.

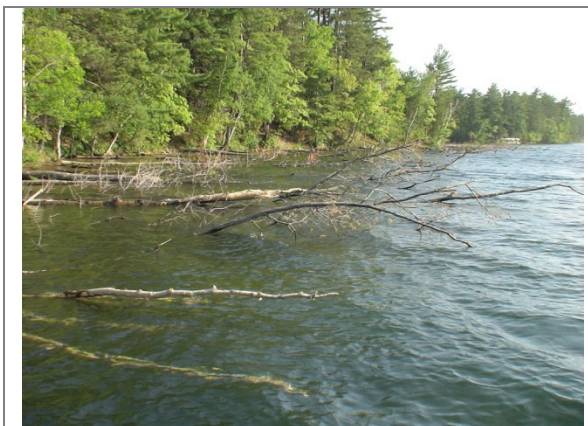
Photograph 3.3-1. Example of coarse woody habitat in a lake.

Emerging research in Wisconsin has shown that coarse woody habitat (sometimes called “coarse woody debris”), often stemming from natural or undeveloped shorelands, provides many ecosystem benefits in a lake. Coarse woody habitat describes habitat consisting of trees, limbs, branches, roots and wood fragments at least four inches in diameter that enter a lake by natural or human means (Photograph 3.3-1). Coarse woody habitat provides shoreland erosion control, a carbon source for the lake, prevents suspension of sediments and provides a surface for algal growth which is important for aquatic macroinvertebrates (Sass, 2009). While it impacts these aspects considerably, one of the greatest benefits coarse woody habitat provides is habitat for fish species.

Coarse woody habitat has shown to be advantageous for fisheries in terms of providing refuge, foraging area, as well as spawning habitat (Hanchin, Willis, & St. Stauver, 2003). In one study, researchers observed 16 different species occupying coarse woody habitat areas in a Wisconsin lake (Newbrey, Bozek, Jennings, & Cook, 2005). Bluegill and bass species in particular are attracted to this habitat type; largemouth bass stalk bluegill in these areas while the bluegill hide amongst the debris and often feed upon many macroinvertebrates found in these areas, who themselves are feeding upon algae and periphyton growing on the wood surface. Newbrey et al. 2005 found that some fish species prefer different complexity of branching on coarse woody habitat, though in general some degree of branching is preferred over coarse woody habitat that has no branching.

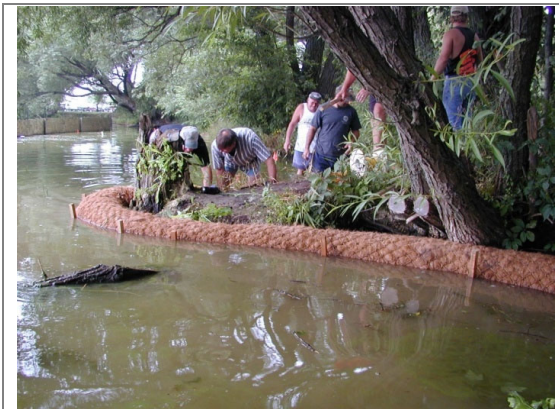
Photograph 3.3-2. Example of a biolog restoration site.

In recent years, many lakefront property owners have realized increased aesthetics, fisheries, property values, and water quality by restoring portions of their shoreland to mimic its unaltered state (Photograph 3.3-2). An area of shore restored to its natural condition, both in the water and on shore, is commonly called a shoreland buffer zone. The shoreland buffer zone creates or restores the ecological habitat and benefits lost by traditional suburban landscaping. Simply not mowing within the buffer zone does wonders to restore some of the shoreland's natural function.

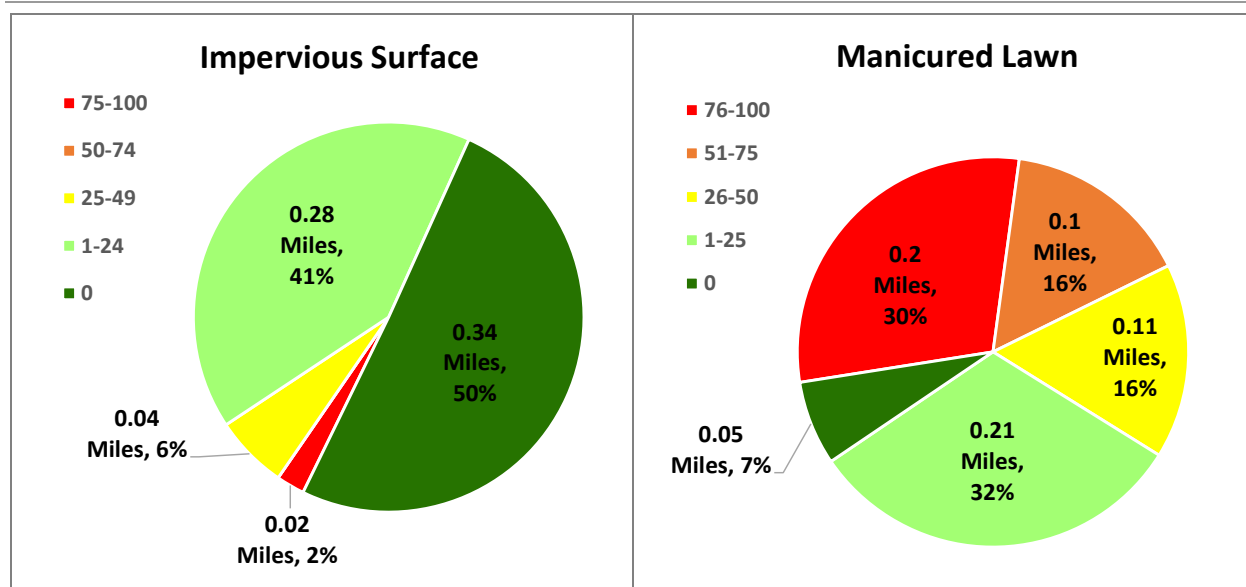
Figure 3.3-2. Chilton Millpond 2022 shoreland parcel canopy cover, shrub-herbaceous cover, impervious surface, and manicured lawn. Data from Onterra 2022 Survey.

Impervious surface is an area that releases all or a majority of the precipitation that falls onto it (e.g., rooftops, concrete, stairs, boulders and boats flipped over on shore). Approximately 91% of the shoreline had parcels with less than 24% of impervious surface within the shoreland zone (Figure 3.3-2, Map 7).

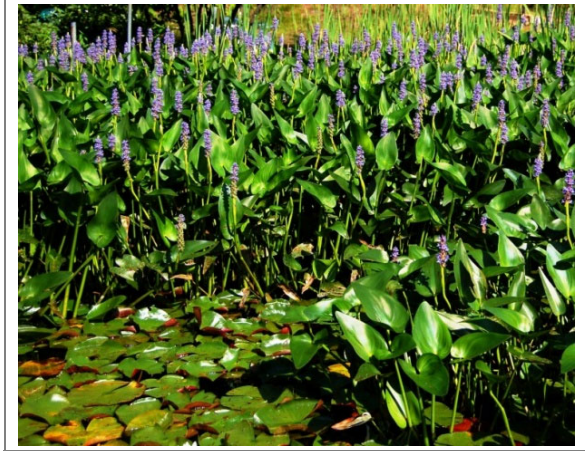
Photograph 3.4-1. Example of emergent and floating-leaf communities.

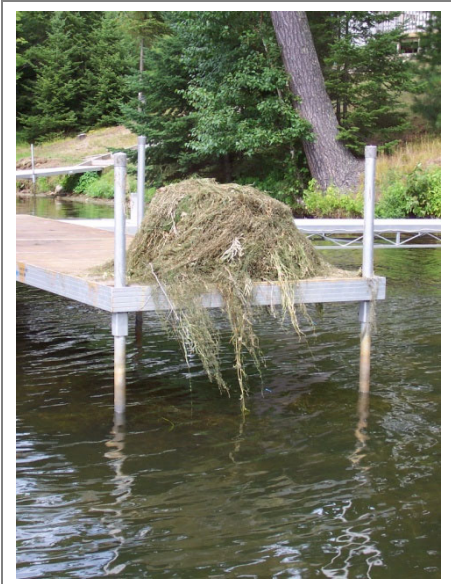
Photograph 3.5-2. Example of aquatic plants that have been removed manually.

Manual removal methods include hand-pulling, raking, and hand-cutting. Hand-pulling involves the manual removal of whole plants, including roots, from the area of concern and disposing them out of the waterbody. Raking entails the removal of partial and whole plants from the lake by dragging a rake with a rope tied to it through plant beds. Specially designed rakes are available from commercial sources or an asphalt rake can be used. Hand-cutting differs from the other two manual methods because the entire plant is not removed, rather the plants are cut similar to mowing a lawn; however, Wisconsin law states that all plant fragments must be removed (Photograph 3.5-2).

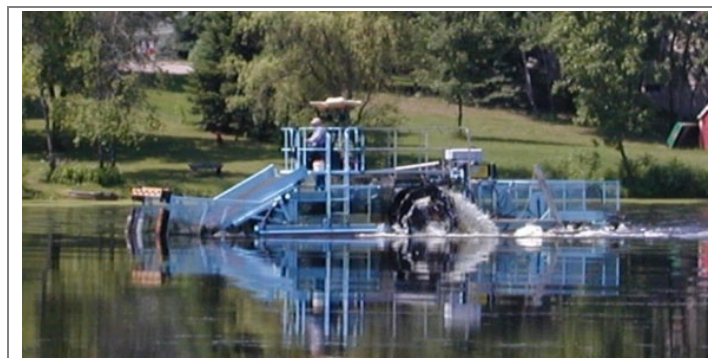
Photograph 3.4-3. Mechanical harvester.

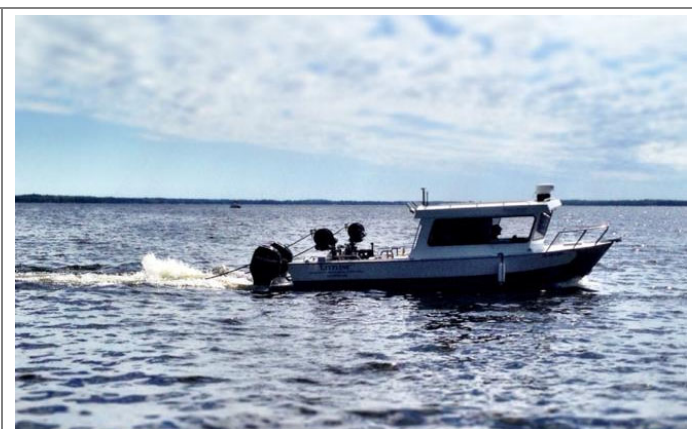
Photograph 3.4-4. Liquid herbicide application.
Photo credit: Amy Kay, Clarke.

The use of herbicides to control aquatic plants and algae is a technique that is widely used by lake managers (Photo 3.4-4). Traditionally, herbicides were used to control nuisance levels of aquatic plants and algae that interfere with navigation and recreation. While this practice still takes place in many parts of Wisconsin, the use of herbicides to control aquatic invasive species is becoming more prevalent. Resource managers employ strategic management techniques towards aquatic invasive species, with the objective of reducing the target plant's population over time; and an overarching goal of attaining long-term ecological restoration. For submergent vegetation, this largely consists of implementing control strategies early in the growing season; either as spatially-targeted, small-scale spot treatments or low-dose, large-scale (whole lake) treatments. Treatments occurring roughly each year before June 1 and/or when water temperatures are below 60°F can be less impactful to many native plants, which have not emerged yet at this time of year. Emergent species are targeted with foliar applications at strategic times of the year when the target plant is more likely to absorb the herbicide.

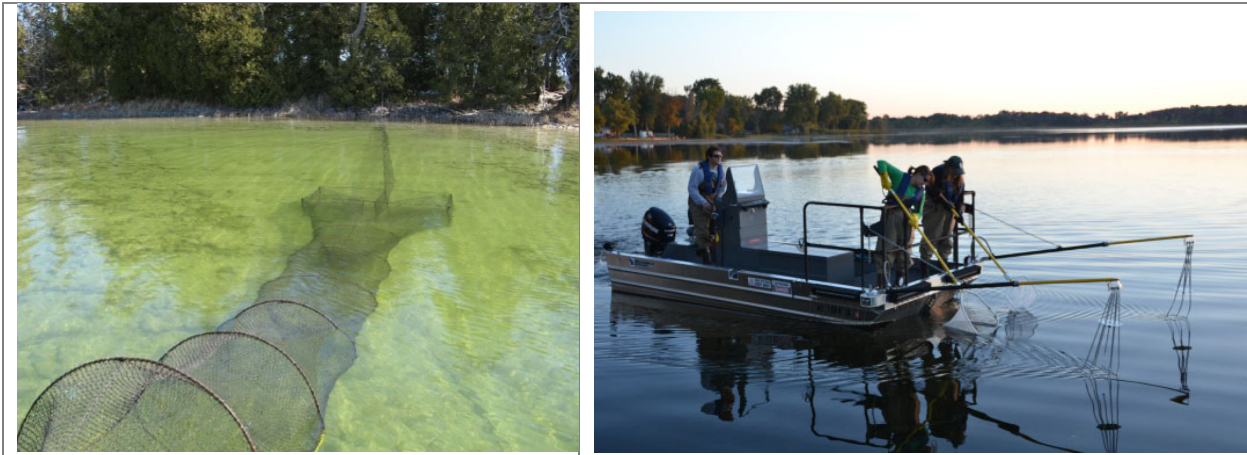
Photograph 3.6-1. Fyke net positioned in the littoral zone of a Wisconsin Lake (left) and an electroshocking boat (right).

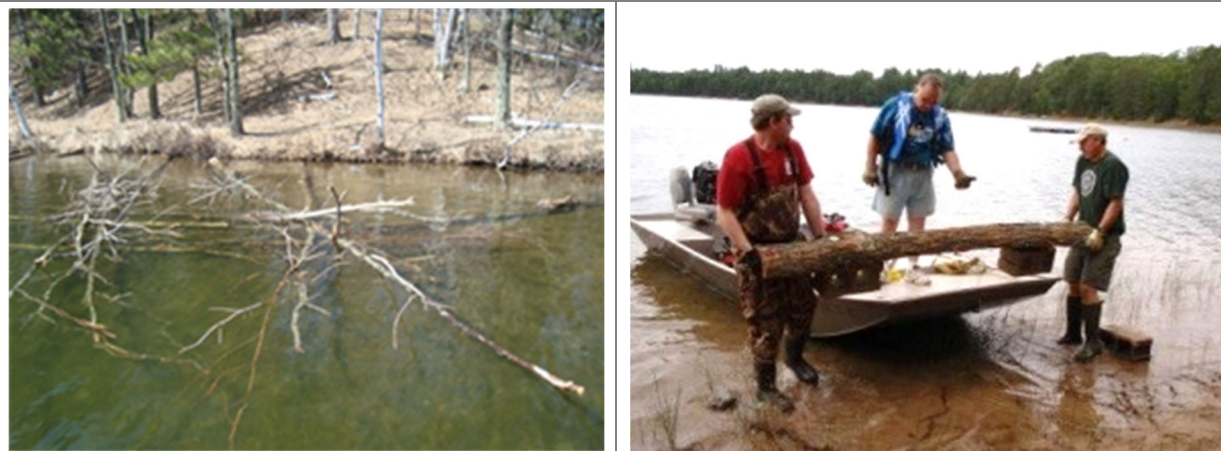
Photograph 3.6-3. Examples of fish sticks (left) and half-log habitat structures. (Photos by WDNR)

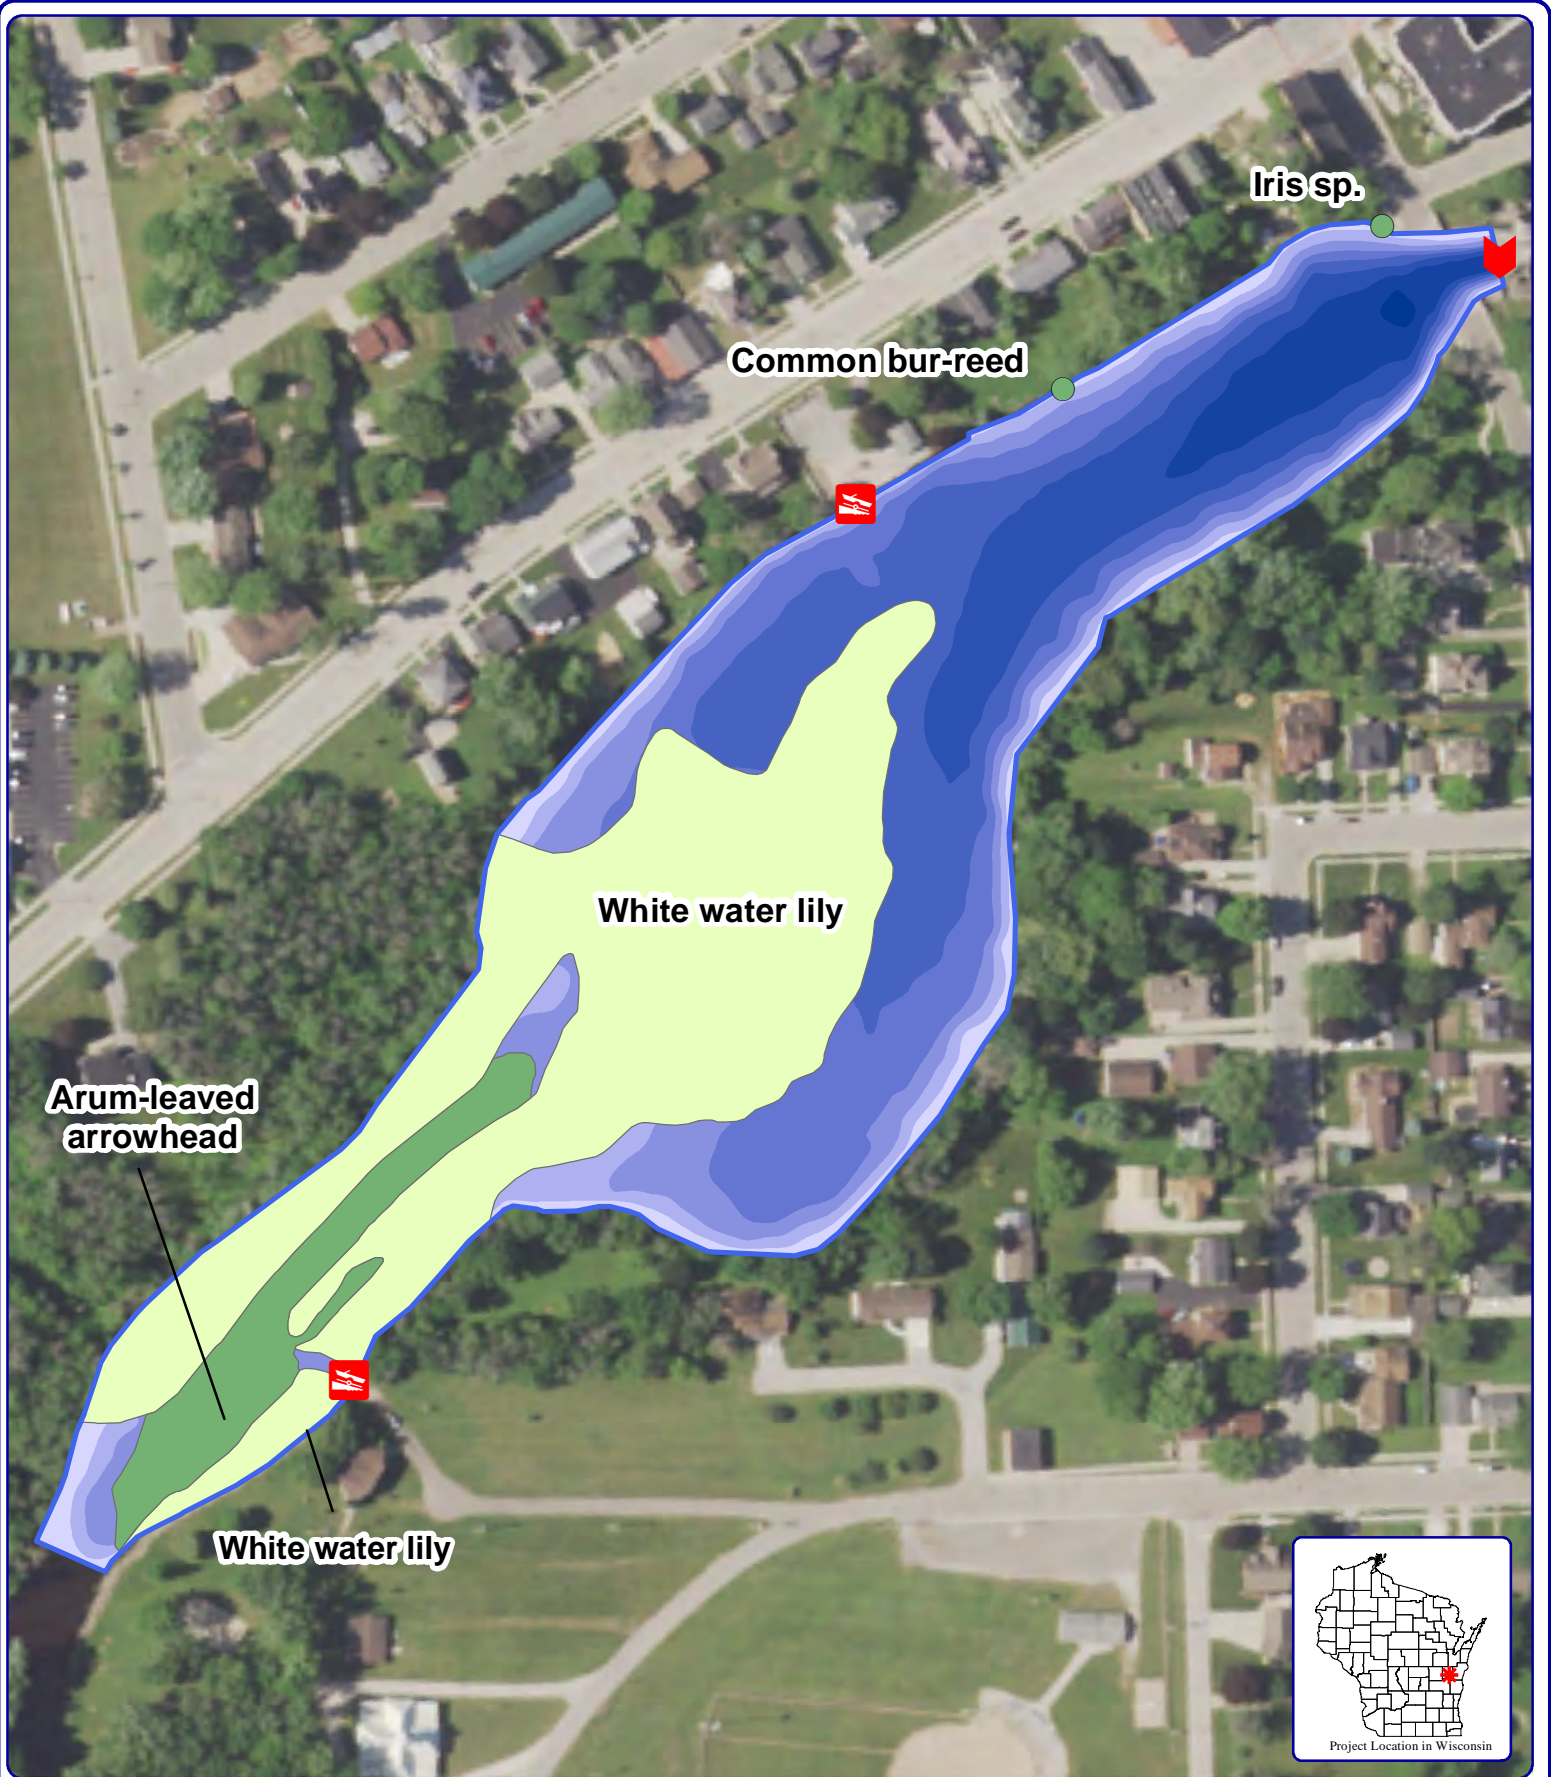
Map 8
 Chilton Millpond
 Calumet County, Wisconsin
**Coarse Woody
 Habitat**

- No Branches
- Some Branches
- Full Canopy
