November 19, 2023

**Desair Lake Restoration, Inc. (DLR) Lake Protection Grant LPT66920  
Dostal Catchment Basin Reconstruction Report**

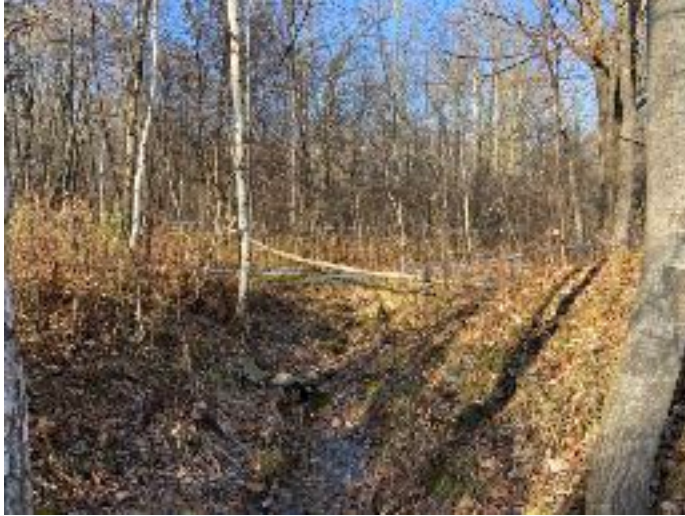
West weir existing condition

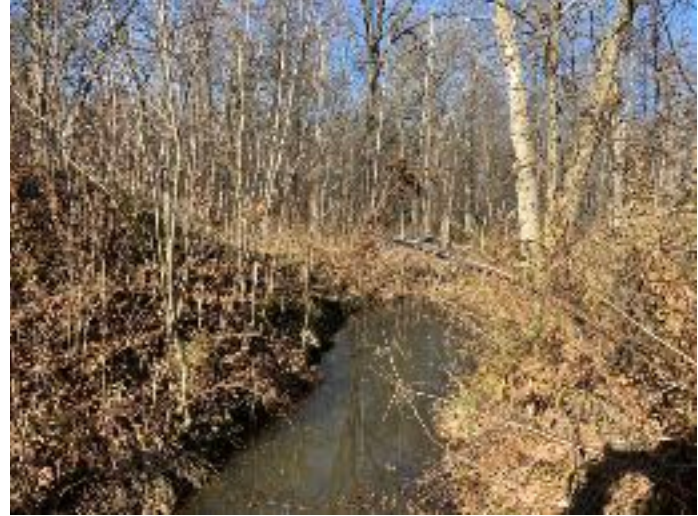
East weir existing condition

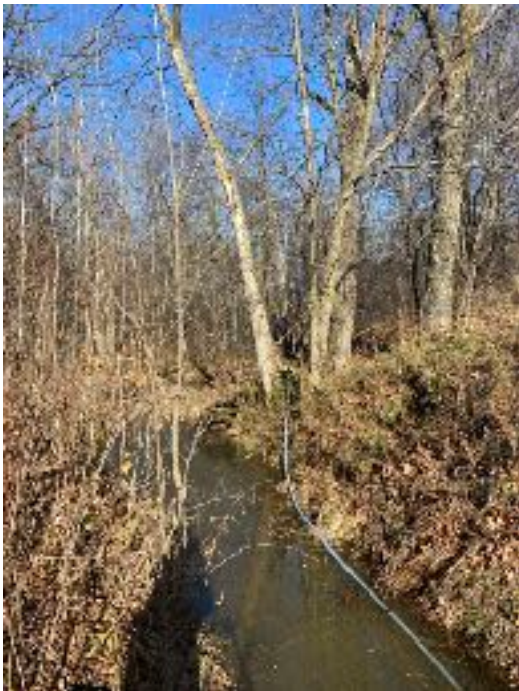
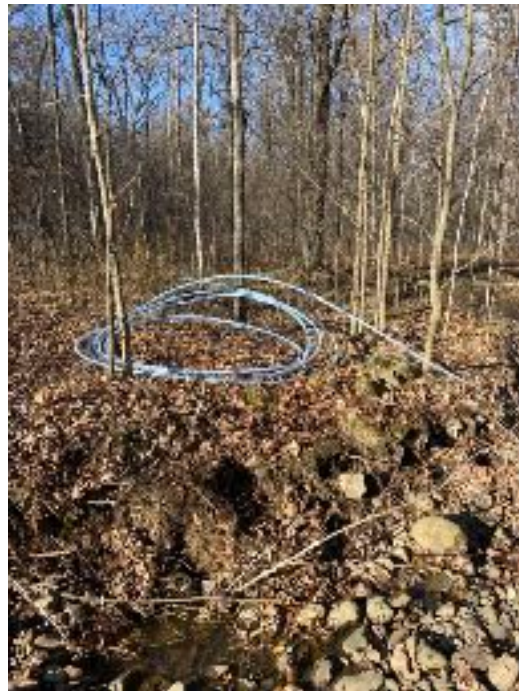
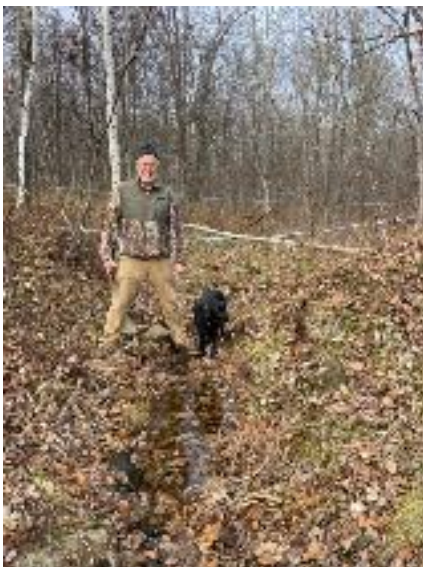
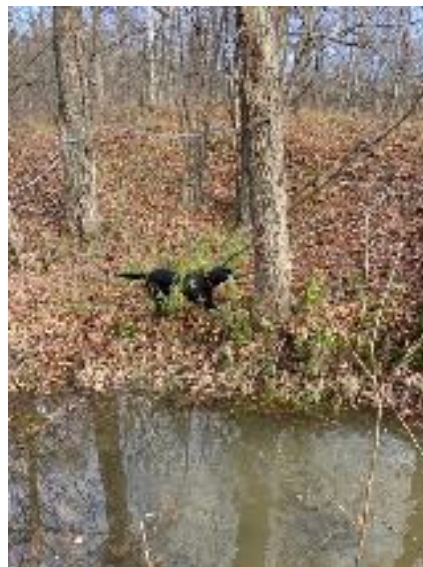
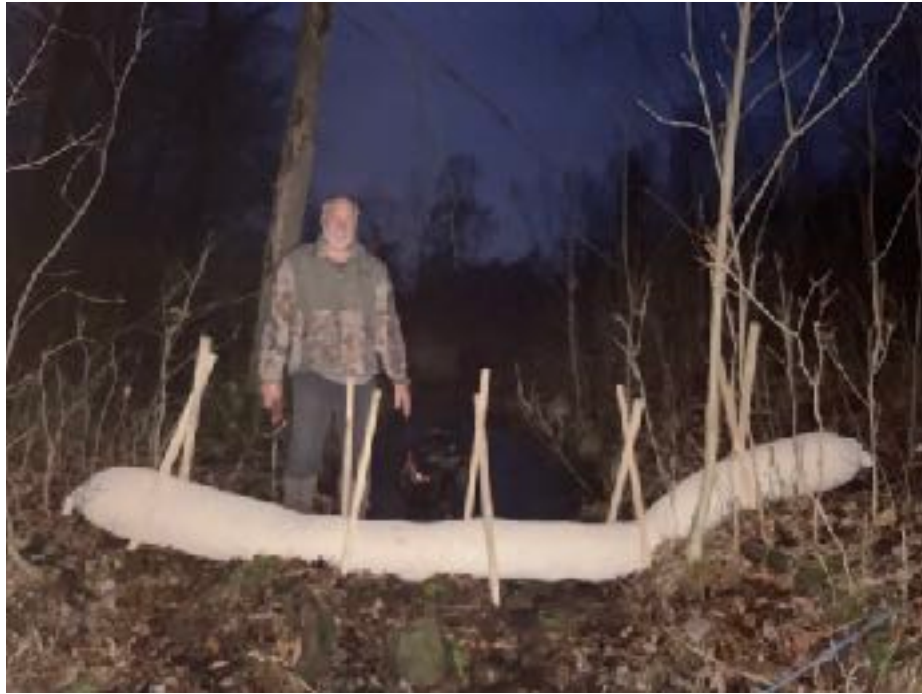
Antczak was hired, but they had to work us in around other projects that they were closing out. On November 4, DLR volunteers worked on site preparation for access to the site. The work included cutting a dead tree, trimming branches, removing a section of barb wire fence, cutting sap lines that interfered with construction, and installing erosion control. Site preparation pictured are shown below.

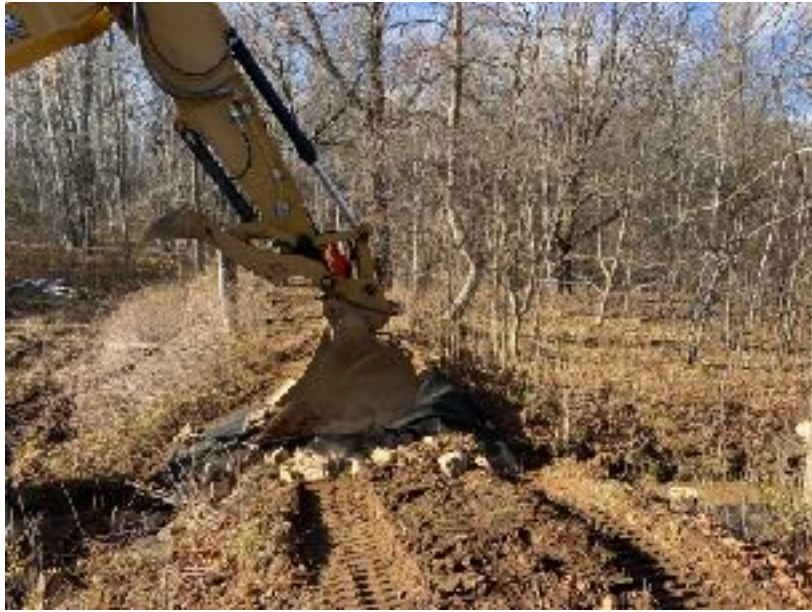
East weir

Rip rap, that was left over from the Henkel and Parkman projects, was brought to the Dostal site by Antczak. Compaction gravel was hauled to the site with a dump truck. A backhoe and skid steer was used to build the two weirs. The berm was reconnected at the two locations and weirs built at each. The east weir was set approximately three feet above the dry run invert and approximately one foot below the west weir, which will act as a secondary spillway. The weirs were built by installing compaction gravel, compacting that, installing geotextile fabric over the gravel, and adding rip rap.

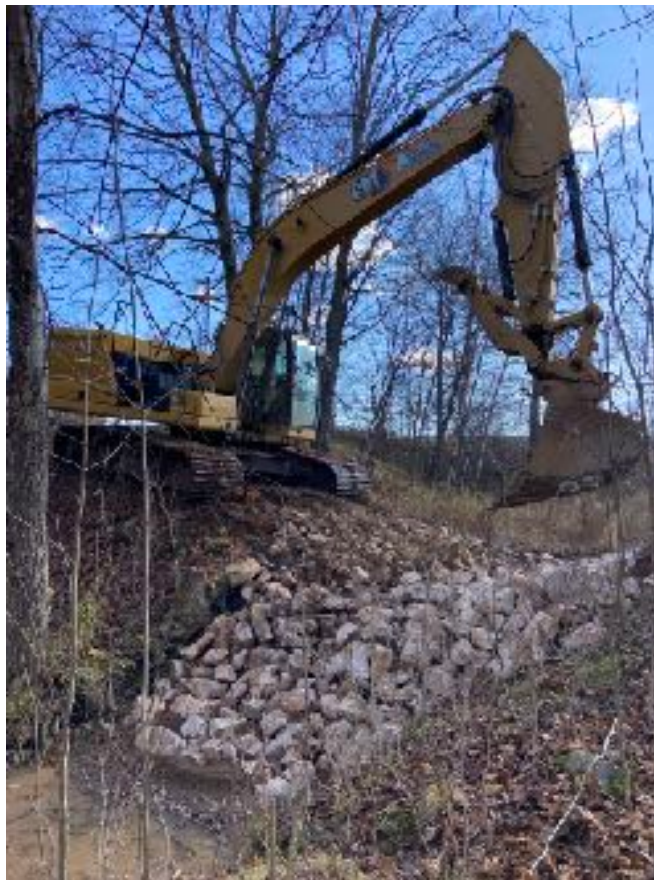
East weir

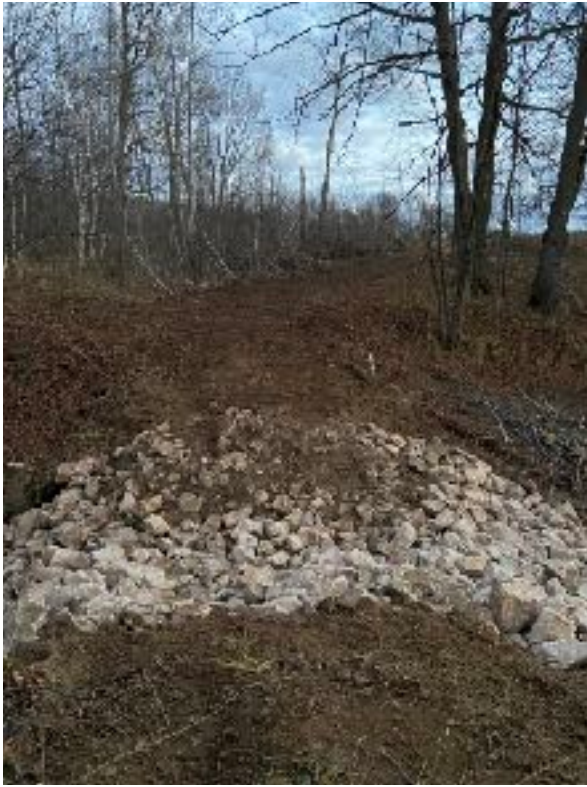
East Weir

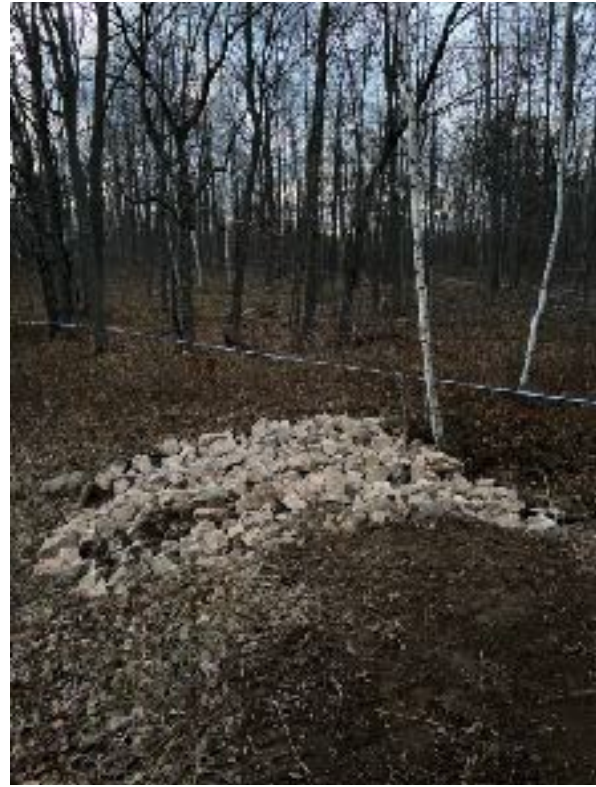
West Weir

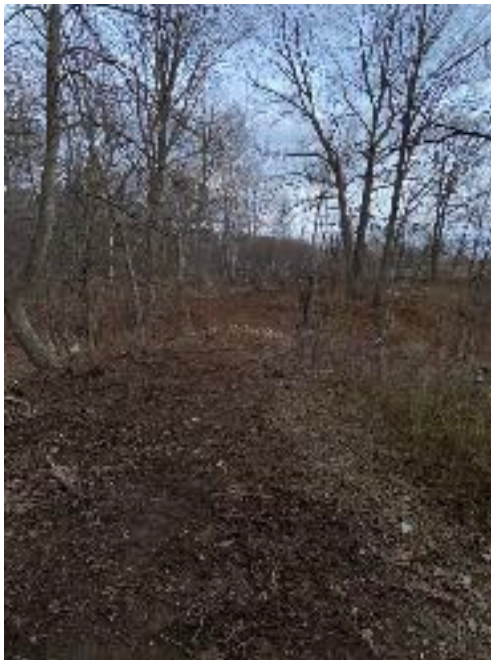
Site Access from weir

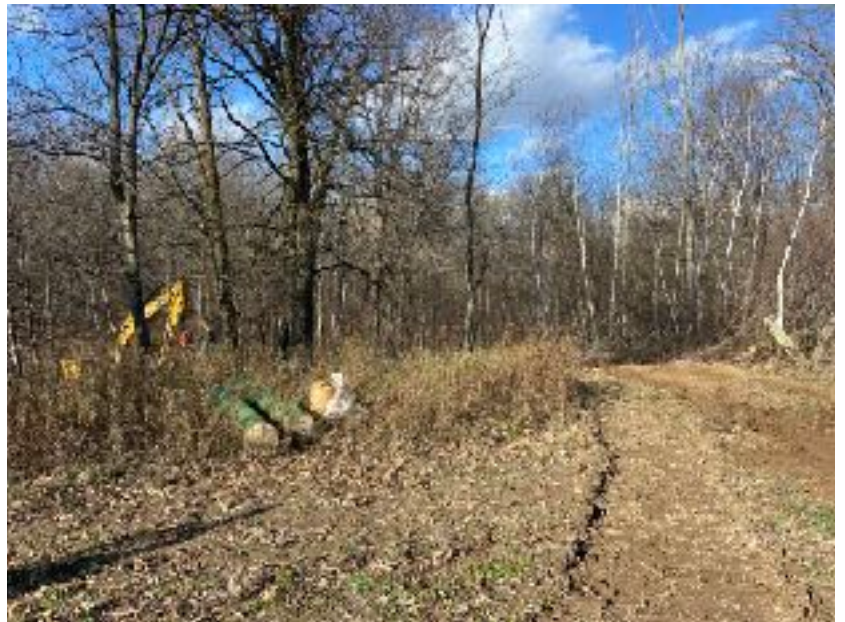
Site access from farm field

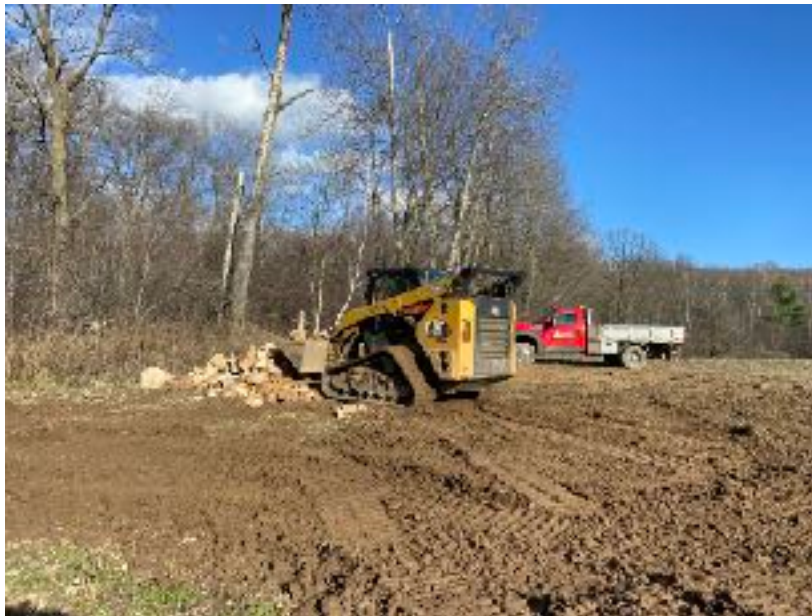
Landing area for equipment and materials

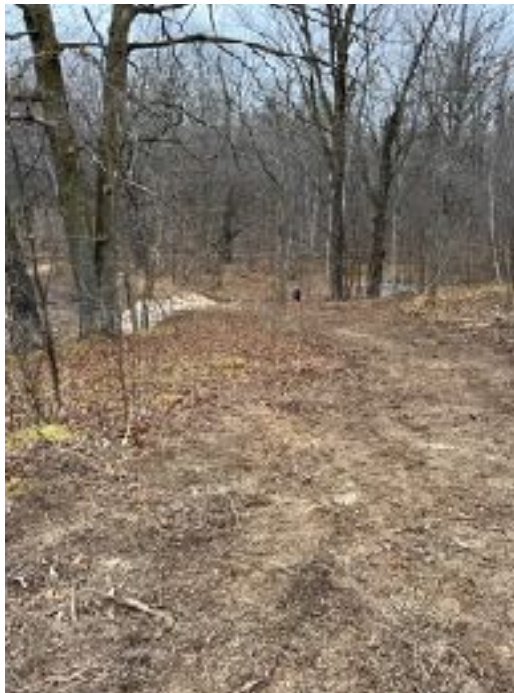
The above picture is the prepared access route prior to seeding and erosion matting. This was erosion matted, but we do not have a picture.

On their way out, the skid steer smoothed out ruts left by the heavy equipment in the farm field. I stayed and raked all disturbed areas that would be seeded and erosion matted. On November 10 and November 11, Dominic and I seeded and erosion matted the disturbed areas.
