# VERMILLION LAKES BARRON COUNTY

2018 AQUATIC PLANT MANAGEMENT  
IMPLEMENTATION SUMMARY REPORT  
WDNR WBIC: LOWER VERMILLION 2098200;  
UPPER VERMILLION 2098800

Prepared by: Dave Blumer, Lake Educator

May 21, 2019

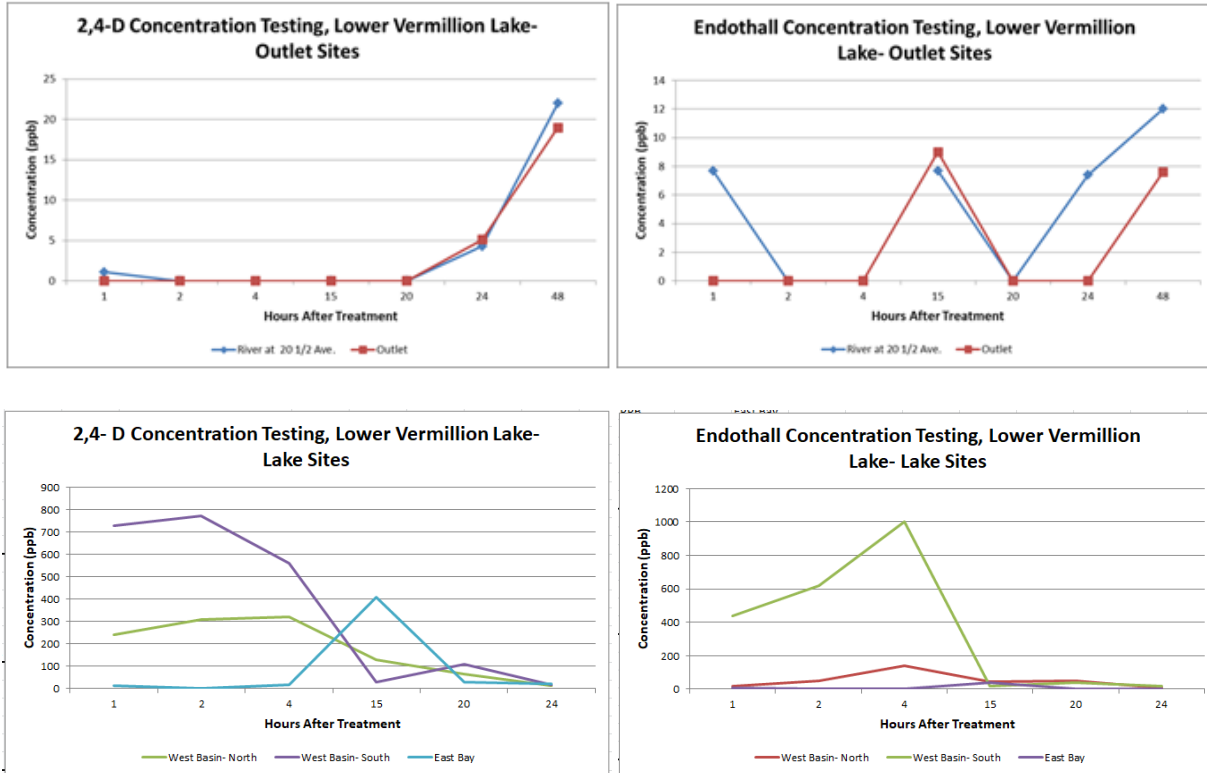
Figure 4: 2018 Herbicide concentration testing results on Lower Vermillion Lake

Herbicide concentration testing is required on Lower Vermillion Lake due to there being wild rice near the outlet and downstream of the lake in the Vermillion River. Since both 2,4-D (EWM) and endothall (CLP) were used SLOH testing included an analysis of the presence of both herbicides in the water samples collected by VLA volunteers in 2018. Figure 4 shows the results of herbicide residual testing in 2018. Herbicide did reach the outlet in 2018 with both 2,4-D and endothall showing an increasing trend after 20 hours post-treatment (2,4-D 0.005-0.022 ppb; Endo 0.008-0.012 ppb). This suggests that if herbicide concentration testing is required in 2019, it should be extended out beyond 48 hours after treatment.

Herbicide concentrations in the treated areas of the lake reached above 700 ppb in the west basin along the south shore, but quickly dropped after that. Herbicide placed in the lake along the north shore of the west basin and in the east bay did not get anywhere close to the intended application rate of 2000-3000 ppb as planned. This likely explains the burned but not killed EWM in the east basin. Visual results suggest that the chemical treatments in the west basin were successful at providing seasonal relief, but it is likely that there will still be EWM plants growing in the 2018 treatment areas, in 2019.

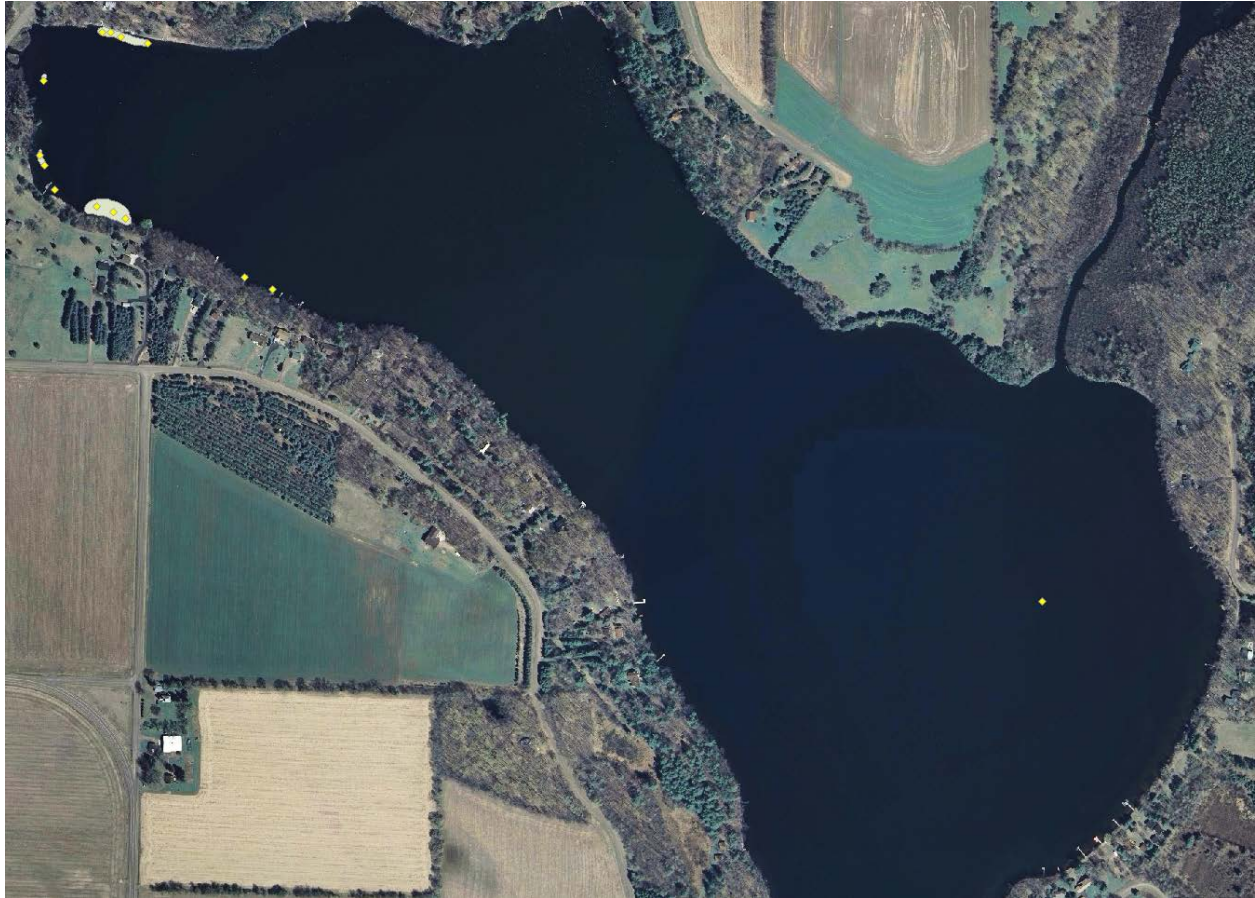
Fall EWM bed mapping was completed by LEAPS on October 15, 2018. Four beds or high density areas were identified covering a total of 0.59 acres (Figure 7). An additional four points with EWM were identified outside of the high-density areas.

**Figure 7: 2018 EWM bedmapping results (gray-beds or high-density areas; yellow dots-individual plants)**

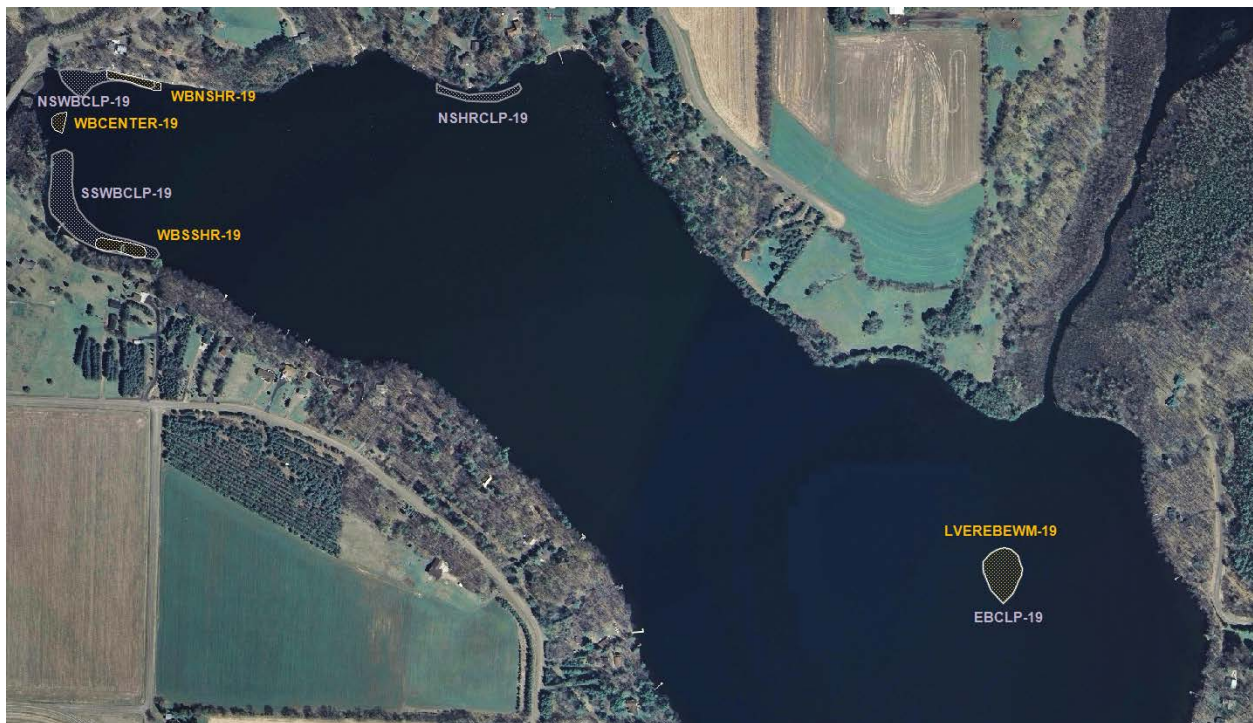
**Figure 8: 2019 Preliminary CLP and EWM chemical treatment map**

Based on the CLP and EWM treatment plan for LVer and fall bed mapping results in 2018, a preliminary CLP and EWM treatment proposal was put together. This preliminary proposal included 2,95 acres of CLP in four beds, and 1.21 acres of EWM in four beds. Granular herbicide was again proposed for use in the east bay treatment area (Table 3, Figure 8).

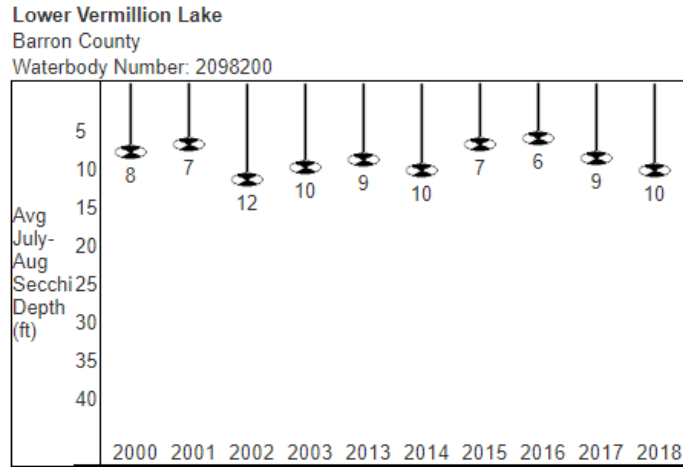
Water /clarity quality in Lower Vermillion Lake in 2018 was exceptional, much better than it has been in the last few years. Lower Vermillion Lake at the Deep Hole was sampled 13 different days during the 2018 season. Parameters sampled included: water clarity, temperature, dissolved oxygen, total phosphorus, and chlorophyll. The average summer (July-Aug) Secchi disk reading for Lower Vermillion Lake - Deep Hole (Barron County, WBIC: 2098200) was 10.5 feet (Figure 10). The average for the Northwest Georegion was 8.5 feet. Typically the summer (July-Aug) water was reported as clear and blue.

**Figure 10: Average summer (July and August) Secchi disk readings at the Deep Hole**
