# VERMILLION LAKES BARRON COUNTY

2019 AQUATIC PLANT MANAGEMENT  
IMPLEMENTATION SUMMARY REPORT  
WDNR WBIC: LOWER VERMILLION 2098200;  
UPPER VERMILLION 2098800

Prepared by: Dave Blumer, Lake Educator

March 31, 2020

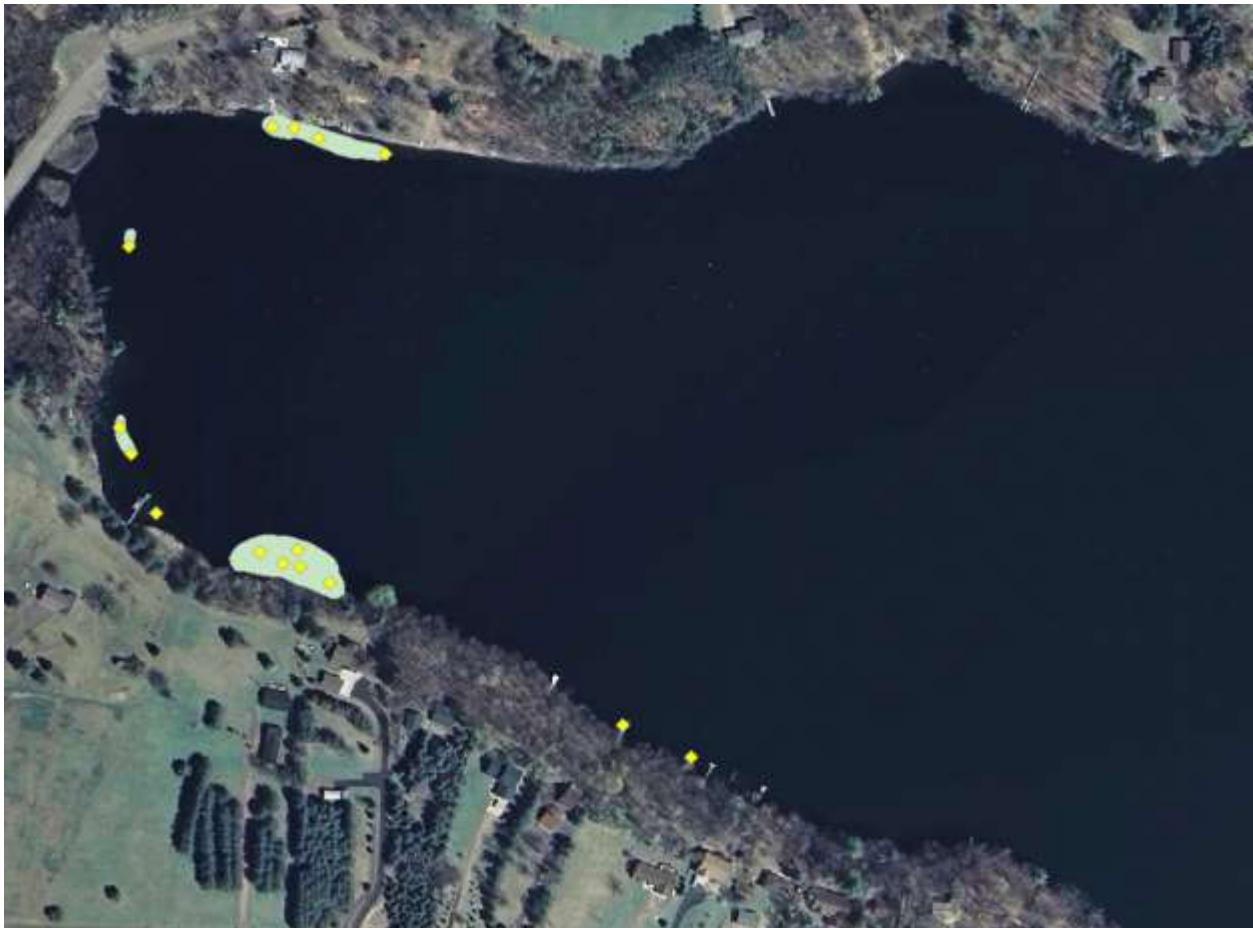
Figure 1: 2018 fall EWM survey results – West Basin

In the grant that covers 2018, 2019, and 2020 it was set up that LEAPS and VLA volunteers would complete fall EWM bedmapping in 2018 and again in 2020, with ERS completing it in 2019. On October 15<sup>th</sup>, 2018, the lake's littoral zone was searched for EWM by LEAPS accompanied by a VLA volunteer. Four areas covering 0.53 acre where EWM formed small beds were mapped. Outside of these areas, four additional plants were found and rake-removed including on is the East Basin near an area that has supported EWM growth in the past (Figures 1&2). This total represented a 0.22 acre increase over the 0.31 acres found in 2017, but a decrease in the number of outside plants from 12 in 2017 to only 4 in 2018.

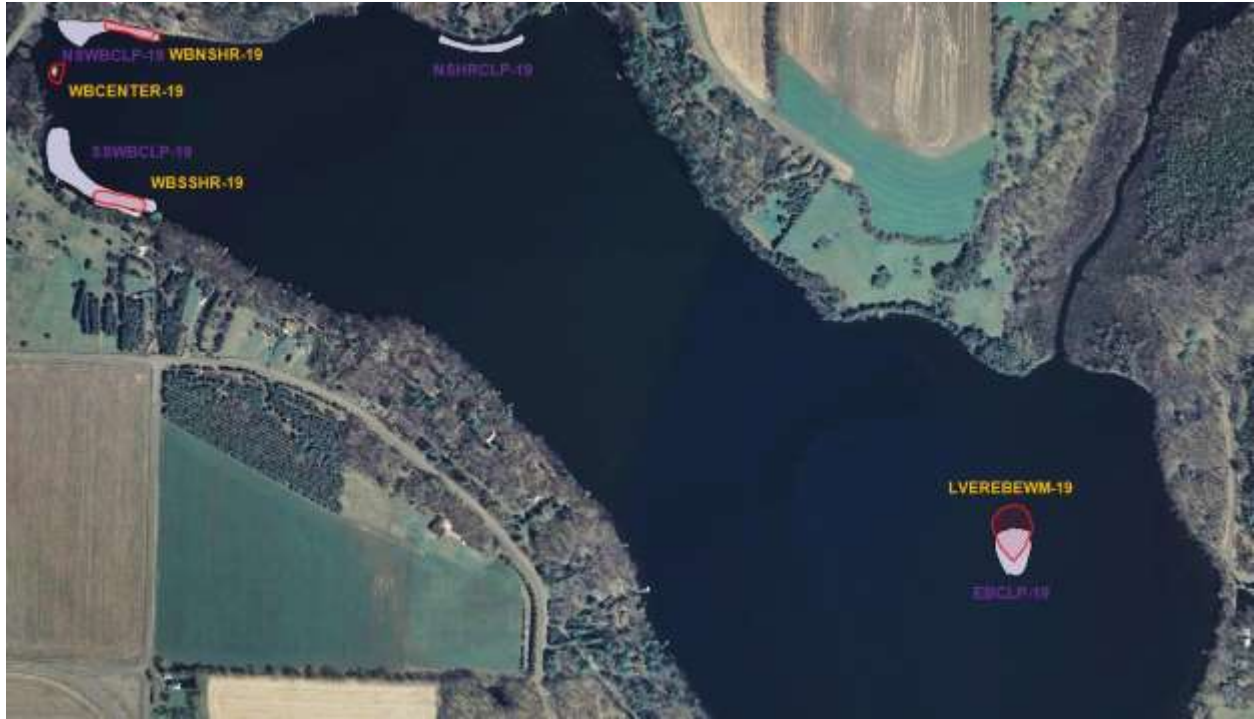
Figure 4: 2019 CLP (purple) and EWM (red/orange) chemical treatment areas

In the 2019 CLP and EWM chemical treatment proposals, the areas to be chemically treated overlap or are contained within each other. In the west basin along the north shore, 0.18 acres of EWM is included in the proposal to chemically treat 0.56 acres of CLP. In the west basin along the south shore, 0.26 acres of EWM is contained in 1.15 acres of CLP to be chemically treated. In the east basin, the area to be treated for CLP and EWM are the same at 0.67 acres. Where the CLP and EWM treatments overlap, the acreage is not increased however two different herbicides are applied - 2,4D to EWM and endothall to CLP.

One area of CLP along the north shore totaling 0.30 acres is just being treated with endothall; and one area of EWM in the west basin totaling 0.10 acres is just being treated with 2,4D. The final 2019 chemical treatment map for both CLP and EWM is in Figure 4.

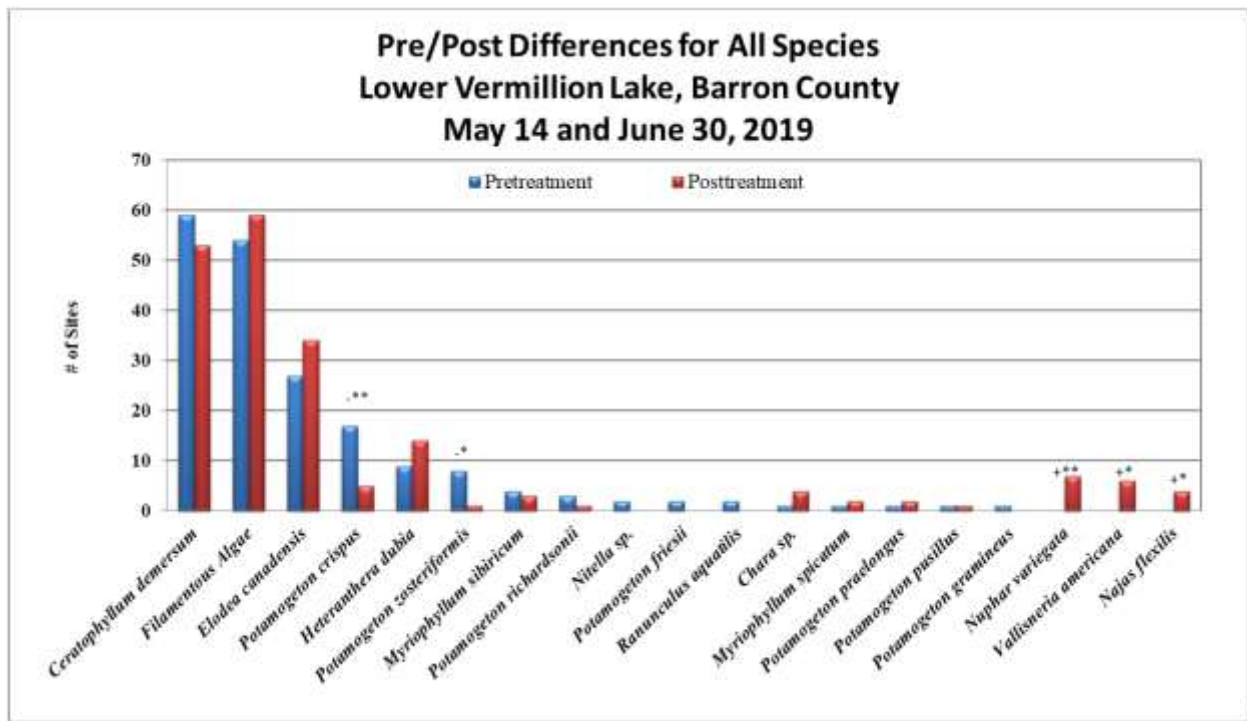
Figure 8: 2019 significant changes in aquatic vegetation from pre to post-treatment

Flat-stem pondweed, a species known to be sensitive to endothall – was the only native species that suffered a significant decline in distribution posttreatment. Conversely, several late-growing species experienced significant expansions – spatterdock saw a moderately significant increase, and wild celery and slender naiad both demonstrated significant increases in distribution.

Coontail and common waterweed were the two most common native species in both the pre and posttreatment surveys. Present at 59 sites during the pretreatment survey, coontail experience a non-significant decline in distribution to 53 sites posttreatment. It also suffered a moderately significant decline in mean rake fullness from 1.68 pre to 1.36 post.

Common waterweed was present at 27 sites with a mean rake fullness of 1.74 during the pretreatment survey. Posttreatment, there was a non-significant expansion to 34 sites. However, this was accompanied by a significant decline in density to a mean rake fullness of 1.32.

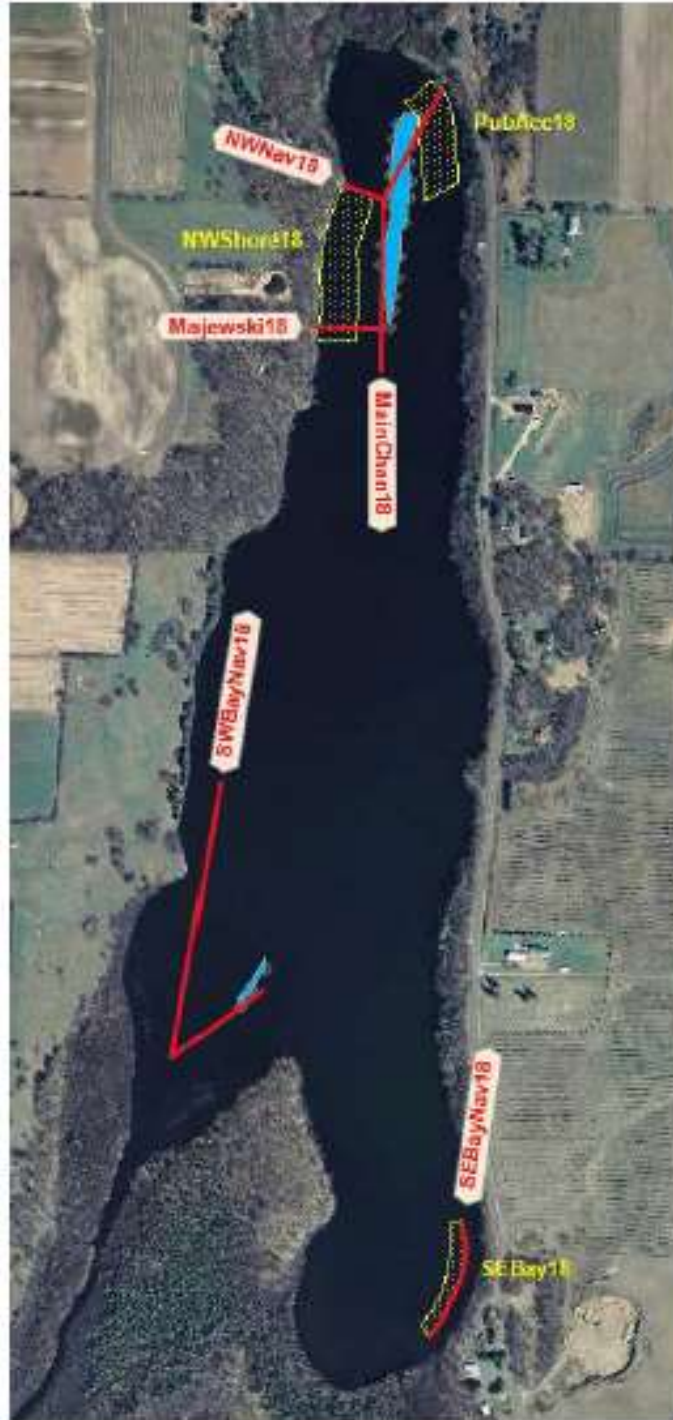
Figure 11: 2019 CLP harvested area in Upper Vermillion Lake

The CLP harvest on Upper Vermillion was an eleven hour undertaking on June 7th. TSB Restoration from Chippewa Falls brought in a harvesting machine with a trailer that had a conveyor for moving and dumping vegetation easily. During the project 10 full loads of 99% CLP were harvested and estimated to be 2200 cubic feet. The cut vegetation was moved to farm land approximately 3 miles away. The WDNR does not provide grants for harvesting vegetation, thus the entire cost of the harvesting project was covered by VLA. This endeavor was considered an experiment to not only make an immediate difference but to generate ideas and potential solutions for future lake improvements on Upper Vermillion. The VLA goal is to collaborate with the WDNR to provide direction and financial assistance in the near future. A follow-up survey was completed on Upper Vermillion Lake on June 17<sup>th</sup> with assistance from LEAPS. It showed a definitive path that was cleared with the harvester from the boat landing to close to the channel/outlet (Figure 11). This was the only area that was harvested in the 11-hr day. Photos of the harvesting day are included in Figure 12.

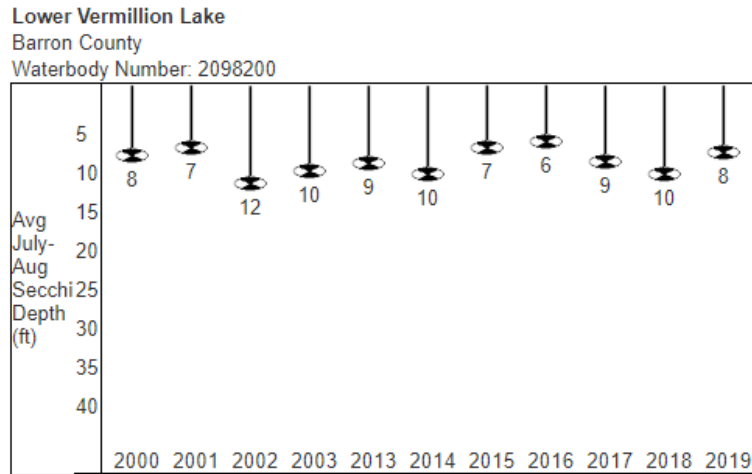
**Figure 13: 2019 Average summer (July and August) Secchi disk readings at the Deep Hole on Lower Vermillion Lake**

Lower Vermillion Lake - Deep Hole was sampled 13 different days during the 2019 season. Parameters sampled included: water clarity, temperature, dissolved oxygen, total phosphorus, and chlorophyll. The average summer (July-Aug) secchi disk reading for Lower Vermillion Lake - Deep Hole (Barron County, WBIC: 2098200) was 7.75 feet (Figure 13). The average for the Northwest Georegion was 8.6 feet. Typically the summer (July-Aug) water was reported as clear and blue. The deepest Secchi disk reading taken in 2019 was 20.75ft on May 30<sup>th</sup>. The least or shallowest reading was 6.0ft on August 26<sup>th</sup>.
