**Eurasian Water-milfoil (*Myriophyllum spicatum*)
Manual Rake Removal and Bed Mapping Surveys
Echo Lake – WBIC: 2630200
Barron County, Wisconsin**

Endangered Resource Services, LLC
Matthew S. Berg, Research Biologist
St. Croix Falls, Wisconsin
July 2 and August 24, 2020

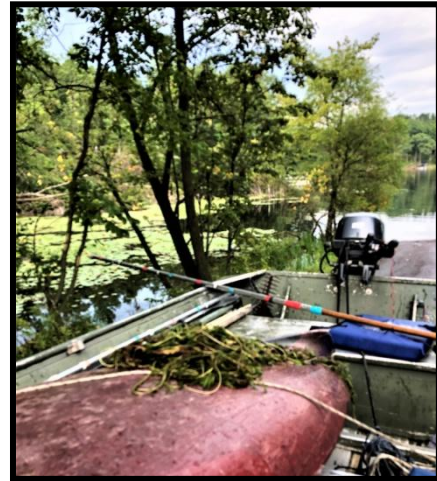
EWM removed 8/24/20

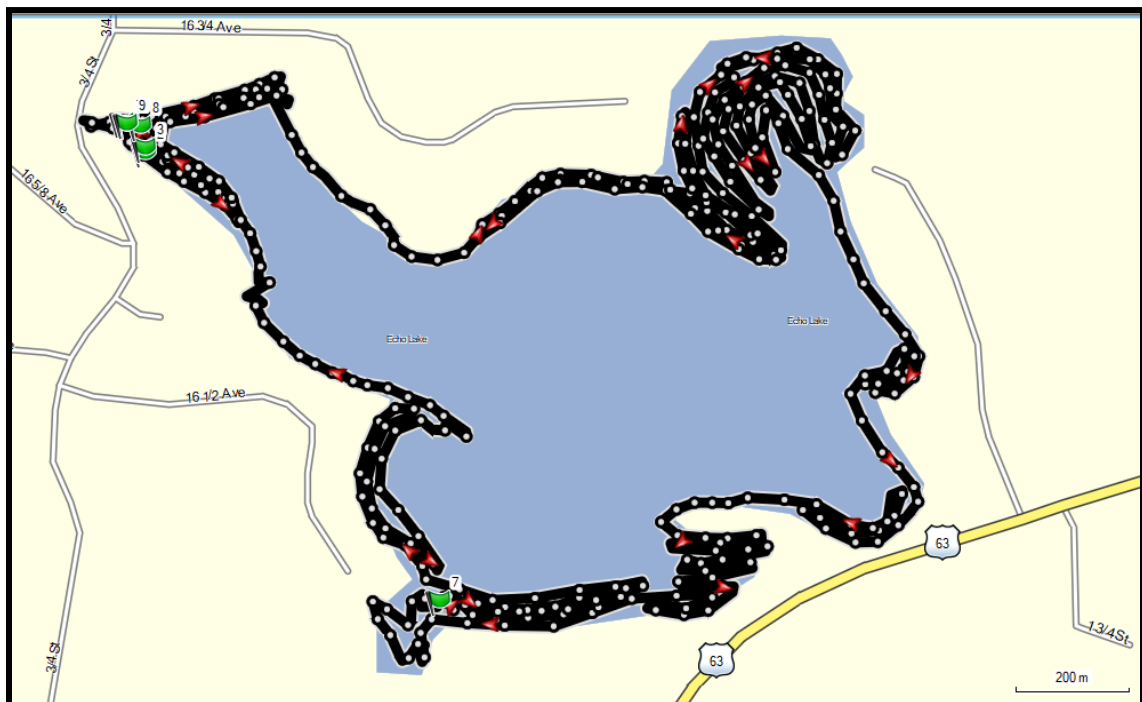
Figure 2: July 2, 2020 Survey Tracks and EWM Locations

During our initial visit in July, we searched along transects totaling 16.0km (9.9 miles), and concentrated our efforts in the northeast bay (2019 treatment area) and near the boat landing where we found EWM plants during the fall 2019 survey (Figure 2). In total, we found and removed nine plants. Eight were near the boat landing and a ninth occurred near the entrance to the southwest bay.

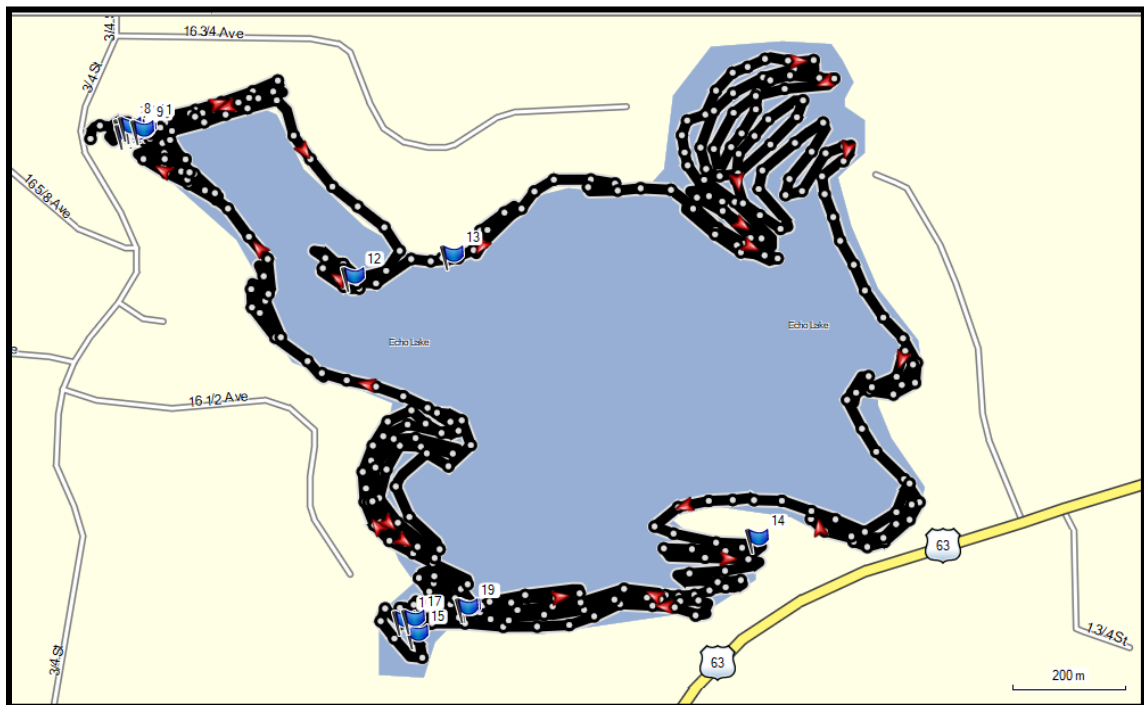
Figure 3: August 24, 2020 Survey Tracks and EWM Locations

In late August, we covered transects totaling 16.9km (10.5miles) (Figure 3) and found 19 total Eurasian water-milfoil plants. This included a single large canopied plant on the northwest rock bar that may have been the source for the 11 small “sprouts” found near the landing. We also found a small scattering of five plants near and in the southwest bay. A single plant was also removed from the north-central shoreline and another from the southeast finger bay. No plants were seen anywhere in the 2019 treatment areas, along the eastern shoreline, or in the southeast bay. Although this was an increase from the five plants found in October of 2019 and the nine plants found in July 2020 (Figure 4), it was still down significantly from the 209 in the fall of 2017 and 180 in the fall of 2018 (Appendix I). These results also meant that **no true Eurasian water-milfoil beds were present** (Table 1).

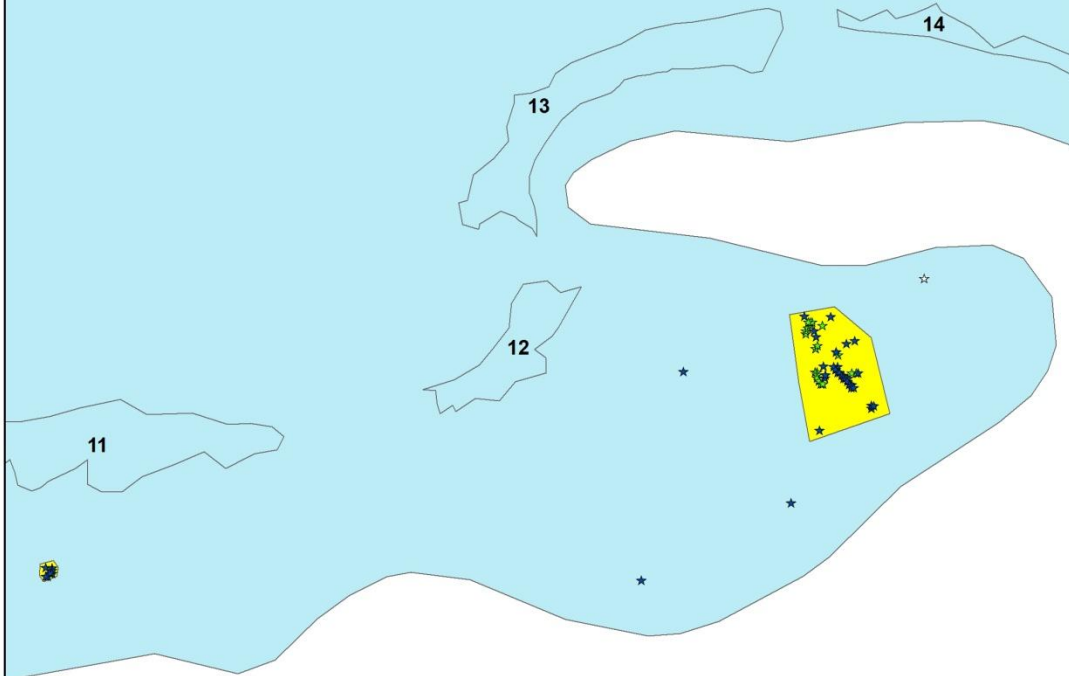
Exotic species
Fall Bed Mapping Survey
Echo Lake - South Bays
Barron County, WI
September 24, 2017

EWM 9/24/17

- * 1 Plant
- ☆ 30+ Cluster
- ★ 50+ Cluster
- * EWM 7/27/17
- ☆ EWM 6/23/17
