**Aquatic Plant Management Plan**  
**White Ash and North White Ash Lakes**  
**White Ash Lake Protection and Rehabilitation District**

**JANUARY 2023**

Flambeau Engineering, LLC  
PO Box 273  
Park Falls, WI 54552

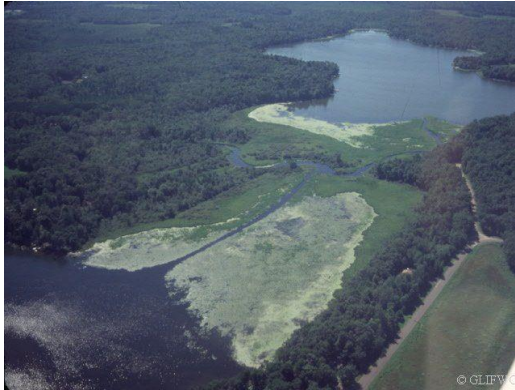
North White Ash and White Ash

Wild rice is very beneficial to the lake ecosystem but can cause navigation problems. The following photos were taken from the GLIFWC website that show the wild rice beds on the lakes and the Apple River.

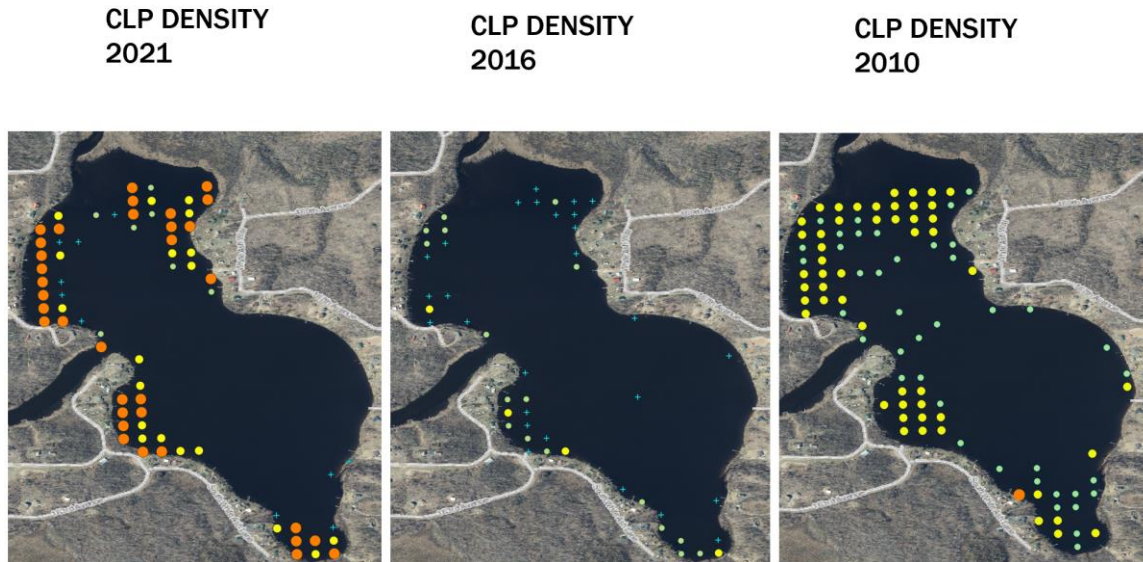
**Figures 9 White Ash CLP Comparison**

Based on the maps above, CLP was at its lowest coverage and density in 2016. The CLP appears to have covered more area in 2010 but may have been less dense.

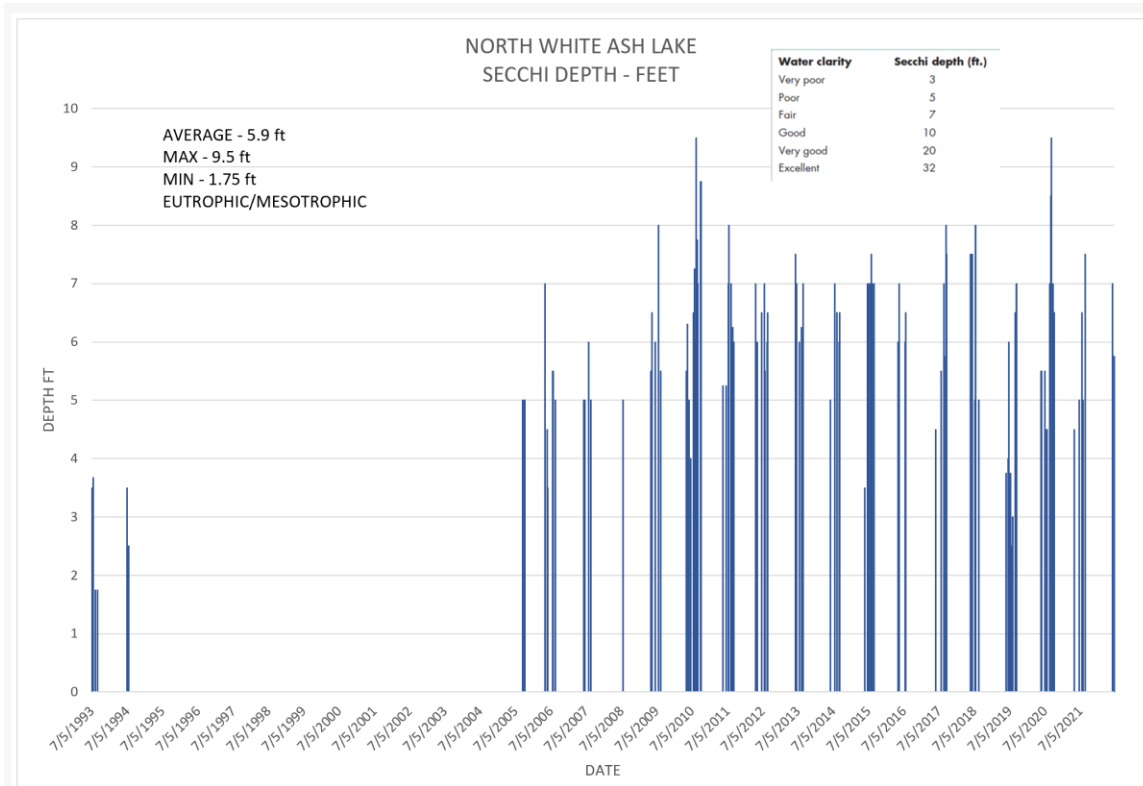
**Figure 12 - North White Ash - Secchi Depth**

The clarity on North White Ash has increased since the early 1990's from an annual average of 2.8 ft to 6.5 feet since 2010.

In North White Ash the average clarity is 5.9 feet, ranging from 1.75 to 9.5 feet indicating poor to fair water quality and mesotrophic conditions. The following graph illustrates the historical water clarity measurements on White Ash and North White Ash Lakes.

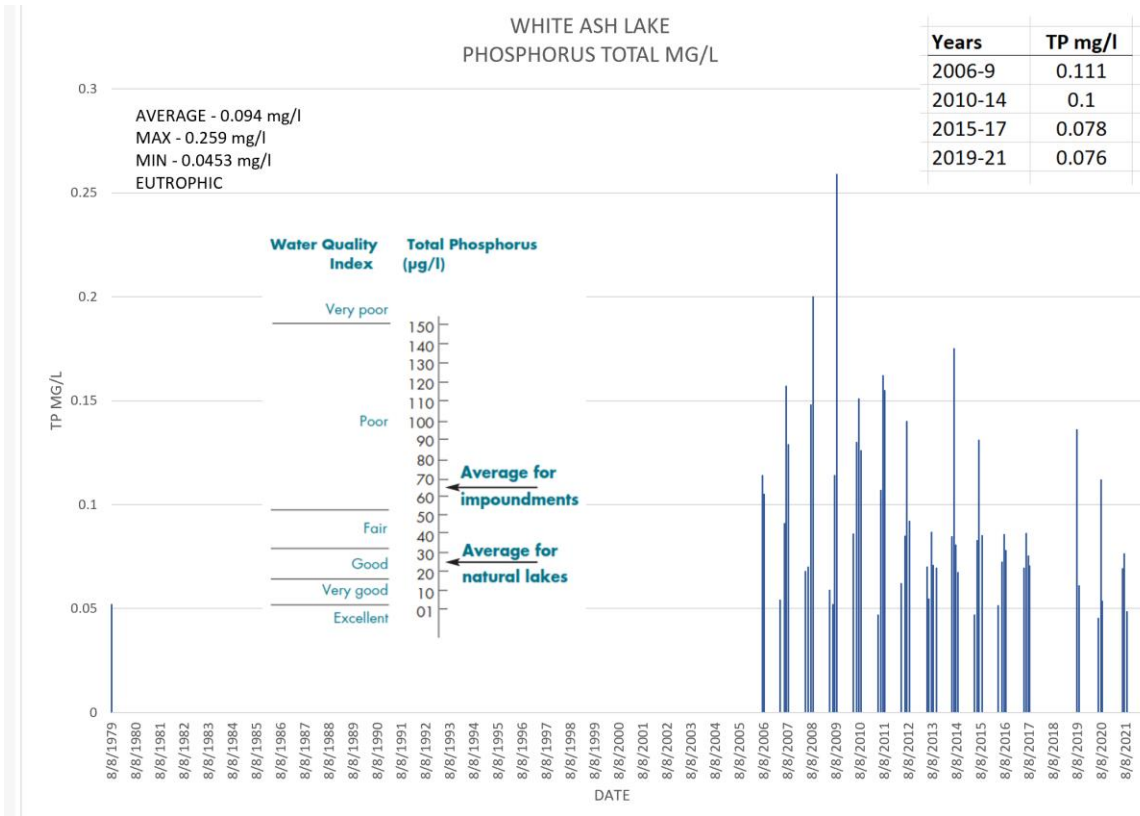
**Figure 13 - White Ash – Total Phosphorous**

The graph indicates the TP has been decreasing since a peak in 2009.

Following is a discussion of the total phosphorous and chlorophyll a concentration in the lakes over the years of data. Historically, White Ash has had an average phosphorus reading of 94 micrograms per liter (ug/l - parts per billion). The total phosphorus has varied from 45 ug/l to 259 ug/l indicating poor water quality and eutrophic conditions. North White Ash has had an average phosphorus reading of 51 ug/l. The total phosphorus has varied from 25 ug/l to 103 ug/l

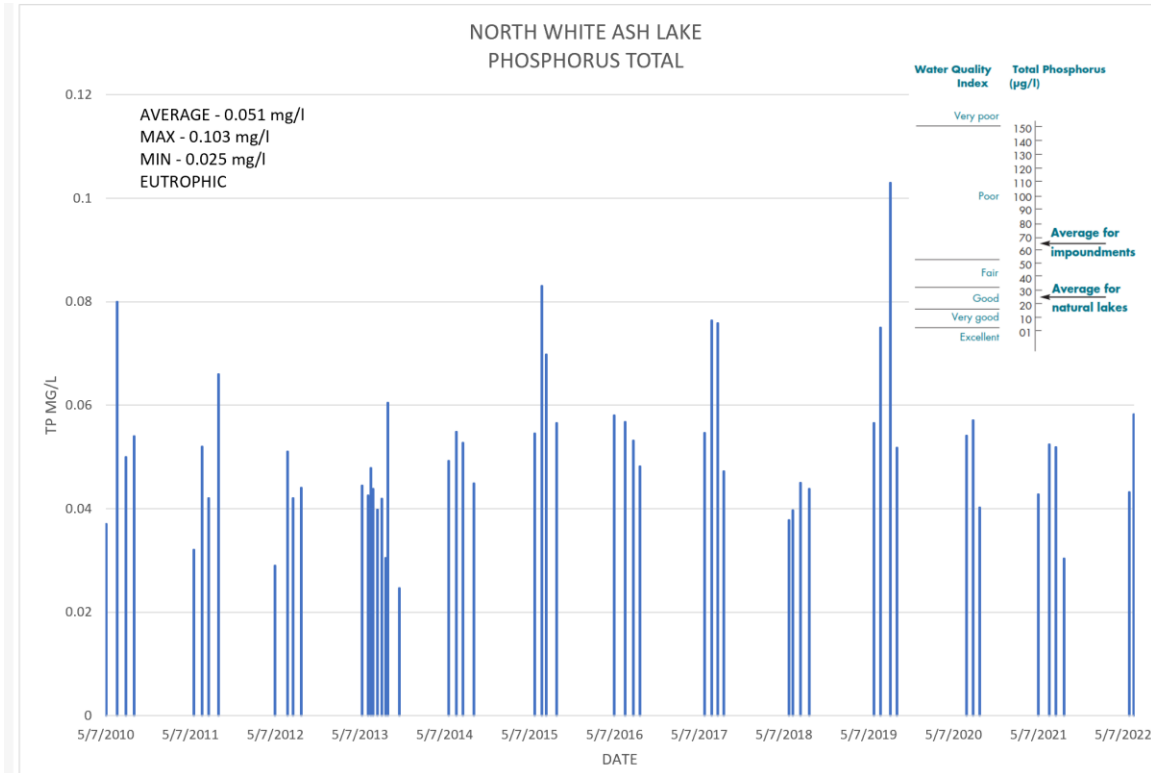
**Figure 14 - North White Ash – Total Phosphorous**

The TP in North White Ash has remained relatively steady but is showing a downward trend since an average high in 2015. One item to note is the spike in 2019; the highest recorded TP levels occurred following the tornado in 2019. This is likely due to the increased runoff during the storm and the mixing of the lake that occurred from the turbulence created by the tornado passing over.

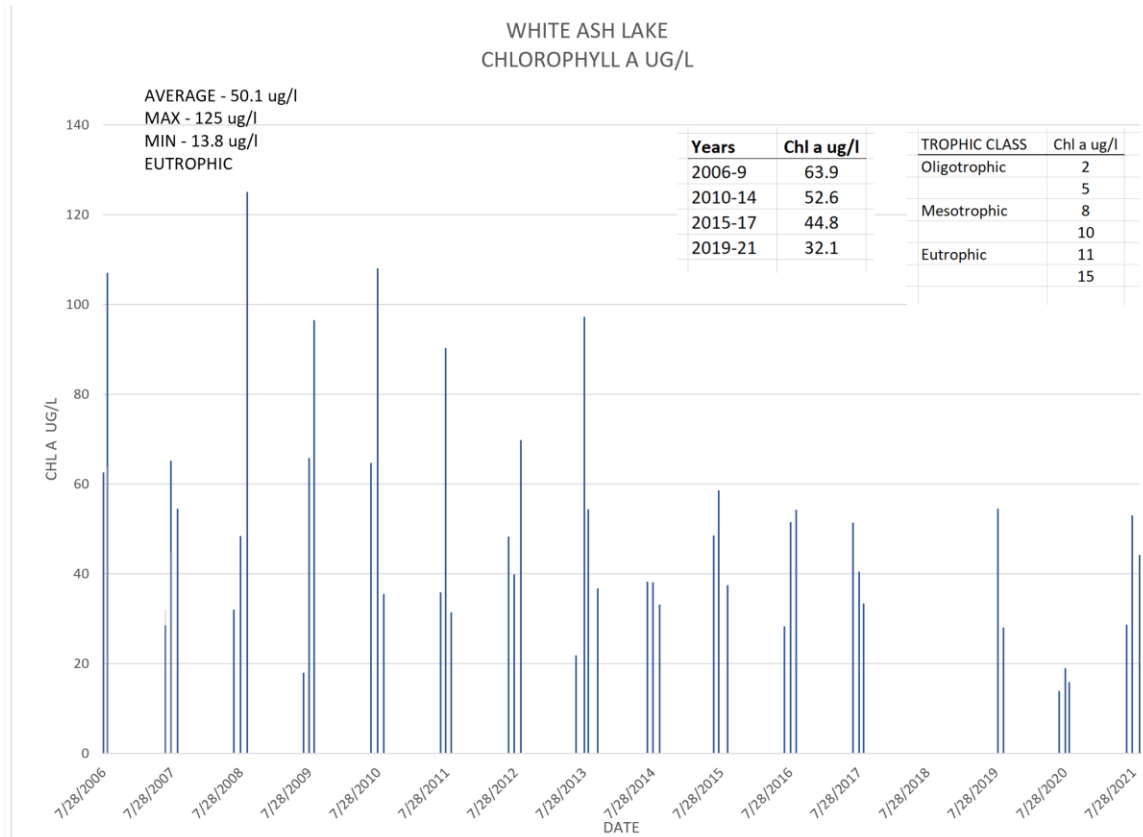
**Figure 15 - White Ash– Chlorophyll a**

When the average annual values are graphed it is readily seen that the chl a is decreasing in White Ash from about 70 ug/l prior to 2010 to about 50 ug/l in the last couple years. The decrease in chl a should have resulted in fewer algae blooms in the last several years.

The chlorophyll *a* concentration in White Ash has an average of 50.1 µg/l indicating very poor water quality and eutrophic conditions. The average for Northwest WI lakes is 13 µg/l, values over 30 µg/l indicate very poor water quality. Data ranged from 13.8 µg/l to 125 µg/l. Chlorophyll *a* concentrations in North White Ash average 13.9 µg/l indicating eutrophic conditions. Data ranged from 5 µg/l to 44.2 µg/l. The following graphs show the Chlorophyll *a* concentrations for White Ash and North White Ash lakes.

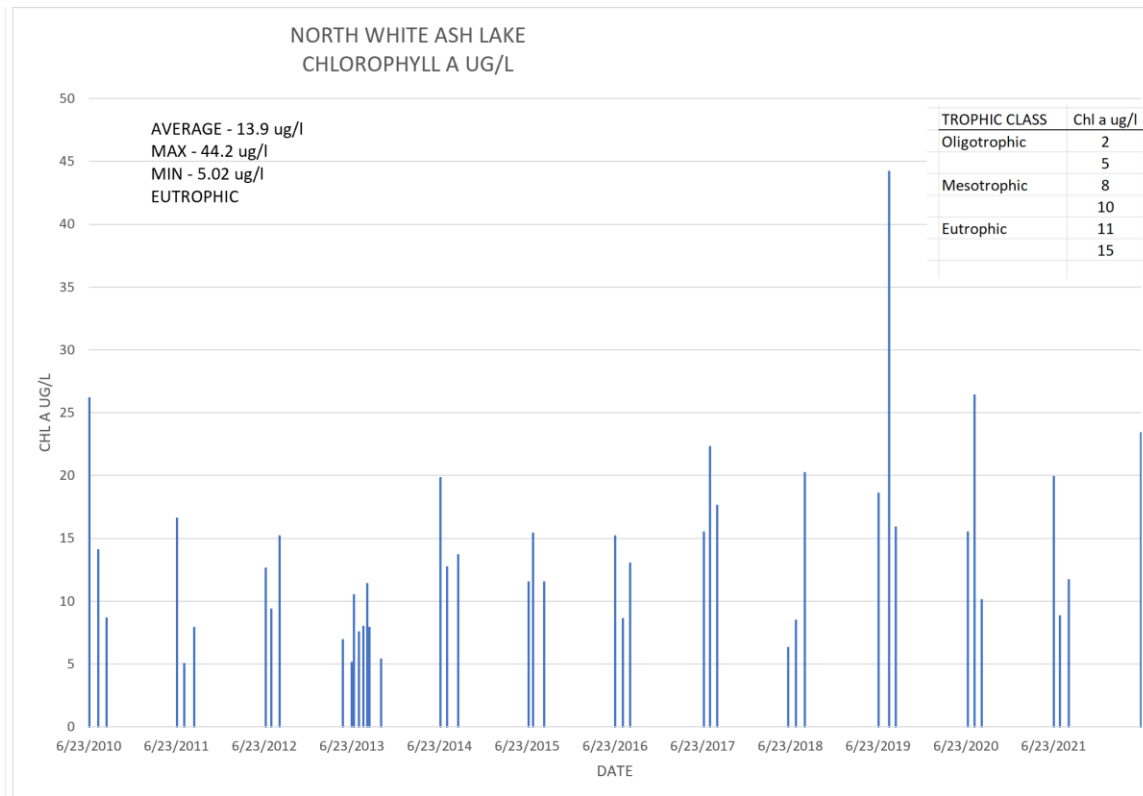
**Figure 16 - North White Ash– Chlorophyll a**

The chl a on North White Ash appears to be trending down since a peak in 2019. The influx of TP in to the system likely fueled the chl a spike seen in 2019; which was the highest recorded level on the lake. Since that spike, the chl a appears to be decreasing.

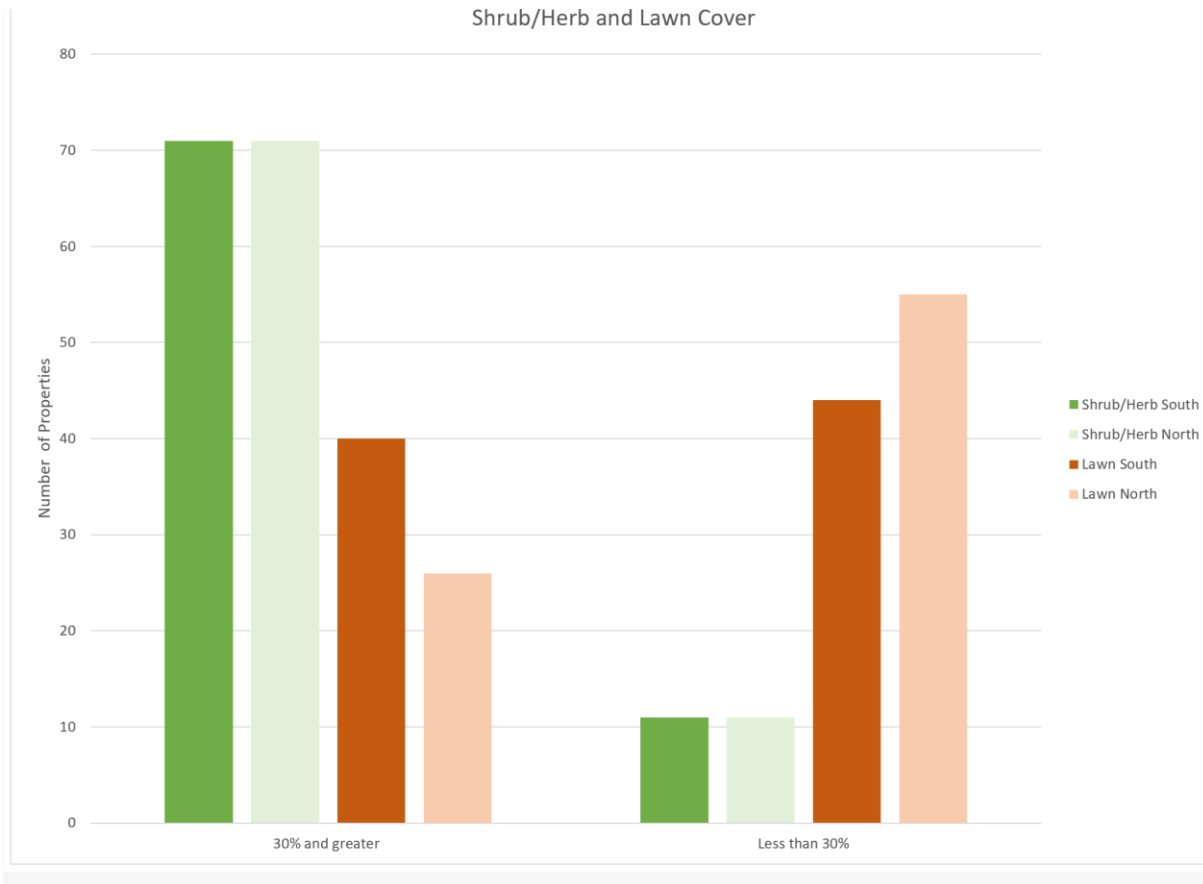
**Figure 21 - Landcover in the Shoreland**

The following figure shows the landcover in the shoreland area.

- The parcels generally have adequate canopy cover; the majority had 30% or more canopy
  - White Ash – 60% of the lots
  - North White Ash – 79% of the lots
- The majority of the parcels have adequate shrub and/or herbaceous plants present (30% or greater)
  - White Ash – 86% of the lots
  - North White Ash – 75% of the lots
- There are a few lots with impervious area but it covered less than 10% of the lot
  - White Ash – 24% of the lots
  - North White Ash – 7% of the lots
- The majority of the lots had less than 30% maintained lawn as follows:
  - White Ash – 53% of the lots
  - North White Ash – 63% of the lots

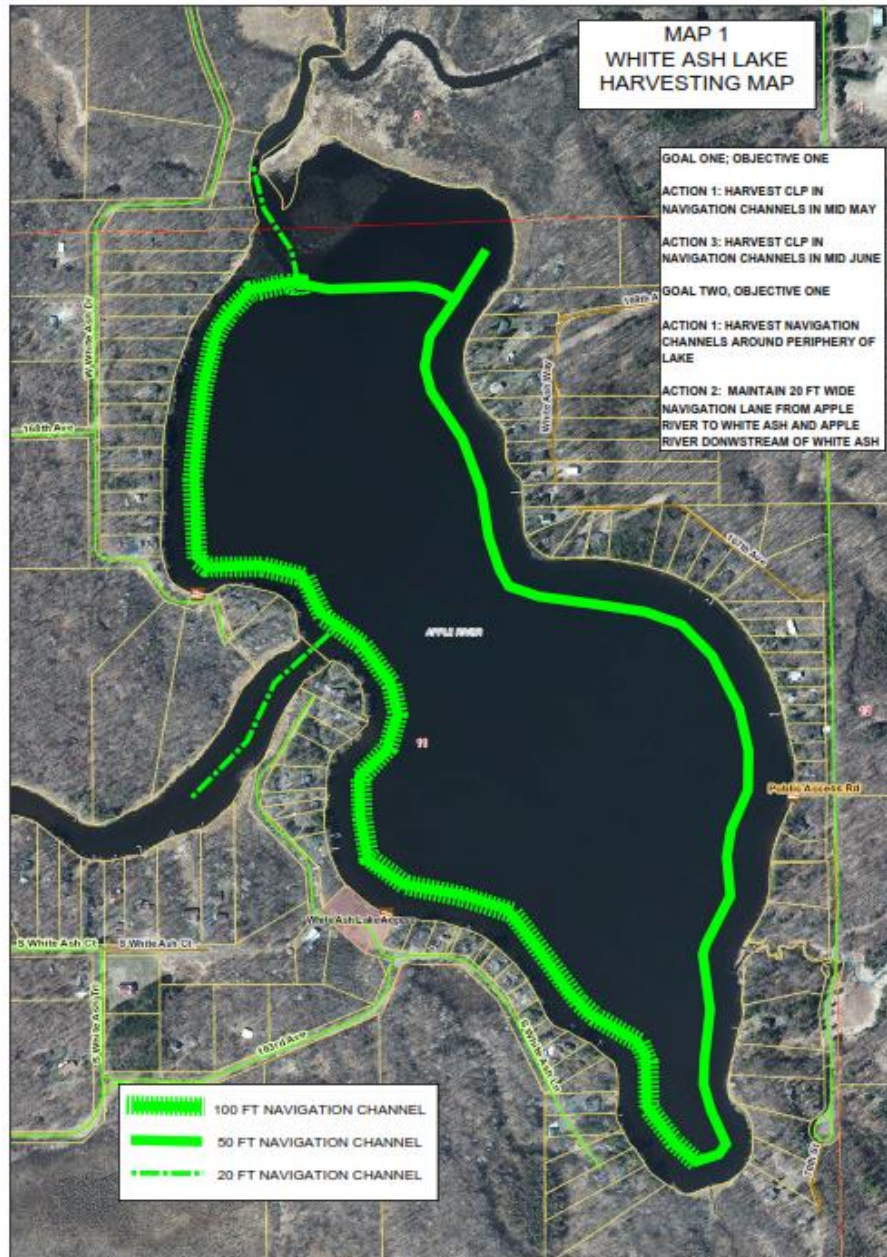
MAP 1 – WHITE ASH LAKE HARVESTING MAP

- Navigation channels will be established and included in any permit application each year, regardless of plant density to keep the option of harvesting, if necessary, open
- Position of navigation channels will vary with lake level, but will generally follow the 3-ft depth contour around the lake
- Harvesting is not allowed in 3-ft of water or less
- Cutting heads may be operated no deeper than 12 inches off the bottom
- Review conditions on the lakes; if the current harvesting plan is not obtaining desirable results, consult DNR to modify harvesting plan accordingly
