Beaver Dam Lake

Dodge County, Wisconsin

Management Plan Phase II

May 13, 2019

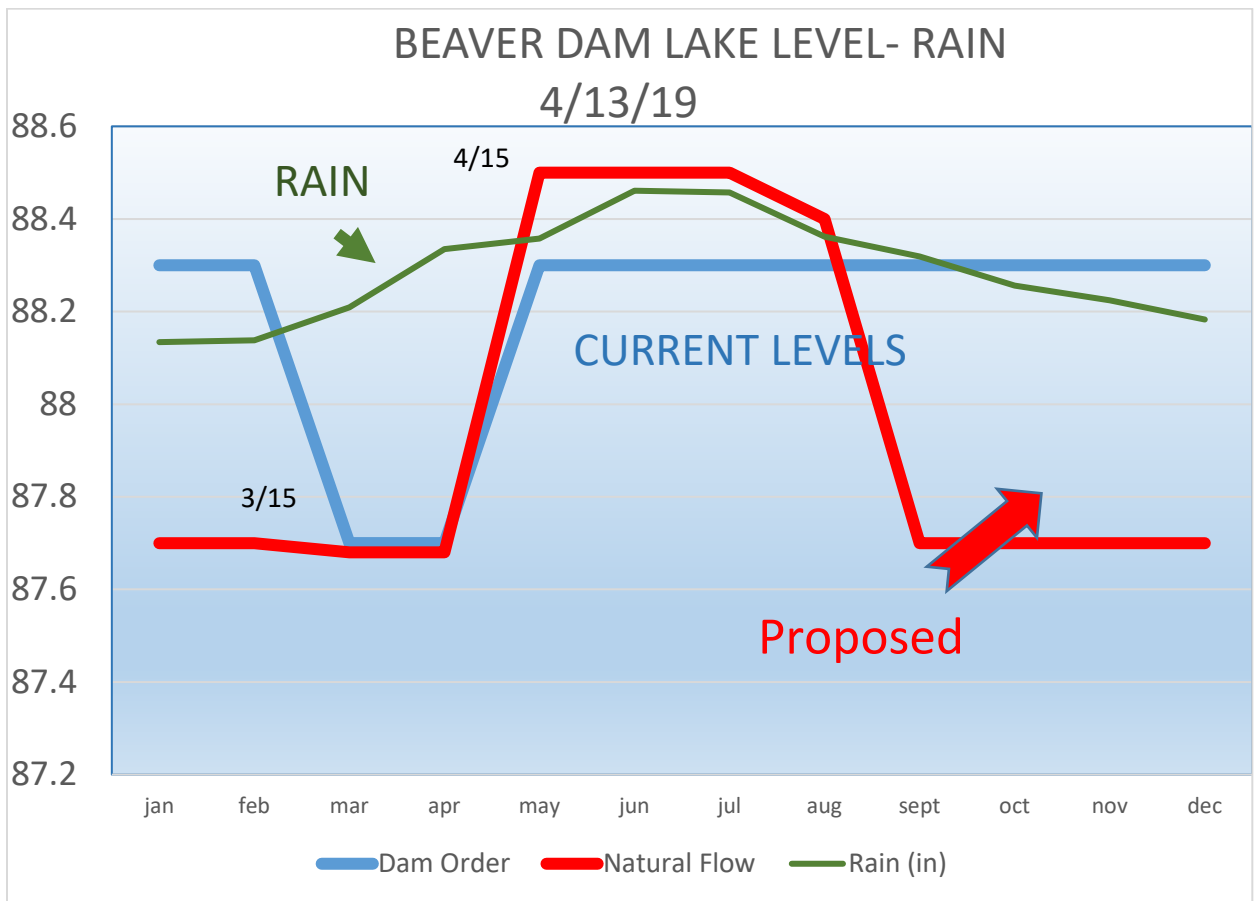
The proposed modification to the Dam Order would use natural rainfall averages (inch per month) as a guide for lake level targets for the proposed lake elevation targets (feet at dam).

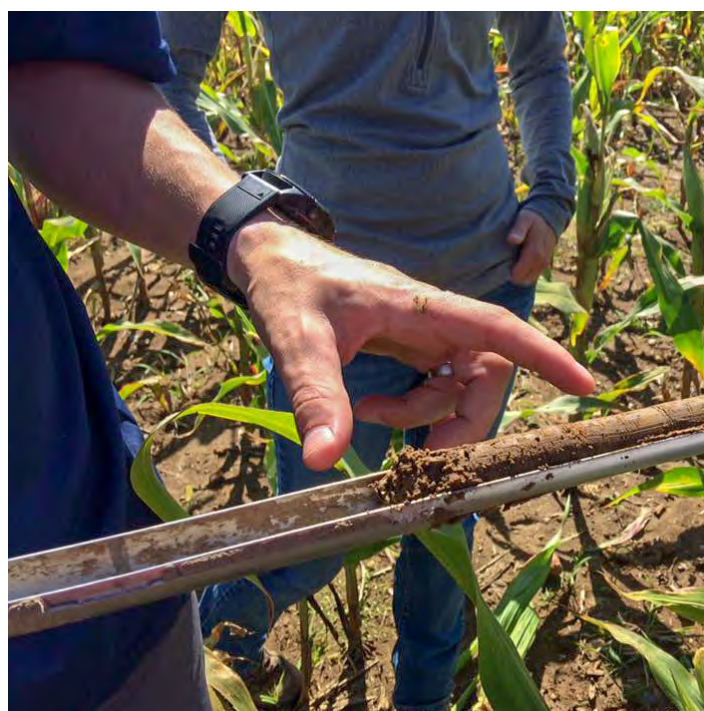
Figure 11: Bray-1 P in soil samples.

Figure 11 shows the soil test P levels (ppm) from each of the samples. Lines across the bars show the crop-optimal P (ppm) as identified by UW-Extension (Laboski and Peters, 2012). With the exception of sample #7, soils at all locations had Bray-1 P levels above or far above crop-optimal levels, meaning that soil P levels are in excess of nutrient recom-

mendations. Note that only sample 7 was lower than optimal. Samples 4 – 7 were from the same area of the field, indicating variability in nutrient levels within the same field. The number of soil samples did not allow for statistical comparisons and are not representative of the entire subwatershed.

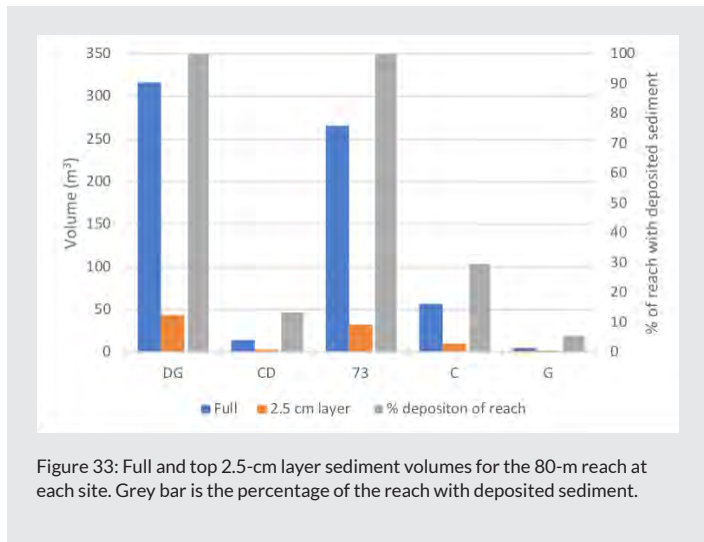
Figure 33: Full and top 2.5-cm layer sediment volumes for the 80-m reach at each site. Grey bar is the percentage of the reach with deposited sediment.

Total deposited sediment volume within the five reaches varied from 5.6 to 316 m³ (198 – 11,159 ft³). The largest volumes of 316 m³ and 265 m³ (9,358 ft³) were at DG and 73, respectively; the deposition zones within these reaches covered 100% of the 80-meter (262.5 ft) reach. The least amount of sediment, 14 m³ (494 ft³) and 5 m³ (177 ft³), was observed at Crossings CD and G, respectively; the proportion of these reaches considered deposition zones was 13% for CD and 5% for G (Figure 33).

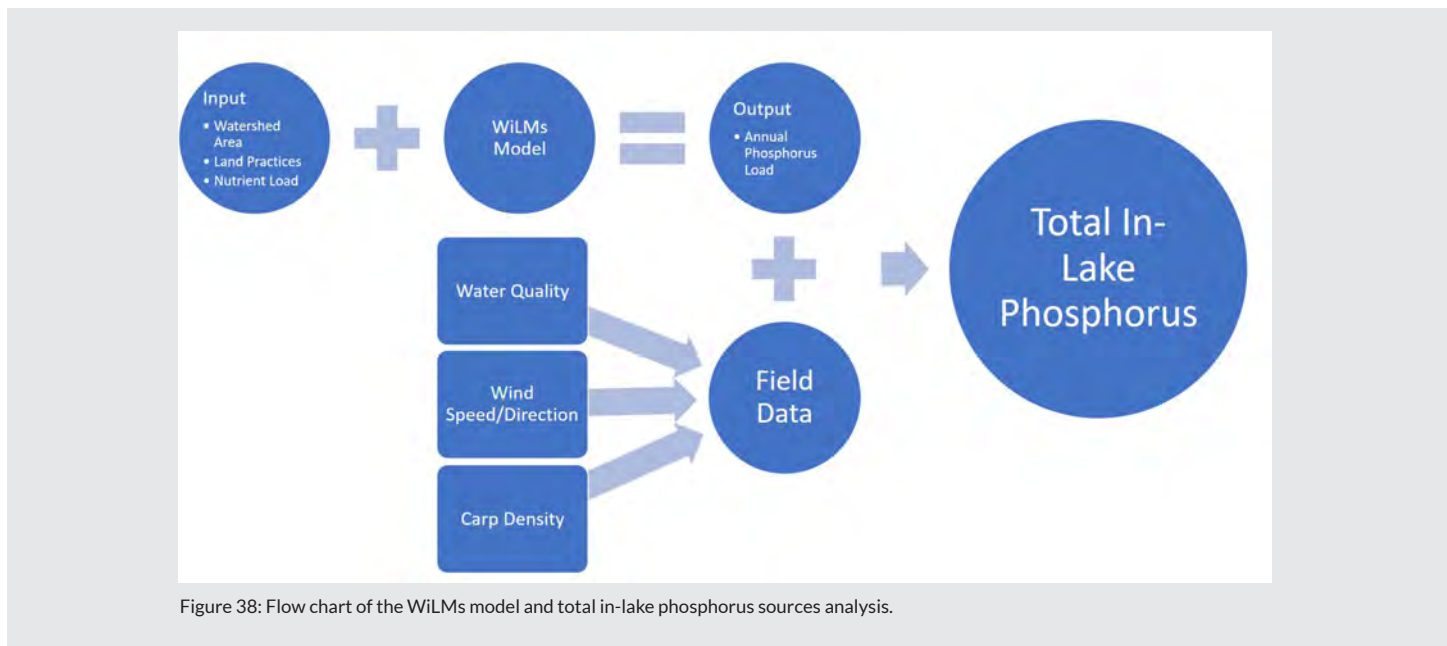
Figure 38: Flow chart of the WiLMS model and total in-lake phosphorus sources analysis.

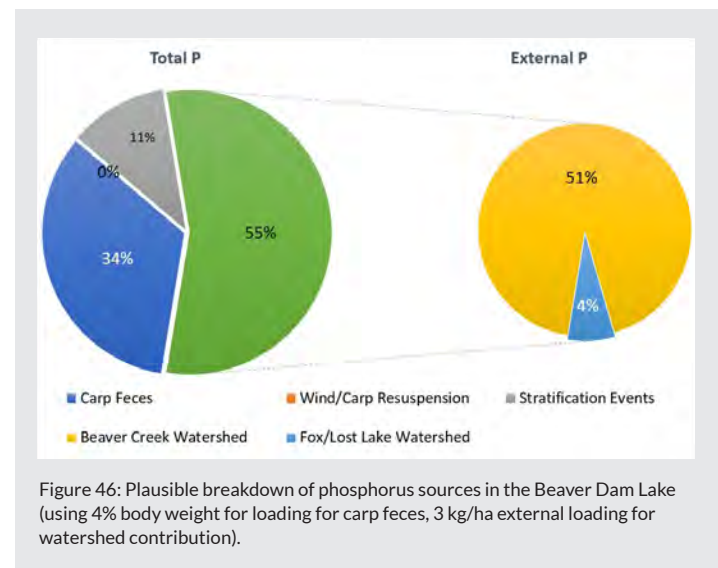
Figure 46: Plausible breakdown of phosphorus sources in the Beaver Dam Lake (using 4% body weight for loading for carp feces, 3 kg/ha external loading for watershed contribution).

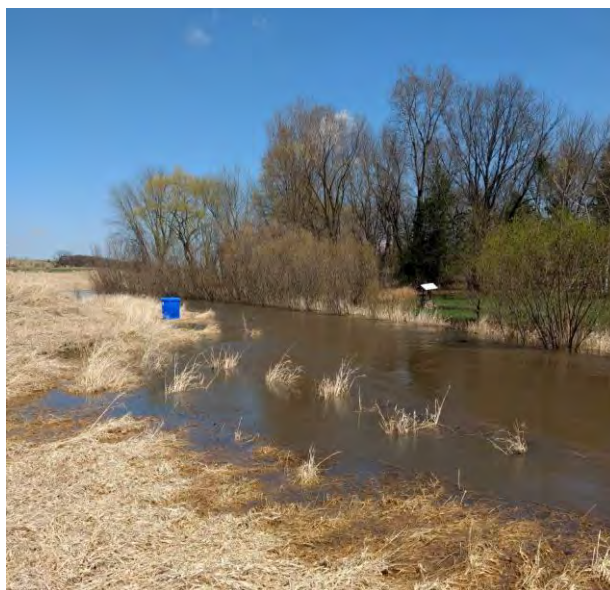
Heavy flow and muddy water at the Beaver Creek monitoring site, May 4, 2018

Relevant to the potential for TSS and TP loading to Beaver Dam Lake, heavy rainfall occurred in late April and early May, in a heavy snow/heavy rain weather system that produced substantial local runoff. Visual observations and collected data indicate that the April/May runoff was very turbid compared to typical conditions. Additional significant rainfall occurred in June and July. The record-high rainfall events struck the area in late August and early September, with more than 16 inches of rainfall occurring.

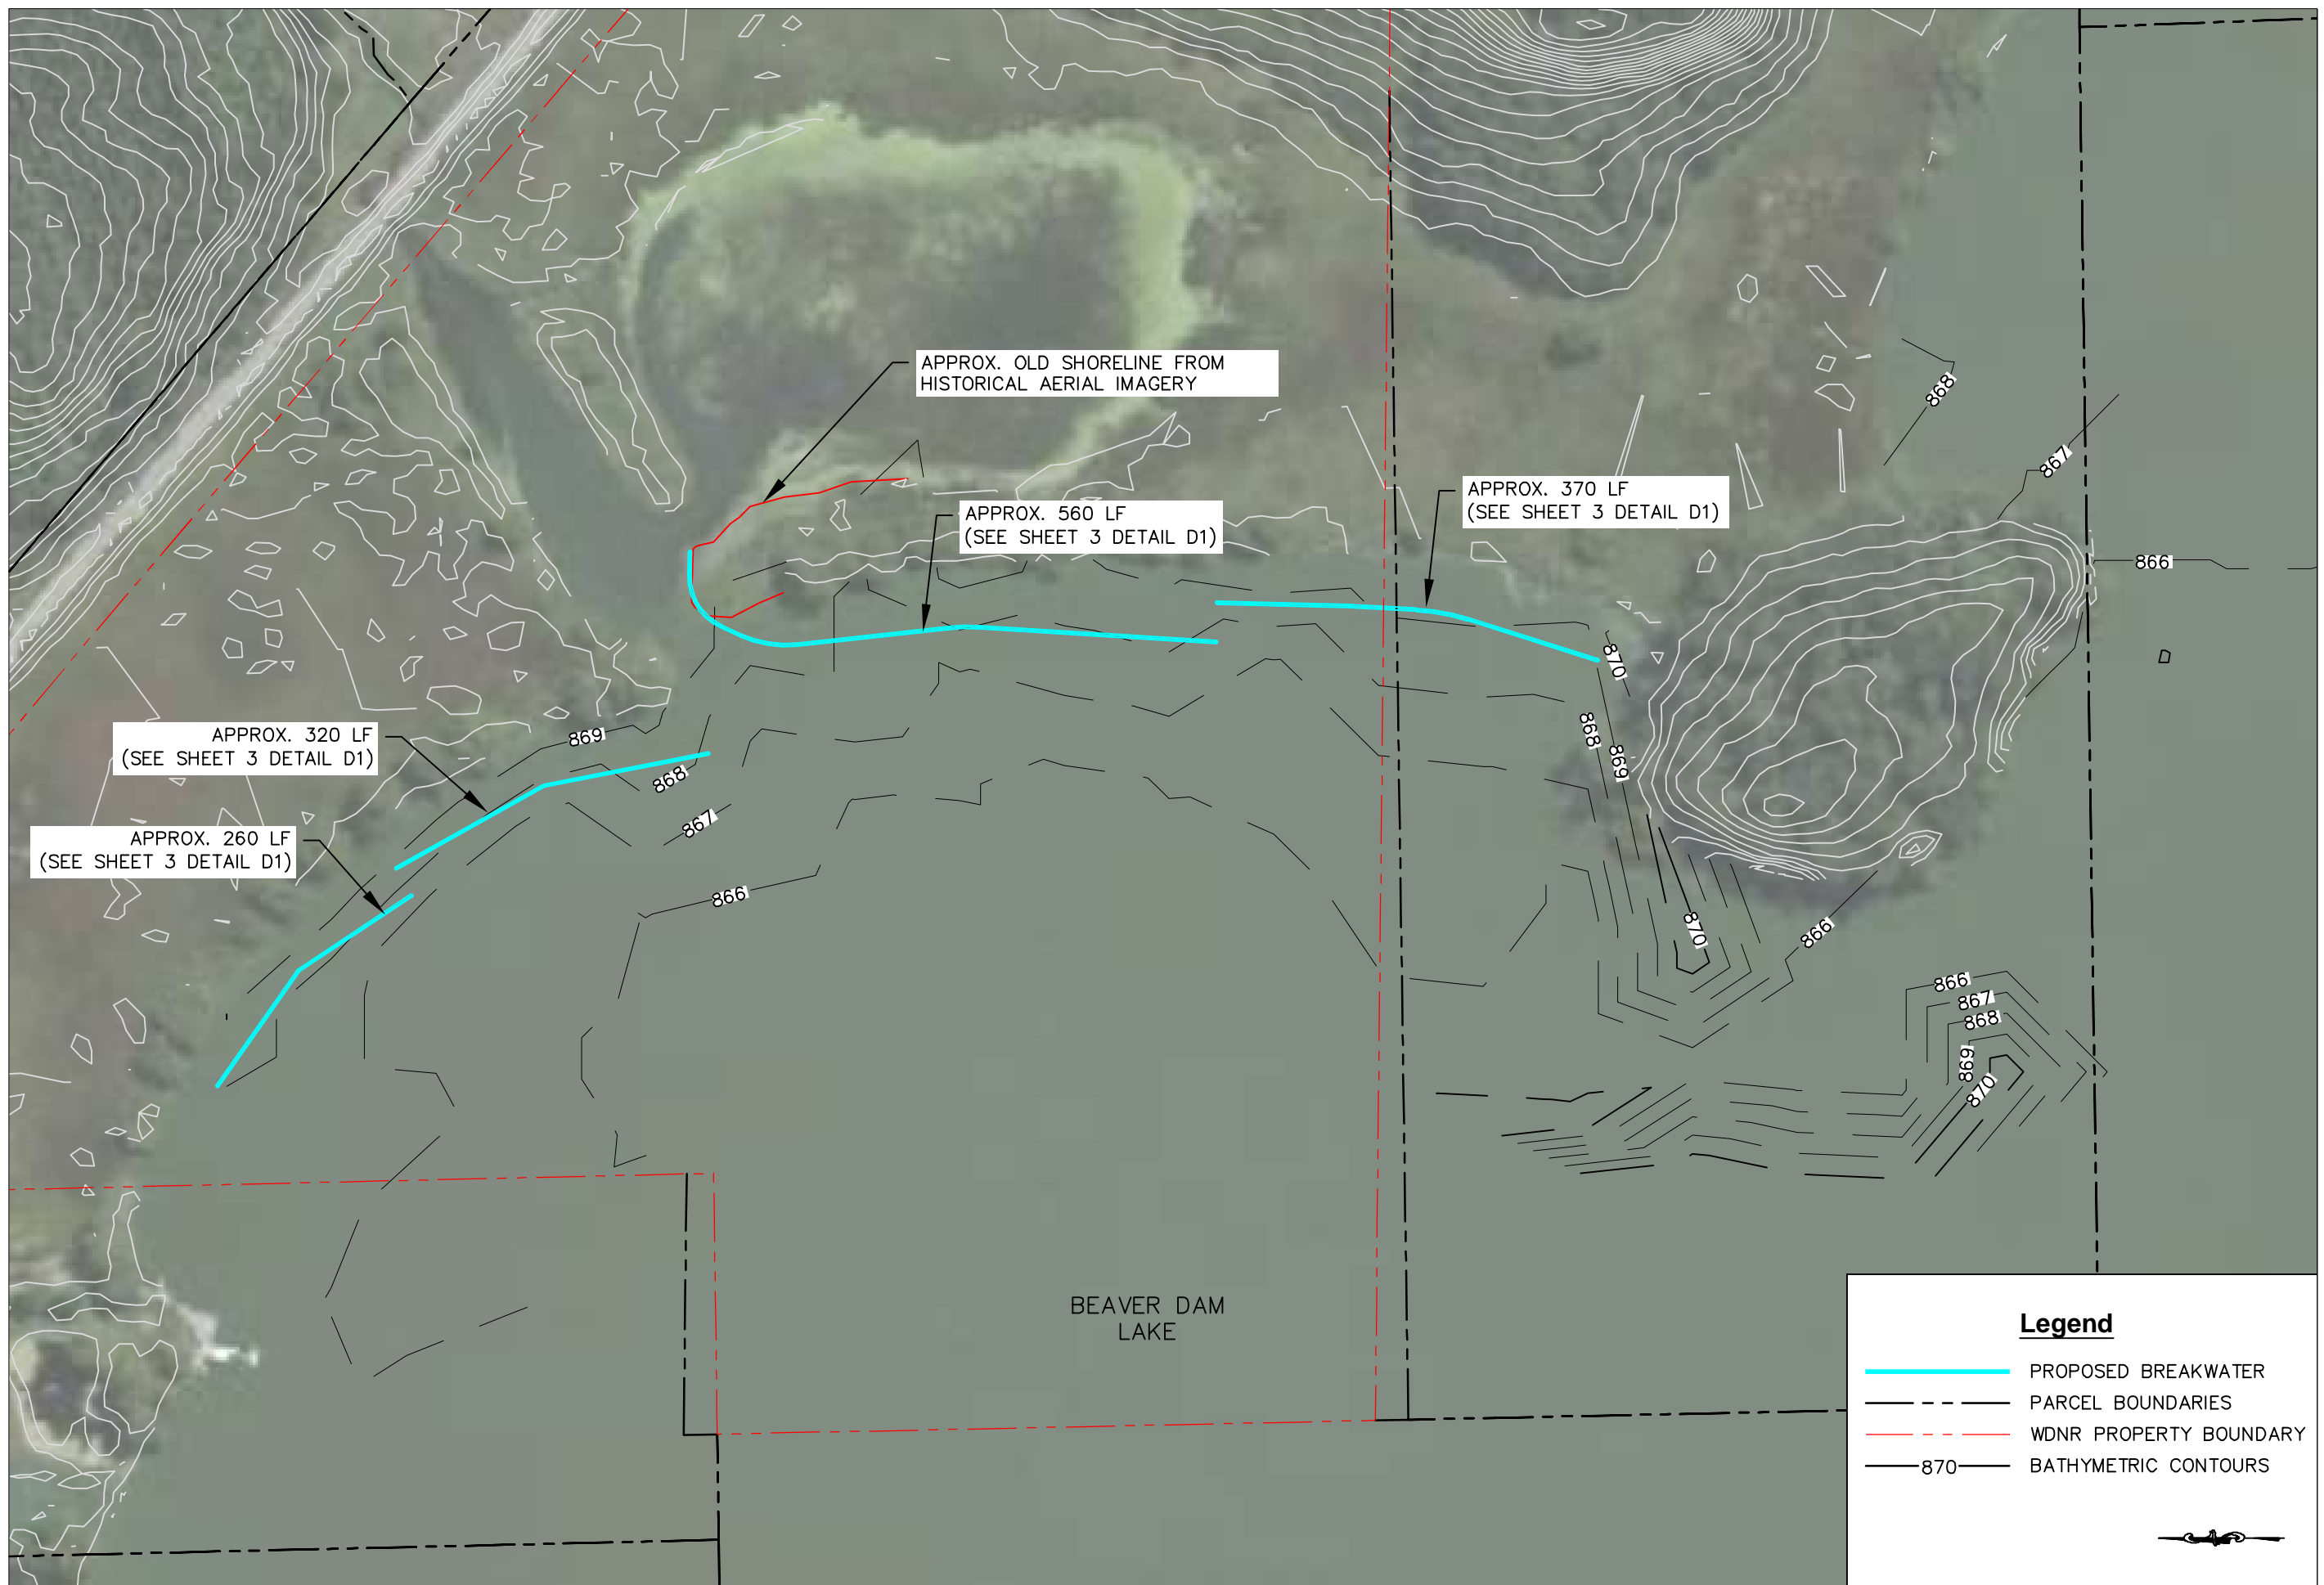
SHEET NO.
 1 / 3

APPROX. OLD SHORELINE FROM HISTORICAL AERIAL IMAGERY

APPROX. 560 LF (SEE SHEET 3 DETAIL D1)

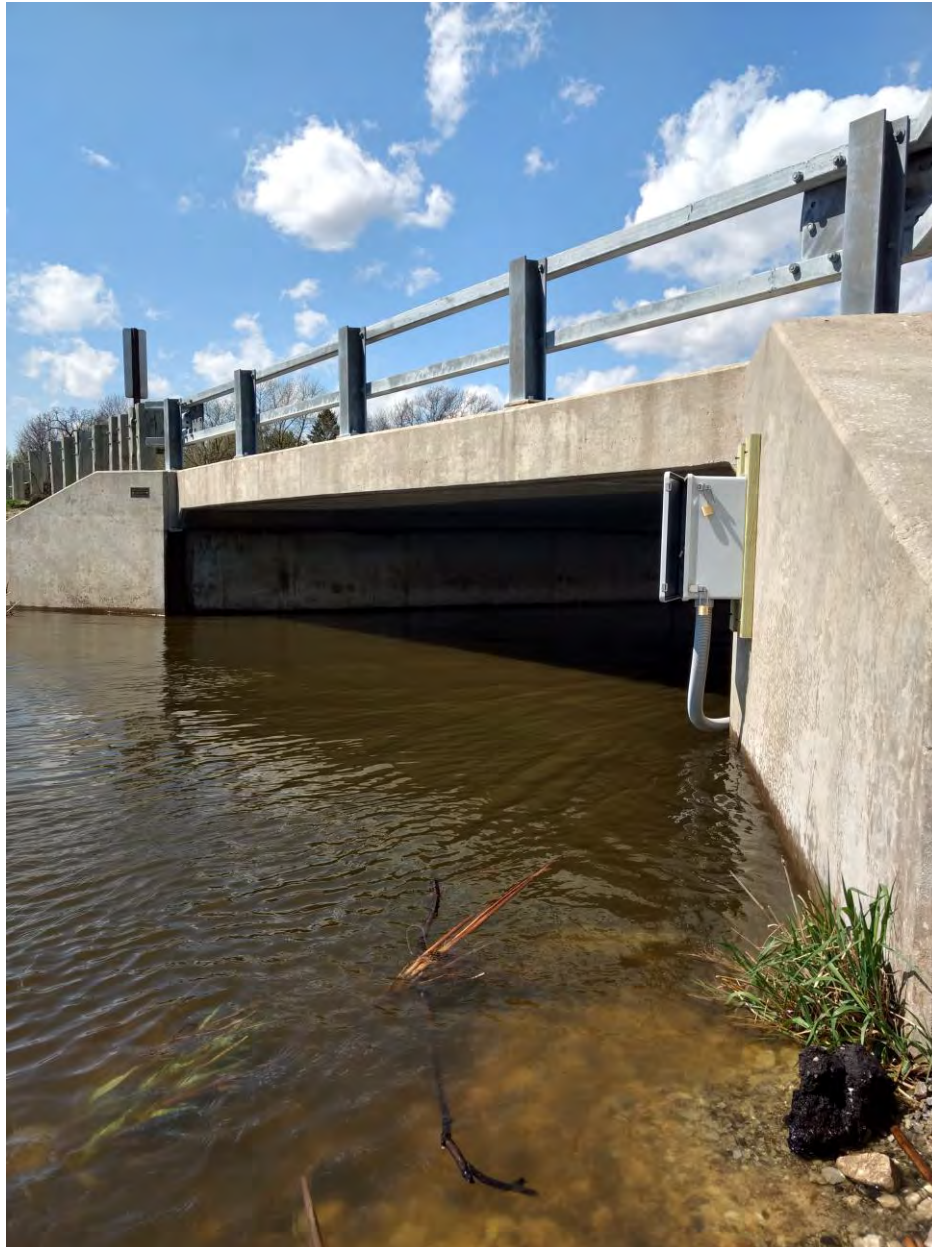
Velocity elevation sensor mounting on the CTH G southeast abutment wall. The data loggers were installed in the locking cabinet. The flexible piping contains the cables for the sensors located beneath the bridge.

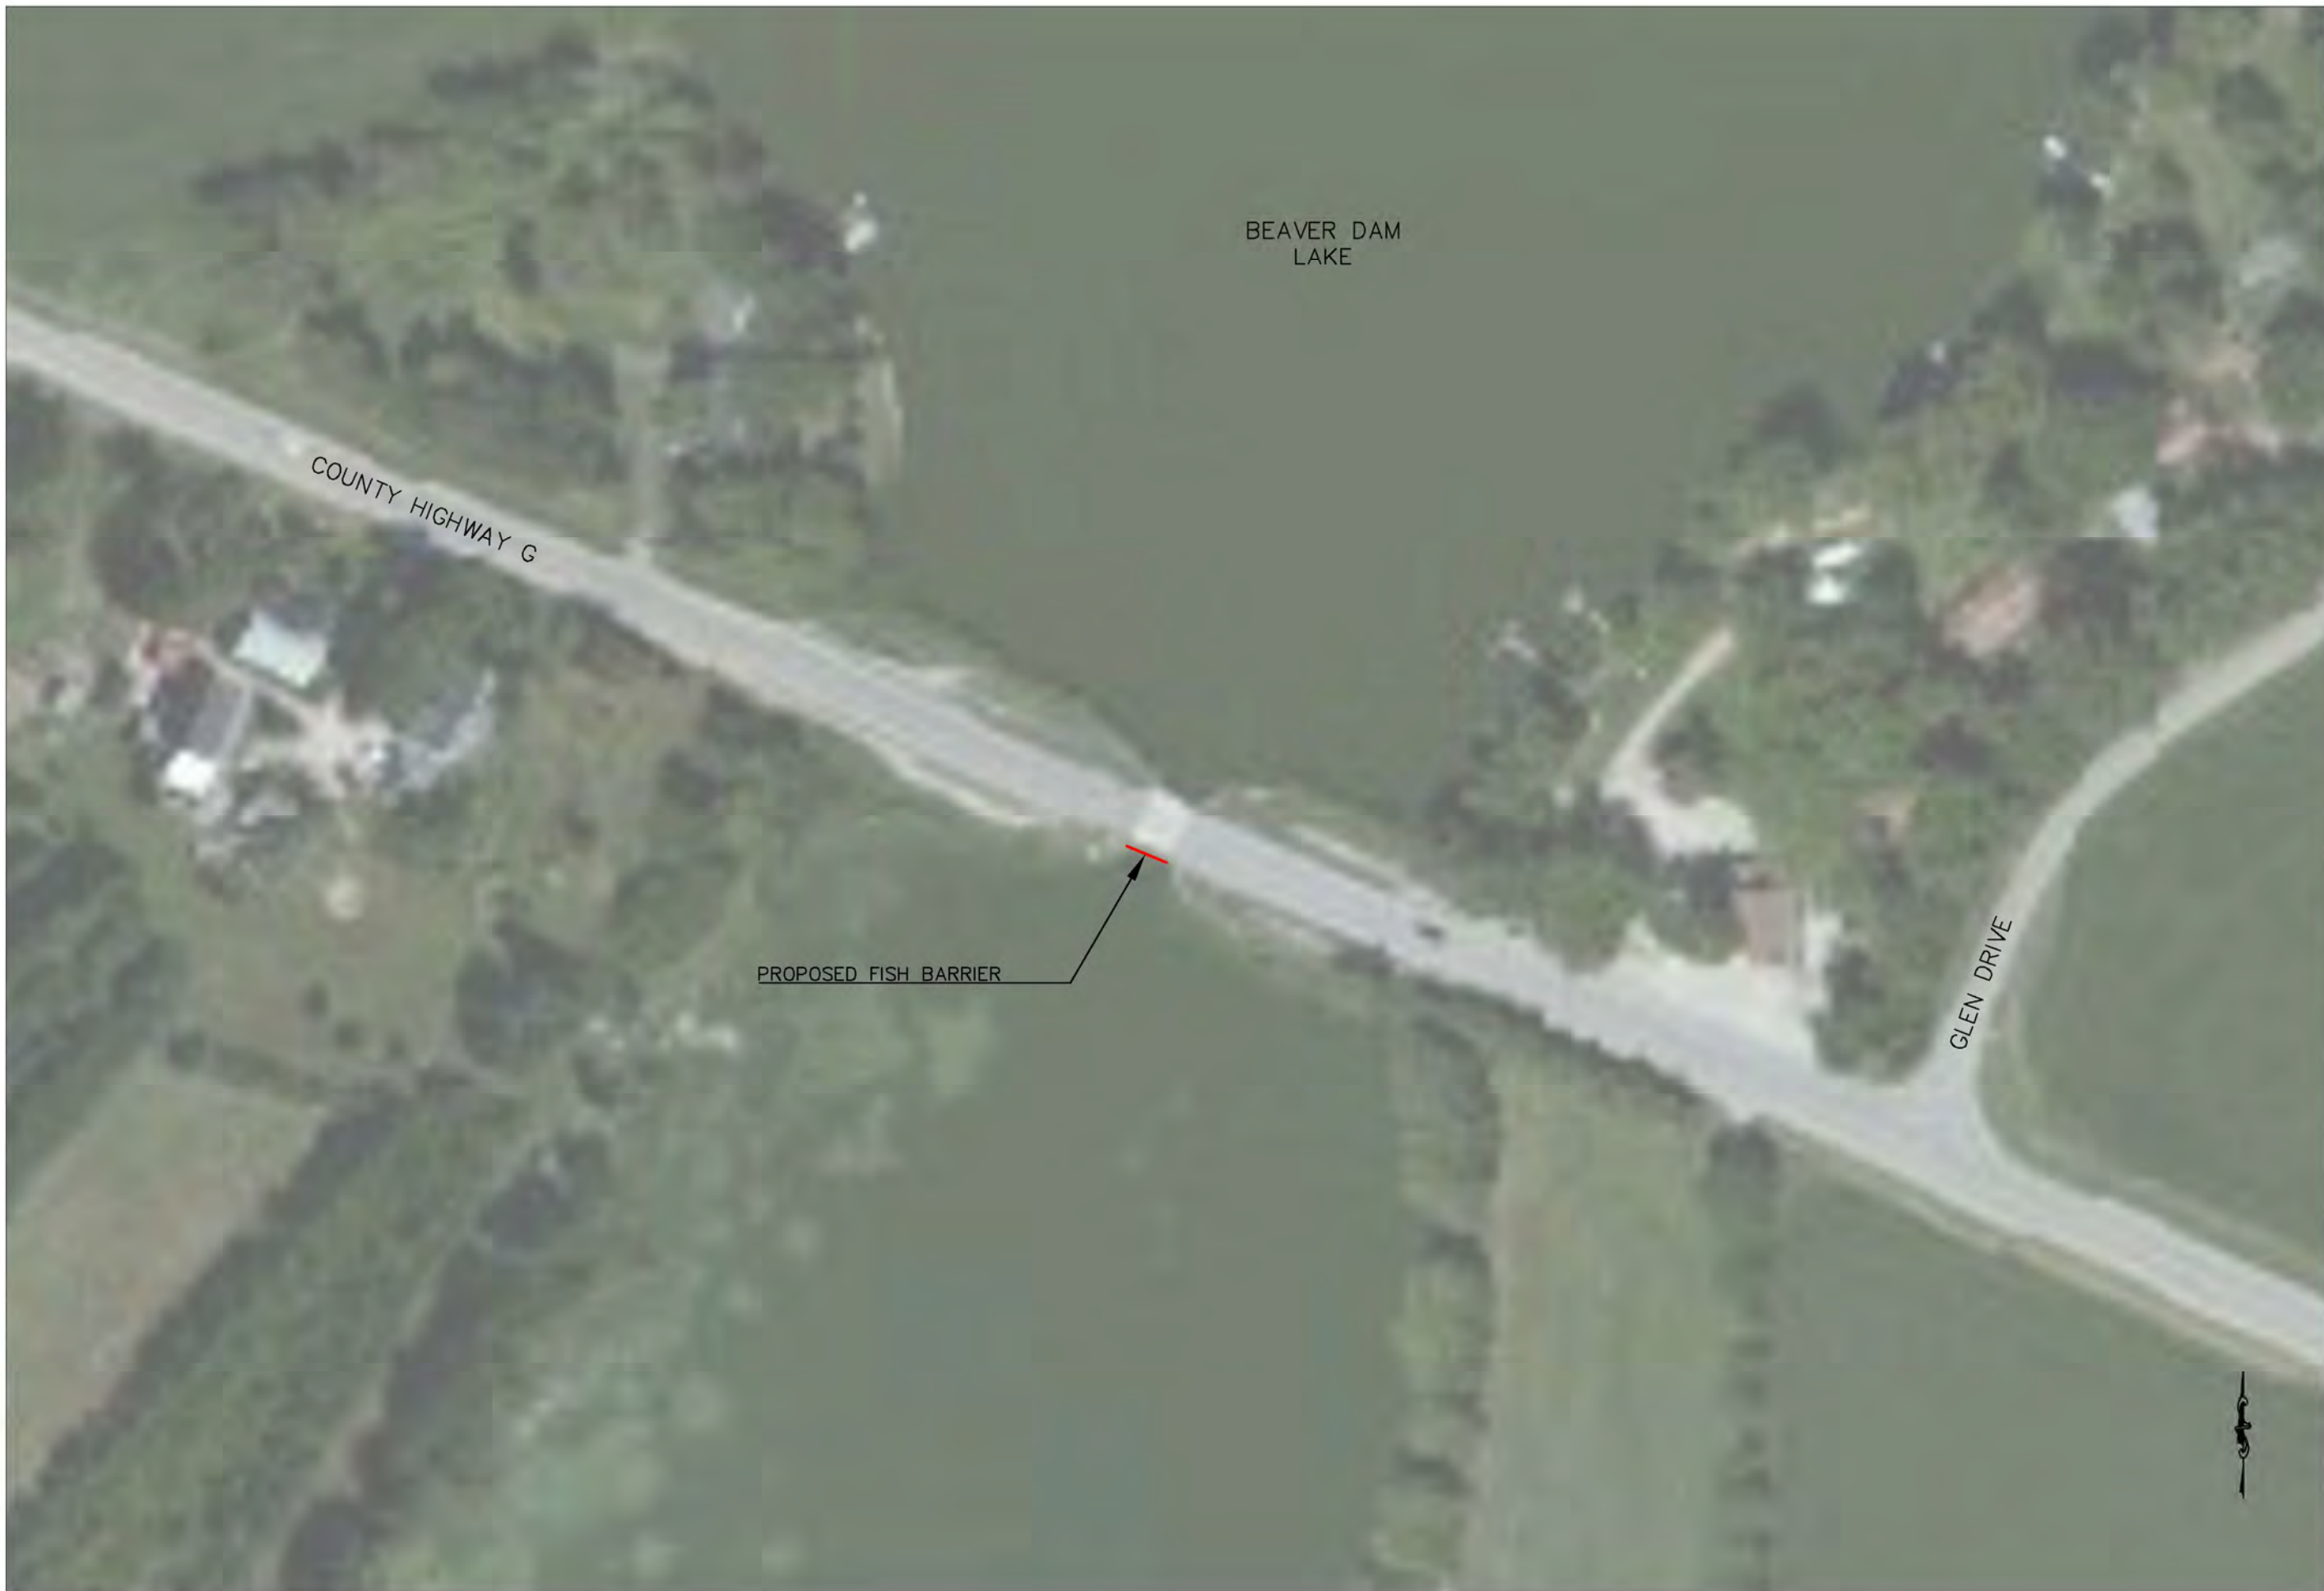
Attachment: Drawing sheets 1 and 2 illustrating Rakes Bay fish barrier

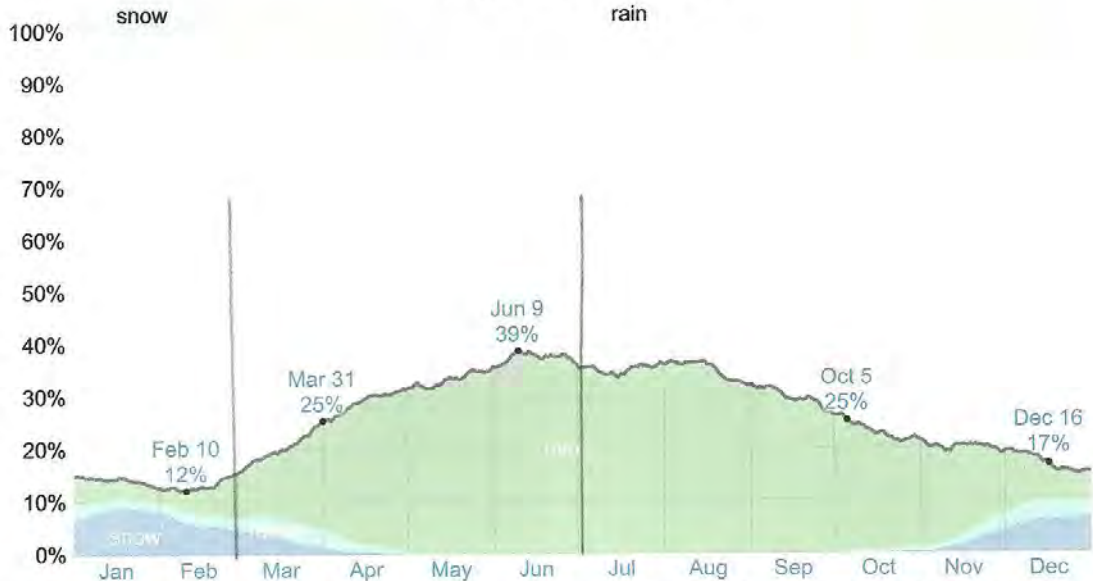
The percentage of days in which various types of precipitation are observed, excluding trace quantities: rain alone, snow alone, and mixed (both rain and snow fell in the same day).
