Big Arbor Vitae Lake 2018 Lake Assessment Report

Prepared by
Vilas County Land & Water Conservation

January 9, 2020

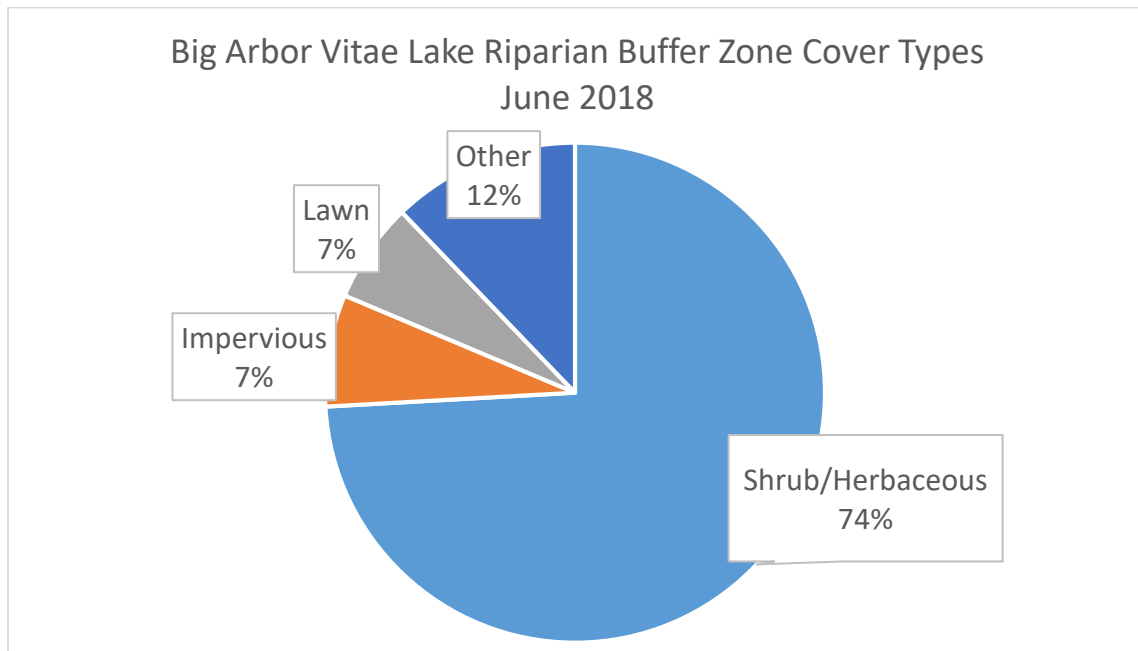
Figure 3. Ground cover type in Riparian Buffer Area (35 ft. inland from shore) on Big Arbor Vitae Lake, 2018. “Other” category includes duff.

Lake-wide, 74% of the riparian area (35 ft. inland from ordinary high water mark) was covered by a shrub/herbaceous layer. Lawn made up 7% of the riparian area, and Impervious surfaces made up 7%. In some instances the Impervious surface consisted of segments of road surfaces and rights-of-way and do not reflect the parcel owner's structures. The "other" category was comprised of duff, bare soil, and mulch sand pit sand and covered 7% of riparian buffer zone. See Appendix 5 for Riparian Buffer Zone Cover Types.

- **Encourage native vegetation to grow in the 35 ft. shoreland buffer areas:**
 - 7% of the 35 ft buffer zone was lawn. Encourage willing landowners remove turf grass in the buffer area and replace with native vegetation. Contact Cathy Higley from Vilas County Land & Water Conservation 715-479-3738 or cahigl@vilascountywi.gov for assistance.

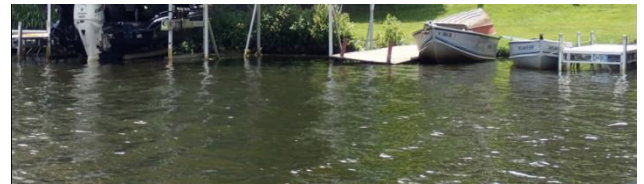
Figure 4. Some areas of Big Arbor Vitae Lake showed denser dock placement. Lake-wide, there were 14.0 docks/mile on Big Arbor Vitae Lake. Having a lake-wide dock density greater than 16 docks/mile has been shown to have negative effects on fish diversity (Jacobsen et.al).

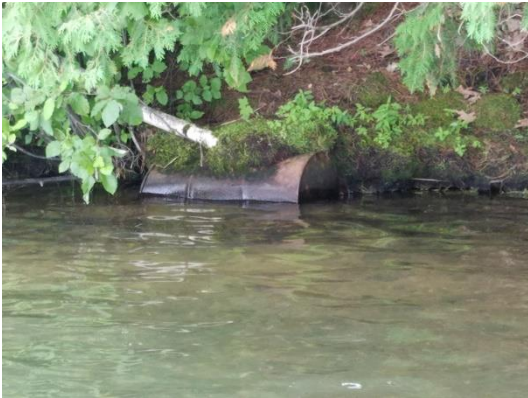
Figure 6. An old metal barrel was found along the shoreline.

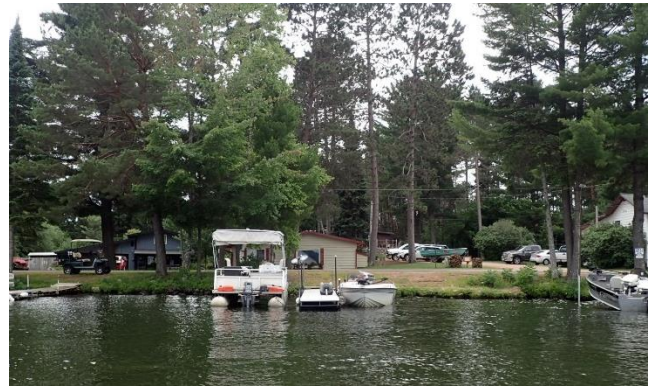
Figure 7. Several parcels on Big Arbor Vitae Lakes are split by a road and right-of-way. These have higher percentages of impervious surfaces but do not reflect land use of the referenced parcel.

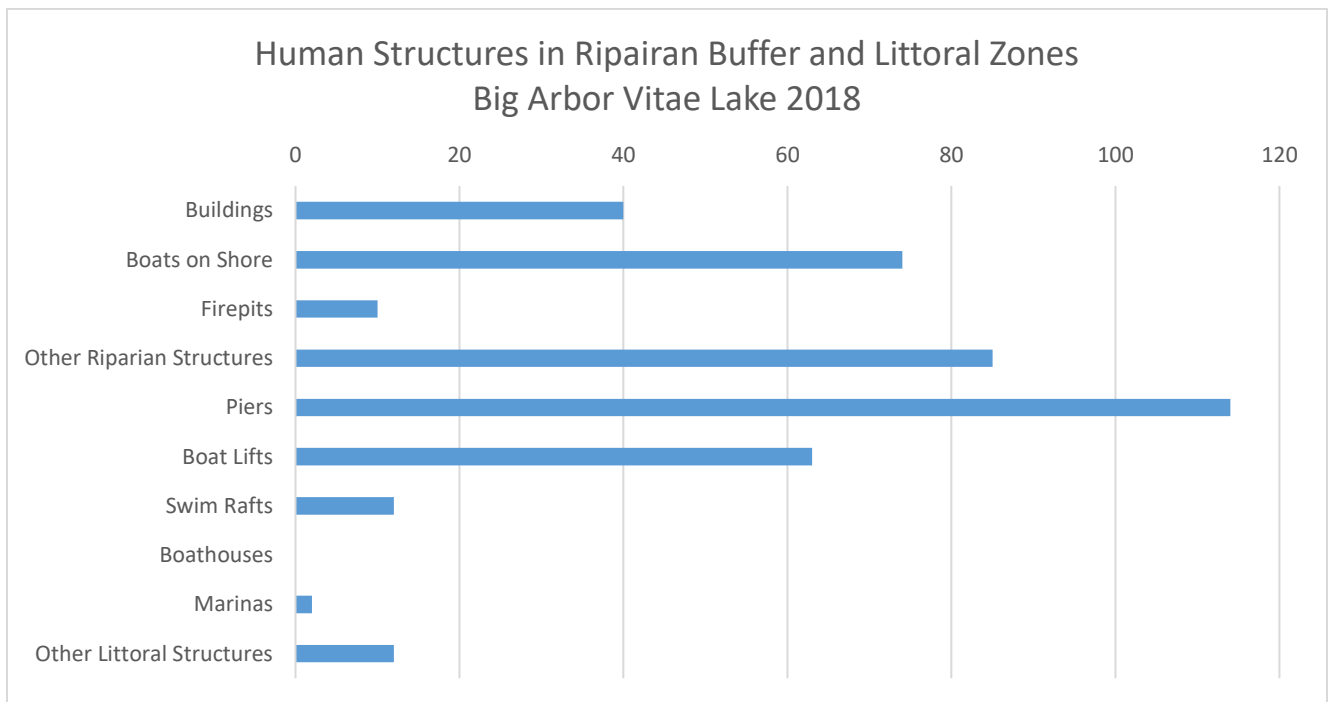
Many human structures or modifications were noted in the Riparian, Bank, and Littoral Zones. See Figure 8 for Human Structures in Riparian Buffer, Bank and Littoral Zones Charts. Because of their ecological importance, these areas are typically protected by County Zoning and DNR regulations and permits are often required to modify or place new structures in these areas. In Big Arbor Vitae Lake, piers were the most common structure. Ten docks or less per kilometer (16 docks/mile) of shoreline has been shown to be a threshold of maintaining high quality fish diversity in Minnesota (Jacobsen et. al). Big Arbor Vitae Lake is below this figure at 14.0 docks/mile. Additional littoral structures such as boat lifts, swim rafts, etc. would intuitively seem to add to this stress. Other major categories for structures were: other riparian structures (85); boats on shore (74); boat lifts (63); and buildings (40) within the riparian area.

Figure 8. Number of human structures documented in the Riparian Buffer and Littoral Zones on Big Arbor Vitae Lake 2018.

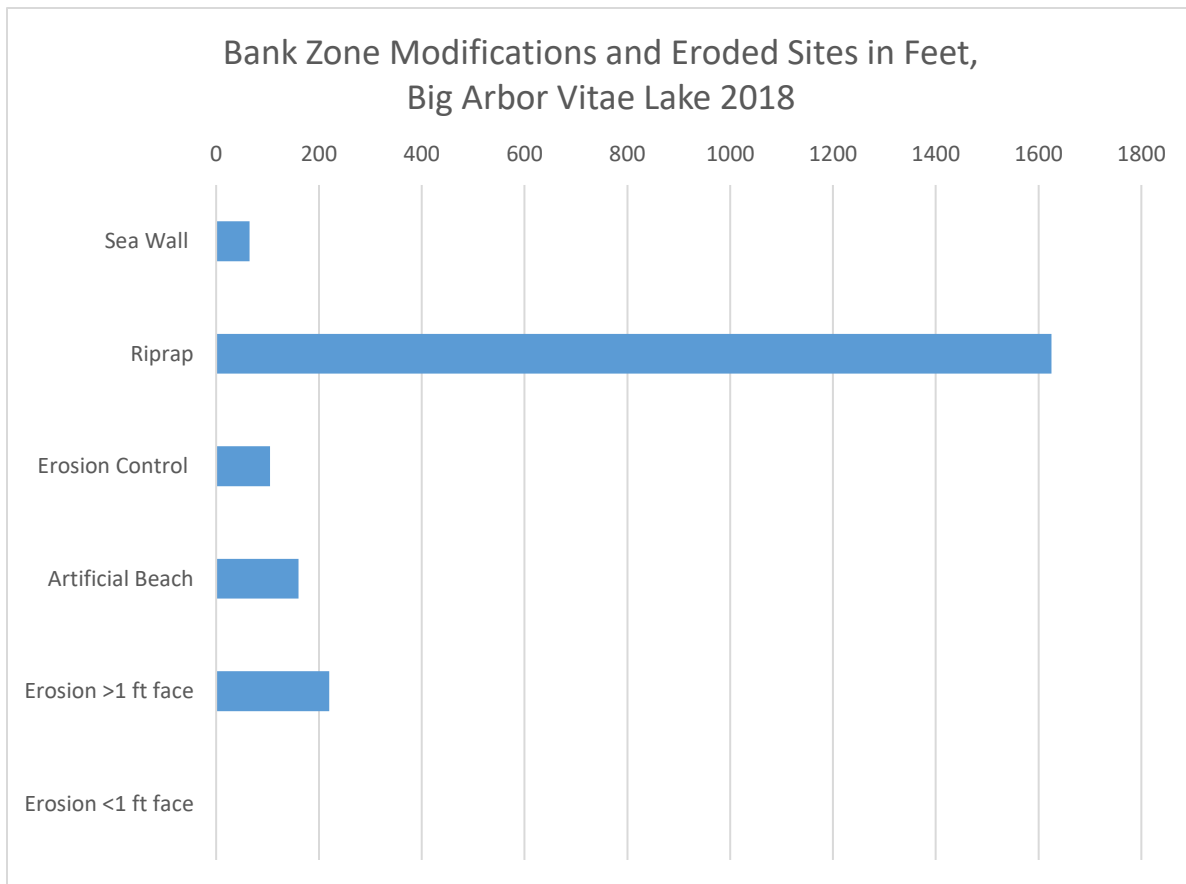
Within the Bank Zone, modifications included riprap, artificial beach, erosion control structures, and seawalls. There was 1625 ft of riprap noted, which would comprise about 4% of the total shoreline. Note that Big Arbor Vitae Lake is naturally quite rocky, and many shoreline areas could have been riprapped many years ago, but vegetation has been growing in. Riprap was not noted unless it was obvious. Artificial beaches totaled 160 feet of shoreline (less than 1% of the total shoreline). Bank erosion with a greater than 1 ft face was noted across 220 ft of shoreline. One seawall accounted for 65 ft of shoreline. Other erosion control structures were in place on 105 ft of shoreline. No bank erosion less than 1 ft face was noted. (See Figure 9.)

Figure 9. Length in feet of human modifications & eroded sites to Bank Zone on Big Arbor Lake 2018.

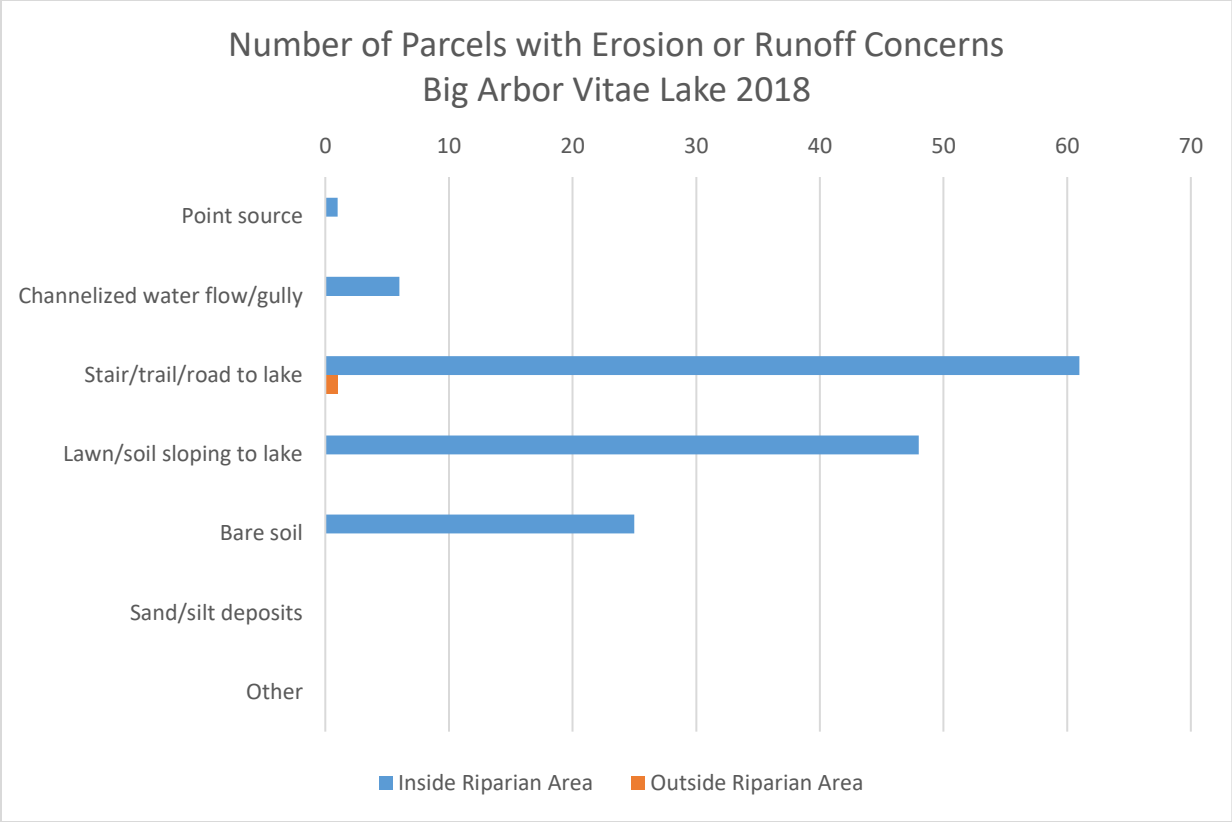
Several runoff and erosion concerns were documented within the riparian area: 1 parcel had

a point source; 61 parcels had stairs/trail/road to the lake; 48 had lawn/soil sloping to the lake; and 25 had bare soil. See Figure 10 for Number of Parcels with Erosion or Runoff Concerns.

Figure 12. Number of parcels with runoff and erosion concerns in Riparian Zone and Outside Riparian Zone on Big Arbor Vitae Lake 2018.

- Prioritize the 6 active erosion areas (point source & channelized waterflow/gully) for improvements as landowners are willing. Contact Cathy Higley for assistance cahigl@vilasocuntywi.gov or 715-479-3738.

- The number of parcels with erosion concerns was fairly high (86%). Addressing these issues with willing private landowners will take a coordinated effort, ideally with a well versed riparian being locally available for those interested. Stormwater management (gutters, infiltrations, etc.) outside the 35 ft. buffer zone should also be addressed with willing landowners. Contact Cathy Higley from Vilas County Land & Water Conservation 715-479-3738 or cahigl@vilascountywi.gov for assistance.

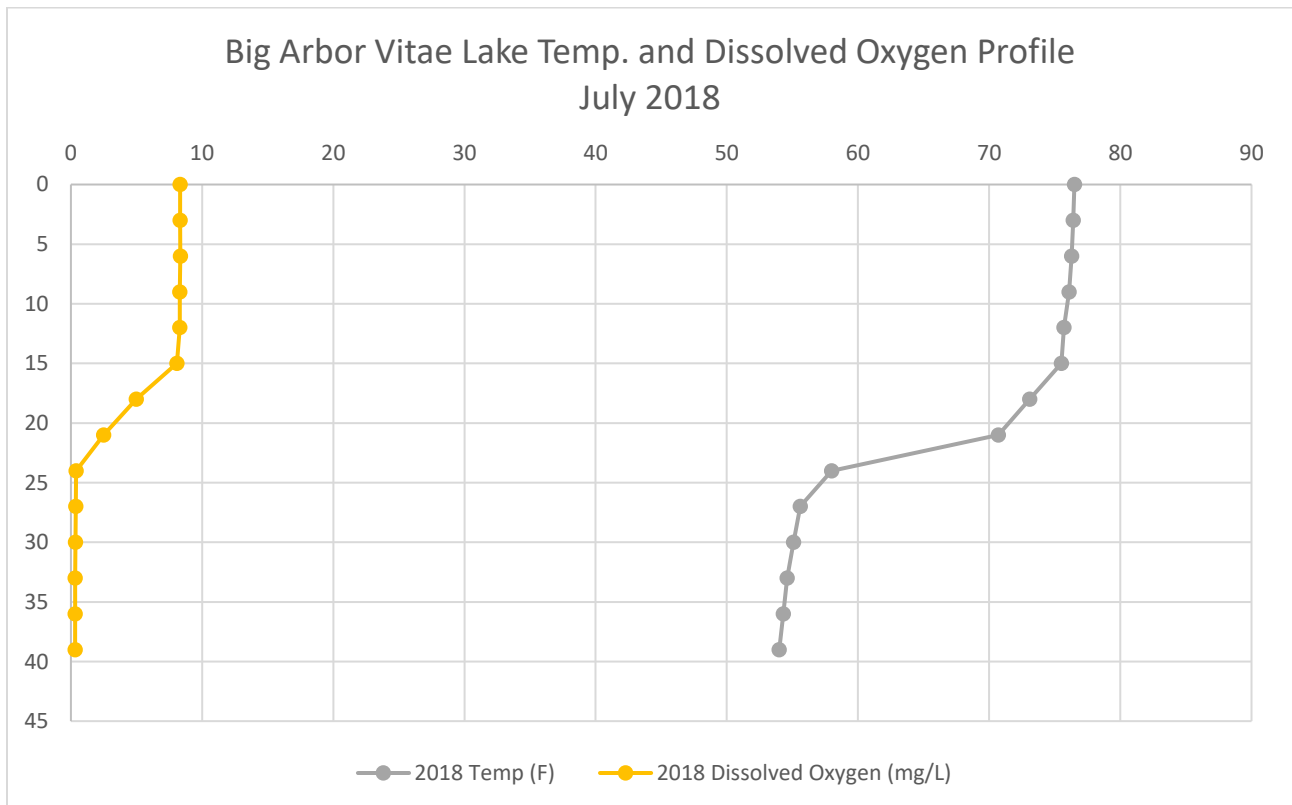
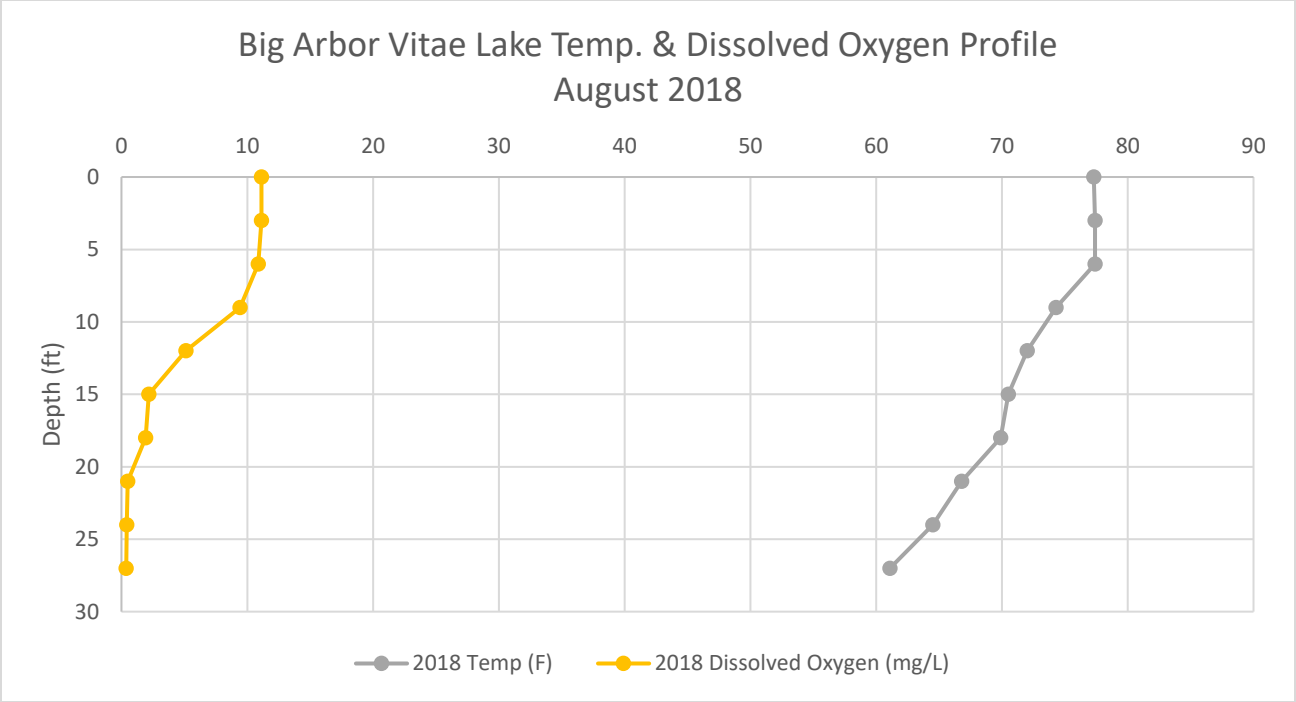
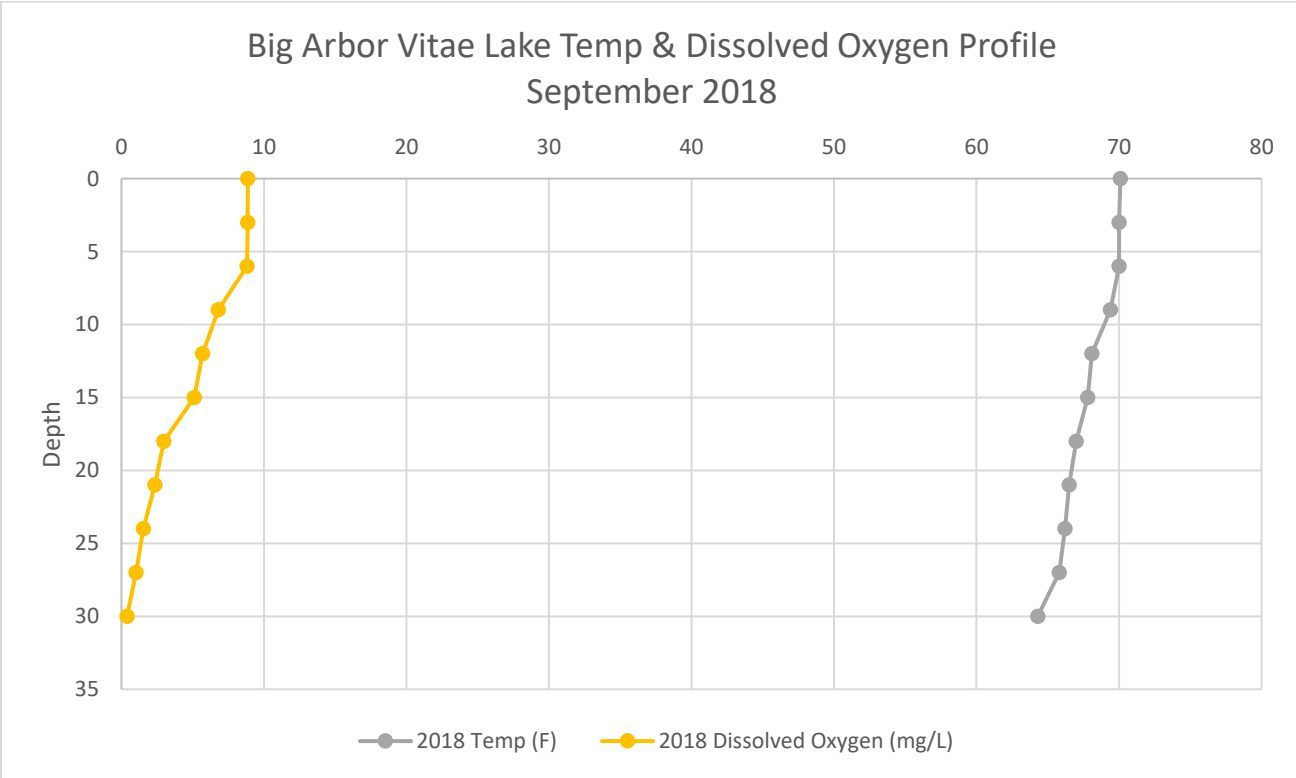
Temperature and dissolved oxygen monitoring showed that Big Arbor Vitae Lake was stratified. “Warm water” fish need dissolved oxygen levels of at least 5 mg/L (Shaw et.al.). More than 5 mg/L dissolved oxygen was found on Big Arbor Vitae Lake down to 12-15 ft. deep. At 0 mg/L dissolved oxygen, chemical processes differ in this anoxic environment and certain nutrients like phosphorus can be converted to bio-available forms and released lake-wide during turnover events, fueling algae and plant growth. See Appendix 2 for water quality raw data and temperature and dissolved oxygen profiles.

The July, August, and September temperature and dissolved oxygen profiles show the lake stratified.

Figure 14. Temperature and dissolved oxygen profiles for Big Arbor Vitae Lake 2018. Sampling dates were: 7/17/2018; 8/16/2018; and 9/18/2018.

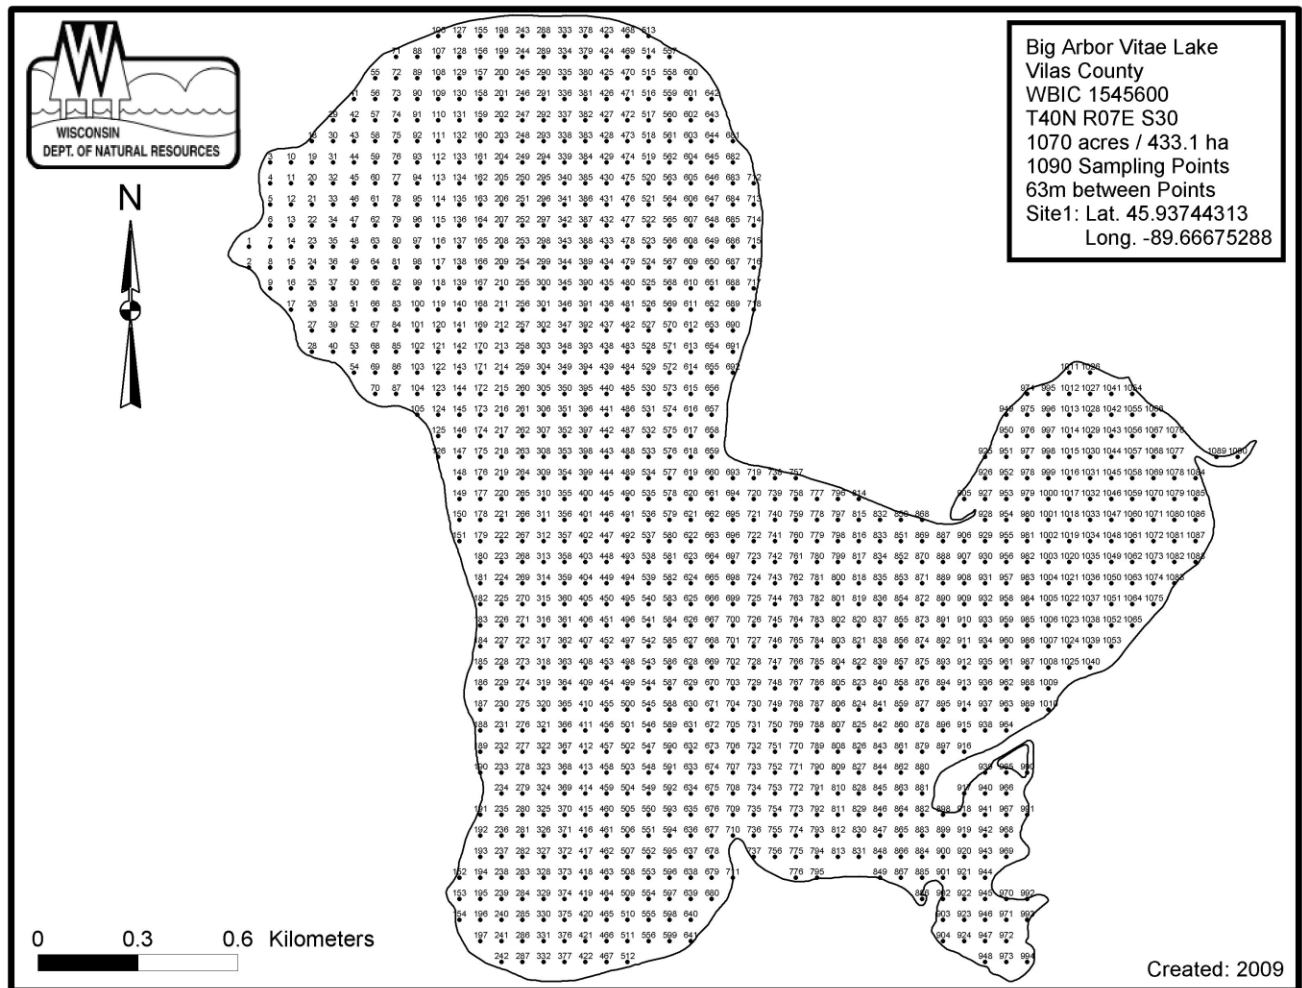
The Point-Intercept survey was done from July 20-July 31, 2018. Of the 1,090 point-intercept (PI) locations, 426 were visited – see Appendix 3 Figure 15. Those that were not visited were skipped because either they were deeper than the maximum depth of plants, or the points were non-navigable, terrestrial, or a temporary obstacle was encountered.

Figure 15. Big Arbor Vitae Lake Point Intercept Map. Courtesy of WI DNR.

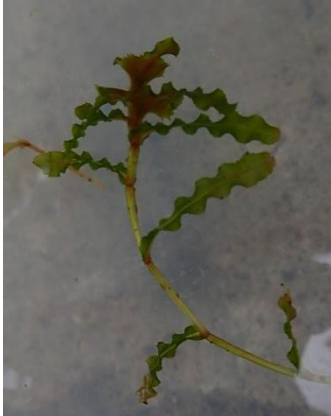
survey, all of which were previously documented as in SWIMS as “Verified”. In addition, curly leaf pondweed was listed as a Verified species, 1st documented in 2008. While curly leaf pondweed was not found during the AIS survey here, it was found during the Aquatic Plant Point Intercept survey. No AIS are listed as “Observed”.

Figure 16. Curly leaf pondweed (*Potamogeton crispus*) found in Big Arbor Vitae Lake 2018 point-intercept survey. This invasive plant was first reported in the lake in 2008.

- Continue routine monitoring of aquatic invasive species.
 - Consider any curly leaf pondweed management needs based on monitoring.
 - Contact Cathy Higley from Vilas County Land & Water Conservation 715-479-3738 or cahigl@vilascountywi.gov for assistance with aquatic invasives.

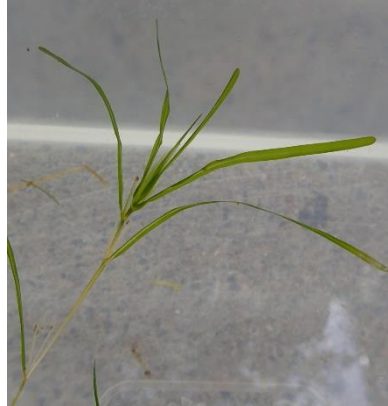
Figure 17. Fried Pondweed (*Potamogeton friesii*) found in Big Arbor Vitae Lake 2018 point-intercept survey.

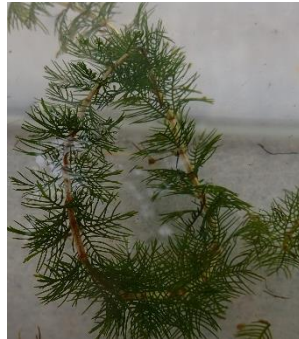
Figure 20. Northern watermilfoil (*Myriophyllum sibiricum*) found in Big Arbor Vitae Lake 2018 point-intercept survey.

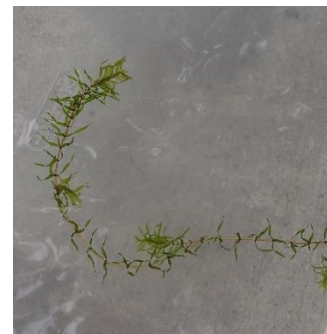
Figure 21. Slender waterweed (*Elodea nuttallii*) found in Big Arbor Vitae Lake 2018 point-intercept survey.

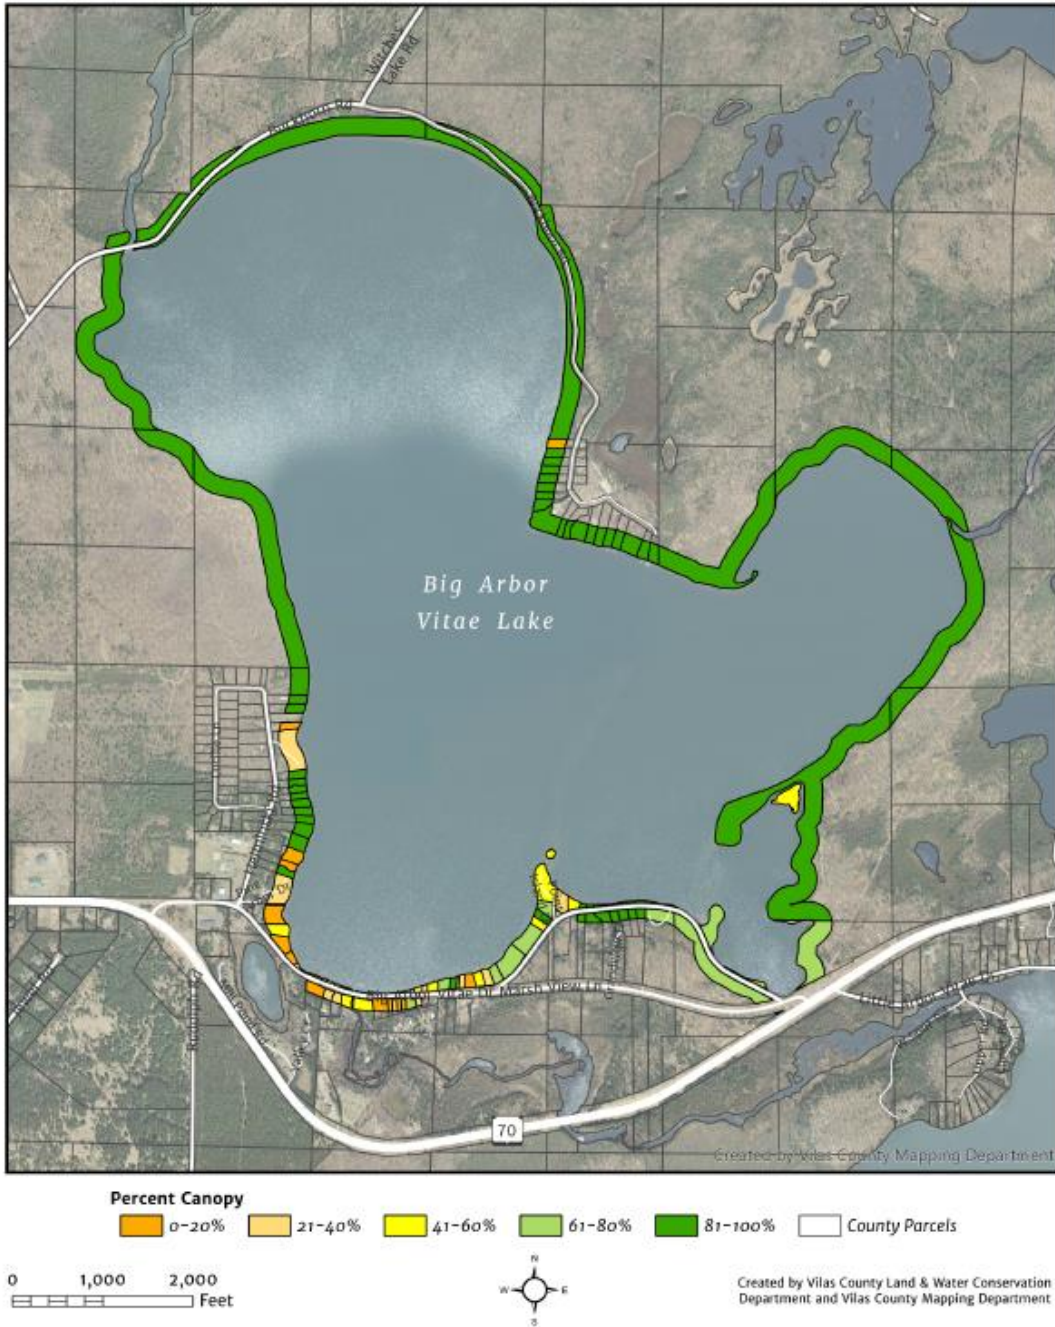
Shoreland Habitat Map 2018 - Big Arbor Vitae Lake (1545600)

Figure 25. Canopy cover percent per parcel within 35 ft buffer area on Big Arbor Vitae Lake 2018.

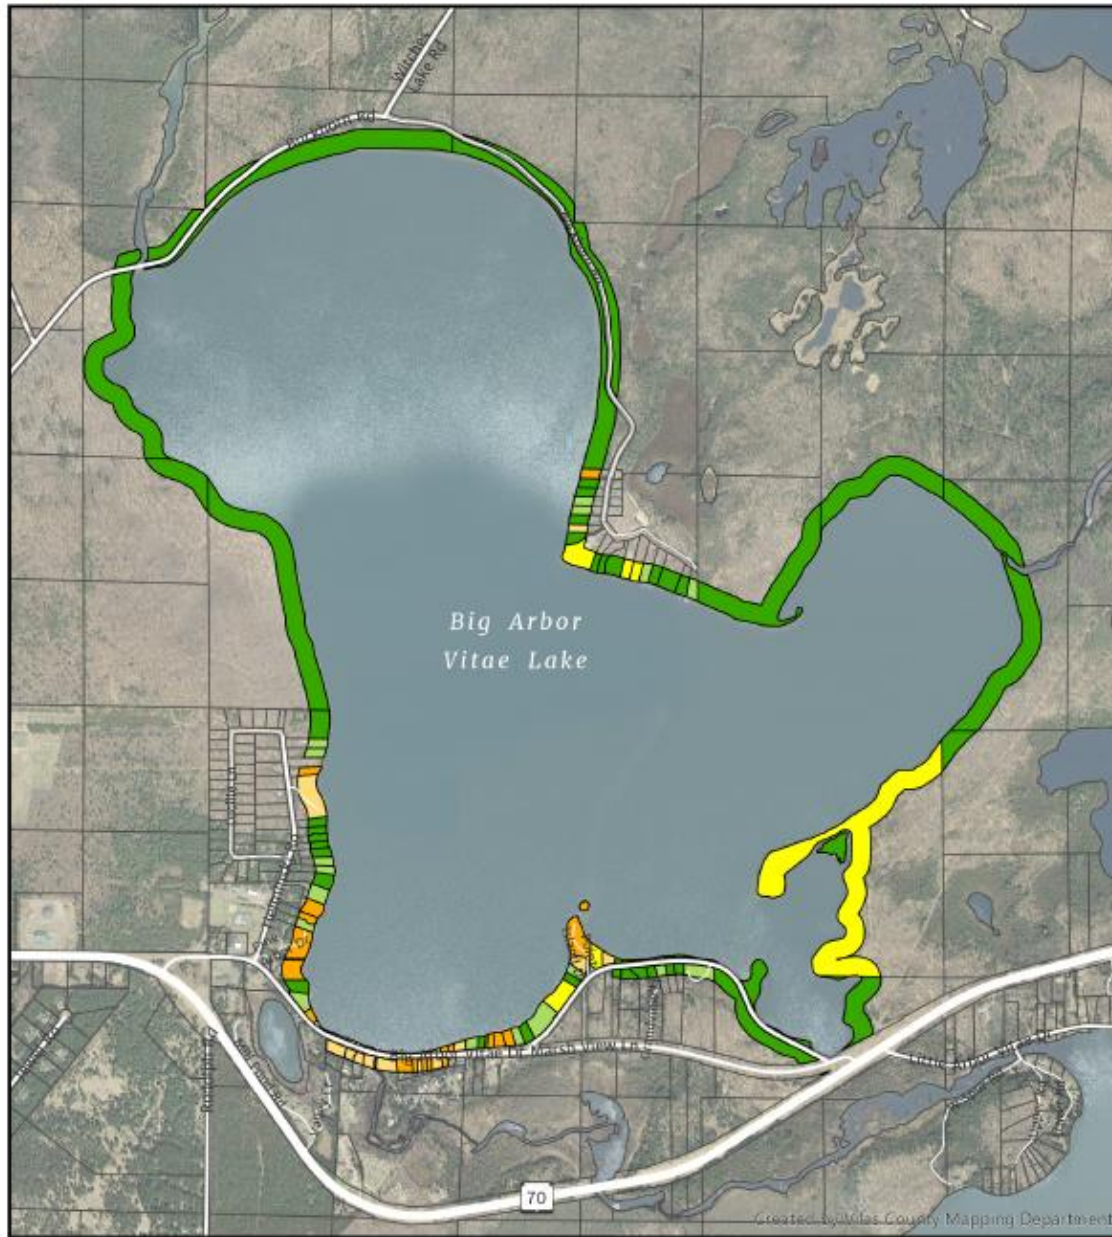
Shoreland Habitat Map 2018 - Big Arbor Vitae Lake (1545600)

Percent Shrub/Herbaceous

- 0-20%
- 21-40%
- 41-60%
- 61-80%
- 81-100%
- County Parcels

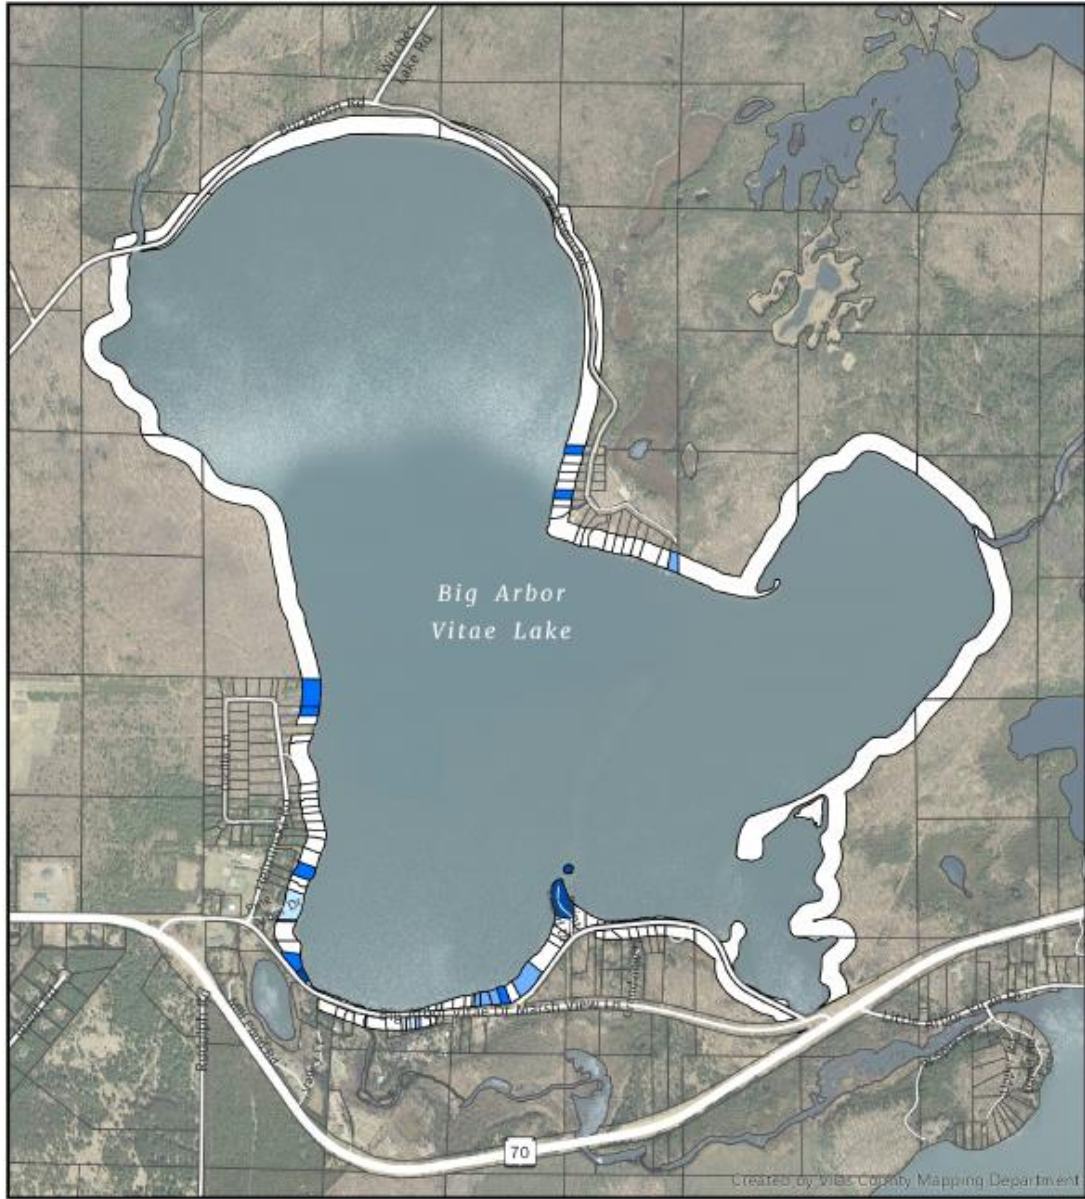
Shoreland Habitat Map 2018 - Big Arbor Vitae Lake (1545600)

Rip Rap

Feet of Rip Rap

- None
- 1-50ft
- 51-100ft
- 101-150ft
- 151-200ft
- County Parcels

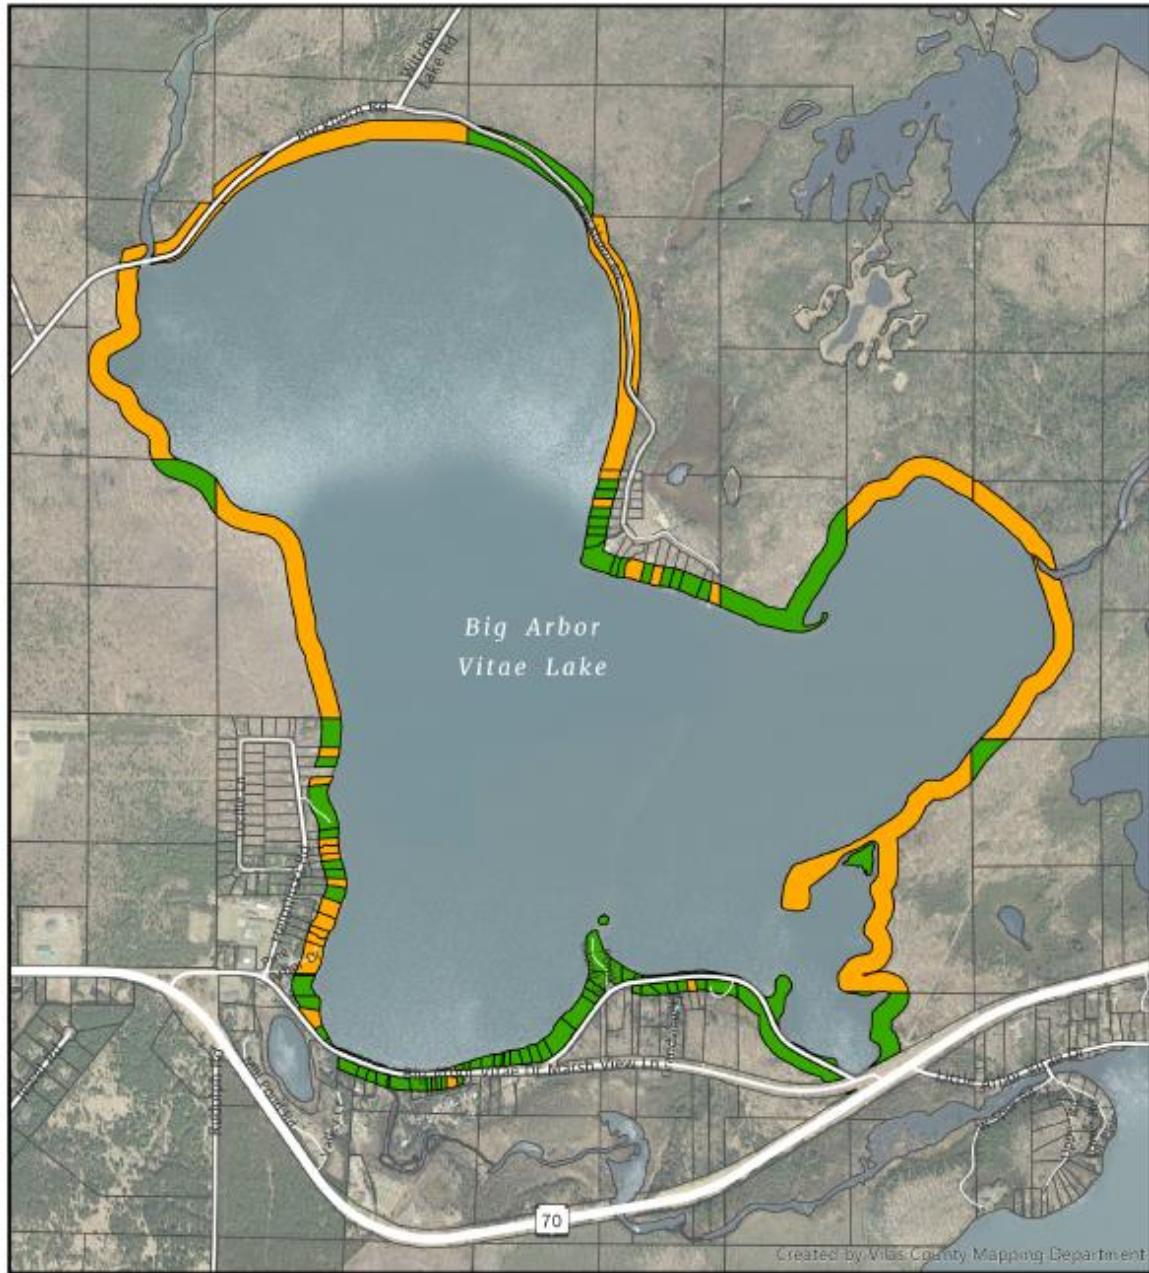
Shoreland Habitat Map 2018 - Big Arbor Vitae Lake (1545600)

Bare Soil

Bare Soil Presence
■ Absent ■ Present in Riparian Zone □ County Parcels

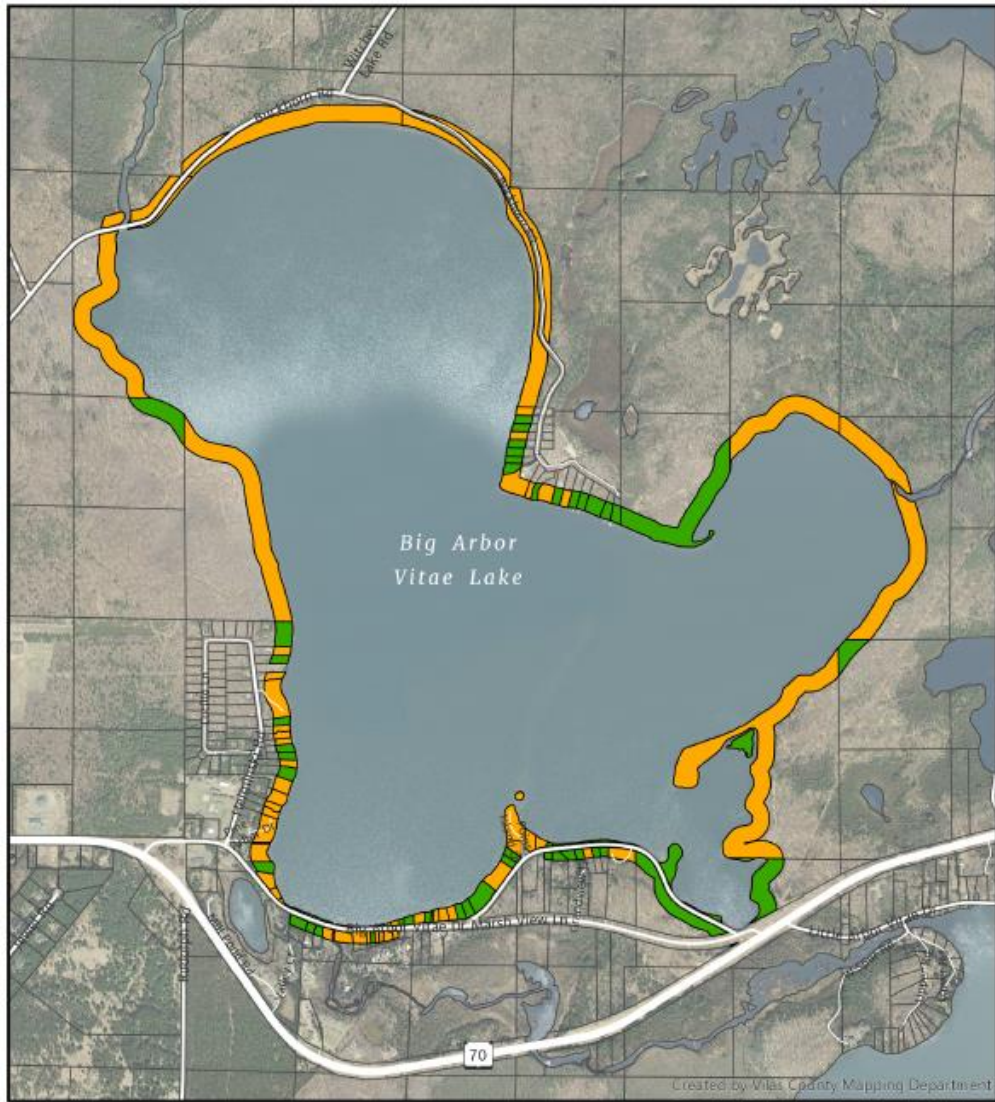
Shoreland Habitat Map 2018 - Big Arbor Vitae Lake (154,5600)

Lawn/Soil Sloping to Lake

Absent Present in Riparian Zone County Parcels

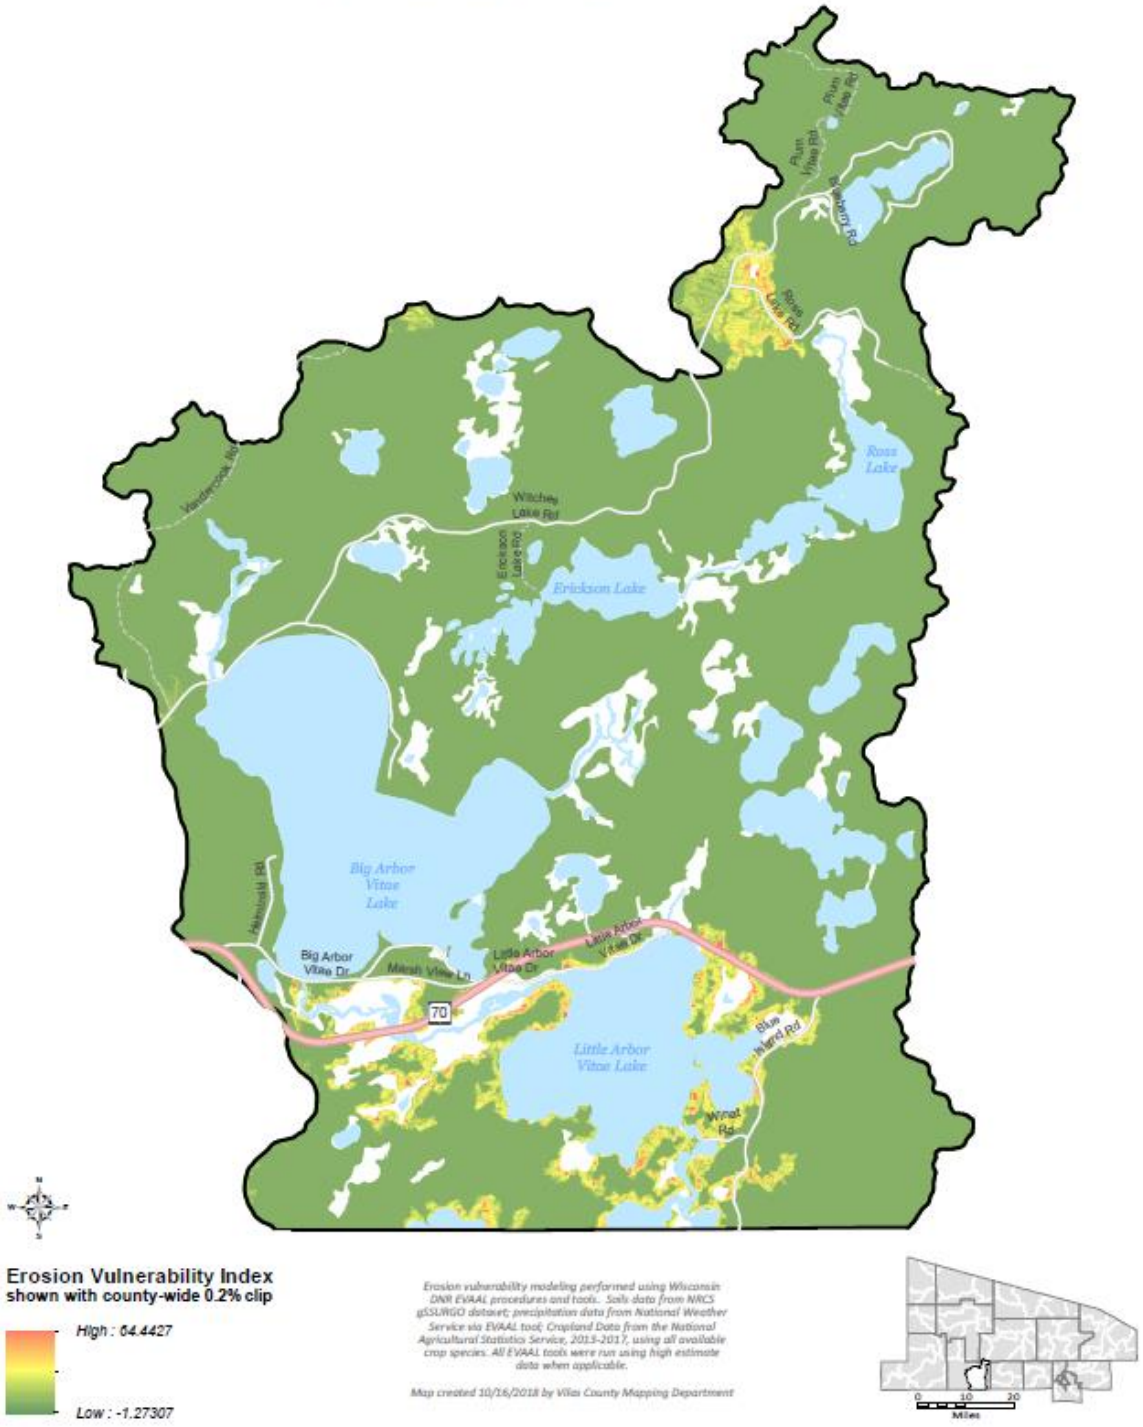
Arbor Vitae Lakes Subwatershed (070700010801)

Areas Most Susceptible to Sheet, Rill and Gully Erosion
