Mamie Lake 2017-2018 Lake Assessment Report

Prepared by
Vilas County Land & Water Conservation

January 2, 2020

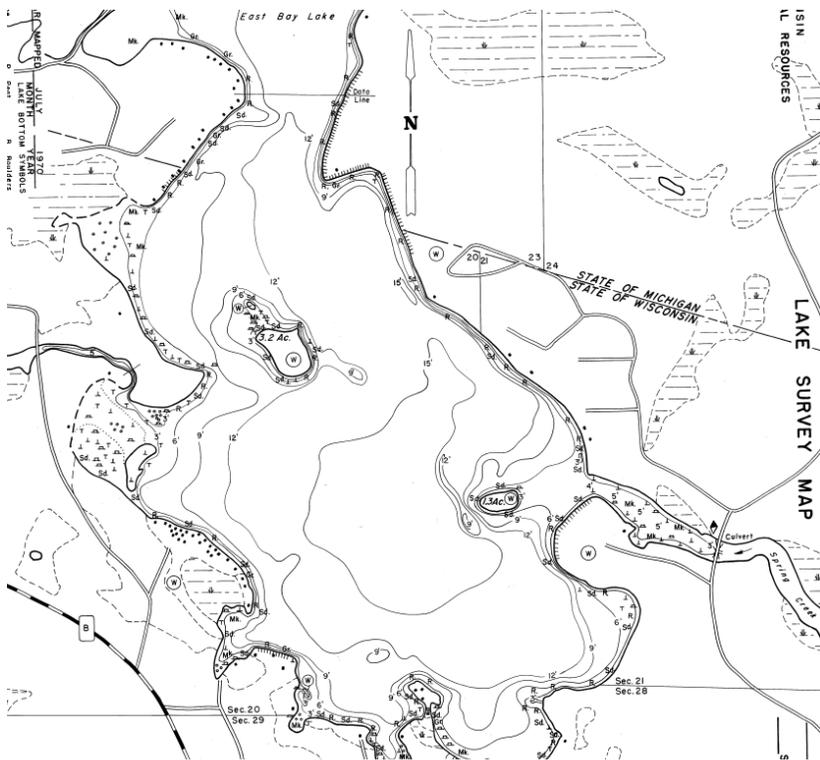
Figure 2. Mamie Lake bathymetry map. Courtesy WI DNR.

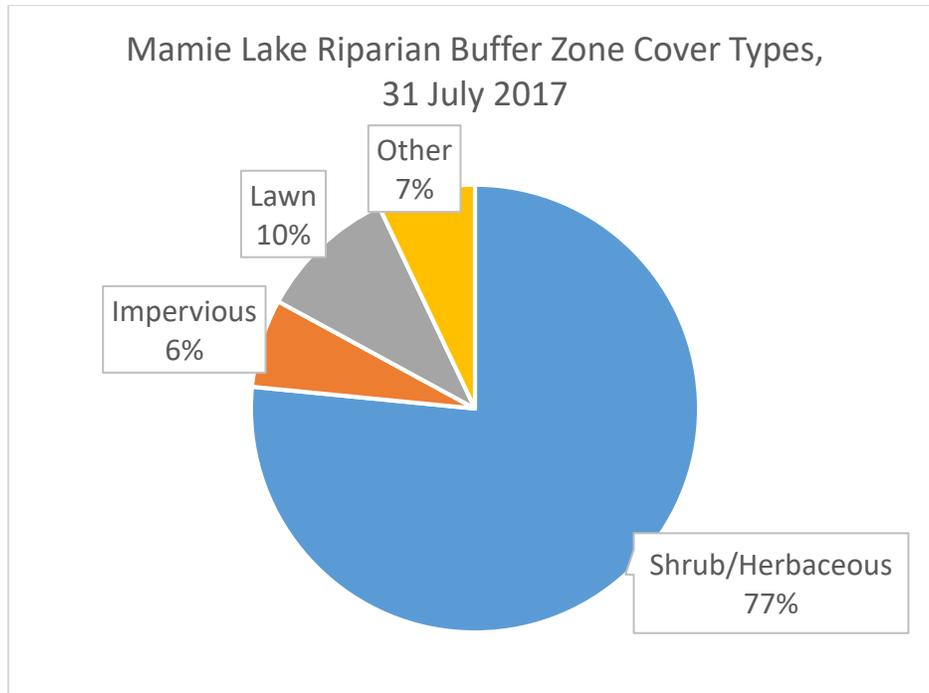
Figure 3. Ground cover type in Riparian Buffer Area (35 ft. inland from shore) on Mamie Lake, 2017. "Other" category includes duff.

Lake-wide, 77% of the riparian area (35 ft. inland from ordinary high water mark) was covered by a shrub/herbaceous layer. Lawn made up 10% of the riparian area, and Impervious surfaces made up 6%. The "other" category was comprised of duff, bare soil, and mulch and covered 7% of riparian buffer zone. See Appendices 7-9 for Riparian Buffer Zone Cover Types.

- **Encourage native vegetation to grow in the 35 ft. shoreland buffer areas:**
 - 10% of the 35 ft buffer zone was lawn. Encourage willing landowners remove turf grass in the buffer area and replace with native vegetation. Contact Cathy Higley from Vilas County Land & Water Conservation 715-479-3738 or cahigl@vilascountywi.gov for assistance.

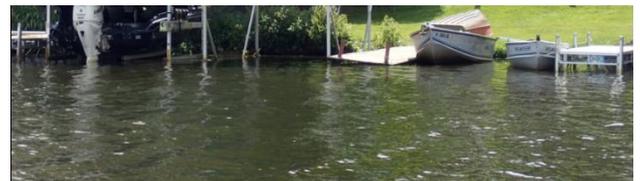
Figure 4. Some areas of Mamie Lake showed denser dock placement. Lake-wide, there were 16.8 docks/mile on Mamie Lake. Having a lake-wide dock density greater than 16 docks/mile has been shown to have negative effects on fish diversity (Jacobsen et.al).

- **Discourage additional piers/docks on Mamie Lake:**
 - Mamie Lake is already over the 16 docks/mile threshold for impacting fish diversity (Jacobson et. al.). Consider the ability to share dock access in appropriate instances. Contact Cathy Higley from Vilas County Land & Water Conservation 715-479-3738 or cahigl@vilascountywi.gov for assistance.

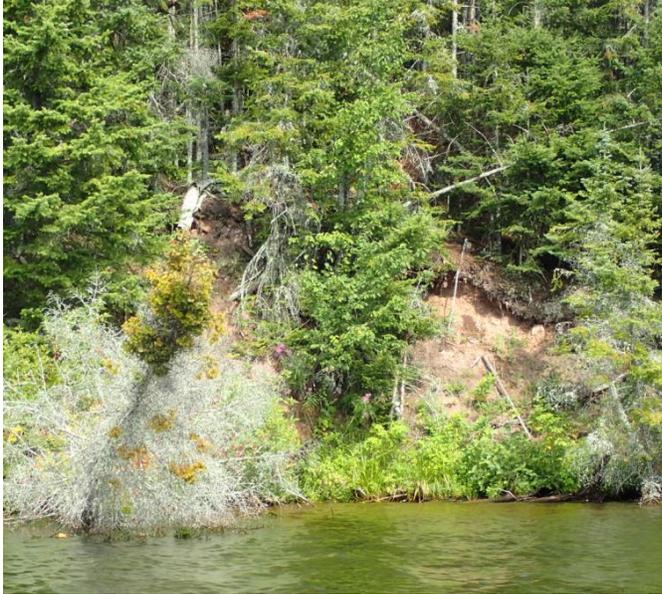
Figure 5. Erosion on steep slopes with natural vegetation was often seen on Mamie Lake properties.

total shoreline). Bank erosion with a greater than 1 ft face was noted across 12 ft of shoreline. No seawalls, erosion control structures, or bank erosion less than 1 ft face was noted. See Figure 9.

- **Initiate a campaign on erosion awareness to varied lake users (riparians, resort guests, public access boaters, etc.):**
 - Boat wake and shoreland erosion
 - Impervious surfaces impacts to water quality, habitat, fish, and wildlife
 - County cost sharing programming opportunities
 - DNR Healthy Lakes best practices and funding opportunities
 - Create connections on how smaller land parcels often lead to less native vegetation and more runoff – encourage keeping established parcels whole
 - The water level in Mamie Lake is higher than historic due to the construction of the dam on Cisco Lake in the early 1900's. The surrounding soils on the "new" banks and slopes are sandy, and often steep and fragile. In some instances, whole slopes were slumping into the lake. Contact Cathy Higley from Vilas County Land & Water Conservation 715-479-3738 or cahigl@vilascountywi.gov for assistance.

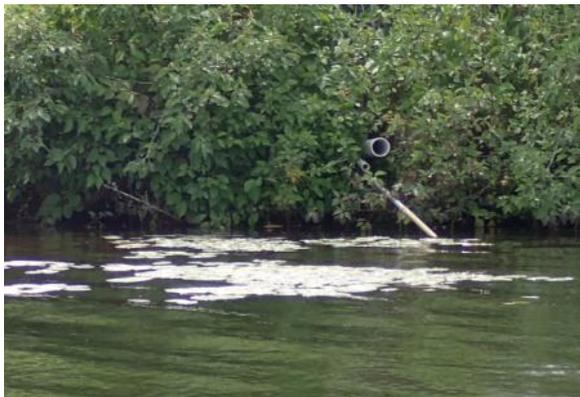
Several runoff and erosion concerns were documented: 1 parcel had a point source; 26 parcels had stairs/trail/road to the lake; 17 had lawn/soil sloping to the lake; 14 had bare soil; and 1 had sand/silt deposits. See Figure 10 for Number of Parcels with Erosion or Runoff Concerns.

Figure 6. A point source was found on 1 property.

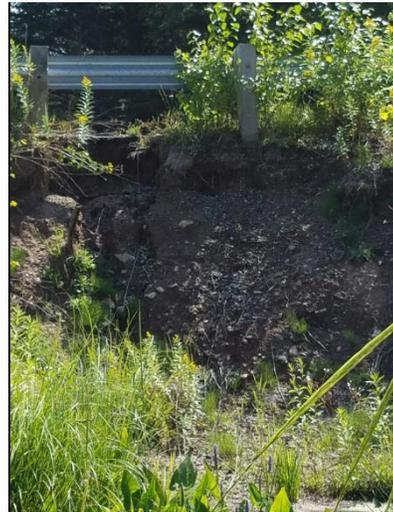
Figure 7. Erosion near Spring Creek Inlet crossing on Thousand Island Lake Rd.

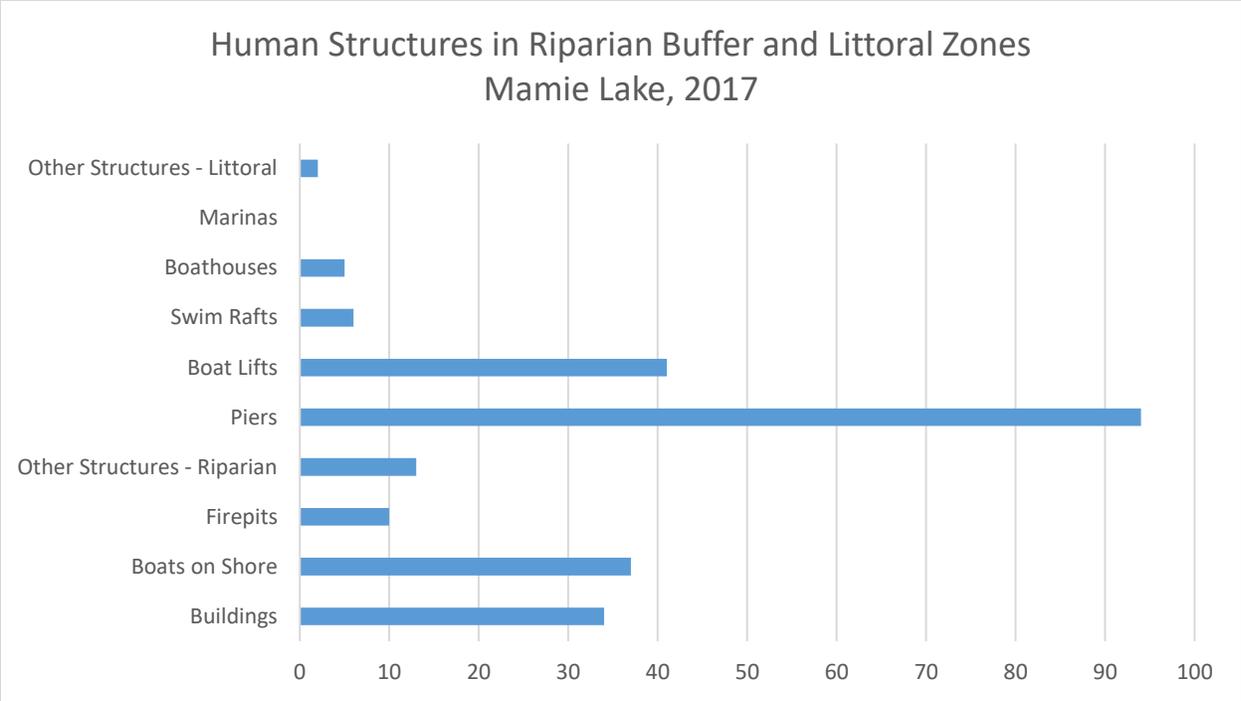
Many human structures or modifications were noted in the Riparian, Bank, and Littoral Zones. See Figure 8 for Human Structures in Riparian Buffer, Bank and Littoral Zones Charts. Because of their ecological importance, these areas are typically protected by County Zoning and DNR regulations and permits are often required to modify or place new structures in these areas. In Mamie Lake, piers were the most common structure. Ten docks or less per kilometer (16 docks/mile) of shoreline has been shown to be a threshold of maintaining high quality fish diversity in Minnesota (Jacobsen et. al). Mamie Lake just exceeds this figure at 16.8 docks/mile. Additional littoral structures such as boat lifts, swim rafts, etc. would intuitively seem to add to this stress. Other major categories for structures were: boat lifts (41); boats on shore (37); and buildings within the riparian area (34).

Figure 8. Number of human structures documented in the Riparian Buffer and Littoral Zones on Mamie Lake 2017.

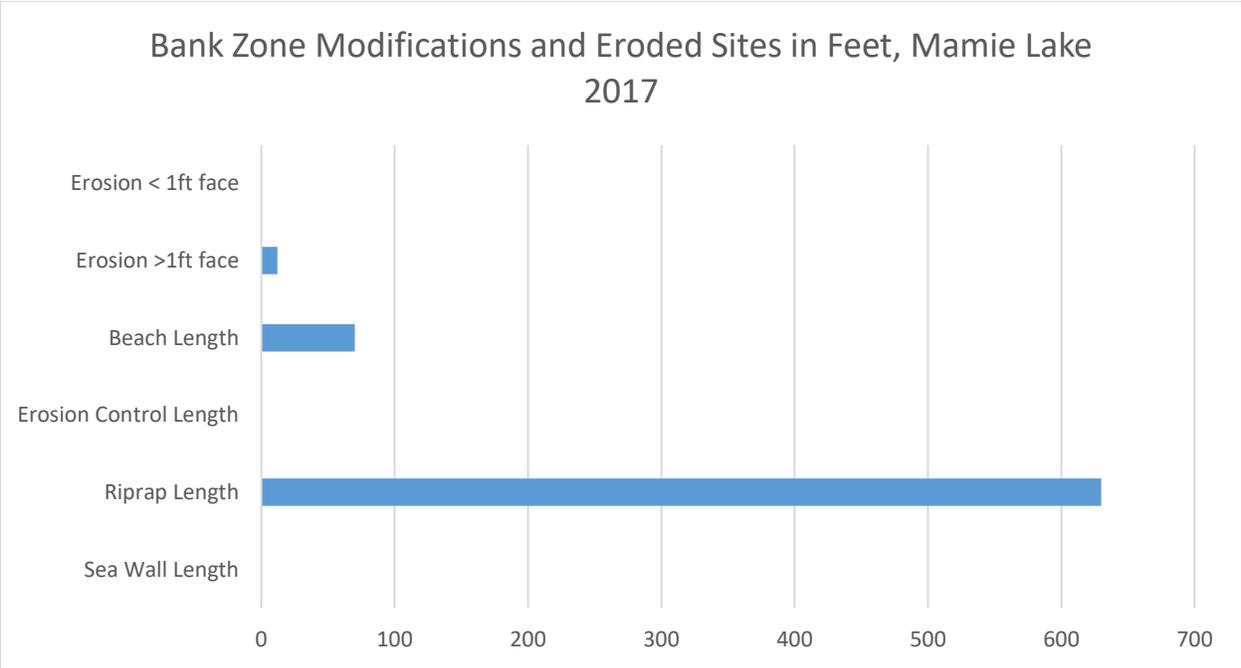
Within the Bank Zone, modifications included riprap and artificial beaches. There was 630 ft of riprap noted, which would comprise 2% of the lake. Note that Mamie Lake is naturally quite rocky, and many shoreline areas could have been riprapped many years ago, but vegetation has been growing in. Riprap was not noted unless it was obvious. Artificial beaches totaled 70 feet of shoreline (less than 1% of the

Figure 9. Length in feet of human modifications to Bank Zone on Mamie Lake 2017.

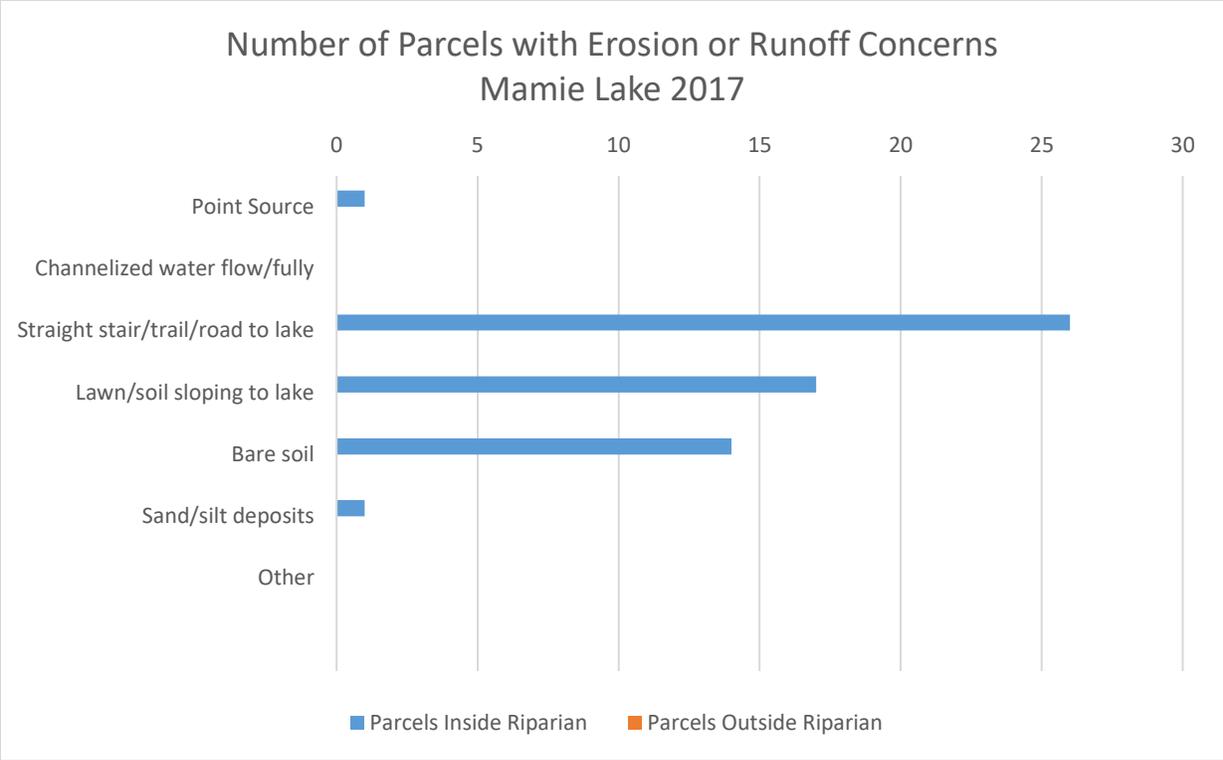
Figure 10. Number of parcels with runoff and erosion concerns in Riparian Zone and Outside Riparian Zone on Mamie Lake 2017.

- **Create a Shoreland Improvement Team to coordinate on-the-ground best practices for runoff and habitat concerns for interested landowners (liaison with County & DNR):**
 - Lead Healthy Lakes campaign on Mamie Lake
 - Provide materials and serve as a point-of-contact for landowners to increase native vegetation and install erosion control practices within 35 ft. buffer zones and beyond
 - The number of parcels with erosion concerns was fairly high (85%), and much work could be done on Mamie Lake. Addressing these issues with willing private landowners will take a coordinated effort, ideally with a well versed riparian being locally available for those interested. Contact Cathy Higley from Vilas County Land & Water Conservation 715-479-3738 or cahigl@vilascountywi.gov for assistance.

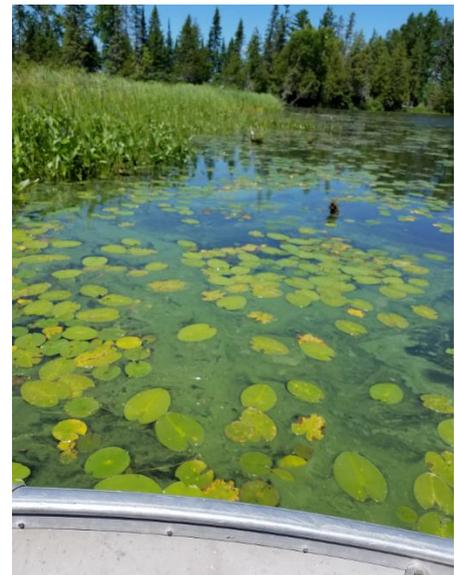
Blue green algae was noted blooming in spots on the lake in 2017. While the zebra mussel veliger samples were negative, DNR staff analyzing the sample noted the presence of an algae bloom of *Dolichospermum* within the submitted sample – this is a blue green algae that is capable of producing toxins (SWIMS).

Figure 12. Blue green algae bloom on Mamie Lake July 24, 2017.

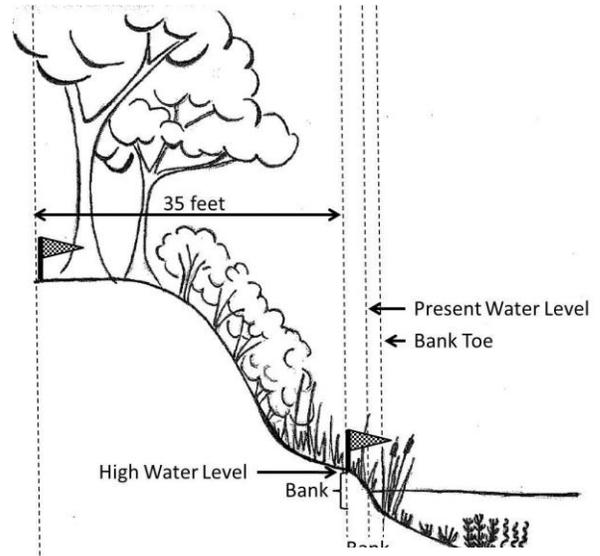
The Shoreland Assessment protocols call for documenting the condition of the Riparian Buffer Zone 35 ft. inland from shore, the bank zone, and the littoral zone – see Figure 13.

Figure 13. Shoreland areas assessed included the Riparian Buffer Zone, Bank Zone, and Littoral Zone. Graphic courtesy of WI DNR.

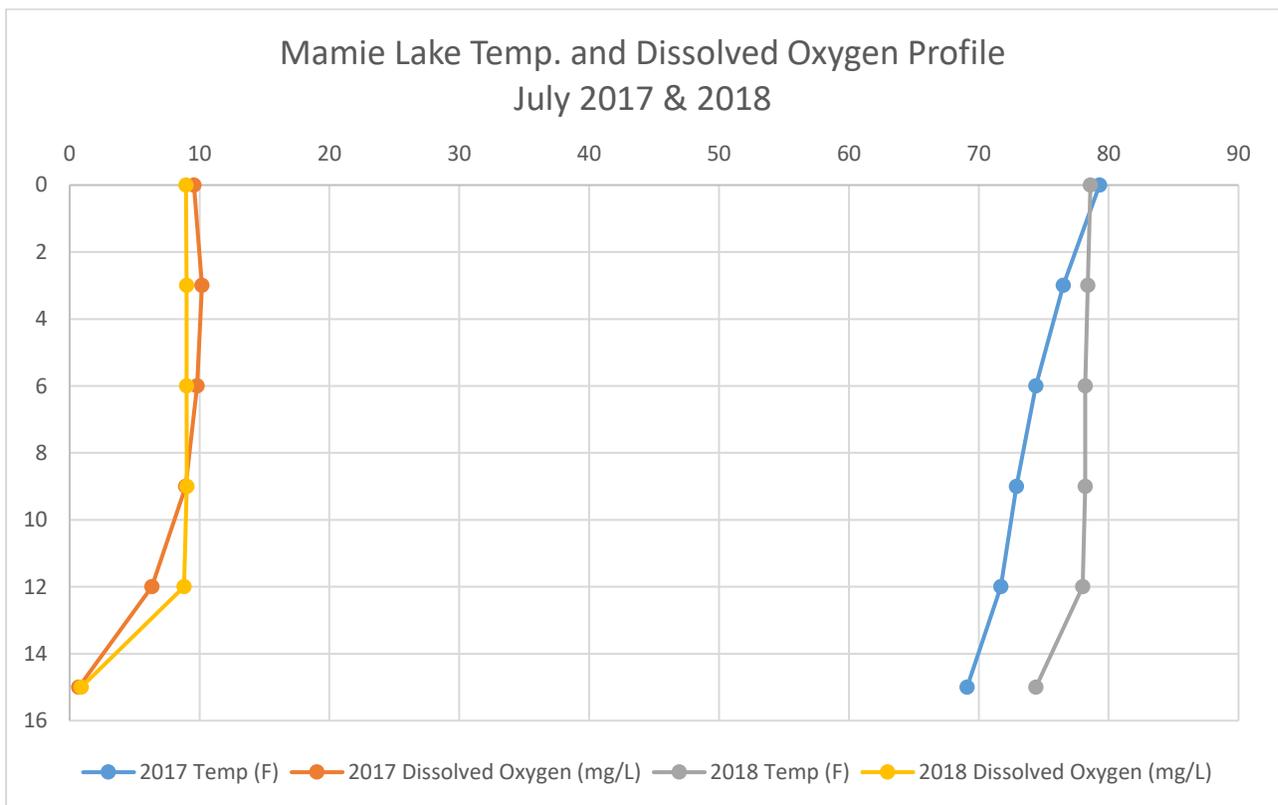
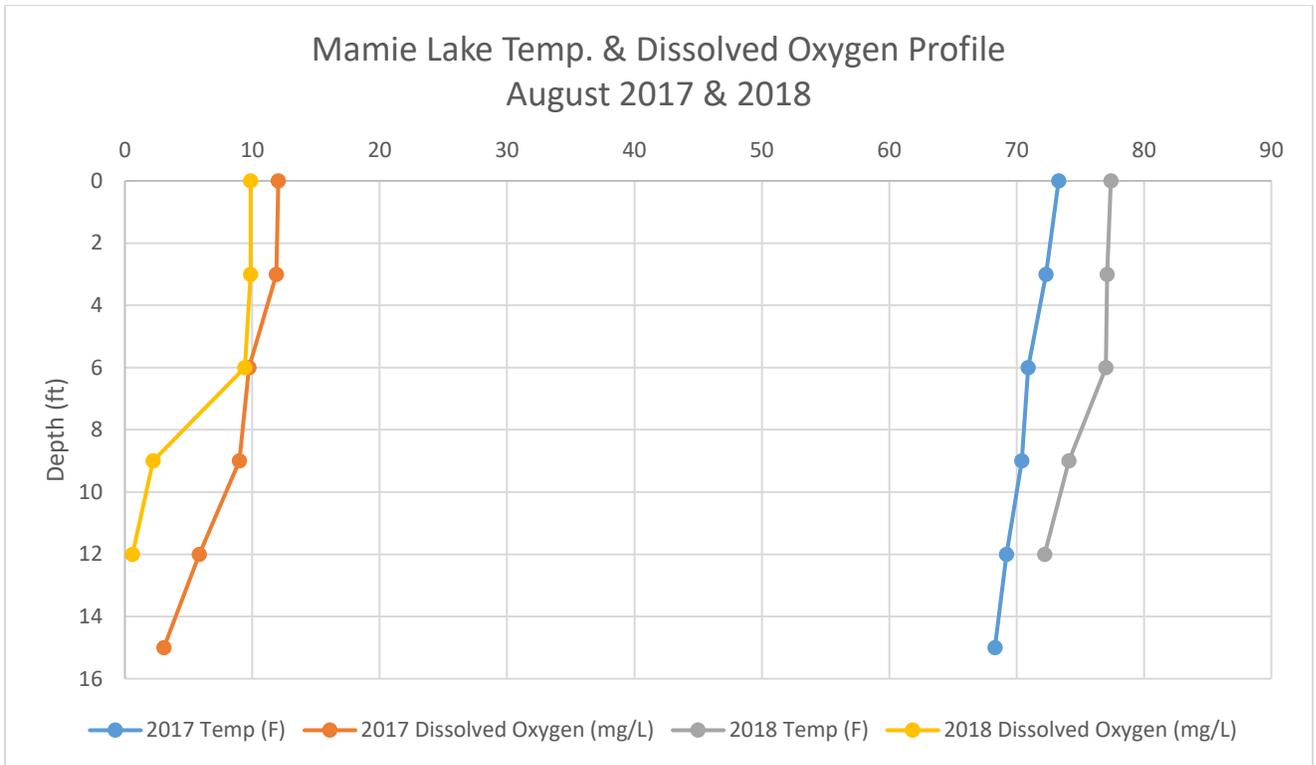
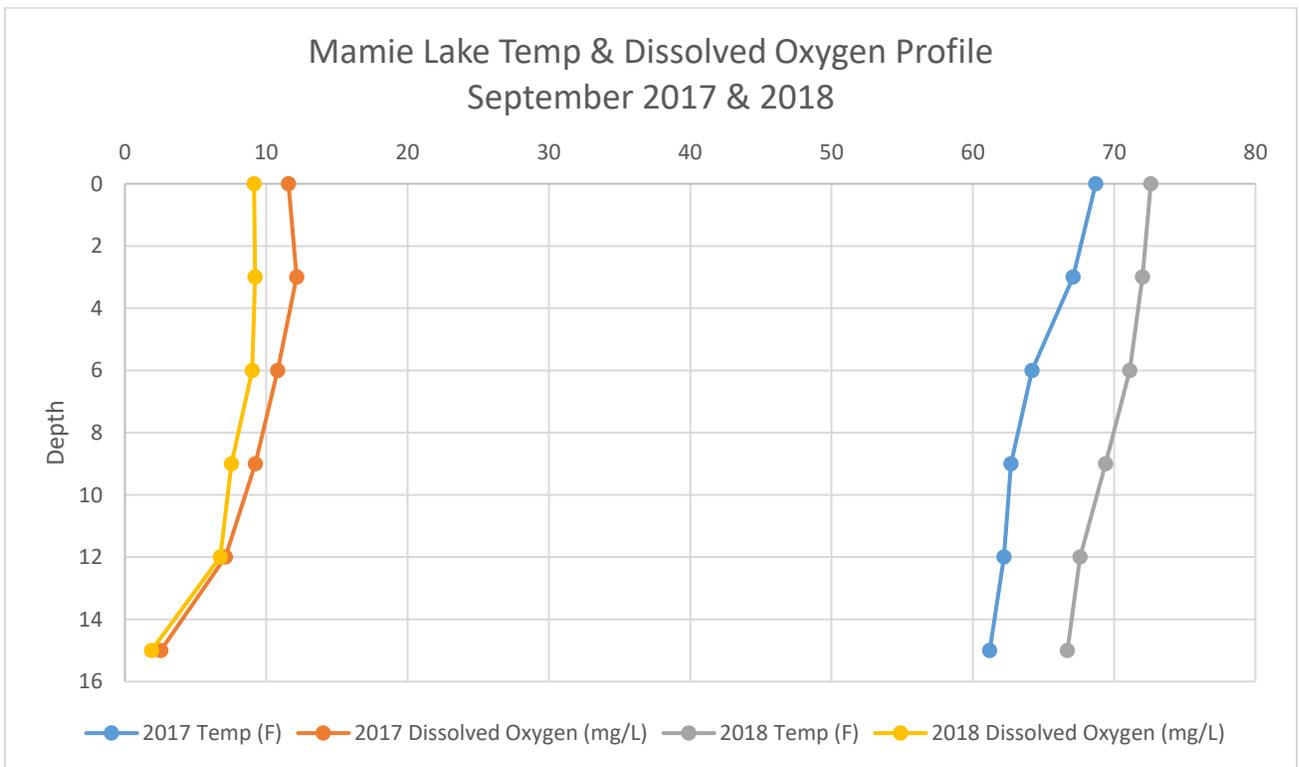
Temperature and dissolved oxygen monitoring showed that Mamie Lake was not stratified. “Warm water” fish need dissolved oxygen levels of at least 5 mg/L (Shaw et.al.). More than 5 mg/L dissolved oxygen was found on Mamie Lake up to 12 ft. deep with one exception: the August 2018 sampling found dissolved oxygen concentrations at <5mg/L at only 9 feet deep. At 0 mg/L dissolved oxygen, chemical processes differ in this anoxic environment and certain nutrients like phosphorus can be converted to bio-available forms and released lake-wide during turnover events, fueling algae and plant growth. See Appendix 2 for water quality raw data and temperature and dissolved oxygen profiles.

The July, August, and September temperature and dissolved oxygen profiles show the lake did not stratify.

Figure 14. Temperature and dissolved oxygen profiles for Mamie Lake in 2017 and 2018. Sampling dates were: 7/19/2017; 8/21/2017; 9/13/2017; 7/16/2018; 8/15/2018; and 9/17/2018.

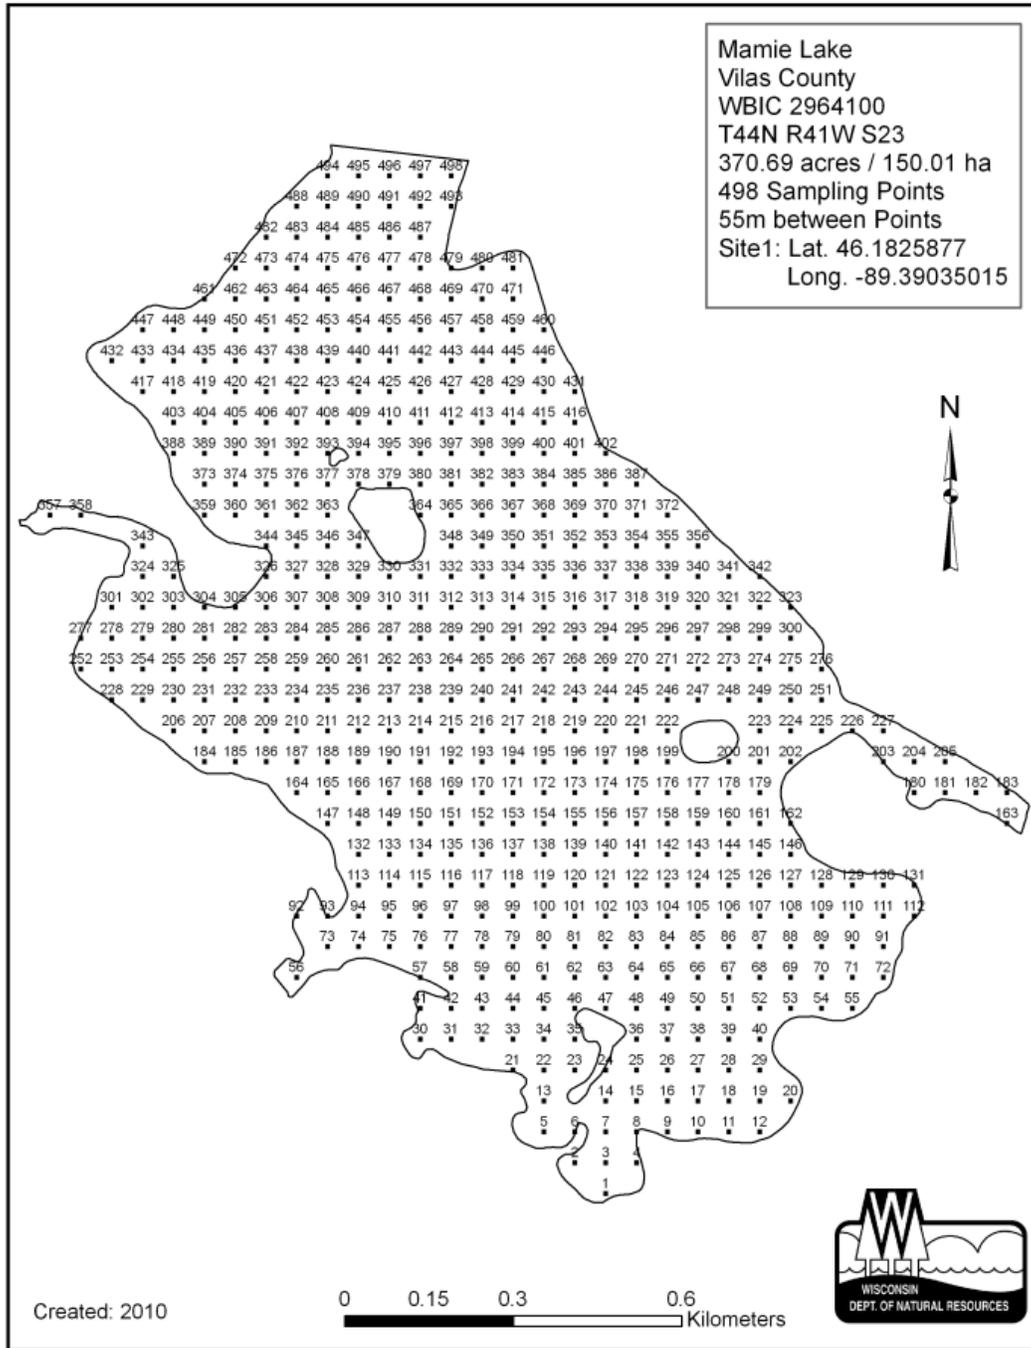
The Point-Intercept survey was done from July 24-July 28, 2017. Of the 498 point-intercept (PI) locations, 160 were visited – see Appendix 3 Figure 15. Those that were not visited were skipped because either they were deeper than the maximum depth of plants, or the points were non-navigable/terrestrial.

Figure 15. Mamie Lake Point Intercept Map. Courtesy of WI DNR.

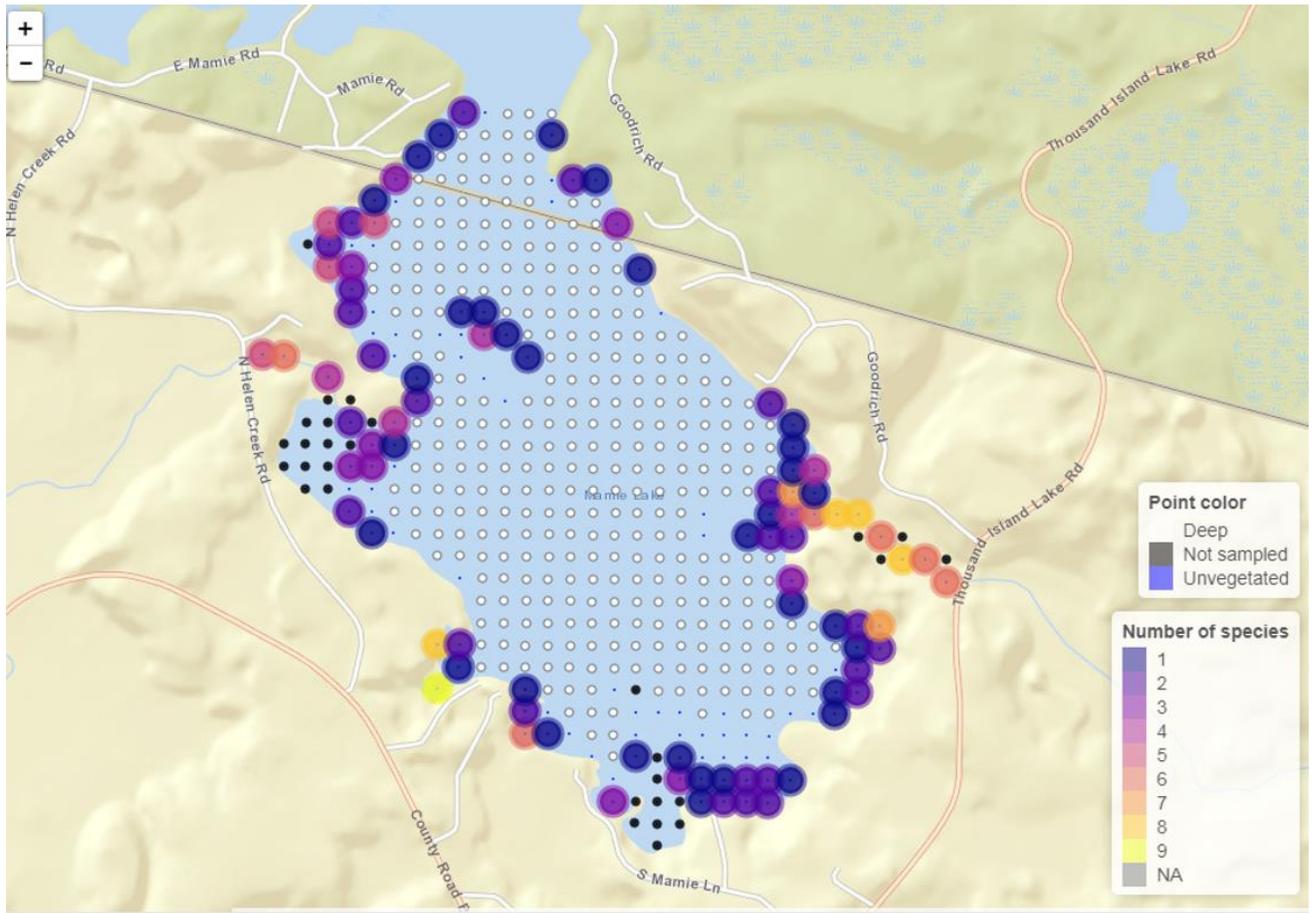
Of all the sampling points on Mamie Lake, the most species rich areas occurred in the small bay just south of Bent’s Camp Resort (southwest side of lake), Spring Creek as it empties into Mamie Lake (southeast side of lake), and Helen Creek as it leaves Mamie Lake (west side of lake). See Appendix 3 Figure 23.

Figure 23. Mamie Lake species richness by sampling point. Map courtesy of WI DNR.

- **Protect the biodiversity of the aquatic plant community in diversity “hot-spots”**
 - Spring Creek channel from Thousand Island Lake Rd boat launch flowing into Mamie Lake
 - Helen Creek access from Helen Creek Rd flowing out of Mamie Lake
 - Small bay just south of the Bent’s Camp resort
 - Four plants (Wild celery, flat stemmed pondweed, forked duckweed, and coontail) make up the bulk of the aquatic plants found on Mamie Lake. However, the above three areas are where biodiversity spiked. These areas should be protected from further littoral development/plant removals. Contact Cathy Higley from Vilas County Land & Water Conservation 715-479-3738 or cahigl@vilascountywi.gov for assistance.

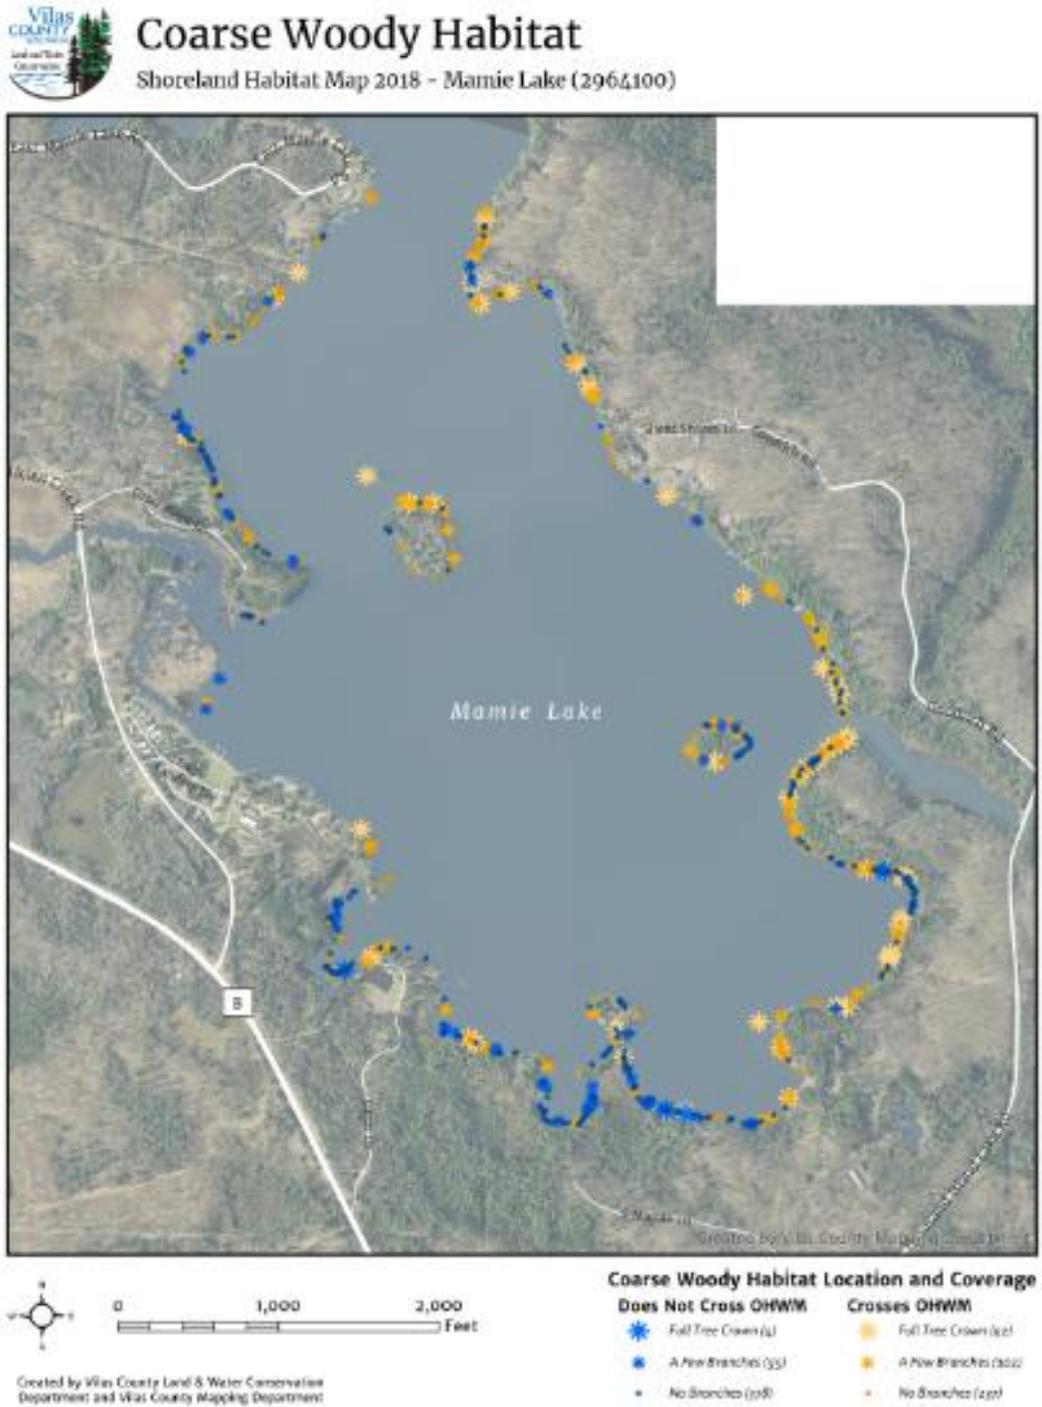
Coarse woody habitat was mapped on June 6, 2017 when the water was fairly clear and easy to detect submerged logs. 828 logs were counted between the ordinary high water mark and the 2 ft depth contour along the 5.6 miles of shoreline, giving the density of 148 logs/mile of shoreline – see Appendix 4. Note that not all logs were completely submerged on this day due to the water being below the ordinary high water mark.

Figure 24. Coarse Woody Habitat Characterization for Mamie Lake, 2017. 148 logs/mile were documented.

- **Maintain and Increase Coarse Woody Habitat:**
 - The Cisco Chain appears to be a productive fishery. Encourage leaving down wood where it falls to maintain fish habitat. Landowners may be interested in creating more coarse woody habitat along their shorelines by placing “fish sticks”. Contact Cathy Higley from Vilas County Land & Water Conservation 715-479-3738 or cahigl@vilascountywi.gov for assistance.

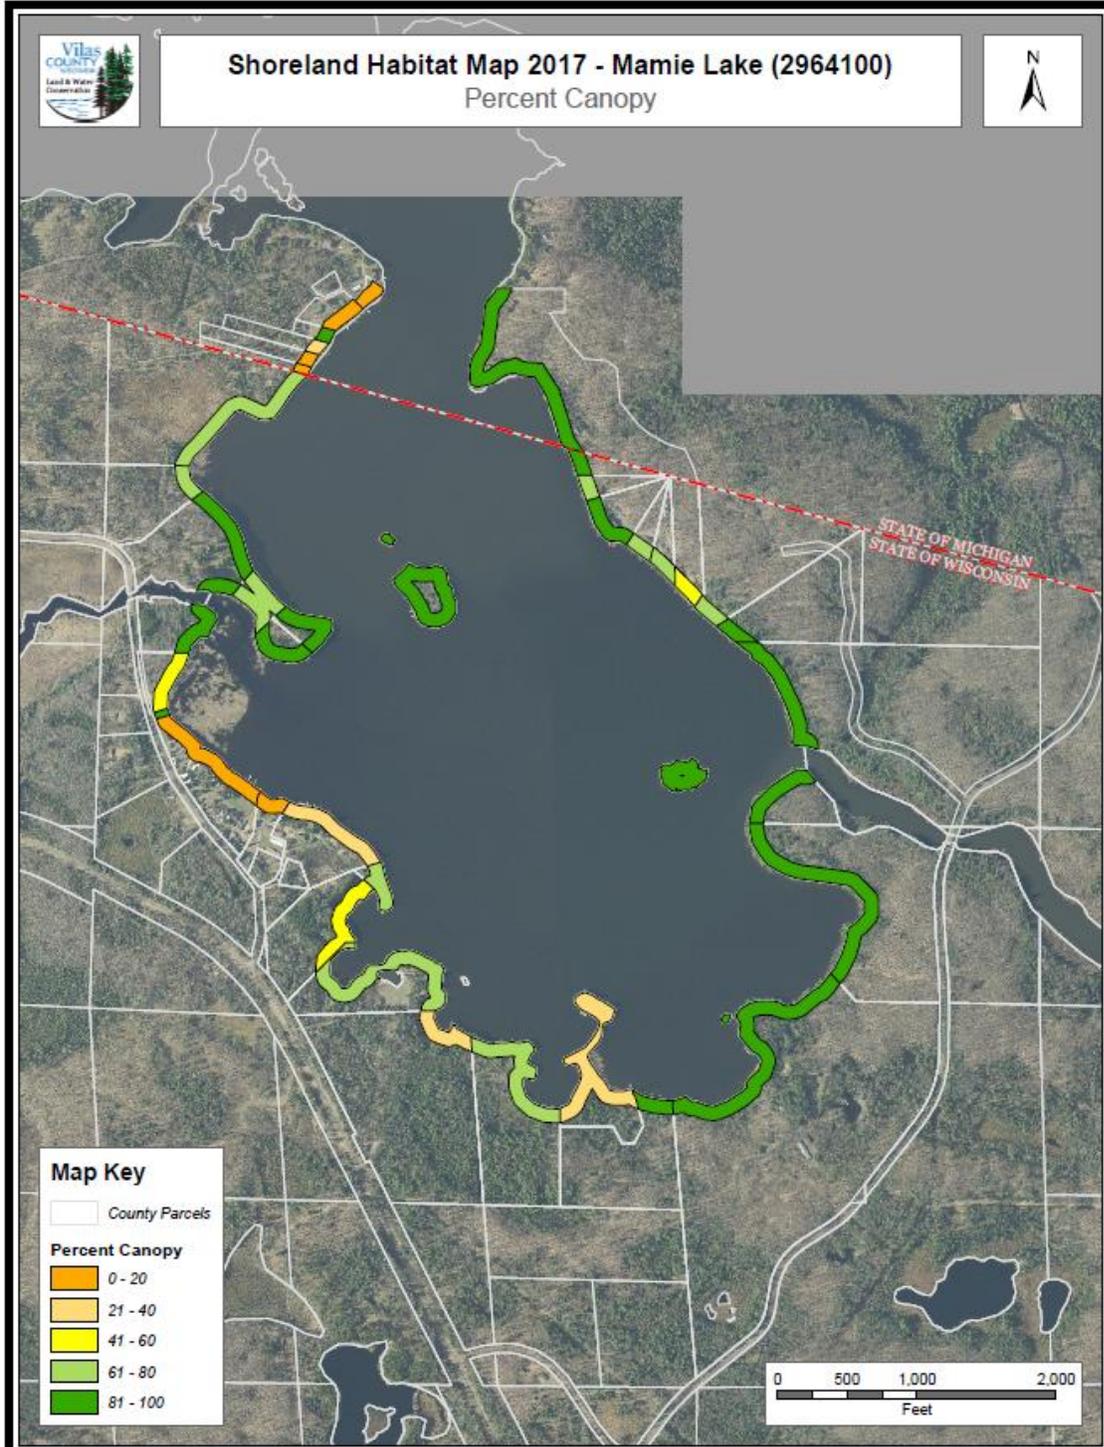
Figure 25. Canopy cover percent per parcel within 35 ft buffer area on Mamie Lake 2017.

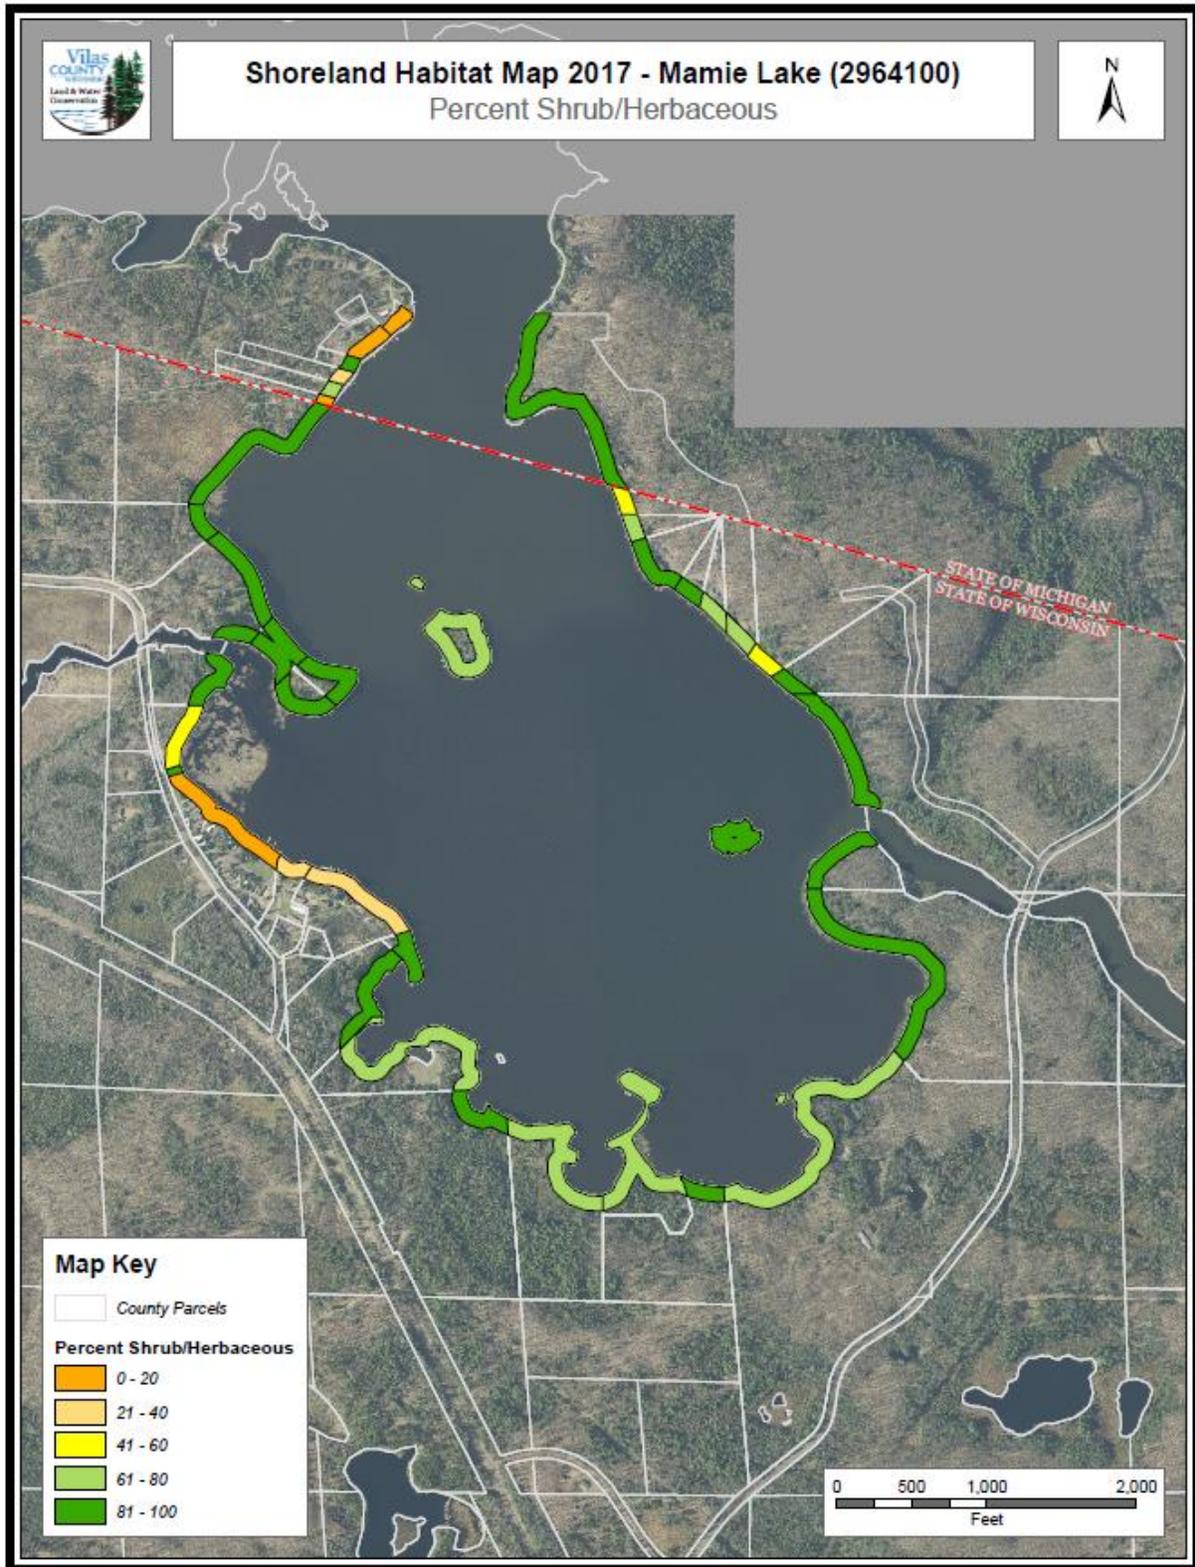
Figure 26. Percent shrub/herbaceous cover per parcel within 35 ft buffer area on Mamie Lake 2017.

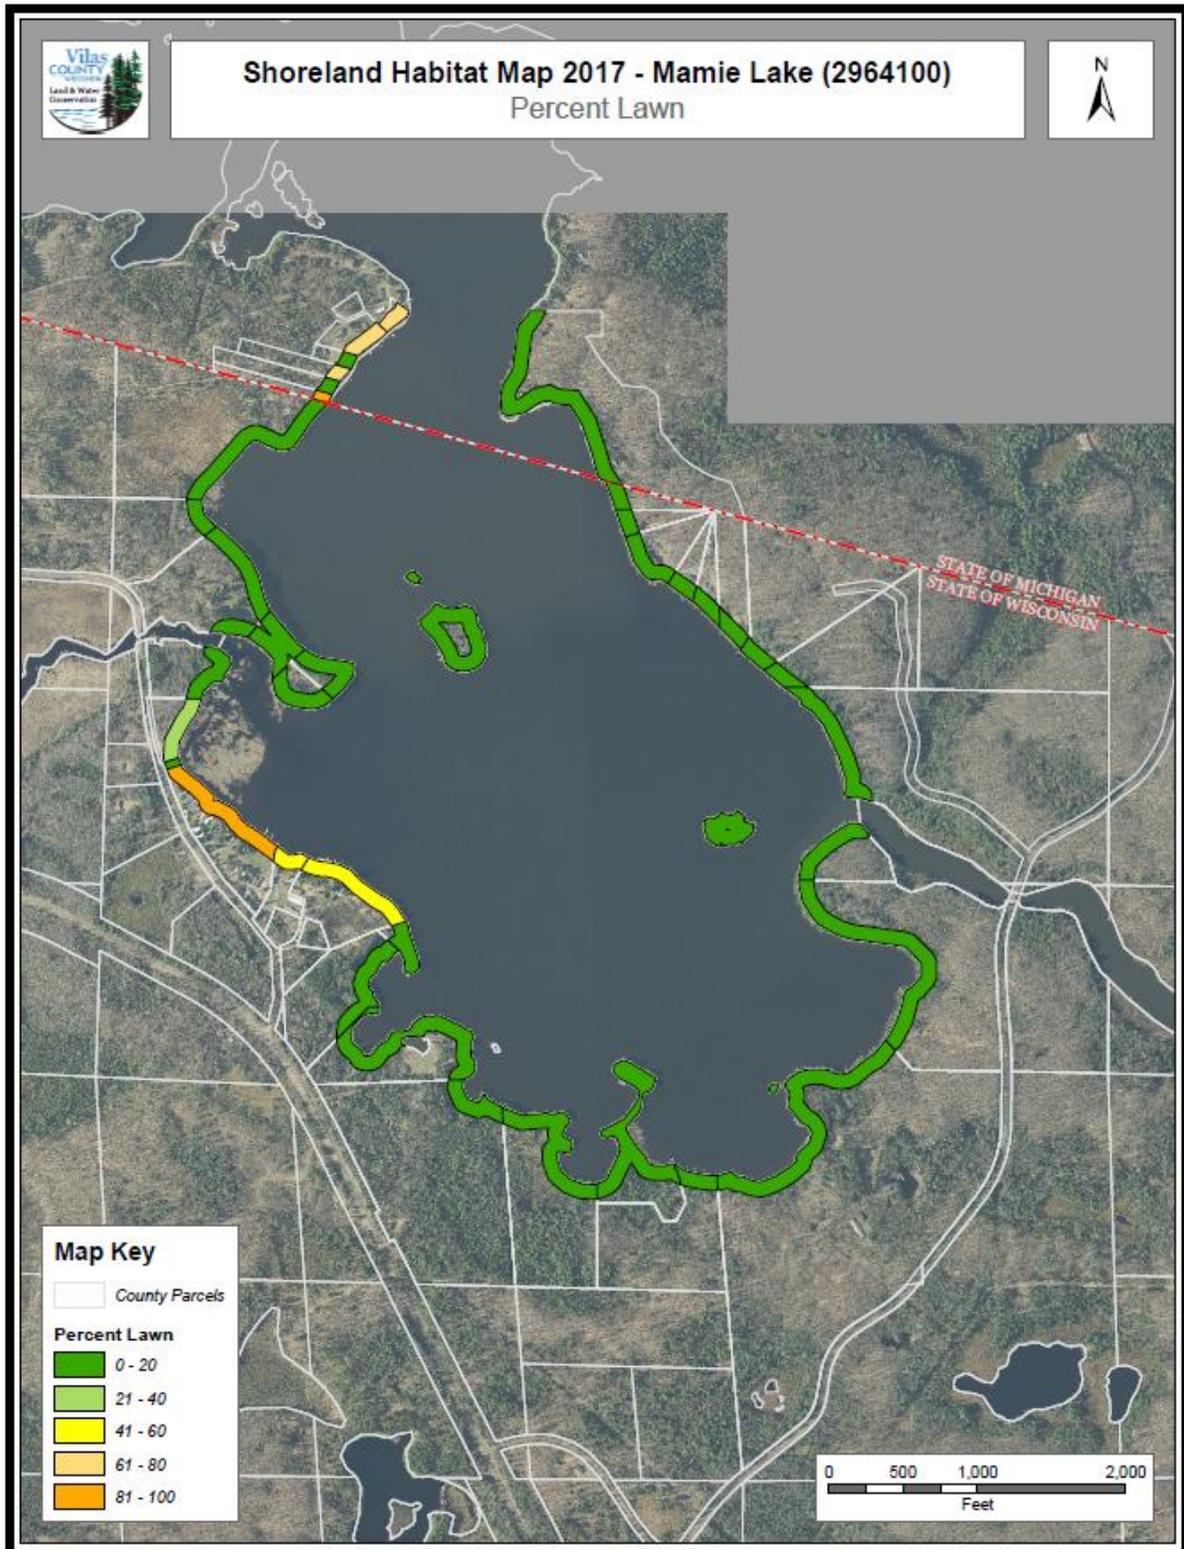
Figure 27. Percent lawn cover per parcel within 35 ft buffer area on Mamie Lake 2017.

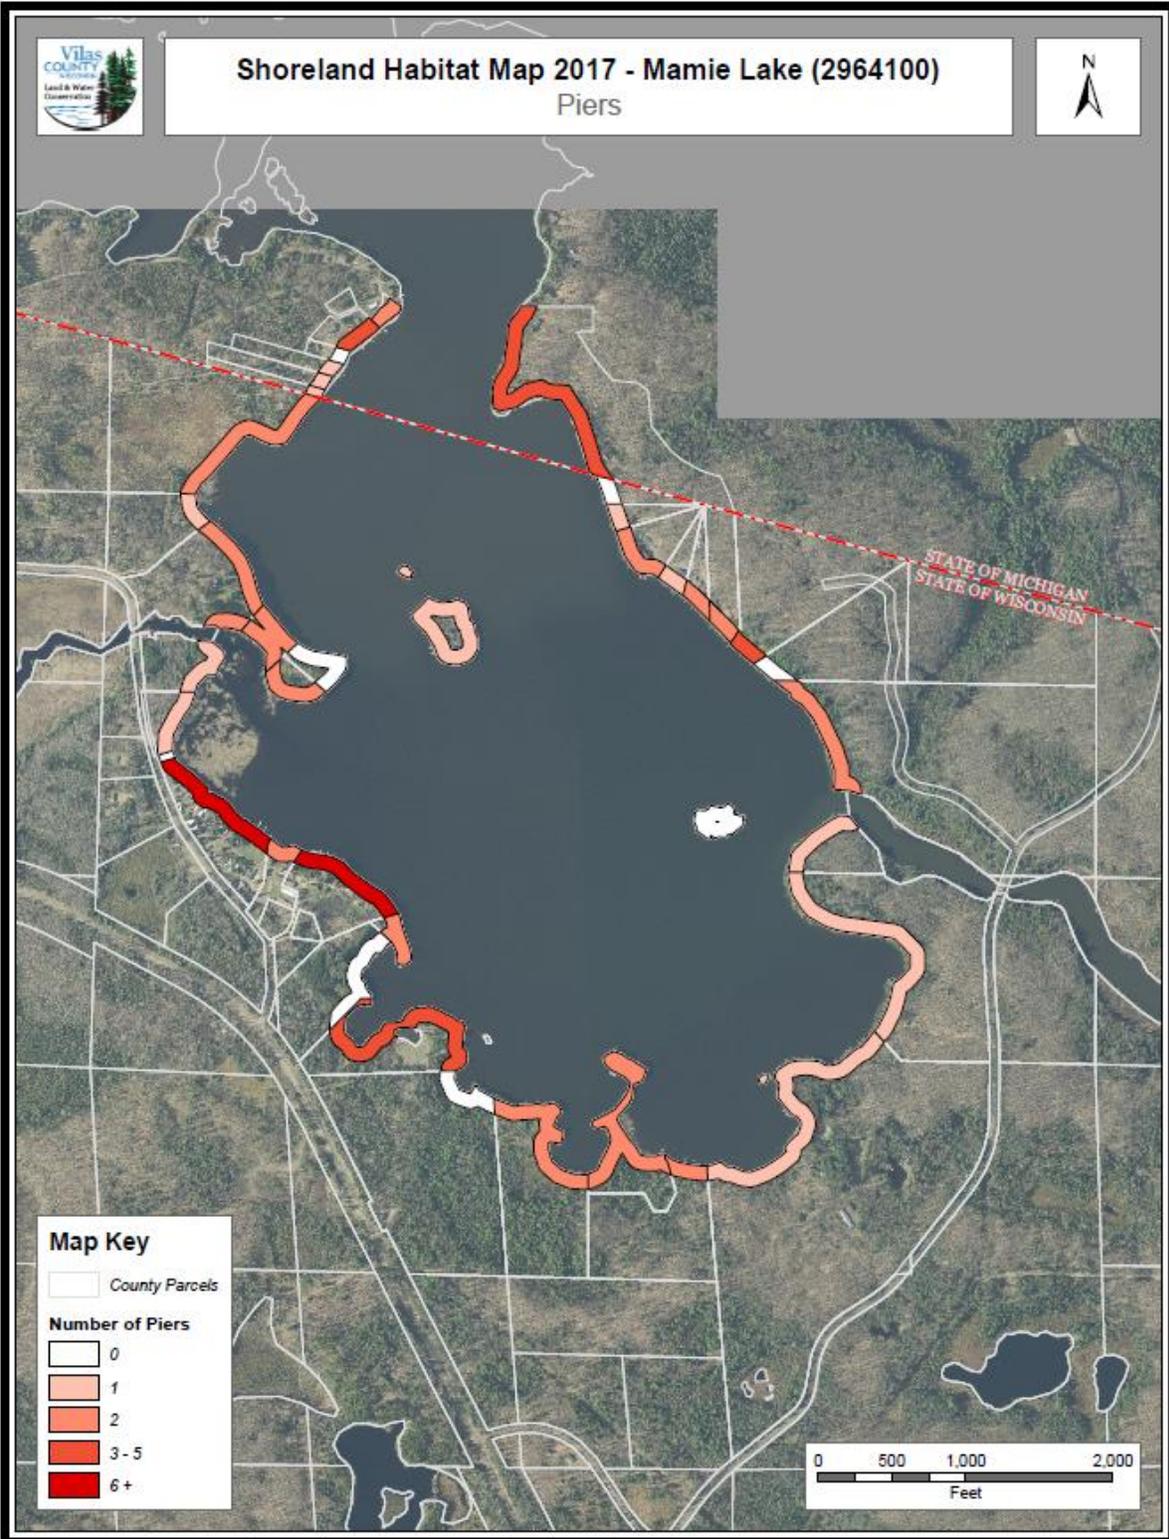
Figure 28. Piers per parcel on Mamie Lake 2017.
