Mamie Lake 2017-2018 Lake Assessment Report

Prepared by
Vilas County Land & Water Conservation

January 2, 2020

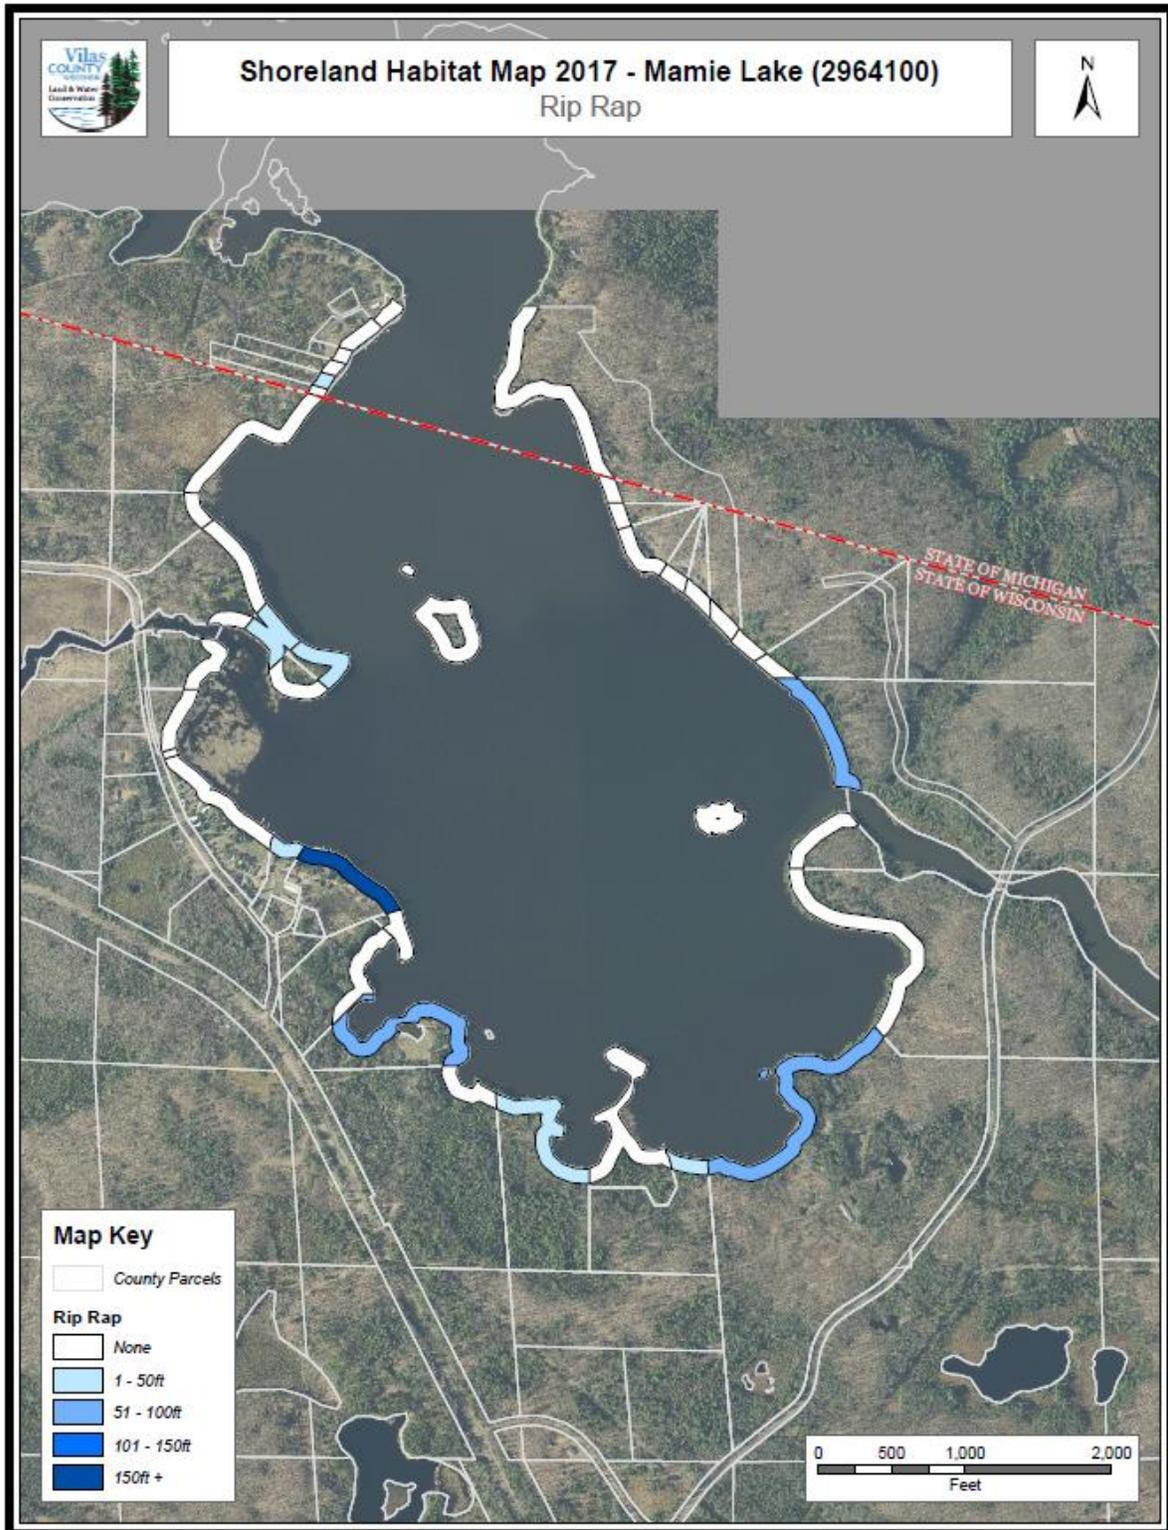
Figure 29. Riprap feet per parcel on Mamie Lake 2017.

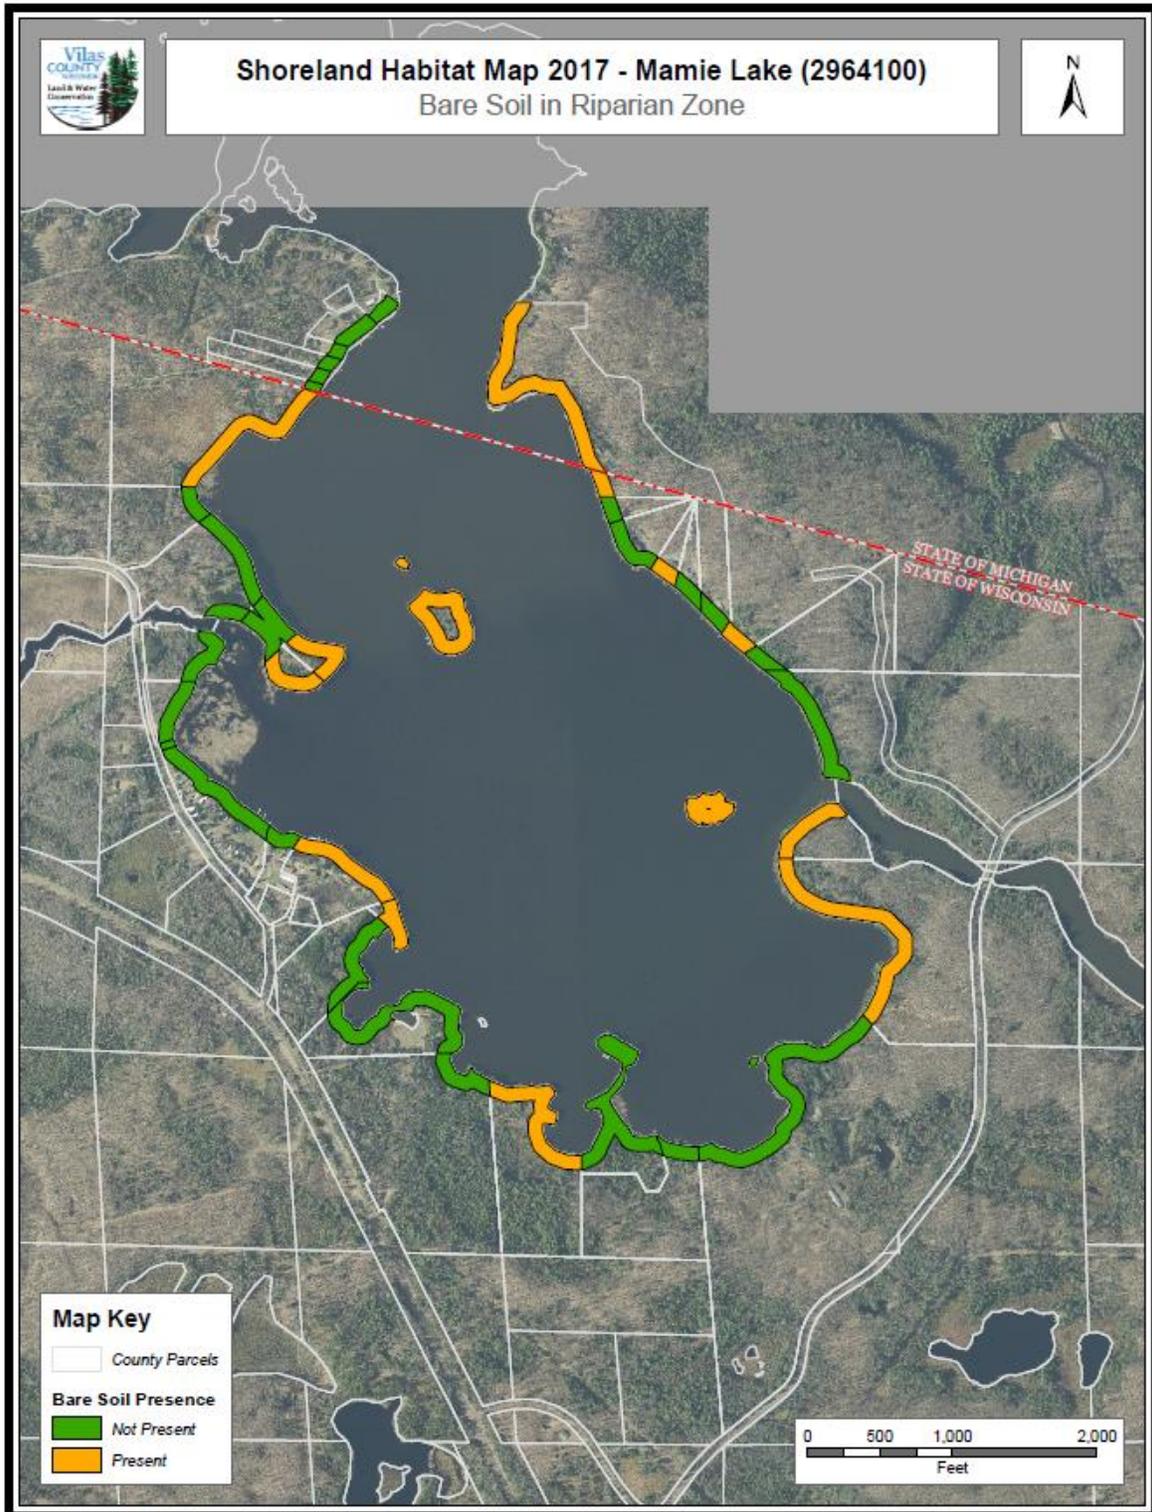
Figure 30. Parcels where bare soil is present on Mamie Lake 2017.

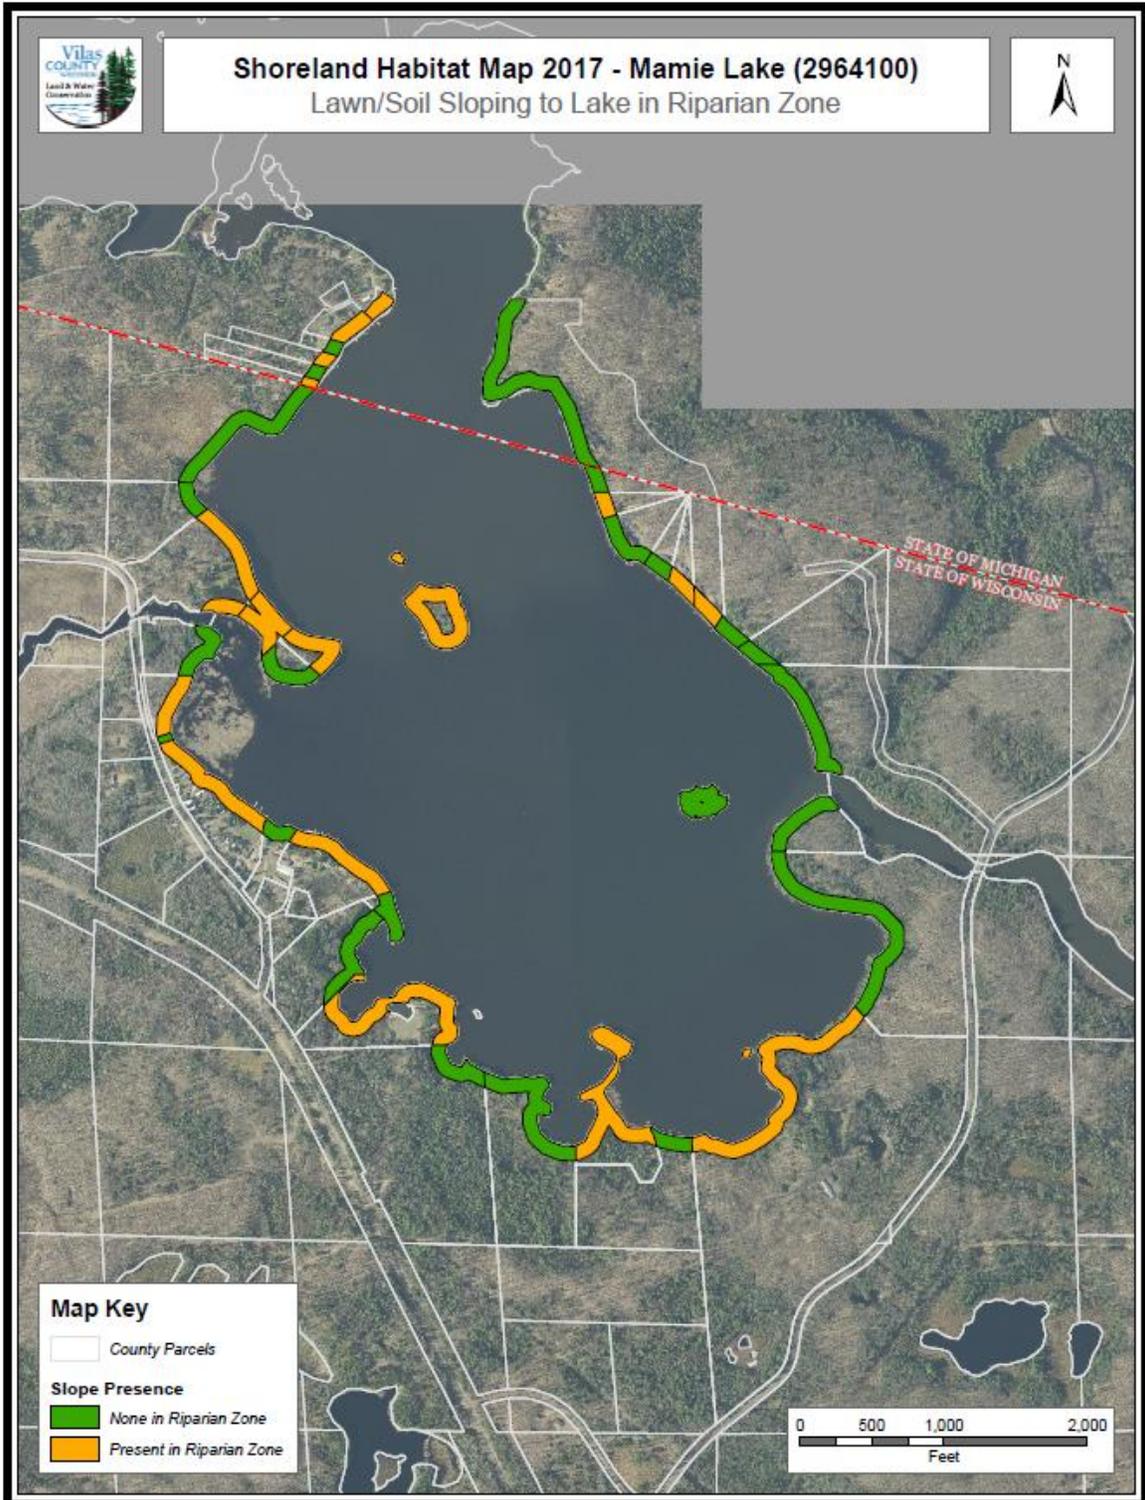
Figure 31. Parcels where lawn or soil slopes to lakes on Mamie Lake 2017.

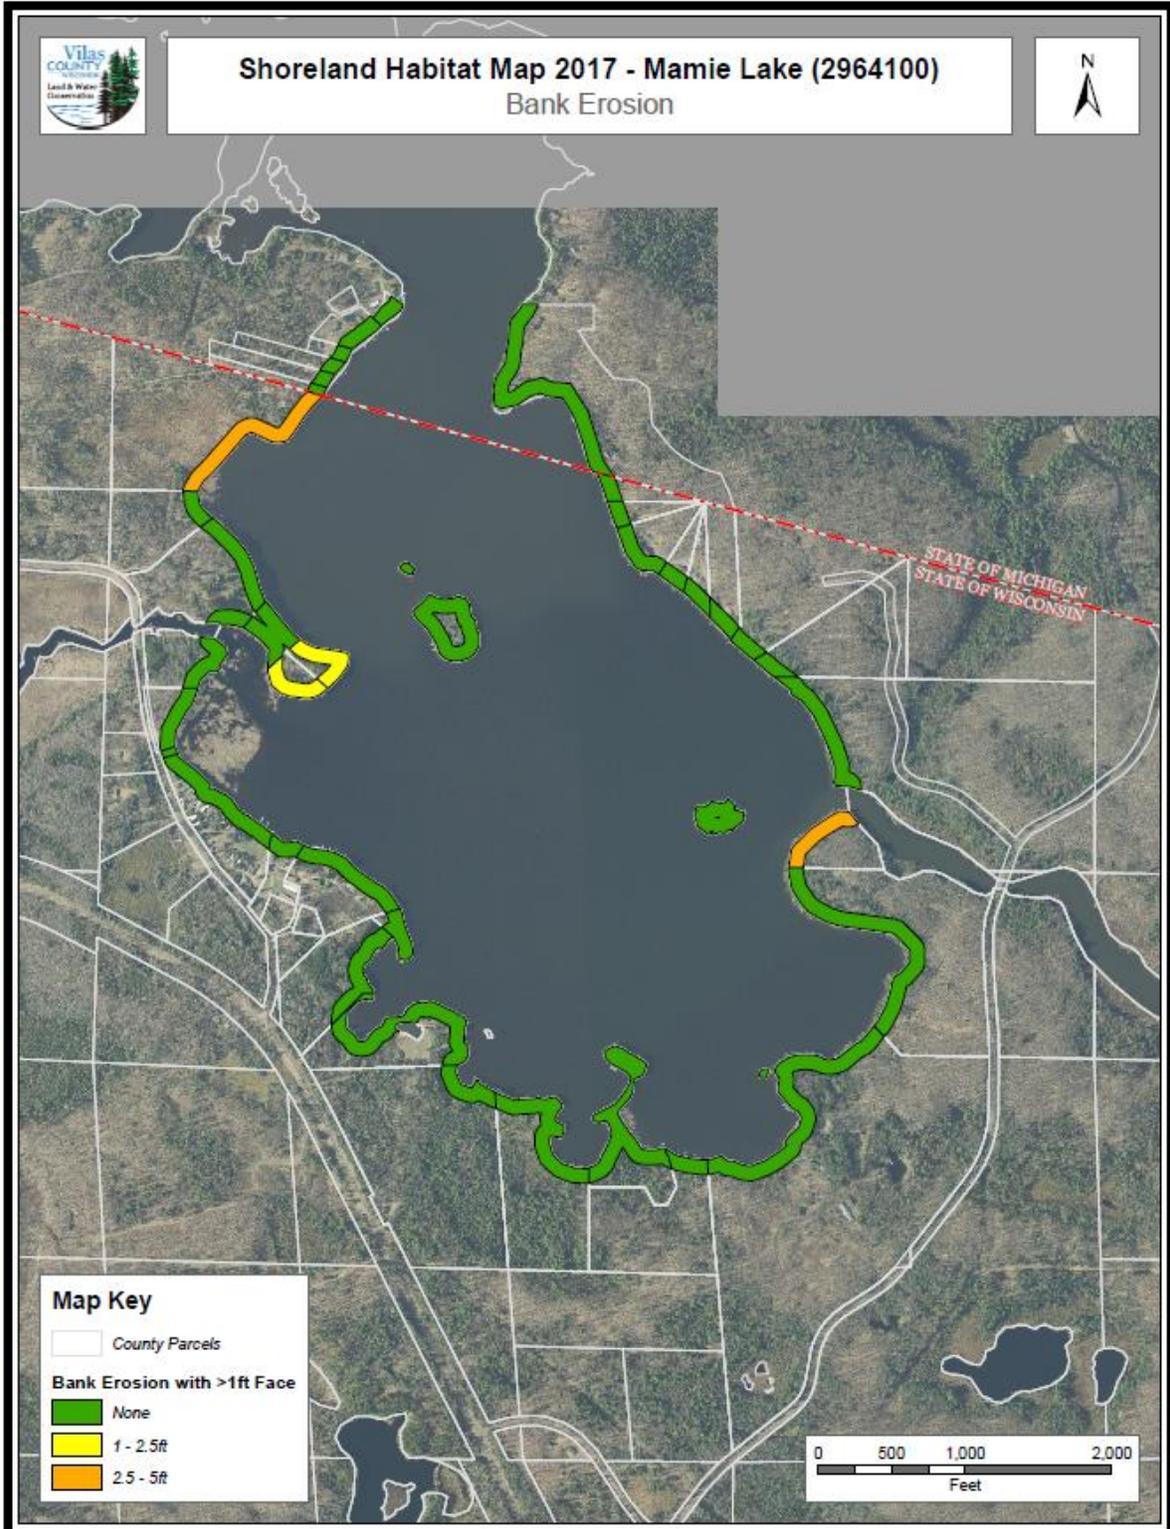
Figure 32. Shoreland length of bank erosion with >1 ft. face per parcel on Mamie Lake 2017.

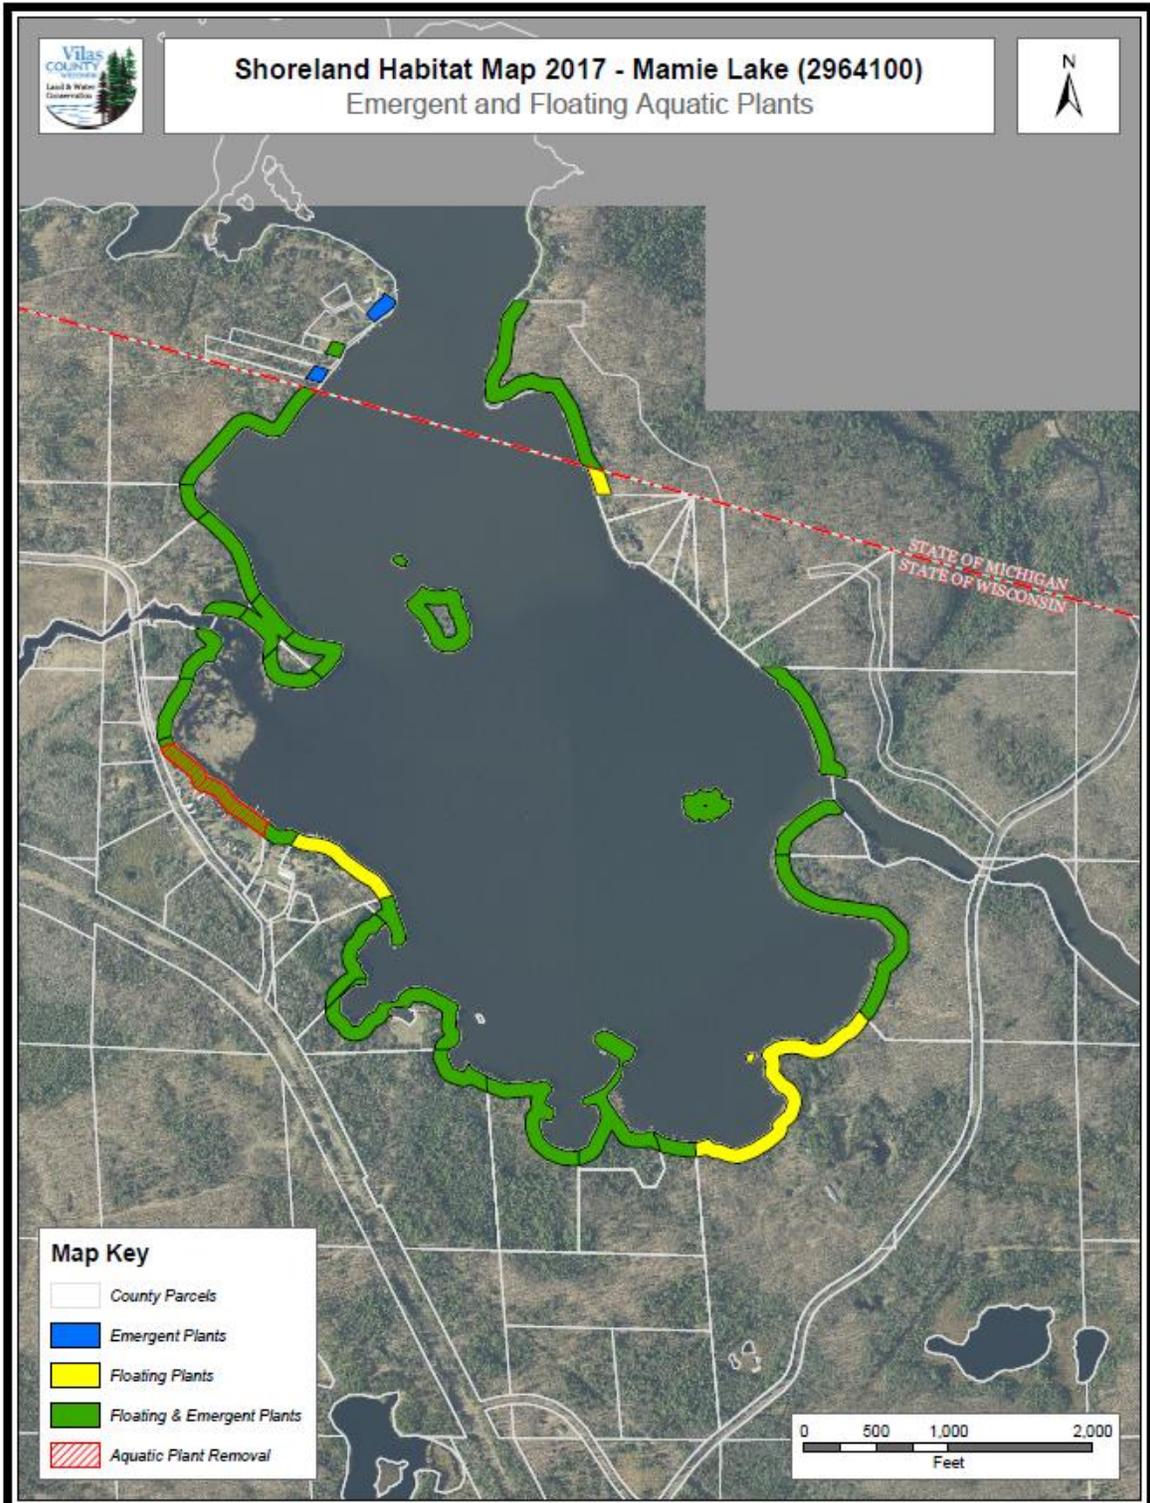
Figure 33. Emergent and floating aquatic plants and aquatic plant removal observations on Mamie Lake 2017.

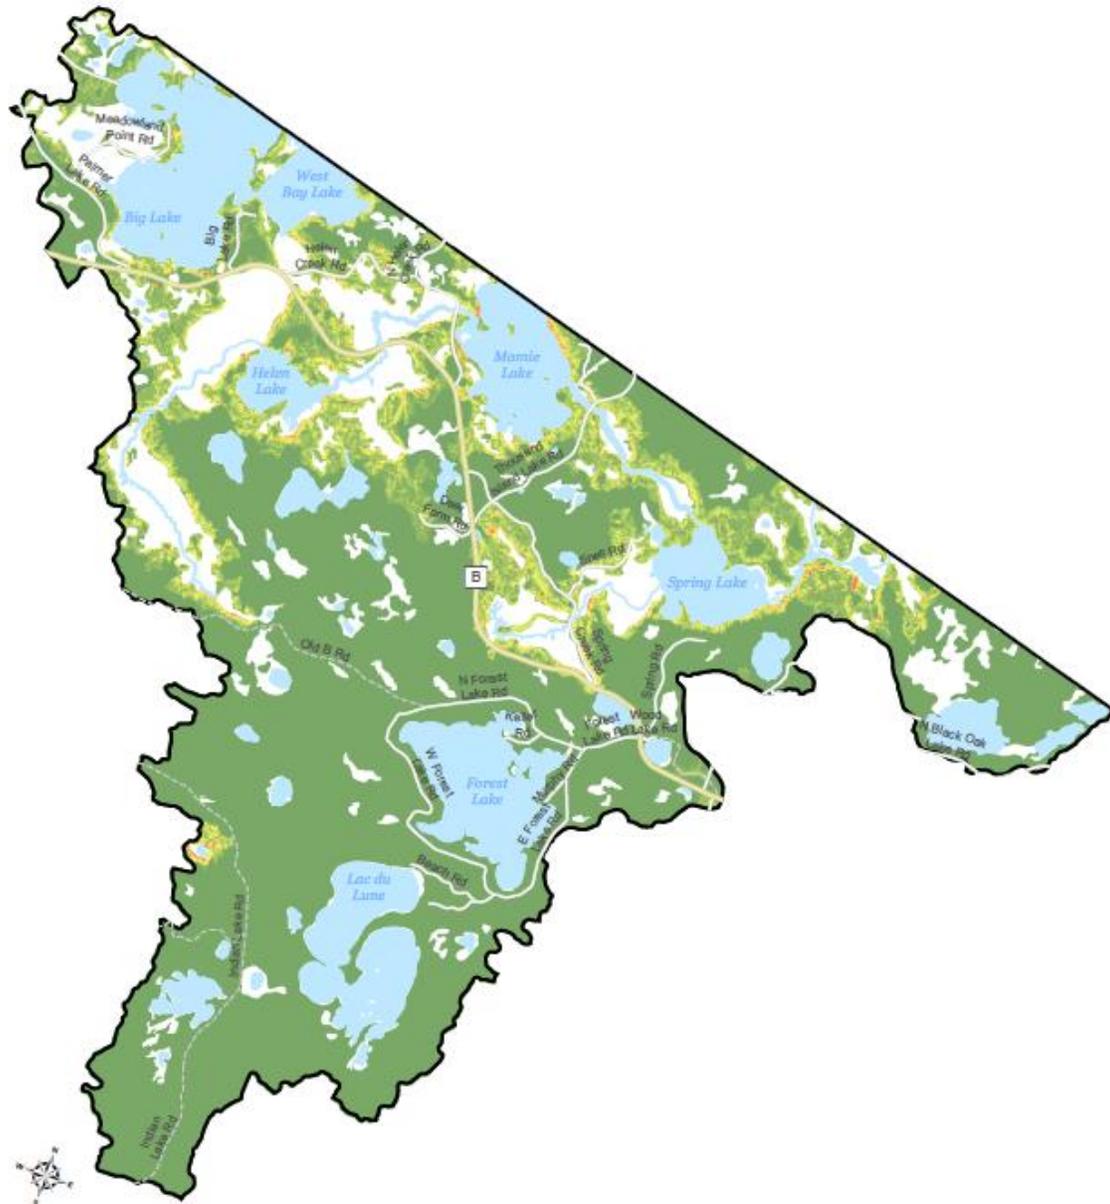
Areas Most Susceptible to Sheet, Rill and Gully Erosion

Erosion Vulnerability Index
shown with county-wide 0.2% clip
