## Little Arbor Vitae Lake 2018 Lake Assessment Report

Prepared by  
Vilas County Land & Water Conservation

January 2, 2020

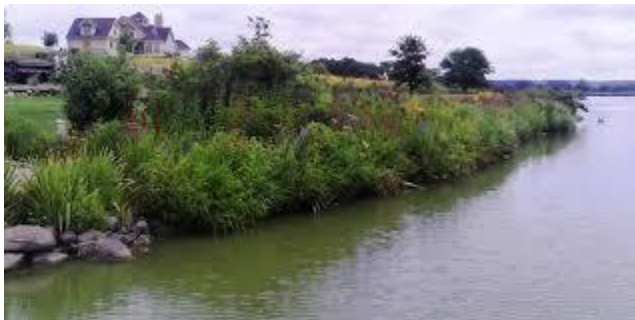
Figure 5. Landowners experiencing minor-moderate erosion issues may find that Healthy Lakes practices such as native plantings are enough to reduce runoff. Contact Land & Water Conservation for an assessment. Photo courtesy of Healthy lakes WI.

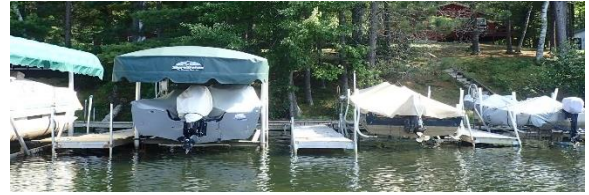
Figure 4. Some areas of Little Arbor Vitae Lake showed denser dock placement. Lake-wide, there were 10.3 docks/mile on Little Arbor Vitae Lake. Having a lake-wide dock density greater than 16 docks/mile has been shown to have negative effects on fish diversity (Jacobsen et.al).

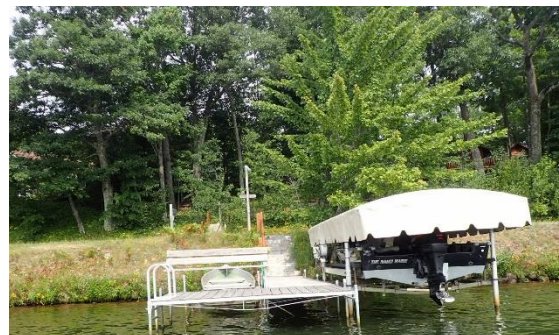
Figure 6. Several parcels on Little Arbor Vitae Lake are split by a road and right-of-way. These have higher percentages of impervious surfaces but do not reflect landowner's use of the parcel.

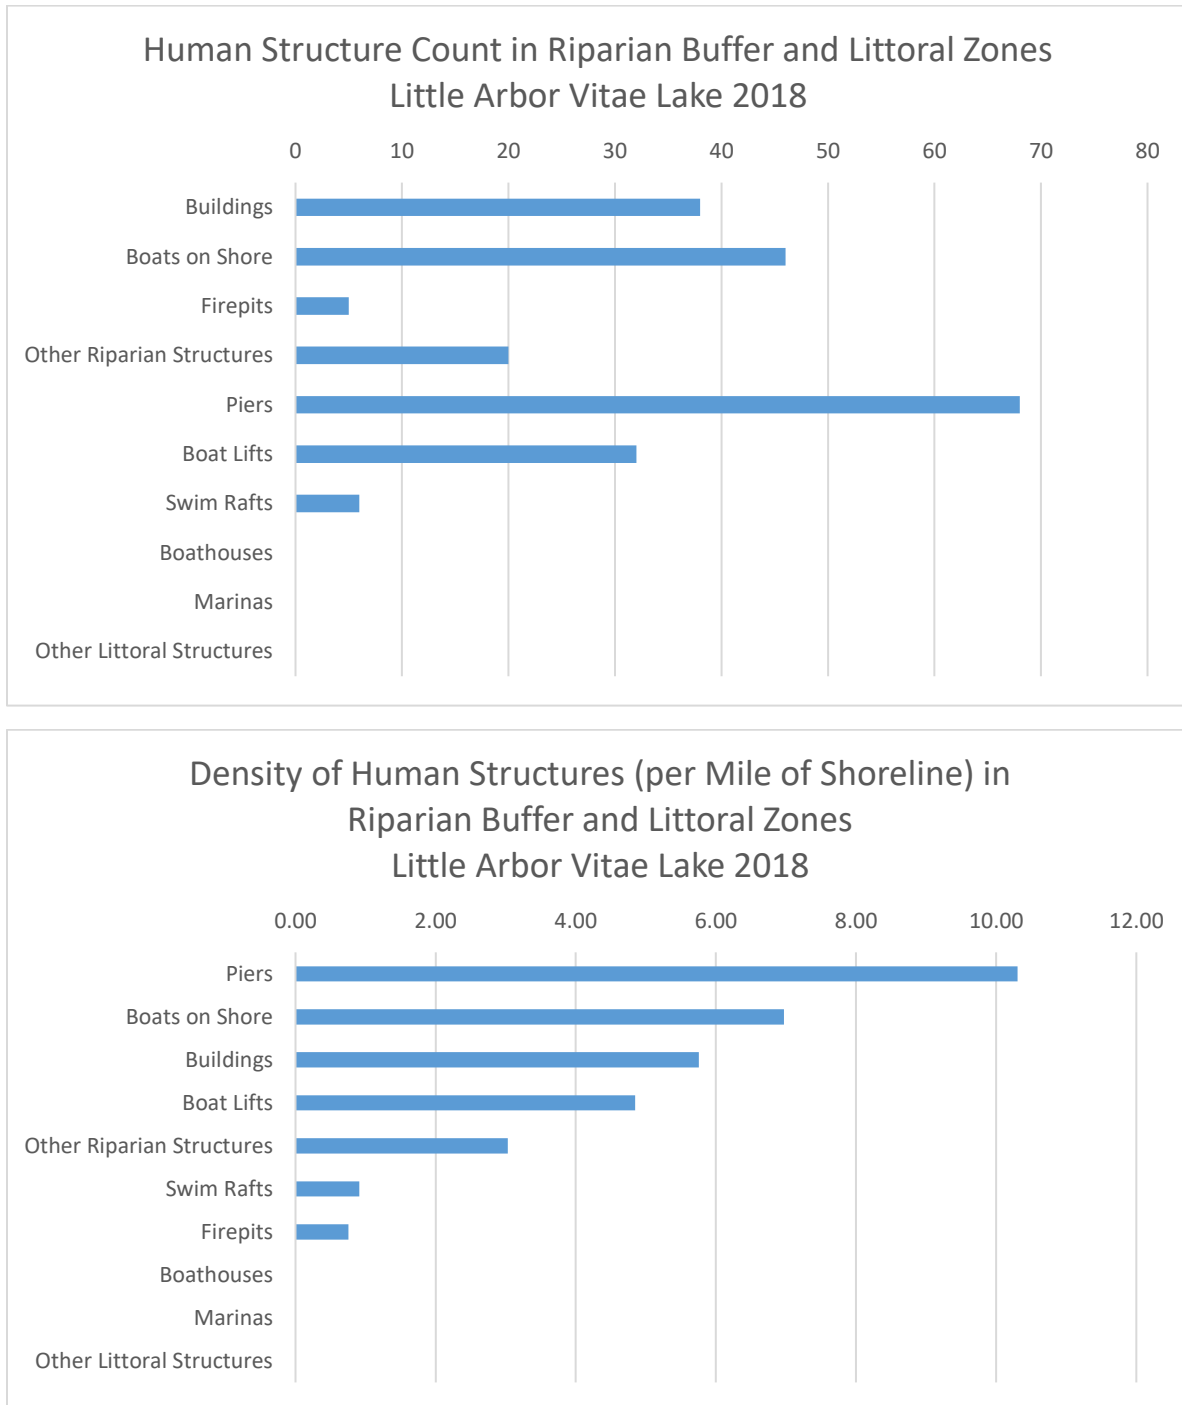
Many human structures or modifications were noted in the Riparian, Bank, and Littoral Zones. See Figure 7 for Human Structures in Riparian Buffer, Bank and Littoral Zones Charts. Because of their ecological importance, these areas are typically protected by County Zoning and DNR regulations and permits are often required to modify or place new structures in these areas. In Little Arbor Vitae Lake, piers were the most common structure. Ten docks or less per kilometer

16 docks/mile) of shoreline has been shown to be a threshold of maintaining high quality fish diversity in Minnesota (Jacobsen et. al). Little Arbor Vitae Lake is below this figure at 10.3 docks/mile. Additional littoral structures such as boat lifts, swim rafts, etc. would intuitively seem to add to this stress. Other major categories for structures were: boats on shore (46); buildings (38); boat lifts (32); and other riparian structures (20).

Figure 7. Number and density per mile of shoreline of human structures documented in the Riparian Buffer and Littoral Zones on Little Arbor Vitae Lake 2018.

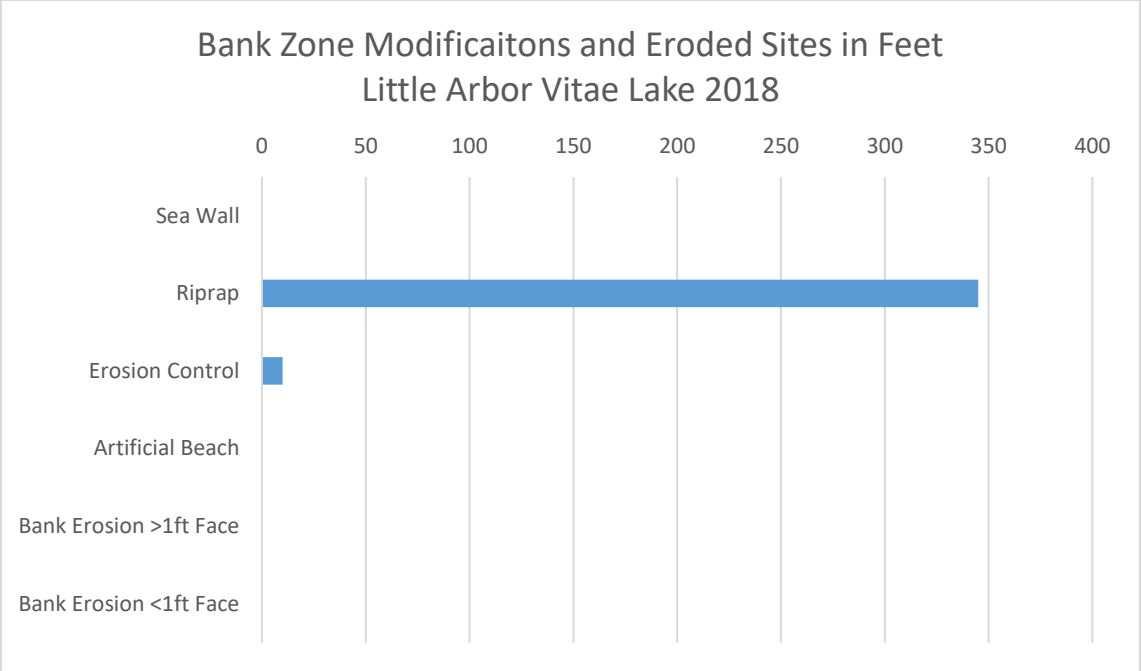
Within the Bank Zone, modifications included riprap and erosion control structures. There was 345 ft of riprap noted, which would comprise less than 0.1% of the total shoreline. Bank erosion was not noted on any parcels on Little Arbor Vitae Lake. One erosion control structure was in place on 10 ft of shoreline (at boat landing). No bank erosion less than 1 ft face was noted. (See Figure 8.)

Figure 8. Length in feet of human modifications & eroded sites to Bank Zone on Little Arbor Lake 2018.

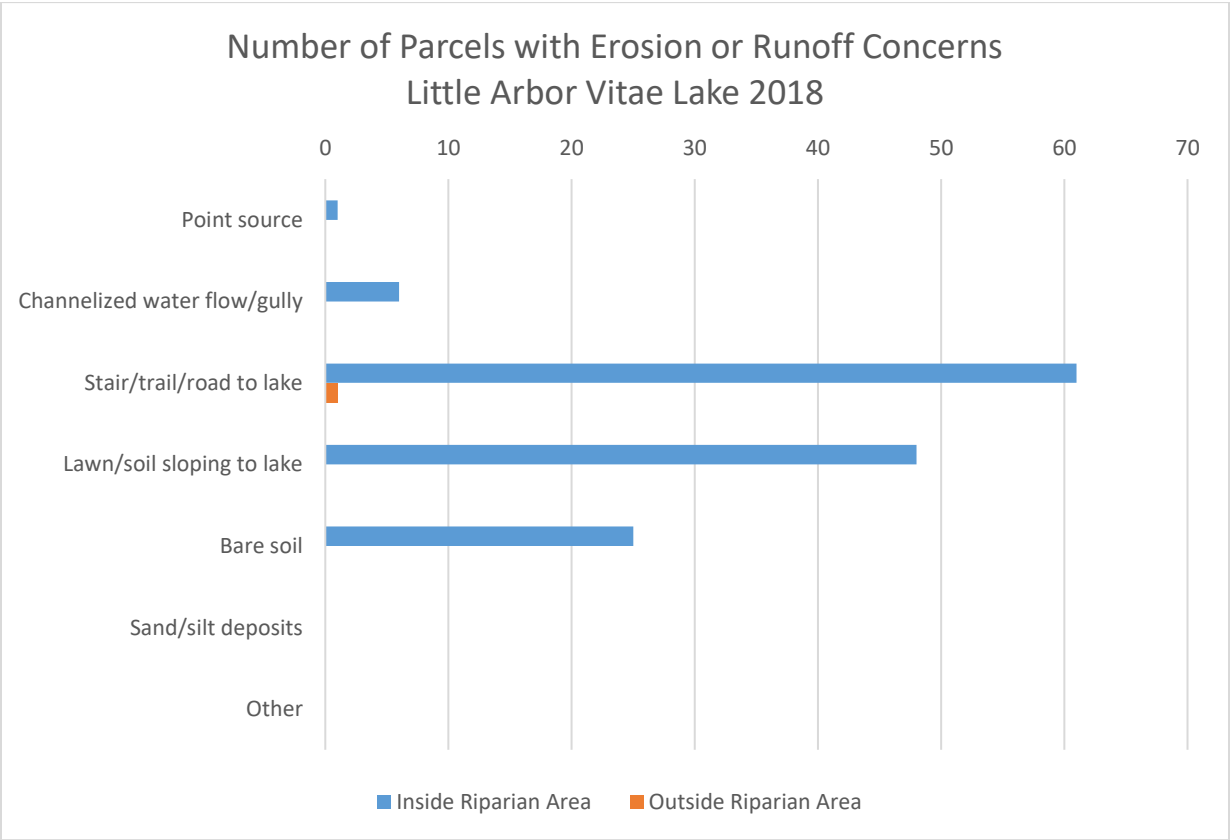
Several runoff and erosion concerns were documented within the riparian area: 40 parcels had stairs/trail/road to the lake; 51 had lawn/soil sloping to the lake; and 9 had bare soil. See Figure 9 for Number of Parcels with Erosion or Runoff Concerns.

Figure 9. Number of parcels with runoff and erosion concerns in Riparian Zone and Outside Riparian Zone on Little Arbor Vitae Lake 2018. Of the 75 parcels, 67 had erosion or runoff concerns (89%).

- The number of parcels with erosion concerns was fairly high (86%). Addressing these issues with willing private landowners will take a coordinated effort, ideally with a well versed riparian being locally available for those interested. Stormwater management (gutters, infiltrations, etc.) outside the 35 ft. buffer zone should also be addressed with willing landowners. Contact Cathy Higley from Vilas County Land & Water Conservation 715-479-3738 or [cahigl@vilascountywi.gov](mailto:cahigl@vilascountywi.gov) for assistance.

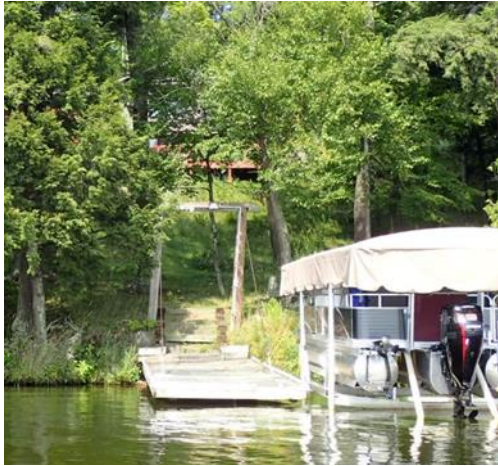
Figure 10. Minimizing impervious surfaces in and around lake access paths, maintaining vegetation, and curving the trail across the slope keeps shoreland erosion in check.

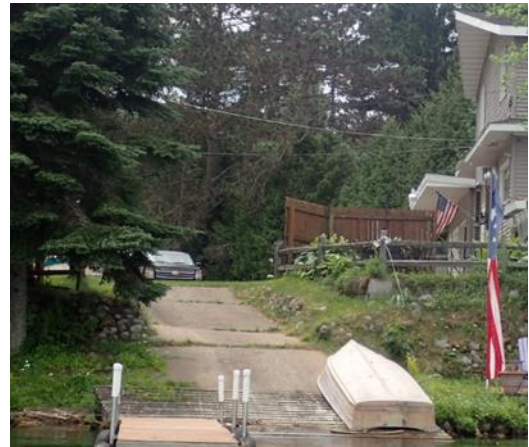
Figure 11. Impervious surfaces and straight trail access make a site even more prone to erosion. This site was augmented with a water infiltration pit to minimize runoff into the lake.

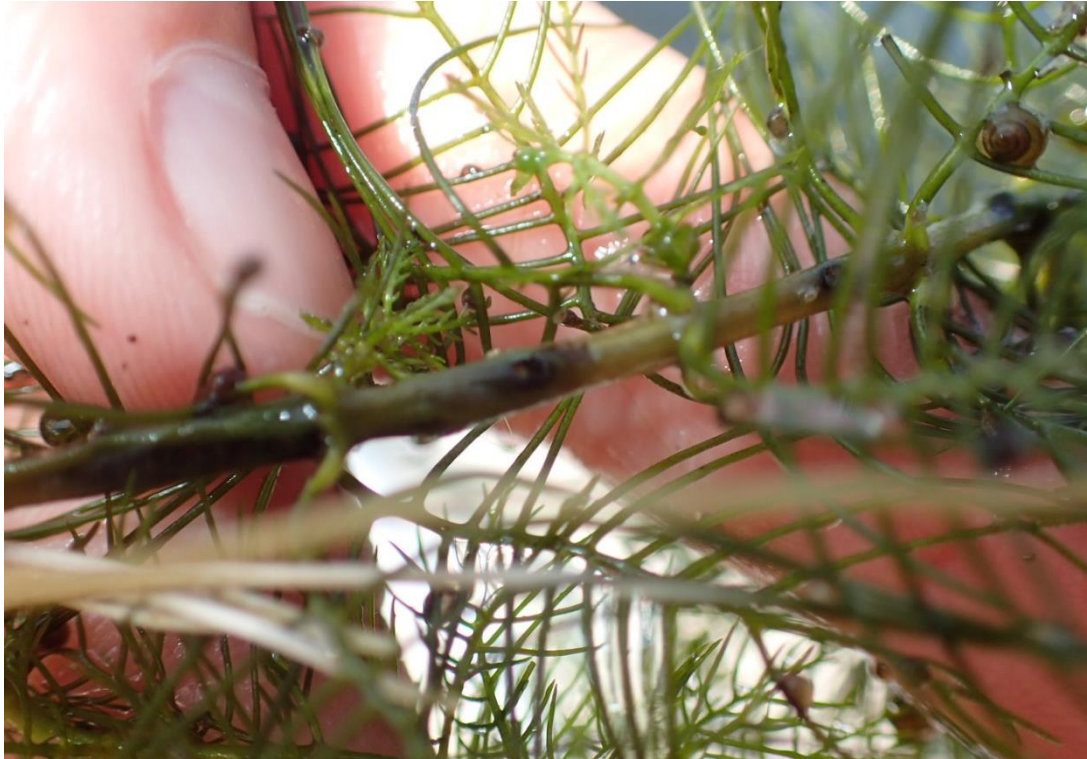
While looking at the native Northern Water-Milfoil during the Aquatic Plant Point Intercept Survey, multiple specimens particularly on the western side of the lake were found that were suggesting signs of the native milfoil weevil, *Euhrychiopsis lecontei*. In fact, most Northern Water-Milfoil specimens that were observed had damage that may be from weevils (Thorstenson). These native weevils will pupate in the milfoil stems, and create a large “blast hole” when they emerge as adults. They also feed on the milfoil. In some areas of WI, stocking these native weevils has been used to as a management tool for invasive Eurasian Water-Milfoil with varying degrees of success.

Figure 10. Possible blast holes from native milfoil weevils on native Northern Water-Milfoil from Little Arbor Vitae Lake.

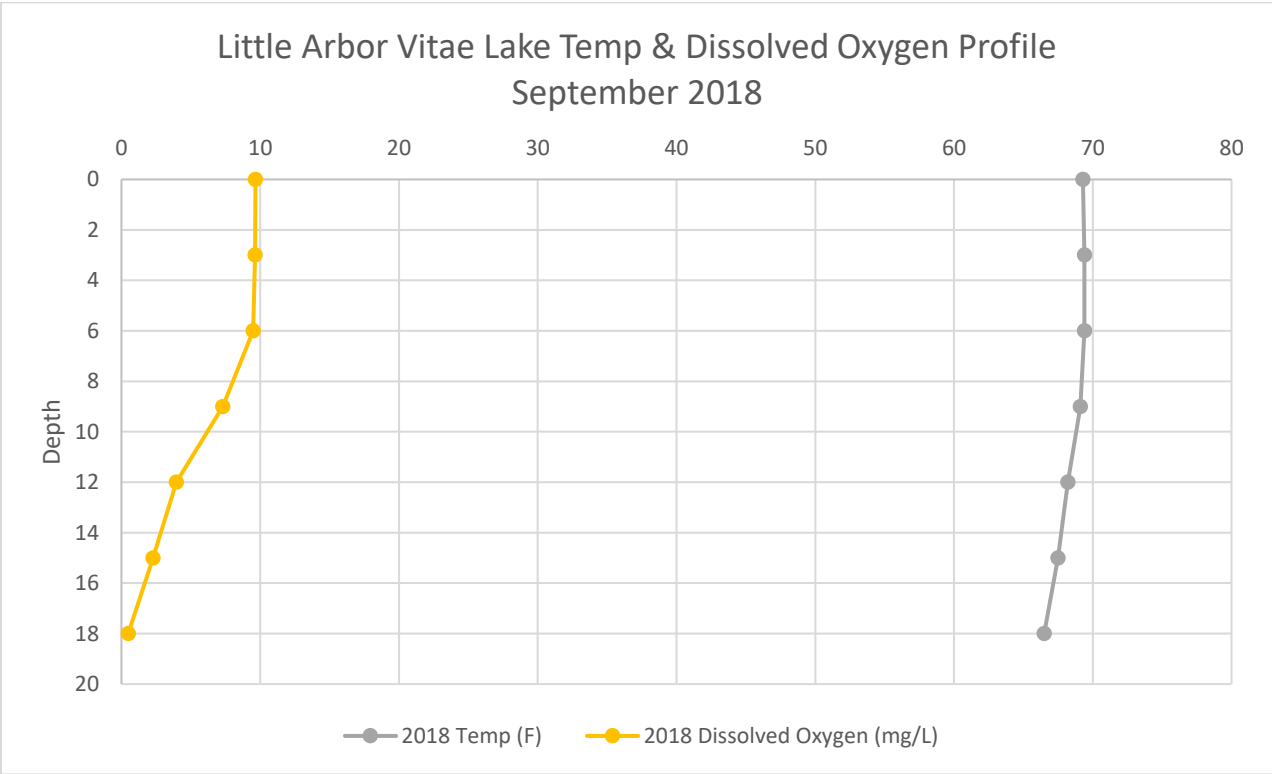
The July, August, and September temperature and dissolved oxygen profiles show the lake stratified.

Figure 12. Temperature and dissolved oxygen profiles for Little Arbor Vitae Lake 2018. Sampling dates were: 7/17/2018; 8/16/2018; and 9/18/2018.

Temperature and dissolved oxygen monitoring showed that Little Arbor Vitae Lake was stratified. “Warm water” fish need dissolved oxygen levels of at least 5 mg/L (Shaw et.al.). More than 5 mg/L dissolved oxygen was found on Little Arbor Vitae Lake down to 9 ft. deep. At 0 mg/L dissolved oxygen, chemical processes differ in this anoxic environment and certain nutrients like phosphorus can be converted to bio-available forms and released lake-wide during turnover events, fueling algae and plant growth. See Appendix 2 for water quality raw data and temperature and dissolved oxygen profiles.

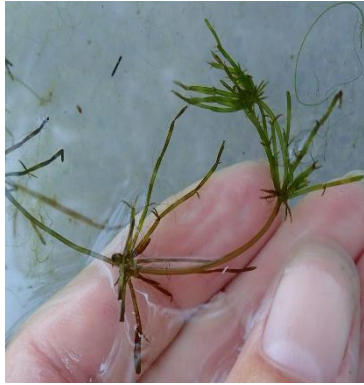
Figure 14. Braun's Stonewort (*Chara braunii*) found in Little Arbor Vitae Lake 2018 point-intercept survey.

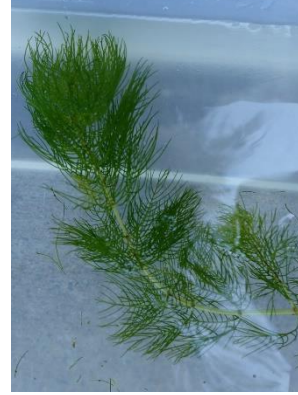
Figure 16. Northern Water-Milfoil (*Myriophyllum sibiricum*) found on Little Arbor Vitae Lake 2018 point-intercept survey.

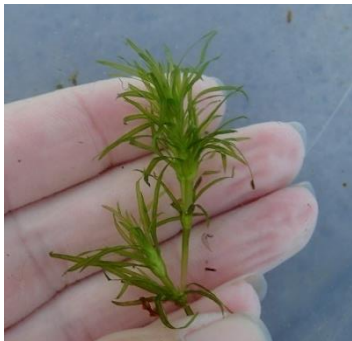
Figure 17. Slender Naiad (*Najas flexilis*) found in Little Arbor Vitae Lake 2018 point-intercept survey.

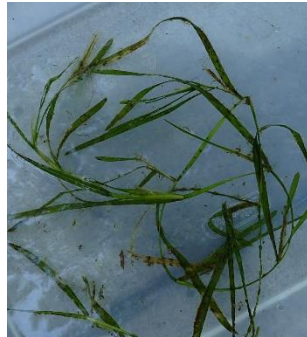
Figure 18. Flat Stem Pondweed (*Potamogeton zosteriformis*) found in Little Arbor Vitae Lake 2018 point-intercept survey. This plant occurred in over 25% of littoral sites surveyed.

Of the plant species found, Common Waterweed (*Elodea canadensis*) Coontail (*Ceratophyllum demersum*), and Flatstem Pondweed (*Potamogeton zosteriformis*) were the most prevalent, with a littoral frequency of occurrence of 35%, 31%, and 26% respectively.

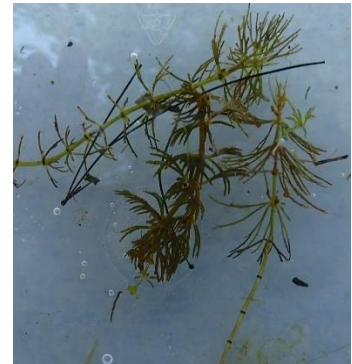
Figure 19. Coontail (*Ceratophyllum demersum*) found in Little Arbor Vitae Lake 2018 point-intercept survey. This plant occurred in over 31% of littoral sites surveyed.

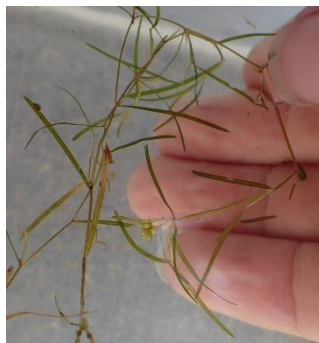
Figure 20. Leafy Pondweed (*Potamogeton foliosus*) found in Little Arbor Vitae Lake 2018 point-intercept survey.

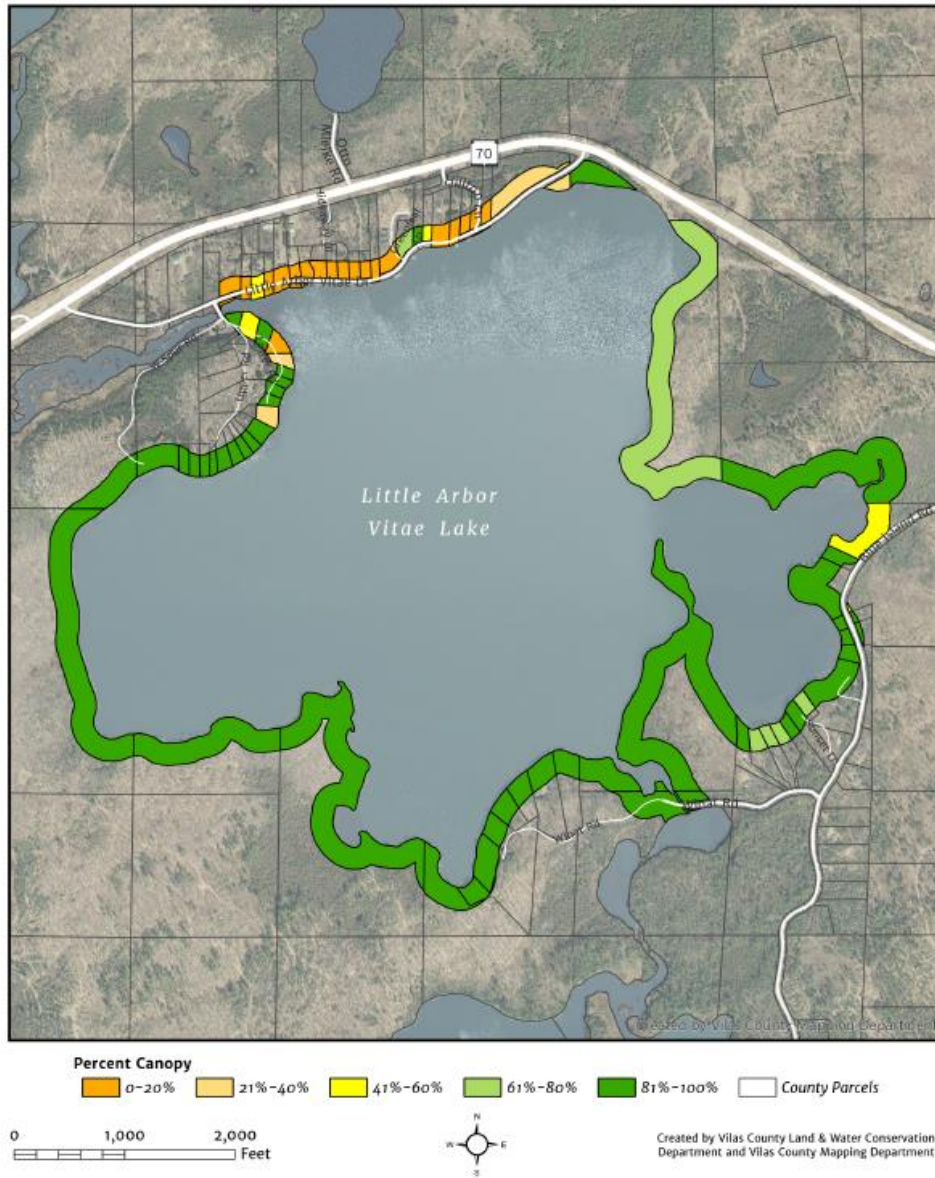
Figure 23. Canopy cover percent per parcel within 35 ft buffer area on Little Arbor Vitae Lake 2018.

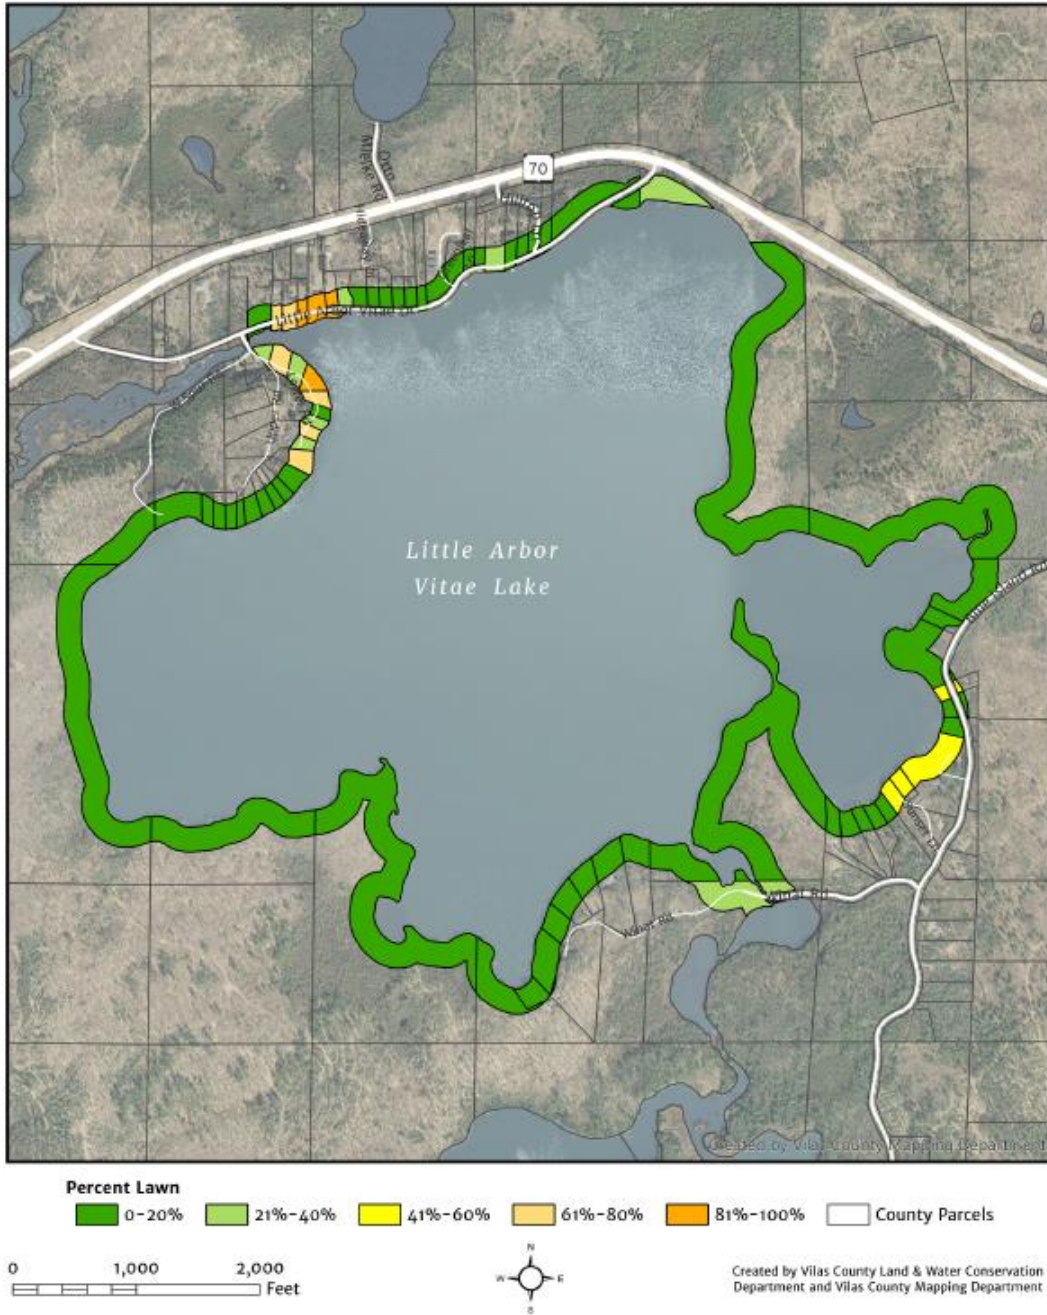
Figure 25. Percent lawn cover per parcel within 35 ft buffer area on Little Arbor Vitae Lake 2018.

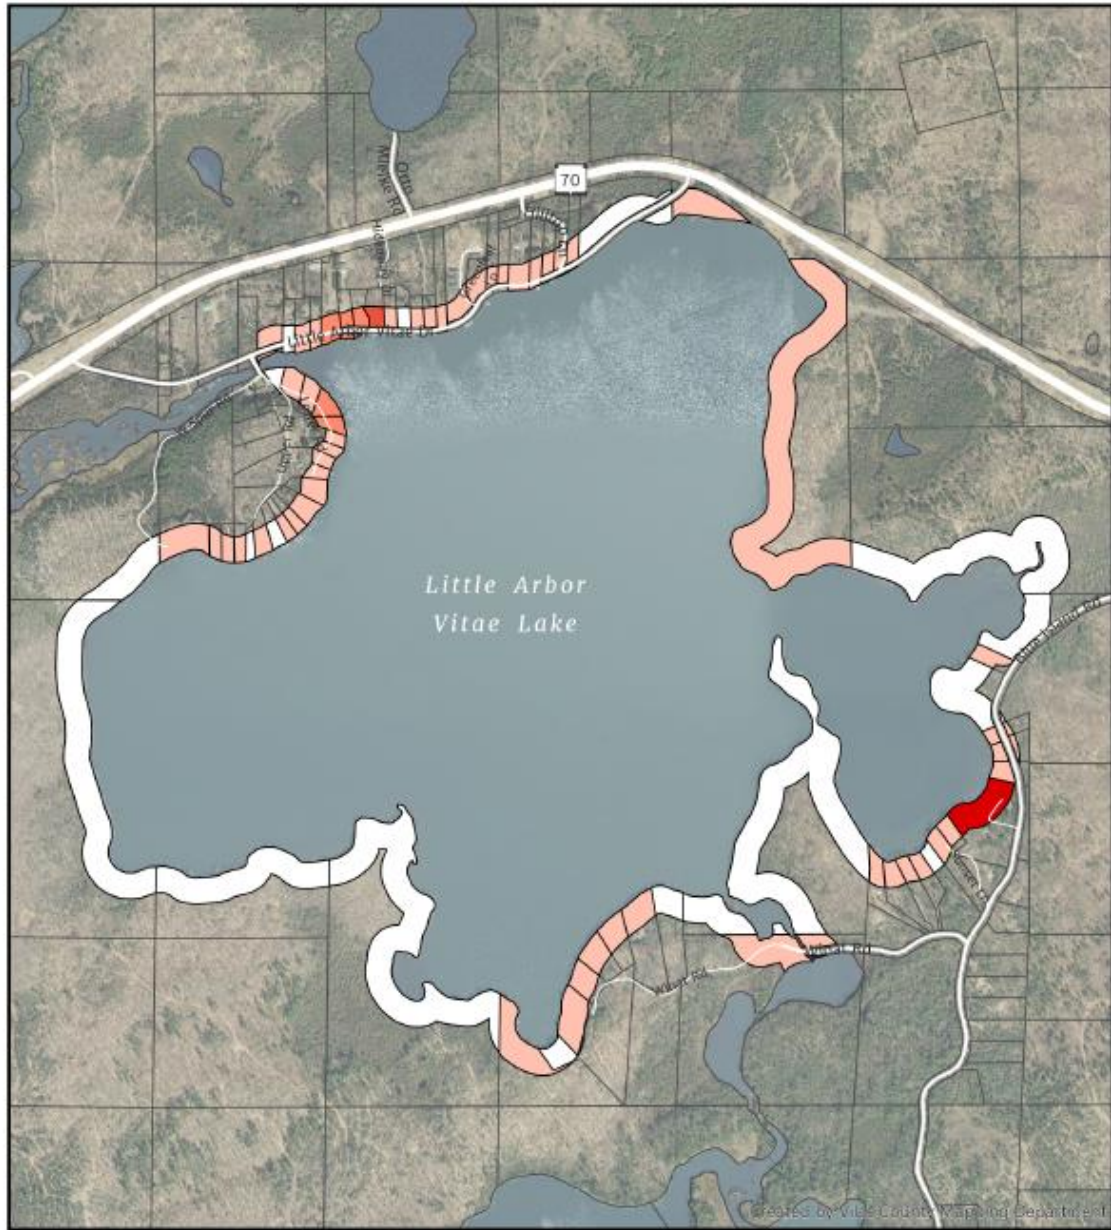
Shoreland Habitat Map 2018 - Little Arbor Vitae Lake (1545300)

Number of Piers

0 1 2 3 5 County Parcels

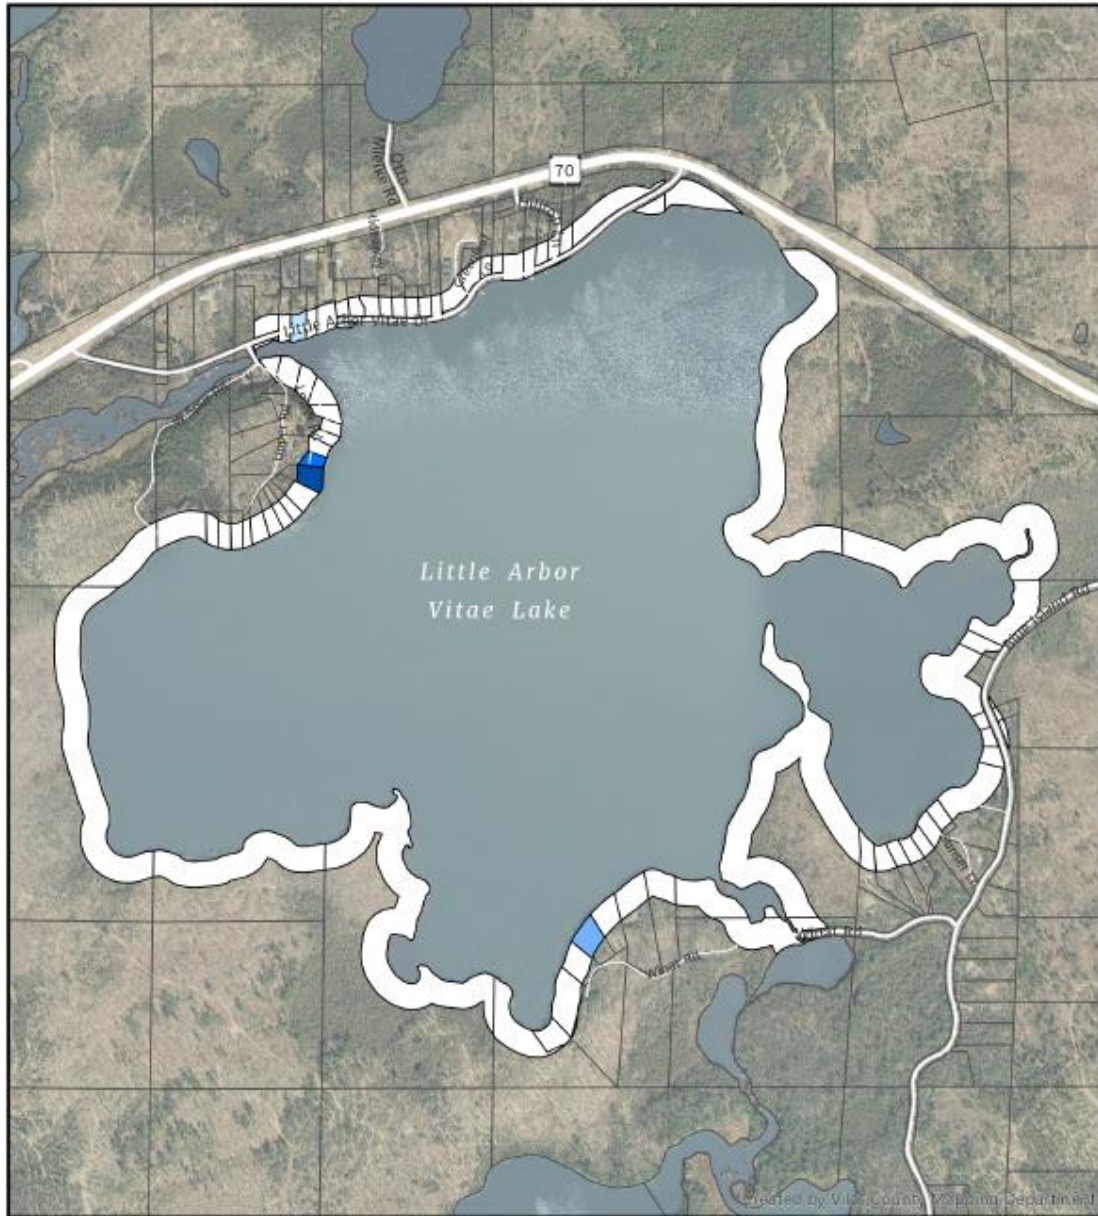
Shoreland Habitat Map 2018 - Little Arbor Vitae Lake (1545300)

### Feet of Rip Rap

None 0-15ft 16-50ft 51-80ft 80ft+ County Parcels

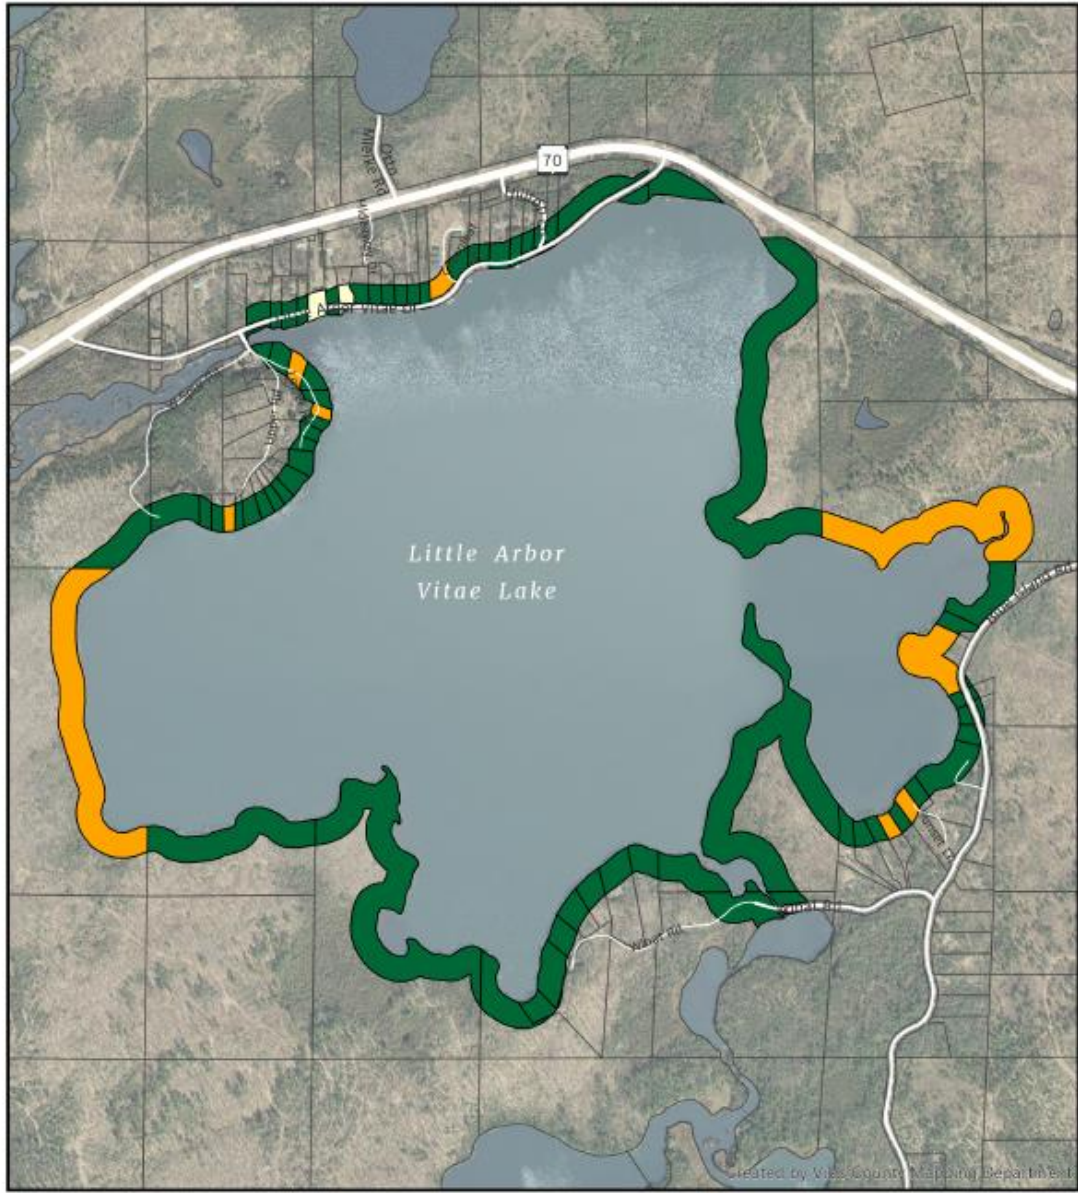
Shoreland Habitat Map 2018 - Little Arbor Vitae Lake (1545300)

**Bare Soil Presence**

- Absent
- Present Outside Riparian Zone
- Present In Riparian Zone
- County Parcels

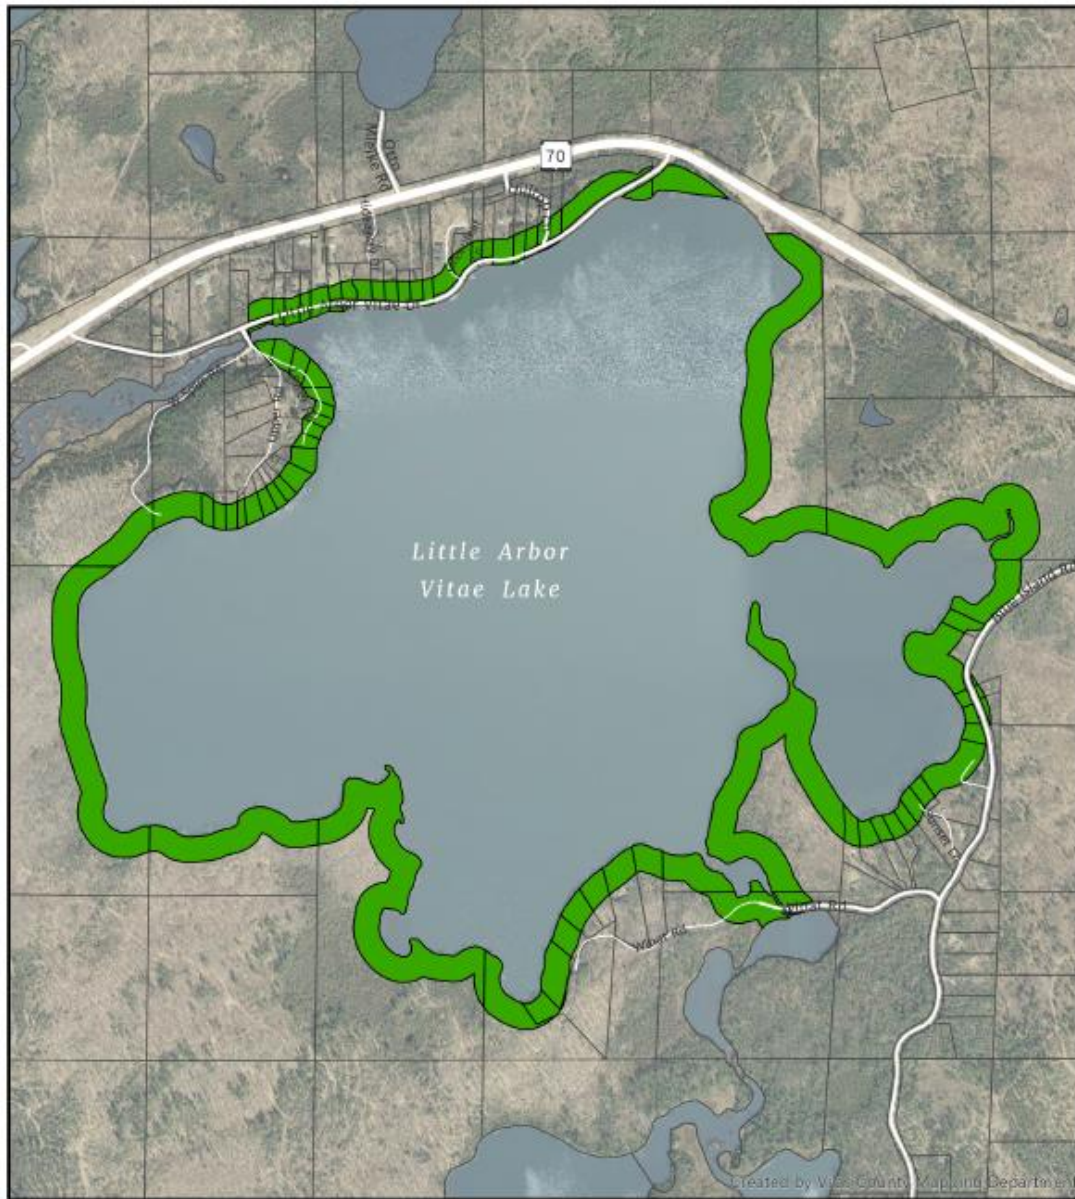
Shoreland Habitat Map 2018 - Little Arbor Vitae Lake (1545300)

**Bank Erosion with >1ft Face**  
None    County Parcels
