## Little John Lake 2017-2018 Lake Assessment Report

Prepared by  
Vilas County Land & Water Conservation  
January 2, 2020

## Executive Summary

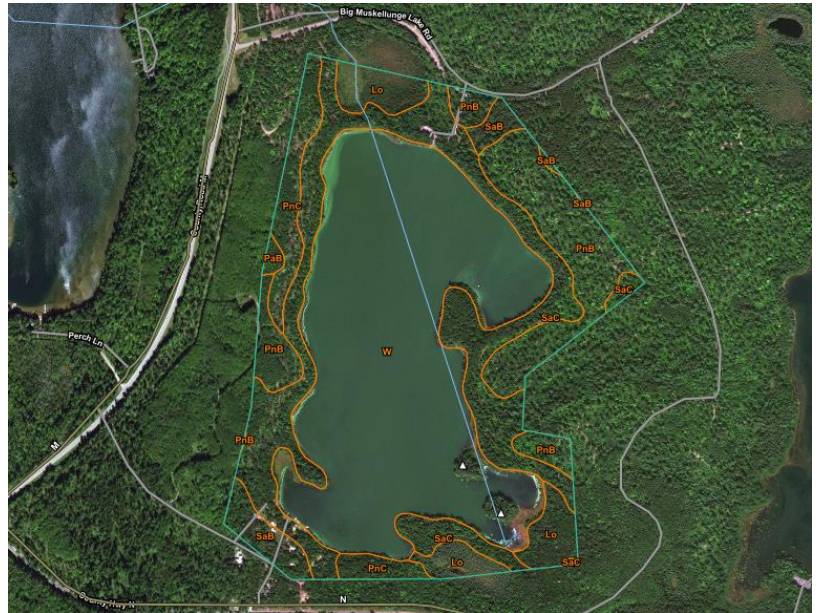
Figure 2. Soils adjacent to Little John Lake. Sayner-Rubicon Complex with 6-15% slopes (SaC) rings the lake. Courtesy Natural Resources Conservation Service Soil Web Survey tool.

The majority (94%) adjacent riparian shoreline is owned by the Northern Highland American Legion State Forest. Private landownership accounts for 6% of the shoreline. The ground cover is primarily forests and wetlands, and development is contained to a small area on the south shore. Surrounding soils are indicated as sandy soils (primarily Sayner-Rubicon Sandy Loam) with slopes ranging from 0-15% (SaB or SaC). These soils are rated "excessively drained" and are listed as a low runoff class. Wetland soils are Loxley & Dawson peats (Lo) with slopes ranging from 0-1% (*Web Soil Survey*).

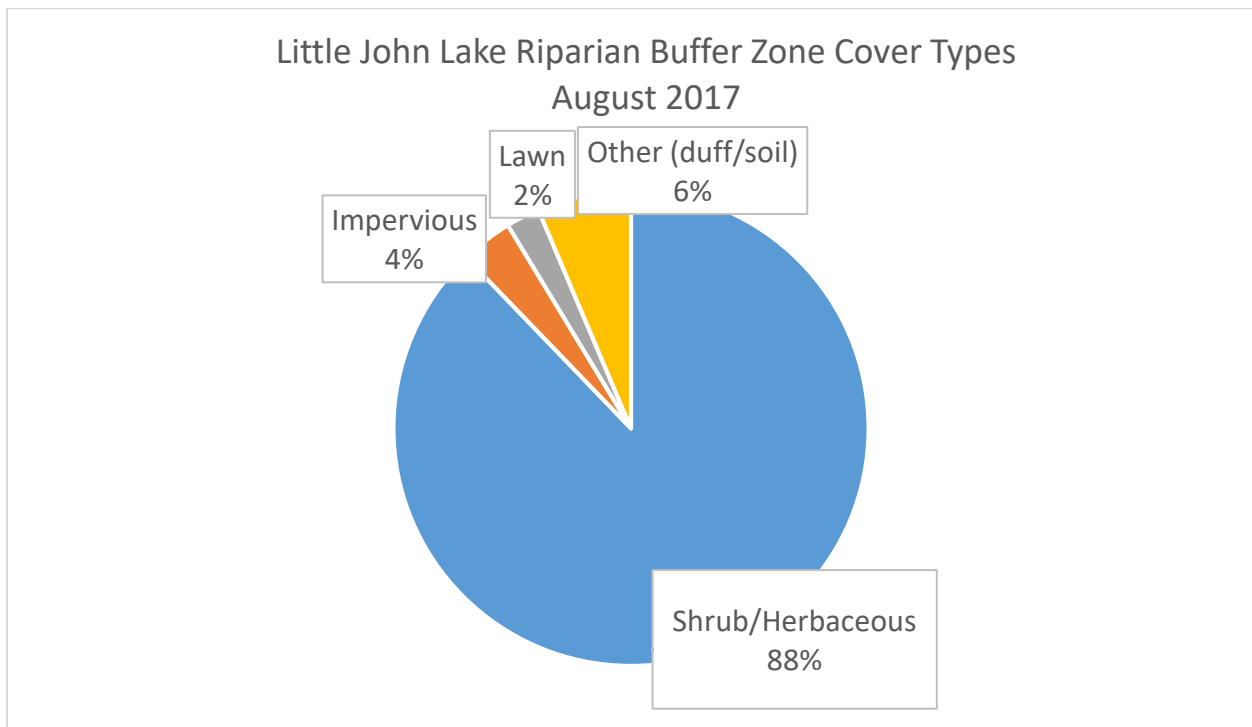
Figure 4. Ground cover type in Riparian Buffer Area (35 ft. inland from shore) on Little John Lake, 2017.

Lake-wide, 88% of the riparian area (35 ft. inland from ordinary high water mark) was covered by a shrub/herbaceous layer. Lawn made up 2% of the riparian area, and Impervious surfaces made up 4%.

The “other” category was comprised of mostly duff along with some bare soil, and covered 6 % of riparian buffer zone. See Appendix 5 for Riparian Buffer Zone Cover Types.

Since Wisconsin now allows 100 ft. frontage lake parcels, and each parcel (or each 100 ft.) is allowed a 35 ft. viewing corridor through the Riparian Buffer Zone (Vilas County Shoreland Zoning Ordinance), 65% native vegetation remaining in the Riparian Buffer Zone is the lake-wide standard target. This rate does not reflect a biological or ecological best practice. Little John Lake exceeds this statistic having 88% covered with shrub/herbaceous cover.

- **Encourage native vegetation to grow in the 35 ft. shoreland buffer areas:**
  - Most private properties had lawn within the 35 ft buffer zone. The roots of these turf grasses are not as well equipped as native shoreline plants at holding down soil and reducing runoff. Encourage willing landowners remove turf grass in the buffer area and replace with native vegetation or establish a no-mow area. Contact Cathy Higley from Vilas County Land & Water Conservation 715-479-3738 or [cahigl@vilascountywi.gov](mailto:cahigl@vilascountywi.gov) for assistance.

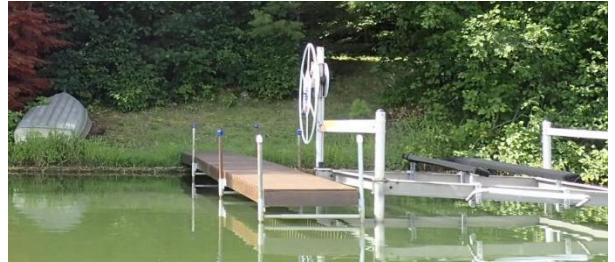
Figure 5. Pier density on Little John Lake was low at 2.42 docks/mile. Having a lake-wide dock density greater than 16 docks/mile has been shown to have negative effects on fish diversity (Jacobsen et.al).

Little John Lake is below this figure at 2.42 docks/mile. Additional littoral structures such as boat lifts, swim rafts, etc. would intuitively seem to add to this stress.

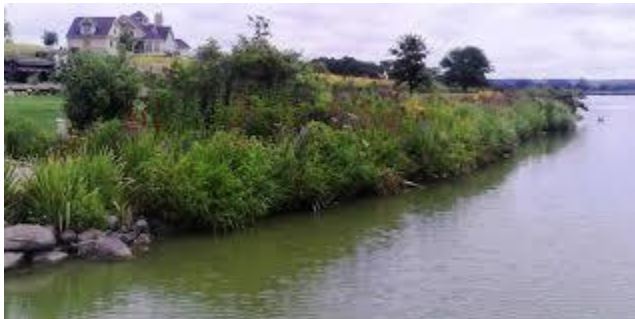
Figure 6. Landowners experiencing minor-moderate erosion issues may find that Healthy Lakes practices such as native plantings are enough to reduce runoff. Contact Land & Water Conservation for an assessment. Photo courtesy of Healthy Lakes WI.

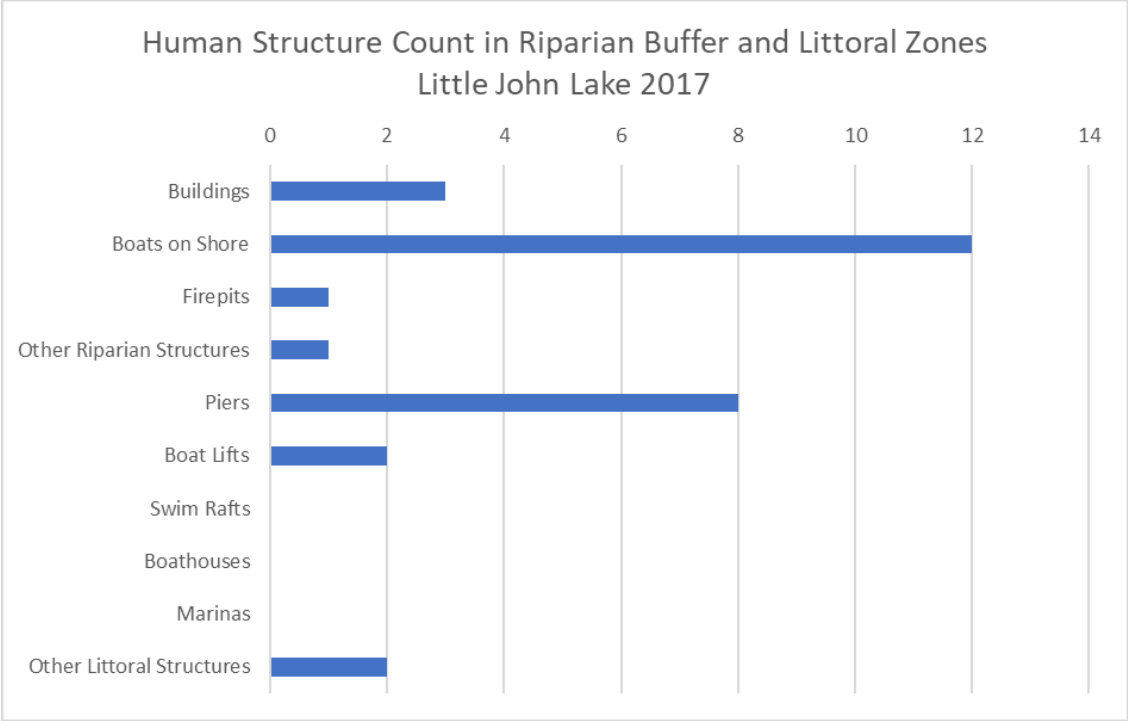
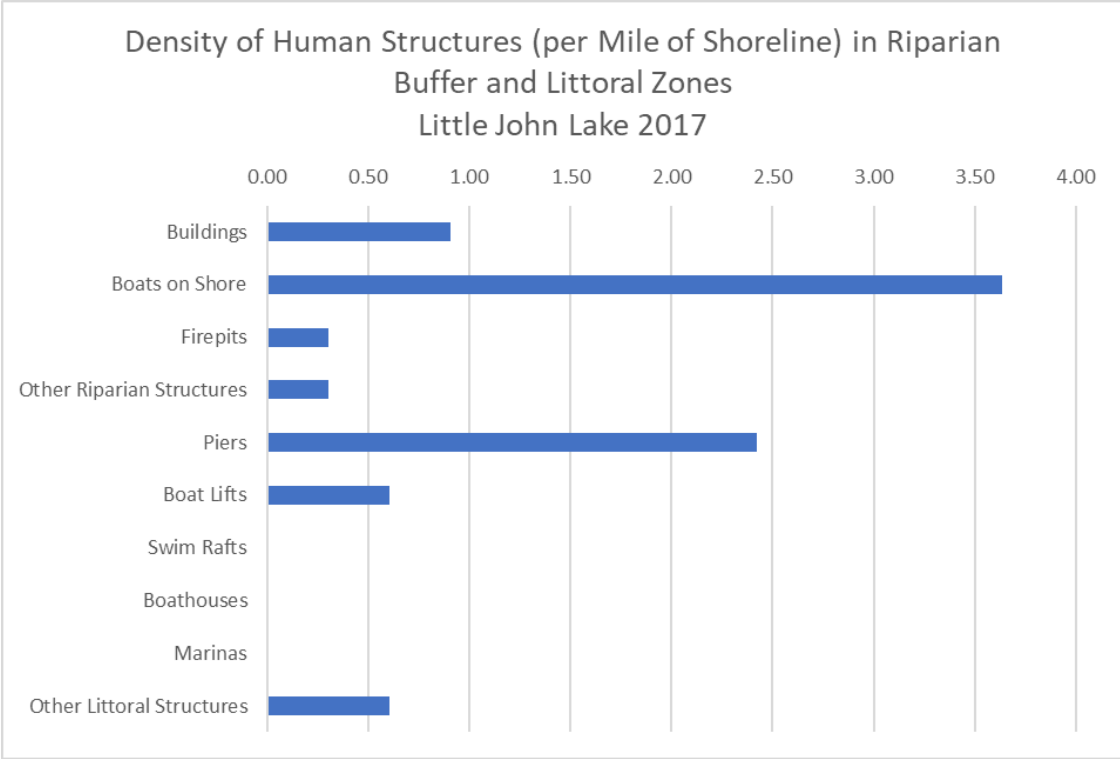
A few human structures or modifications were noted in the Riparian, Bank, and Littoral Zones. See Figure 8 for Human Structures in Riparian Buffer and Littoral Zones Charts. Because of their ecological importance, these areas are typically protected by County Zoning and DNR regulations and permits are often required to modify or place new structures in these areas. In Little John Lake, boats on shore were the most common human structure. Ten docks or less per kilometer (16 docks/mile) of shoreline has been shown to be a threshold of maintaining high quality fish diversity in Minnesota (Jacobsen et. al).

Within the Bank Zone, of erosion concerns, riprap, erosion control structures, artificial beaches, or seawalls, only 10 ft of riprap was observed.

Figure 8. Number and density per mile of shoreline of human structures documented in the Riparian Buffer and Littoral Zones on Little John Lake 2017.

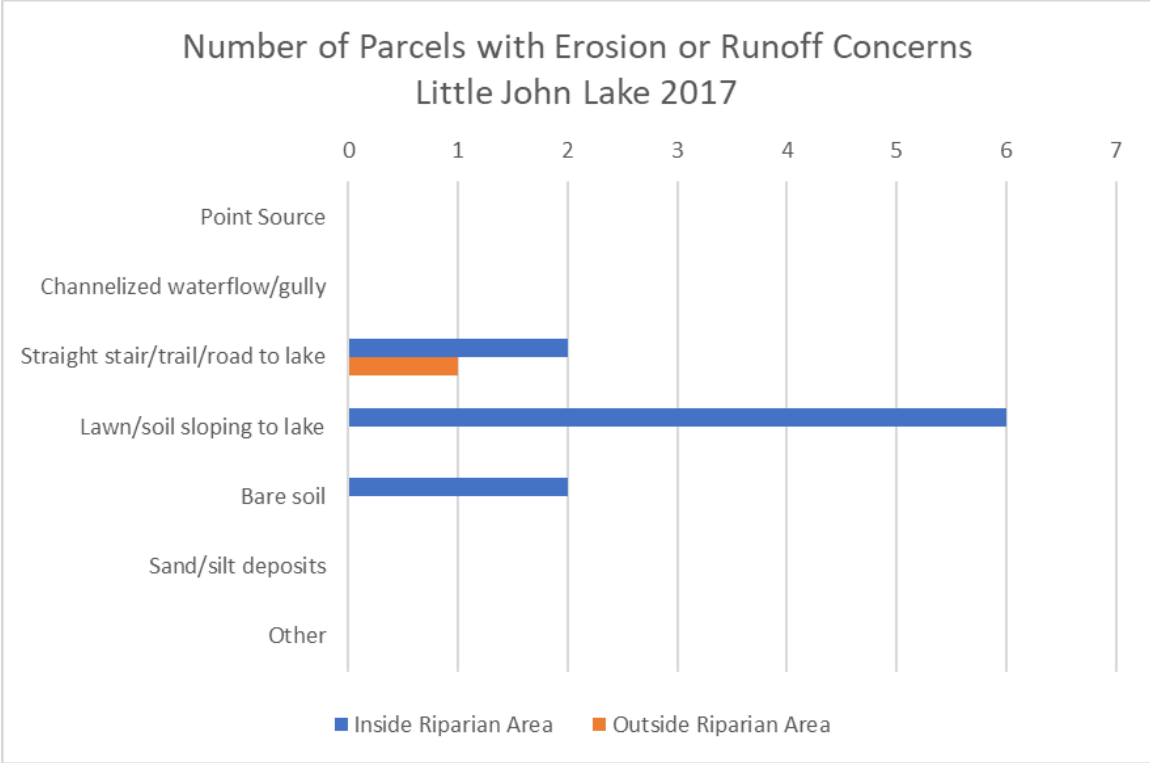
Runoff and erosion concerns were documented within the riparian area: 2 parcels had straight

stairs/trail/road to the lake; 6 had lawn/soil sloping to the lake (6 of the 6 private parcels); and 9 had bare soil areas. No active erosion (channelized flow/gully or sand/silt deposits) or point sources were observed. See Figure 9 for Number of Parcels with Erosion or Runoff Concerns.

Figure 9. Number of parcels with runoff and erosion concerns in Riparian Zone and Outside Riparian Zone on Little John Lake 2017. Of the 75 parcels, 67 had erosion or runoff concerns (89%).

- The number of private parcels with erosion concerns was 100%. Addressing these issues with willing private landowners will take a coordinated effort, ideally with a well versed riparian being locally available for those interested. Stormwater management (gutters, infiltrations, etc.) outside the 35 ft. buffer zone should also be addressed with willing landowners. Contact Cathy Higley from Vilas County Land & Water Conservation 715-479-3738 or [cahigl@vilascountywi.gov](mailto:cahigl@vilascountywi.gov) for assistance.

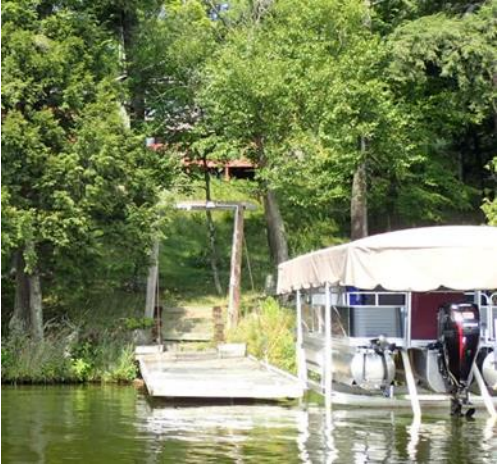
Figure 10. Minimizing impervious surfaces in and around lake access paths, maintaining vegetation, and curving the trail across the slope keeps shoreland erosion in check.

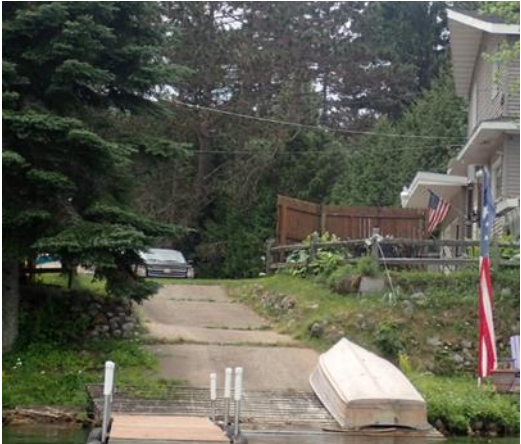
Figure 11. Impervious surfaces and straight trail access make a site even more prone to erosion. This site was augmented with a water infiltration pit to minimize runoff into the lake.

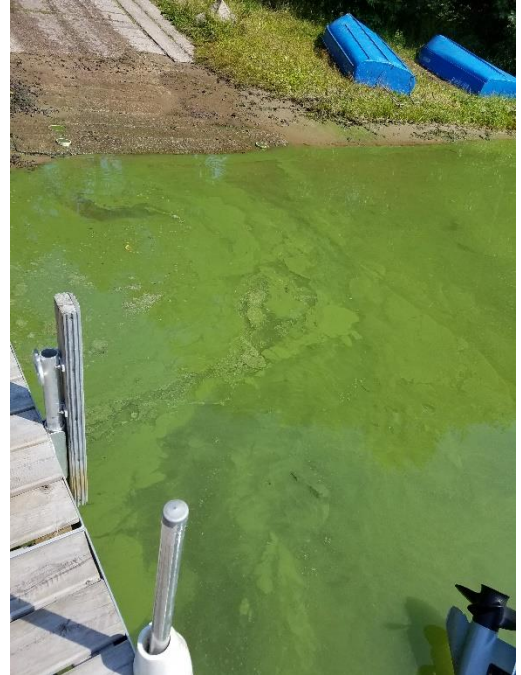
One dense blue-green algae bloom was observed and reported to the Vilas County Public Health Dept. on August 22, 2017. This bloom dissipated within 24 hours.

Figure 12. Blue-green algae bloom at the public landing on Little John Lake August 22, 2017.

- **Encourage awareness of blue-green algae bloom safety:**
  - Report blue-green algae blooms to Vilas County Public Health at 715-479-3656 for potential posting. Disperse information to riparian owners about safety during blue-green algae blooms. For questions contact Cathy Higley from Vilas County Land & Water Conservation 715-479-3738 or [cahigl@vilascountywi.gov](mailto:cahigl@vilascountywi.gov).

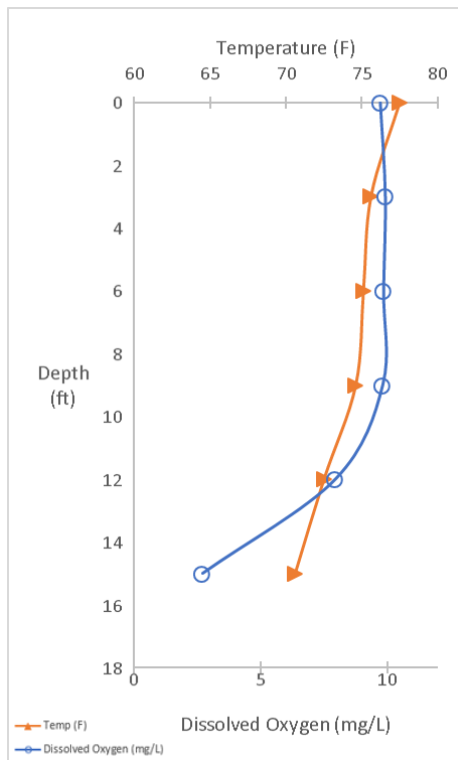
The temperature and dissolved oxygen profiles show the lake was mixed most of the time, but stratified in Aug 2018.

Figure 14. Temperature and dissolved oxygen profile for Little John Lake 7/19/17.

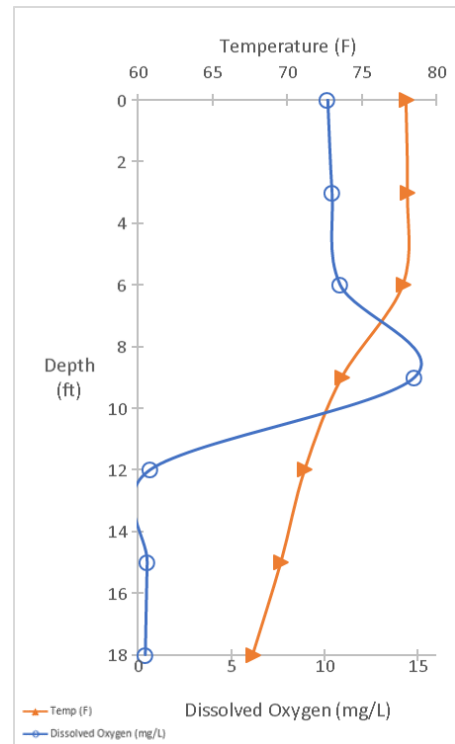
Temperature and dissolved oxygen monitoring showed that Little John Lake was mixed (not stratified) 5 out of 6 sampling events. The lake was documented to stratify once in Aug 2018. “Warm water” fish need dissolved oxygen levels of at least 5 mg/L (Shaw et.al.). More than 5 mg/L dissolved oxygen was found on Little John Lake down to 9-12 ft. deep, depending on the time of sampling. At 0 mg/L dissolved oxygen, chemical processes differ in this anoxic environment and certain nutrients like phosphorus can be converted to bio-available forms and released lake-wide during turnover events, fueling algae and plant growth. See Appendix 2 for water quality raw data and temperature and dissolved oxygen profiles.

Figure 18. Temperature and dissolved oxygen profiles for Little John Lake 8/15/2018.

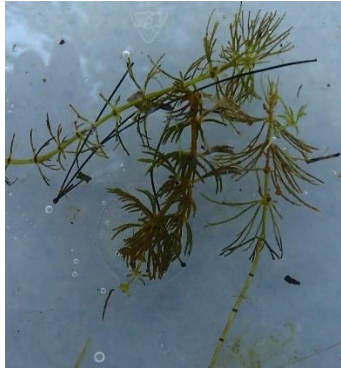
Figure 21. Coontail (*Ceratophyllum demersum*) found in Little John Lake 2017 point-intercept survey. This plant occurred in over 31% of littoral sites surveyed.

Of the plant species found, Common Waterweed (*Elodea canadensis*) Coontail (*Ceratophyllum demersum*), and Flatstem Pondweed (*Potamogeton zosteriformis*) were the most prevalent, with a littoral frequency of occurrence of 57%, 26%, and 23% respectively.

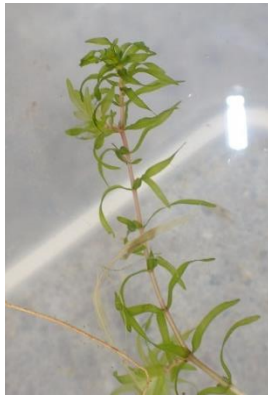
Figure 22. Common Waterweed (*Elodea canadensis*) was found in Little John Lake 2017 point-intercept survey. This plant occurred in over 35% of littoral sites surveyed.

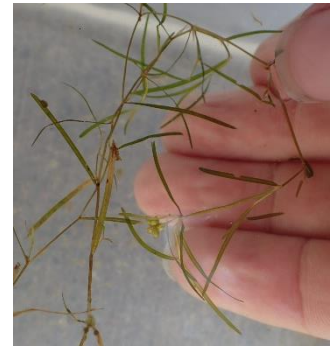
Figure 23. Leafy Pondweed (*Potamogeton foliosus*) was found in the Little John Lake 2017 point-intercept survey.

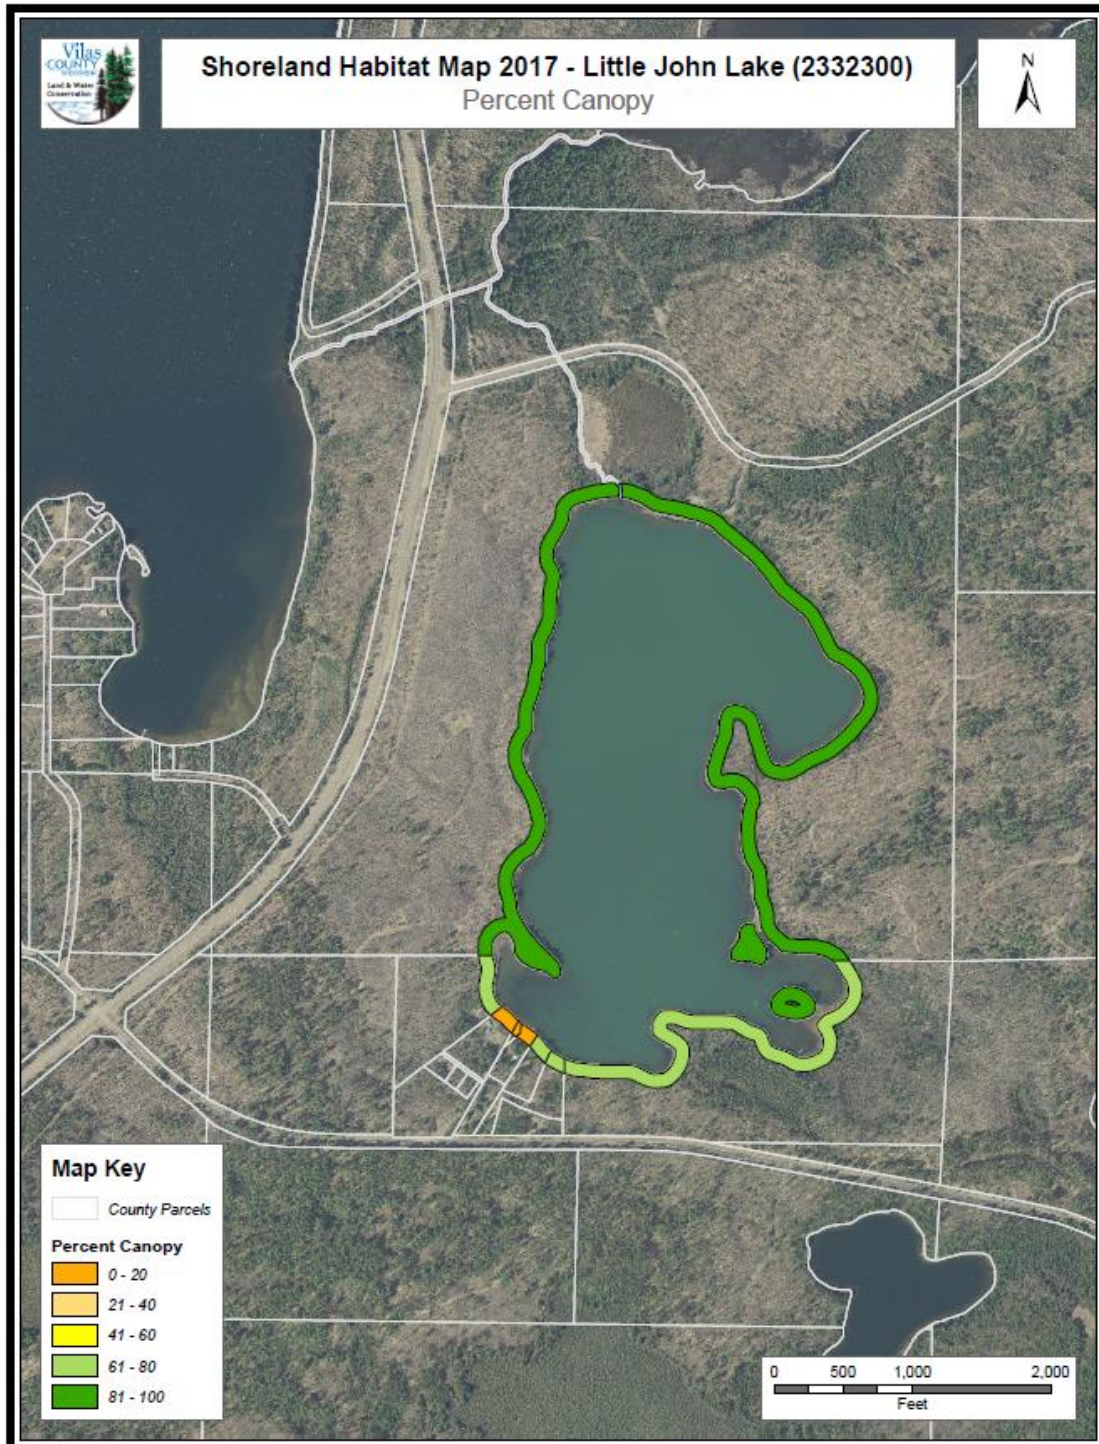
Figure 28. Canopy cover percent per parcel within 35 ft buffer area on Little John Lake 2017.

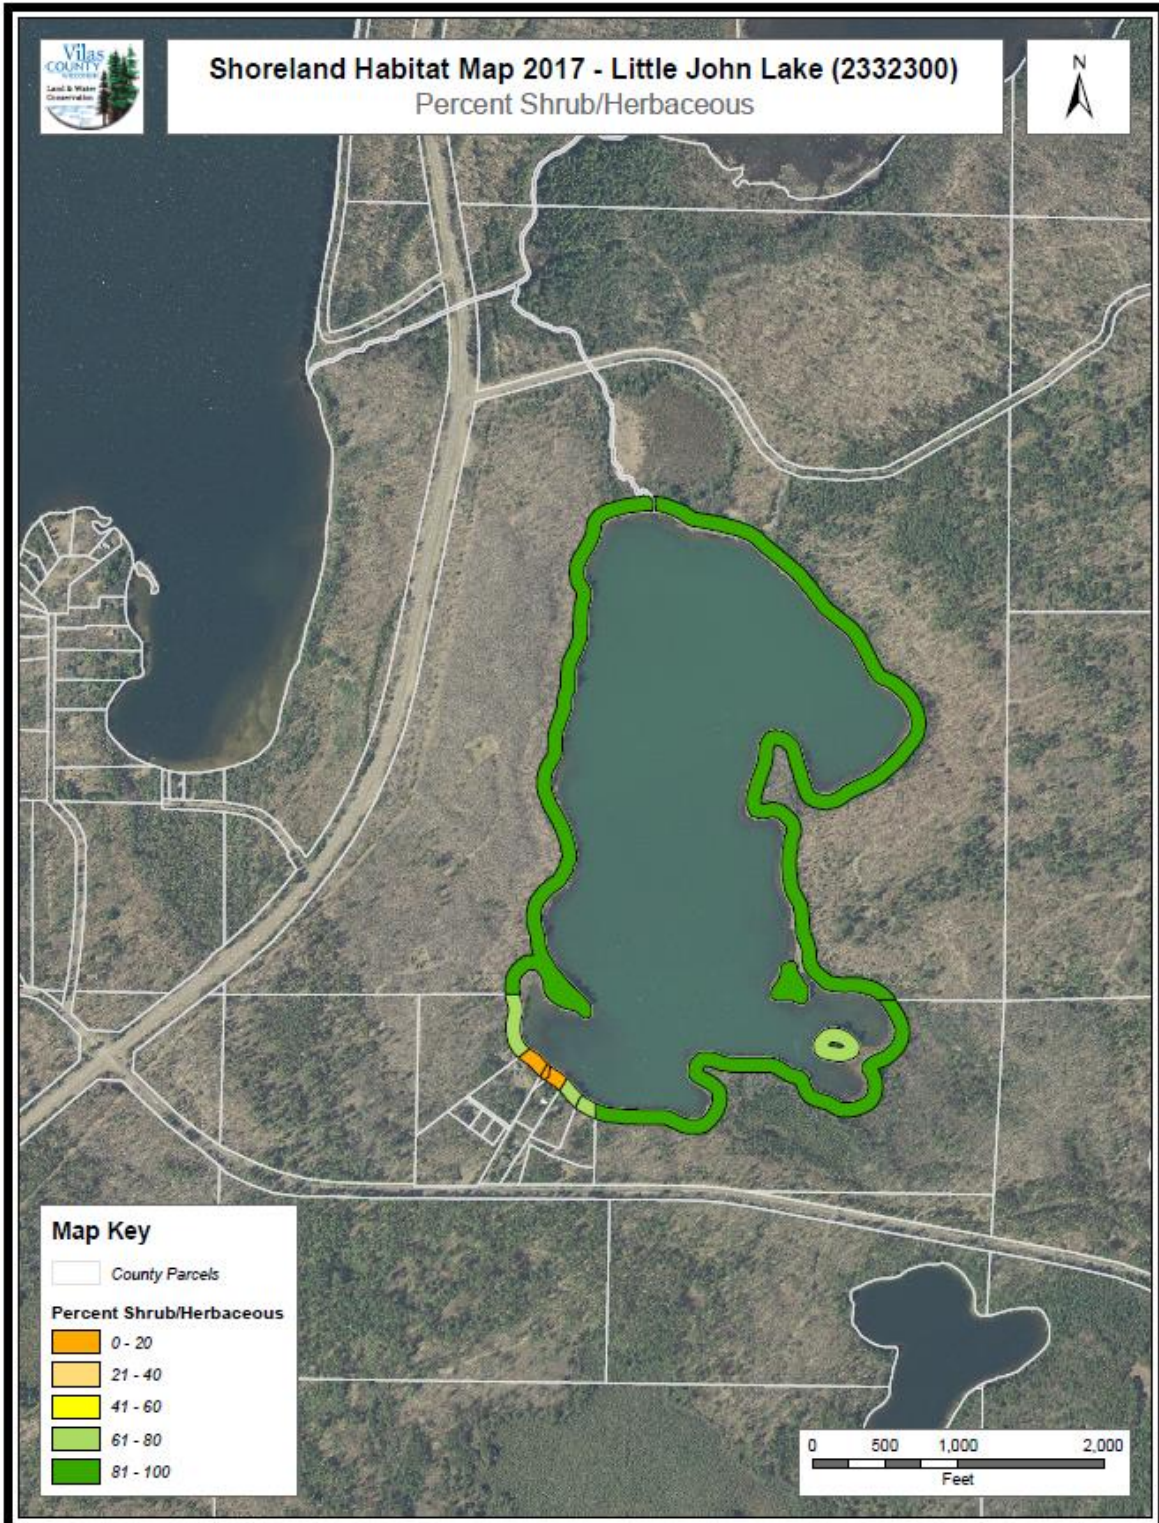
Figure 29. Percent shrub/herbaceous cover per parcel within 35 ft buffer area on Little John Lake 2017.

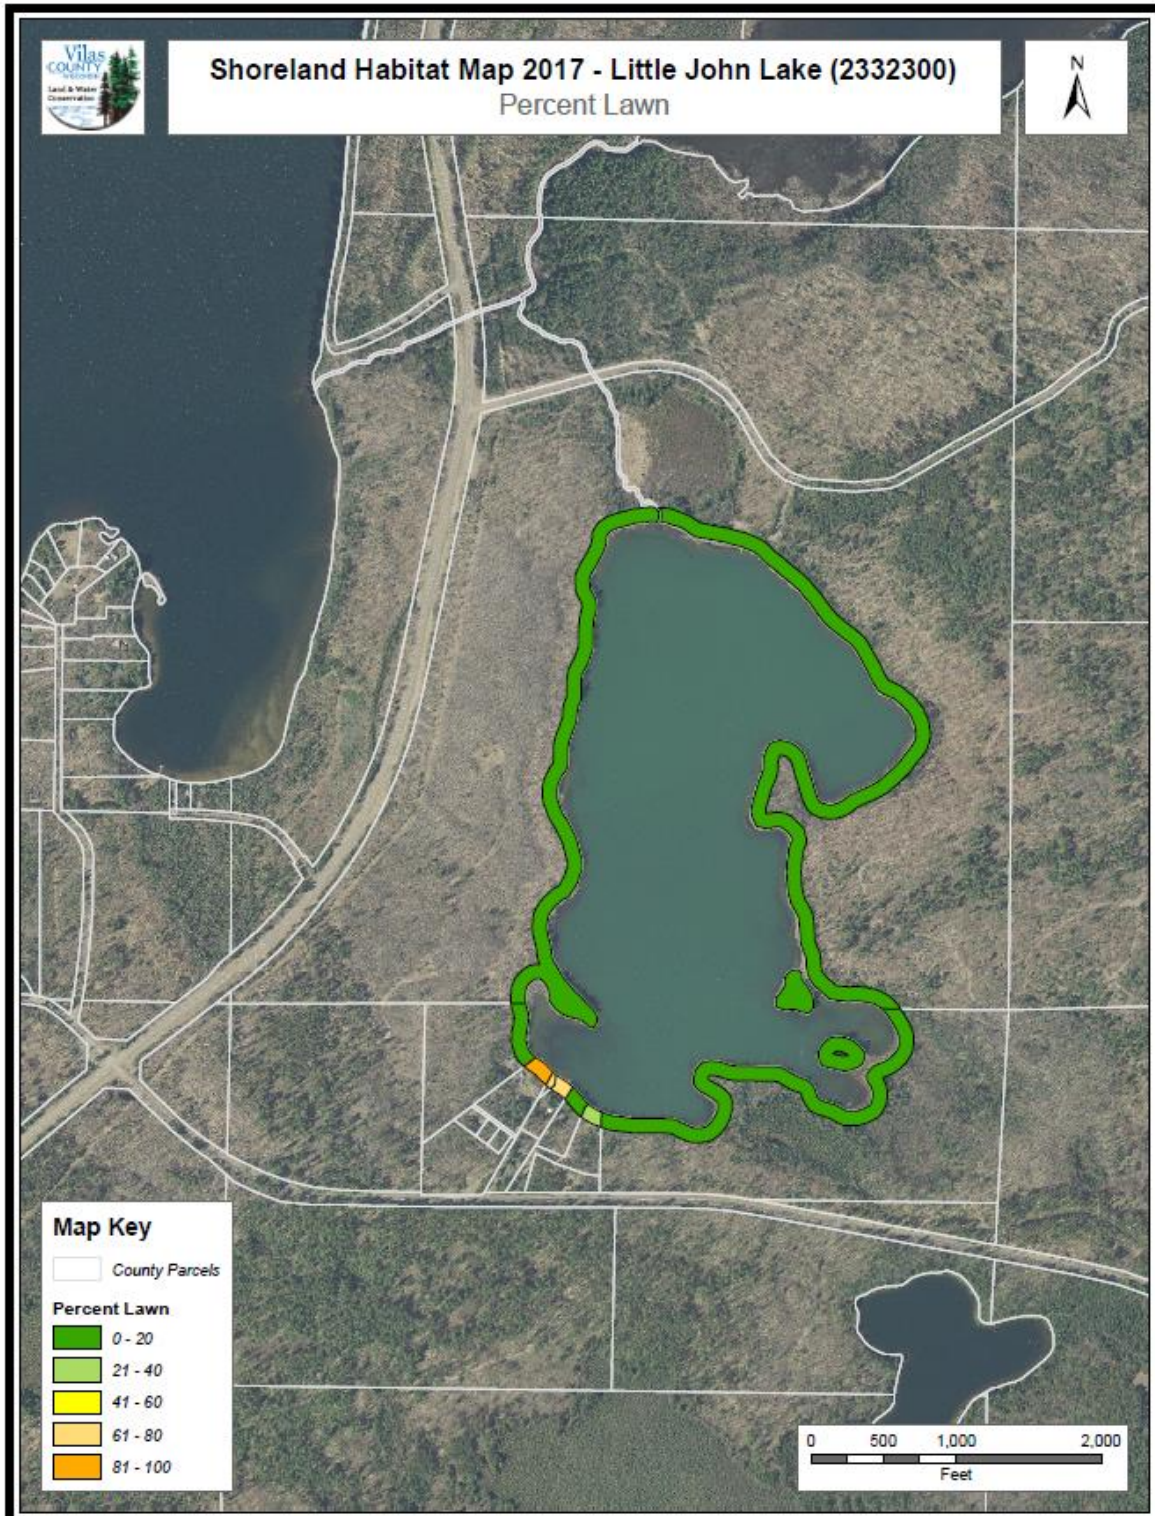
Figure 30. Percent lawn cover per parcel within 35 ft buffer area on Little John Lake 2017.

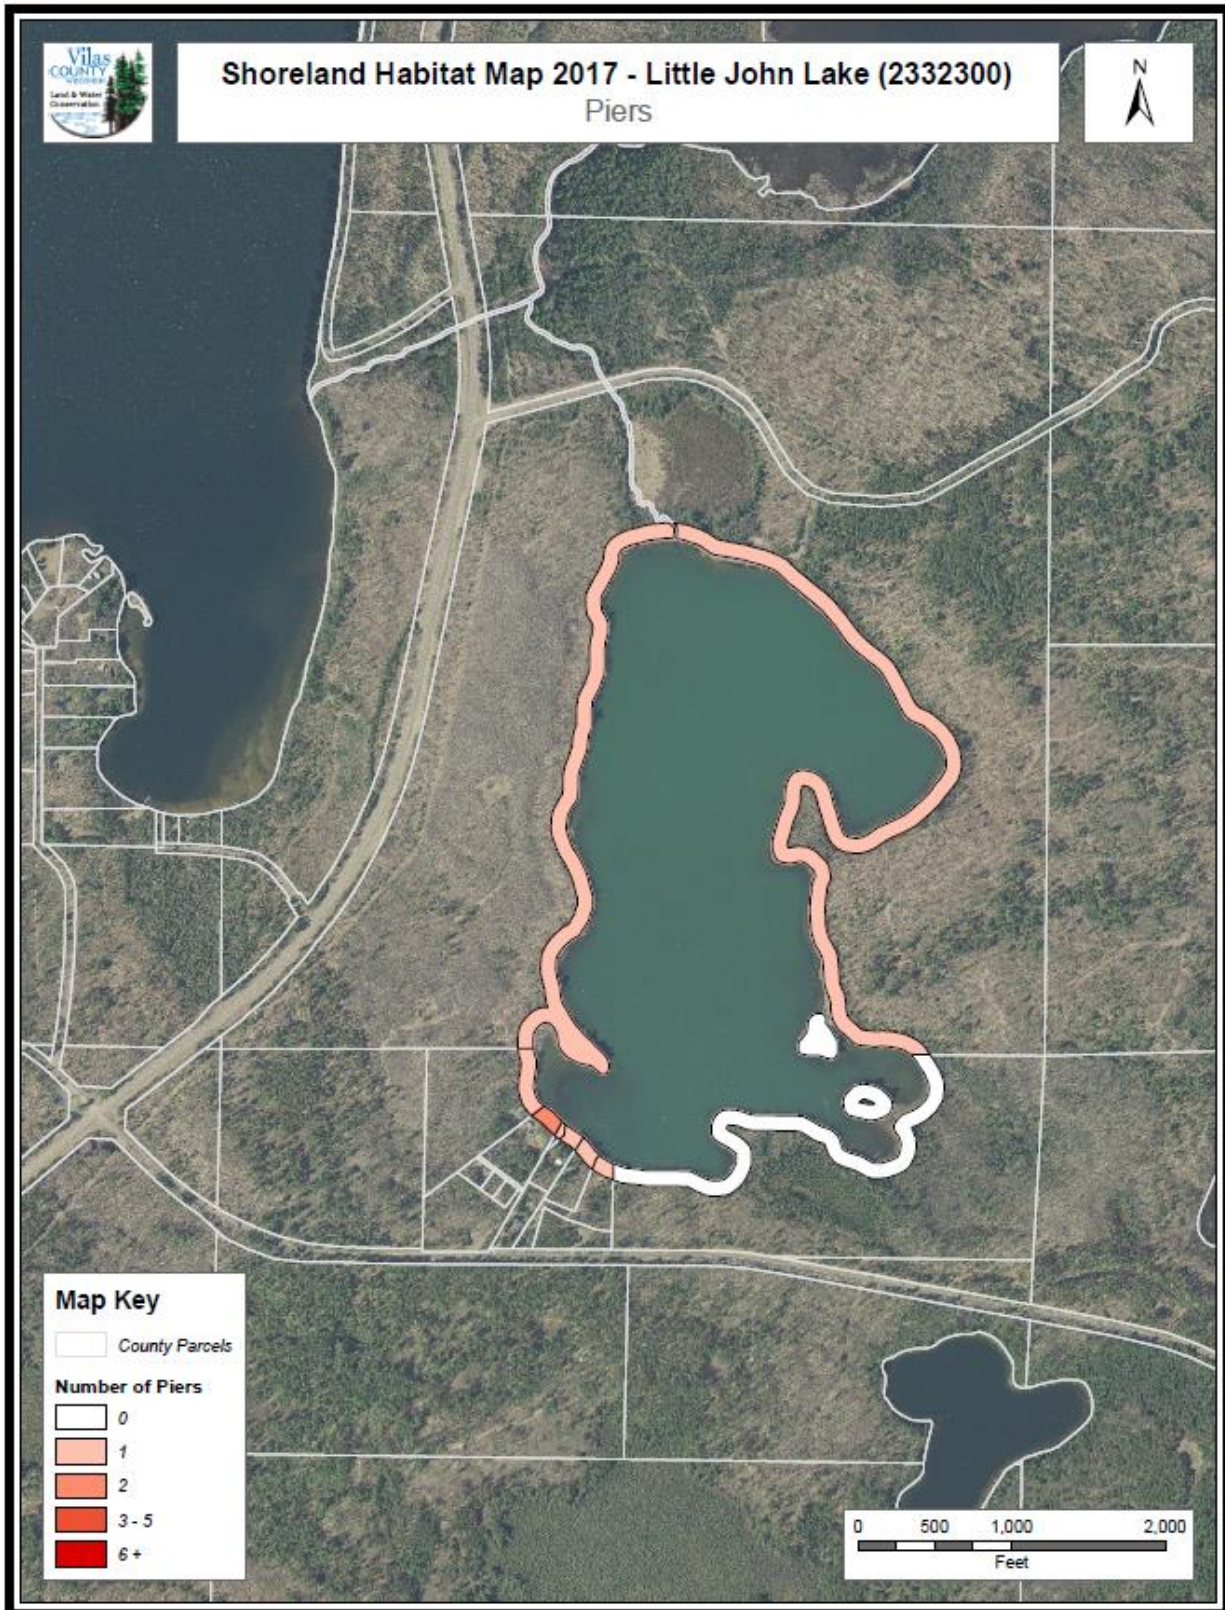
Figure 31. Piers per parcel on Little John Lake 2017.

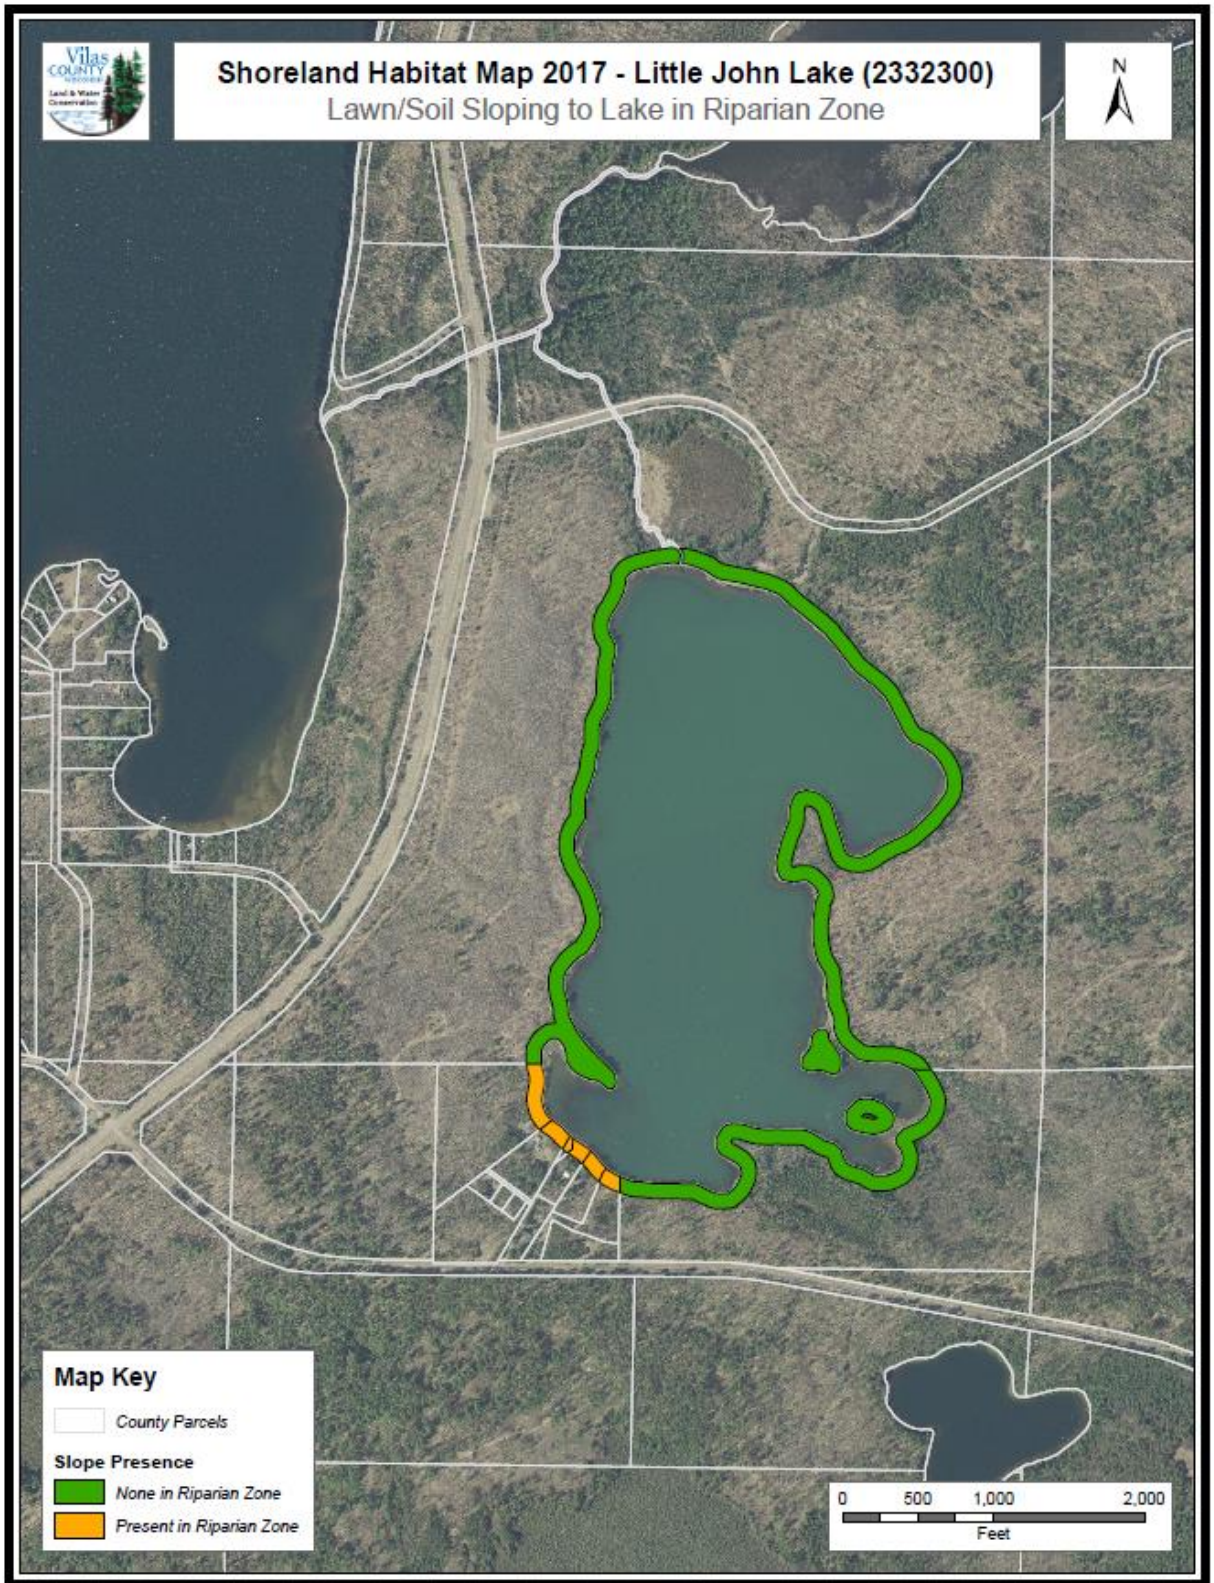
Figure 34. Parcels where lawn or soil slopes to lakes on Little John Lake 2017.
