## Wabasso Lake 2017 Lake Assessment Report

Prepared by  
Vilas County Land & Water Conservation

March 27, 2019

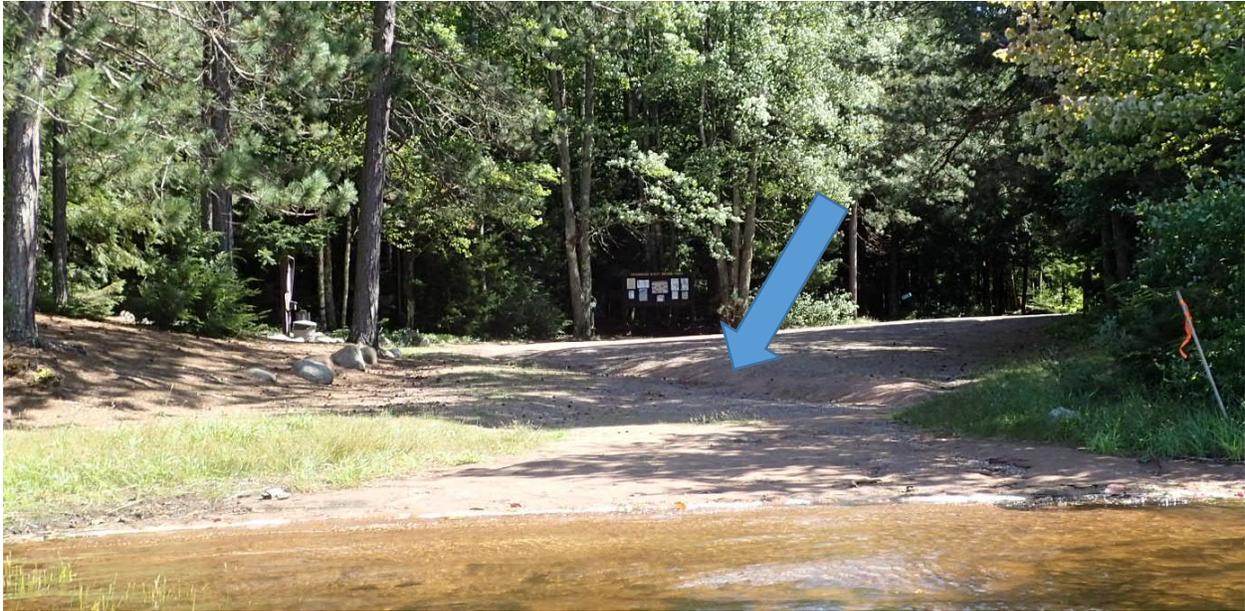
Few runoff and erosion concerns were documented. The shoreline had 1 site where erosion was significant – a gully was present in the boat launch driveway. Others were 2 trails from campsites to the lake including 1 set of stairs, however erosion appeared to be minimal from those sources. See Appendix 11 for Number of Parcels with Erosion or Runoff Concerns.

Figure 1. Gully in boat launch driveway.

- Address erosion in boat launch driveway
  - It appears that an erosion gully has formed in boat launch driveway and is directing stormwater to the lake. Phosphorus naturally occurring in the soil is contained within eroded material, and if entering the lake will likely add to the lake's plant productivity – eutrophication. Water diversions and/or infiltrations should be used to move stormwater to where it can infiltrate rather than run into the lake during storm events. Because this is a site managed by the US Forest Service, USFS agency staff would likely need to engineer and correct this issue.

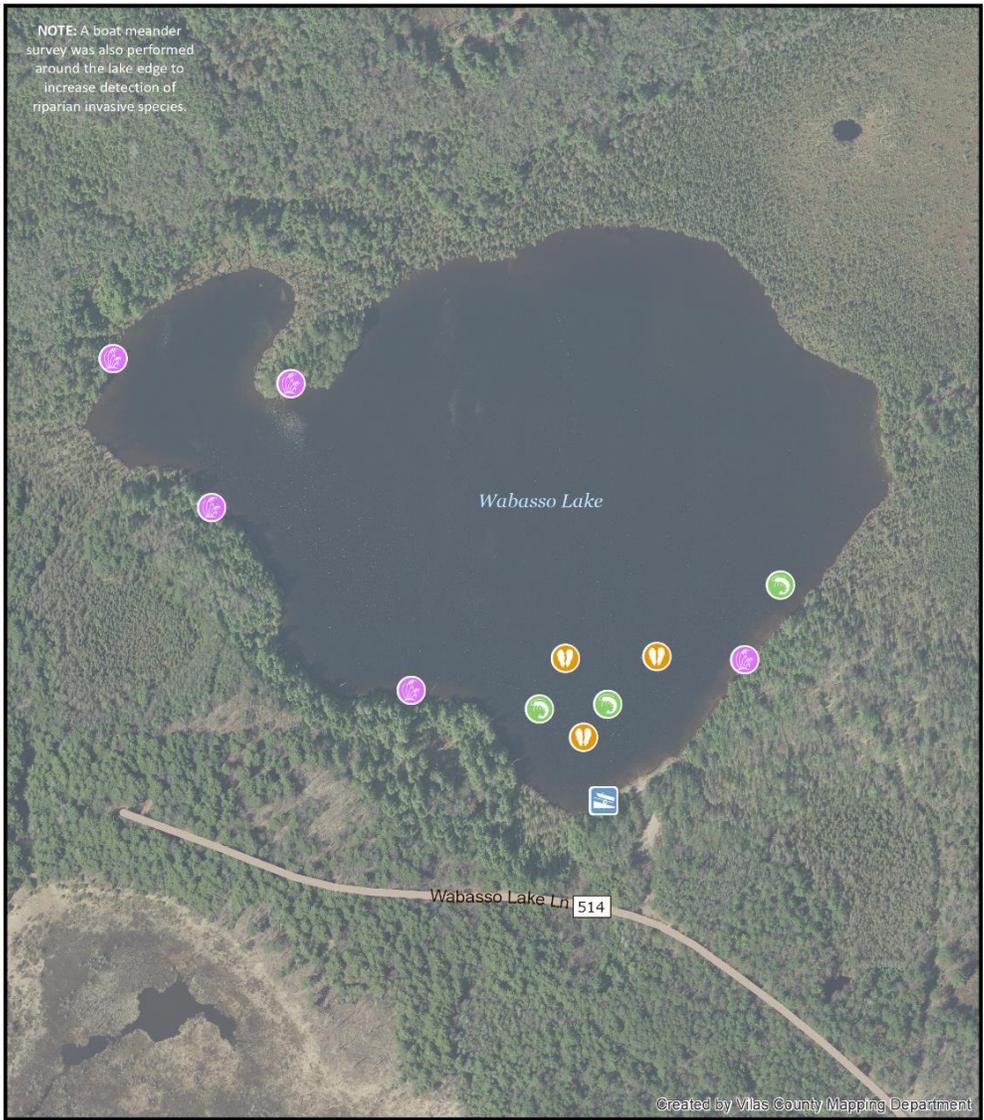
NOTE: A boat meander survey was also performed around the lake edge to increase detection of riparian invasive species.

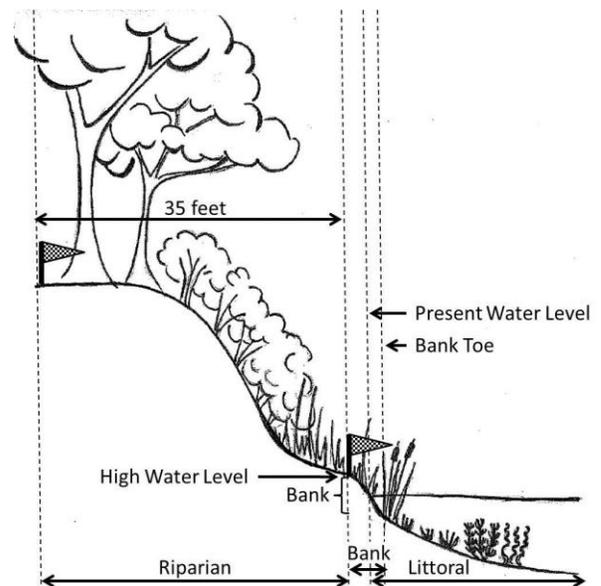
The Shoreland Assessment protocols call for documenting the condition of the Riparian Buffer Zone 35 ft. inland from shore, the bank zone, and the littoral zone – see Figure 4.

Figure 4. Shoreland areas assessed included the Riparian Buffer Zone, Bank Zone, and Littoral Zone. Graphic courtesy of WI DNR.

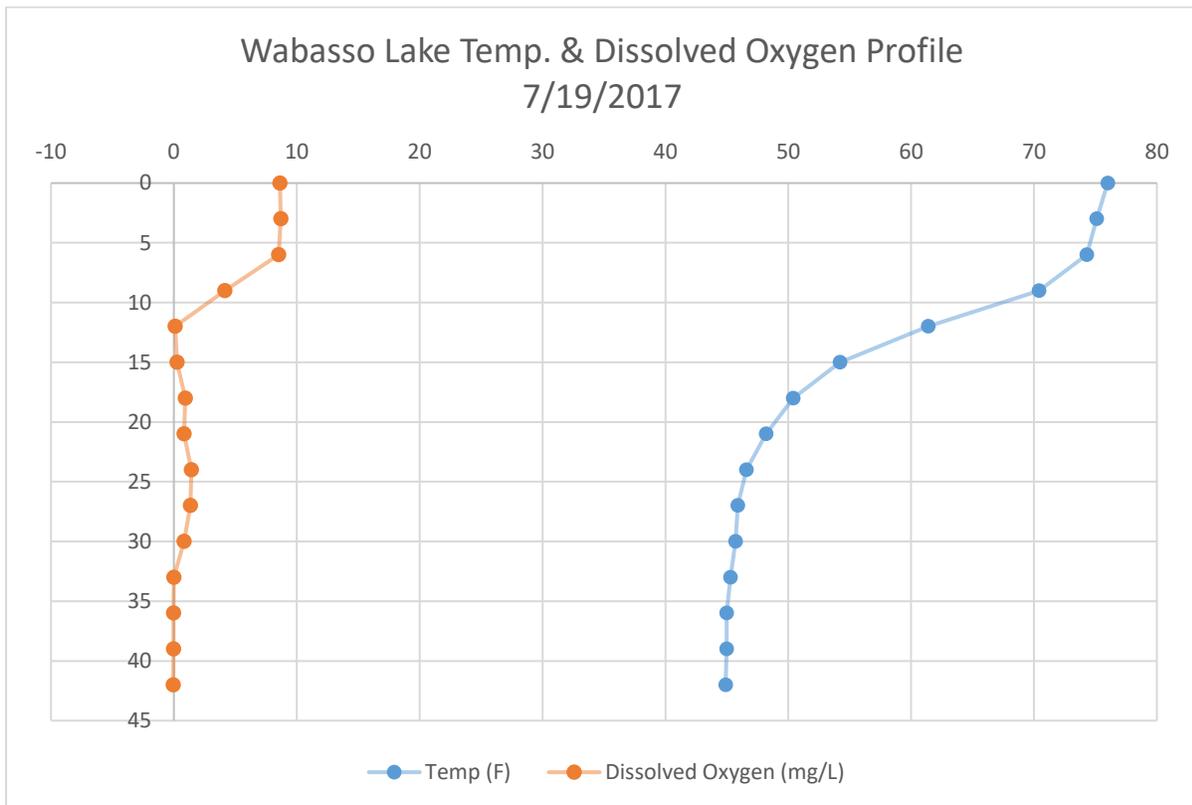
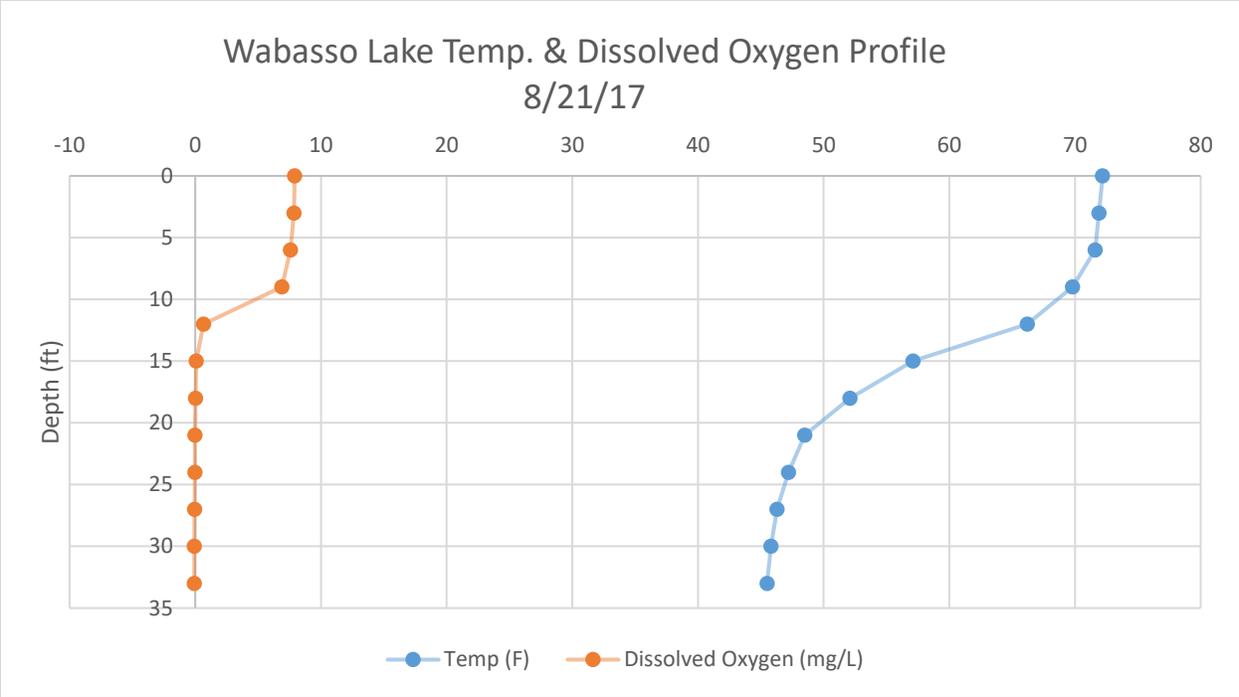
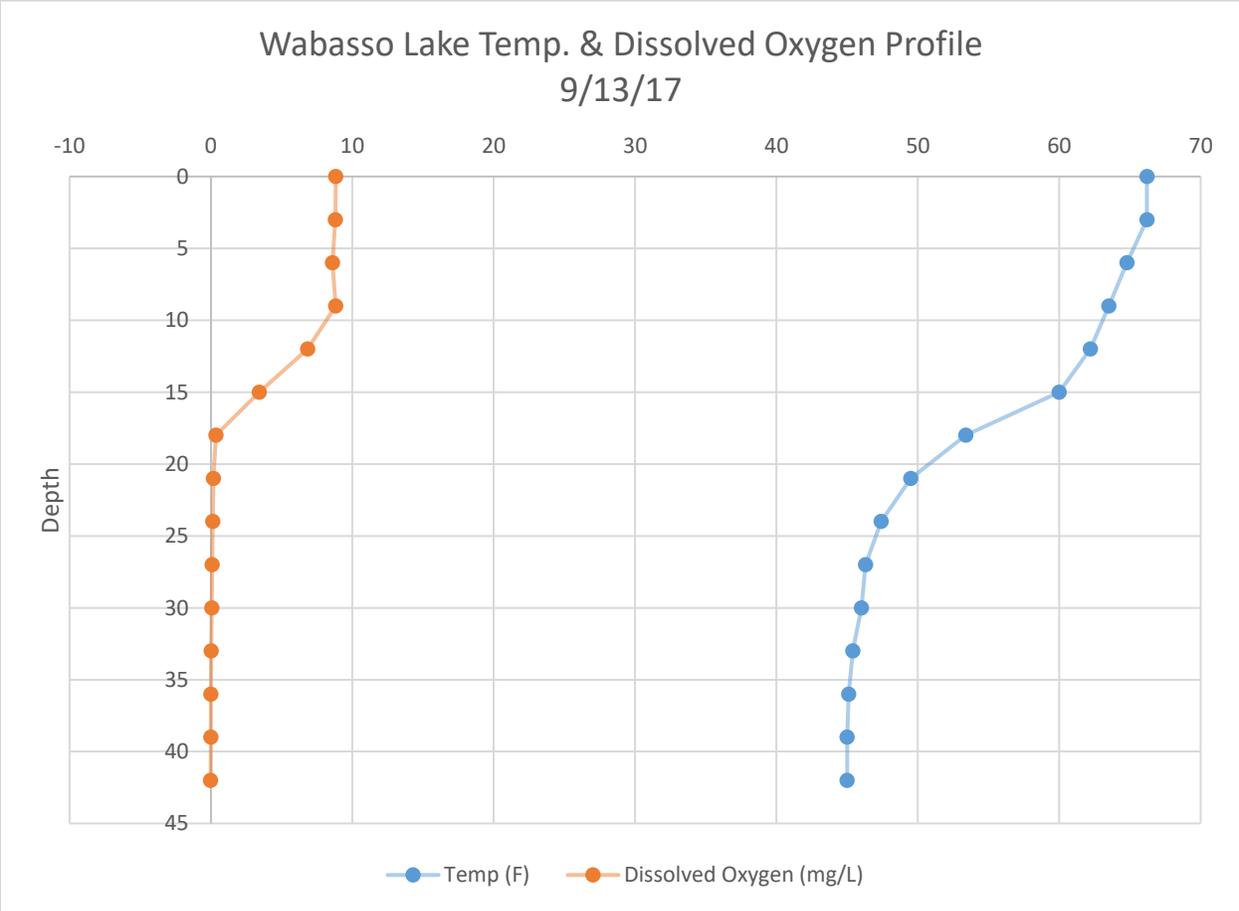
Temperature and dissolved oxygen monitoring showed the lake was stratified, with a thermocline existing at 9-18 ft., depending on the date sampled. “Warm water” fish need dissolved oxygen levels of at least 5 mg/L (Shaw et.al.). This threshold was reached in Wabasso Lake at 6–15 ft. depending on the date sampled, and dissolved oxygen levels of 0 mg/L were reached at 12-18 ft. At 0 mg/L dissolved oxygen, chemical processes differ in this anoxic environment and certain nutrients like phosphorus can be converted to bio-available forms and released lake-wide during turnover events, fueling algae and plant growth. See Appendix 2 for water quality raw data and temperature and dissolved oxygen profiles.

The July, August, and September temperature and dissolved oxygen profiles show the lake was stratified at 9-18 ft. depth, depending on date sampled – see Figure 2.

Figure 5. Temperature and dissolved oxygen profiles for Wabasso Lake in 2017.

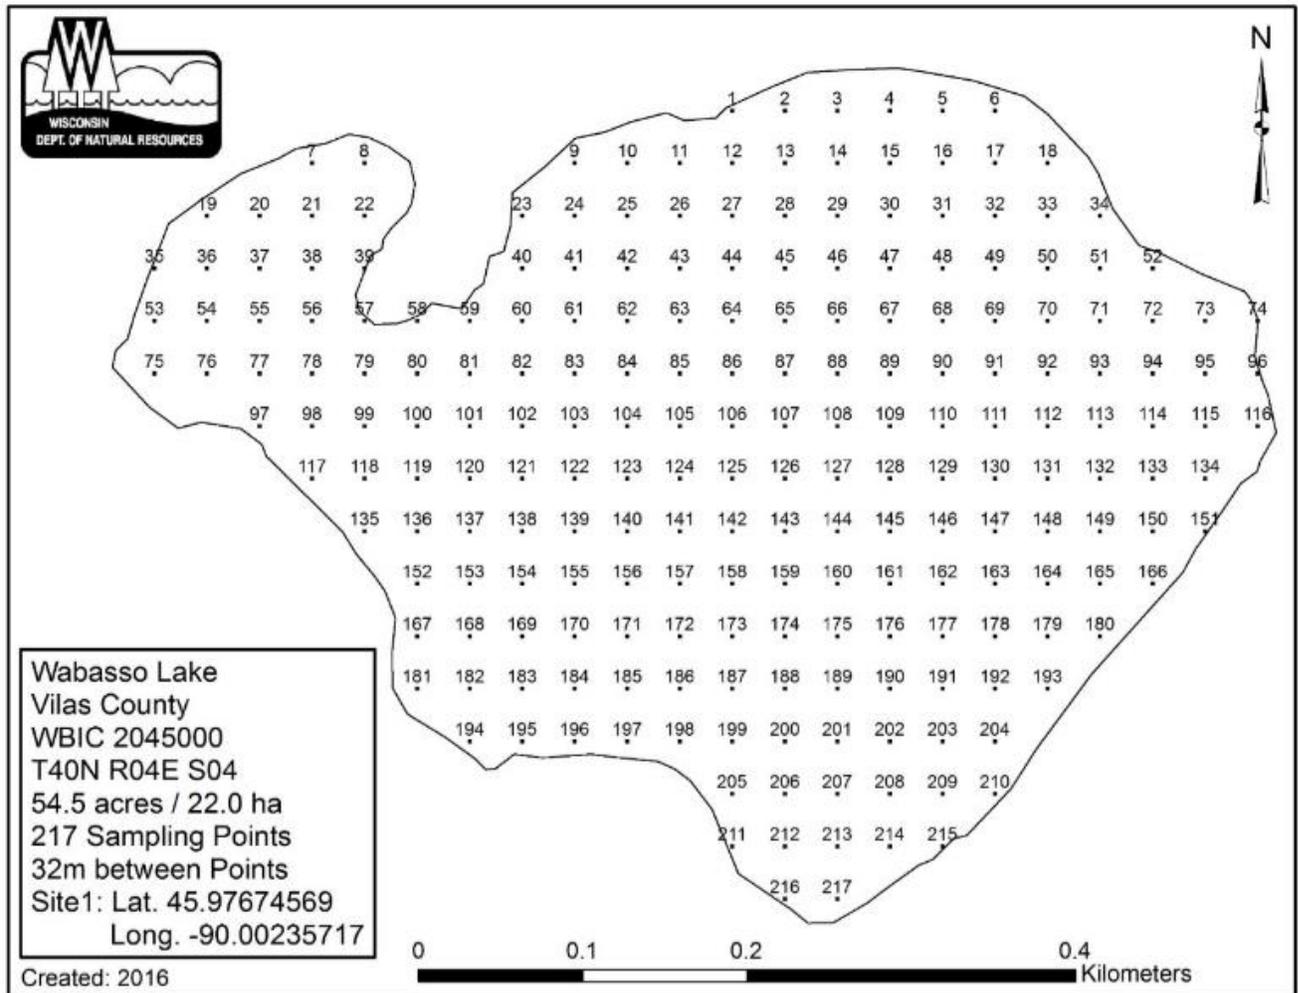
Figure 6. Wabasso Lake Point Intercept Map. Courtesy of WI DNR.

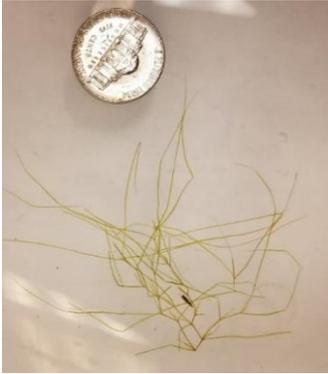
There were a few note-worthy plant findings on Wabasso Lake. Algal leaved pondweed (*Potamogeton confervoides*) is a Threatened species in WI. Vasey’s pondweed (*Potamogeton vaseyi*) is a species of Special Concern in WI. Oakes pondweed (*Potamogeton oakesianus*) was also verified on Wabasso Lake and is a species of Special concern (*Wisconsin’s Rare Plants*).

Figure 7. Algal leaved pondweed (*Potamogeton confervoides*) found in Wabasso Lake 2017 point-intercept survey.

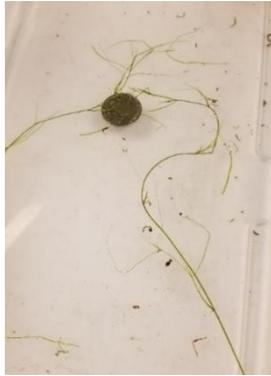
Figure 8. Vasey's Pondweed (*Potamogeton vaseyi*) found in Wabasso Lake 2017 point-intercept survey.

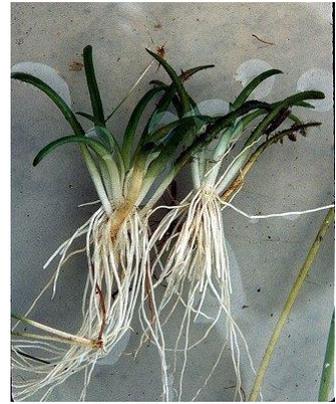
Water lobelia (*Lobelia dortmanna*) was seen at four sites, but its structure makes it difficult to catch on a rake. It is likely that water lobelia was under-surveyed for calculations affecting the average value of conservatism and floristic quality.

Figure 9. Water lobelia (*Lobelia dortmanna*). Photo courtesy of WI State Herbarium, Robert W. Freckmann.

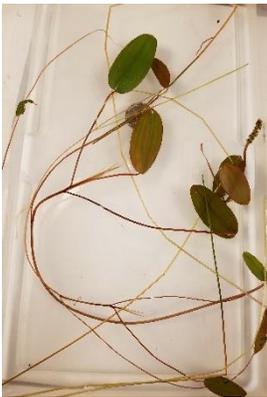
Figure 10. Oakes pondweed (*Potamogeton oakesianus*) found in Wabasso Lake 2017 point-intercept survey.

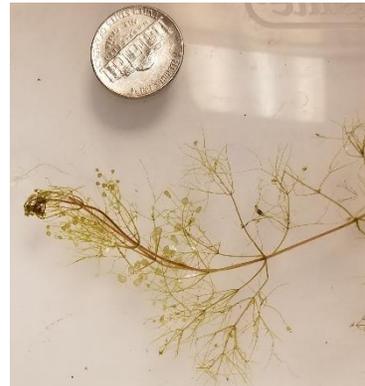
Of the plant species found, large purple bladderwort (*Utricularia purpurea*) was by far the most prevalent, with a littoral frequency of occurrence of 76%. It grew deeper than most other plants in the lake (with the exception of aquatic moss) being found from depths ranging from 1 ft. - 14 ft.

Figure 12. Large purple bladderwort (*Utricularia purpurea*) had a 76% frequency of occurrence in the 2017 point-intercept survey on Wabasso Lake.

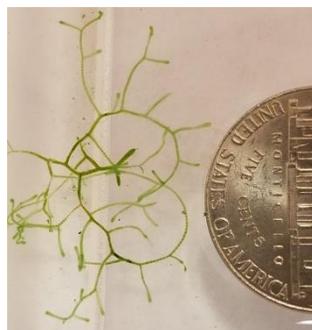
An odd-looking algae was collected on the rake at more than 2 PI points and was sent to the DNR in Madison for identification. From there, DNR staff Gina LaLiberte worked with experts in California to identify the specimen to the genus *Sirodotia*, and suspecting *Sirodotia suecica*, although species is not officially verified due to the lack of fruiting bodies. *Sirodotia* is a red algae that has been largely undocumented in WI.

Figure 13. Red algae (*Sirodotia* sp.) found during Wabasso Lake 2017 point-intercept survey.

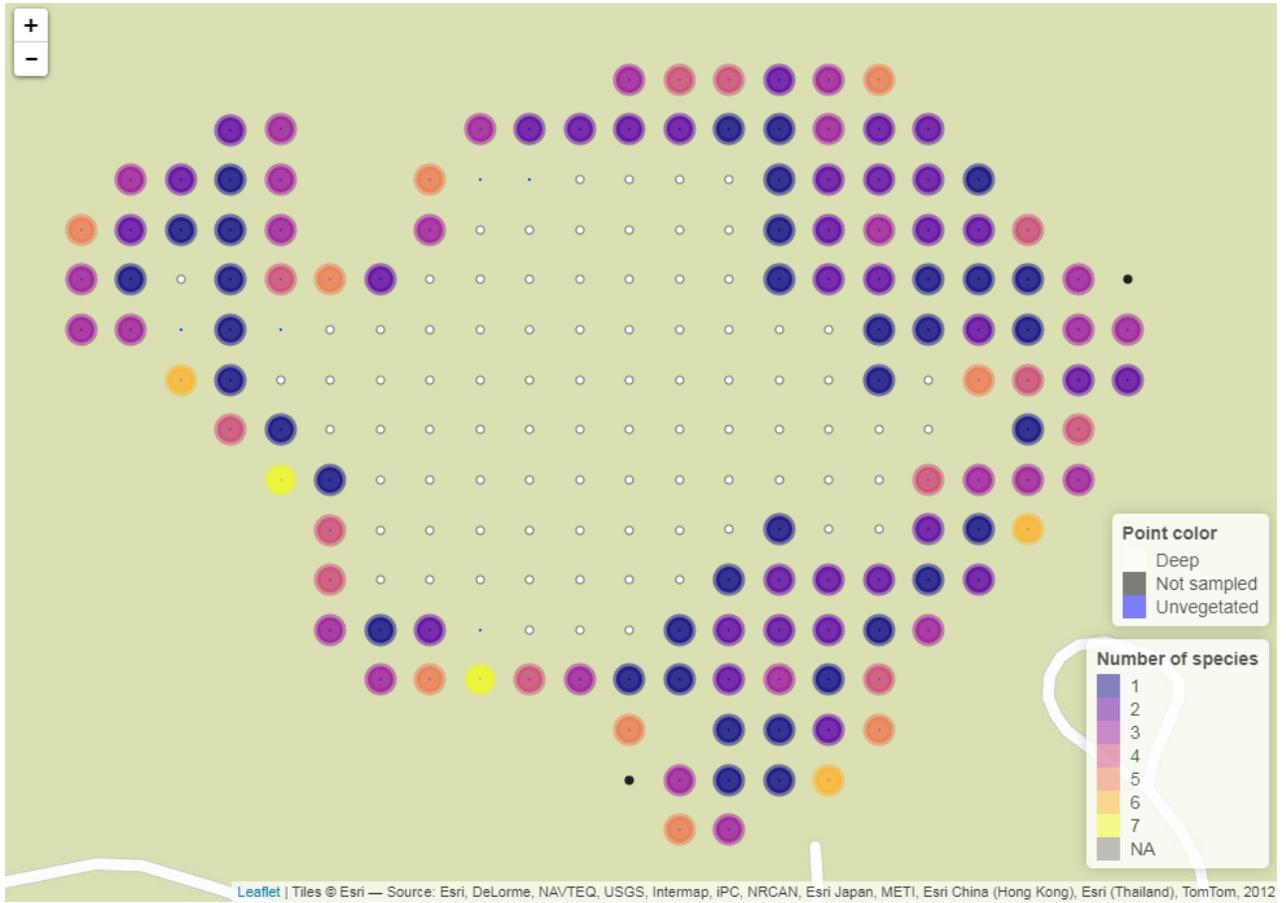
The Species Richness for Wabasso Lake is 12. This figure includes only those species collected with the rake, and does not include visual sightings. Wabasso Lake has slightly less species on average than other lakes: average Species Richness for the Northern Lakes and Forests Ecoregion is 13 and the state of Wisconsin average is 13 (Nichols). See Appendix 5 for Species Richness Map.

Figure 14. Wabasso Lake species richness by sampling point. Map courtesy of WI DNR.

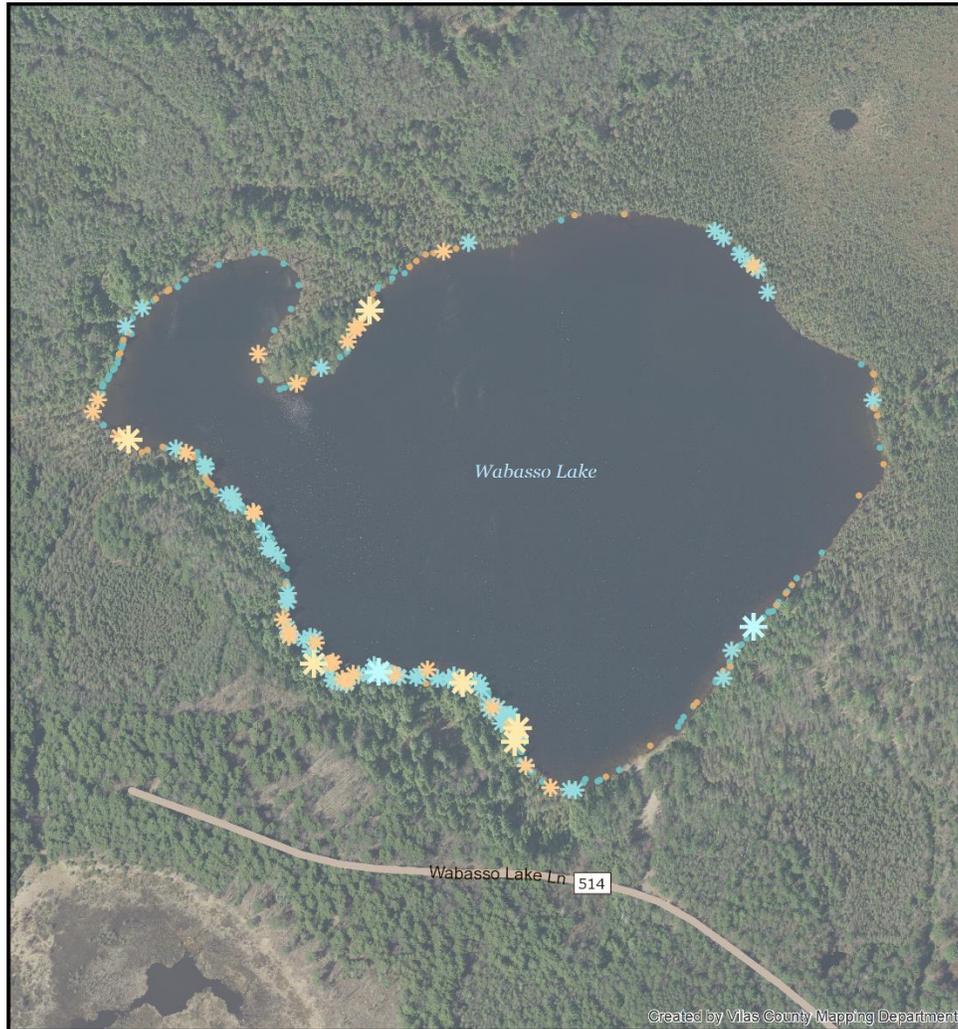
Coarse woody habitat was mapped on May 9, 2017 when the water was clear and easy to detect submerged logs. 450 logs were counted between the ordinary high water mark and the 2 ft depth contour along the 1.32 miles of shoreline, giving the density of 341 logs/mile of shoreline – see Appendix 6.

Figure 15. Coarse Woody Habitat Characterization for Wabasso Lake, 2017. 341 logs/mile were documented.

- Maintain Coarse Woody Habitat
  - Wabasso Lake appears to be rich with bass and panfish. Encourage leaving down wood where it falls to maintain fish habitat. Again, keeping the motorless designation is important here – at low speeds (canoeing or trolling) these branches are not considered hazardous and boaters are less likely to want to remove them. From the scope of these assessments, adding Coarse Woody Habitat (i.e. tree drops) is not necessary.

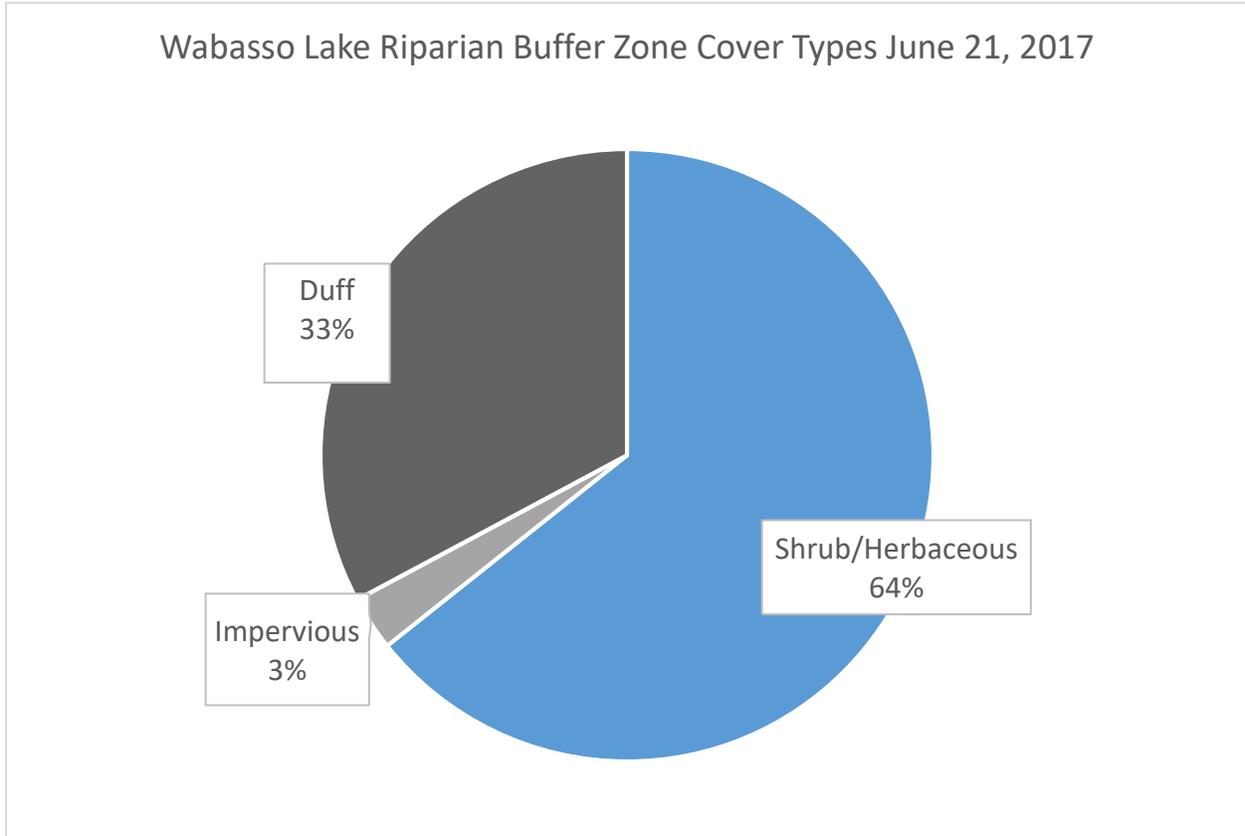
Lake-wide, 64% of the riparian area (35 ft. inland from shore) is covered by a shrub/herbaceous layer. However, 33% of the riparian area is covered by duff – this is naturally occurring and does not present runoff or erosion concerns. Together, this makes 97% of the lakeshore riparian area as undisturbed. Only 3% of the riparian area was categorized as Impervious due to the boat launch and campground areas. See Appendices 7-9 for Riparian Buffer Zone Cover Types.

Figure 16. Ground cover type in Riparian Buffer Area (35 ft. inland from shore) on Wabasso Lake, 2017.

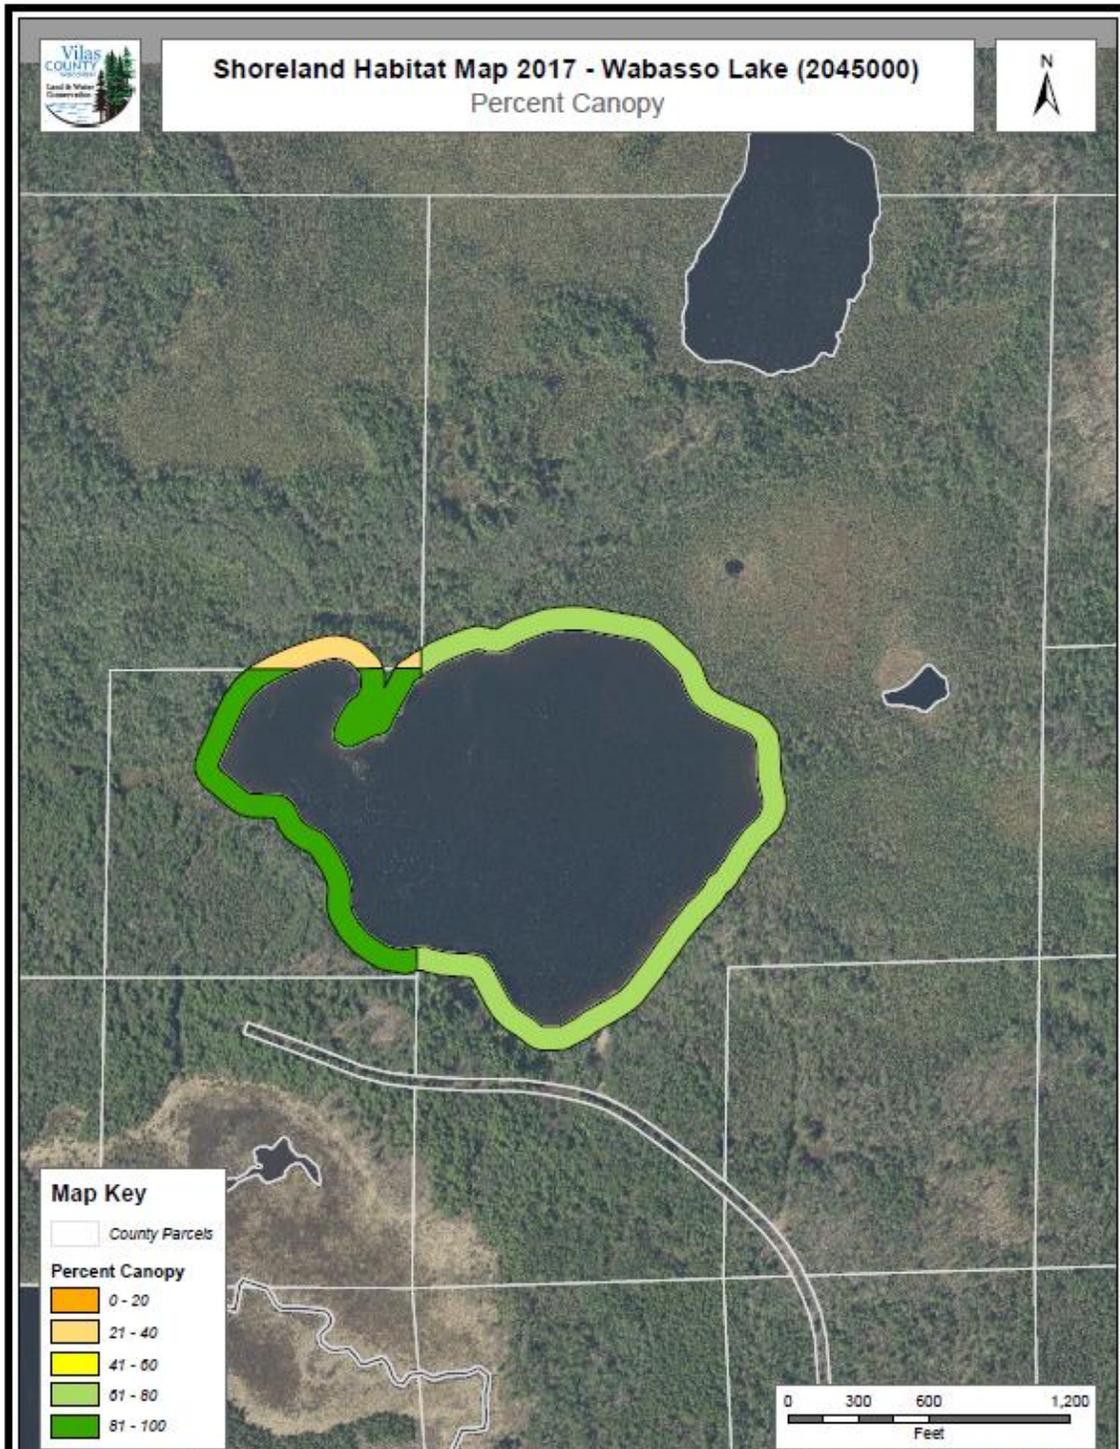
Figure 17. Canopy cover percent per parcel within 35 ft buffer area on Wabasso Lake 2017. Lower coverage amounts due to wetland habitats.

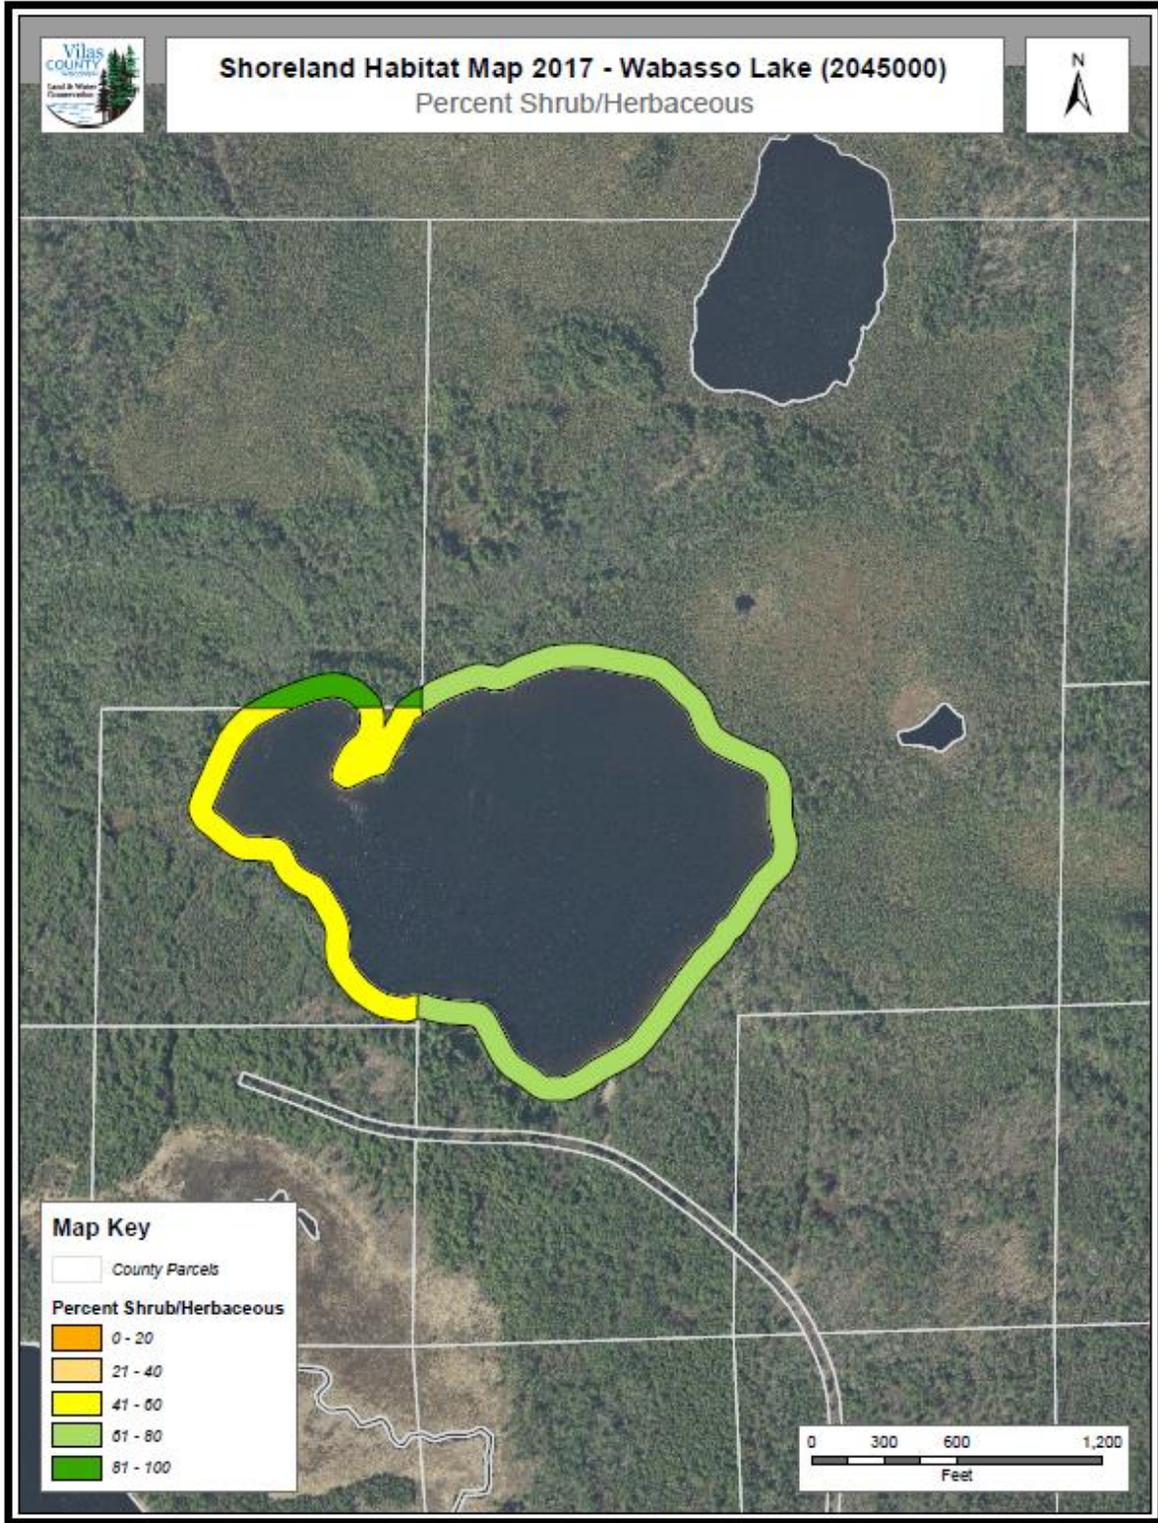
Figure 18. Percent shrub/herbaceous cover per parcel within 35 ft buffer area on Wabasso Lake 2017. Lower coverage amounts due to pine duff cover.

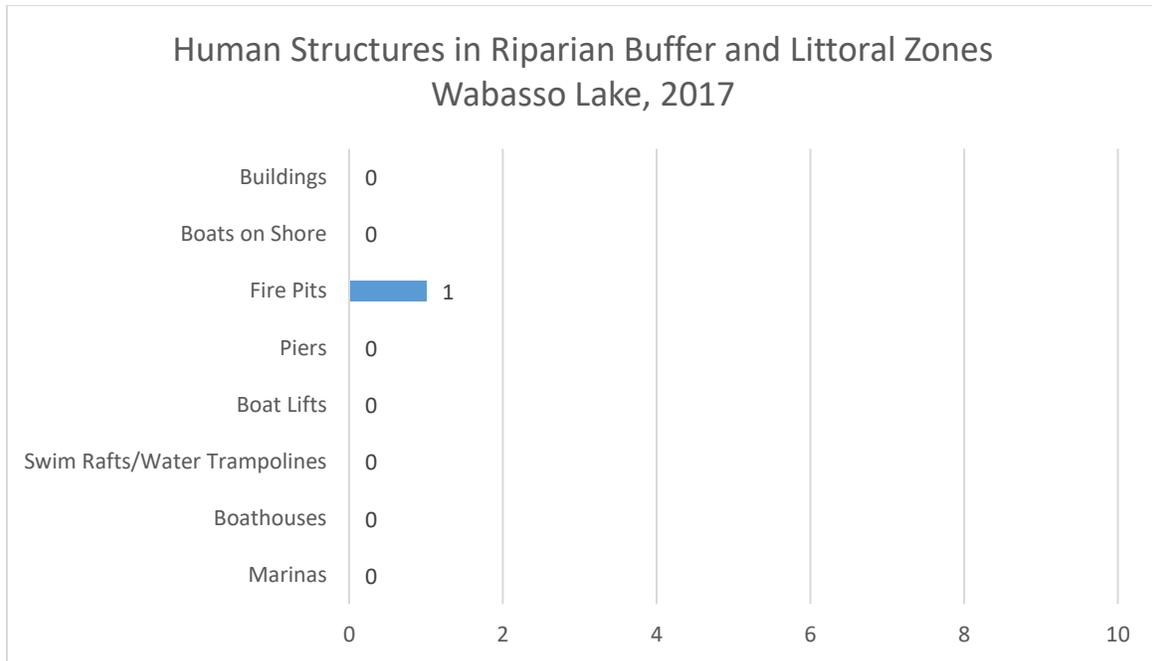
The only human structure noted in the Riparian and Littoral Zones was 1 fire pit. No docks were observed. Ten docks or less per kilometer (16 docks/mile) of shoreline has been shown to be a threshold of maintaining high quality fish diversity in Minnesota (Jacobsen et. al). See Appendix 10 for Human Structures in Riparian Buffer and Littoral Zones Chart.

Figure 19. Human structures documented in the Riparian Buffer and Littoral Zones on Wabasso Lake 2017.

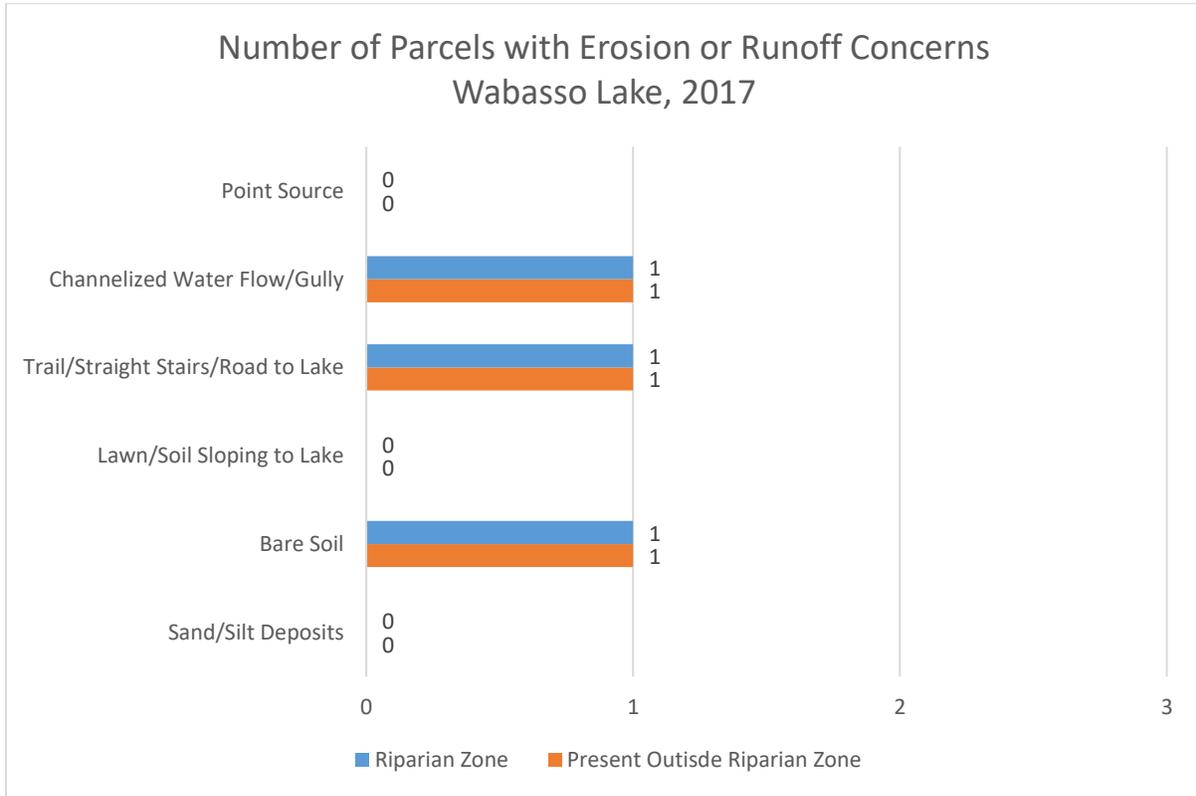
Figure 20. Number of parcels with runoff and erosion concerns in Riparian Zone and Outside Riparian Zone. Wabasso Lake 2017.

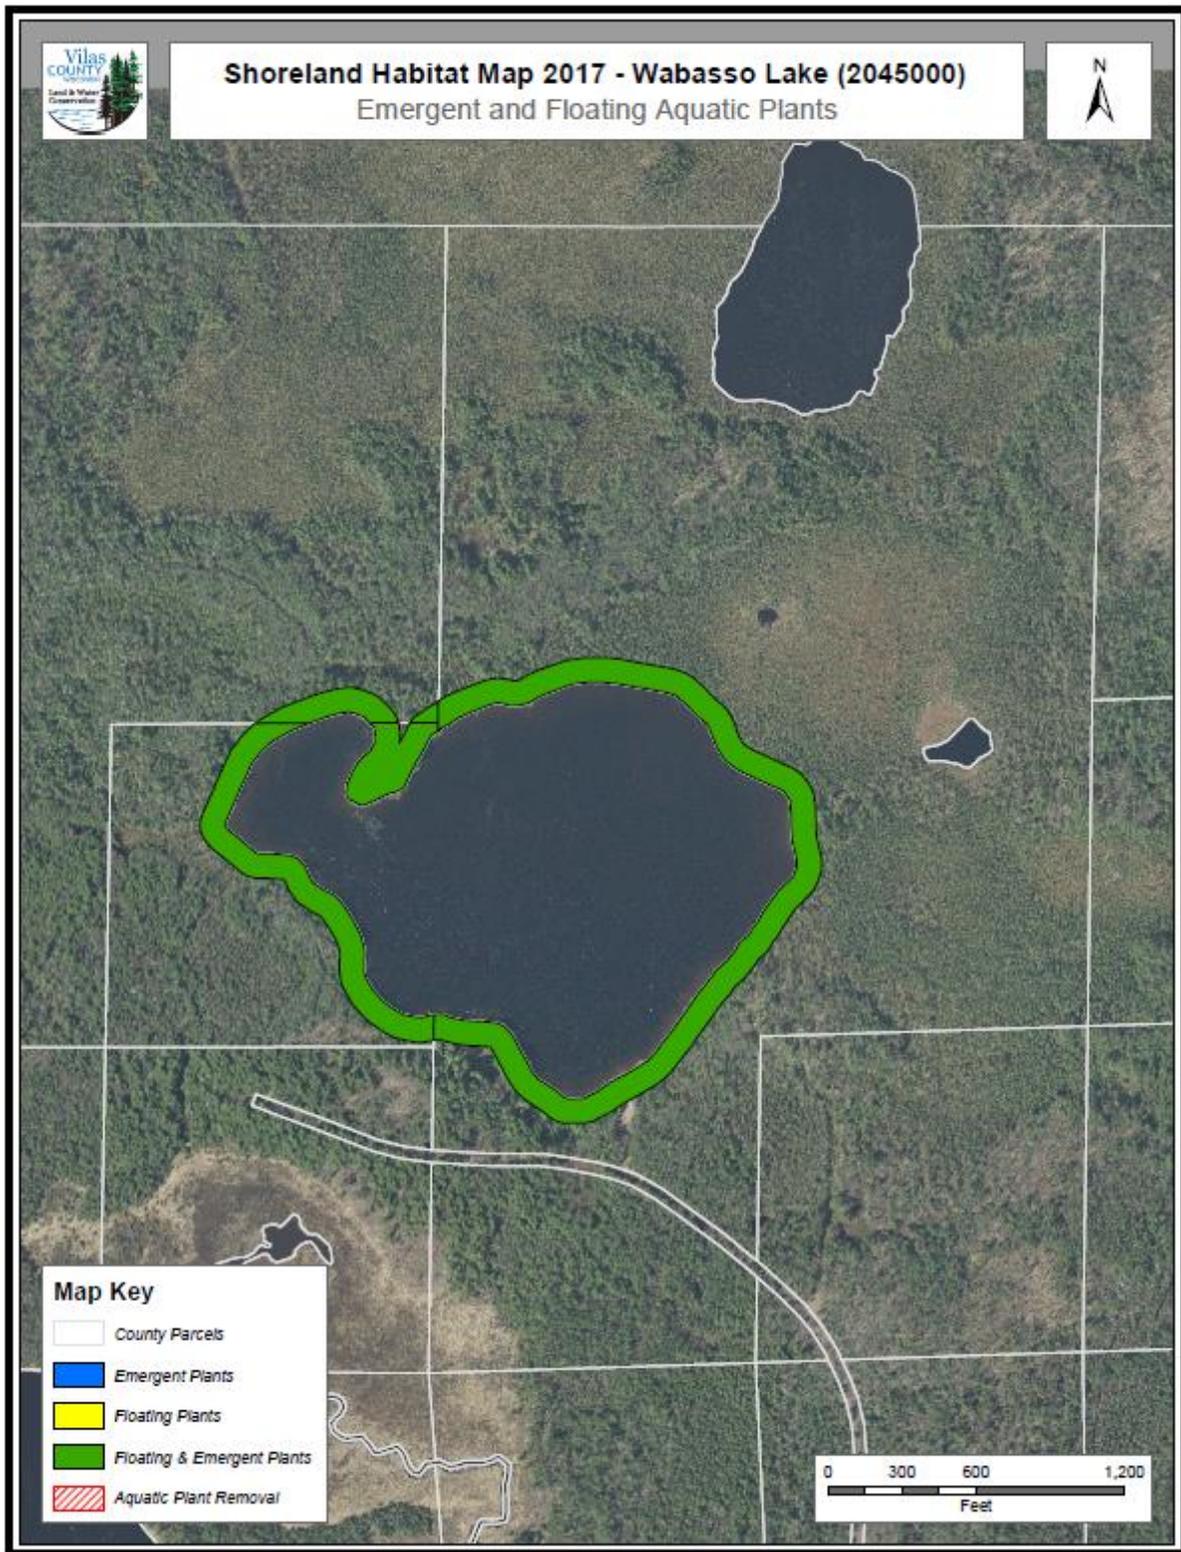
Emergent and floating plants were seen at each parcel's adjacent littoral zone. No plant removal was observed. See Appendix 12 for Aquatic Plant Observations Per Parcel.

Figure 21. Emergent and floating aquatic plants were observed adjacent to all 3 parcels on Wabasso Lake, 2017. No aquatic plant removal was evident.
