LAKE EDUCATION AND PLANNING SERVICES, LLC  
PO BOX #26  
CAMERON, WISCONSIN 54822

# 2023-27 AQUATIC PLANT MANAGEMENT PLAN

SAND BAR & TOMAHAWK LAKES  
BAYFIELD COUNTY  
WDNR WBICS: 2494900 & 2501700

July, 2022

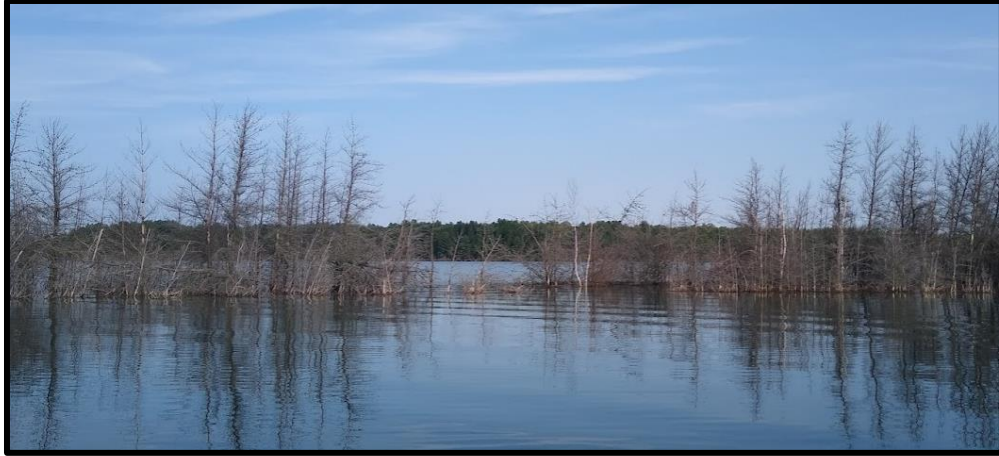
**Figure 1: Flooded sandbar looking from Tomahawk Lake to Sand Bar Lake taken on 8/31/21 by Megan Mader – LEAPS**

After enjoying a separation of the two lakes for a decade or more due to low water conditions, around 2018 water levels increased to the point where surface water moves freely between the two lakes (Figure 1). This rapid increase in water level also left a ring of submerged small trees and shrubs, now dead almost all around both lakes. The lakeside water depth where these submerged trees and shrubs begin is between 5 and 7 feet of water. From the dry shoreline, the ring of submerged trees extends some 10-20 feet into the lake.

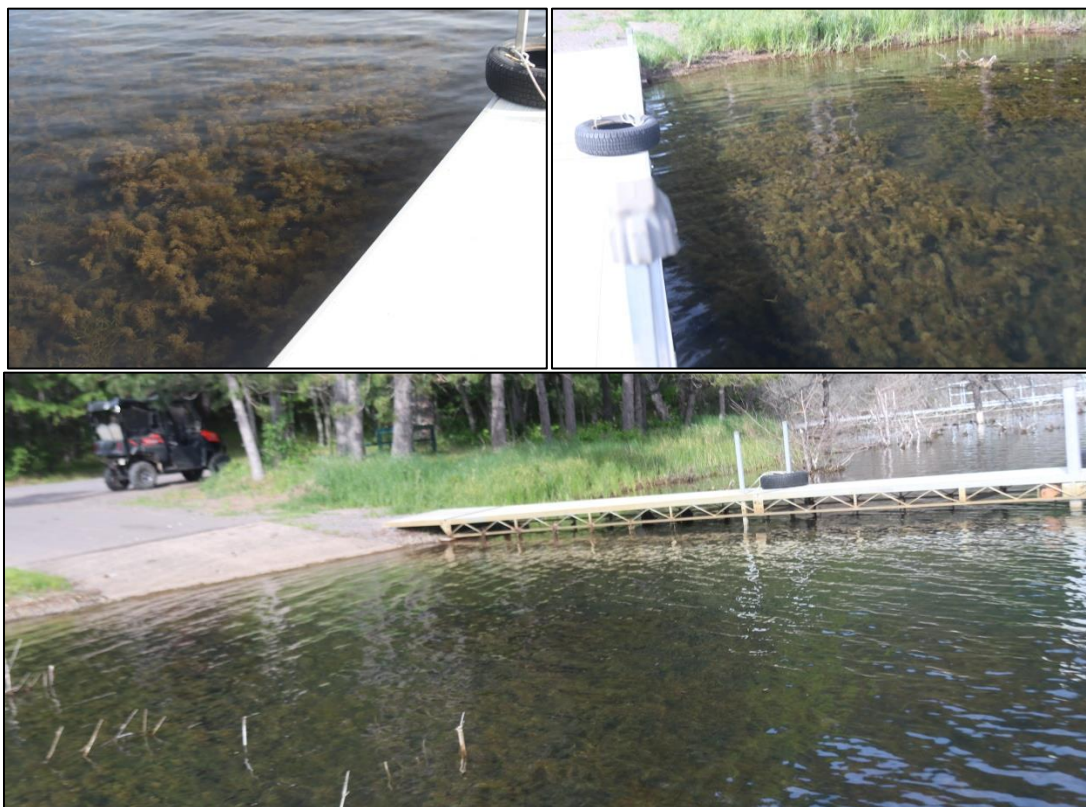
All recreation activities in both lakes can be hindered by EWM. Additionally, these lakes may serve as a source point of EWM to other waterbodies if boats and trailers are not properly inspected. Case in point, Figure 2 shows photos taken on June 14, 2022 on the dock that is in place at the Tomahawk Lake public boat landing. EWM covers the entire area, except for the concrete pad that forms the ramp of the boat landing. These photos are representative of what the beds of EWM looked like along most of the north shoreline of Tomahawk Lake in June 2022. Some level of management of this invasive species is absolutely necessary to allow full recreational use of the lakes and prevent further spread into un-infected lakes.

**Figure 2: Non-launch side of the Tomahawk Lake boat landing looking out to the lake (top left); Non-launch side of the boat landing looking into shore (top right); launch side of the boat landing (bottom)  
Photo Credit: Julia Lyons**

Figure 2, earlier in this plan, is a photo taken in June 2022 of a large dense bed of EWM immediately adjacent to the dock at the boat landing. Any boat that launches and then moors to the dock on the other side will be sitting in EWM. It may be possible to install a bottom barrier at the boat launch and/or beach area of Tomahawk Lake to reduce the amount of EWM that interferes with swimming or that could be transported out of the lake by transient boaters. If used, it is recommended that this barrier be installed and removed each year, rather than leaving it in the lake indefinitely.

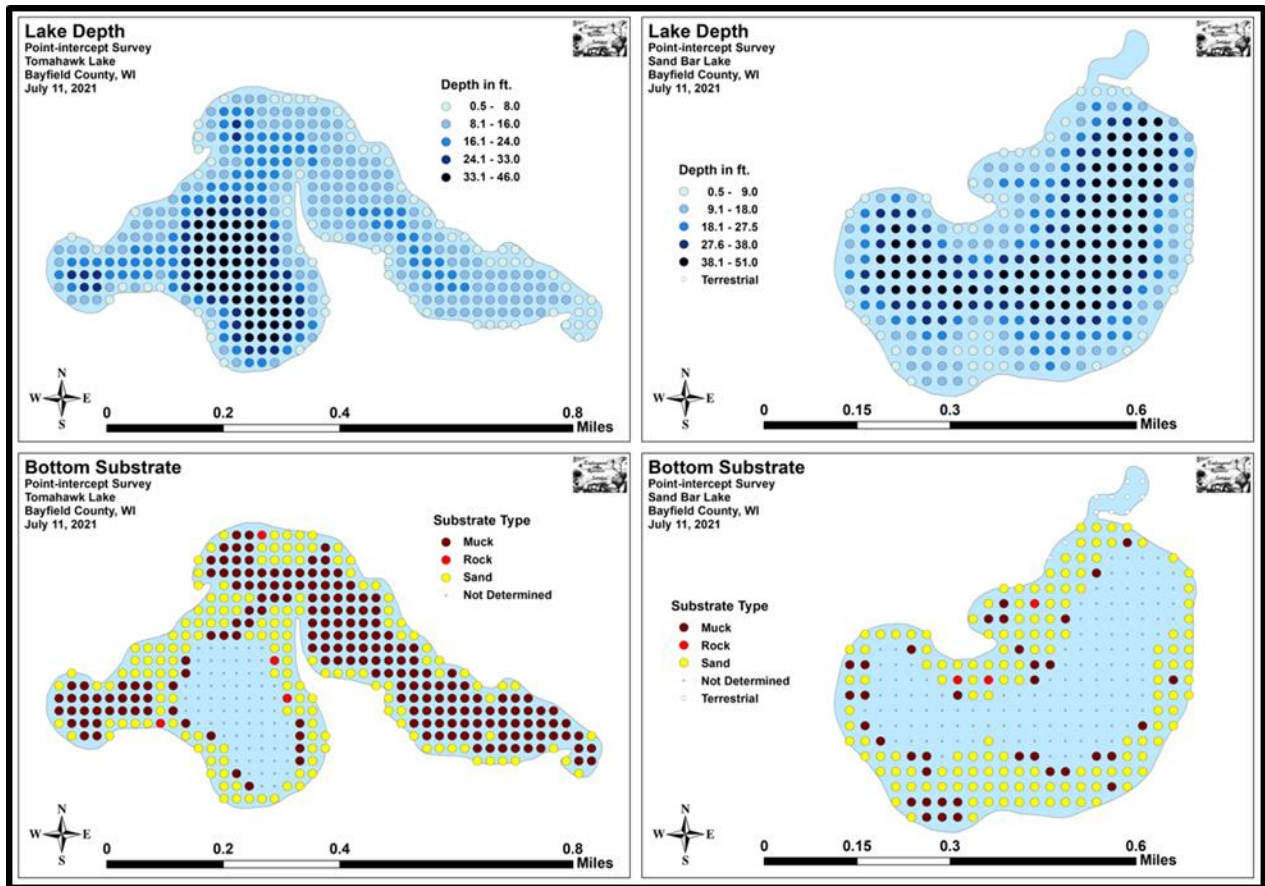
Figure 5: Sand Bar and Tomahawk Lakes depth and bottom substrate. Berg (2021a) (2021b)

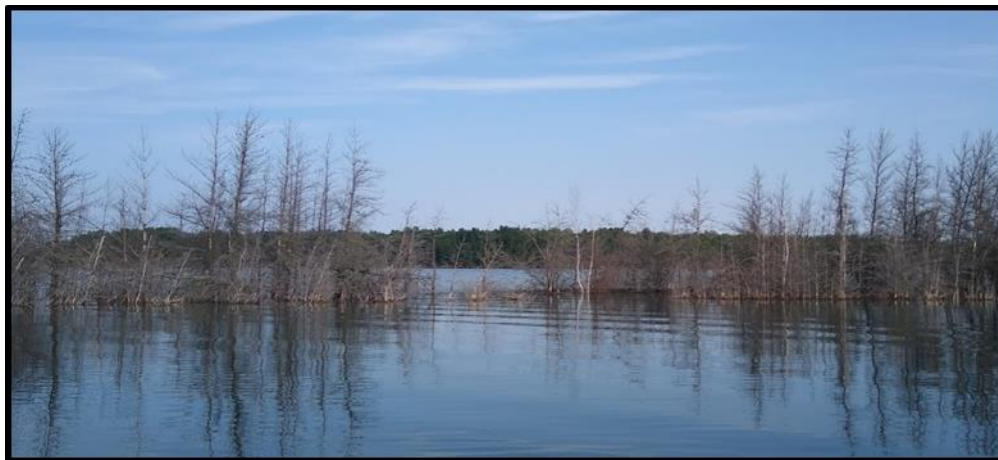
**Figure 9: Coarse woody habitat under high water conditions in Sand Bar and Tomahawk Lake (photo taken by Megan Mader on 8/31/2021)**

Much of the coarse woody habitat around both lakes is due to high water inundating shoreland woody shrubs and small trees in the nearshore area (Figure 9). The coarse woody habitat created by this source changes with the water level - high water creates more, and low water creates less. The amount of larger coarse woody habitat, the kind created when large trees fall into the lakes, has never been inventoried. After such a survey has been completed, property owners may consider the addition of coarse woody habitat through the installation of Fishsticks. Fishsticks are created by using whole, live trees that are cut down and installed along the shoreline. In most cases, 3-5 40-60ft trees are stacked on top of each other and fastened to the shore. Fishsticks installation is usually completed in the winter when there are good ice conditions that support the use of large equipment (skid steers and trucks).

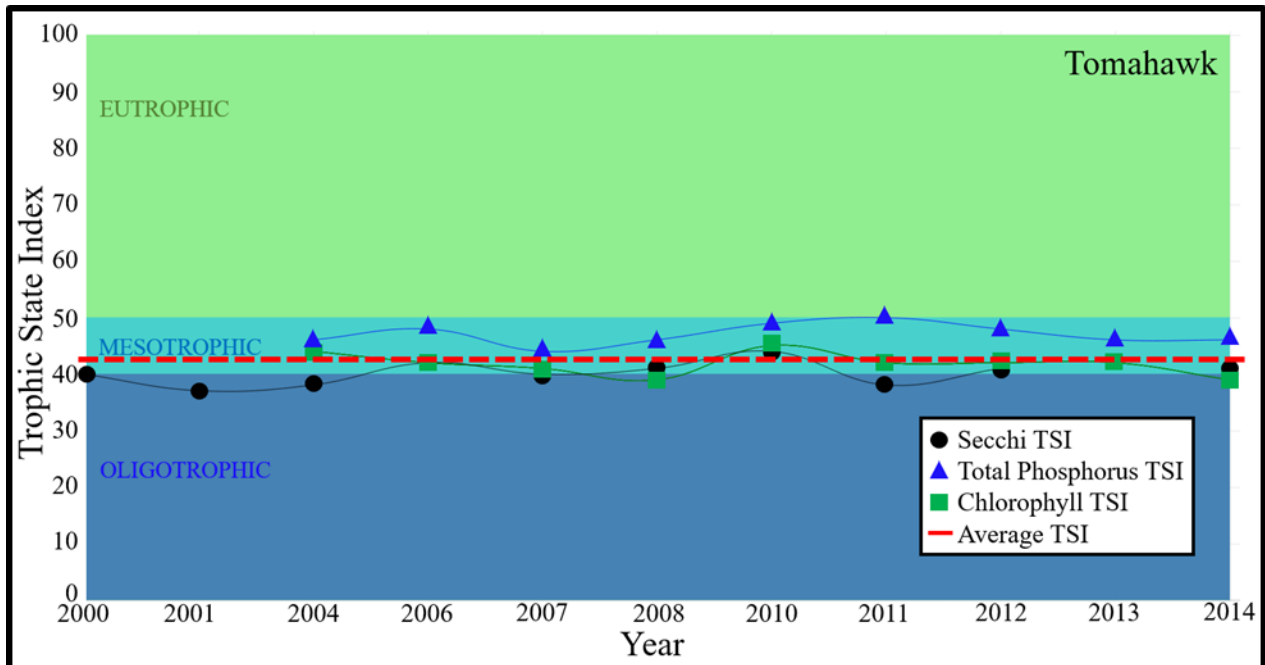
Figure 12: Tomahawk Lake, Bayfield County Trophic State Index (WDNR 2022)

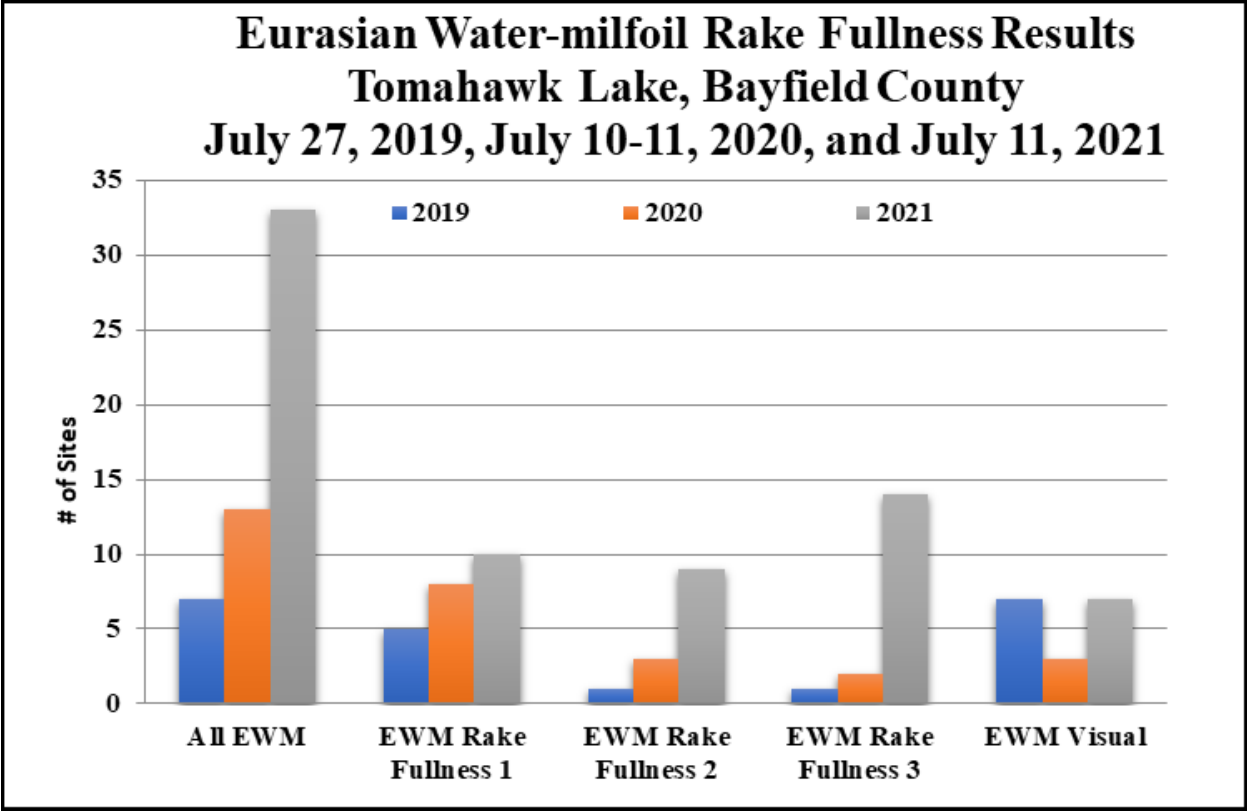
Figure 19: 2019, 2020, and 2021 Changes in EWM Rake Fullness

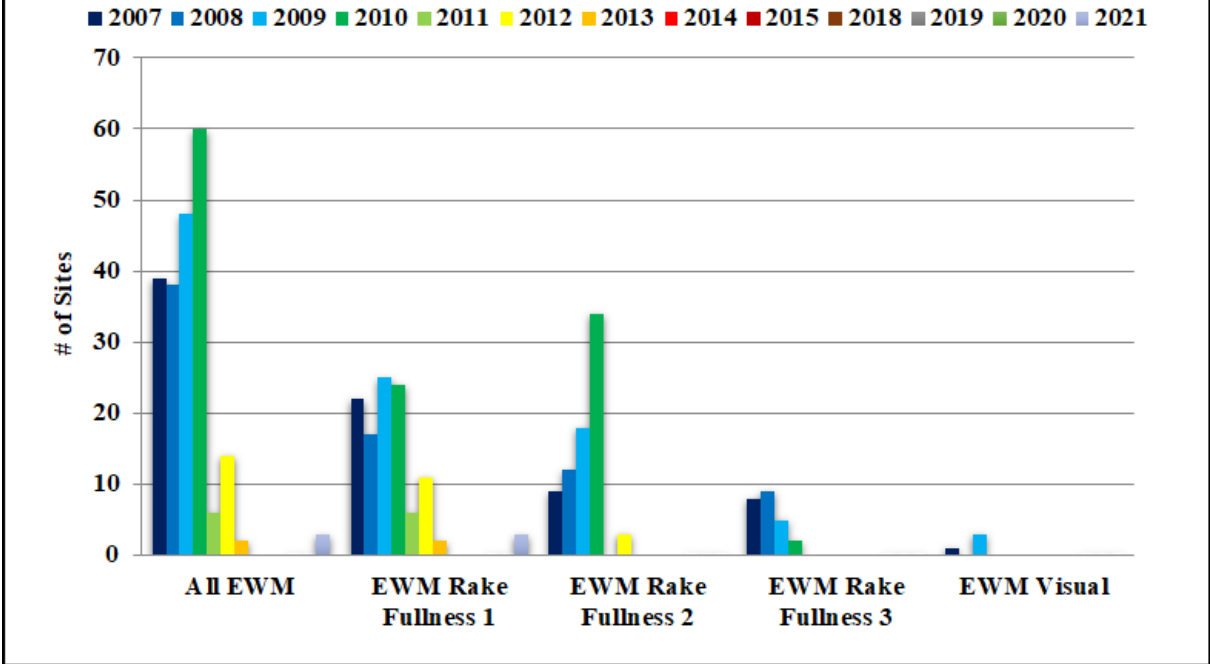
Figure 24: EWM rake fullness results 2007-2015, 2018-2021 (Berg, 2021a)

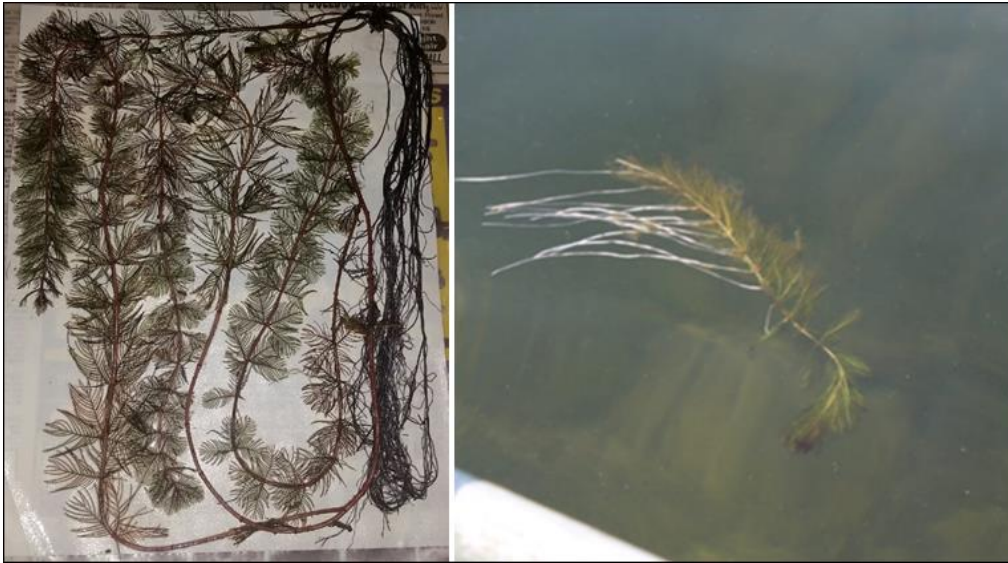
EWM (Figure 27) is a submersed aquatic plant native to Europe, Asia, and northern Africa. It is the only non-native milfoil in Wisconsin. Like the native milfoils, the Eurasian variety has slender stems whorled by submersed feathery leaves and tiny flowers produced above the water surface. The flowers are located in the axils of the floral bracts, and are either four-petaled or without petals. The leaves are threadlike, typically uniform in diameter, and aggregated into a submersed terminal spike. The stem thickens below the inflorescence and doubles its width further down, often curving to lie parallel with the water surface. The fruits are four-jointed nut-like bodies. Without flowers or fruits, EWM is difficult to distinguish from Northern water milfoil. EWM has 9-21 pairs of leaflets per leaf, while Northern milfoil typically has 7-11 pairs of leaflets. Coontail is often mistaken for the milfoils, but does not have individual leaflets.

Figure 27: EWM complete root and stem and floating fragment with adventitious roots

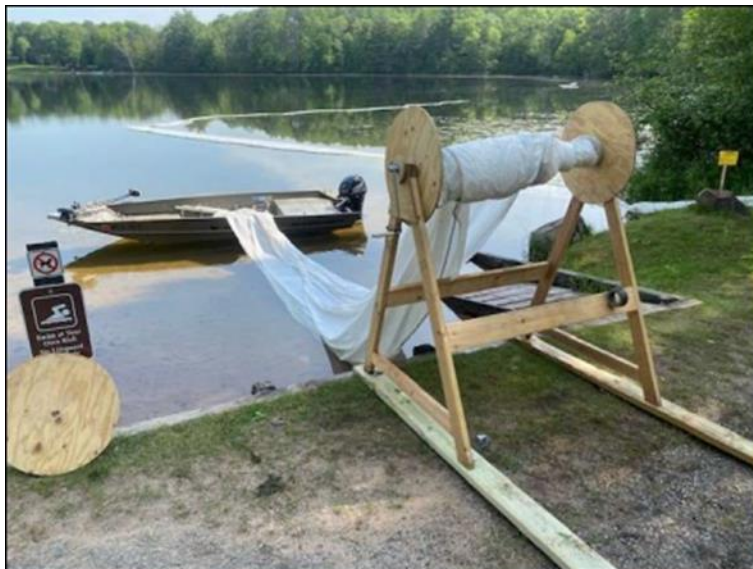
Figure 37: Limno-curtain material on a roll before installation (photo from Marinette Co. LWCD)

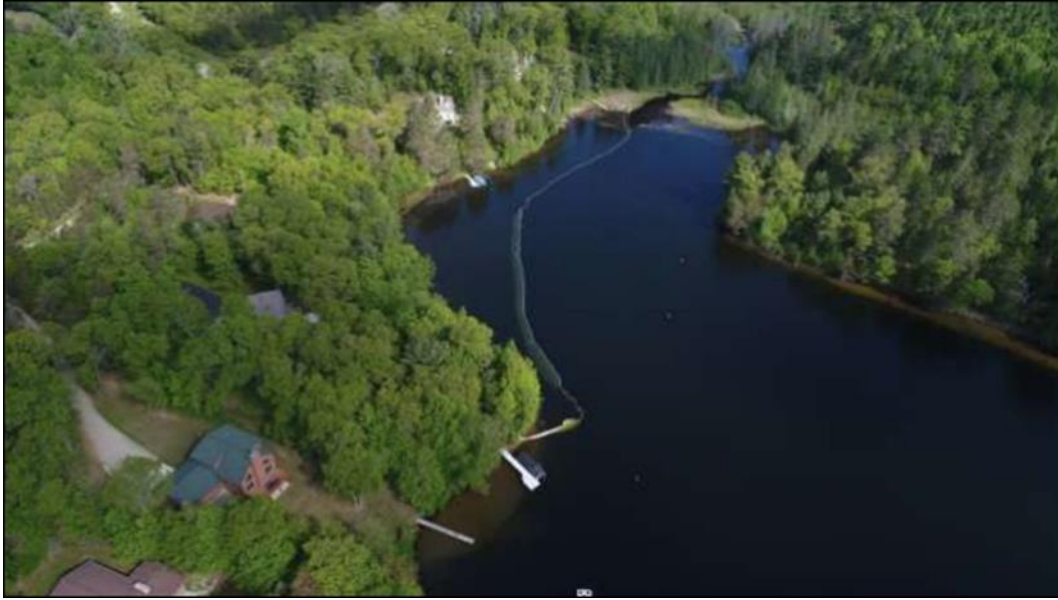
**Figure 38: Limno-curtain installed on Thunder Lake (photo from Marinette Co. LWCD)**

Small-scale herbicide applications can be made more effective by installing a limno-barrier or curtain around a treatment area to help hold the applied herbicide in place, longer. By doing so, the herbicide/target species contact time is increased. The curtain is generally a continuous sheet of plastic that extends from the surface to the bottom of the lake (Figure 37). The surface edge of the curtain is generally supported by floatation devices. The bottom of the curtain is held in place by some form of weighting. The curtain or barrier, sometimes thousands of feet of it, is installed around the proposed treatment area with the purpose of holding the herbicide in place longer by preventing dilution and drift away from the treated area (Figure 38).

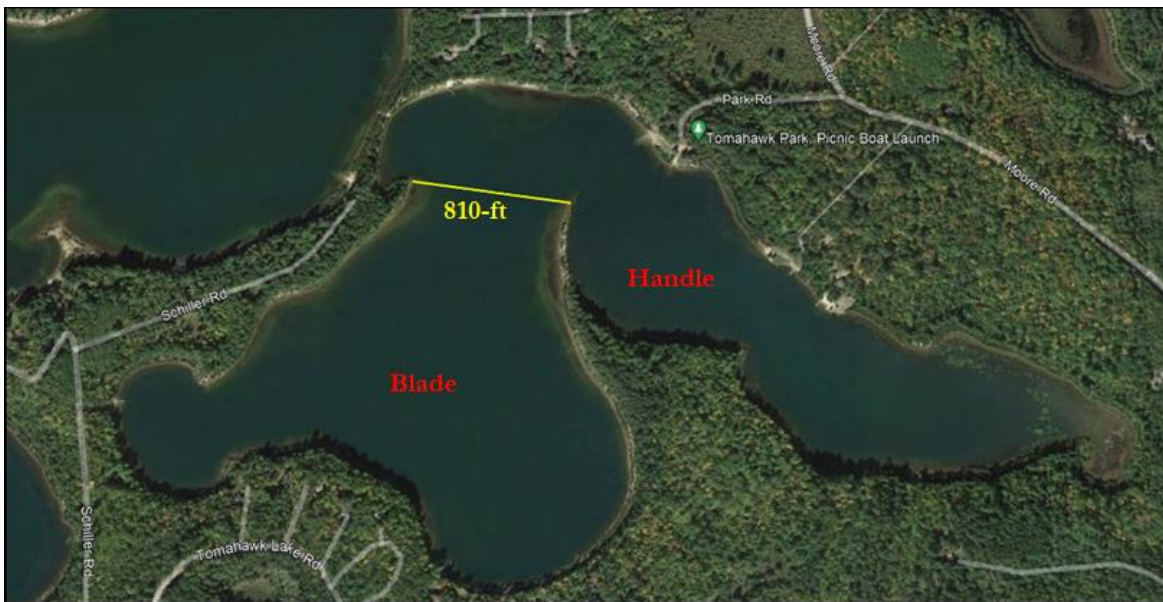
**Figure 40: Tomahawk Lake – blade versus handle**

into two different basins (yellow line in Figure 40) that would require less than 1000-ft of curtain to complete. A curtain placed at this location would divide Tomahawk Lake into two approximately 63-acre basins. The curtain that has been built by the Eau Claire Lakes Conservation Club is up to 1000-ft long and hangs into the water down to 20-ft, more than enough to get below the established thermocline. In order to improve the efficiency of a whole-basin treatment in the handle area of the lake, the curtain would only need to be in place for 2 or 3 days. The difficulty in installing and removing the curtain would be minimized as it is a straight line, and would not have to be moved in order to affect a successful treatment.

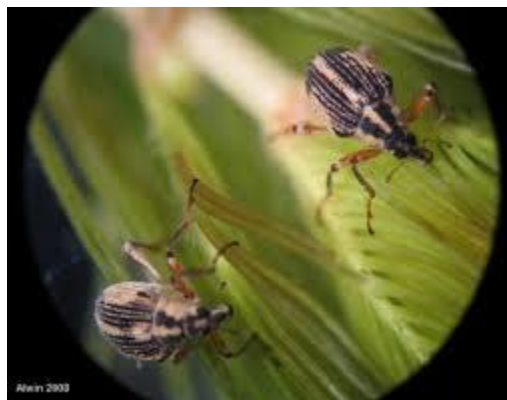
While many biological controls have been studied, only one has proven to be effective at controlling EWM under the right circumstances. *Eubrychiopsis lecontei* is an aquatic weevil native to Wisconsin that feeds on aquatic milfoils (Figure 41). Their host plant is typically northern watermilfoil; however they seem to prefer EWM when it is available. Milfoil weevils are typically present in low numbers wherever northern or Eurasian water milfoil is found. They often produce several generations in a given year and over winter in undisturbed shorelines around the lake. All aspects of the weevil's life cycle can affect the plant. Adults feed on the plant and lay their eggs. The eggs hatch and the larva feed on the plant. As the larva mature they eventually burrow into the stem of the plant. When they emerge as adults later, the hole left in the stem reduces buoyancy often causing the stem to collapse. The resulting interruption in the flow of carbohydrates to the root crowns reduces the plant's ability to store carbohydrates for over wintering reducing the health and vigor Newman et al. (1996).

Figure 41: EWM weevil

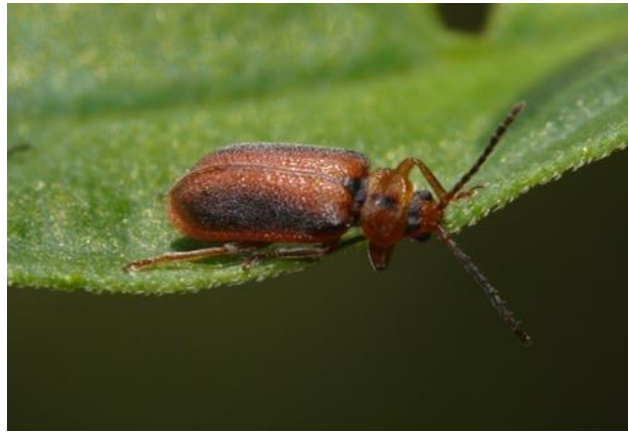
Galerucella beetles are currently approved for the control of purple loosestrife in Wisconsin (Figure 42). The entire lifecycle of Galerucella beetles is dependent on purple loosestrife. In the spring, adults emerge from the leaf litter

**Figure 42: Galerucella beetle**

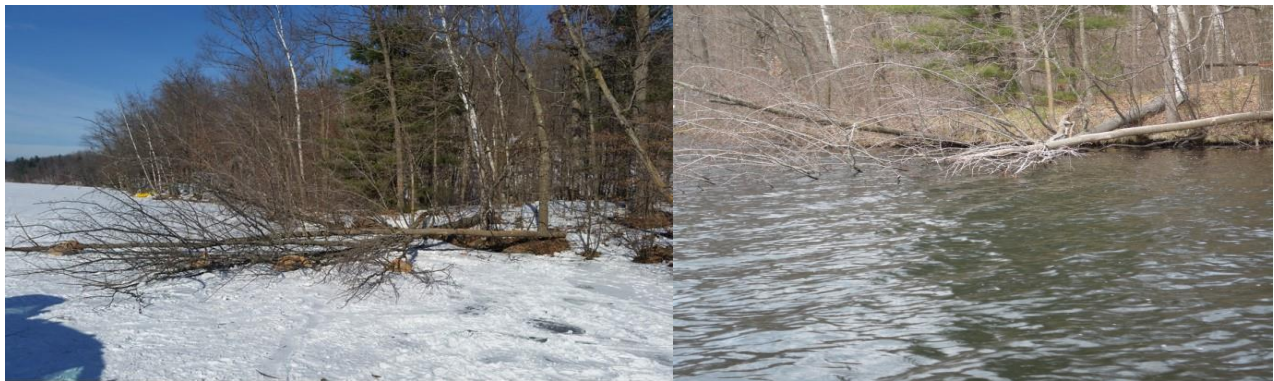
Fish Sticks involve taking trees from the inland area of the lake, and installing them in the lake to mimic shore trees that will eventually fall into the lake (Figure 45). The trees used must be taken from a minimum of 35 feet inland and are then secured to the shore with cables for approximately 3 years. This provides habitat for fish, birds, and many other animals. In addition to providing habitat, fish sticks help protect the shoreline from bank erosion. Fish sticks project costs range anywhere from \$100 to \$1000, averaging about \$500. These are very low maintenance because it is only necessary to occasionally check the cables to ensure they are secure. Despite the presence of abundant “standing” trees along the shore due to high water, adding larger trees that reach out past this area, would benefit lake habitat even in periods of lower water.

Figure 45: Fishsticks installation (left) and after ice out (right)

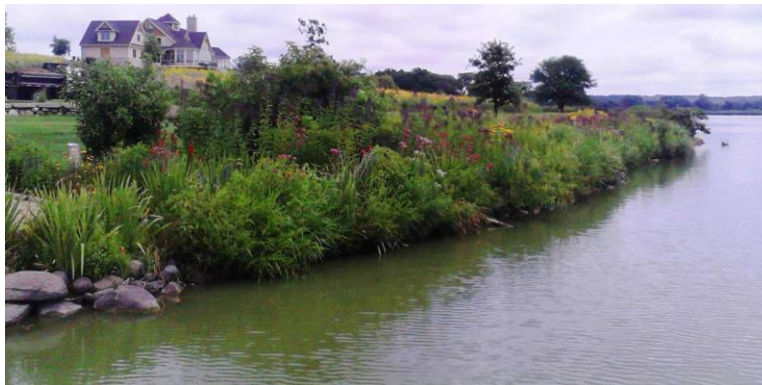
Native plantings (Figure 47) are intended to establish a buffer zone between the developed portion of a parcel and the lake. The buffer helps filter and slow rainwater runoff so much of it filters into the ground. This buffer zone is created by changing a strip of turf grass, at least ten feet wide, along the shoreline to a natural area composed of native shoreline plants. Similar to rain gardens, these are fairly low maintenance requiring water only until the plants have become established. The only ongoing maintenance is the removal of any invasive species that find their way into the planting. On average, native plantings cost around \$1000. This project will work for almost any developed parcel that does not have a sand beach as the primary frontage.

**Figure 47: Completed native planting (photo from HealthyLakesWI.com)**

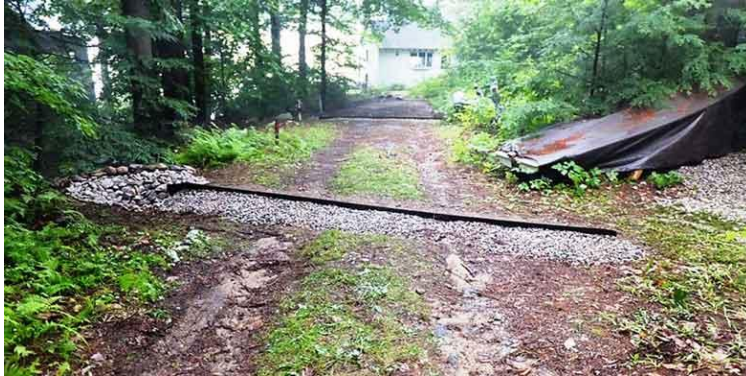
Diversions (Figure 48) are placed across a sloping path or driveway to divert runoff water to an area where it can be absorbed into the ground instead of flowing directly into the lake. In addition to helping improve lake health, these can also reduce the effects of erosion on the paths that the diversions are installed on. Diversions are created by entrenching a log or creating a small earthen berm approximately 30 degrees from the angle of the slope. The cost of these range anywhere from \$25 to \$3,750, but the average diversion costs \$200. These are very low maintenance, and only require some debris removal that could get stuck in the diversion and occasionally ensuring everything is still secure and in place. This practice does not work well for the purposes of this particular survey, but it is mentioned here as a nod to projects that could be completed further inland than this survey was meant to assess.

Figure 48: Completed diversion (photo from HealthyLakesWI.com)
