**Eurasian water-milfoil (*Myriophyllum spicatum*)
Late Summer Bed Mapping Survey
Tomahawk Lake - WBIC: 2501700
Bayfield County, Wisconsin**

Endangered Resource Services, LLC
Matthew S. Berg, Research Biologist
St. Croix Falls, Wisconsin
September 4, 2022

**Eurasian water-milfoil (*Myriophyllum spicatum*)
Late Summer Bed Mapping Survey
Sand Bar Lake - WBIC: 24924900
Bayfield County, Wisconsin**

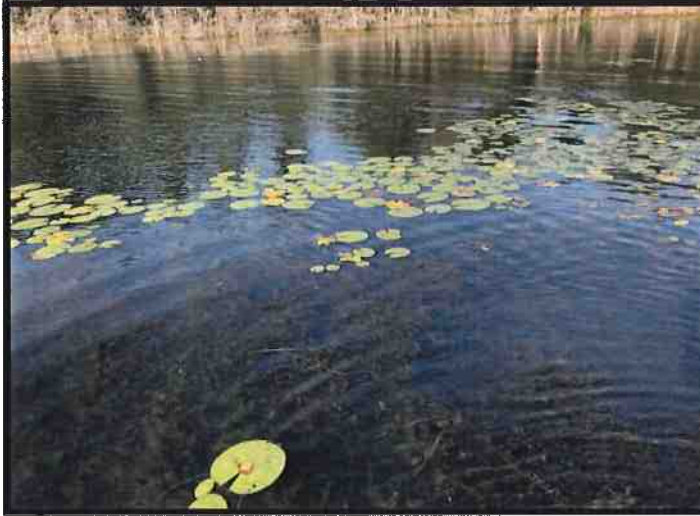
Dense canopied EWM in Tomahawk Lake's east bay - 9/4/22

Bed 6 – This bed started just outside of the northeastern end of the treatment area, continued into the eastern bay, and then wrapped around the southeastern shoreline. On the north shoreline, the bed was similar to Beds 4 and 5 – narrow and only a minor impairment. The eastern bay would likely cause severe impairment (Figure 7), but the area that was dense and canopied was relatively small. Along the southeastern shoreline, EWM was largely restricted to the immediate shoreline, and, as we moved to the west, plants became less and less common before disappearing altogether.

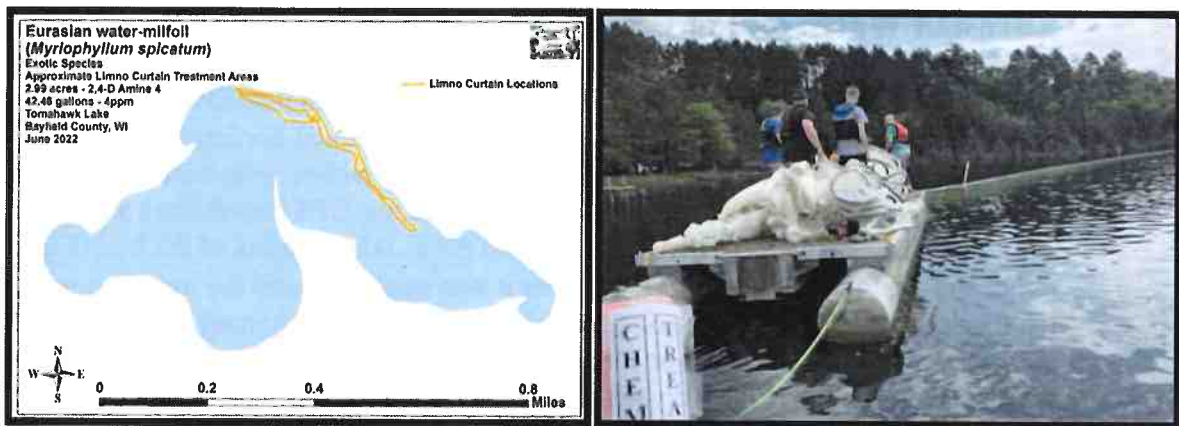
**Figure 3: Approximate June 2022 EWM Treatment Areas -
Limnocurtain Deployment**

The three treatment areas along the lake's north shoreline totaled 2.99 acres (2.28% of the lake's total surface area) (Table 1). Treatment occurred over three days so the limnocurtain could be moved with each successive treatment (Figure 3) (Appendix I). Applications occurred on June 10, June 13, and June 16 with Northern Aquatic Services (Dale Dressel - Dresser, WI) applying 2,4-D (Amine 4) at a target rate of 4ppm (42.46 total gallons).

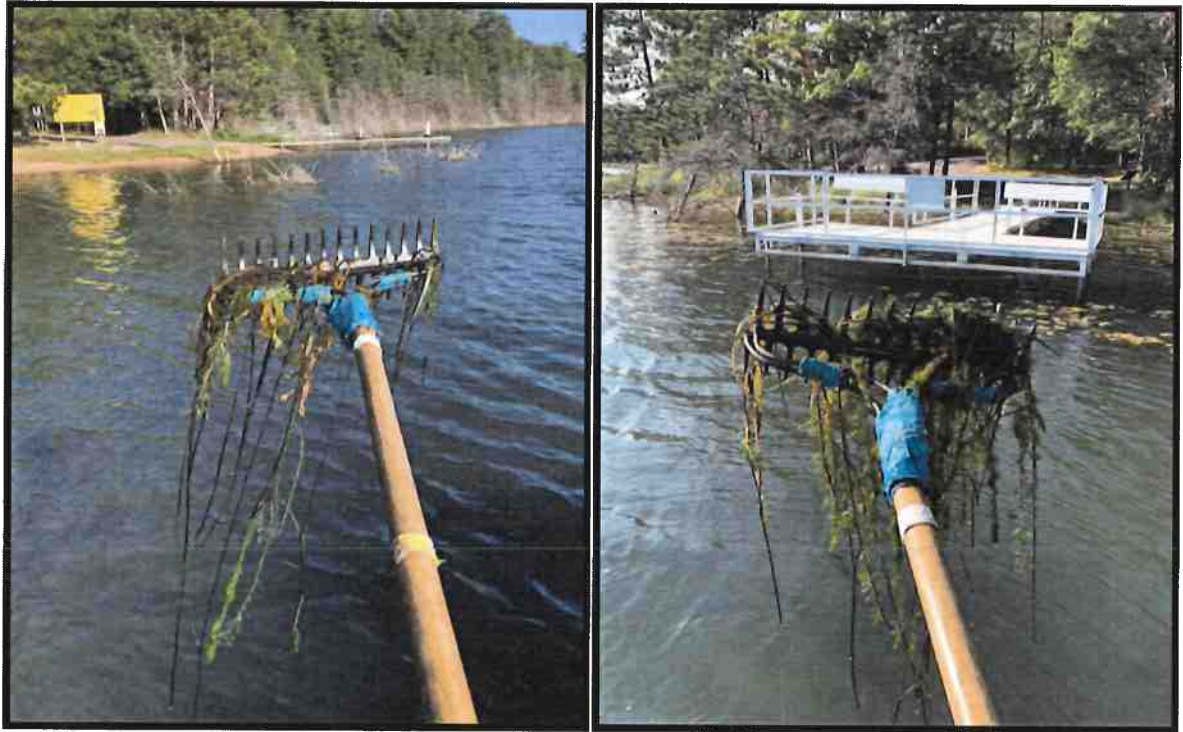
Figure 6: Typical Regrowing EWM from Severely Burned Root Crowns – Beds 2 and 3 Near the Public Landing

Beds 2 and 3 – These beds were also relatively narrow and likely wouldn't have caused more than a minor impairment. Unfortunately, it appeared the majority of plants in these areas survived the treatment despite having been severely burned. We observed new shoots throughout and almost all were shown to be regrowing from large root crowns (Figure 6).

For unknown reasons, the 2022 treatment appears to have been relatively unsuccessful. EWM levels certainly declines, and most impairment seems to have been eased. However, the majority of mature plants with well-established root balls appeared to have survived and immediately started to regrow. Because the treatment did not reduce levels back to something the BAISS could easily keep up with, it is likely that another herbicide treatment or extensive manual removal will be needed in 2023. In addition to any future management, a decision on how much monitoring will be needed in 2023, if any, is a conversation that needs to take place. Ultimately, the TOB, LEAPS, and the WDNR will have to decide on a future course of action.

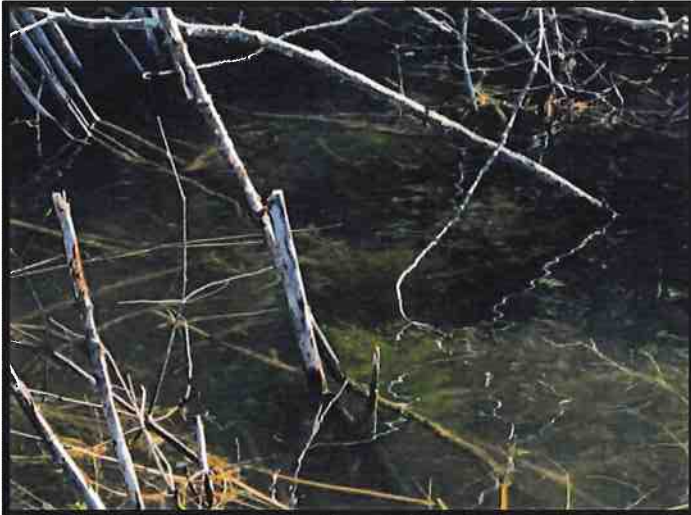
EWM among the dead jack pine along Sand Bar Lake's shoreline - 9/4/22

Bed 8 – This bed near the channel to Tomahawk Lake was the worst area on Sand Bar. We found dense patches of canopied EWM were beginning to expand beyond the ring of dead pines, and individual plants were spreading into deeper water. Although still not an impairment to navigation, wave action was causing the plants growing in open water to break apart, and we saw a concentration of floating fragments throughout this area. Interestingly, especially in this area, we noticed that beyond 7-10ft, the majority of the lake had no vegetation (Figure 6). This may account for the unusually poor water clarity we observed during the survey.

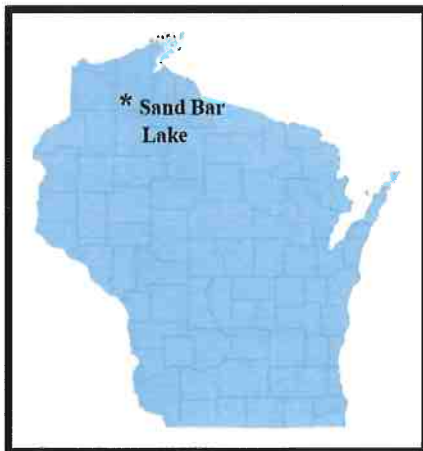
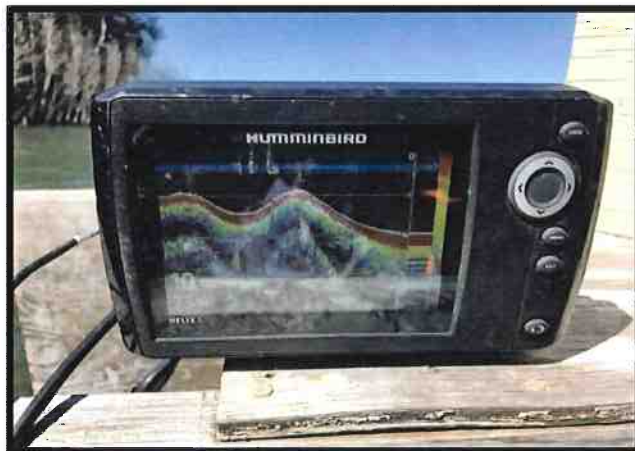
Very sparse vegetation on Sand Bar Lake – 9/4/22

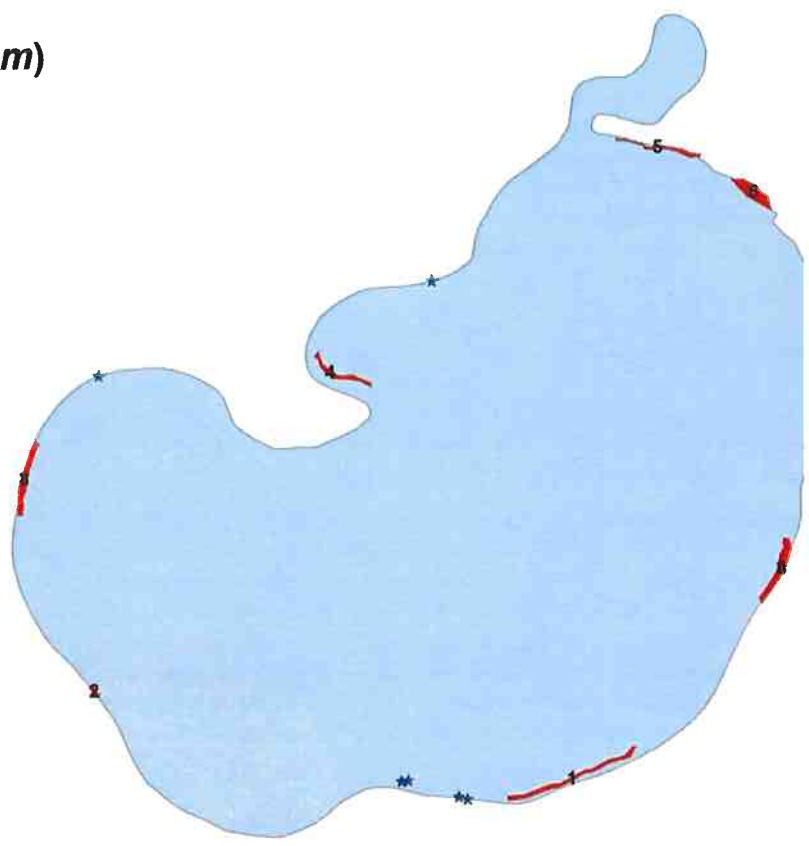
Appendix I: 2022 Eurasian Water-milfoil Bed Map

Exotic Species
EWM Bed Mapping Survey
Sand Bar Lake
Bayfield County, WI
September 4, 2022
