# Curly-leaf pondweed (*Potamogeton crispus*) Fall Turion Survey Upper Turtle Lake - WBIC: 2079800 Barron County, Wisconsin

Endangered Resource Services, LLC  
Matthew S. Berg, Research Biologist  
St. Croix Falls, Wisconsin  
October 17, 2021

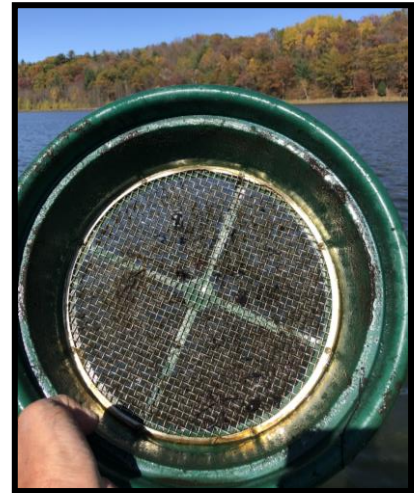
Upper Turtle Lake 2021 treatment areas and posttreatment CLP density and distribution

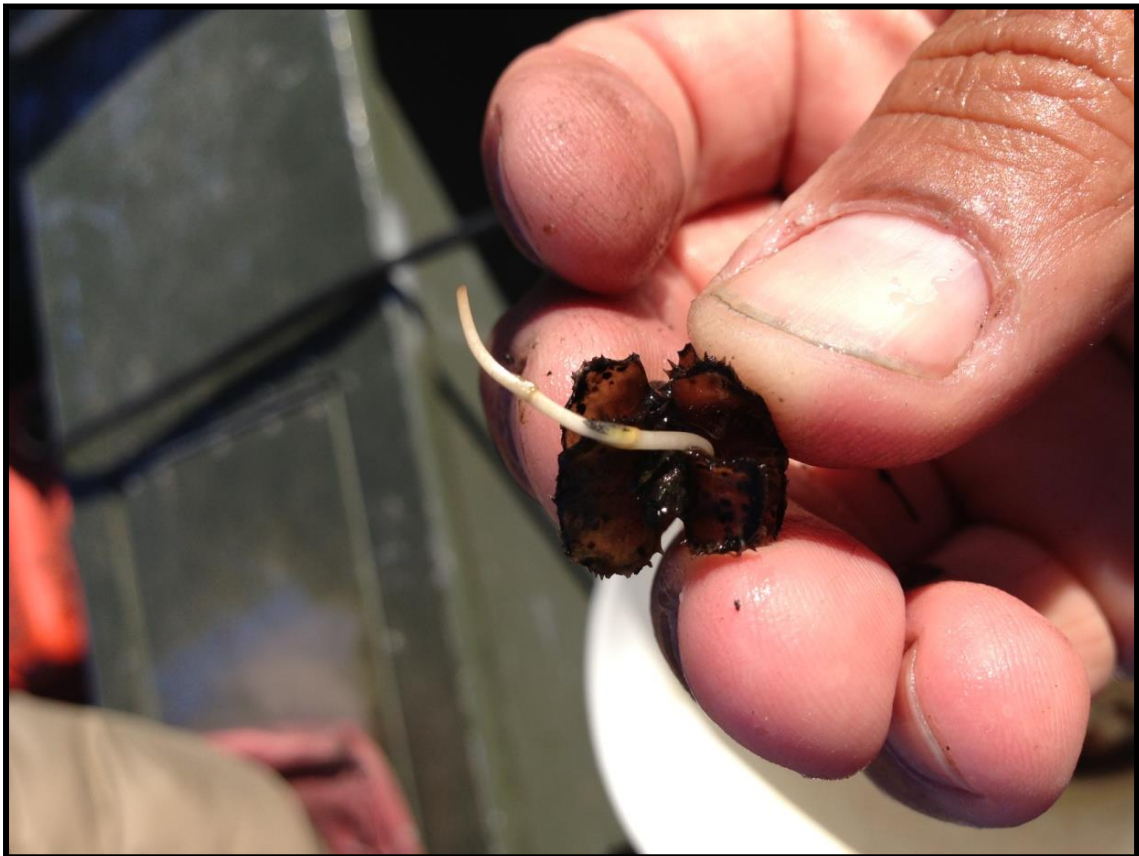
**Figure 3: Germinating CLP Turion**

Although Curly-leaf pondweed occasionally reproduces by seed, the vast majority of plants resprout from stiff overwintering buds called turions that are normally produced in number by the plants prior to their late June/early July senescence (Figure 3). After the pinecone-like turions germinate in late fall or early winter, plants continue to grow slowly under the ice. Following ice out, growth accelerates, and plants rapidly canopy allowing them a competitive advantage over slower growing native species (Capers 2005).

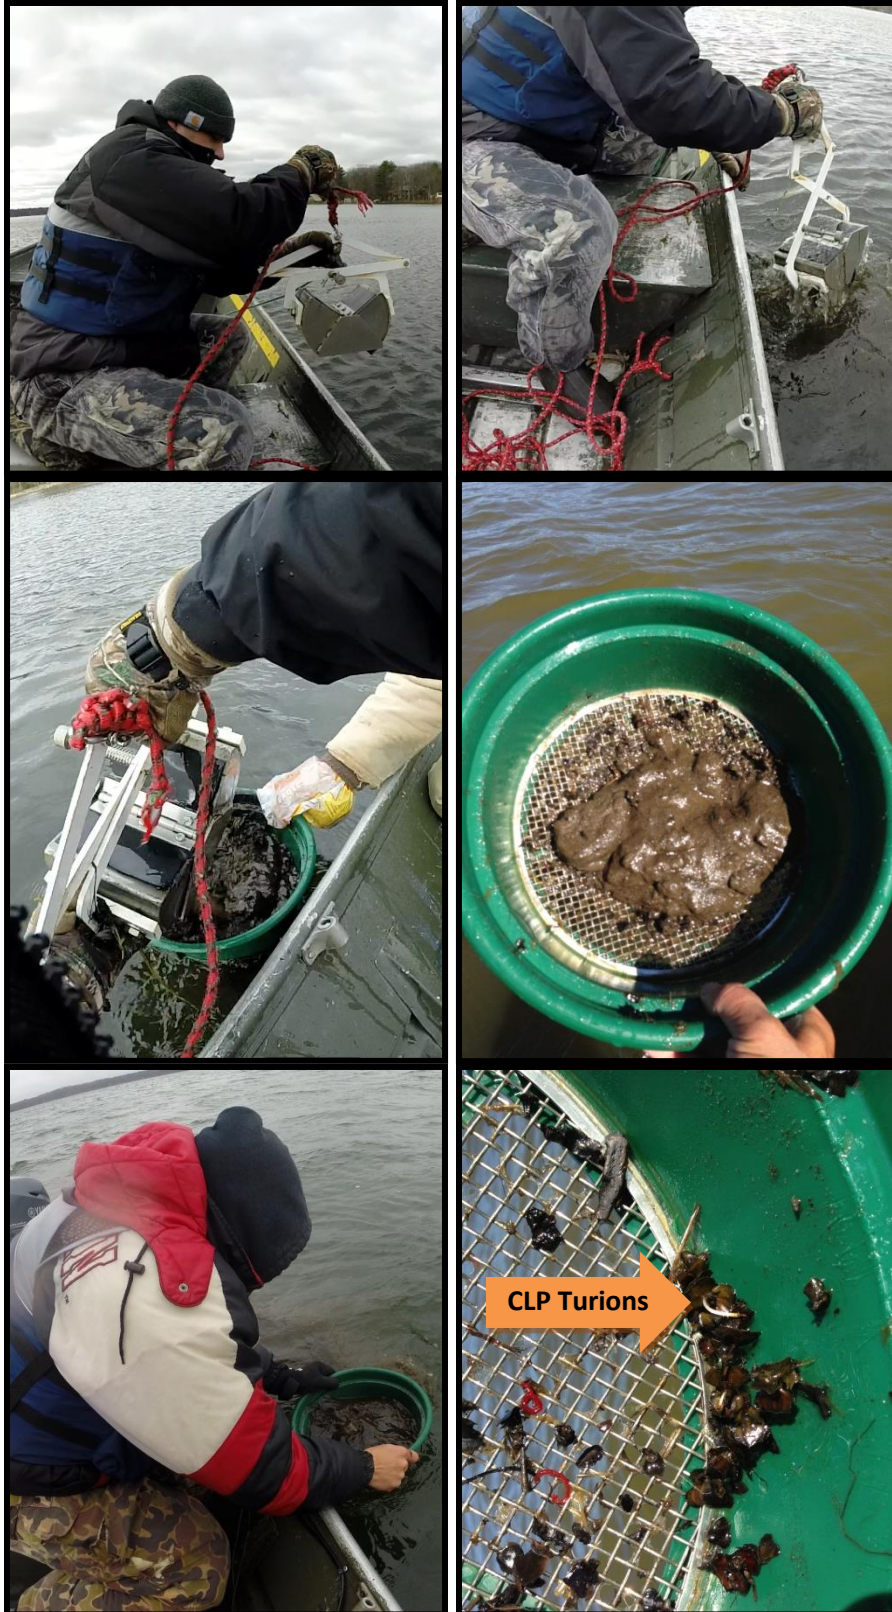
**Figure 5: Ponar Grab and Turion Sieving**

During the survey, we located each point with a handheld mapping GPS unit (Garmin 76CSx) and used a Petite Ponar dredge with a  $0.0232\text{m}^2$  ( $36\text{in}^2$ ) sample area to take a bottom sediment grab from each side of the boat at each location. These samples were then rinsed in a fine sieve to separate out the sediment (Figure 5). Samples with high numbers of turions or significant amounts of detritus were bagged for later analysis; at which time we discarded all rotten turions, tallied all live turions, and multiplied the combined total live turions from the two samples by 21.53 to estimate turions/ $\text{m}^2$  at each location. This value gives an idea of how many CLP plants will germinate in an area during the 2022 growing season.

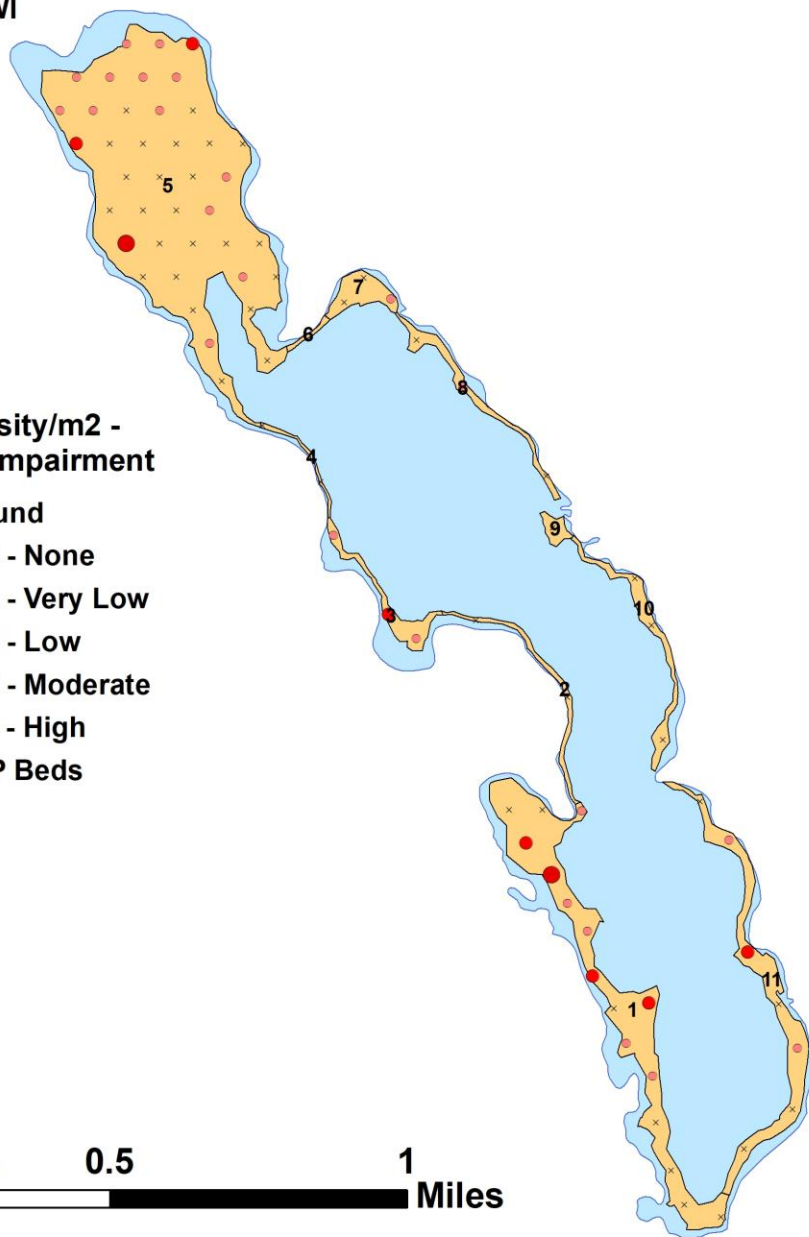
Exotic Species  
CLP Turion Survey  
Upper Turtle Lake  
Barron County, WI  
October 17, 2021

## Turion Density/m2 - Potential for Impairment

Our 2021 survey showed a dramatic and highly significant reduction of CLP turions in the lake following three years of large-scale active management. Collectively, we counted a total of just 68 turions – a **77.0%** reduction compared to the 2018 survey. Turions were present at 33 of 80 points (41.3% coverage) – a **37.7%** reduction in total coverage (Table 1). Of these, **none exceeded the expected “nuisance level” of 200/m<sup>2</sup>**, and only nine points (11.3% coverage/27.3% of points with turions) topped 50 turions/m<sup>2</sup> suggesting they would have any potential for navigation impairment (Figure 7) (Appendix II). The standard deviation of 31.60 turions/m<sup>2</sup> was nearly double the mean density of 18.30 turions/m<sup>2</sup> suggesting there will likely be significant variability during the 2022 growing season. Visual analysis of the map found no areas are likely to have widespread impairment with the possible exception of the northern half of Bed 1 on the southwest shoreline. Despite this area, **the lake-wide reduction in the mean density compared to 2018 was highly significant ( $p < 0.001$ ).**
