**Curly-leaf pondweed (*Potamogeton crispus*)
Point-intercept and Bed Mapping Surveys, and
Warm-water Point-intercept Macrophyte Survey
Upper Turtle Lake - WBIC: 2079800
Barron County, Wisconsin**

Endangered Resource Services, LLC
Matthew S. Berg, Research Biologist
St. Croix Falls, Wisconsin
June 11 and July 14, 2022

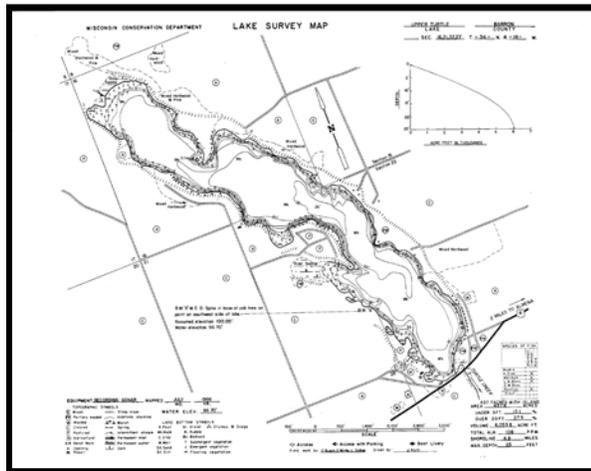
Figure 1: Upper Turtle Lake Bathymetric Map

Upper Turtle Lake (WBIC 2079800) is a 427-acre drainage lake located in west-central Barron County, Wisconsin in the Town of Almena (T34N R14W S16, 21-22, and 27). It reaches a maximum depth of 25ft in the central basin and has an average depth of 14ft (WDNR 2022). The lake is eutrophic in nature with Secchi readings from 1994-2022 averaging 5.4ft (WDNR 2022). This poor water clarity produced a littoral zone that reached approximately 13.0ft in 2022. The lake's bottom substrate is predominantly organic and sandy muck in the north, south, and western bays as well as the majority of the main basin, while a narrow ring of sand and rock occurs along most of the eastern shoreline and on scattered exposed points (Figure 1) (Bush et al. 1966).

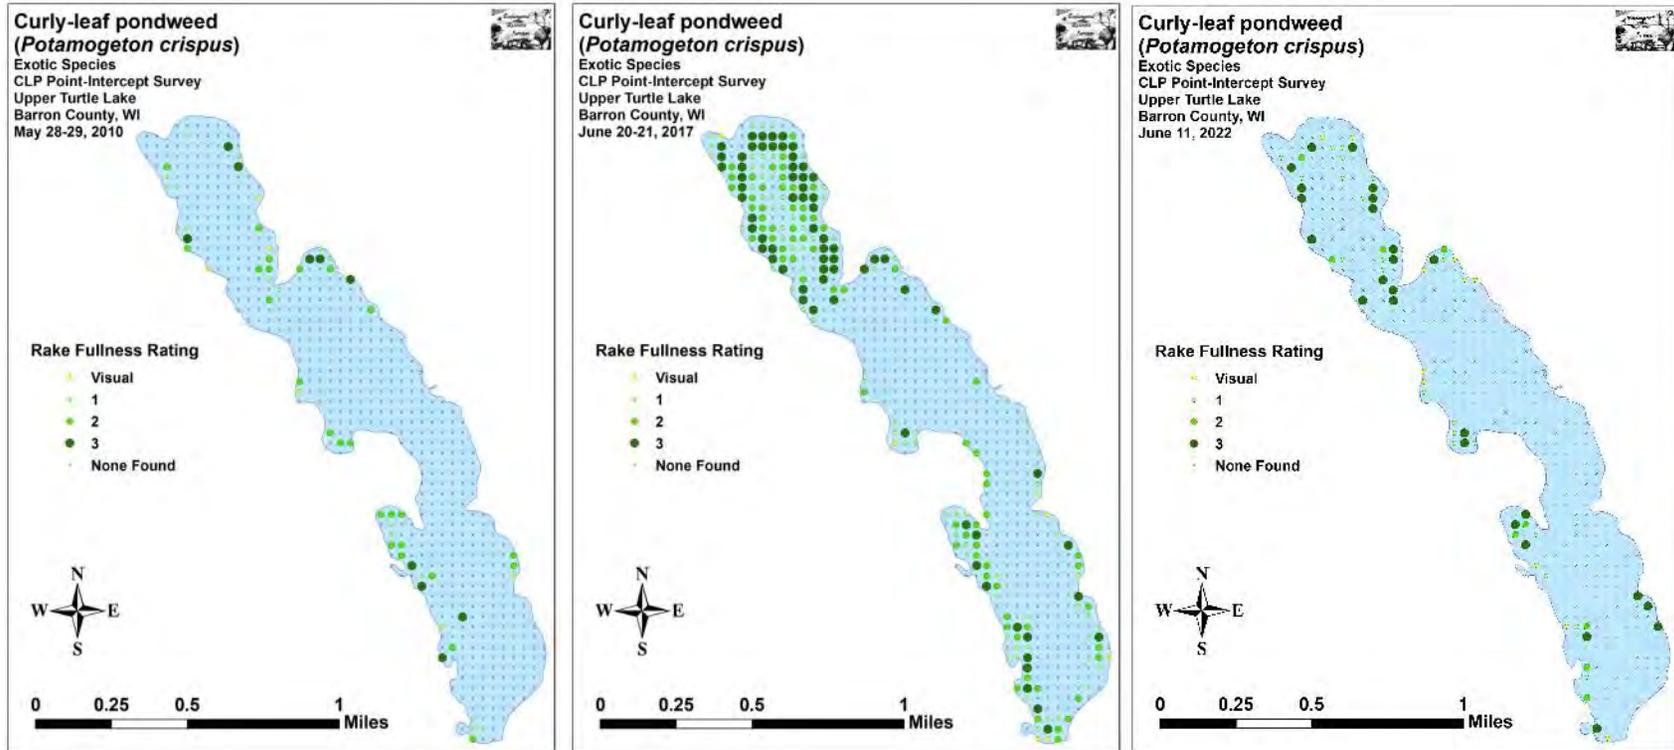
Figure 3: 2010, 2017, and 2022 Early-season Curly-leaf Pondweed Density and Distribution

The 2017 early-season survey documented CLP at 216 points – 36.3% of the entire lake/74.5% of the then 15.0ft littoral zone. We rated 69 points a rake fullness value of 3, 71 a rake fullness of 2 (140 points with significant CLP/23.5% of the entire lake and 48.3% of the littoral zone), and the remaining 76 points a 1 for a combined mean rake fullness of 1.97. We also noted CLP as a visual at eight points (Figure 3) (Appendix III).

Following four years of active management, our 2022 results documented a complete reversal as we found highly significant declines ($p<0.001$) in total CLP as well as rake fullness 3, 2, and 1 (Figure 4). The decline in combined mean rake fullness was, however, again not significant ($p=0.22$). Collectively, from 2017-2022, there was a **-73.6%** decline in total CLP coverage as well as an even **-75%** decline in areas where the infestation was significant enough to likely be considered a nuisance.

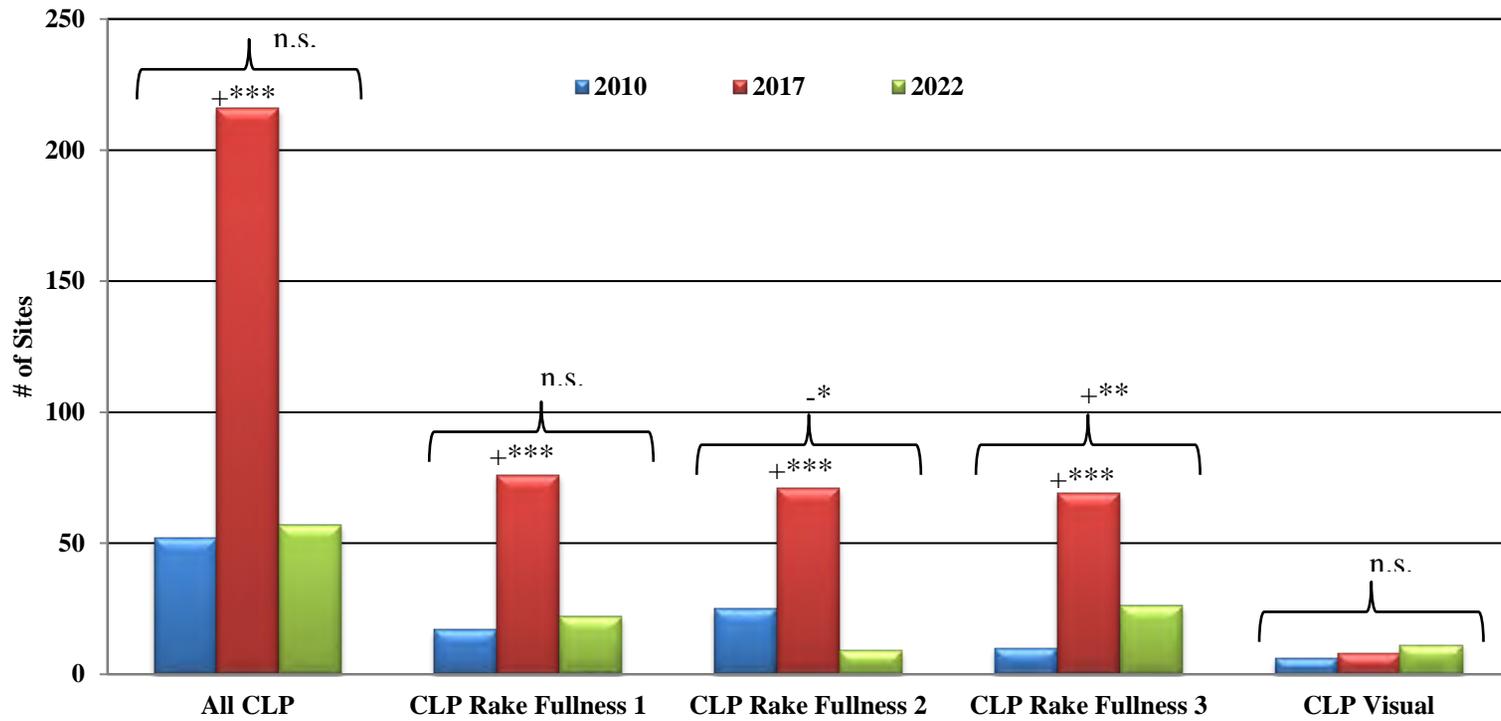
Figure 4: 2010, 2017, and 2022 Changes in Early-season CLP Rake Fullness

Curly-leaf Pondweed Rake Fullness Results
Upper Turtle Lake - Barron County, WI
May 28-29, 2010, June 20-21, 2017, and June 11, 2022

Significant differences = * $p < 0.05$, ** $p < 0.01$, *** $p < 0.001$

Comparing the results from 2010 and 2017 showed a highly significant increase ($p < 0.001$) in total CLP as well as rake fullness 3, 2, and 1 (Figure 4); however, the increase in combined mean rake fullness was not significant ($p = 0.19$). Collectively, from 2010-2017, there was a 315% increase in total CLP coverage as well as an even 300% increase in areas where the infestation was significant enough to likely be considered a nuisance.

To better understand the changes since the original 2010 survey, we also compared that data with the 2022 survey (brackets in Figure 4). These results showed non-significant **increases** in total density ($p=0.10$), total distribution ($p=0.18$), rake fullness 1 ($p=0.20$), and visual sightings ($p=0.13$); a moderately significant **increase** ($p=0.001$) in rake fullness 3; and a significant **decline** ($p=0.01$) in rake fullness 2. Total coverage from 2010-2022 increased by 9.6%; however, nuisance coverage was unchanged. Taken in this context, the UTLMD's management from 2018-2021 has essentially returned CLP to 2010 levels.

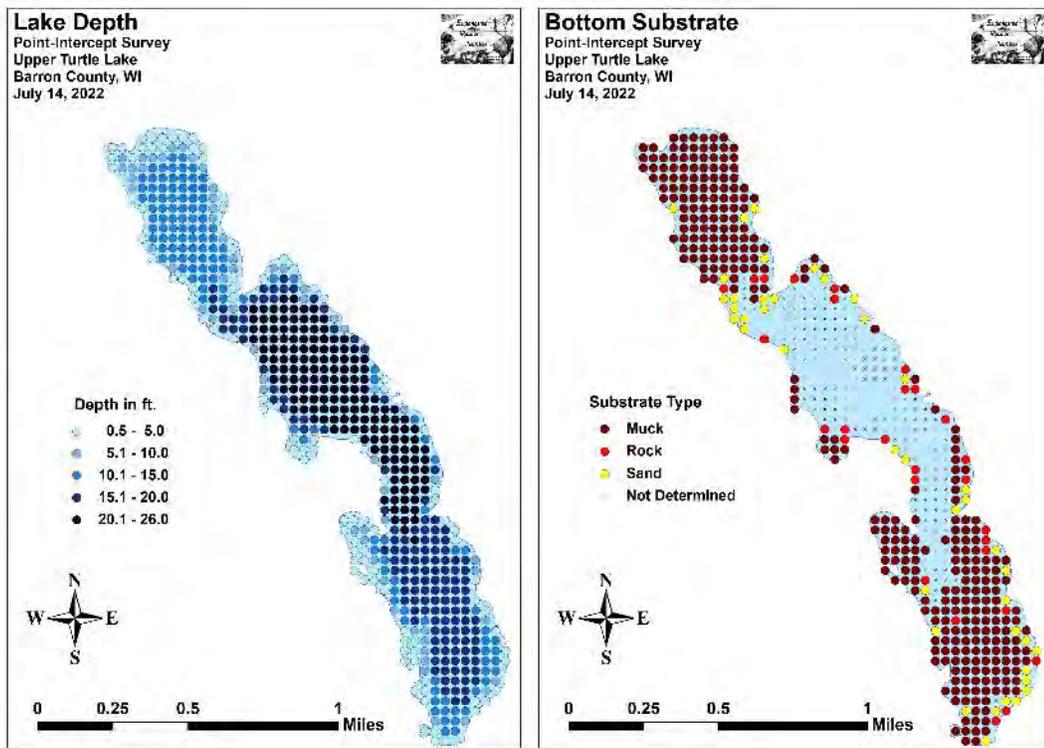
Figure 6: Lake Depth and Bottom Substrate

Of the 381 points that were shallow enough to take a rake sample, we characterized the lake’s substrate as 81.9% organic and sandy muck (312 points), 10.8% pure sand (41 points), and 7.3% rock (28 points). Thick nutrient-rich organic muck dominated the north bay near the creek inlet and the western side bays, while thinner sandy muck covered the majority of the deep basins. Most of the pure sand areas were found around the “neck” leading into the north bay and along the southeastern shoreline. The majority of the gravel and cobble substrates occurred along the steep slopes of the central basin; especially around exposed points (Figure 6) (Appendix IV).

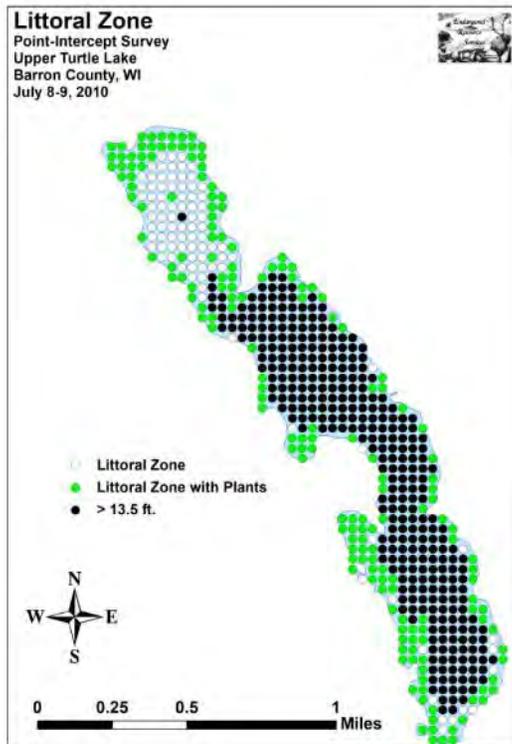
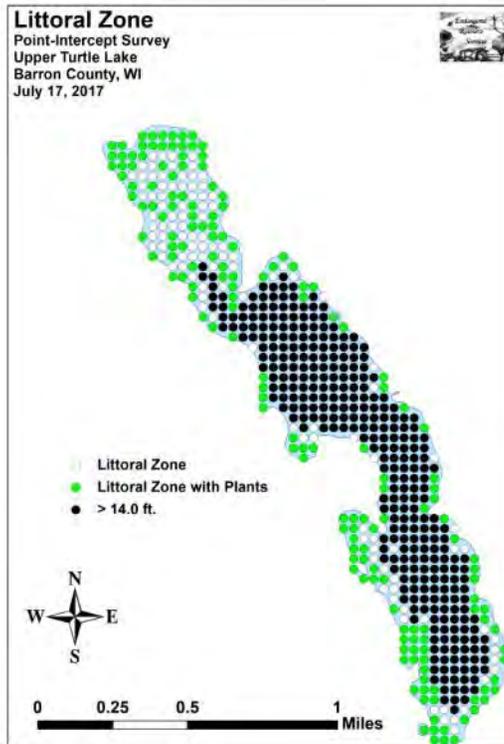
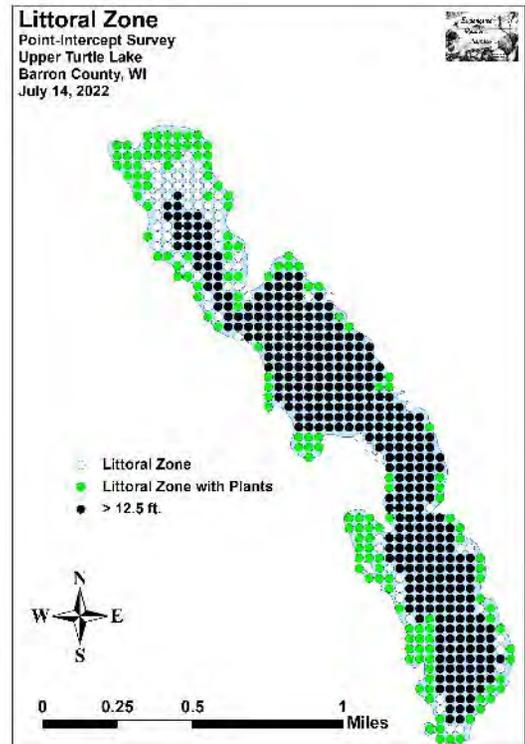
Figure 7: 2010, 2017, and 2022 Littoral Zone

**Maximum Depth of Plant Colonization
Upper Turtle Lake - Barron County, WI
July 8-9, 2010, July 17, 2017, and July 14, 2022**

In July 2022, we found plants growing to 12.5ft (down from 14.0ft in 2017 and 13.5ft in 2010) (Table 2). The 155 points with vegetation (approximately 26.1% of the entire lake bottom and 66.8% of the littoral zone) were a non-significant decline ($p=0.60$) from 2017 when we found plants at 163 sites (27.4% of the entire lake bottom/59.7% of the littoral zone). This decline was also non-significant ($p=0.47$) when compared to the 166 points with vegetation found during the 2010 survey (27.9% total coverage/62.6% littoral coverage) (Figure 7) (Appendix V).

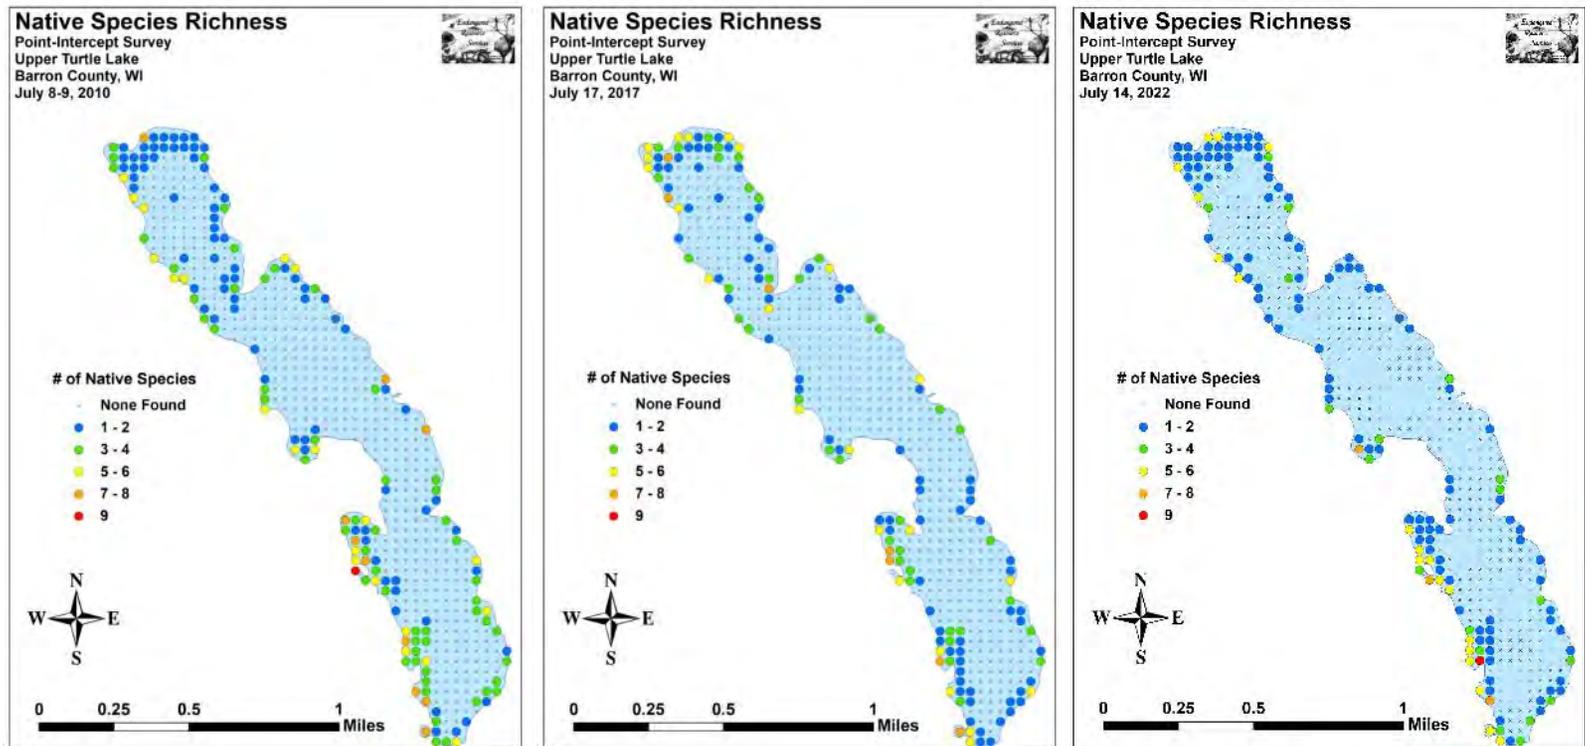
Figure 9: 2010, 2017, and 2022 Native Species Richness

In 2022, we recorded a further and highly significant decline ($p<0.001$) to 2.17 species/site. Although these losses in localized richness appeared to be a lakewide event, they were especially pronounced in the north bay (Figure 9) (Appendix V).

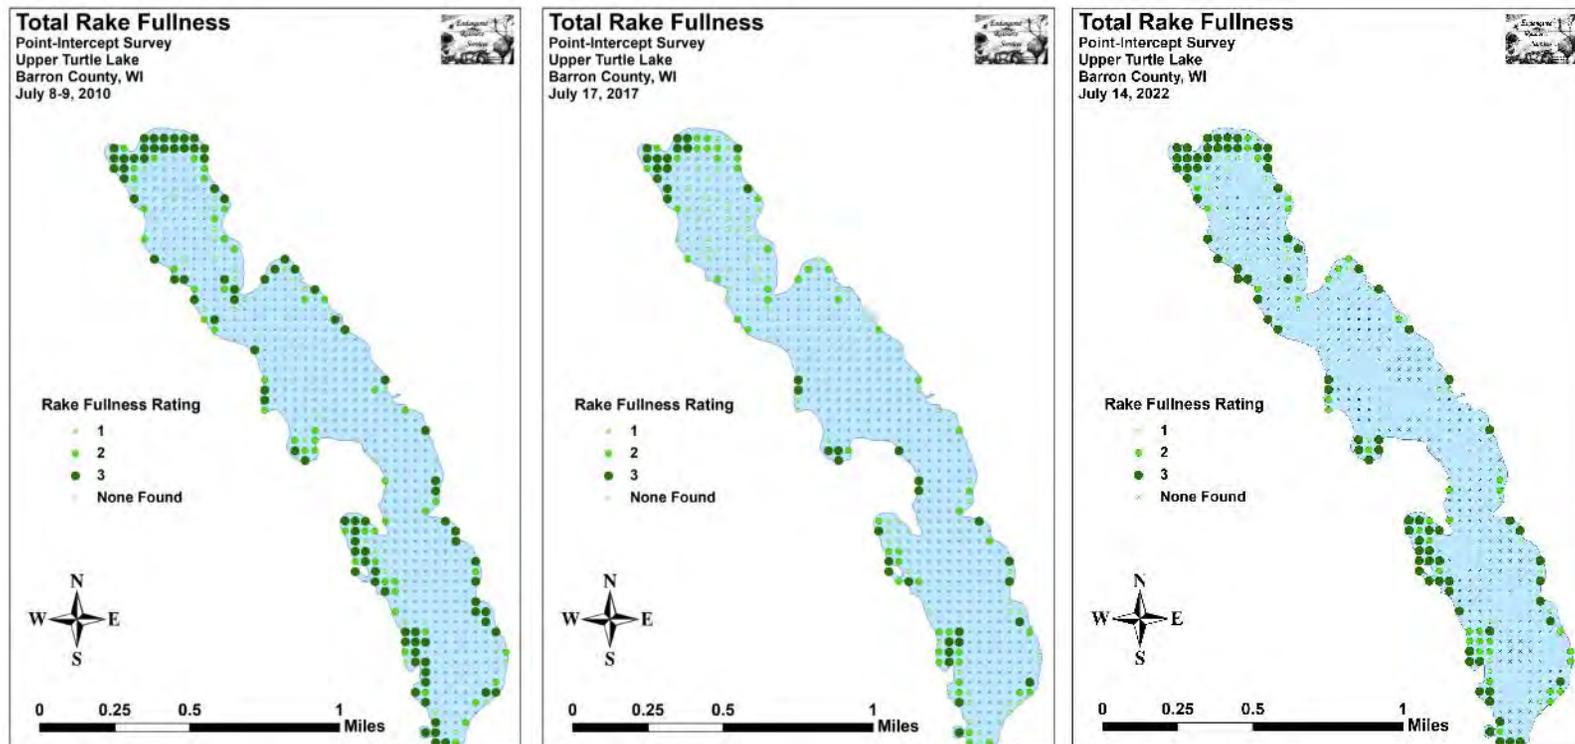
Figure 10: 2010, 2017, and 2022 Total Rake Fullness

Total rake fullness experienced a highly significant decline ($p<0.001$) from a high/moderate 2.33 in 2010 to a low/moderate 1.79 in 2017. We noted this decline was a lakewide event, and, with few exceptions, the only sizable remaining high-density beds occurred near the creek inlet and in shallow water near shore in the most nutrient-rich bays.

In 2022, the lake's biomass underwent a highly significant rebound ($p<0.001$) to a high/moderate 2.32 – nearly identical to 2010 levels. Interestingly, analysis of the maps showed localized rake density from the 2010 and 2022 surveys were almost identical in all parts of the lake (Figure 10) (Appendix V).

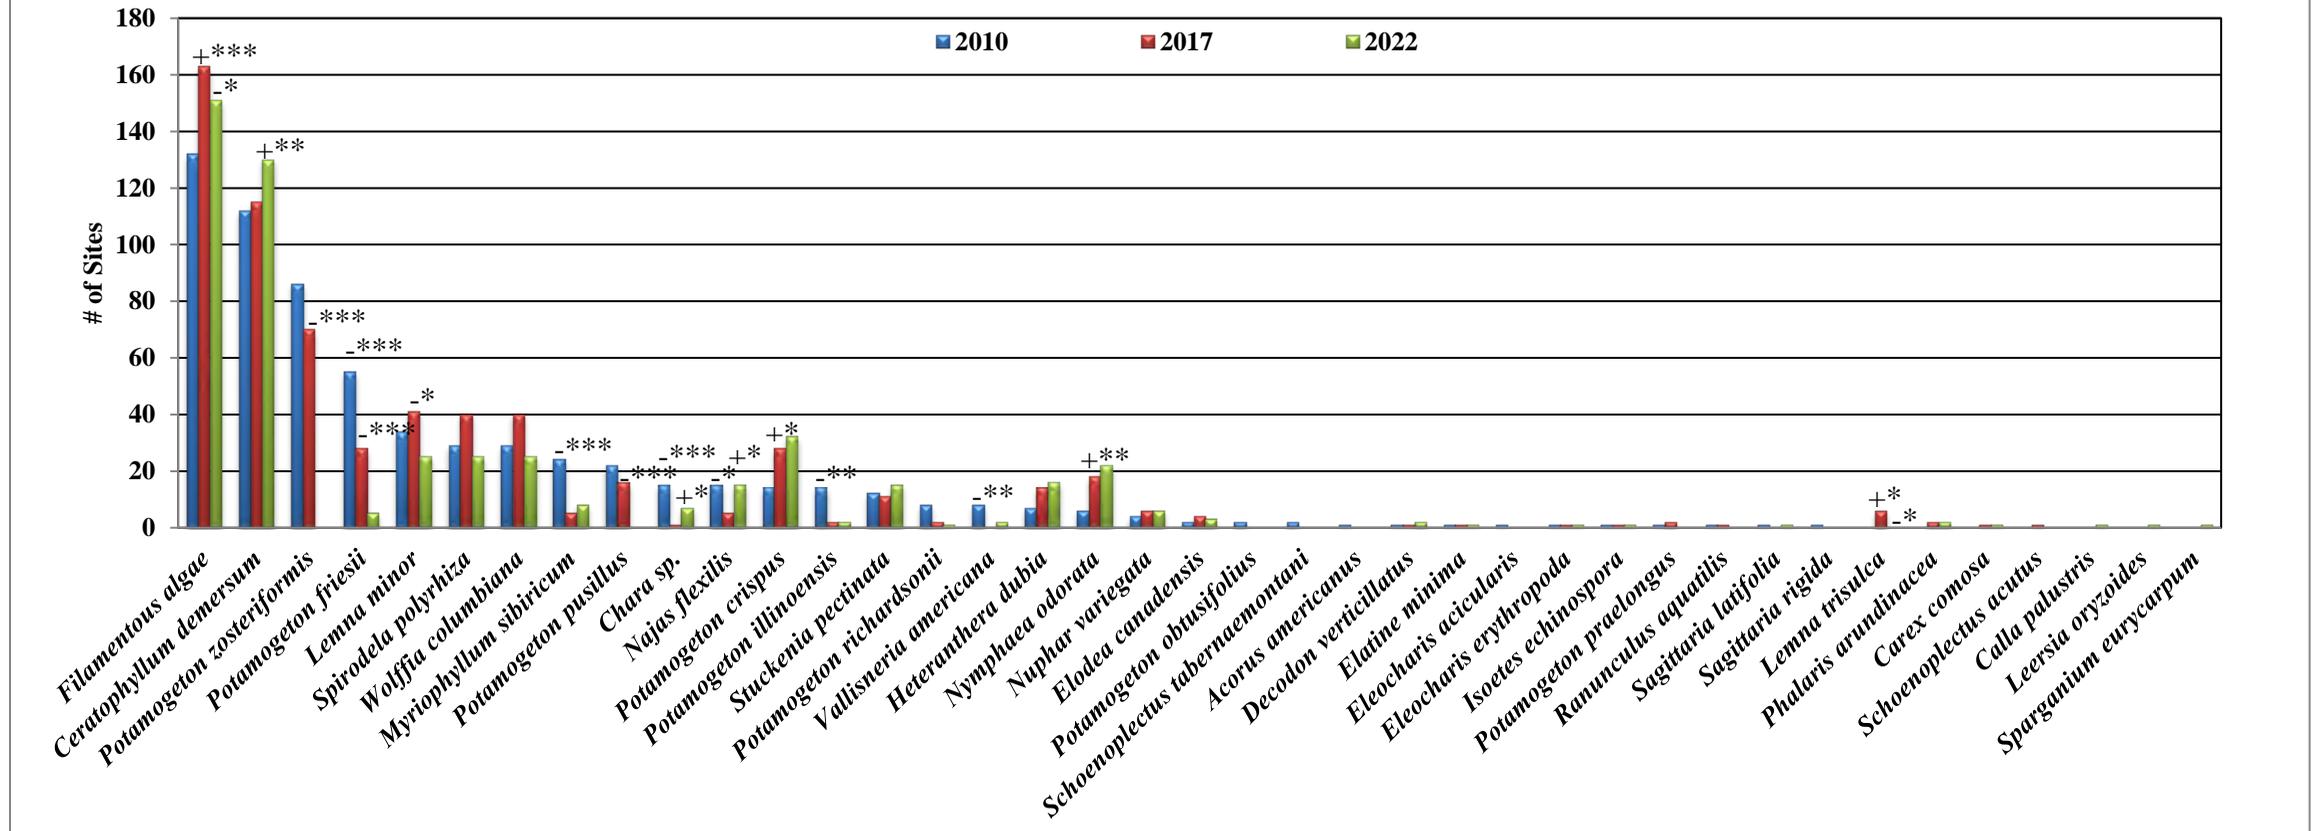
Figure 11: Changes for All Macrophytes – 2010, 2017, and 2022

Differences for All Species Upper Turtle Lake - Barron County, WI July 8-9, 2010, July 17, 2017, and July 14, 2022

Significant differences = * $p < 0.05$, ** $p < 0.01$, *** $p < 0.001$

Lakewide, ten species showed significant changes in distribution from 2010 to 2017 (Figure 11). Fries' pondweed, Northern water-milfoil, and Muskgrass suffered highly significant declines ($p < 0.001$); Illinois pondweed and Wild celery underwent moderately significant declines ($p = 0.002/p = 0.005$); and Slender naiad saw a significant decline ($p = 0.002$). Conversely, filamentous algae demonstrated a highly significant increase ($p < 0.001$); White water lily had a moderately significant increase ($p < 0.01$); and Curly-leaf pondweed and Forked duckweed experienced significant increases ($p = 0.02/p = 0.01$). Taken as a whole, these results suggested the lake had undergone a habitat shift away from rooted species that need at least fair water clarity toward species that can tolerate poor clarity (White water lily), favor high suspended nutrient levels (duckweeds and filamentous algae), and exploit disturbance (Curly-leaf pondweed).

From 2017 to 2022, nine species saw significant changes in distribution (Figure 11). Flat-stem pondweed, Fries' pondweed, and Small pondweed suffered highly significant declines ($p < 0.001$); and filamentous algae, Small duckweed, and Forked duckweed saw significant declines ($p = 0.04/p < 0.05/p = 0.02$). Conversely, Coontail underwent a moderately significant increase ($p = 0.005$); and Slender naiad and Muskgrass each experienced significant increases ($p = 0.02/p = 0.03$). The declines in the formerly dominant pondweeds – which are all sensitive to the chemical used to control CLP (Endothall) – are likely tied to the management program, while Coontail's increase may be in response to its ability to rapidly exploit open habitat.

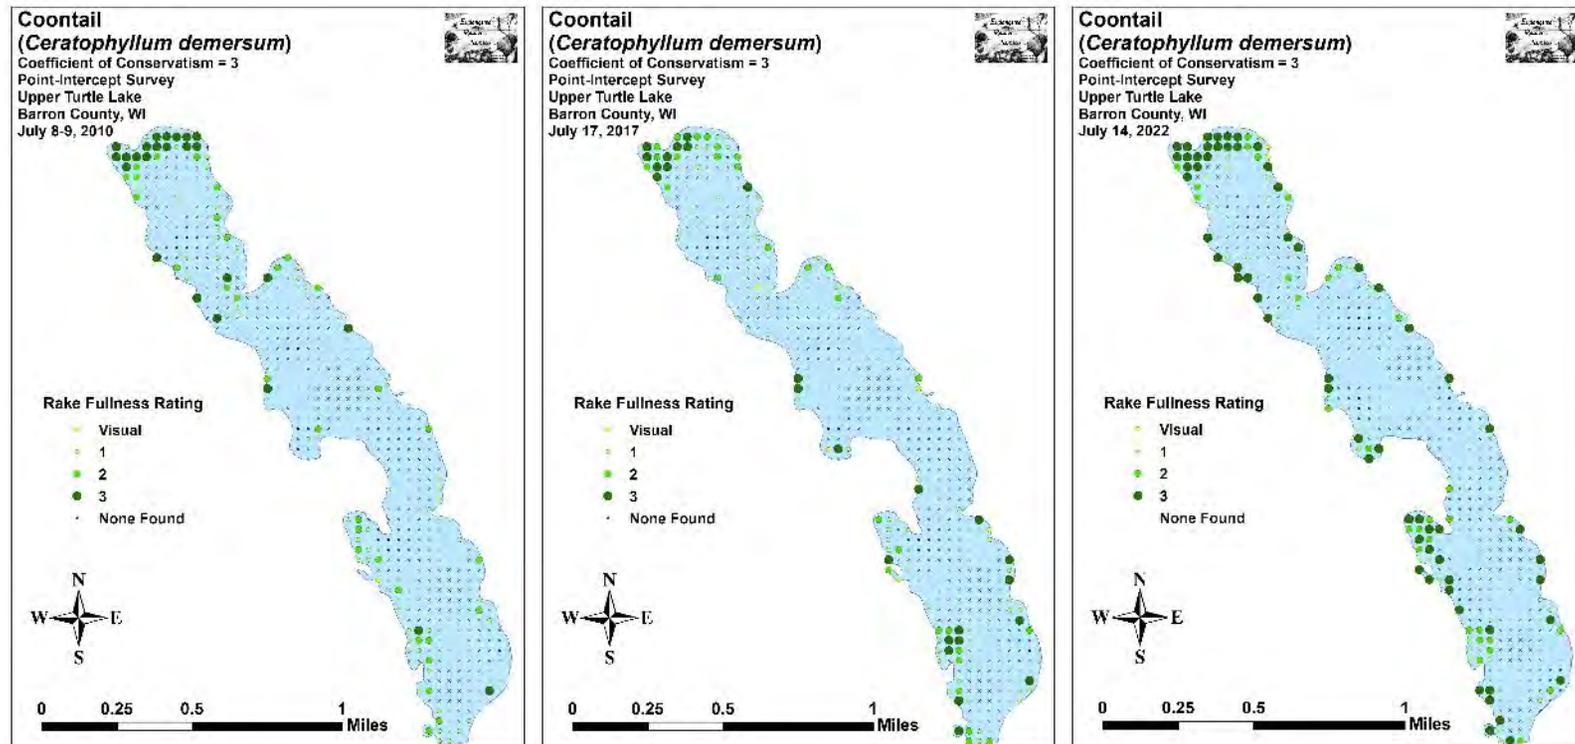
Figure 12: 2010, 2017, and 2022 Coontail Density and Distribution

Found throughout the lake's organic muck bottom bays, Coontail was the most common macrophyte species in 2010, 2017, and 2022. From 2010 to 2017, we noted that both its overall distribution (112 points in 2010/115 in 2017) and density (mean rake fullness of 1.73 in 2010/1.71 in 2017) were essentially unchanged; however, visual analysis of the maps showed it declined in the north bay (presumably in response to competition from CLP and mats of filamentous algae shading it out) but expanded throughout the southern 2/3rds of the lake (likely at the expense of more sensitive species) (Figure 12).

Following four years of treatment that greatly reduced CLP levels (as well as many other early-season pondweeds), the 2022 survey found Coontail had undergone a moderately significant increase ($p=0.005$) in distribution (130 sites) and a highly significant increase ($p<0.001$) in density (mean rake fullness of 2.21). These increases were lakewide and also significant relative to the original survey.

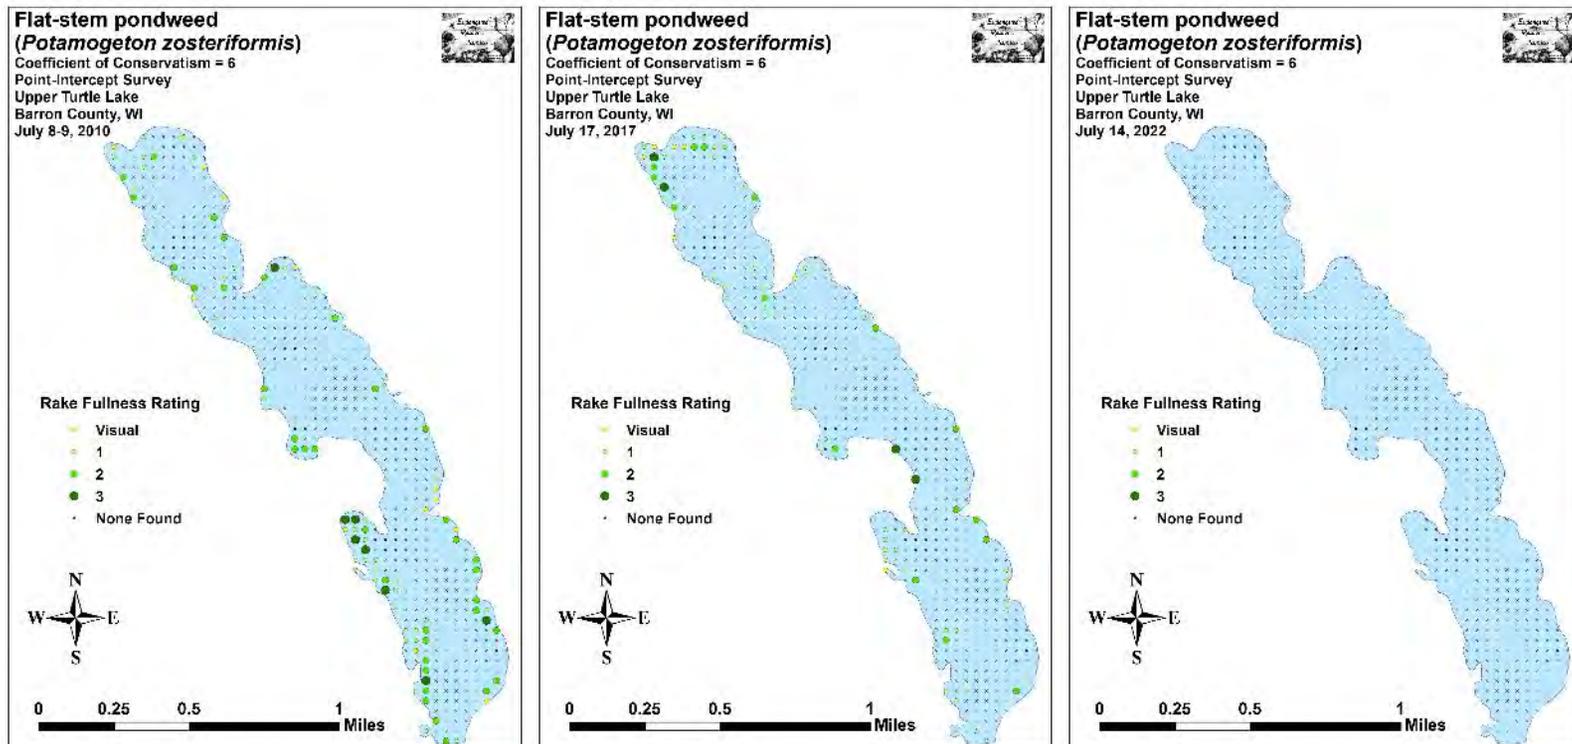
Figure 13: 2010, 2017, and 2022 Flat-stem Pondweed Density and Distribution

The 2022 survey found Flat-stem pondweed had undergone highly significant declines ($p<0.001$) in both distribution and density. In fact, the only sign of this formerly dominant species was a few scattered individuals we found during the boat survey that was growing nearshore in a sheltered bay. A species that is extremely sensitive to Endothall, we have seen similar declines with this species in other systems following widescale multi-year treatment programs targeting Curly-leaf pondweed. This species loss in coverage may also help explain Coontail's expansion as its growth mirrors areas where Flat-stem was formerly the dominant species.

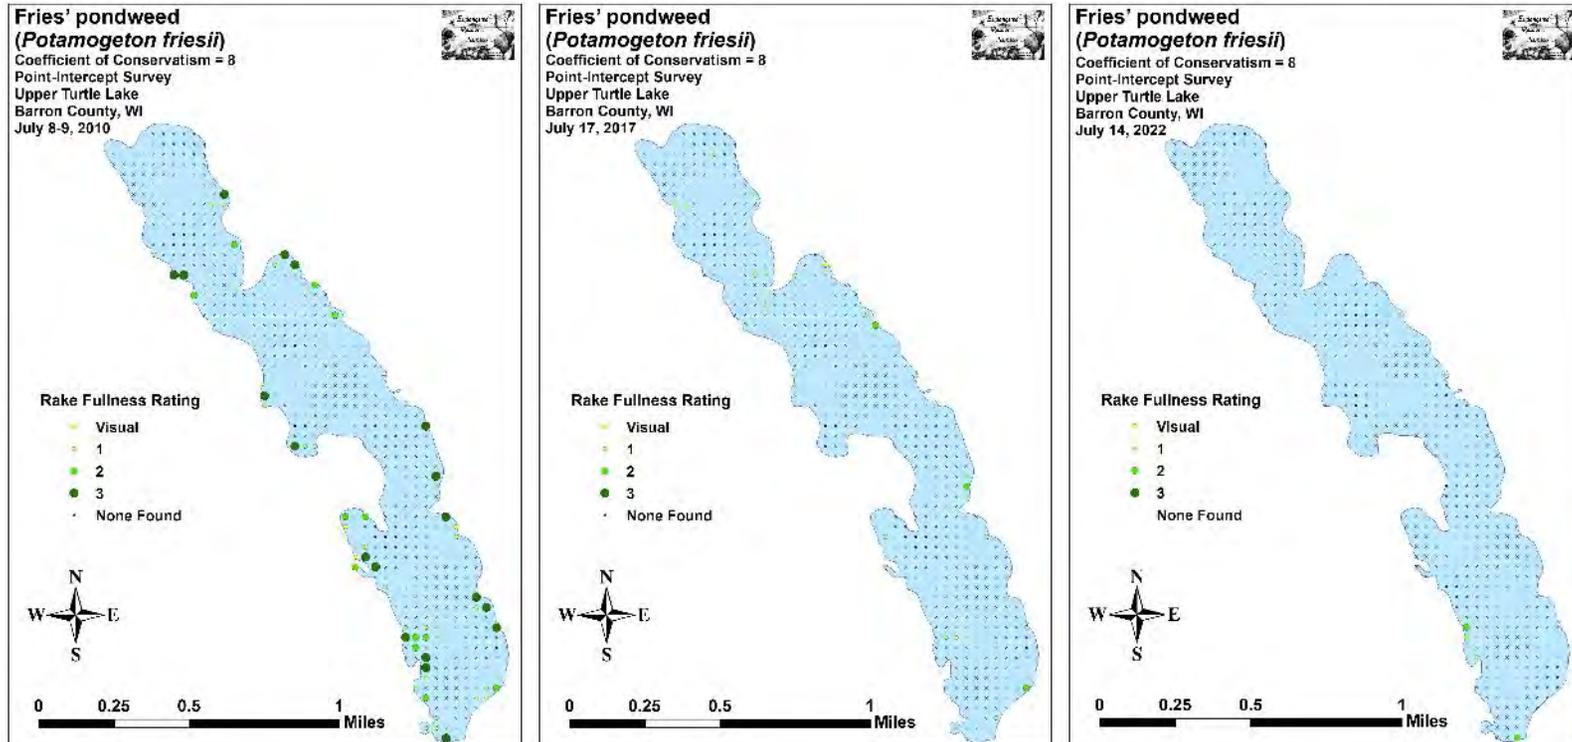
Figure 14: 2010, 2017, and 2022 Fries' Pondweed Density and Distribution

Another species that is sensitive to Endothall, the 2022 survey documented a further highly-significant decline ($p < 0.001$) in distribution (five sites). A formerly wide-spread species, we found Fries pondweed was now essentially restricted to the southwest shoreline. Despite this loss in coverage, it saw a nearly-significant increase ($p = 0.15$) in localized biomass as we calculated a mean rake fullness of 1.40.

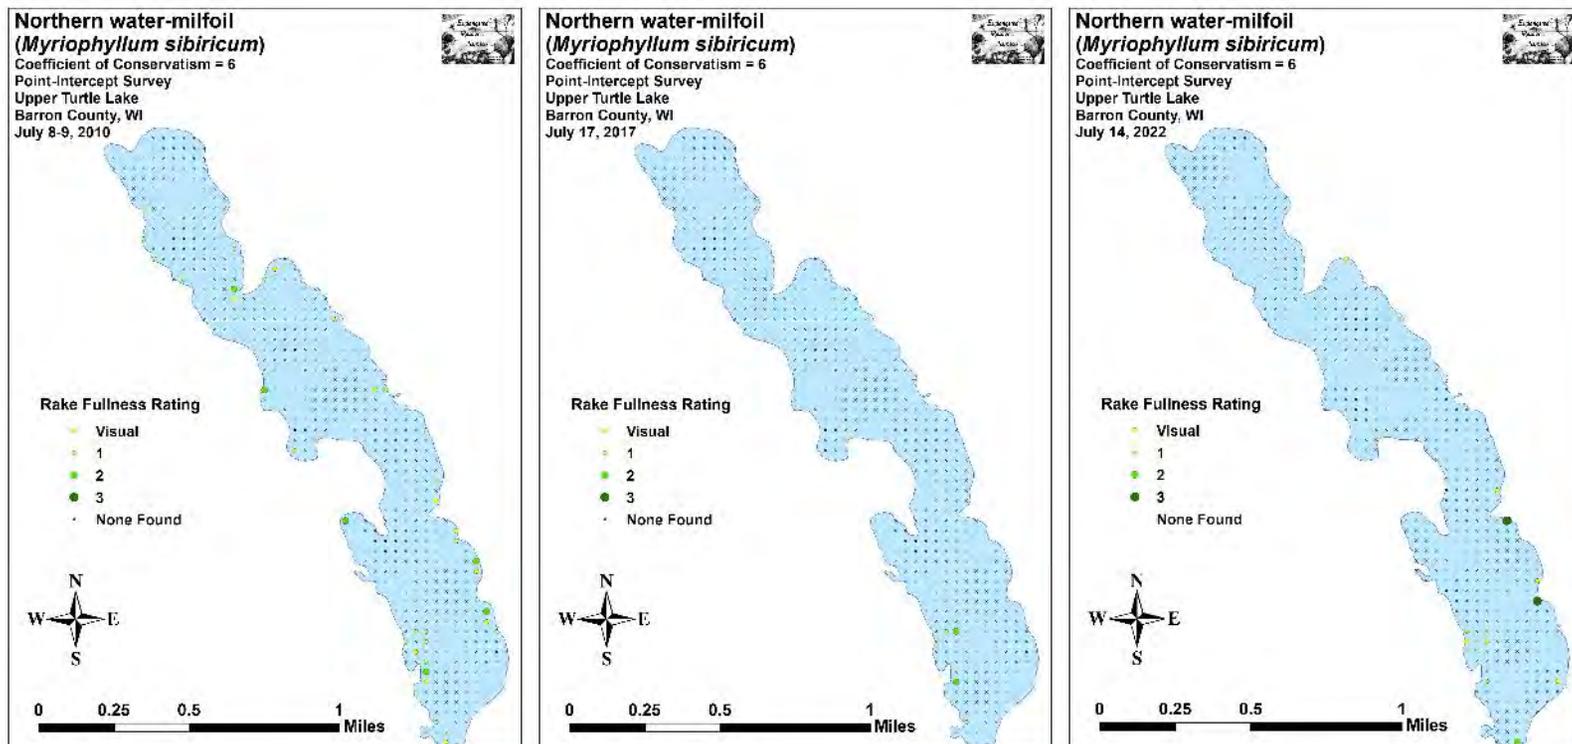
Figure 15: 2010, 2017, and 2022 Northern Water-milfoil Density and Distribution

In 2022, Northern water-milfoil increased both its distribution (eight points) and density (mean rake fullness of 1.63), but, once again, neither of these changes were significant ($p = 0.35/p = 0.30$). Even with this expansion, it fell to the tenth-ranked species in the overall community.

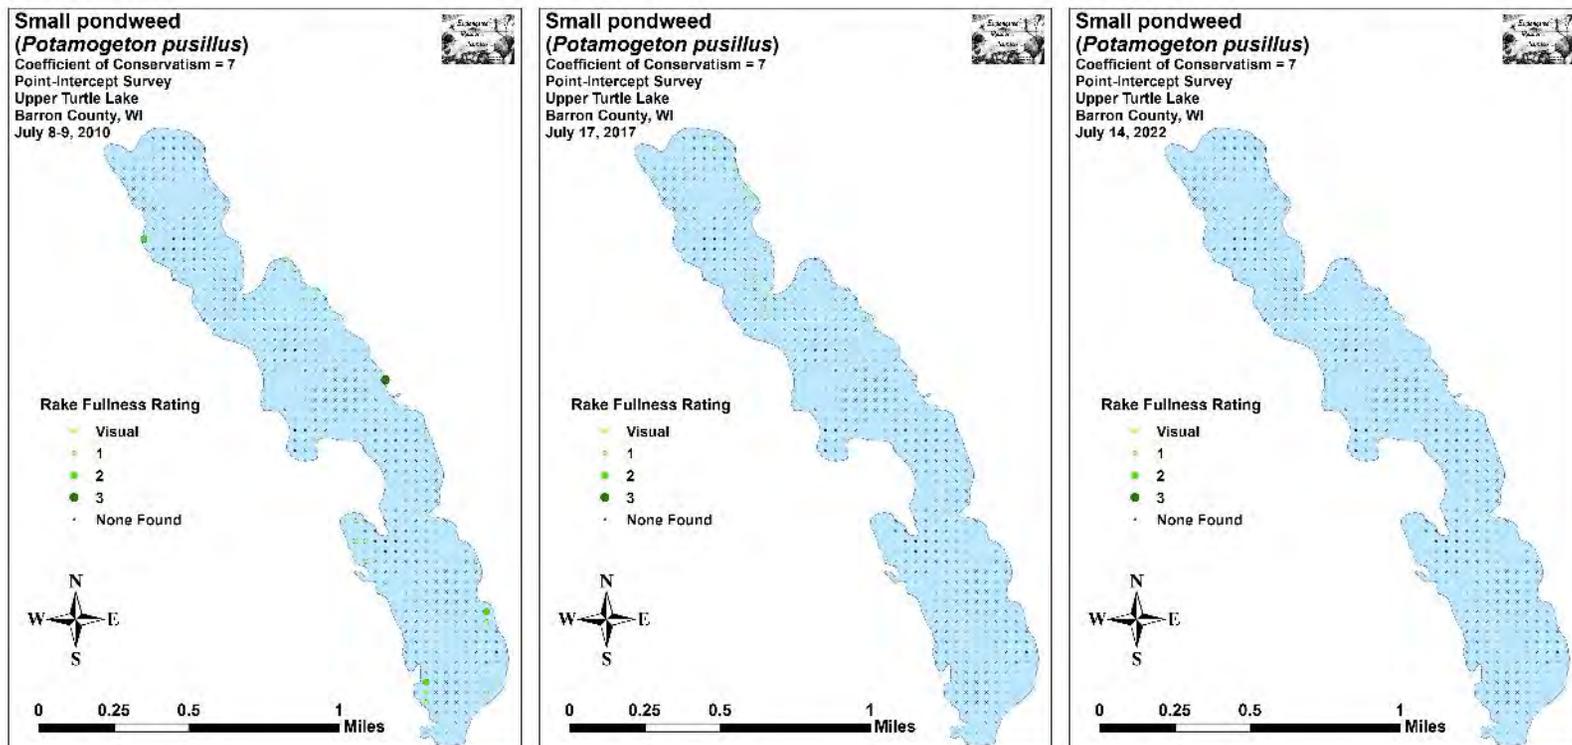
Figure 16: 2010, 2017, and 2022 Small Pondweed Density and Distribution

In 2010, Small pondweed was the eight most common species in the macrophyte community (22 sites/mean rake 1.23) (Figure 16). Despite a non-significant decline ($p=0.33$) in distribution and a significant decline ($p=0.03$) in density, we found it was still the ninth-ranked species in 2017. Similar to Flat-stem pondweed and Fries' pondweed, Small pondweed is extremely sensitive to Endothall, and we've documented its near or complete disappearance in several other systems that embarked on lakewide chemical management programs for Curly-leaf pondweed. Because of this, we weren't surprised that we found no evidence of this species in the lake during our 2022 survey. Statistically, this reduction in both distribution and density was highly significant ($p<0.001$).

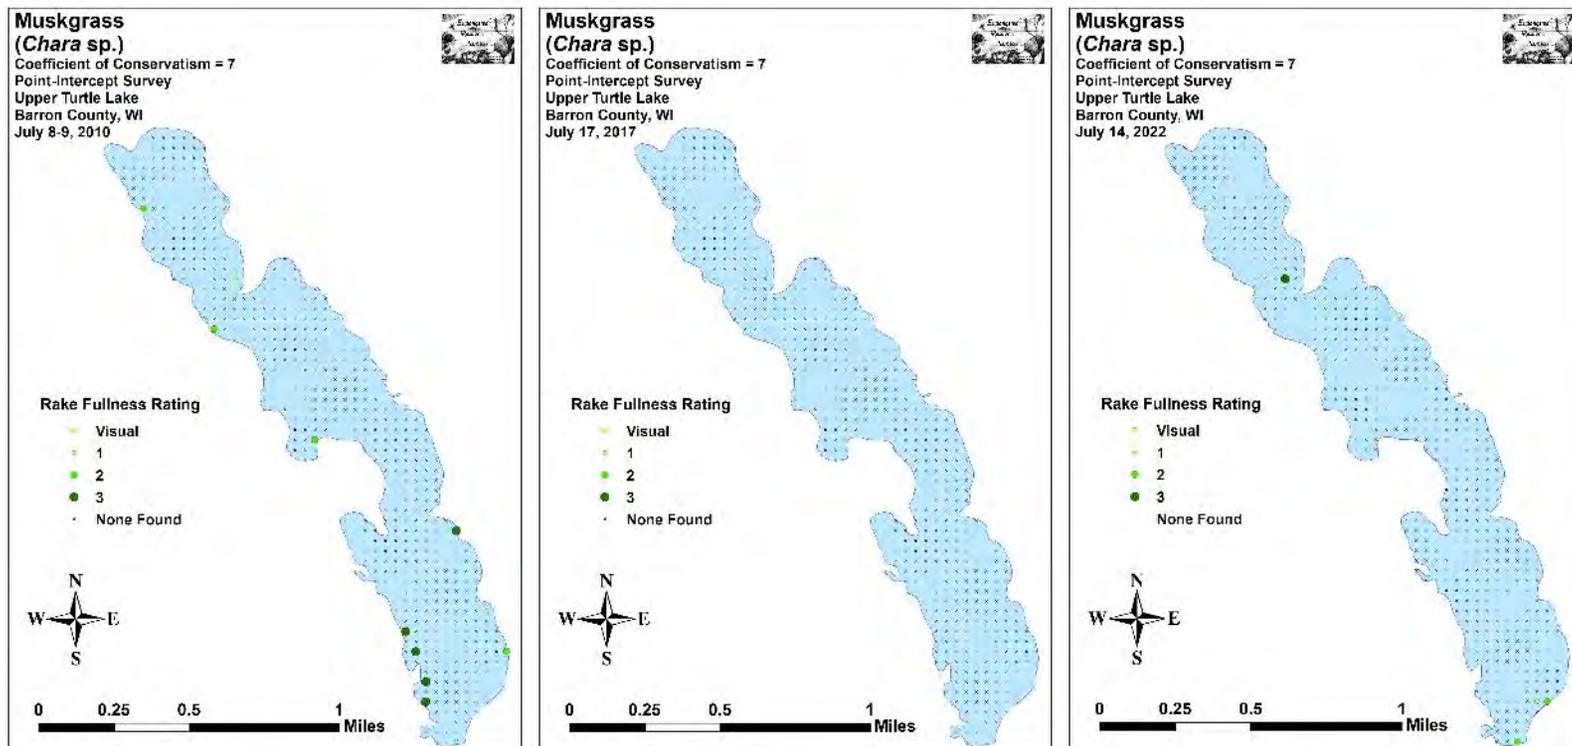
Figure 17: 2010, 2017, and 2022 Muskgrass Density and Distribution

We found carpets of Muskgrass were abundant and widespread in shallow sandy shoreline areas during our original survey when this species was the ninth most common macrophyte (15 sites/mean rake 1.93) (Figure 17). The 2017 survey documented highly significant declines ($p<0.001$) in both distribution and density as the species nearly disappeared from the lake – a single individual was found in the rake at one point.

In 2022, we again found Muskgrass throughout the lake albeit at much lower levels than in 2010. The eleventh most common species in the lake, it was present at seven points with a mean rake fullness of 1.57. This represented a significant increase ($p=0.03$) in distribution, and a highly significant increase ($p<0.001$) in density.

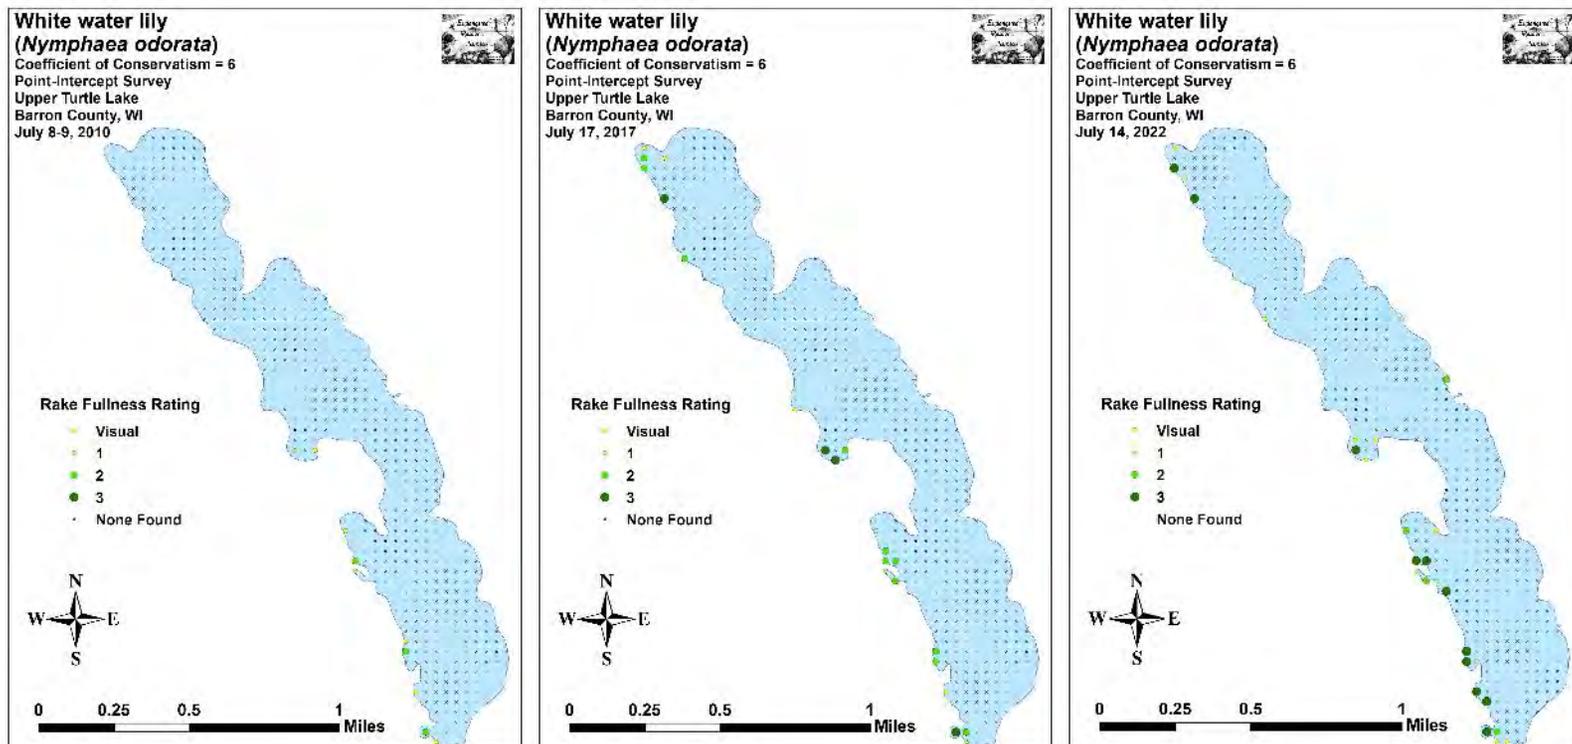
Figure 18: 2010, 2017, and 2022 White Water Lily Density and Distribution

Perhaps no species benefitted more from the changes on the lake than White water lily. Present in the rake at six points with a mean density of 1.50, it was just the seventeenth-ranked species during the original 2010 survey. By 2017, we found it had undergone a moderately significant increase ($p<0.01$) in distribution (18 points) and a significant increase ($p=0.03$) in density (mean rake fullness of 2.06) as it rose to the eight-ranked species in the community (Figure 18). In 2022, it jumped to the sixth-ranked species as it continued to expand – primarily along the western shoreline. Although neither the increase in distribution (22 sites) nor the increase in biomass (mean rake of 2.18) were significant compared to 2017 ($p=0.40/p=0.30$), each of these values represented highly significant increases ($p<0.01$) compared to the original 2010 survey.

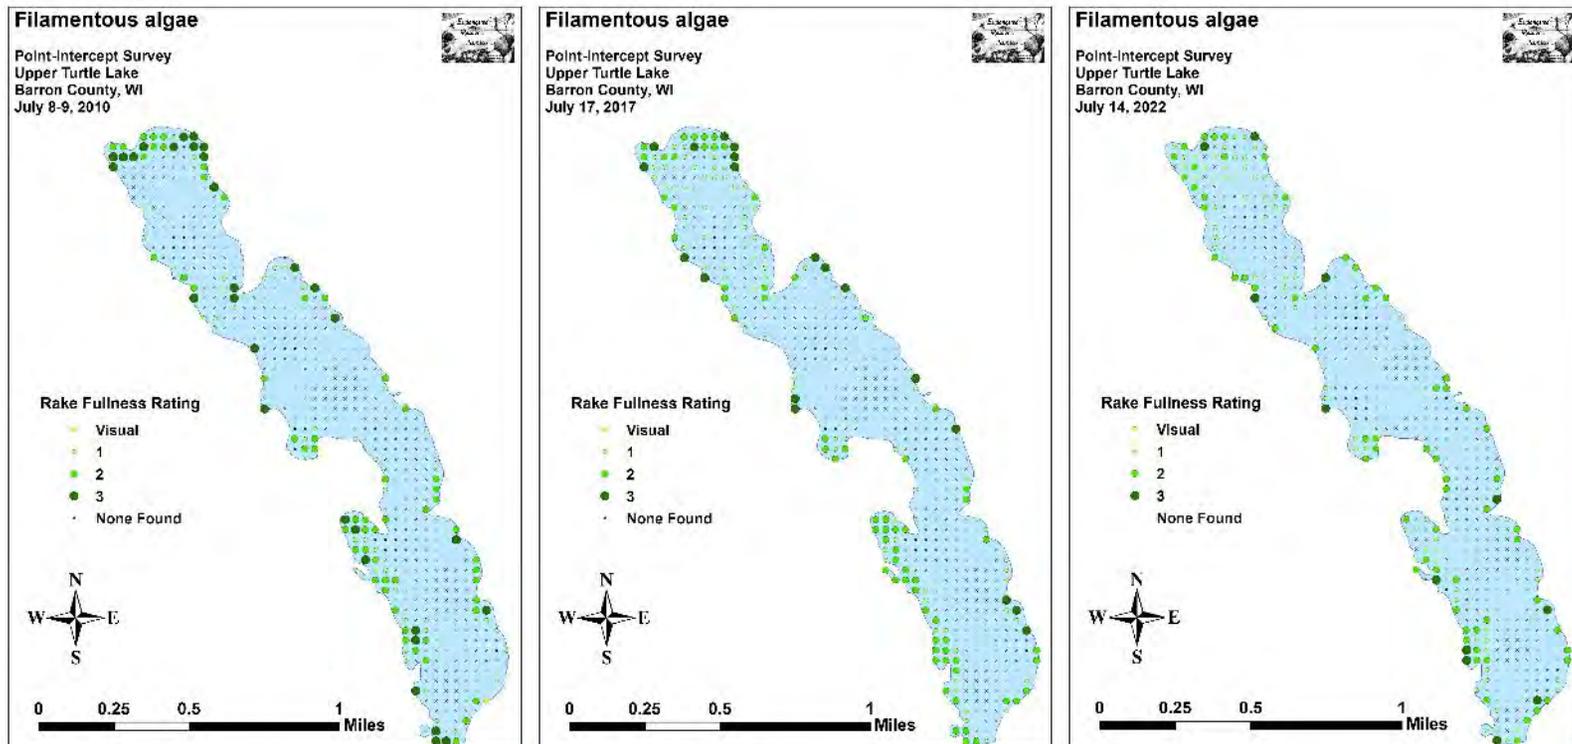
Figure 19: 2010, 2017, and 2022 Filamentous Algae Density and Distribution

Our 2022 survey found filamentous algae had undergone a significant decline ($p=0.04$) in distribution to 151 sites. In addition to this loss in coverage, the mean rake fullness declined to 1.59; however, this was not significant ($p=0.21$). Comparing the 2010 baseline to 2022 confirmed an overall highly significant increase ($p<0.001$) in distribution, but an equally significant decline ($p<0.001$) in density.
