**Curly-leaf pondweed (*Potamogeton crispus*)
Point-intercept and Bed Mapping Surveys, and
Warm-water Point-intercept Macrophyte Survey
Upper Turtle Lake - WBIC: 2079800
Barron County, Wisconsin**

Endangered Resource Services, LLC
Matthew S. Berg, Research Biologist
St. Croix Falls, Wisconsin
June 11 and July 14, 2022

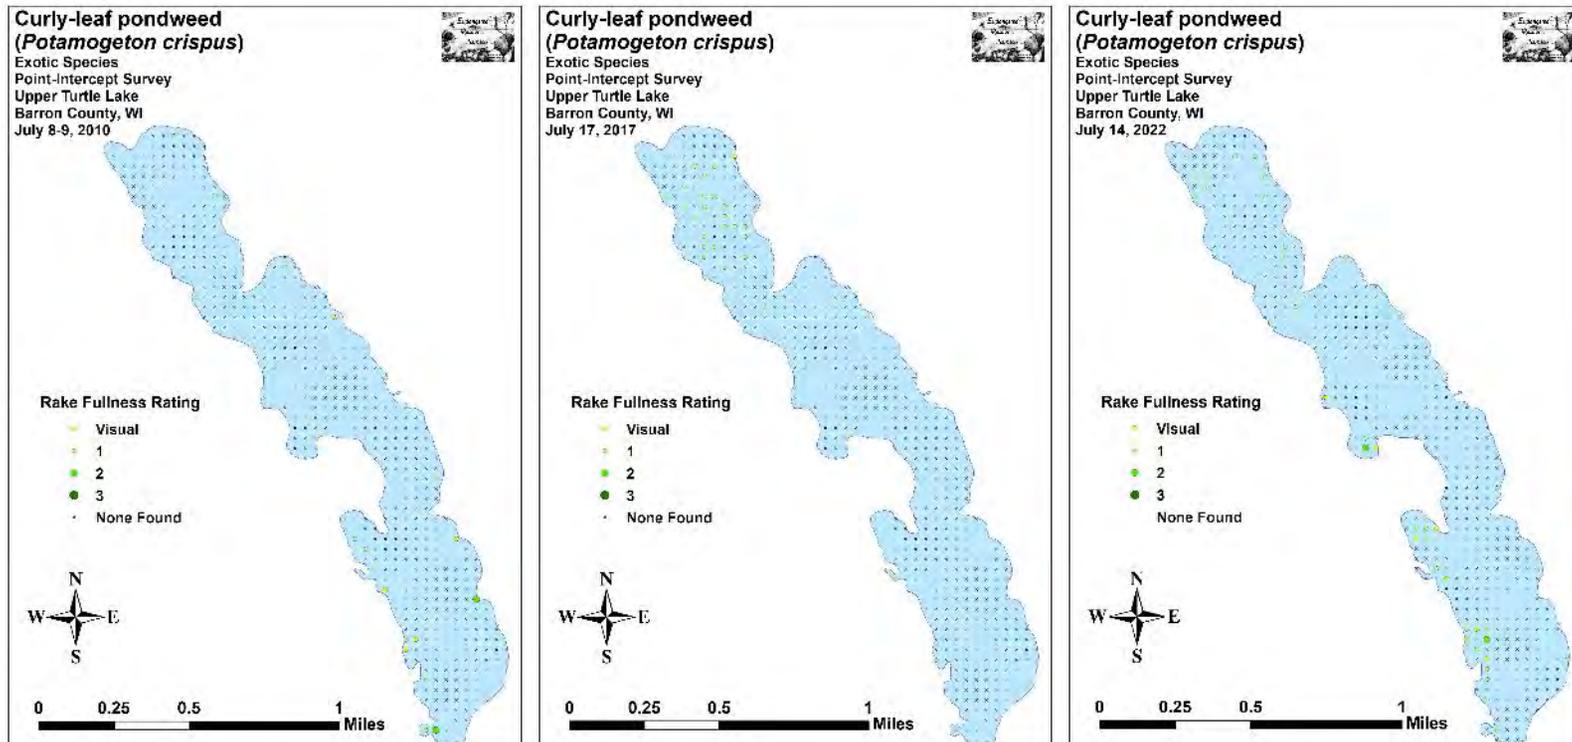
Figure 20: 2010, 2017, and 2022 Midsummer Curly-leaf Pondweed Density and Distribution

Curly-leaf pondweed normally completes its annual life cycle by late June, and most plants have set turions and senesced by early July. In 2010, CLP was still present at 14 points (mean rake fullness 1.14) with five additional visual sightings (Figure 20) (Appendix X). Despite being a week later than the July 2010 survey, in 2017 we documented a significant increase ($p=0.02$) in distribution to 28 points (mean rake fullness of 1.00) with one additional visual sighting. This upward trend in distribution continued in 2022 as we found CLP at 32 sites with a mean rake of 1.06; however, neither of these increases were significant ($p=0.43/p=0.08$).

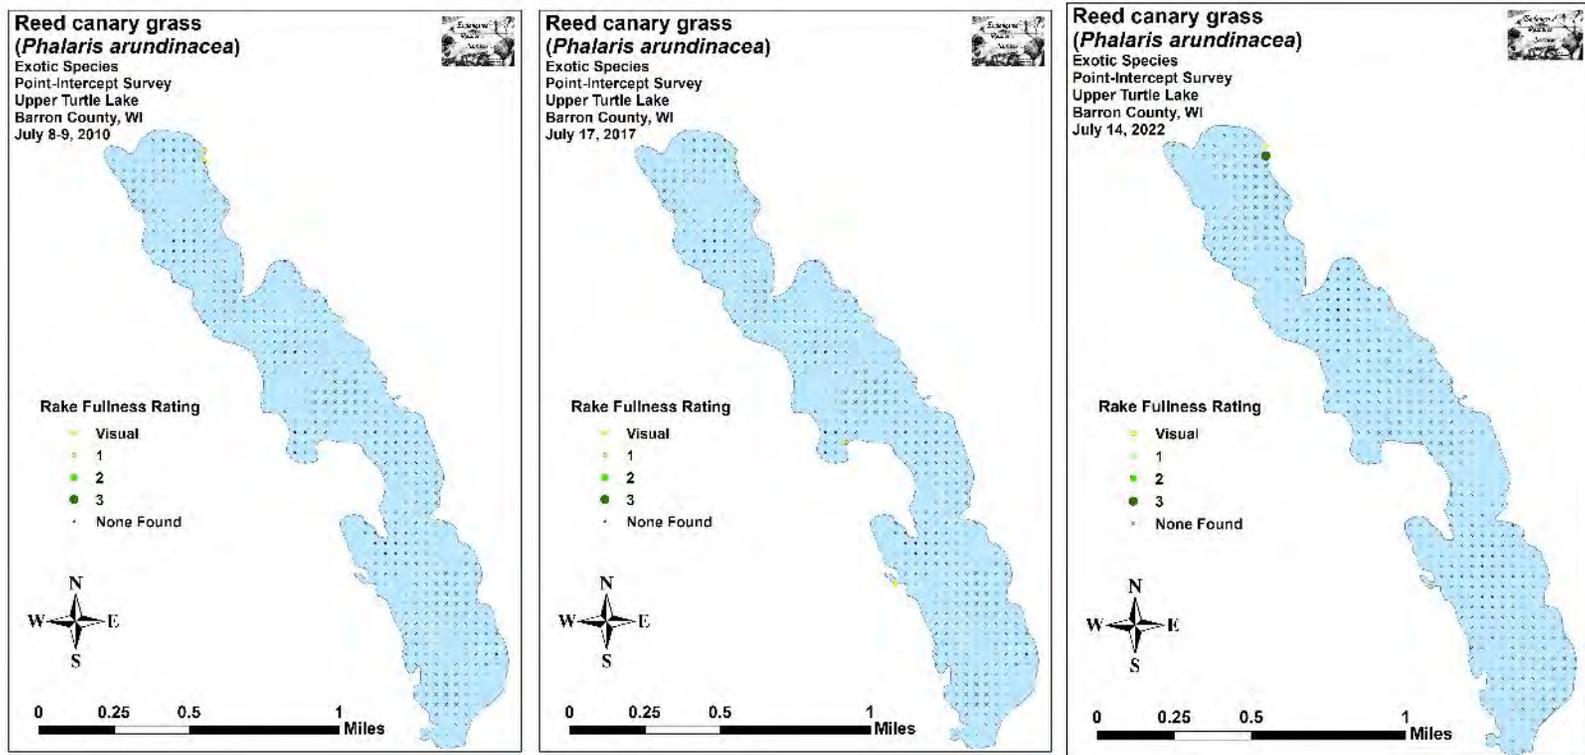
Figure 21: 2010, 2017, and 2022 Reed Canary Grass Density and Distribution

We did NOT find any evidence of Eurasian water-milfoil in Upper Turtle Lake during any of our surveys. However, in addition to Curly-leaf pondweed, we documented two other exotic species growing around the lake: Reed canary grass and Narrow-leaved/Hybrid cattail. Despite never being recorded in the rake at more than two points during any survey, Reed canary grass was often a dominant plant just beyond the lakeshore in adjacent wetlands and next to mowed or otherwise disturbed shoreline areas like cow pastures (Figure 21) (Appendix X). A ubiquitous plant in the state, there's likely little that can be done about it.

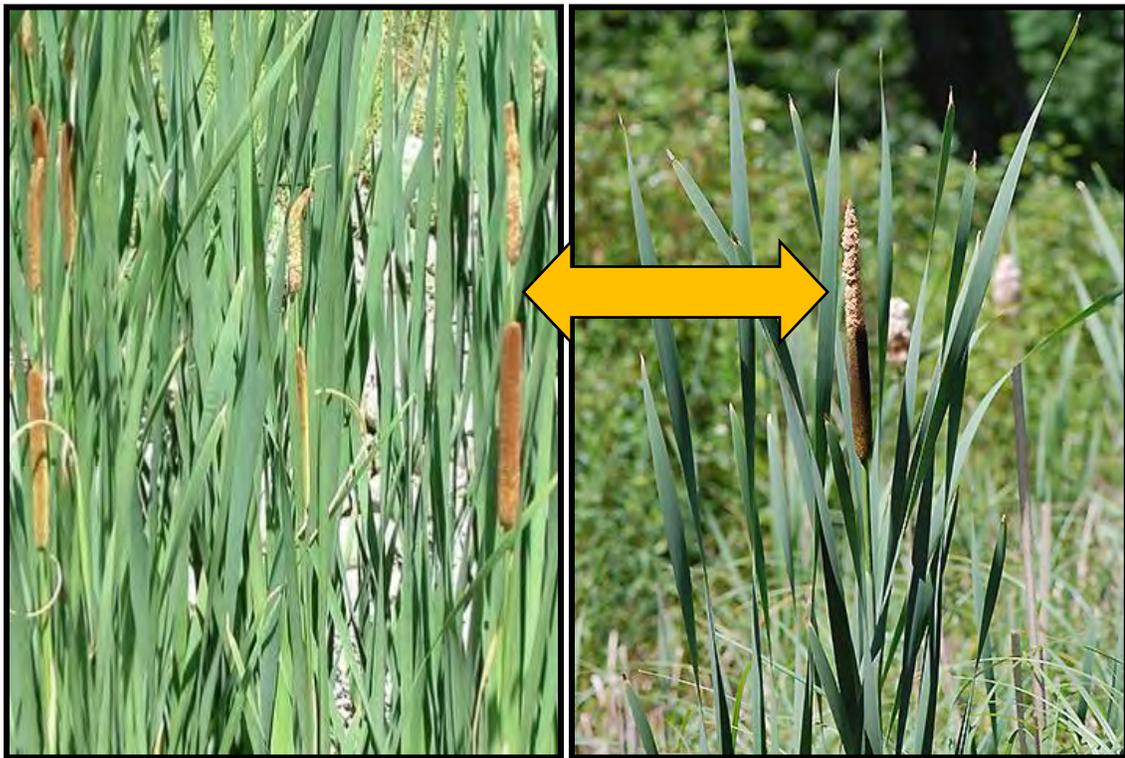
Figure 22: Exotic Hybrid and Native Broad-leaved Cattail Identification

Besides having narrower leaves, the exotics can be told from our native cattails by having a relatively narrower and longer “hotdog-shaped” tan female cattail flower, whereas our native species tends to produce a fatter and shorter “bratwurst-shaped” dark chocolate colored female flower. Narrow-leaved cattail and its hybrids also have a male flower that is separated from the female flower by a thin green stem while the native Broad-leaved cattail has its male and female flowers connected (Figure 22) (Density and distribution maps for all exotic species and information on a sampling of aquatic exotic invasive plant species are located in Appendix X).

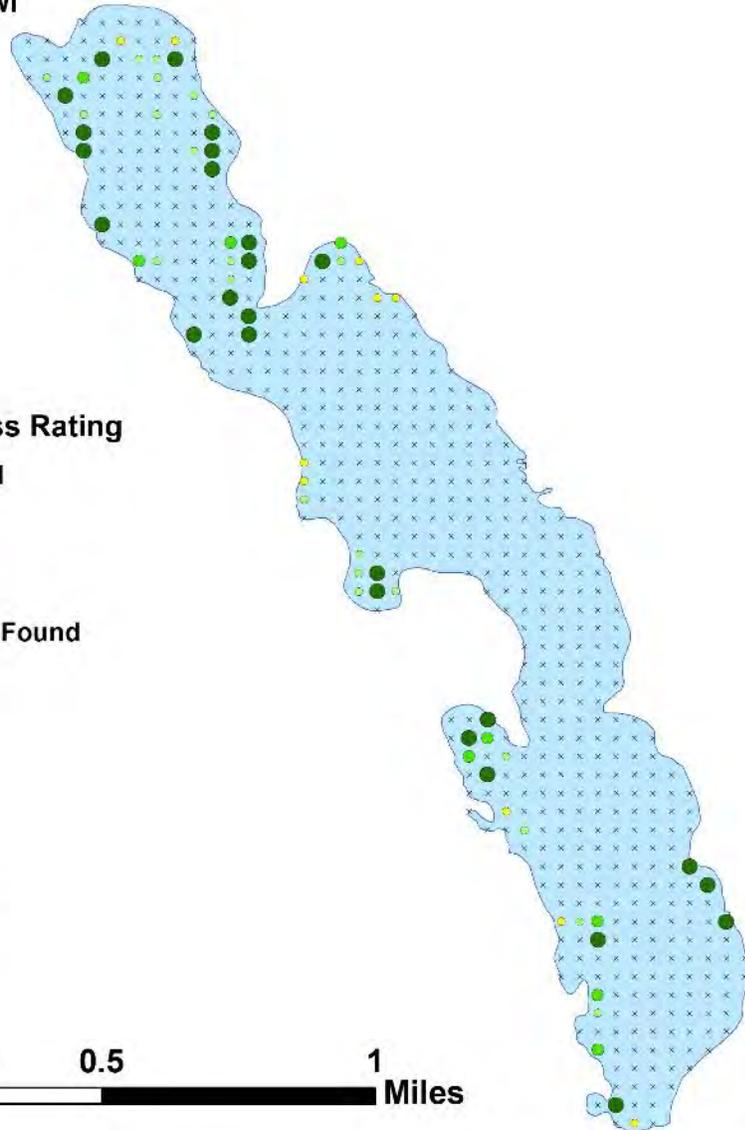
Curly-leaf pondweed (*Potamogeton crispus*)

Exotic Species
CLP Bed Mapping Survey
Upper Turtle Lake
Barron County, WI
May 29, 2010

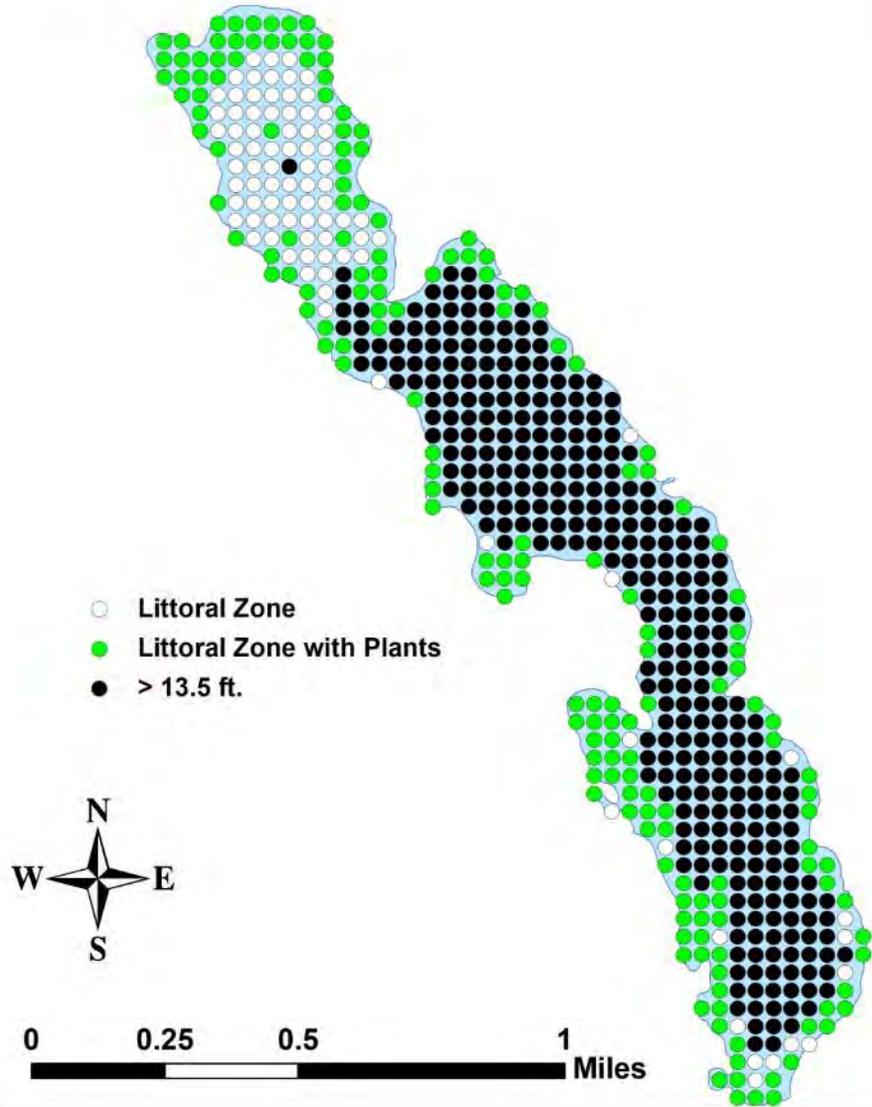
Littoral Zone
Point-Intercept Survey
Upper Turtle Lake
Barron County, WI
July 17, 2017

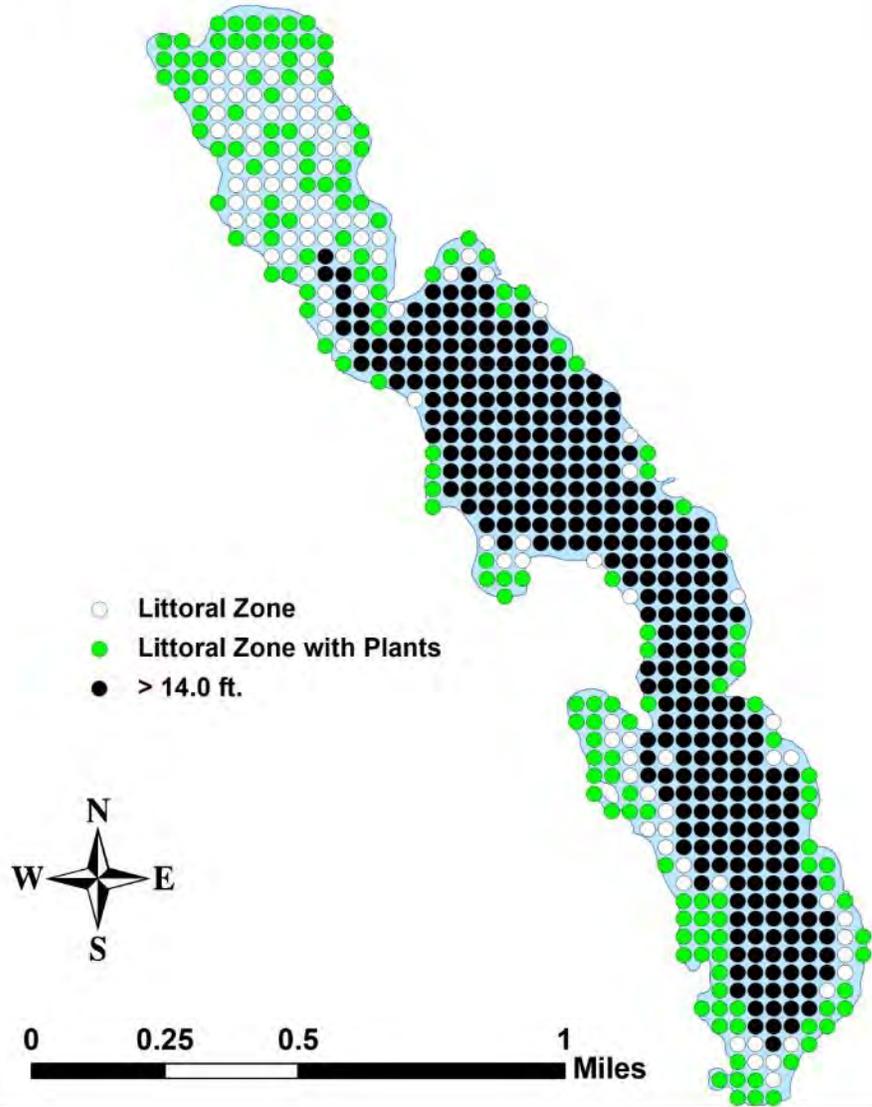
Littoral Zone
Point-Intercept Survey
Upper Turtle Lake
Barron County, WI
July 14, 2022
