SHERWOOD LAKE

LAKE CLASSIFICATION REPORT

NOVEMBER 2008

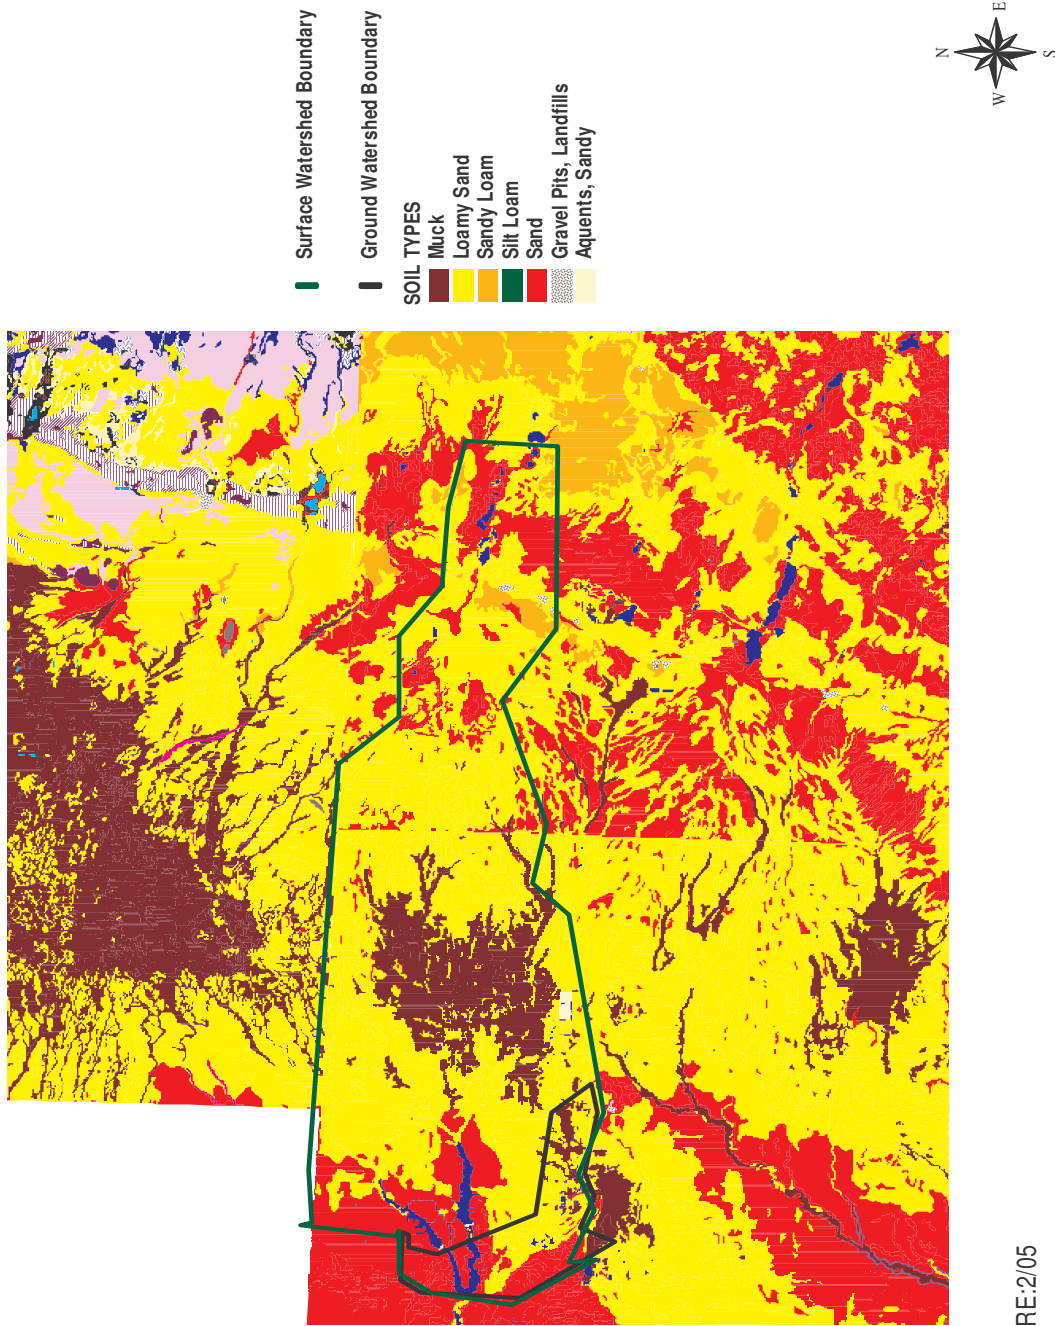
Figure 4: Sherwood Lake Soils

The soil and soil slopes around lakes and streams are very important to water quality. They affect amount of infiltration of surface precipitation into the ground and the amount of contaminants that may reach the groundwater, as well as the amount of

surface stormwater runoff. In addition, these two factors affect the amount and content of pollutants and particles (including soil) that may wash into a water body, affecting its water quality, its aquatic plant community and its fishery. Further, soil types and soil slopes help determine the appropriate private sewage system and other engineering practices for a particular site, since they affect absorption, filtration and infiltration of contamination from engineering practices.

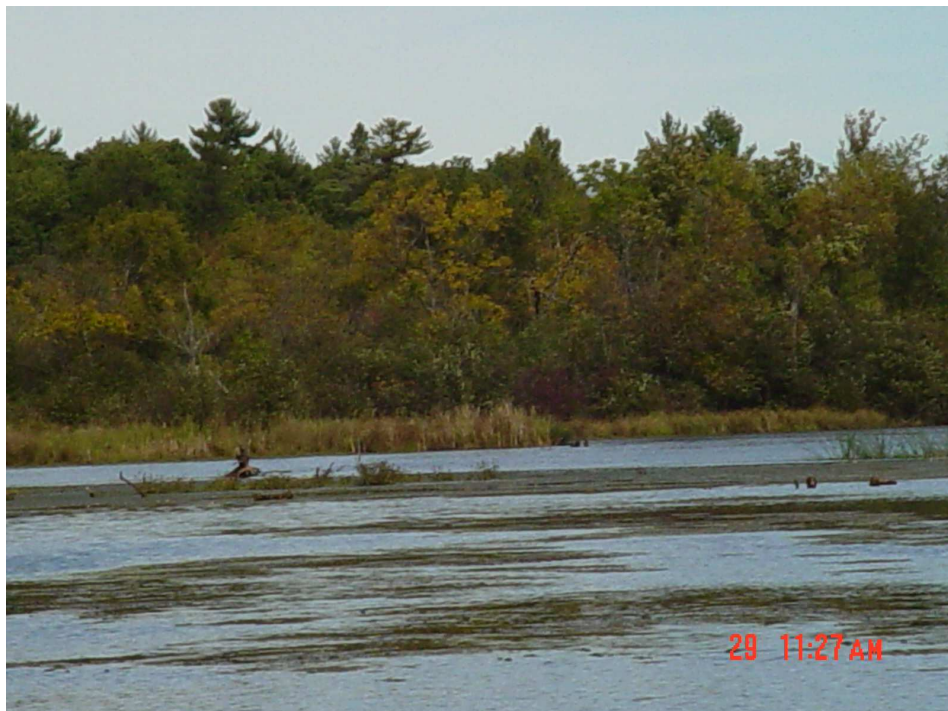
Figure 9:
Example of
lake end
wetland

The large areas of wetlands in the Sherwood Lake watersheds serve as filters and traps that help keep Sherwood Lake as clean as it is. It is essential to preserve these wetlands for the health of all the Tri-Lakes.

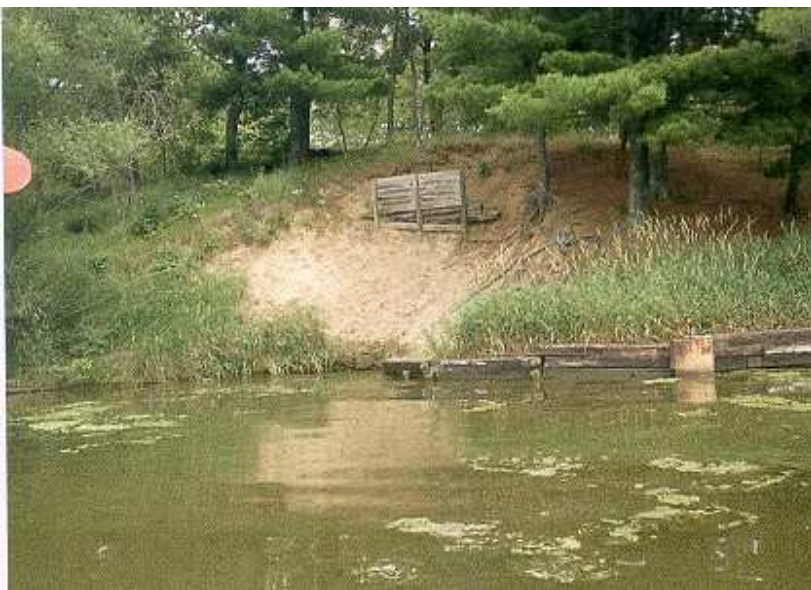
**Figure 11:
Example of Erosion
on Sherwood Lake**

Some of the Sherwood Lake shores were heavily eroded, as shown in Figure 11.

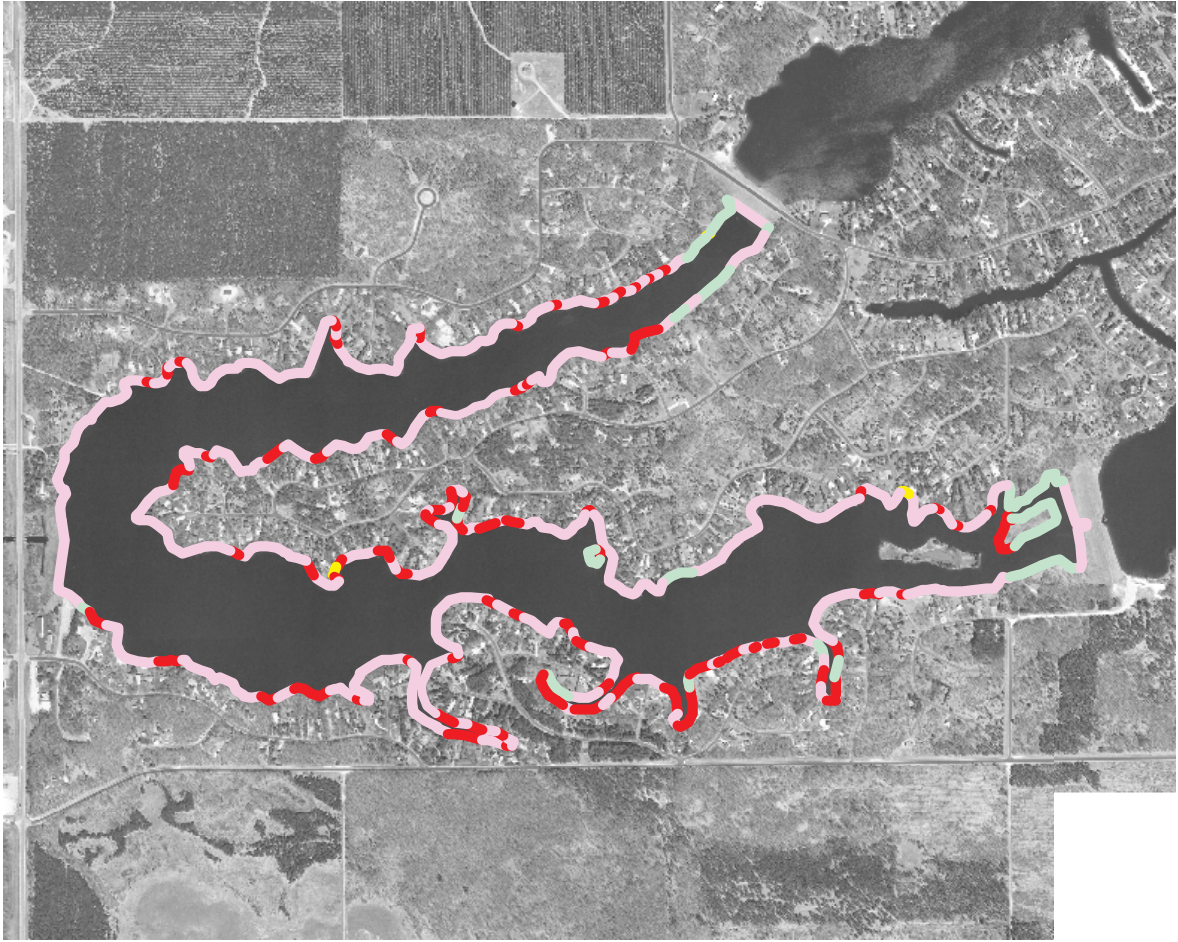
Sherwood Lake Shoreline

- Active Erosion
- Beach or Sand
- Rock or Seawall
- Vegetated Shore

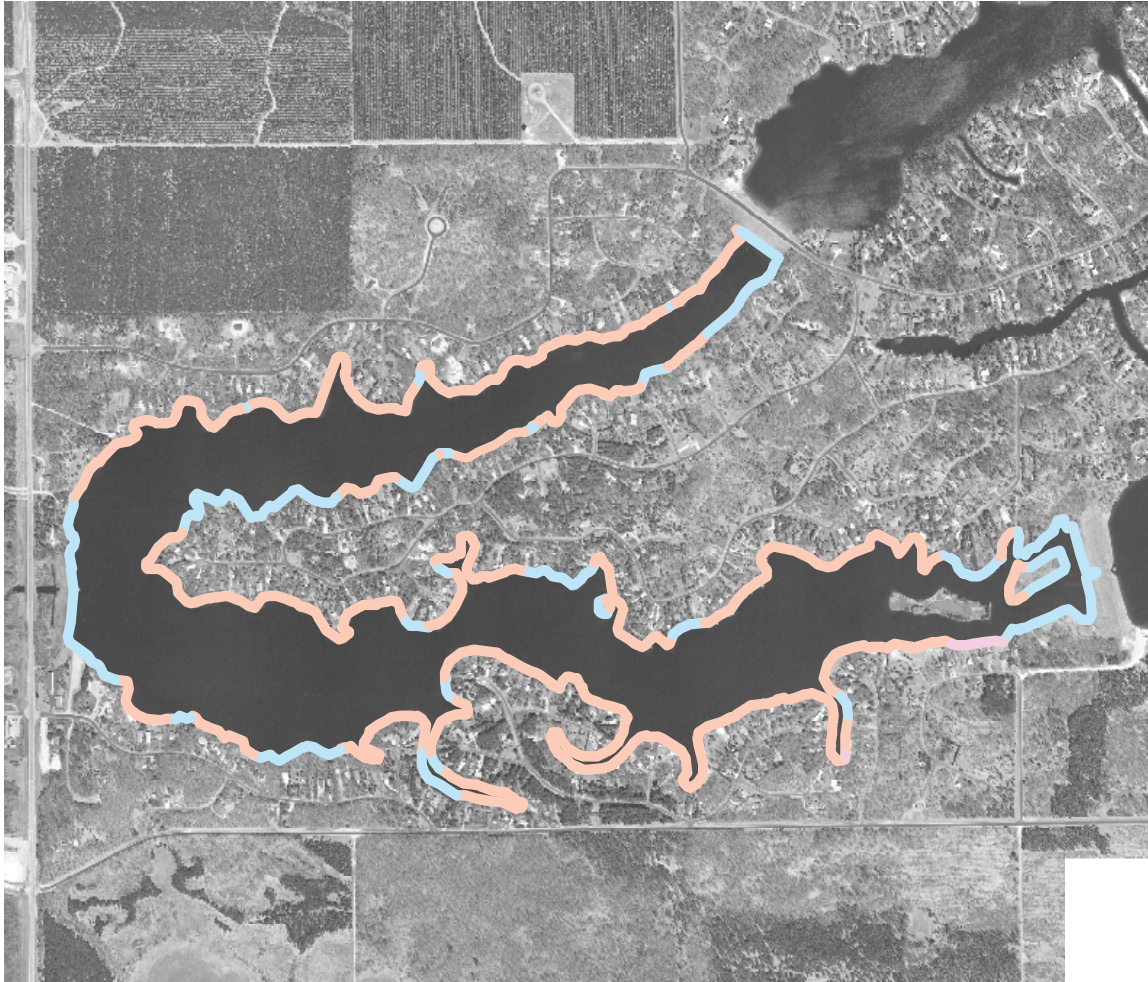
Sherwood Lake--Buffers

Vegetated shoreland buffers help stabilize shoreline banks, thus reducing bank erosion. The plant roots give structure to the bank and also increase water infiltration and decrease runoff. A vegetated shore is especially important when shores are steep and soft, as are many of Sherwood Lake shores. Figure 13 maps the adequate and inadequate buffers on Sherwood Lake.

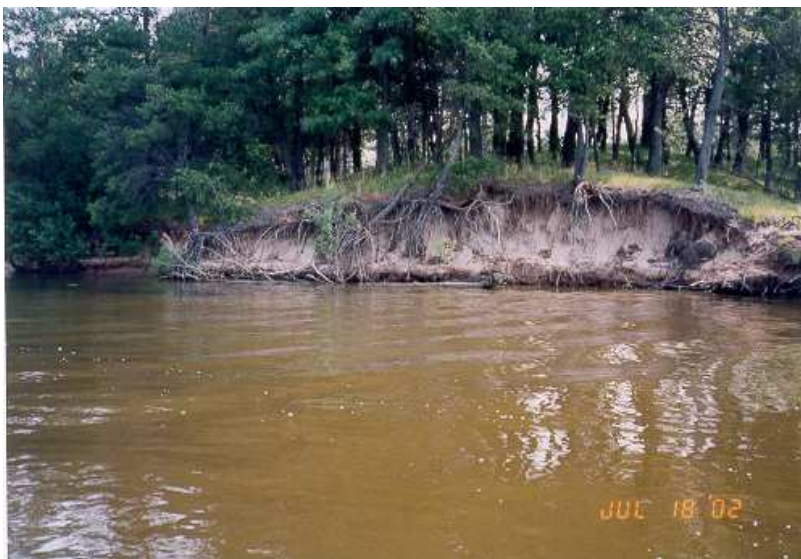
**Figure 16:
Heavily-eroded
Shore on
Sherwood Lake
that would need
installation of
shoreland
protection
practices**

Adequate buffers on Sherwood Lake in some places could be easily installed on the inadequate areas by either letting the first 35 feet landward from the water just grow without mowing it, except for a path to the water, or by planting native seedlings sufficient to fill in the first 35 feet or using biologists to protect the shore that are vegetated. Where areas are deeply eroded, shaping, revegetating and protecting the shores will be necessary to prevent further erosion.

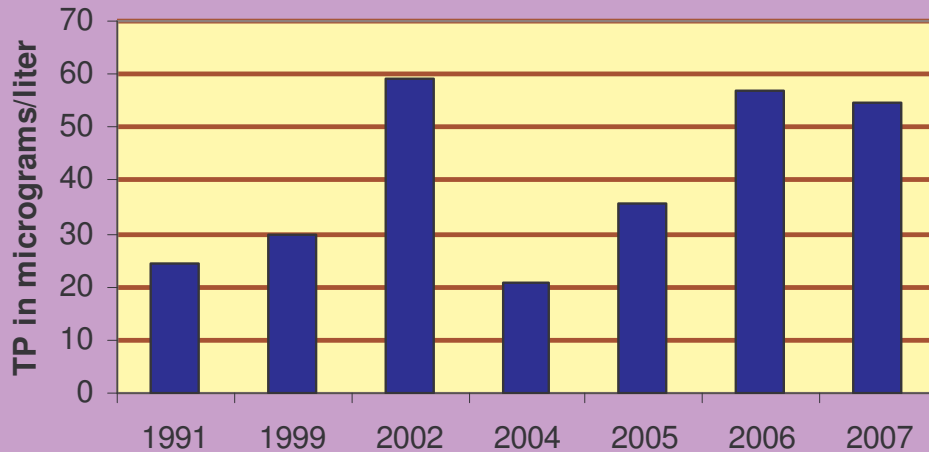
Figure 18: Average Eplimnetic Phosphorus Levels

As the Figure 18 indicates, the average growing season total phosphorus levels have varied and often registered above the level recommended to avoid nuisance algal blooms. However, the epilimnetic total phosphorus levels have stayed below the state impoundment average of 65 micrograms/liter. Especially due to the increasing epilimnetic total phosphorus levels, phosphorus should continue to be monitored and steps should be taken to reduce the phosphorus levels in the lake.

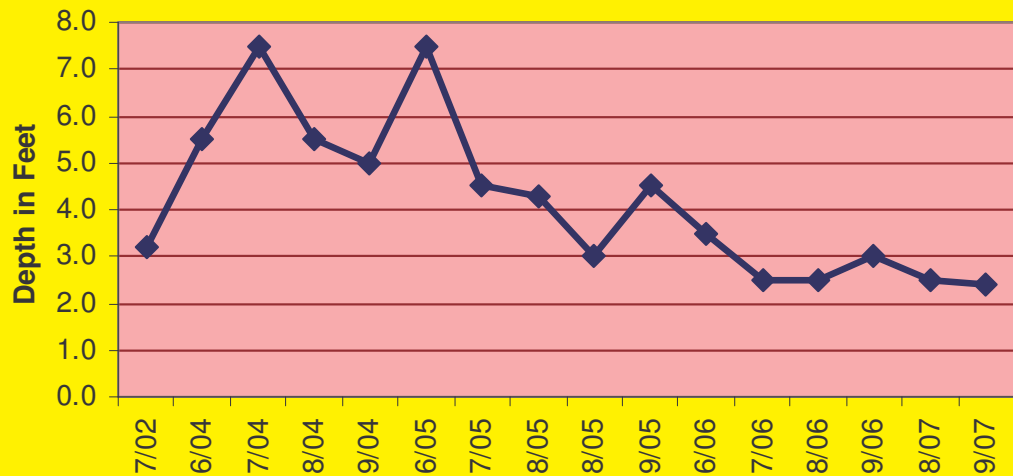
Figure 23c: Secchi Disk 2002-2007

Sherwood Lake has a considerable history of Secchi disk readings in a number of years. A look at the average Secchi depth for the growing season in each year since 1986, Secchi disk depth readings on Sherwood Lake have generally decreased over the years (see figure 24). The overall average depth for the fourteen years for which there are records is 5.0 feet.

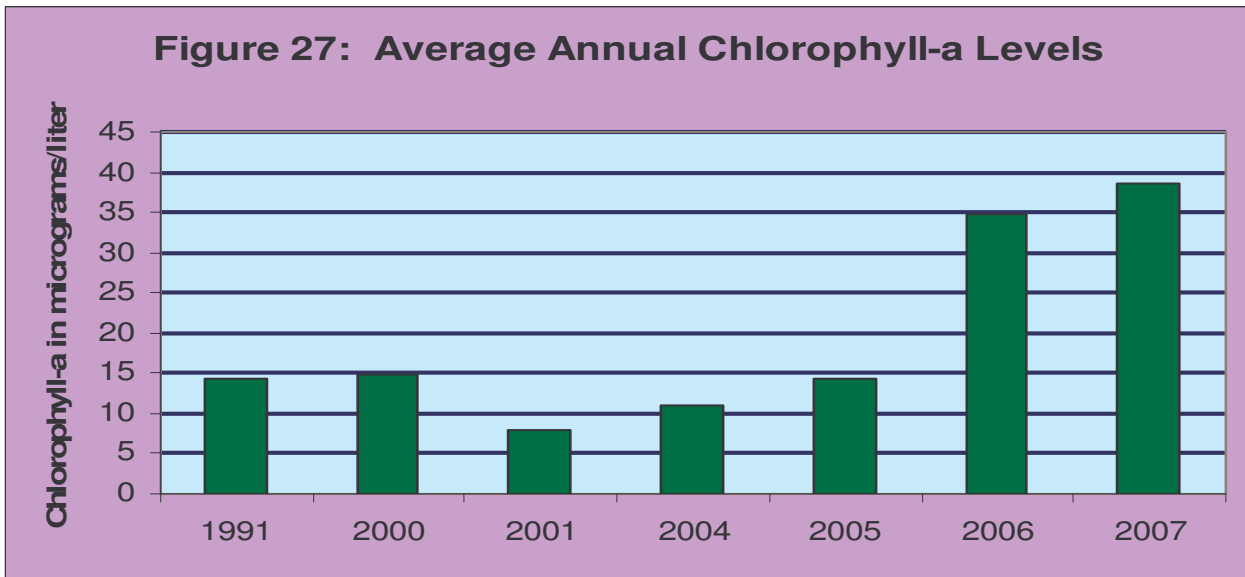
Figure 27 shows that summer chlorophyll-a averages stayed fairly steady from 1991 through 2005, staying in the “fair” category. However, in 2006 and 2007, chlorophyll-a levels shot up substantially. These two years coincide with many days of very hot and still weather. Such weather tends to encourage algal growth. Continued monitoring of chlorophyll-a will need to occur to determine if these high levels were the result of weather or are part of an ongoing trend.

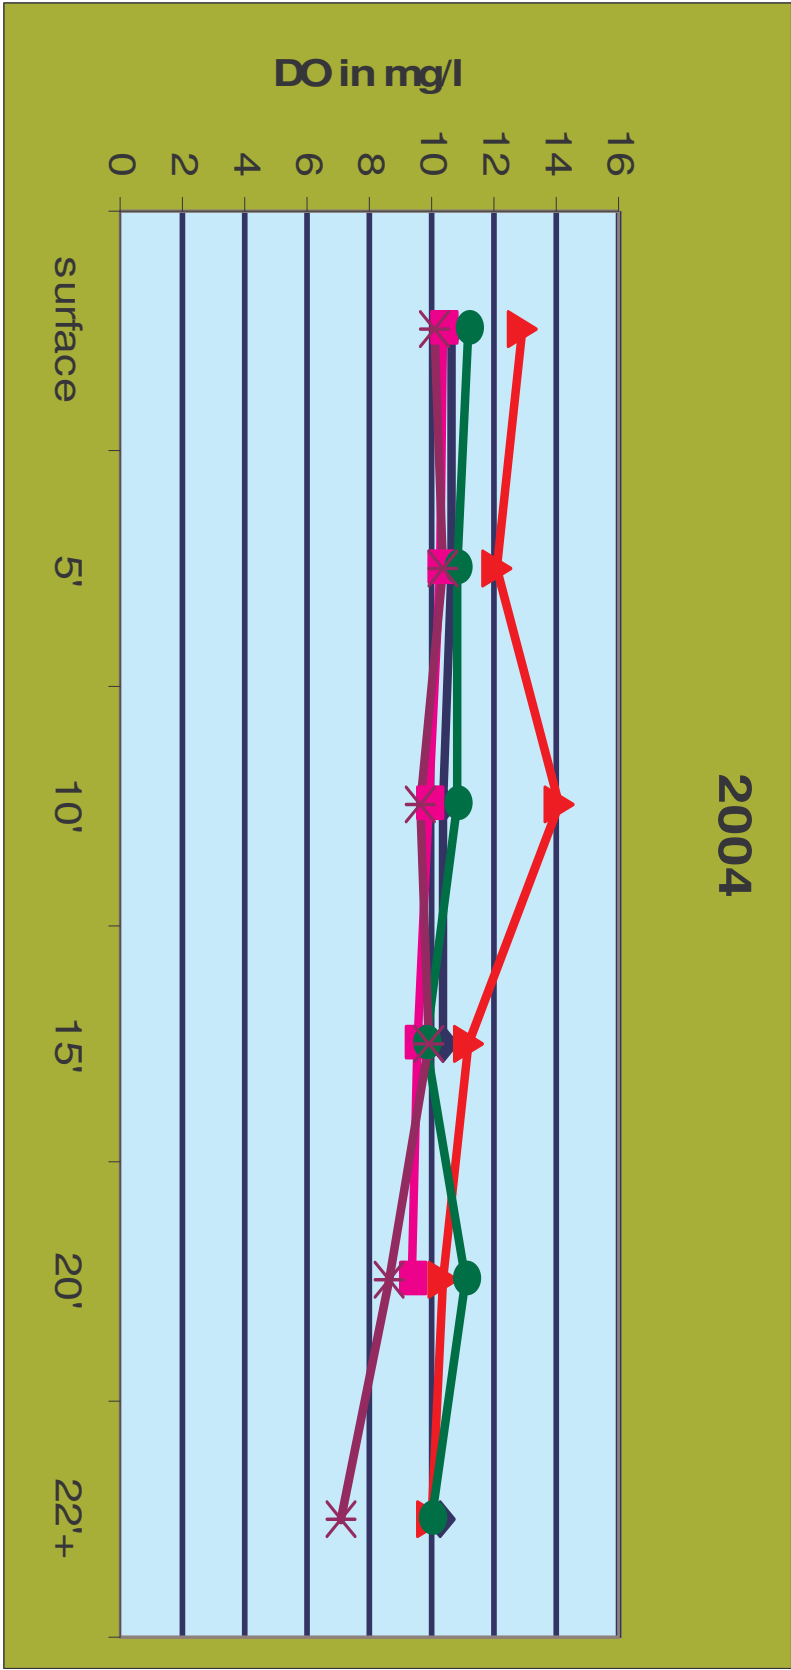
Figure 28a: Dissolved Oxygen Levels 2004 in milligrams/liter

Prior studies of Sherwood Lake have found anoxic (no oxygen) or hypoxic (low oxygen) in Sherwood near the dam (also the location of the deepest water in Sherwood Lake) and in the south “arm” of the lake. However, during the 2004-2006 study, no anoxia was found and hypoxia of just of 5 milligrams/liter occurred only in June 2005. Generally, dissolved oxygen levels didn’t usually go below levels 5 milligrams/liter, the appropriate level for good fish survival. The charts (Figures 28) show the annual variations in dissolved oxygen levels in milligrams/liter, depth in feet and months of the years.

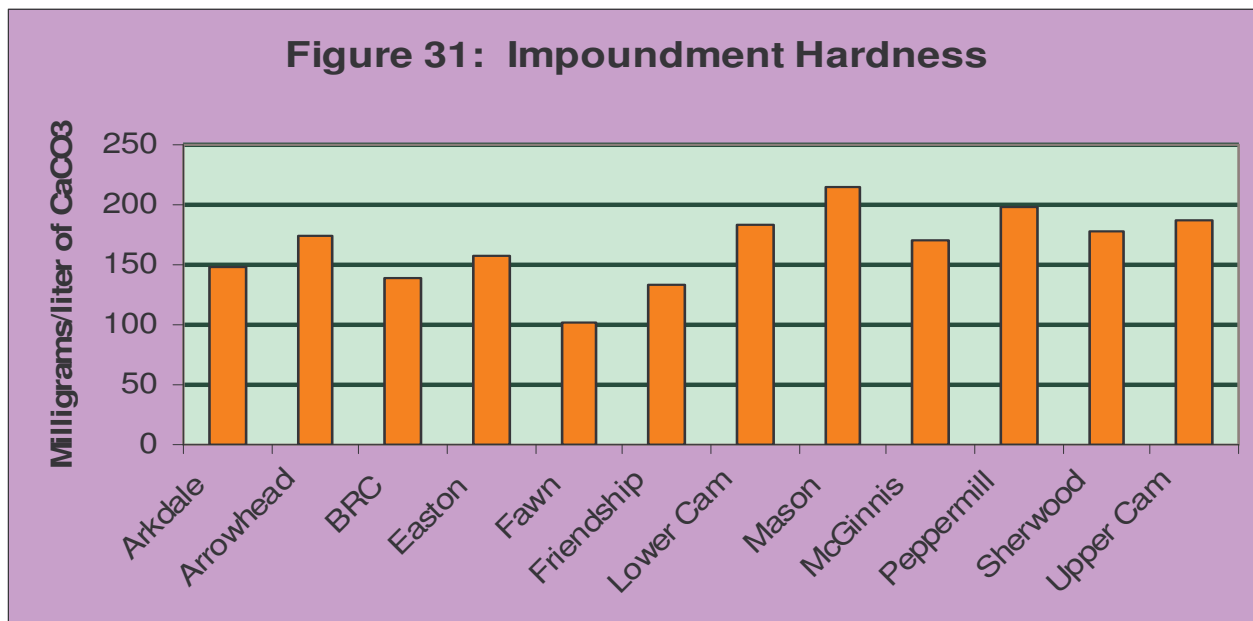
As the graph (Figure 31) shows, Sherwood Lake surface water testing results showed “hard” water (average 178 milligrams/liter CaCO₃), slightly more than the overall hardness average impoundments in Adams County of 166 milligrams/liter of Calcium Carbonate. Hard water lakes tend to produce more fish and aquatic plants than soft water lakes because they are often located in watersheds with soils that load phosphorus into the lake water.

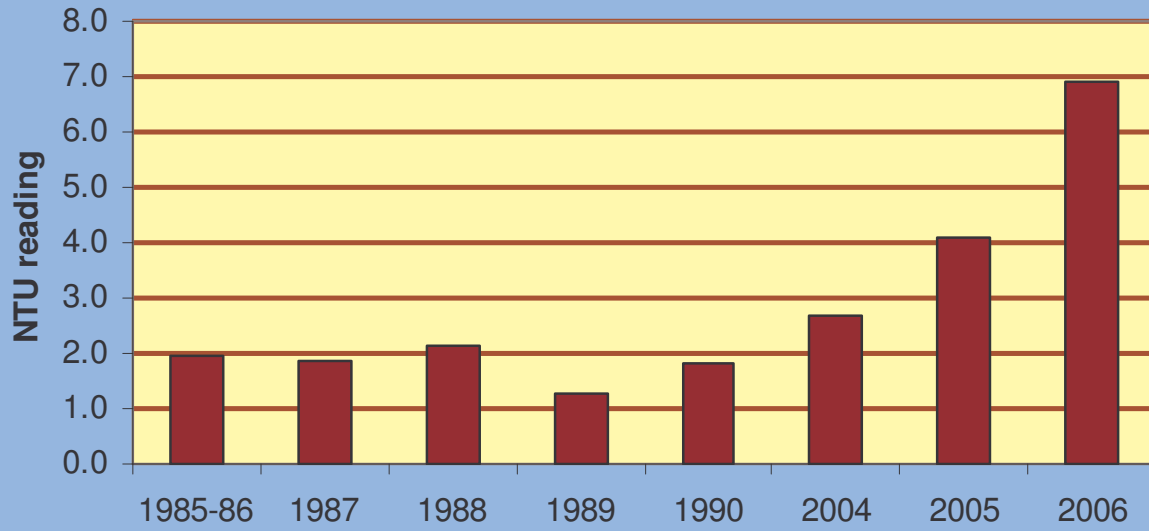
Figure 38: Turbidity Levels in Sherwood Lake

TURBIDITY: Turbidity reflects water clarity. The term refers to suspended solids in the water column—solids that may include clay, silt, sand, plankton, waste, sewage and other pollutants. Turbid water may mask the presence of bacteria or other pollutants because the water looks murky or muddy. In general, turbidity readings of less than 5 NTU are best. Very turbid waters may not only smell, but also tend to be aesthetically displeasing, thus curtailing recreational uses of the water. Turbidity levels for Sherwood Lake’s waters were low in the 1980s, but have risen substantially since, with one reading over the 5 TU mark.

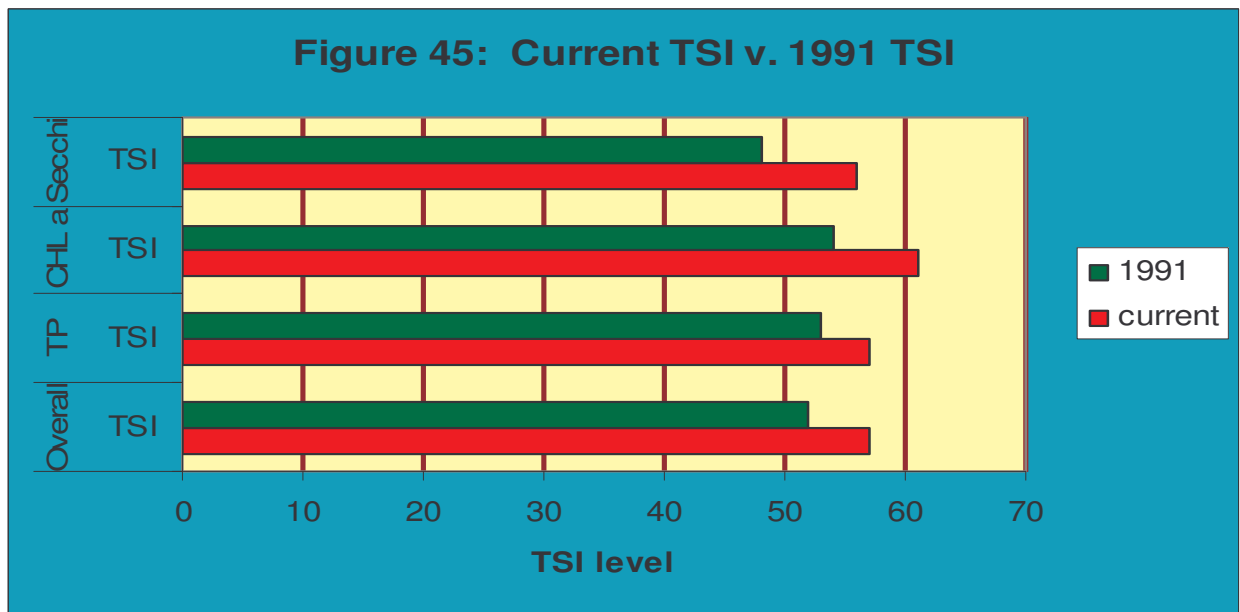
During the 1991 study, water chemistry samples were taken and TSI levels were calculated. Figure 45, which compares the current TSI levels to those from 1991, shows that all the parameters for TSI calculations have increased, indicating that the lake nutrient levels have risen substantially.

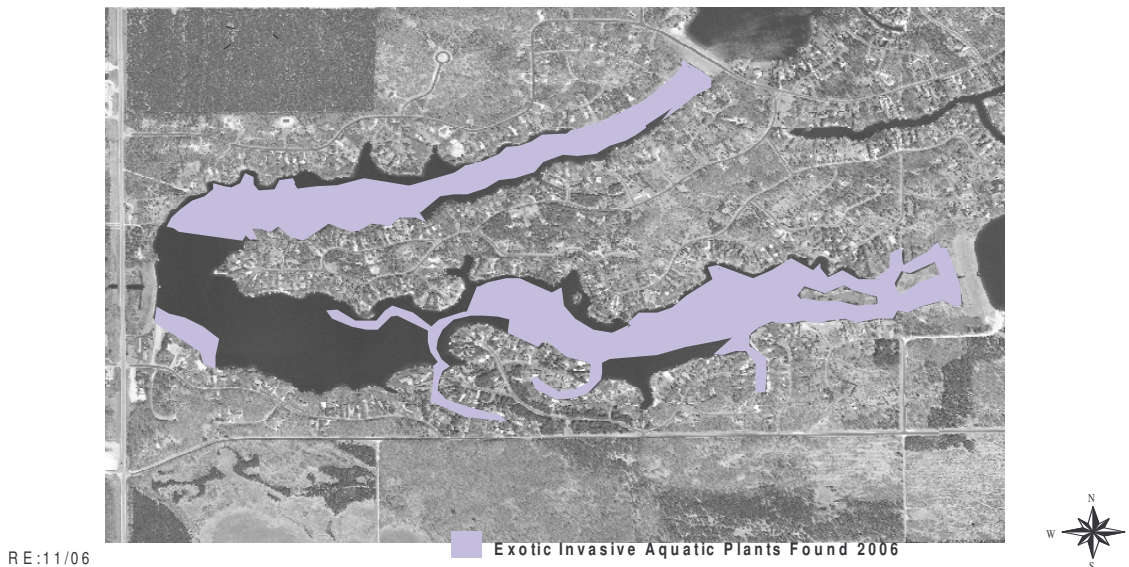
Figure 55: Distribution of Exotic Aquatic Plants in Sherwood Lake

Sherwood Lake has five known invasive aquatic plant species: Curly-Leaf Pondweed (submergent); Eurasian Watermilfoil (submergent); Purple Loosestrife (emergent); Reed Canarygrass (emergent) and Watercress (floating-leaf). The lake gets a significant amount of transient boat traffic due to its location (right off a main highway) and large public boat ramp. The Tri-Lakes Management District has a lake management plan that includes management of aquatic invasives. The lake has been using targeted harvesting for Eurasian Watermilfoil, emphasizing the harvesting of that plant in May and September, while harvesting the summer months for navigation, rather than control of Eurasian Watermilfoil. In 2007, some lake citizens were trained to monitor the aquatic invasives and participate in the Clean Boats, Clean Waters boater education program.

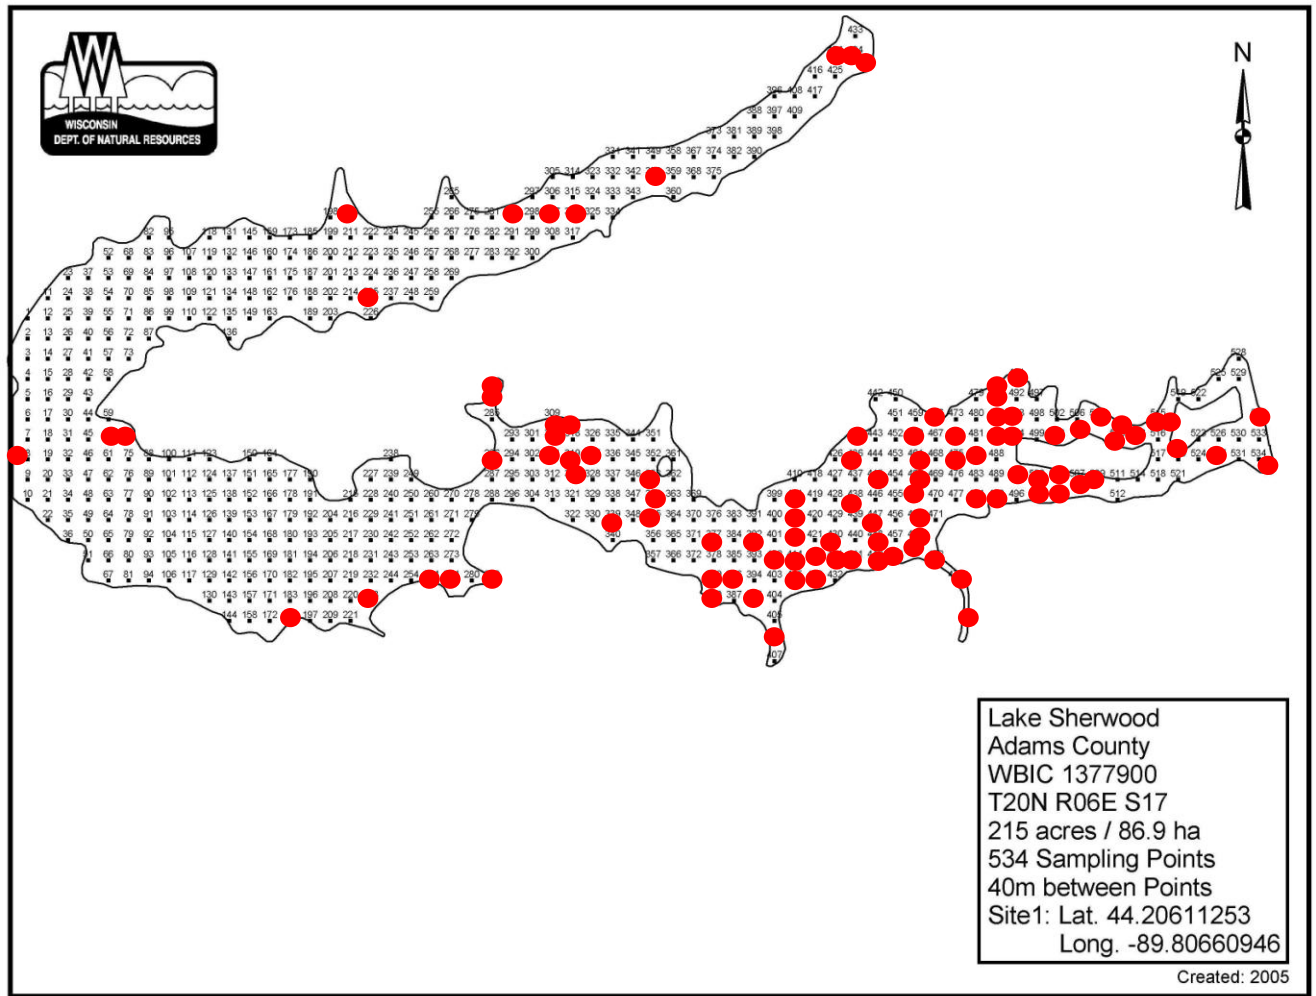
Figure 13: Distribution of Eurasian Watermilfoil 2014 (in red)

As is evident in the following maps, both Curly-Leaf Pondweed and Eurasian Watermilfoil are found throughout Sherwood Lake, except in the deeper areas near the dam. However, there are more of both in the lower arm of the lake, perhaps because that is the part of the lake most accessible from the public boat launch,
