THE AQUATIC PLANT COMMUNITY OF PATRICK LAKE, ADAMS COUNTY, WI 2005 to 2011

**Presented by Reesa Evans
Certified Lake Manager, Lake Specialist
Adams County Land & Water Conservation Department
P.O. Box 287, Friendship, WI 53934
608-339-4268**

LAKE CLASSIFICATION REPORT FOR PATRICK LAKE, ADAMS COUNTY

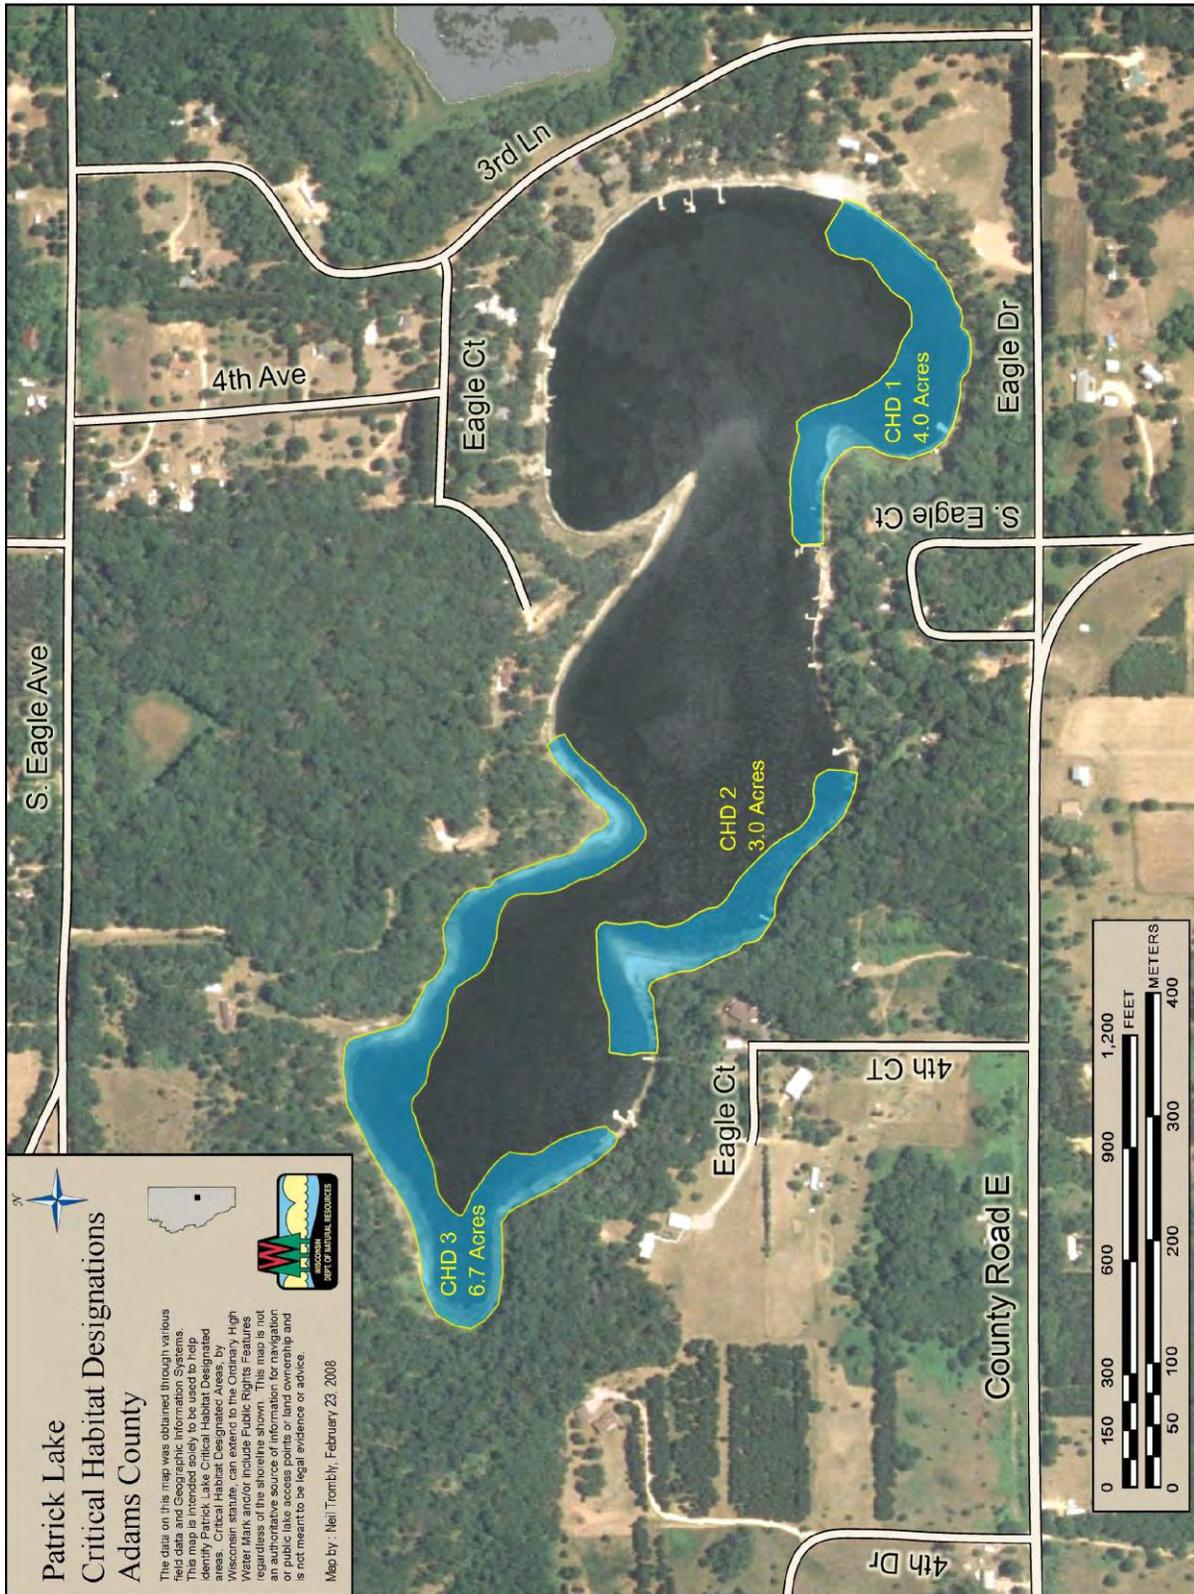
Figure 2. Critical Habitat Designated Areas

FIGURE 2: PATRICK LAKE CRITICAL HABITAT AREAS

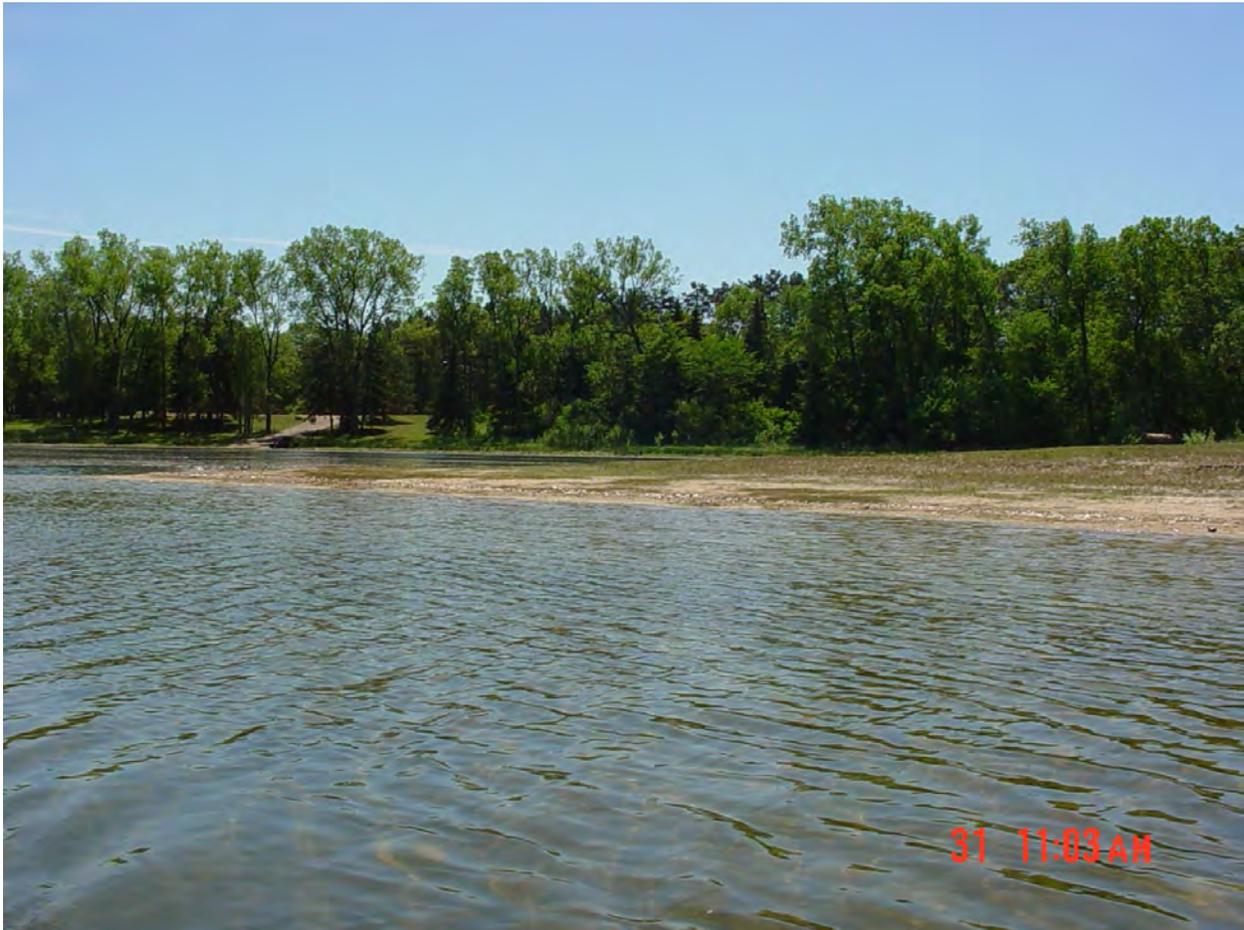
Figure 3: Photo of Part of CHD1

Maximum rooting depth of aquatic vegetation in CHD1 was 5.5 feet. An emergent plant, bulrush is found in this area. Emergents provide important fish habitat and spawning areas, as well as food and cover for wildlife.

Two species of rooted floating-leaf plants found. Floating-leaf vegetation provides cover and dampens waves, protecting the shore. Seven species of submergent plants were found in this area as well. A diverse submergent community provides many benefits.

Curly-Leaf Pondweed (*Potamogeton crispus*), an exotic invasive plant, was found in this area. Most of the aquatic vegetation in this area has multiple uses for fish and wildlife. Because this site provides all three structural types of vegetation, the community has a diversity of structure and species that supports even more diversity of fish and wildlife.

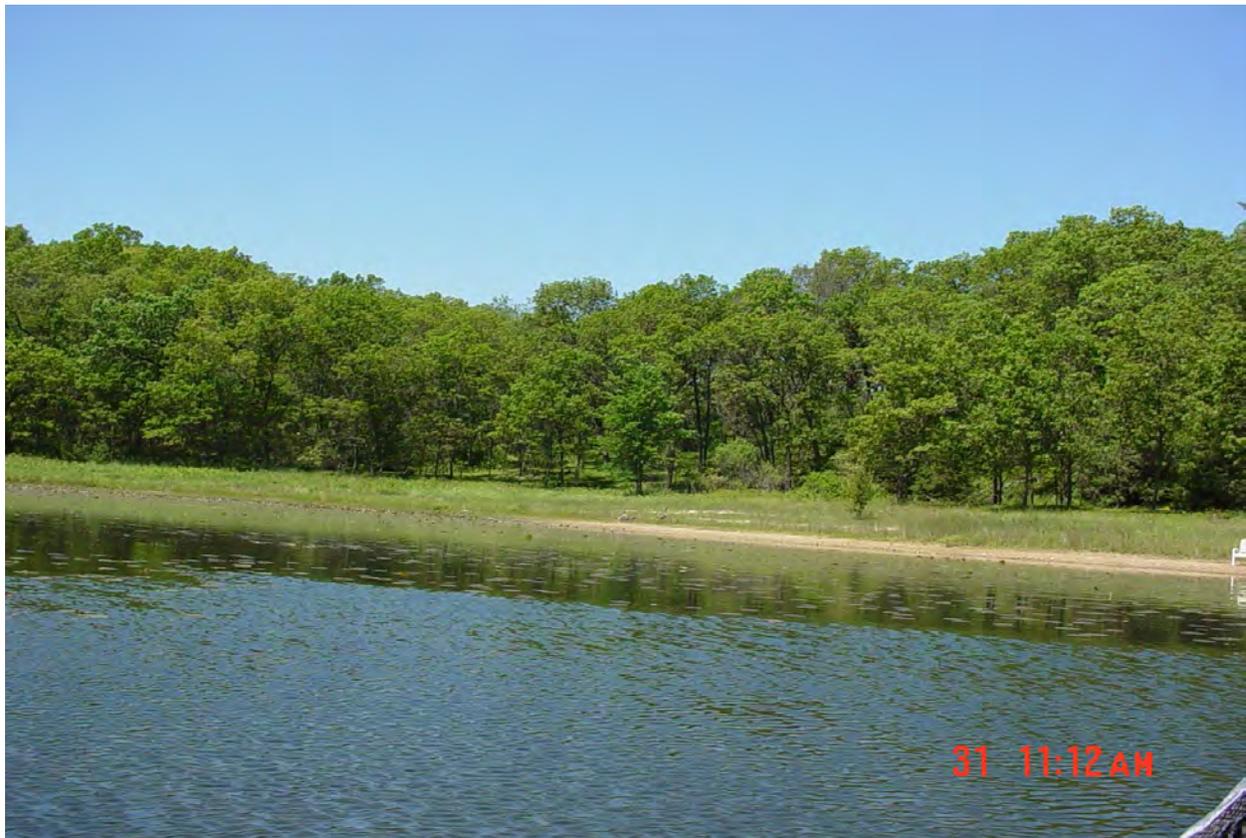
Figure 5: Photo of Part of CHD3

Maximum rooting depth in CHD3 was 7 feet. No threatened or endangered species were found in this area. *Chara* spp and filamentous algae were present in area PA3. The only emergent species found in this area is *Scirpus* (bulrush). One rooted floating-leaf plant was present here. Floating-leaf plants provide cover for fish and invertebrates. Curly-leaf pondweed was common here. Another exotic invasive, Eurasian watermilfoil, was previously found in this area. Five species of submergent plants were also found here.

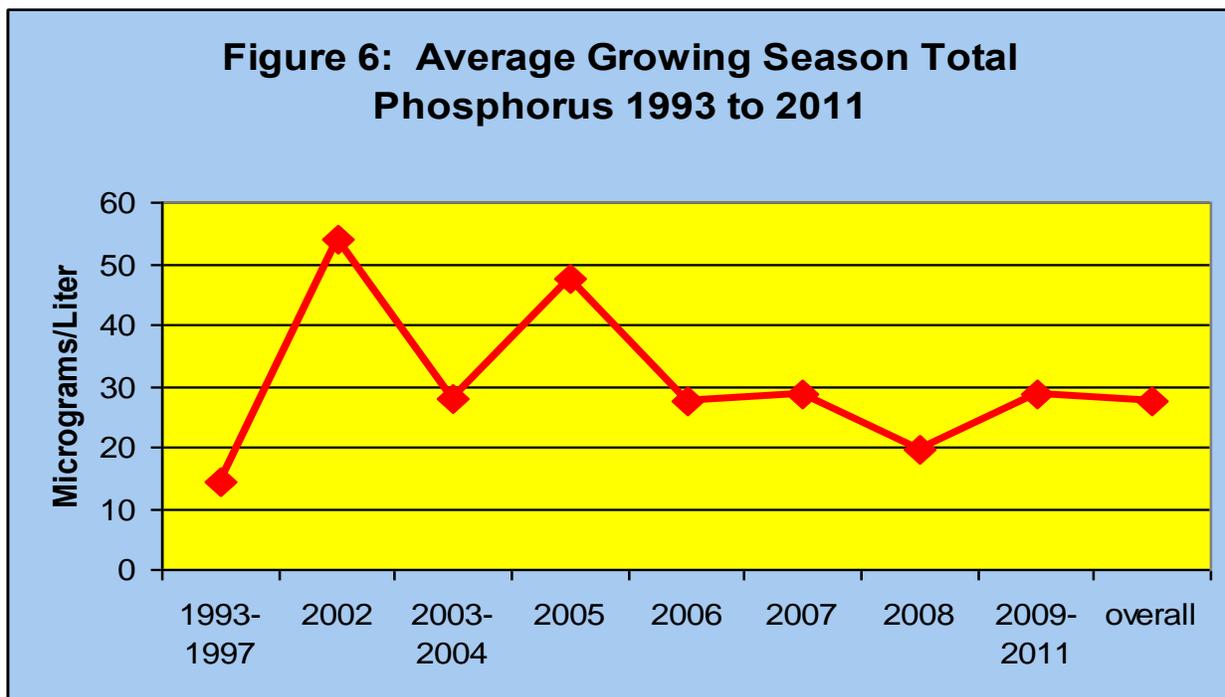
The overall average growing season total phosphorus level for Patrick Lake was 27.4 micrograms/liter. As Figure 6 shows, there has been a range of average levels, depending on the sampling years. The highest average was in 2002, with a growing season score of 54.0 micrograms/liter; the lowest average was found when sampling first started in 1993 to 1997, when the average was 14.5 micrograms/liter.

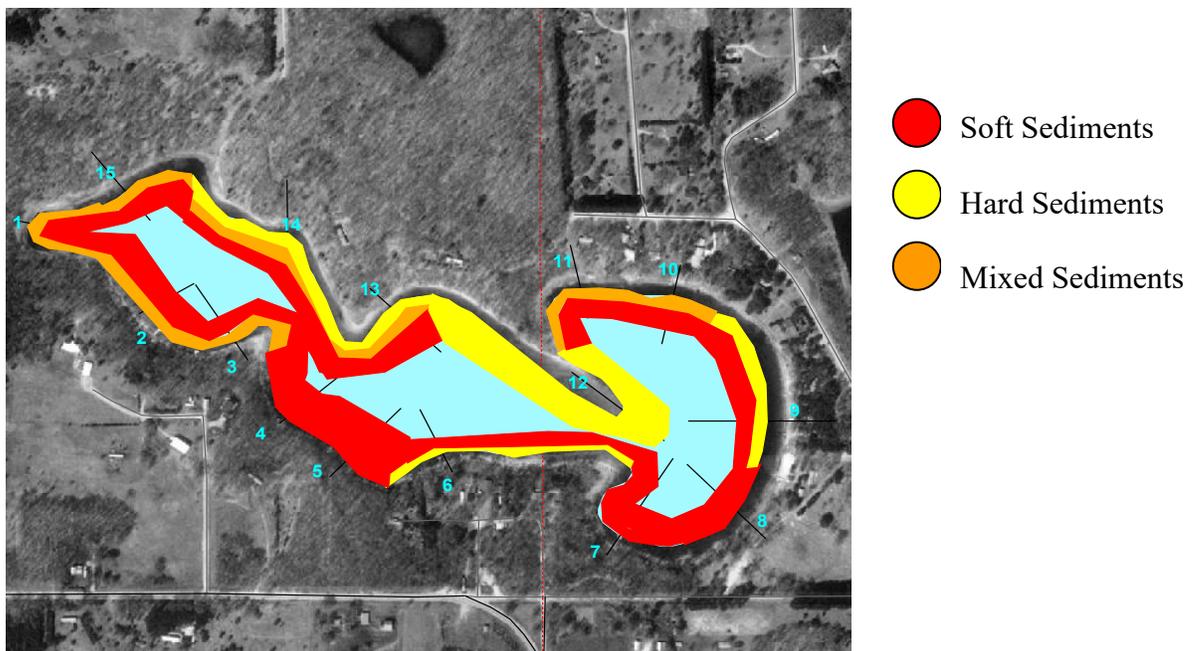
Figure 11: Sediment in Patrick Lake

Peat was the overall dominant sediment found in Patrick Lake and could be limiting for plant growth due its flocculent nature. In the transect surveys all sites were vegetated in Patrick Lake, regardless of the sediment type. 99.5% of the sites were vegetated in the PI survey. It appears that sediment is not a major factor determining plant distribution in Patrick Lake.

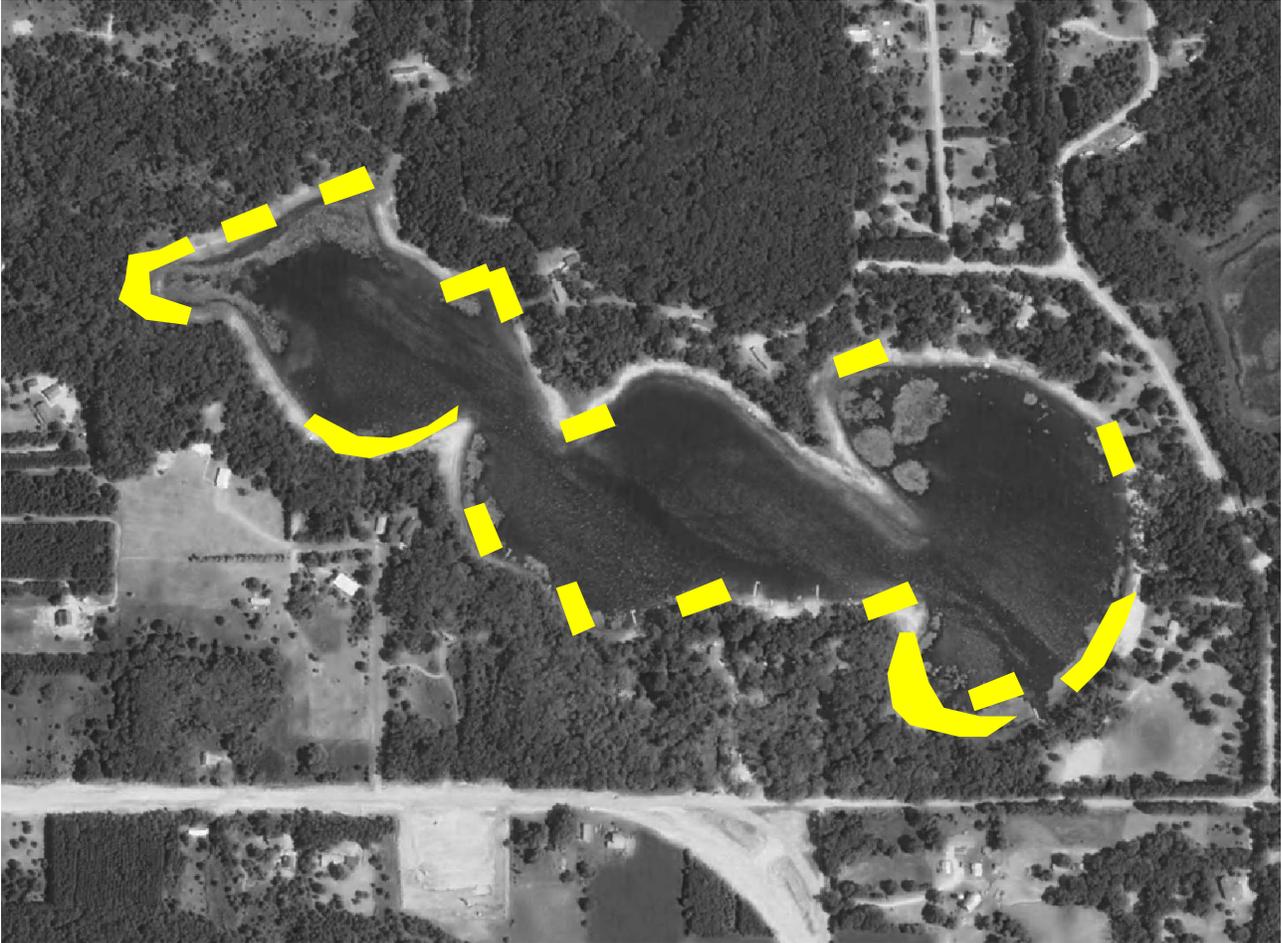
Figure 17a: EMERGENT PLANTS IN PATRICK LAKE 2011 (yellow)

Aquatic plants occurred throughout the entire littoral zone of Patrick Lake in the transect survey and at all but one of the sampling sites in the PI survey. Figures 17a, 17b and 17c show the distribution of the various types of aquatic species found.

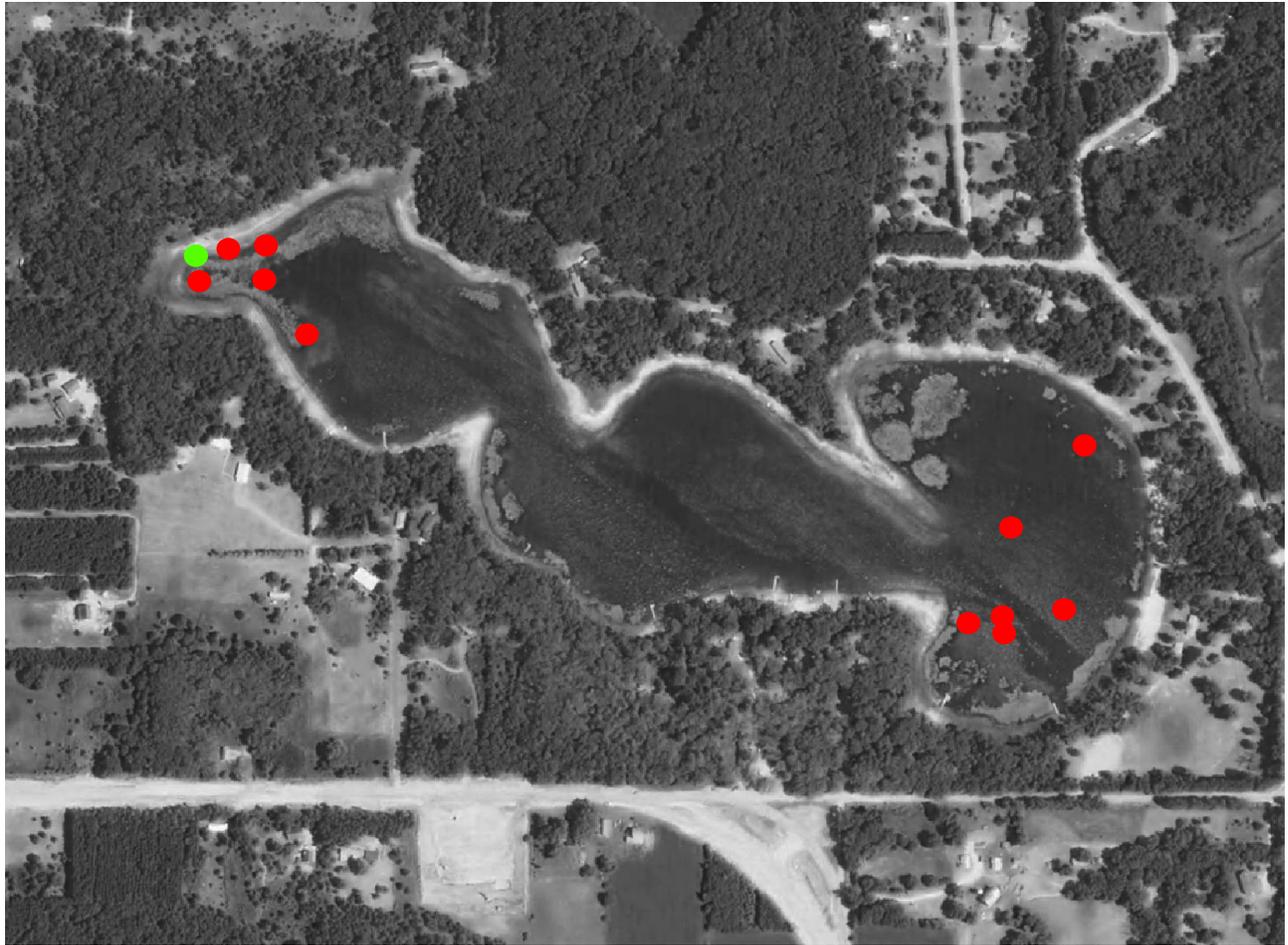
Figure 18: EURASIAN WATERMILFOIL & CURLY-LEAF PONDWEED

However, the 2011 surveys suggest that EWM is rebounding in Patrick Lake. It is also possible that it has hybridized with the native northern milfoil (*Myriophyllum sibiricum*) (testing has not yet been done). Curly-leaf pondweed (*Potamogeton crispus*) was also found in the 2011 surveys. It did not have a high occurrence frequency or density, but since the surveys were done in late July and early August, its presence may be underrated. Figure 18 shows the distribution of these two in in

● EWM found ● CLP found

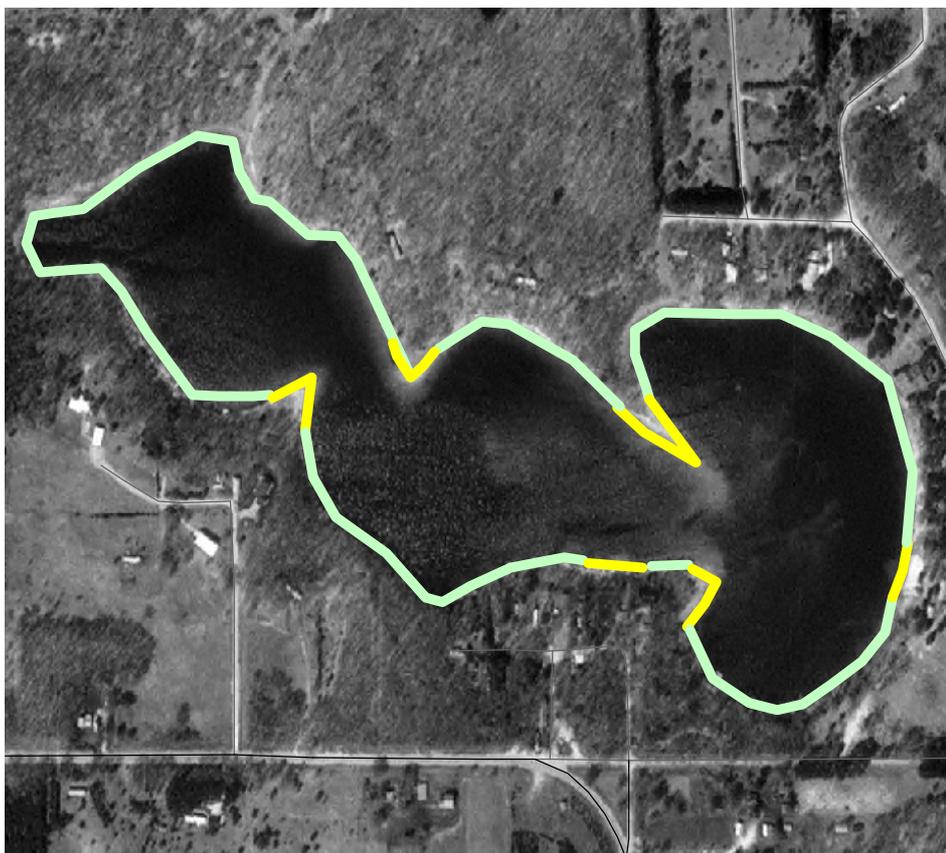
Figure 9: Shoreland Map of Patrick Lake (2004)

Patrick Lake has a total shoreline of 1.68 miles (8870.4 feet). Much of the shore in the northwest lobe and in the west part of the center lobe of the lake has been left mostly undisturbed. Buildings in these areas tend to be uphill and more than 70' from the shore. The eastern lobe of the lake is in residential use and park use. Most of the areas in this lobe are flatter than the northwest end. Buildings in this lobe are generally located closer to the shoreline than those on the west part of the lake. 80% of Patrick Lake's shoreline is vegetated.

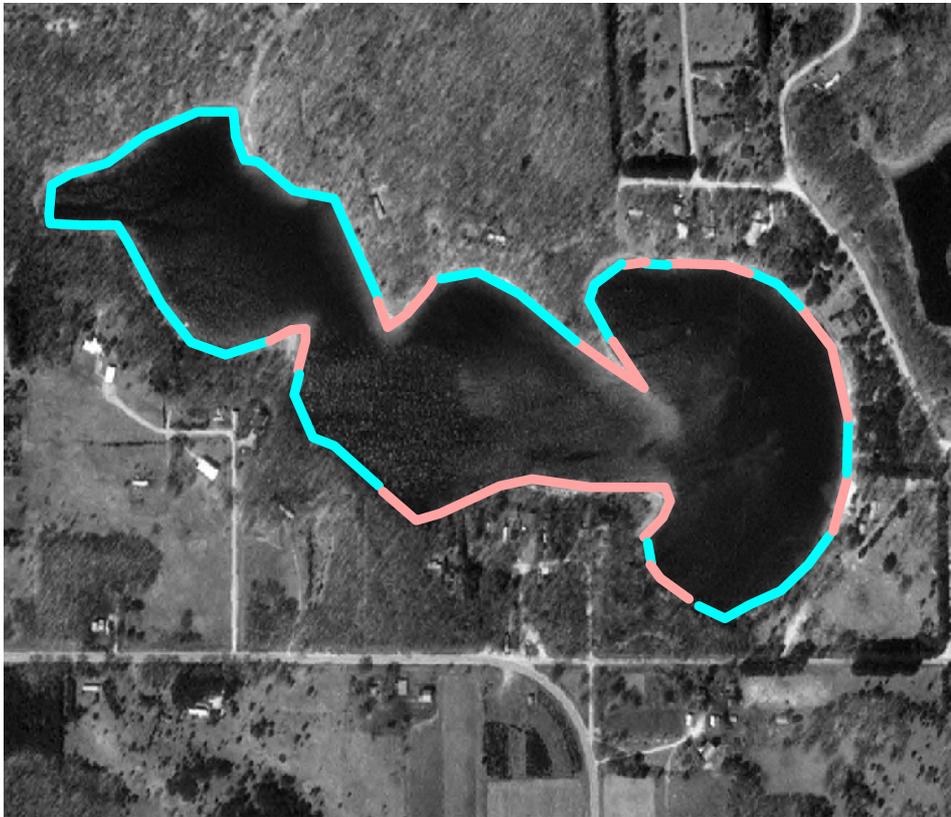
Figure 12: Patrick Lake Buffer Map (2004)

A 2004 shore survey showed that most of the shore had an “adequate buffer.” An “adequate buffer” is a native vegetation strip at least 35 feet landward from the shore. However, there were still areas of “inadequate” buffers, mostly those with mowed lawns and insufficient native vegetation at the shoreline to cover 35 feet landward from the water line. There are also several areas of sand bars and some active erosion.

Vegetated shoreland buffers help stabilize shoreline banks, thus reducing bank erosion. The plant roots give structure to the bank and also increase water infiltration and decrease runoff. A vegetated shore is especially important when shores are steep and soft, as are some of Patrick Lake shores. Figure 12 maps the adequate and inadequate buffers on Patrick Lake.

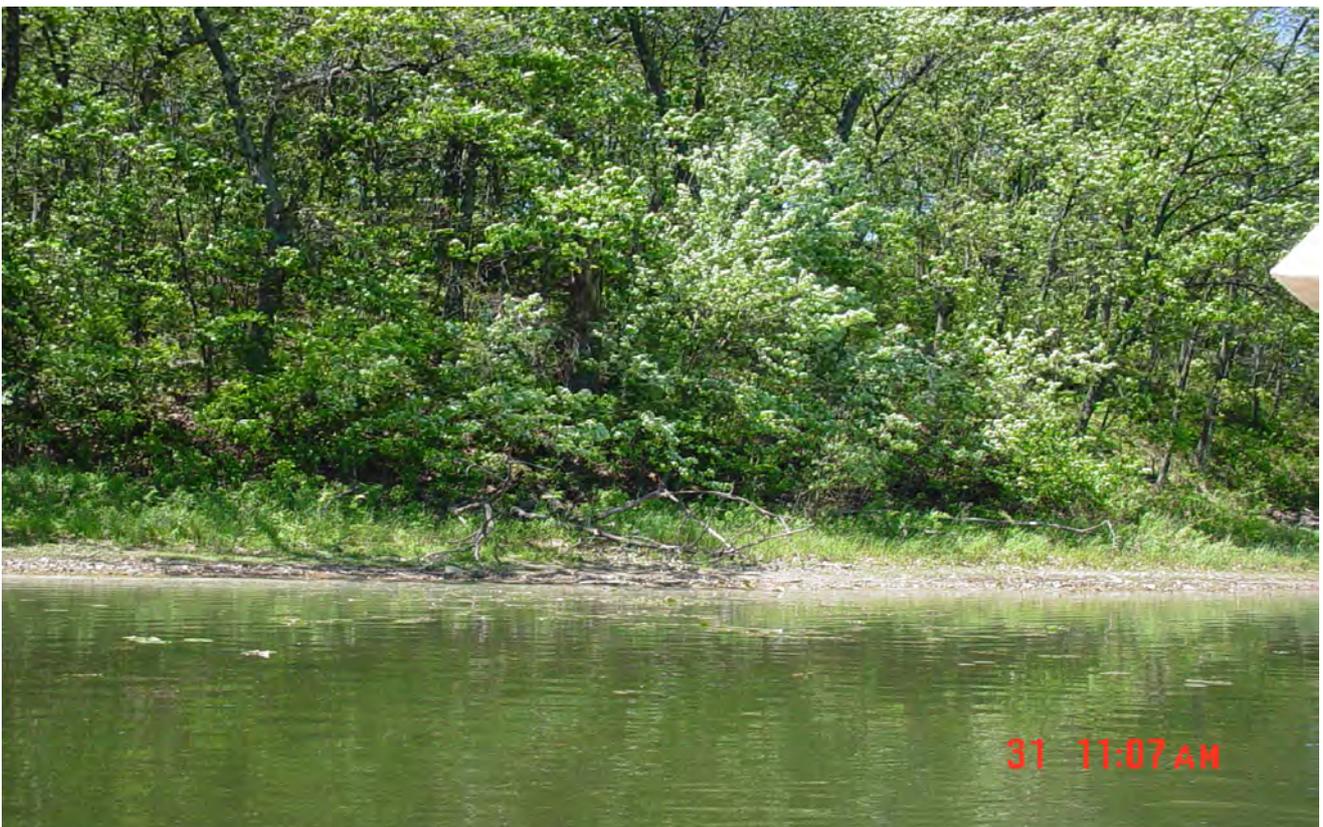
Figure 15: Vegetated Buffer on Patrick Lake

Adequate buffers on Patrick Lake in some places could be easily installed on the inadequate areas by either letting the first 35 feet landward from the water just grow without mowing it, except for a path to the water, or by planting native seedlings sufficient to fill in the first 35 feet or using biologs to protect the shore that are vegetated. Where areas are deeply eroded, shaping, revegetating and protecting the shores will be necessary to prevent further erosion.

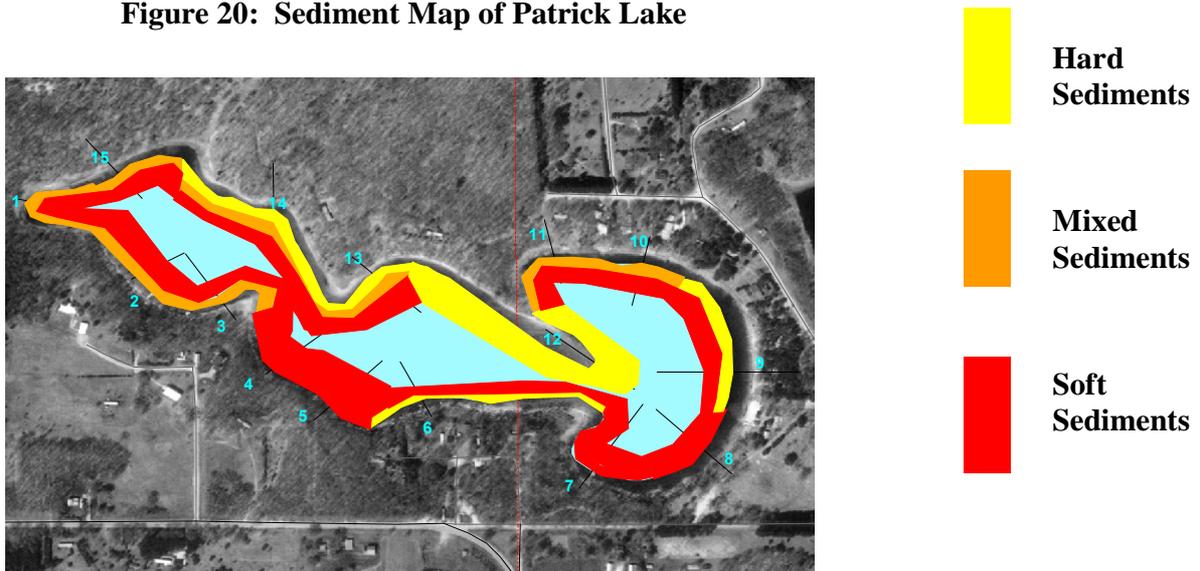
Figure 20: Sediment Map of Patrick Lake

In most lakes in Wisconsin, phosphorus concentration in the bottom sediments of the lake is considerably higher than the concentration in the water column itself. Bottom sediments can “bind up” phosphorus, making it unavailable for aquatic plants or algae to use. Some sediment types hold phosphorus at a higher rate than others. As the sediment map (Figure 20) shows, most of the sediment in Patrick Lake is soft, generally able to support significant aquatic plant growth

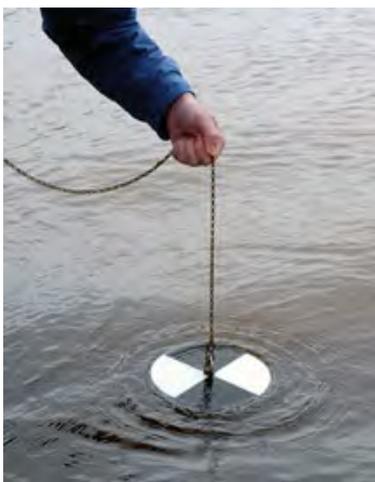
Figure 23: Photo of Testing Water Clarity with Secchi Disk

Patrick Lake has a spotty history of Secchi disk readings in a number of years. A look at the average Secchi depth for the growing season in each year since 1992 reveals fairly steady water clarity (see figure 22). The overall average depth for the years for which there are records is 10.6 feet.

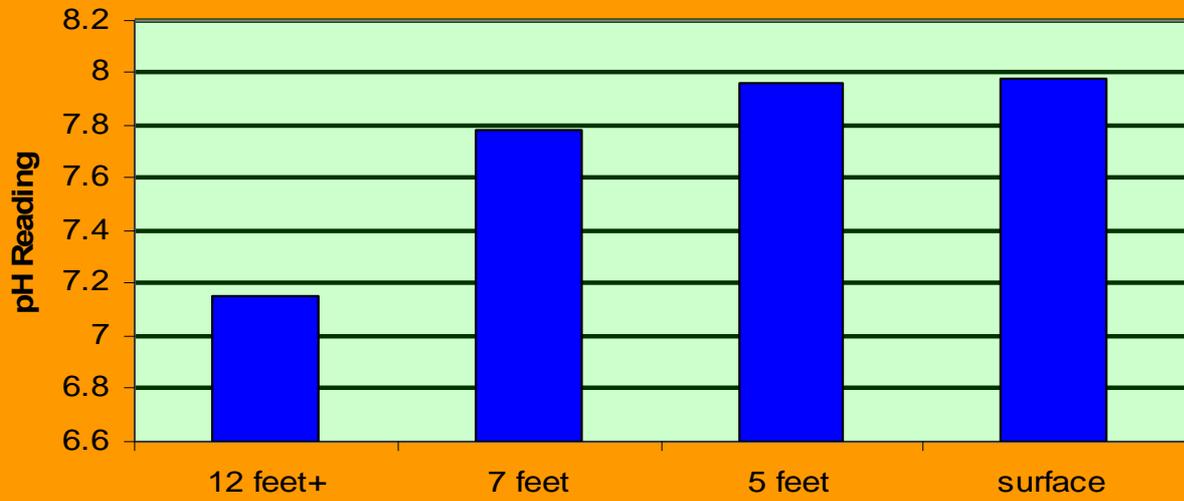
Figure 33: pH v. Depth

Alkalinity also affects the pH level of lake water. The acidity level of a lake’s water regulates the solubility of many minerals. A pH level of 7 is neutral. The pH level in Wisconsin lakes ranges from 4.5 in acid bog lakes to 8.4 in hard water, marl lakes.

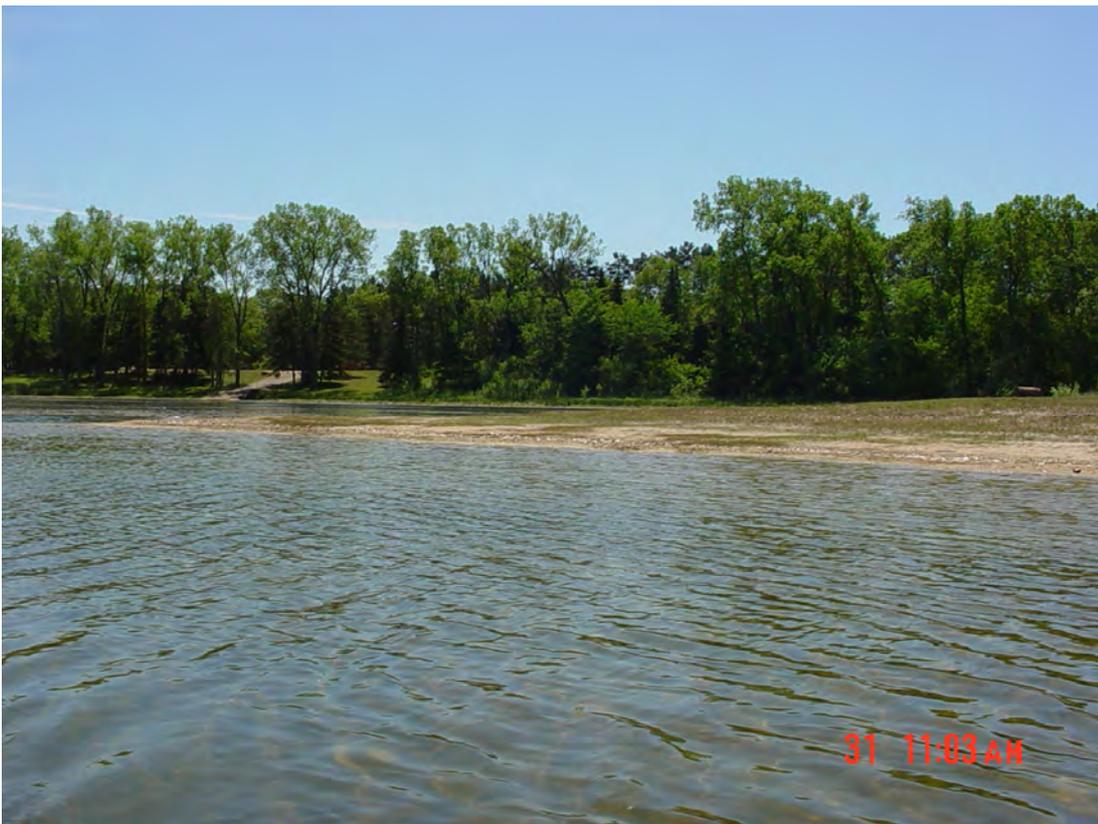
Figure 50: Photo Showing Area PA1

Maximum rooting depth of aquatic vegetation in PA1 was 5.5 feet. No threatened or endangered species were found here. Bulrush, an emergent plant, is found in this area. Emergents provide important fish habitat and spawning areas, as well as food and cover for wildlife. Aquatic vegetation at this site included 2 species of floating-leaf rooted plants and 7 species of submergent aquatic plants. A diverse submergent community provides many benefits. Curly-Leaf Pondweed, an exotic invasive plant, was found in this area. Most of the aquatic vegetation in this area has multiple uses for fish and wildlife. Because this site provides all three structural types of vegetation, the community has a diversity of structure and species that supports even more diversity of fish and wildlife.

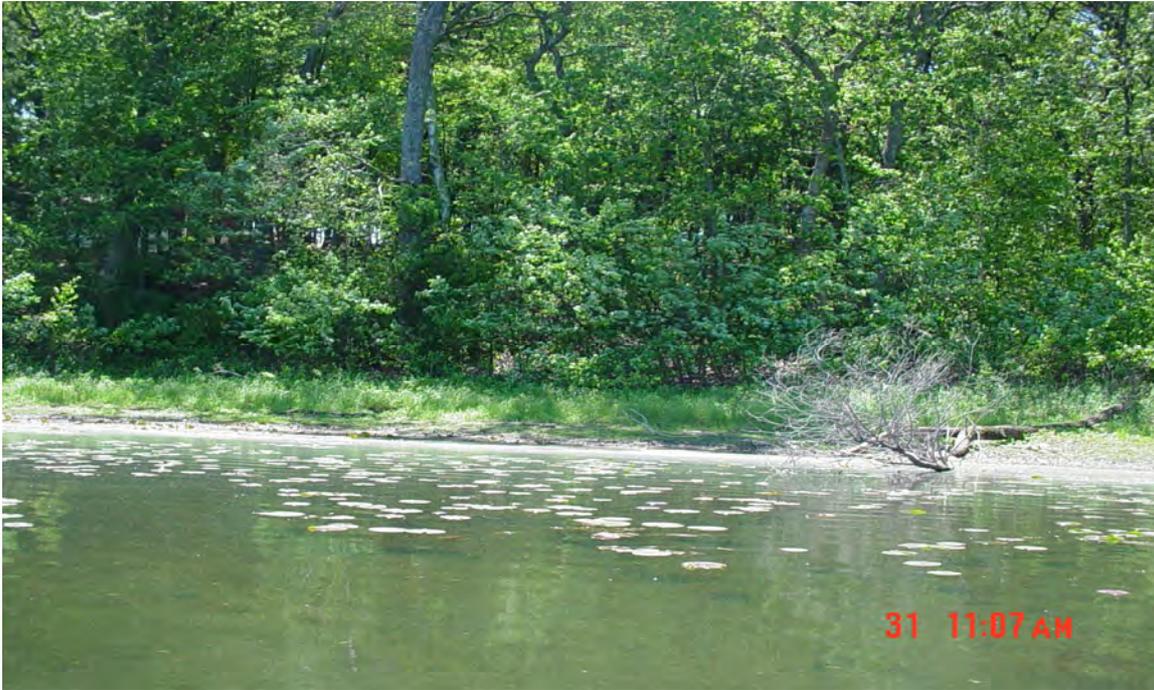
Figure 51: Photo of Part of PA2

Maximum rooting depth in CR2 was 13 feet. No threatened or endangered species were found in this area. One exotic invasive, *Potamogeton crispus* (Curly-Leaf Pondweed), was found in this area. *Myriophyllum spicatum* had been found previously here. Most of the area had filamentous algae, especially near the shores. The plant-like algae, *Chara* spp was abundant in this area. There is a shortage of emergent plants in this area, which is unfortunate, since emergents provide important fish habitat and spawning areas, as well as food and cover for wildlife. One floating-leaf rooted plant species was found. The remaining 6 aquatic plant species were all submergents.

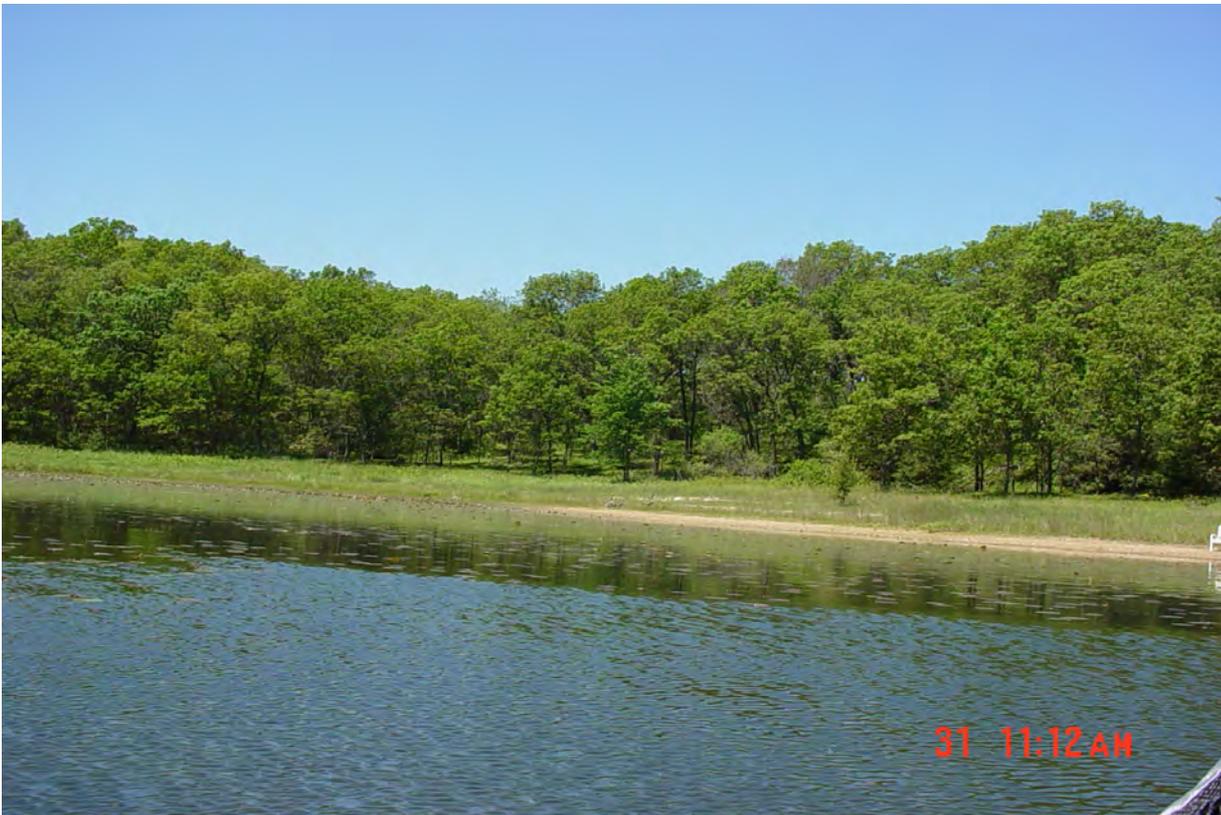
Figure 52: Photo of Part of PA3

Maximum rooting depth in PA3 was 7 feet. No threatened or endangered species were found in this area. *Chara* spp and filamentous algae were present in area PA3. Only one emergent species found in this area. One floating-leaf rooted plant was present here. 5 species of submergent aquatic species were found here. *Potamogeton crispus* was common here. Another exotic invasive, *Myriophyllum spicatum* (Eurasian watermilfoil), was previously found in this area.

Many of these plants are used by wildlife and fish for multiple purposes. Because this site provides all three structural types of vegetation, the community has a diversity of structure and species that supports even more diversity of fish and wildlife.

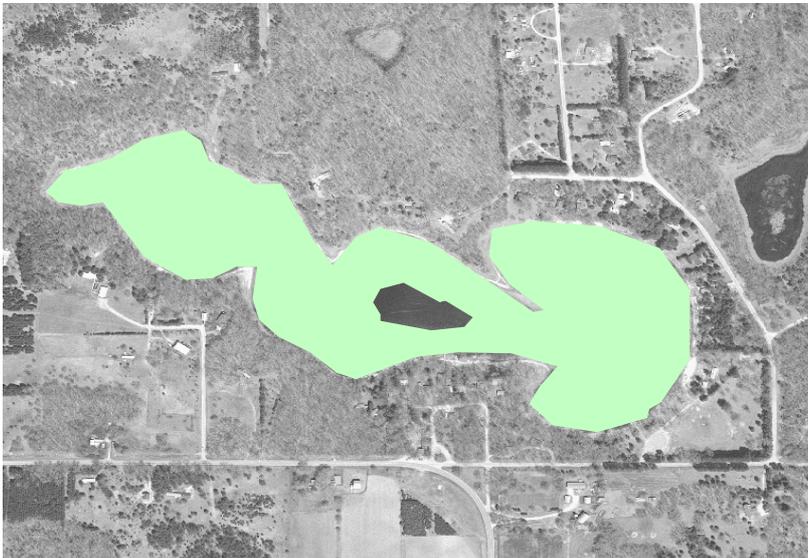
Submergent Vegetation in Patrick Lake

Overall, 3 of the species found were emergent species, 3 were floating-leaf and 12 were submergent. The latter includes Eurasian watermilfoil (*Myriophyllum spicatum*). Filamentous algae was found at 36% of the sample sites.
