# Shoreland Assessments and Critical Habitat Mapping of Alma and Moon Lakes, Vilas County, Wisconsin

Mike Meyer and Jim Kreitlow  
NOVA Ecological Services  
Boulder Junction, WI 54512

March 18, 2024

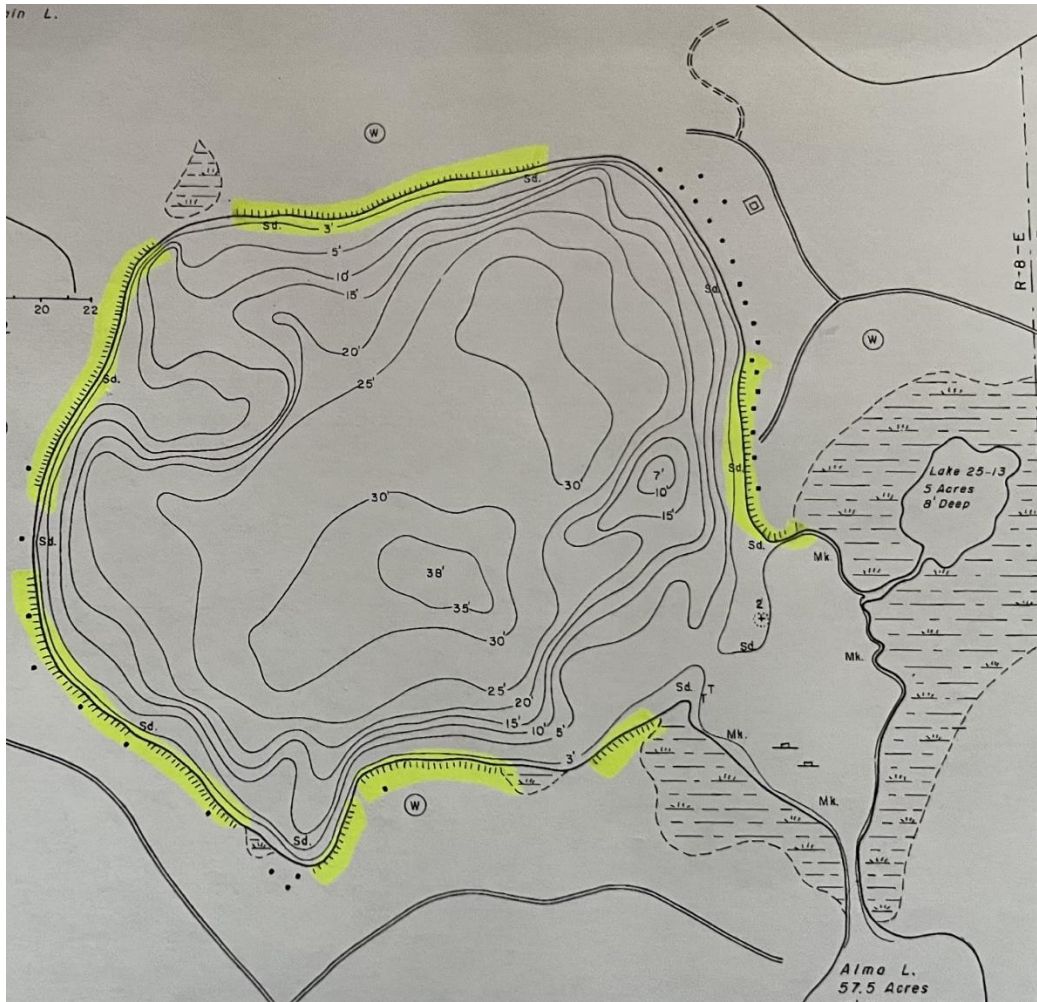
Figure 12b. Location of steep slopes in the Moon Lake shoreland as identified by WDNR lake bathymetry map. Hatch marks shaded in yellow = steep slopes. [Moon Lake - Vilas County, Wisconsin DNR Lake Map, Sep 1977, Not for Navigation](#)

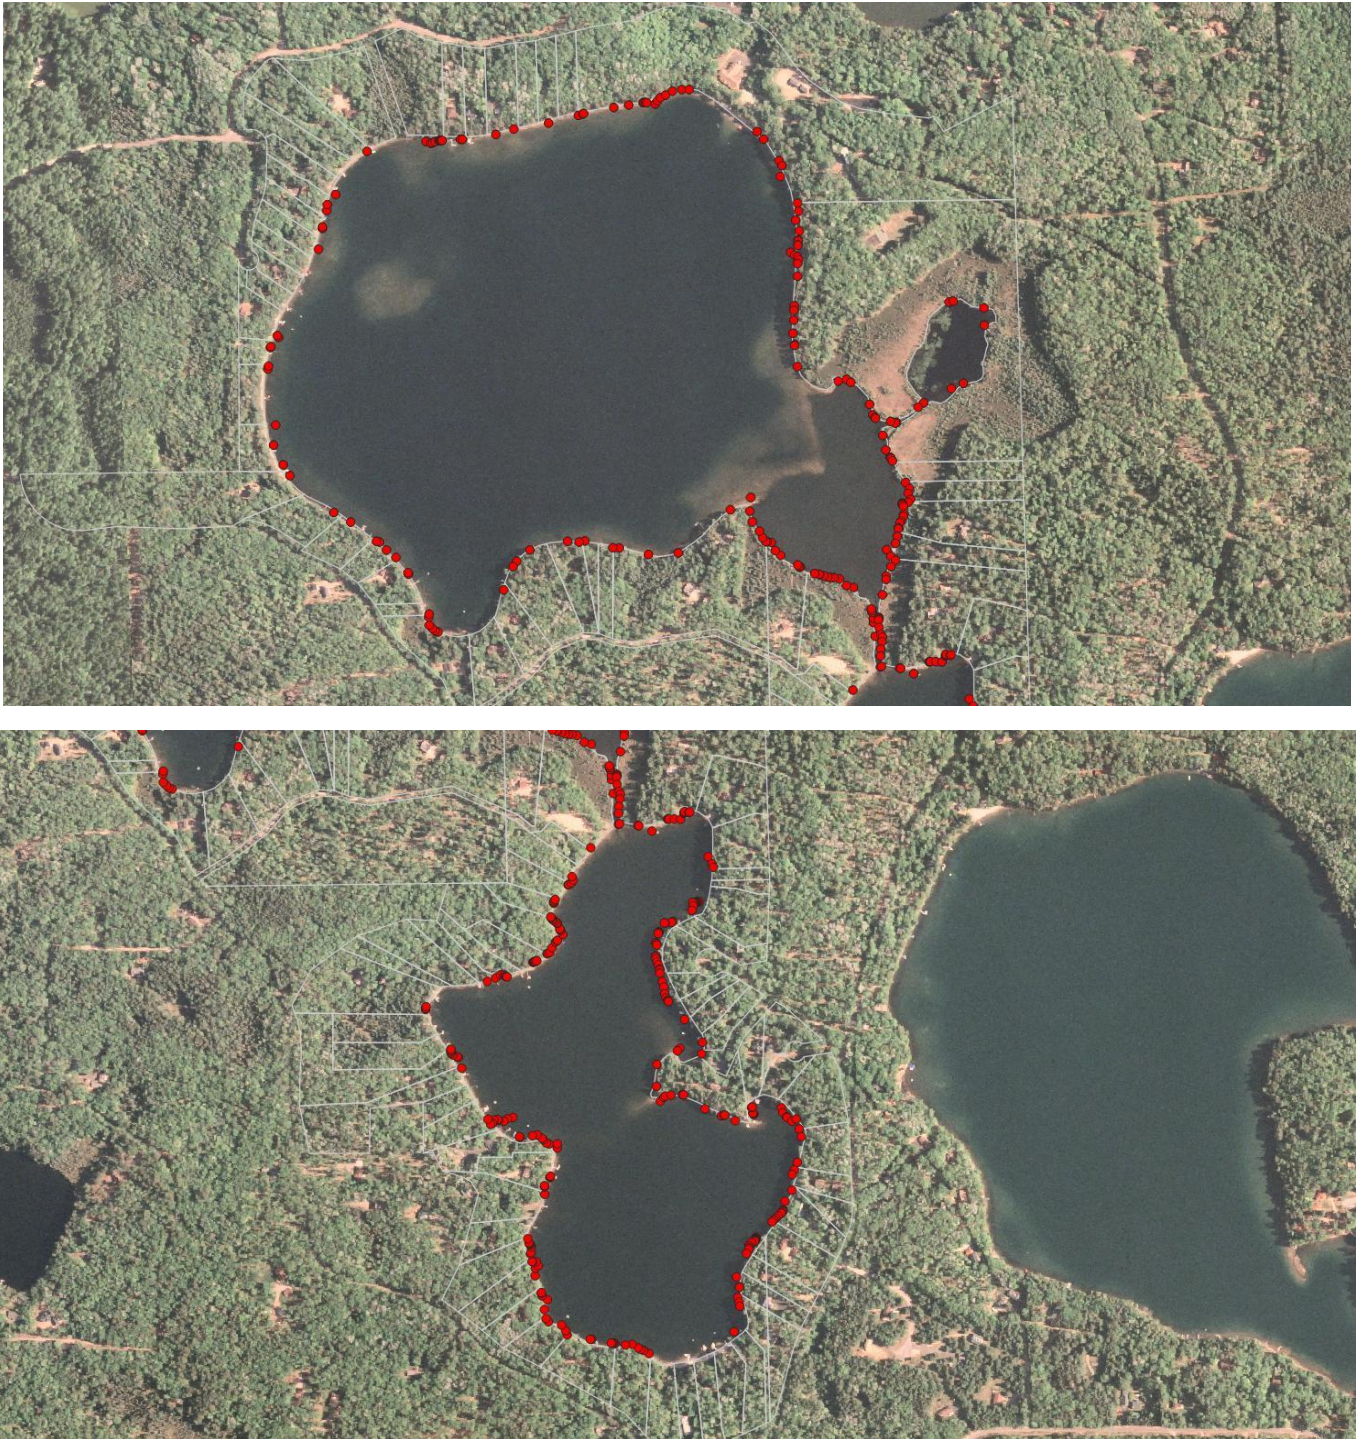
Waypoints were collected of all coarse wood (pieces >4" diameter, >5' length) along the shoreline of Alma and Moon Lakes (Figure 14). The individual coarse wood was further delineated as submerged logs, logs touching shore, full tree crowns, and logs with some branching, following the Hein et al. (2020) protocol. While not equally distributed, there were 231 pieces of coarse wood on Alma Lake, or 140 pieces per mile of shoreline. While the best structure for fish habitat is downed trees with whole crowns, only 4 of the 231 pieces (2%) on Alma Lake were of that type. An additional 14 pieces of coarse wood had some branching (6%), but the majority were either submerged logs or logs touching the shore (203 pieces – 92%). Moon Lake had less coarse wood per mile shoreline (190 pieces, 96 pieces/mile) but it was of greater habitat value with 22 downed trees with crowns (12%), 38 pieces of downed wood with some branching (20%), and 130 submerged logs or logs touching shore (62%).

Figure 14. Red dots represent waypoints of all coarse wood (pieces >4" diameter, >5' length) along the shoreline of Alma and Moon Lakes

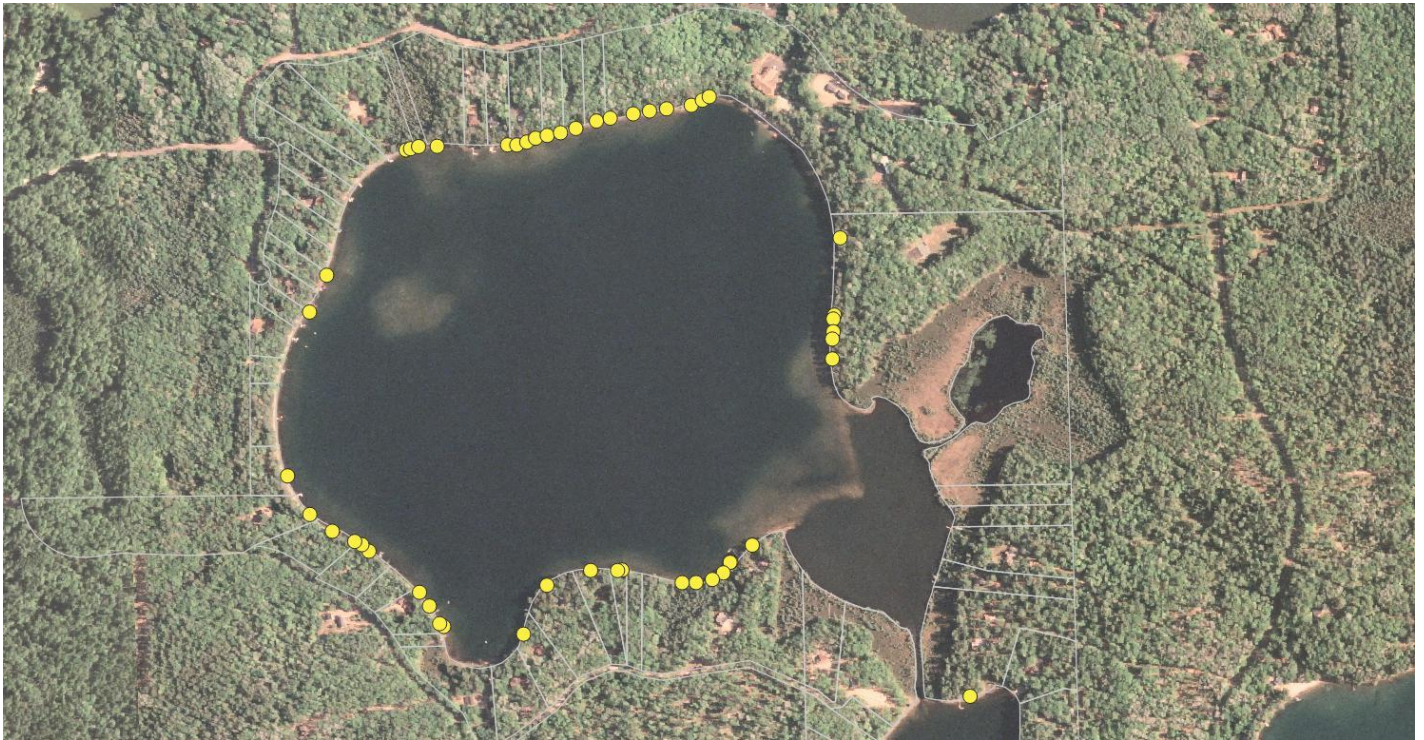
other areas of the lake. Mostly, these were narrow bands of gravel with little rock or rubble on Moon Lake. Differently, there were few and small extents of gravel on Alma Lake.

Figure 15. Waypoints (yellow dots) were collected at shorelines where the lake bottom is dominated by rock, rubble and gravel during the fish habitat surveys in May 2023.

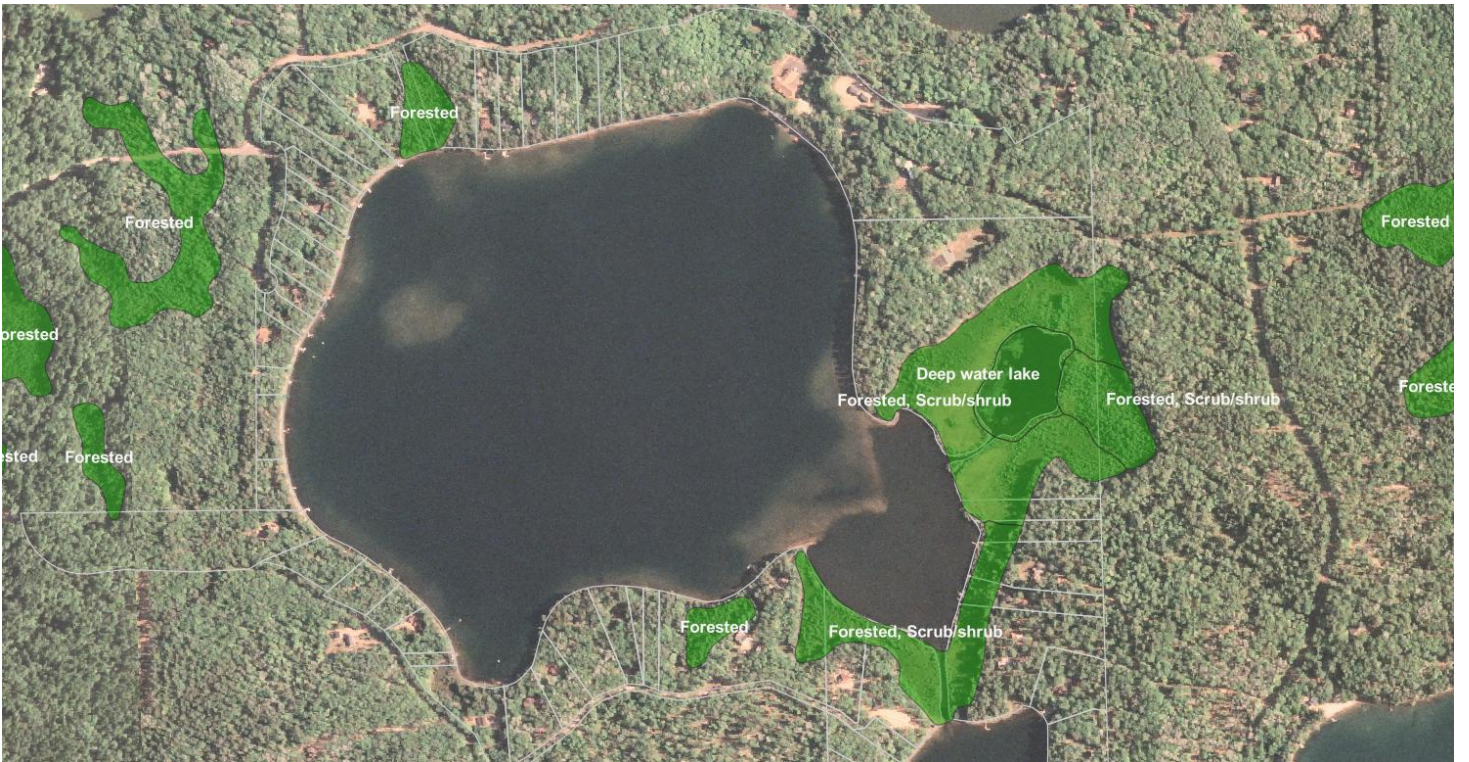
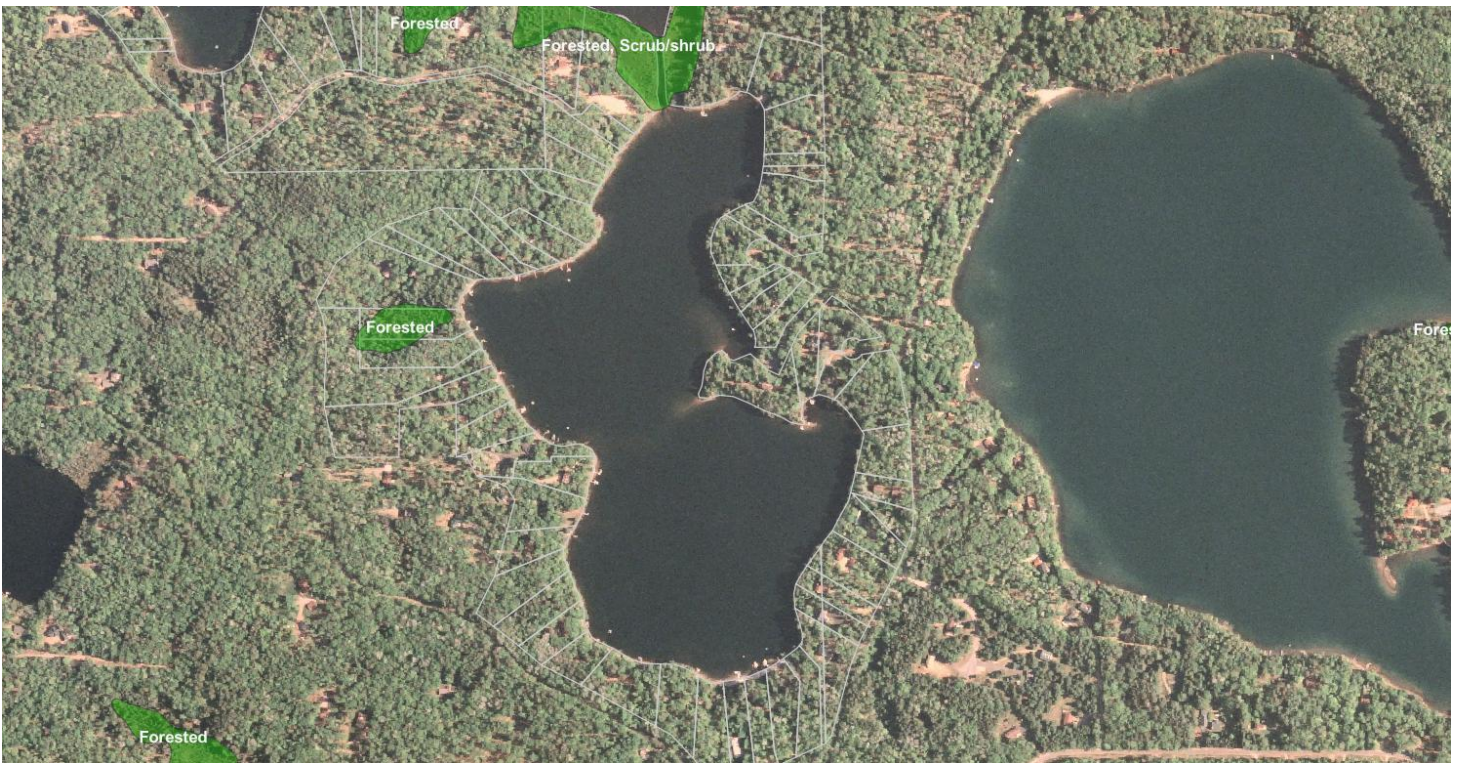
We obtained Wisconsin Wetland Inventory shapefiles for the survey area from the WDNR which show graphic representations of the type, size, and location of wetlands in proximity to Alma and Moon Lakes. These maps have been prepared from the analysis of high-altitude imagery in conjunction with soil surveys, topographic maps, previous wetland inventories and field work. We used QGIS to produce a geo-referenced overlay of wetlands adjacent to Alma and Moon Lakes (Figure 18). The wetland descriptions and naming follow the Wisconsin Wetland Inventory Classification Guide (1992) WDNR Publ. WZ-WZ023. Wetlands predominate the shoreline of the southeast bay of Moon Lake, Engel Lake, and the channel between Alma and Moon Lakes. Only small patches of wetland shoreline are found on the remainder of Moon Lake and only one small area on Alma Lake.

Figure 18. Green polygons show the type, size, and location of wetlands in proximity to Alma and Moon Lakes.

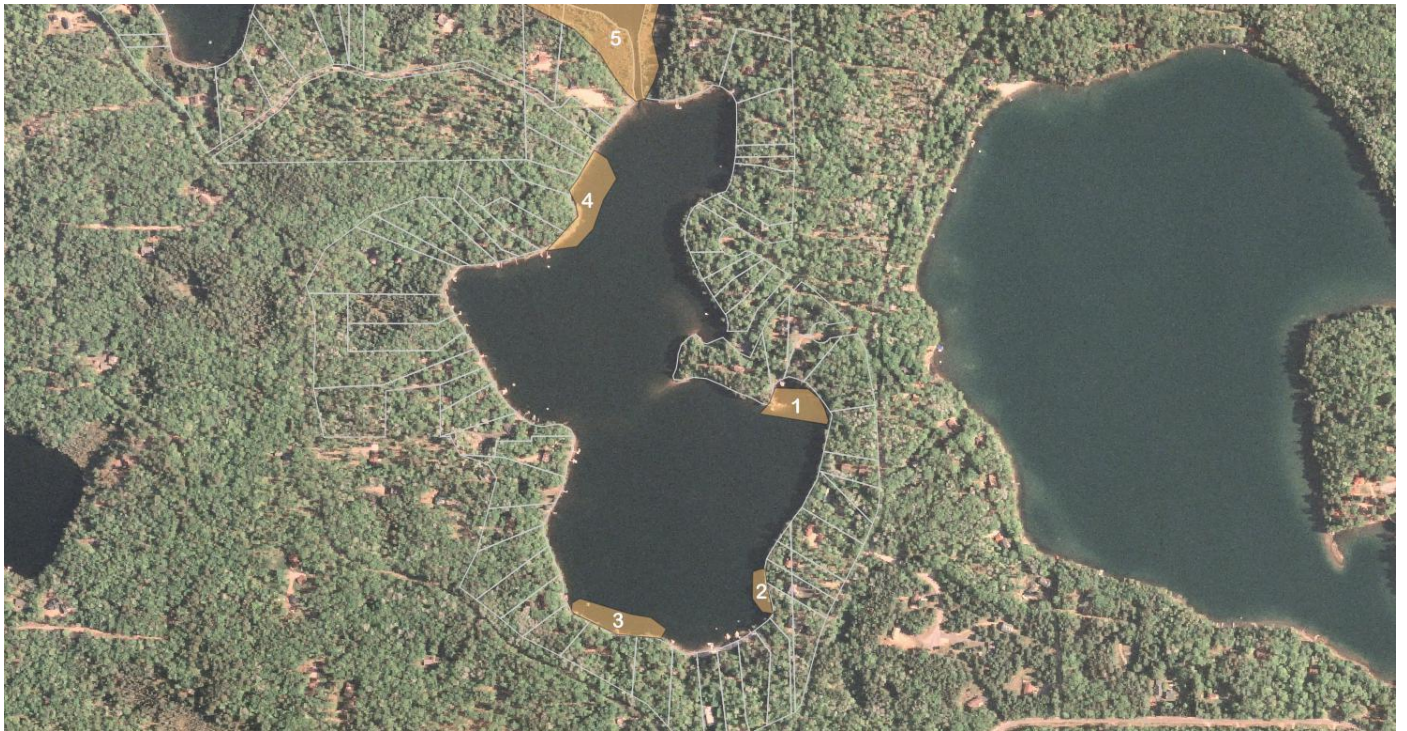
Figure 20. Location of the four areas on Alma Lake recommended for consideration as Critical Habitat (orange shading) by Nova Ecological Services during 2023 surveys and adjacent property lines (white lines).

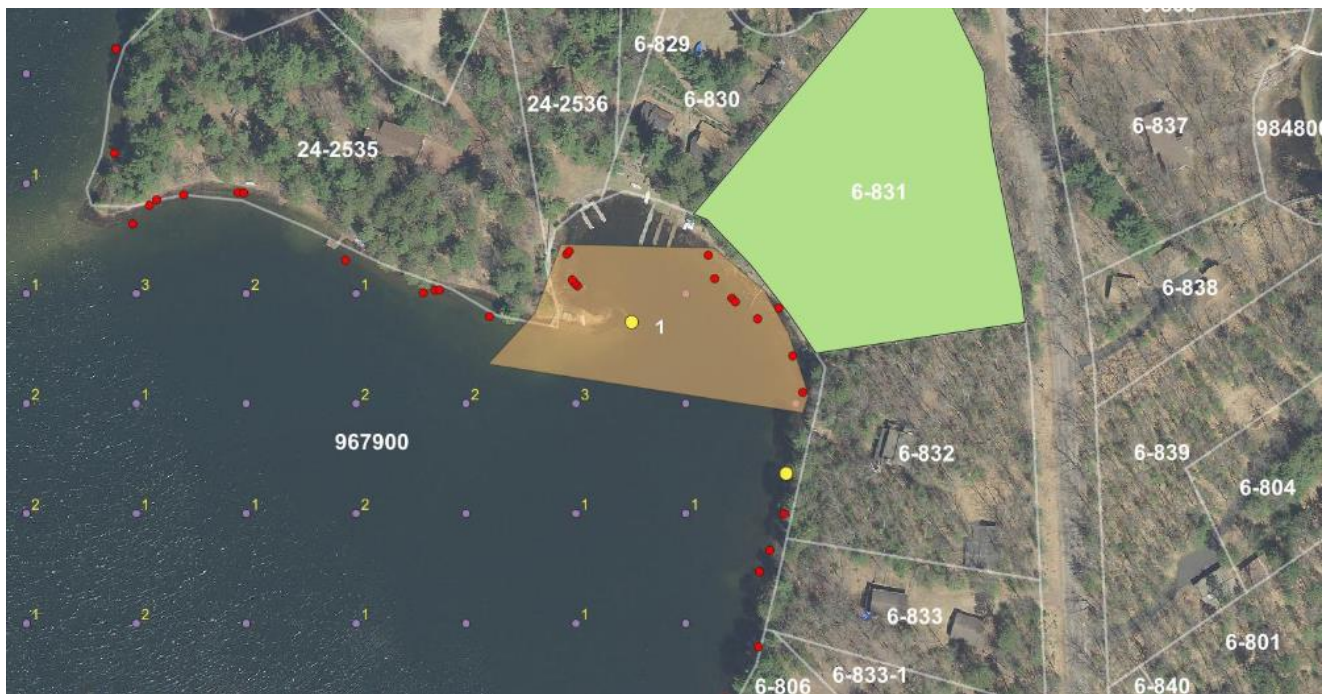
Figure 23. Alma Lake Site 1 - Critical Habitat site (orange polygon, white numeral) in relation to natural features (red dots=coarse wood; yellow dots=rock/rubble/gravel; purple dots and yellow numerals=2019 Onterra PI Survey results with number of native species per point; light green polygons=natural shoreland). Tax parcels white lines, white numerals.

1. No alteration of littoral zone.
2. Maintain existing buffer/riparian zone which is primarily intact.
- 3.. Maintain and do not remove existing coarse wood.

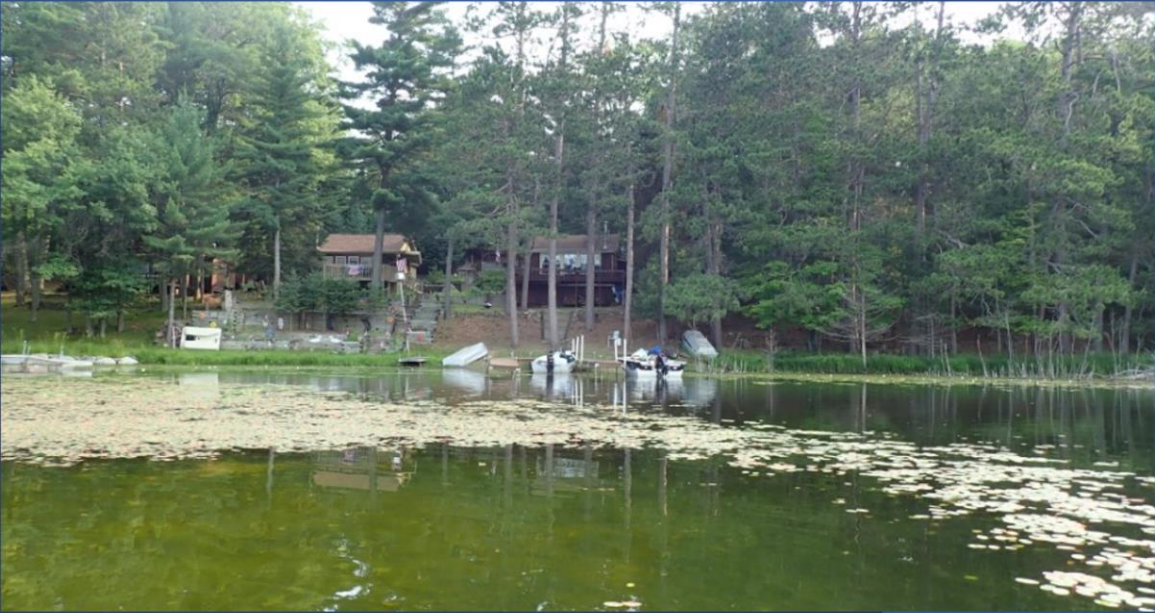
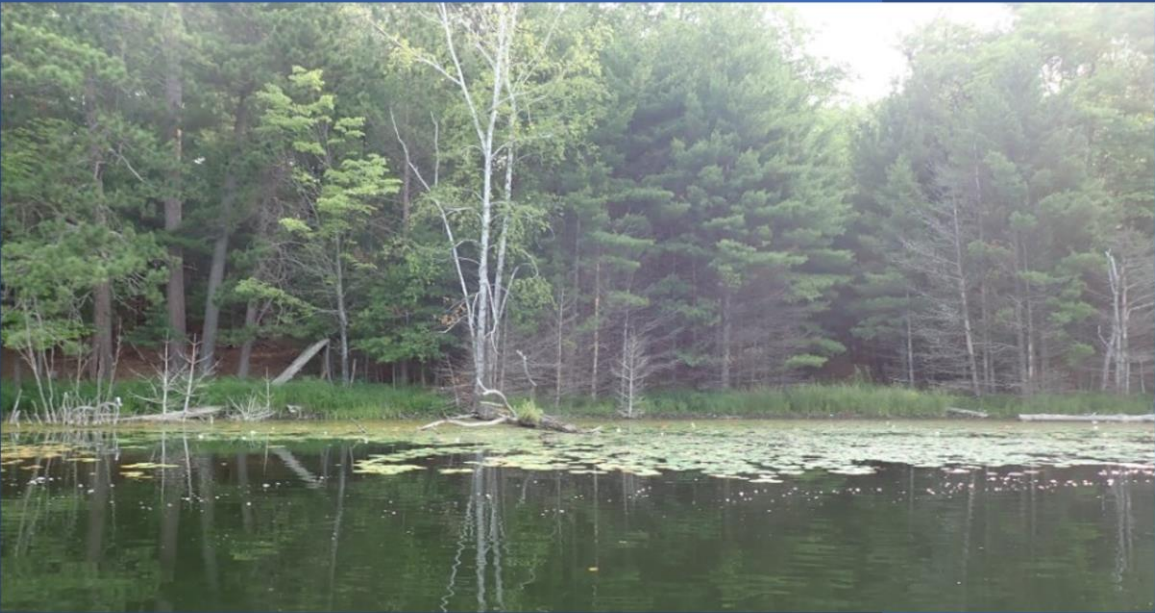
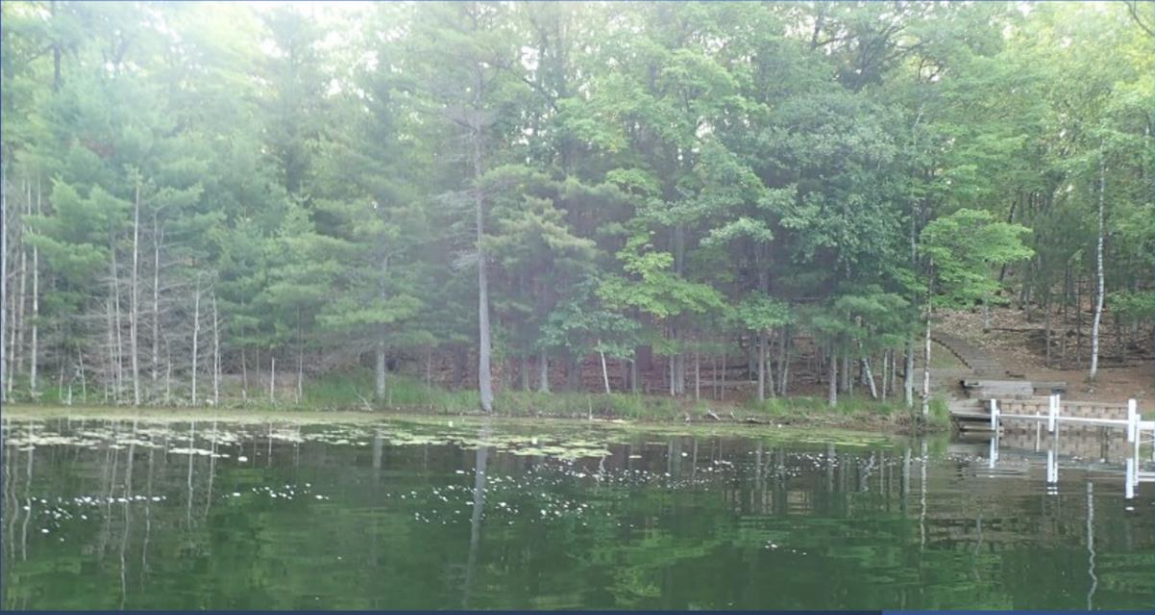
Alma Lake-Site #1

The site includes nearshore terrestrial, shoreline, and littoral zone habitats. The riparian type is 50% developed and 50% wooded. The riparian character (from water's edge to 35 feet back) is dominated by herbaceous plants, shrubs, trees with some lawn present. Roughly half of this site contains a natural shoreline. Coarse woody cover is abundant (see Figure 23).

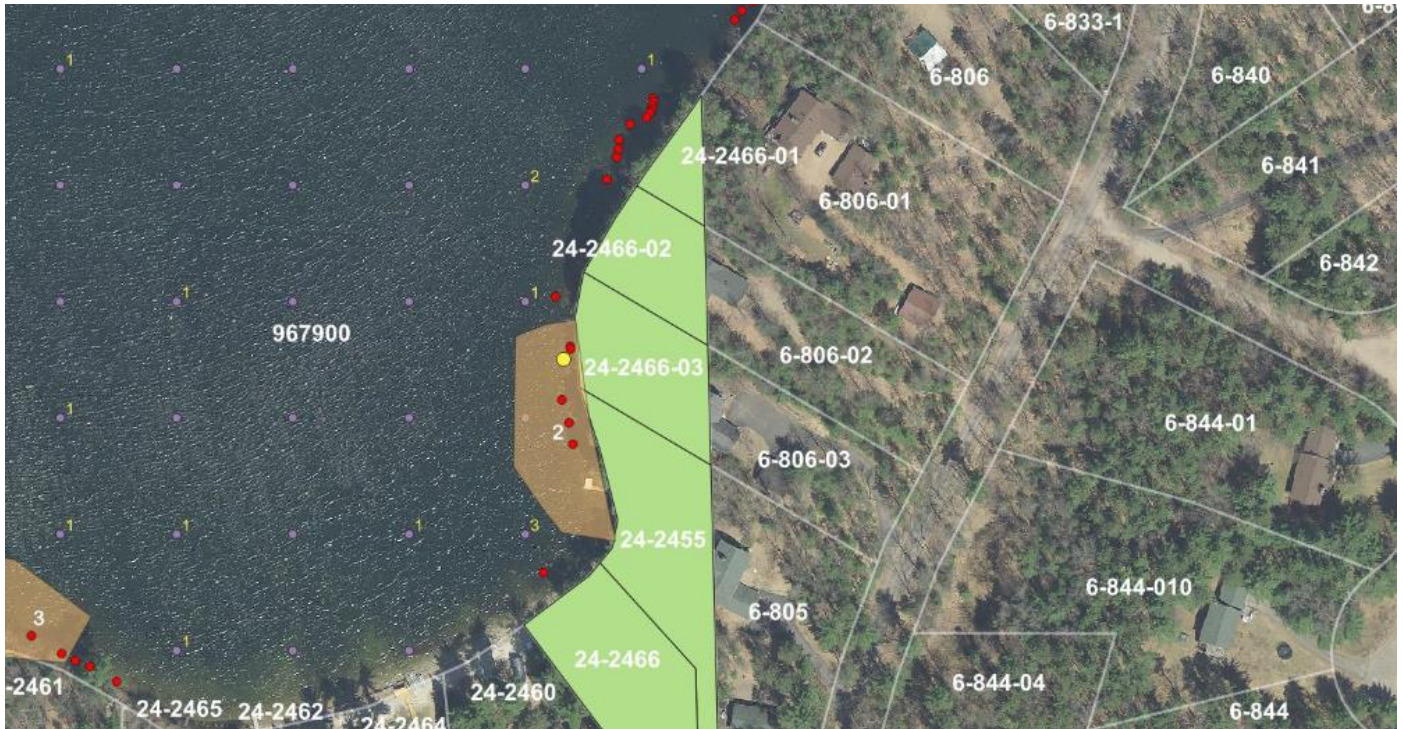
Figure 24. Alma Lake Site 2 - Critical Habitat site (orange polygon, white numeral) in relation to natural features (red dots=coarse wood; yellow dots=rock/rubble/gravel; purple dots and yellow numerals=2019 Onterra PI Survey results with number of native species per point; light green polygons=natural shoreland). Tax parcels white lines, white numerals.

1. No alteration of littoral zone.
2. Maintain existing buffer/riparian zone which is primarily intact.
- 3.. Maintain and do not remove existing coarse wood.

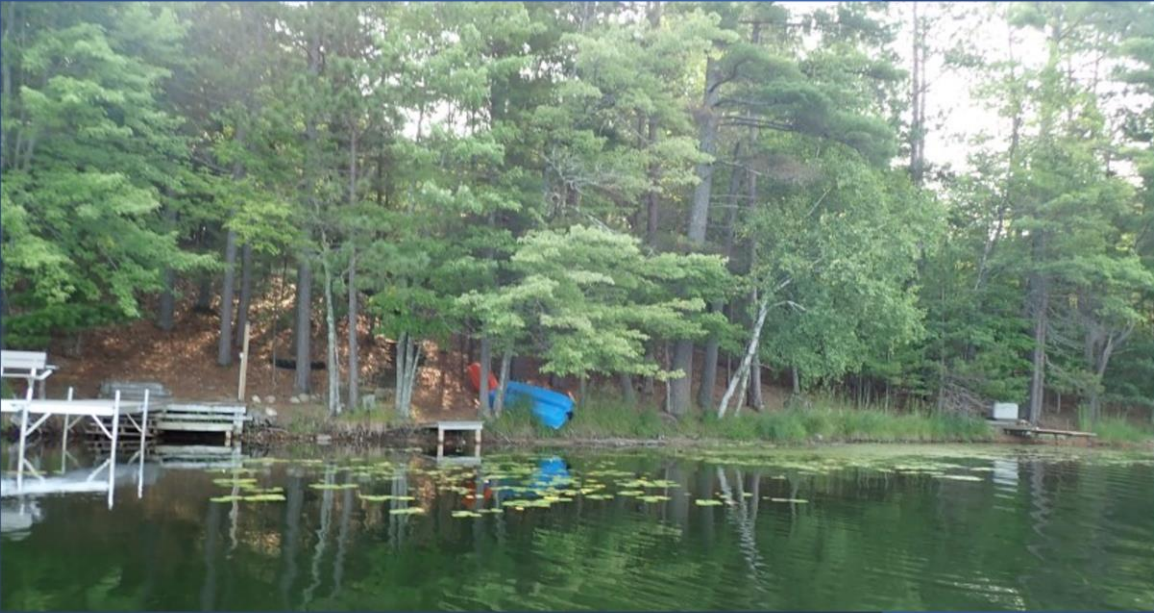
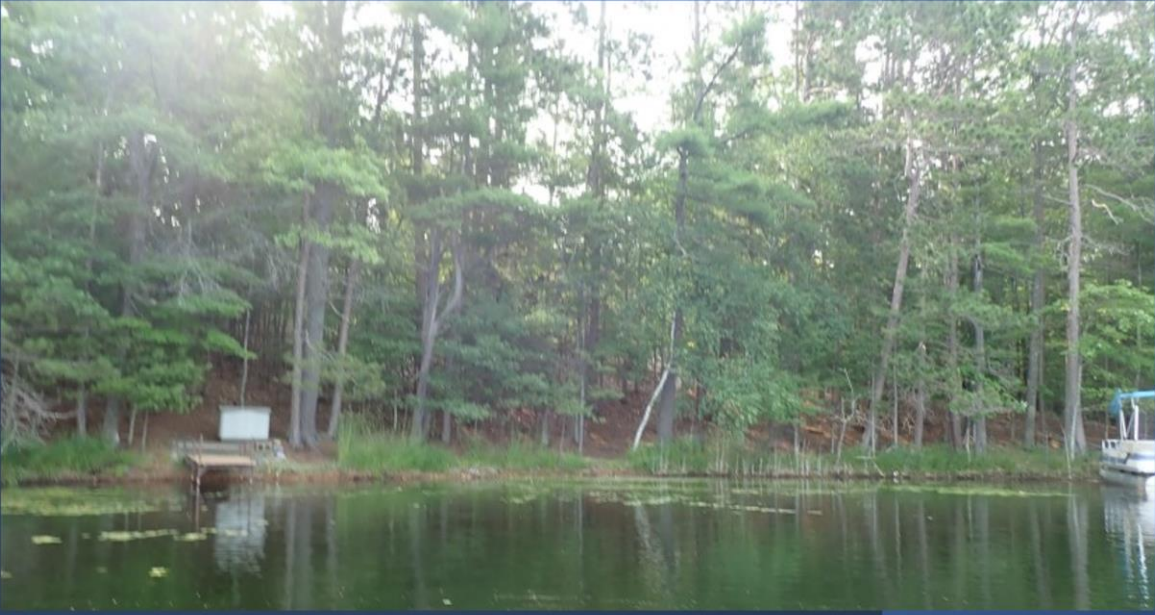
Alma Lake-Site #2

The site includes nearshore terrestrial, shoreline, and littoral zone habitats. The riparian type is 20% developed and 80% wooded. The riparian character (from water's edge to 35 feet back) is dominated by herbaceous plants, shrubs, and trees. Most of this site contains a natural shoreline. Coarse woody cover is common (see Figure 24).

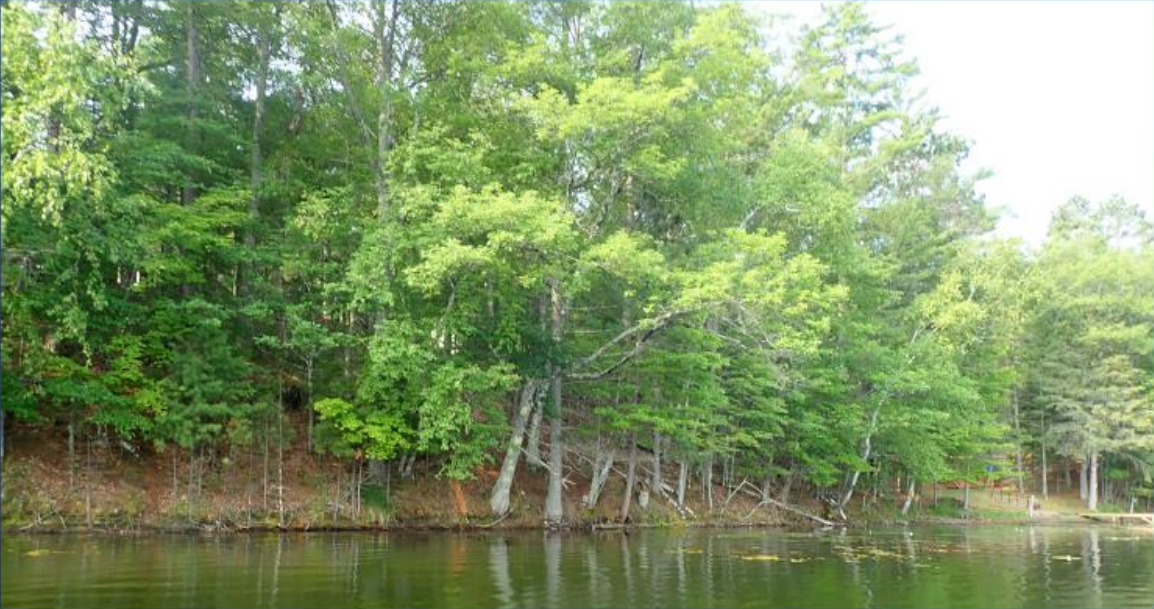
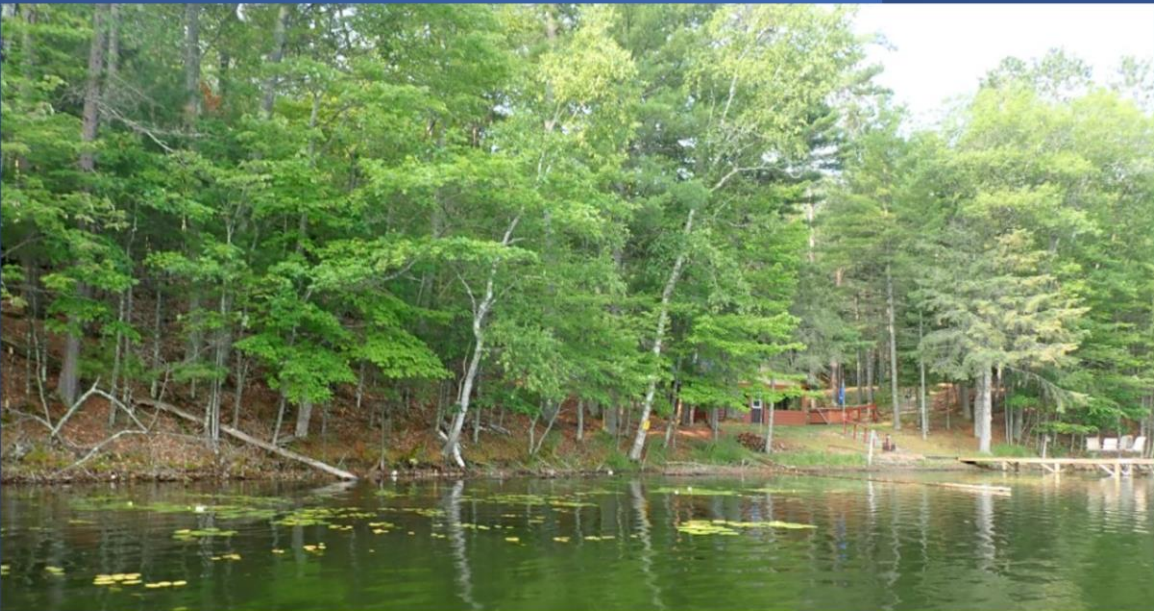
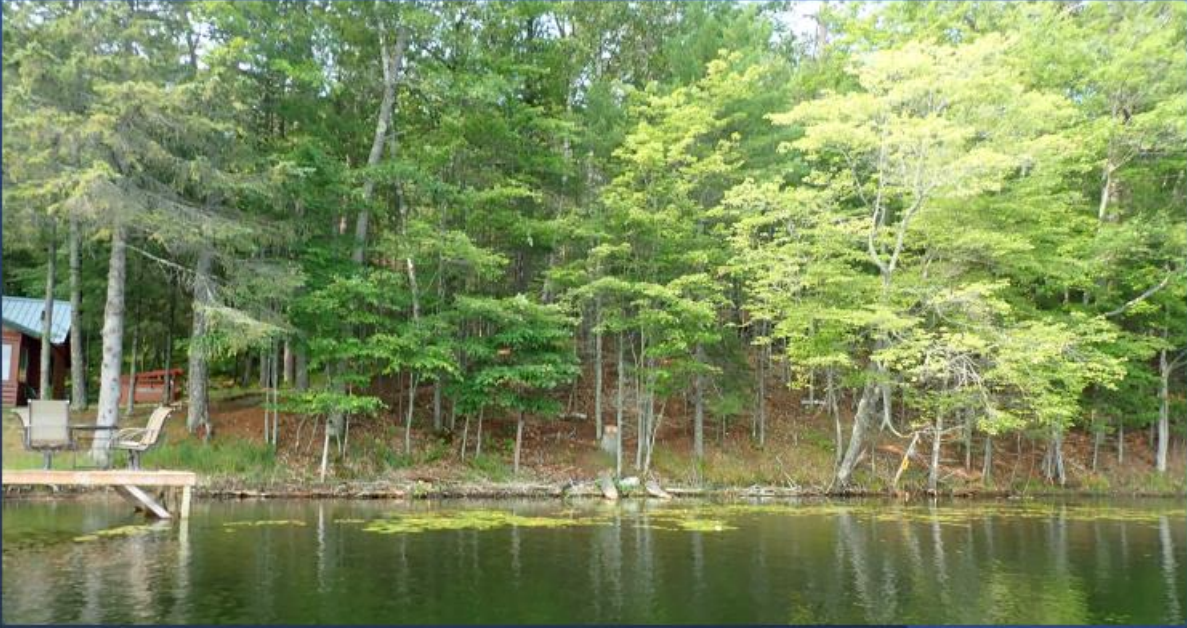
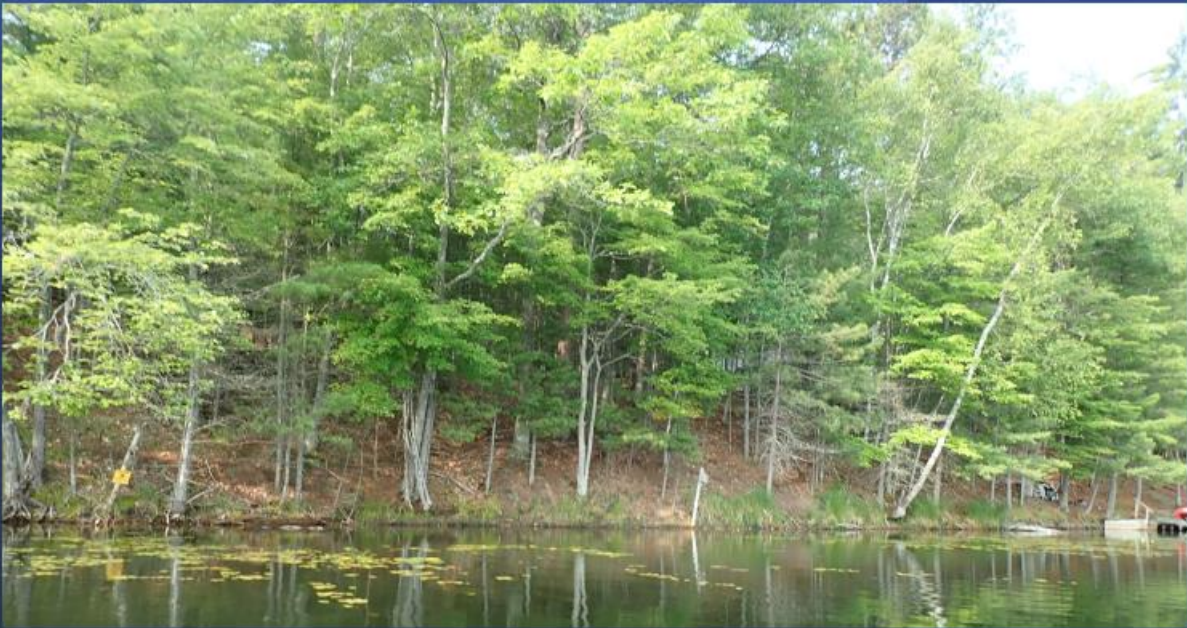
Alma Lake-Site #3

The site includes nearshore terrestrial, shoreline, and littoral zone habitats. The riparian type is 10% developed and 90% wooded. The riparian character (from water's edge to 35 feet back) is dominated by herbaceous plants, shrubs, and trees. Coarse woody cover is common (see Figure 25).

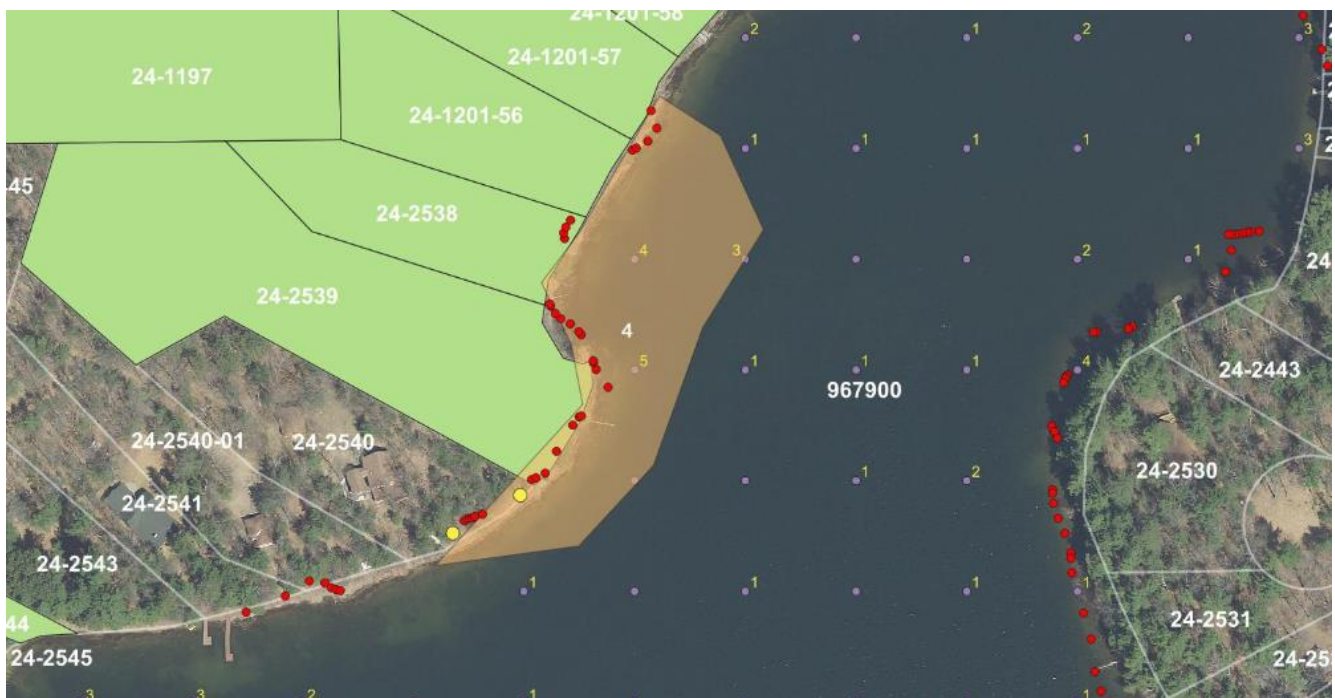
Figure 26. Alma Lake Site 4. Critical Habitat site (orange polygon, white numeral) in relation to natural features (red dots=coarse wood; yellow dots=rock/rubble/gravel; purple dots and yellow numerals=2019 Onterra PI Survey results with number of native species per point; light green polygons=natural shoreland). Tax parcels white lines, white numerals.

1. No alteration of littoral zone.
2. Because of the steep shoreline, maintain the existing buffer/riparian zone which is primarily intact.
3. Maintain and do not remove existing coarse wood.
4. Maintain snag/perch trees.

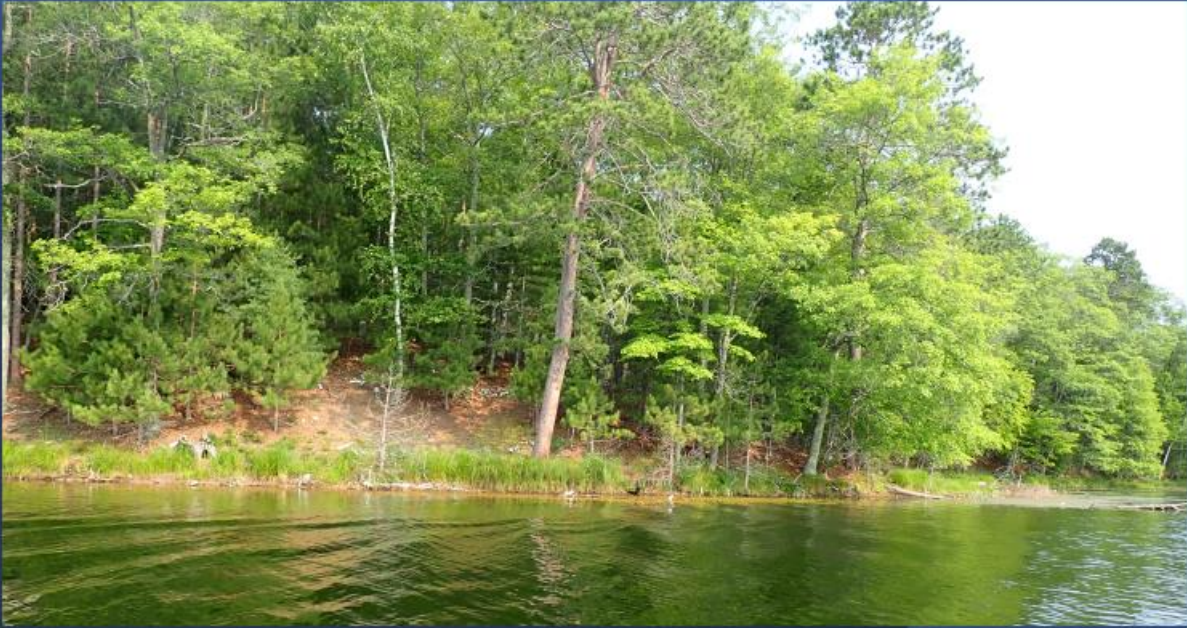
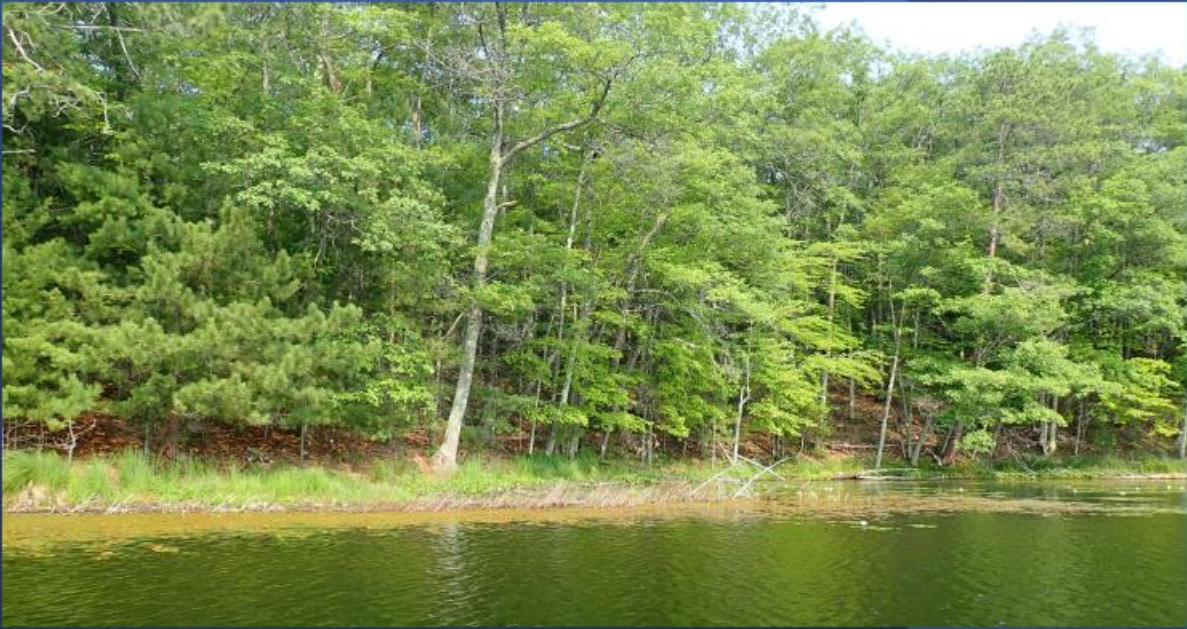
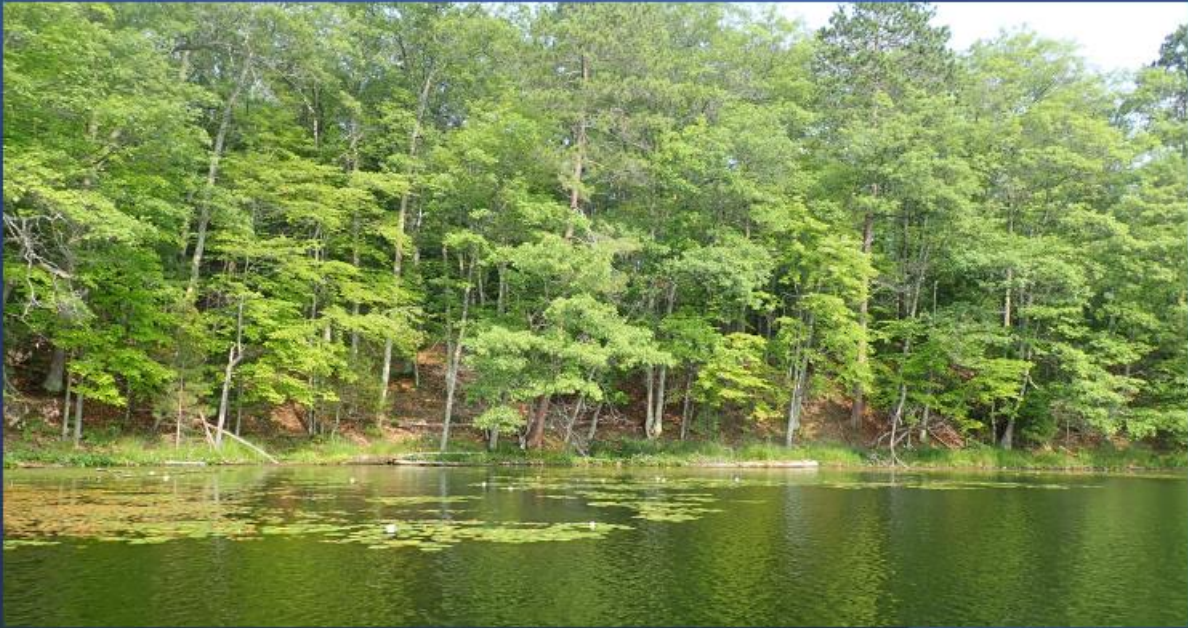
Alma Lake-Site #4

The site includes nearshore terrestrial, shoreline, and littoral zone habitats. The riparian type (%) is 100% wooded. The riparian character (from water's edge to 35 feet back) is dominated by herbaceous plants, shrubs, and trees. This site contains a natural shoreline. Coarse woody cover is abundant (see Figure 26).

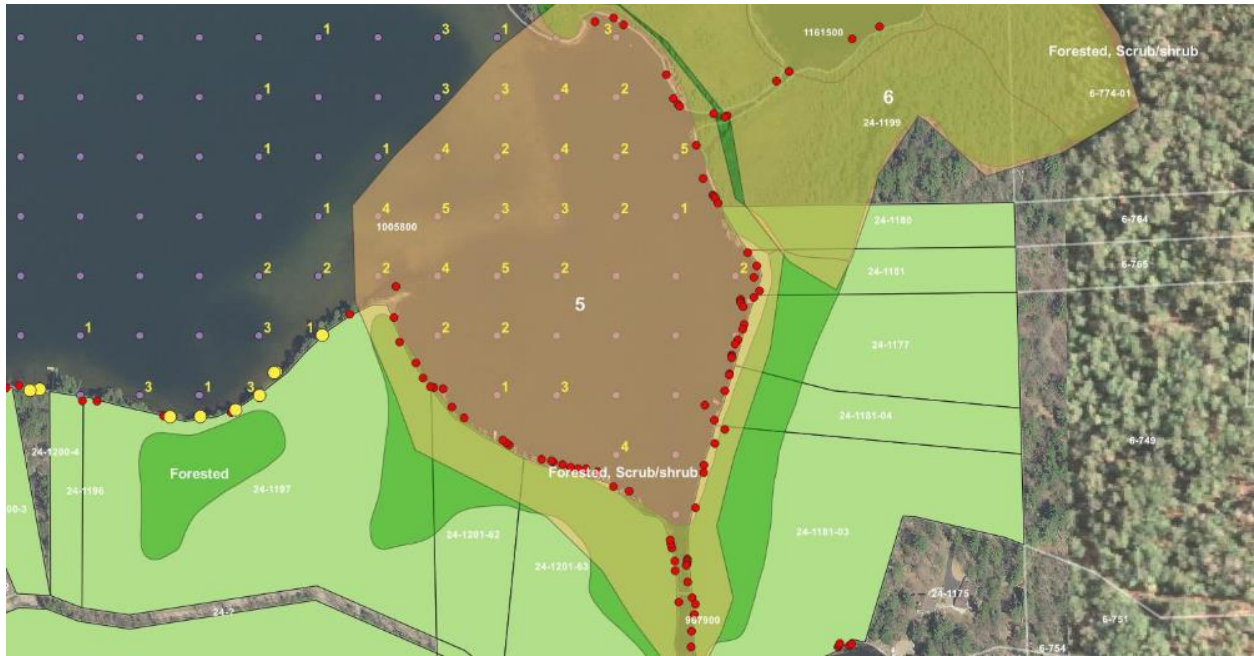
Figure 27. Moon Lake Site 5. Critical Habitat site (orange polygon, white numeral) in relation to natural features (red dots=coarse wood; yellow dots=rock/rubble/gravel; purple dots and yellow numerals=2019 Onterra PI Survey results with number of native species per point; light green polygons=natural shoreland; dark green polygons=wetlands). Tax parcels white lines, white numerals.

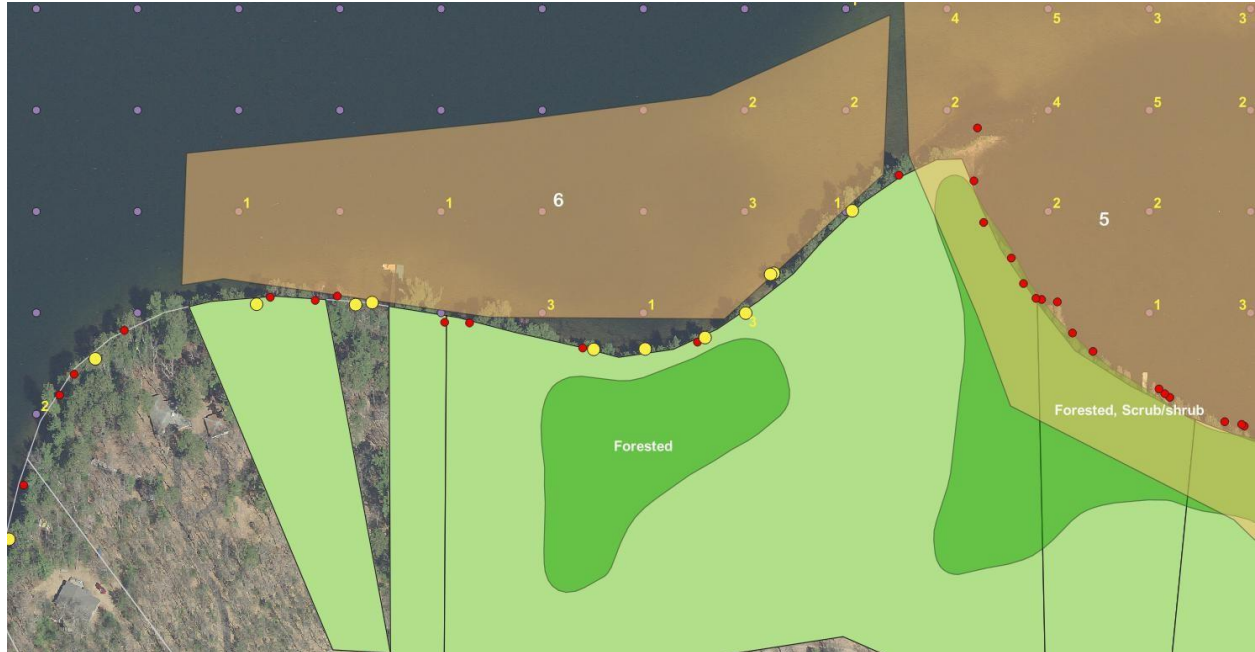
Figure 28. Moon Lake Site 6. Critical Habitat site (orange polygon, white numeral) in relation to natural features (red dots=coarse wood; yellow dots=rock/rubble/gravel; purple dots and yellow numerals=2019 Onterra PI Survey results with number of native species per point; light green polygons=natural shoreland; dark green polygons=wetlands). Tax parcels white lines.
