# Shoreland Assessments and Critical Habitat Mapping of Alma and Moon Lakes, Vilas County, Wisconsin

Mike Meyer and Jim Kreitlow  
NOVA Ecological Services  
Boulder Junction, WI 54512

March 18, 2024

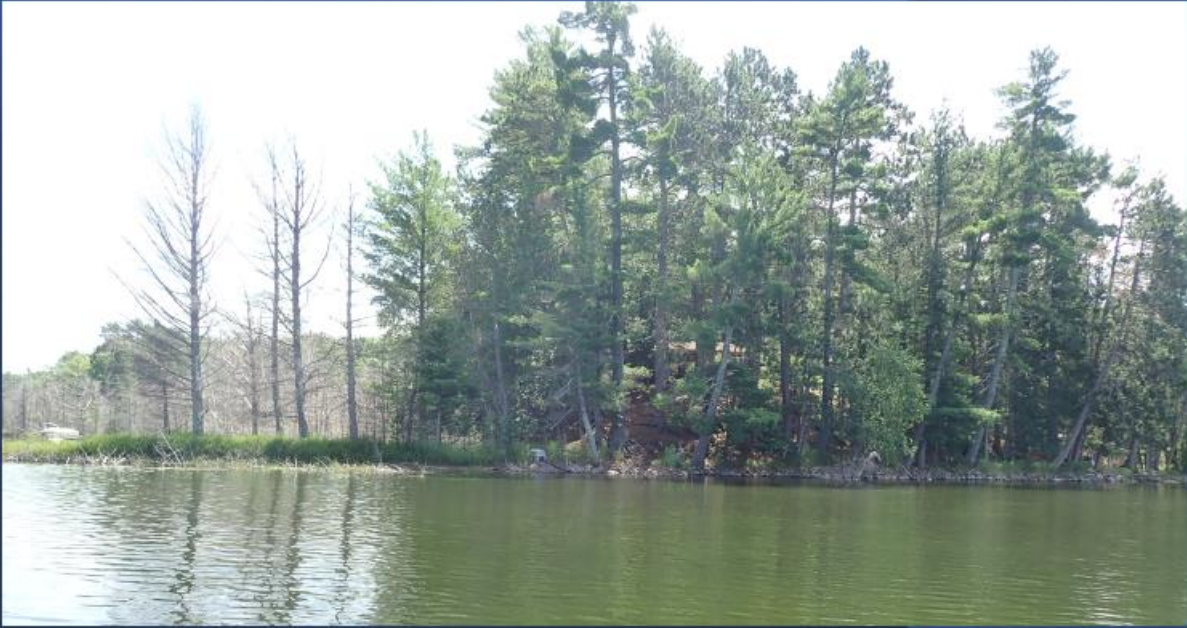
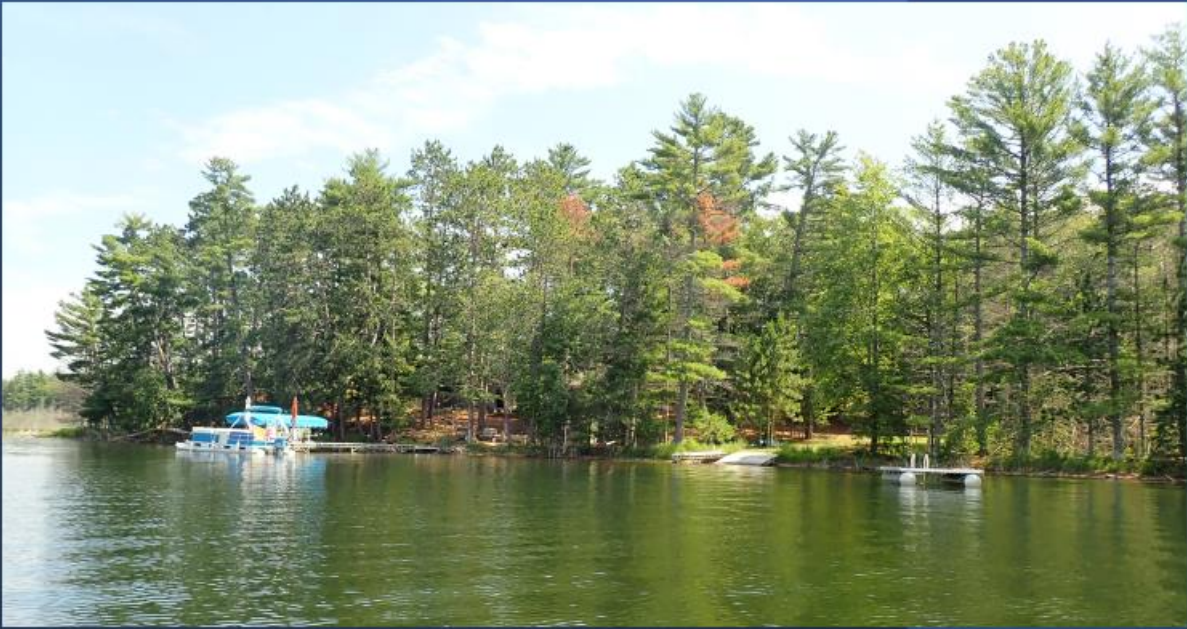
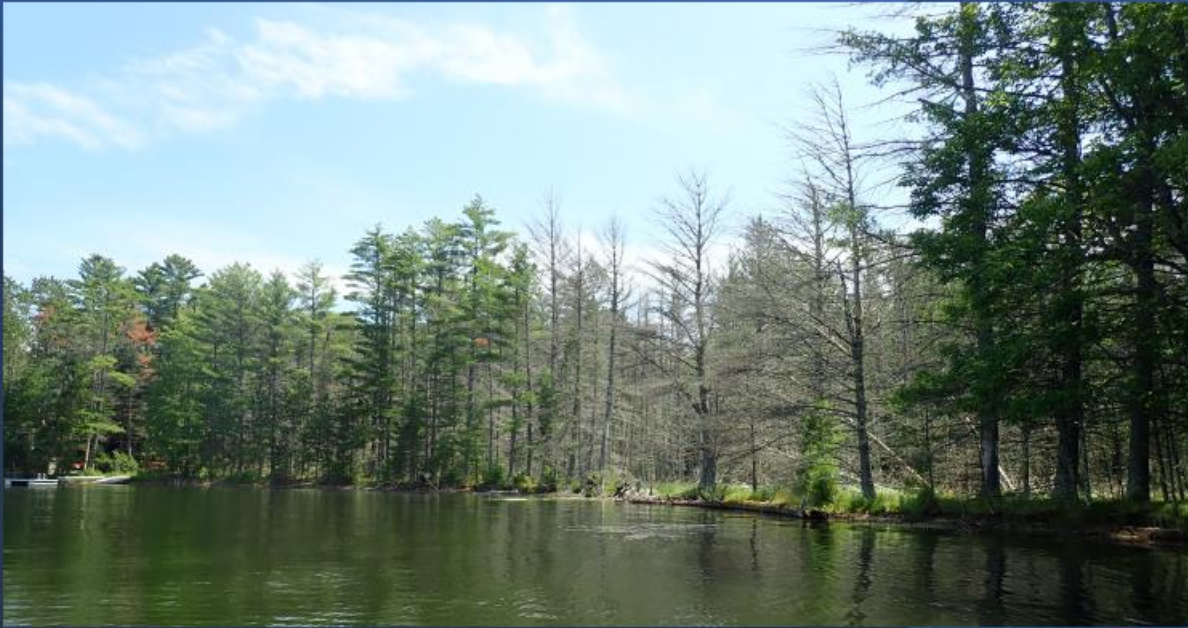
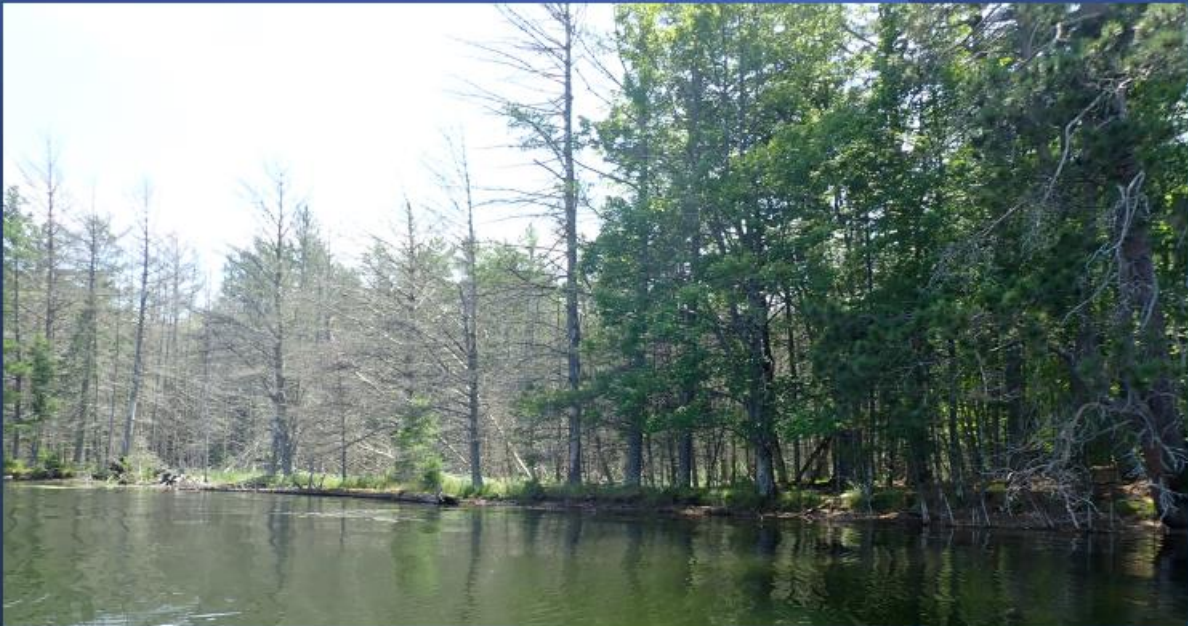
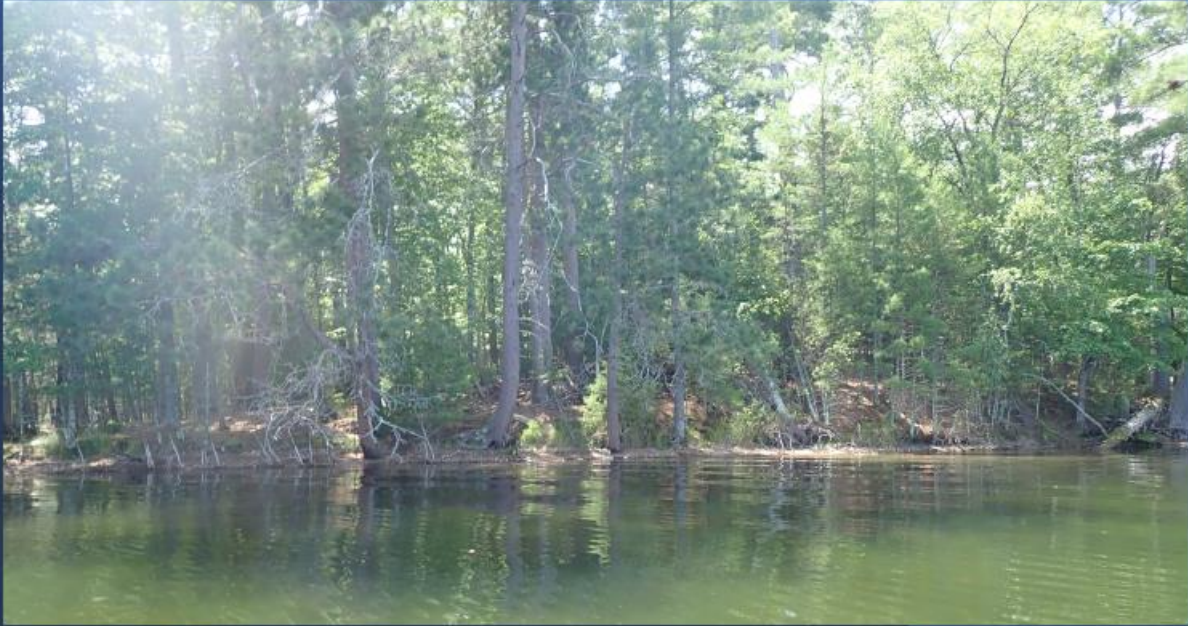
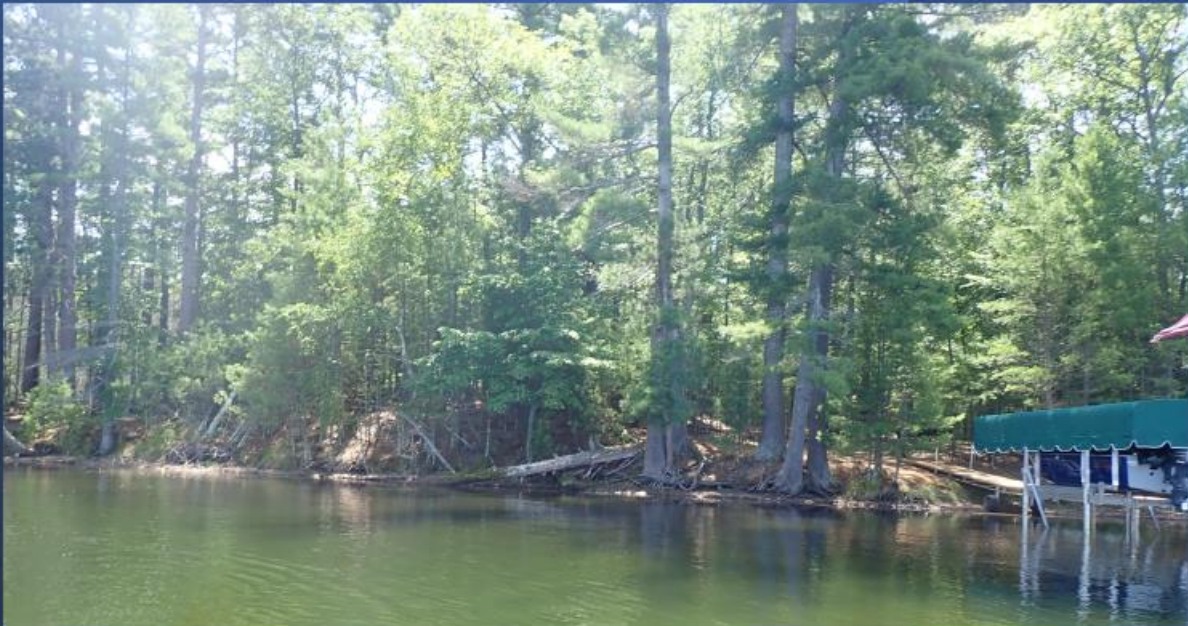
Moon Lake Site #6

The site includes nearshore terrestrial, wetland, and littoral zone habitats. The riparian type is 50% wetland and 50% wooded. The riparian character (from water’s edge to 35 feet back) is dominated by herbaceous plants, shrubs, and trees. This site contains a natural shoreline. Coarse woody cover is present along with gravel tight to shore (see Figure 28). The forested wetland consists of needle leafed evergreen trees (white cedar, balsam fir and black spruce) (see Figure 28).

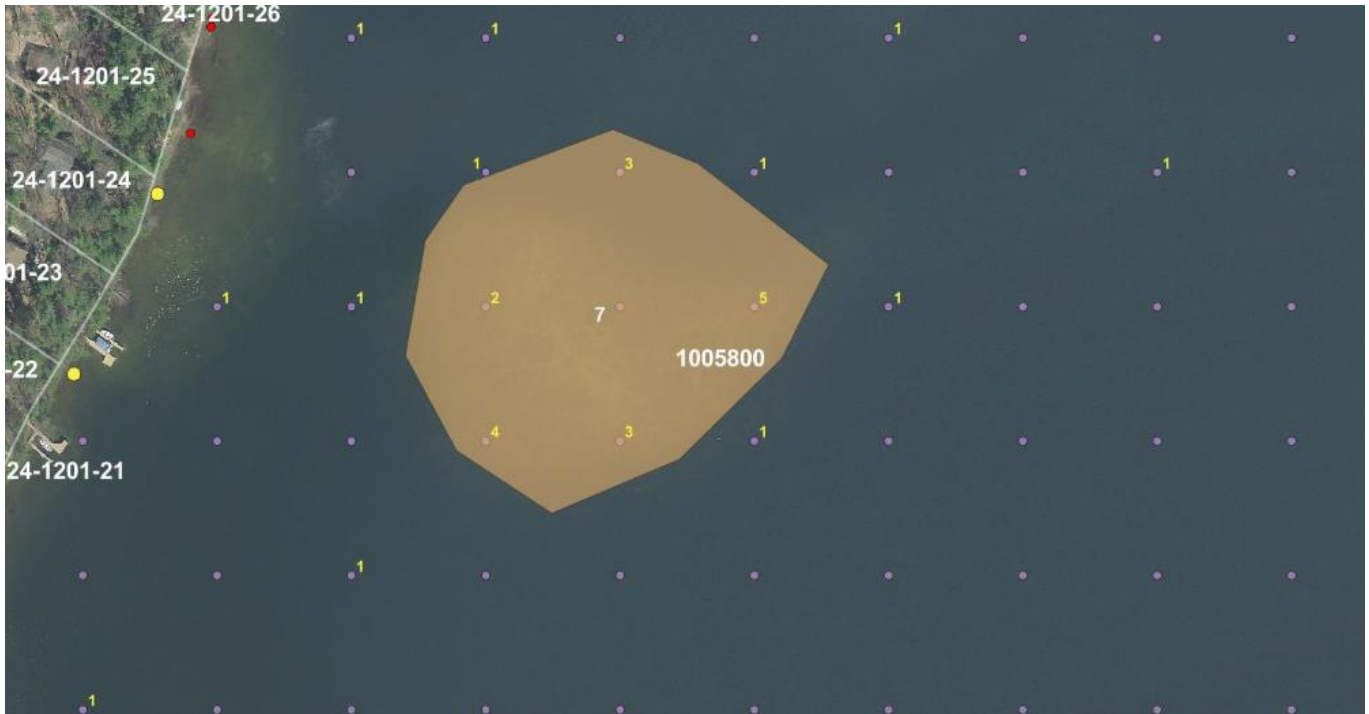
The site includes open water littoral zone habitats (see figure 29). Diverse submergent aquatic vegetation is abundant. The 2019 plant survey showed 2-5 species of plants were found on each rake sample.

Figure 28. Moon Lake Site 7. Critical Habitat site (orange polygon, white numeral) in relation to natural features (red dots=coarse wood; yellow dots=rock/rubble/gravel; purple dots and yellow numerals=2019 Onterra PI Survey results with number of native species per point. Tax parcels white lines, white numerals.

1. Protect this diverse plant bed

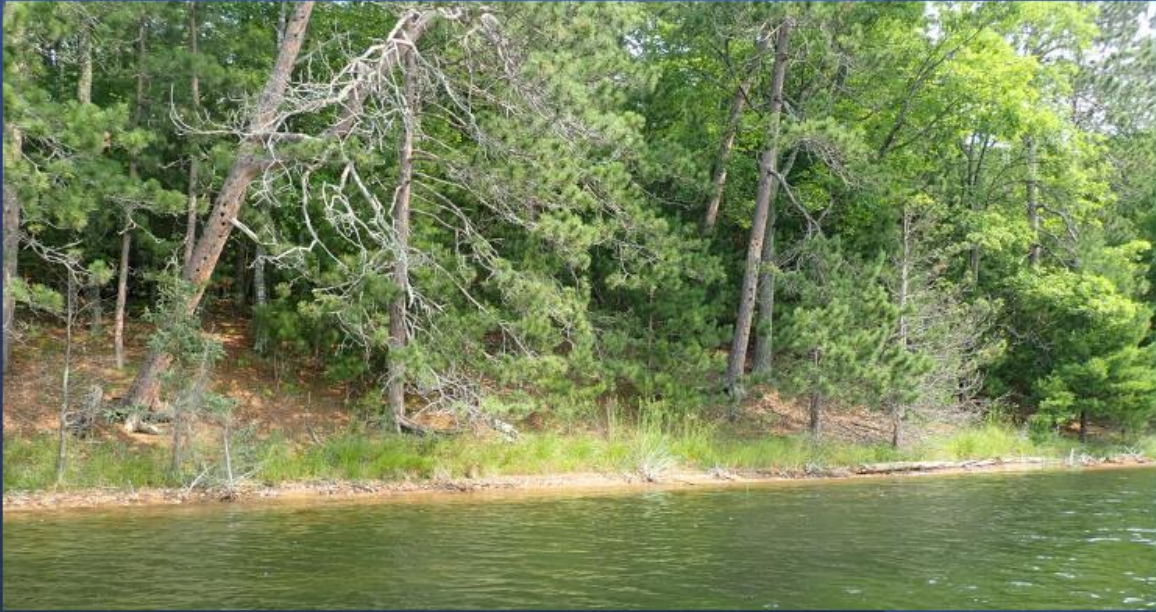
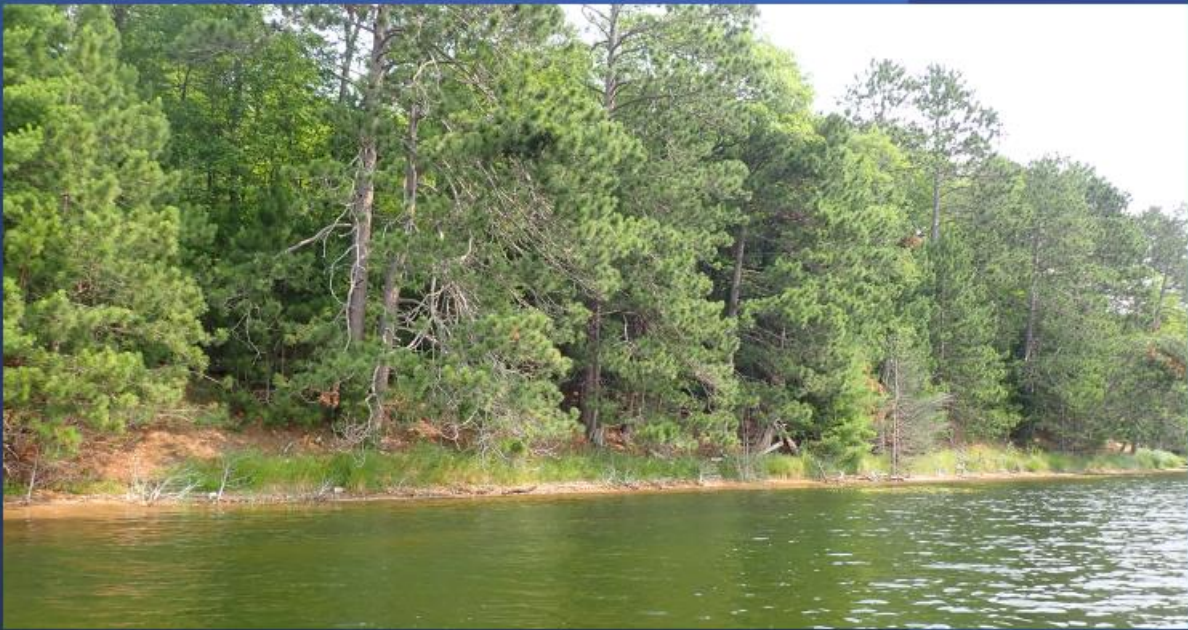
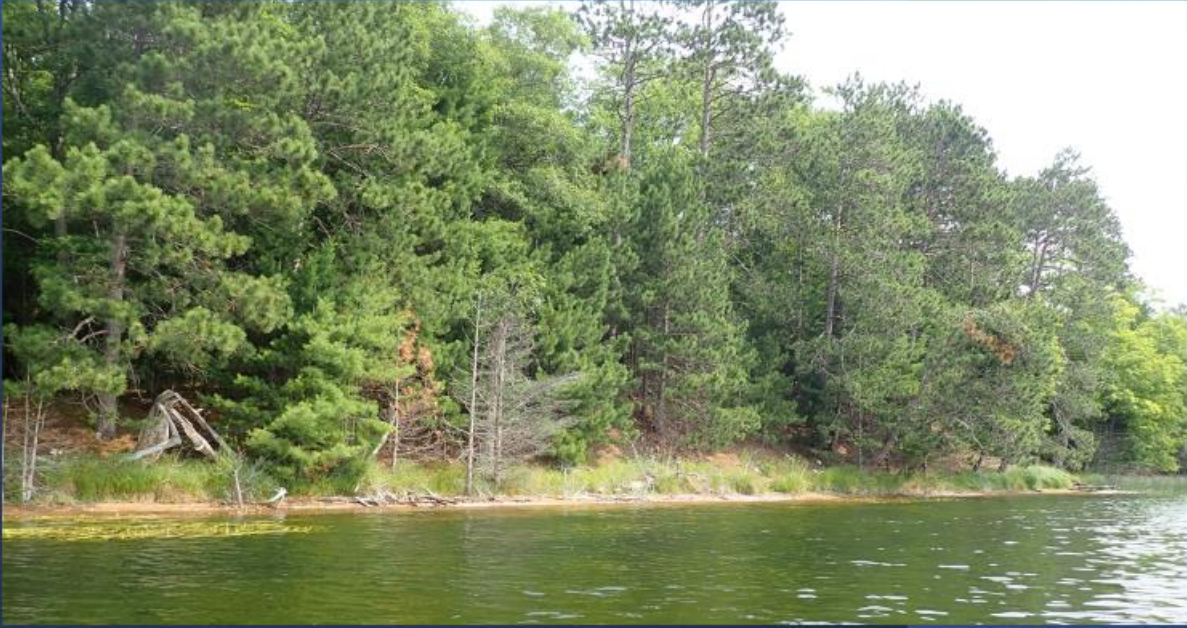
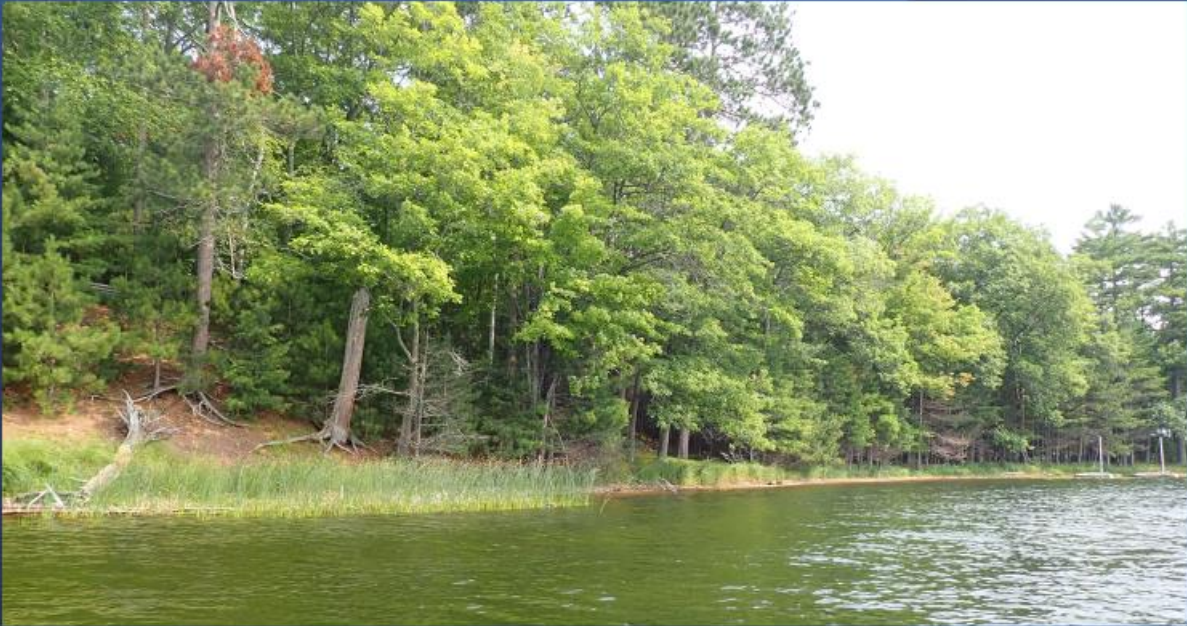
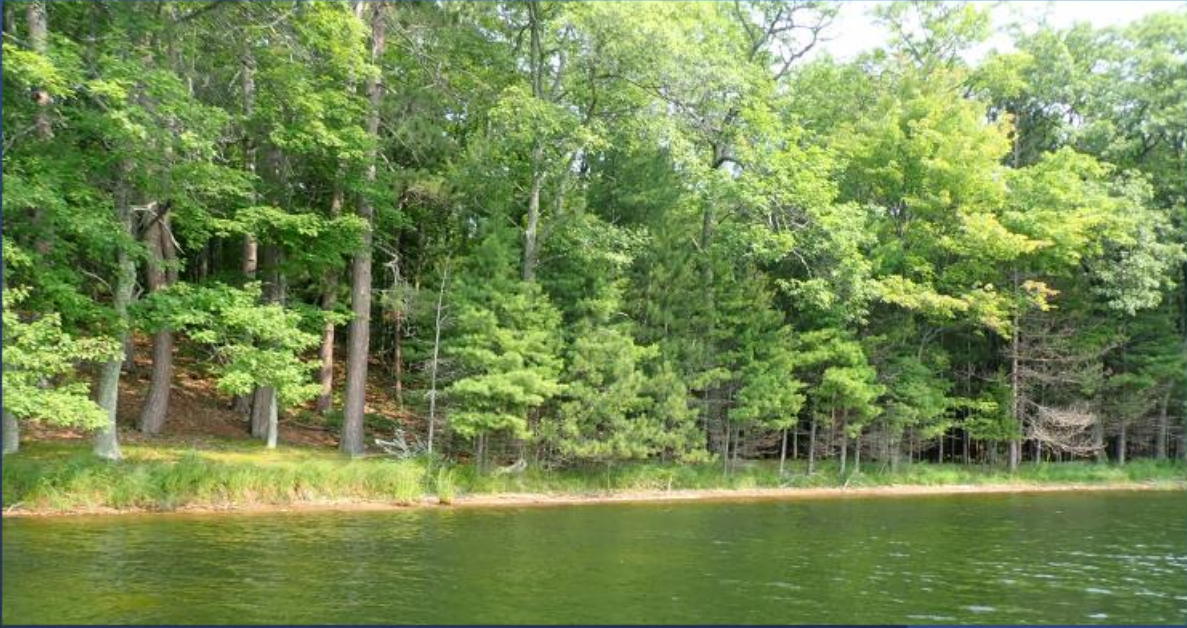
Moon Lake Site #8

The site includes nearshore terrestrial, shoreline, and littoral zone habitats. The riparian type is 100% wooded. The riparian character (from water's edge to 35 feet back) is dominated by herbaceous plants, shrubs, and trees. Gravel is present along this stretch, but it is tight to shore. This site contains a natural shoreline. Coarse woody cover is present (see Figure 30).

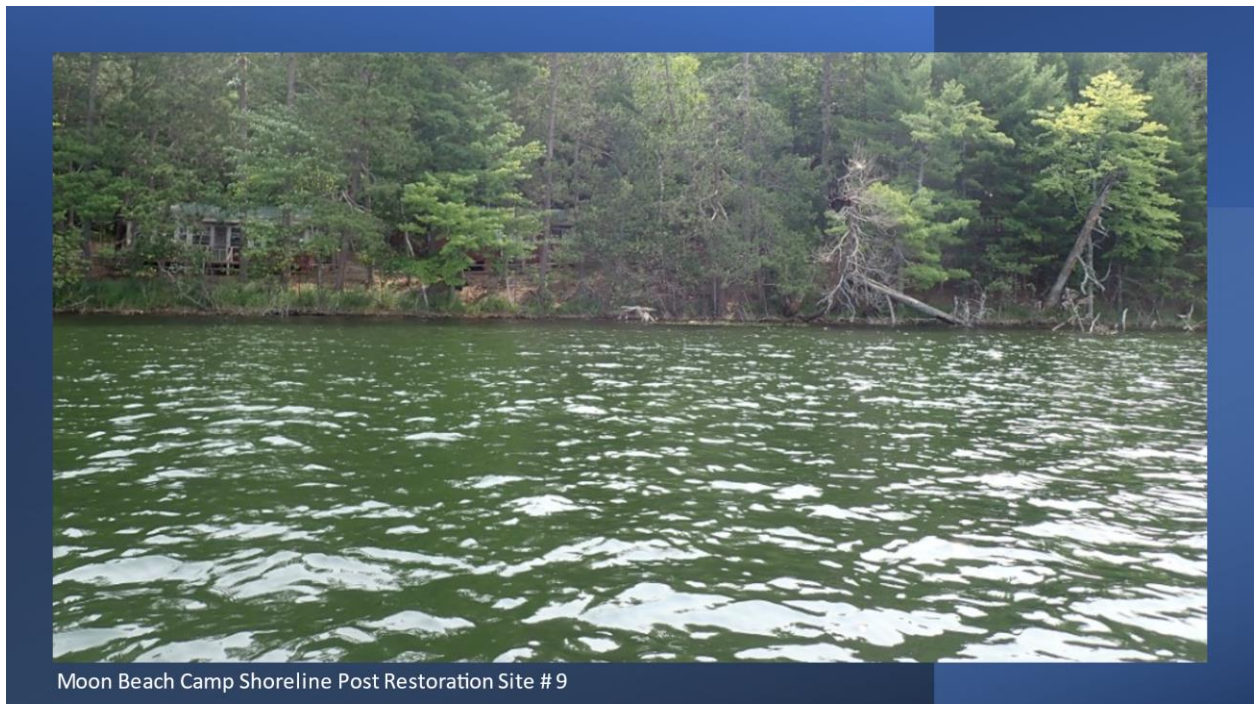
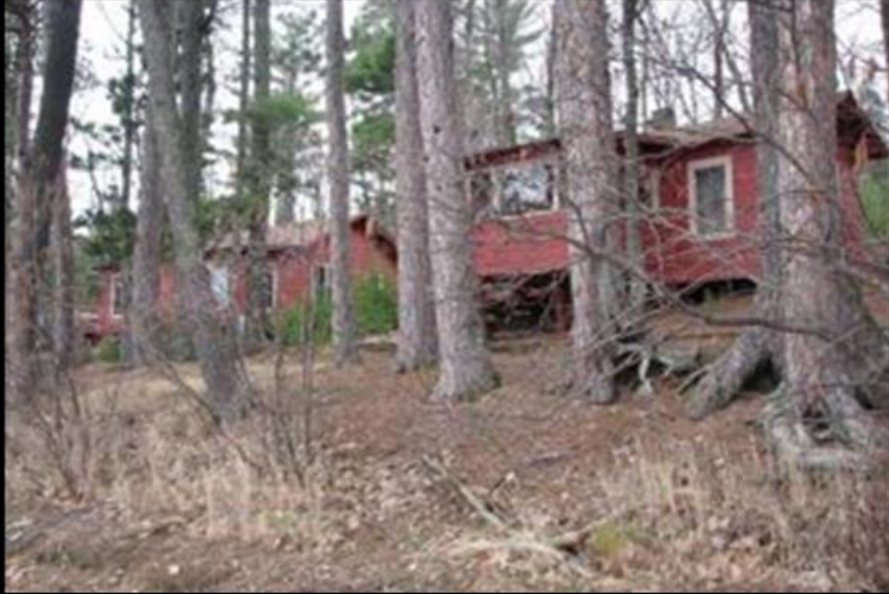
Moon Beach Shoreline before restoration (2008)

The site includes nearshore terrestrial, shoreline, and littoral zone habitats. The riparian type is 100% wooded. The riparian character (from water's edge to 35 feet back) is dominated by herbaceous plants, shrubs, and trees. Coarse woody cover is abundant (see Figure 31). A large shoreline restoration project was coordinated by WDNR and was conducted on the Moon Beach Camp property from May 2008 through August 2010. Fifty plus years of operation of the facility resulted in moderate to severe shoreline erosion. Much of the impacted stretch of shoreline had little native vegetation and contributed large quantities sediment to the lake during heavy rain events. In addition, there was a lack of in water coarse woody material, few downed trees, and sparse aquatic plant beds resulting in little habitat for fish and wildlife. During the 2010 Onterra aquatic plant PI surveys only 8 of 18 sample points (44%) had plants present but by 2019 the number of sample points with aquatic plants increased to 13 of 18 sample points (72%) – with the points sampled at depth showing new plant growth (Onterra LLC 2010 and 2019).

**Moon Beach critical habitat photos before and after restoration.**

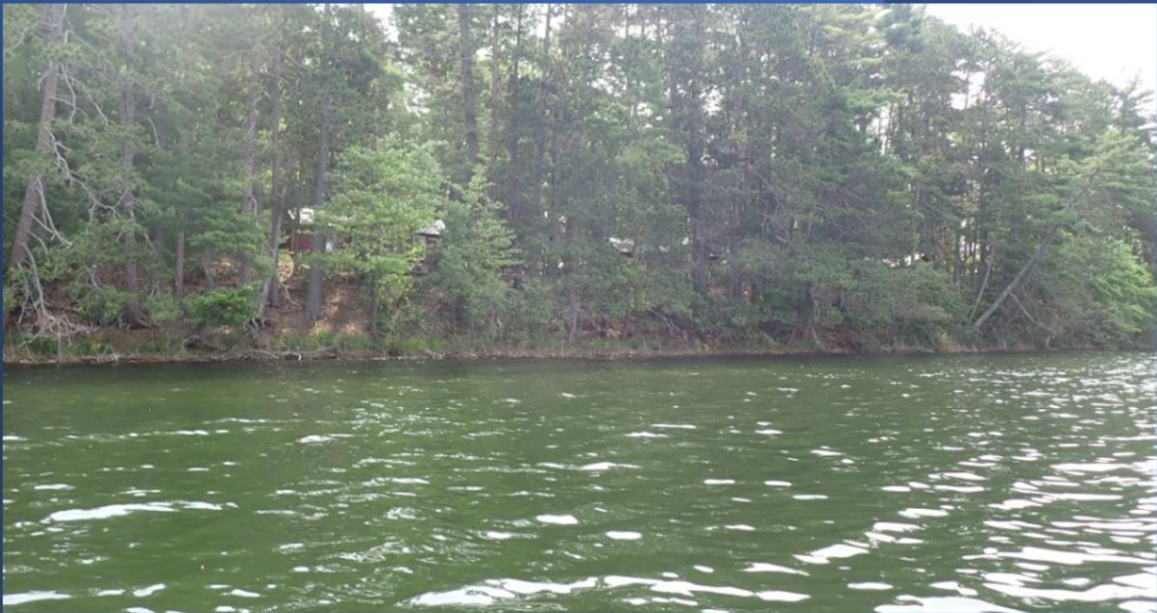
Moon Beach Camp Shoreline Post Restoration Site #9

Erosion problems were corrected through development of rain gardens to capture run-off, as well as use of biodegradable erosion control products to reduce bank erosion. The shoreline was replanted with native trees, shrubs and ground cover that are appropriate for the Moon Lake ecosystem. Tree drops were also added.

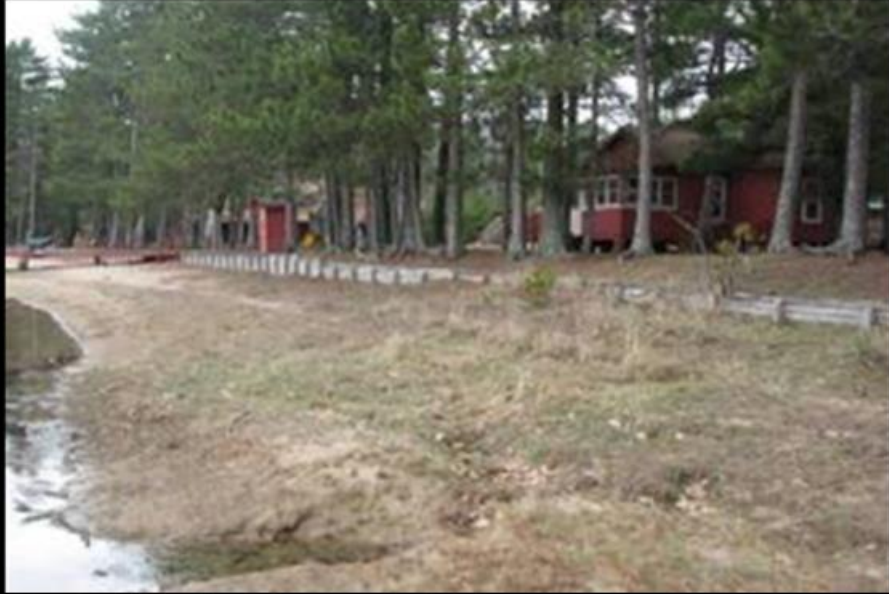
Moon Beach Shoreline before restoration (2008)

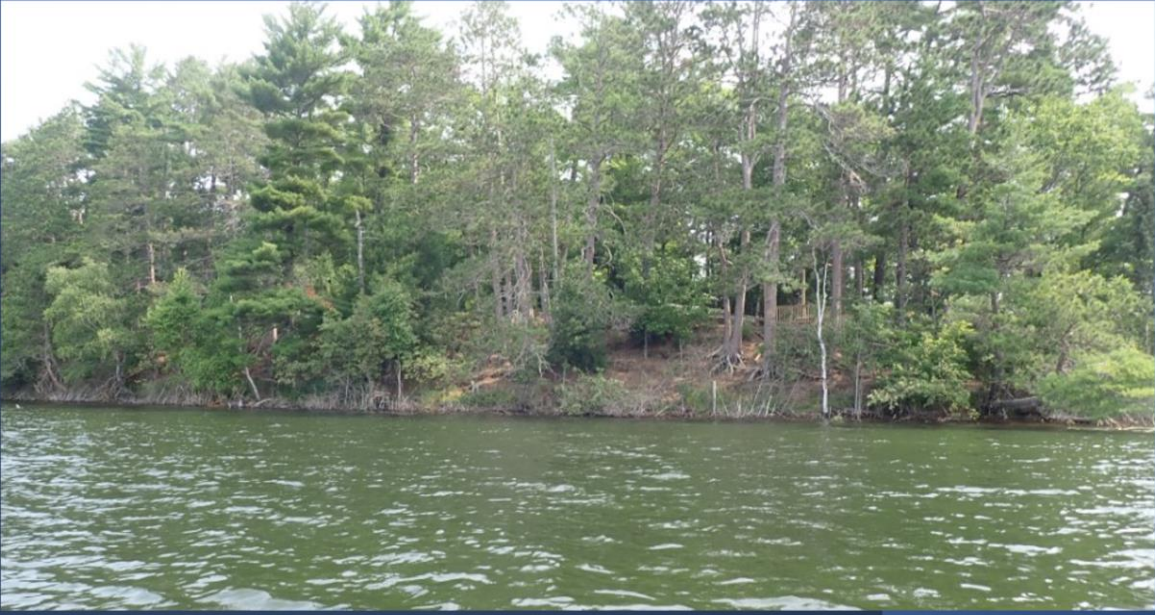
Moon Beach Camp Shoreline Post Restoration Site #9

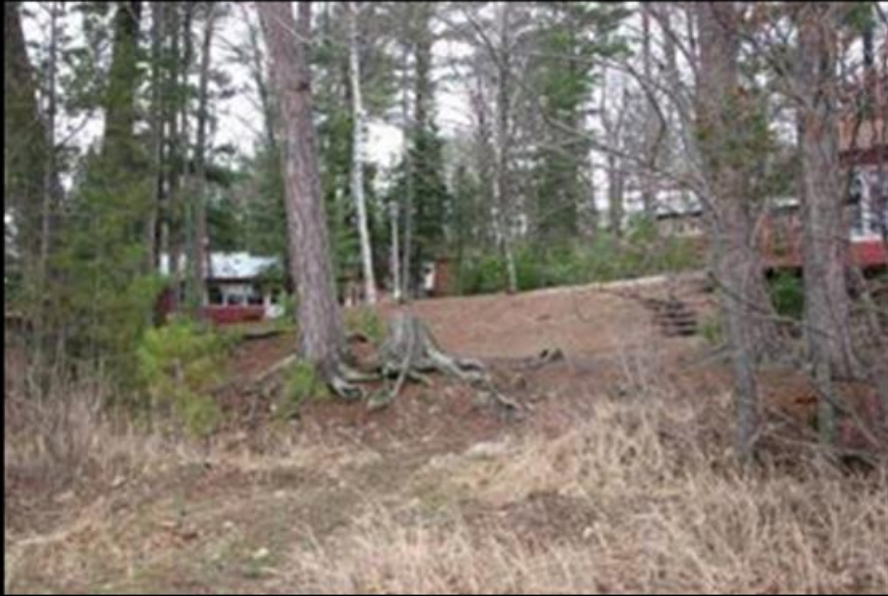
Moon Beach Shoreline before restoration (2008)

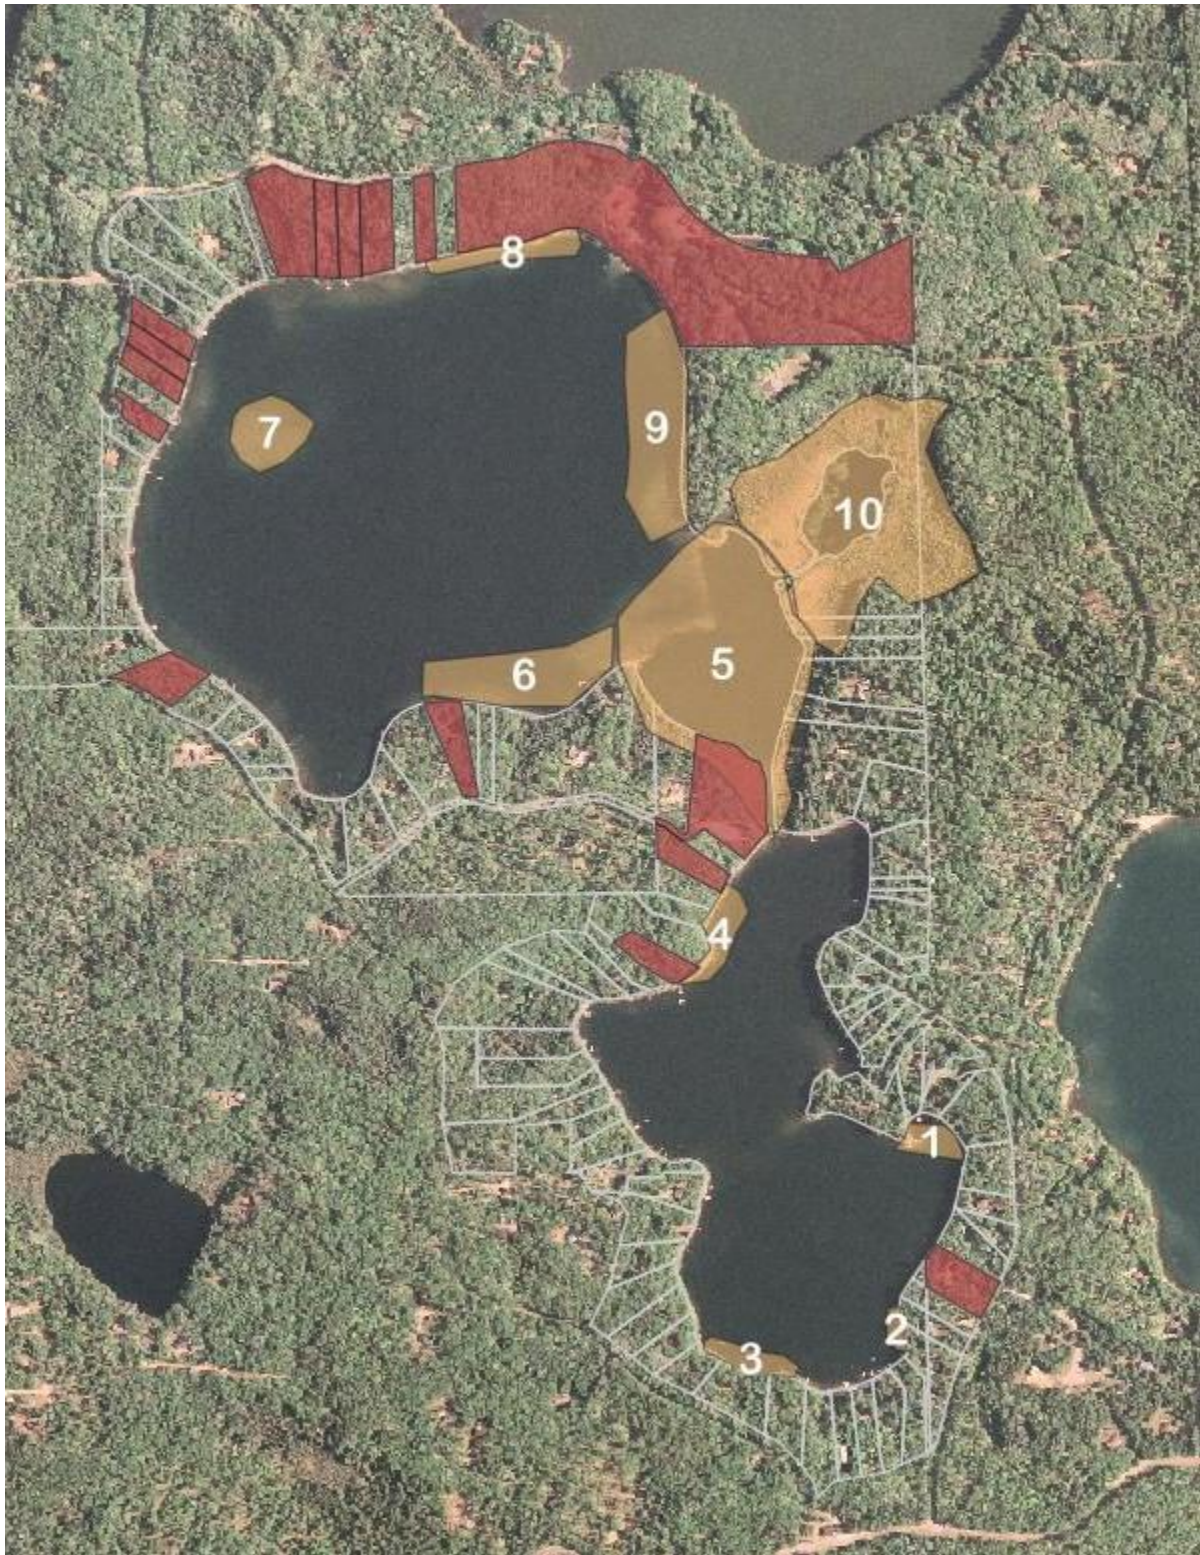
Figure 34. Critical Habitat locations on Alma and Moon Lakes (orange polygons, white numerals) and properties with surface water run-off and/or gully erosion in the shoreland.

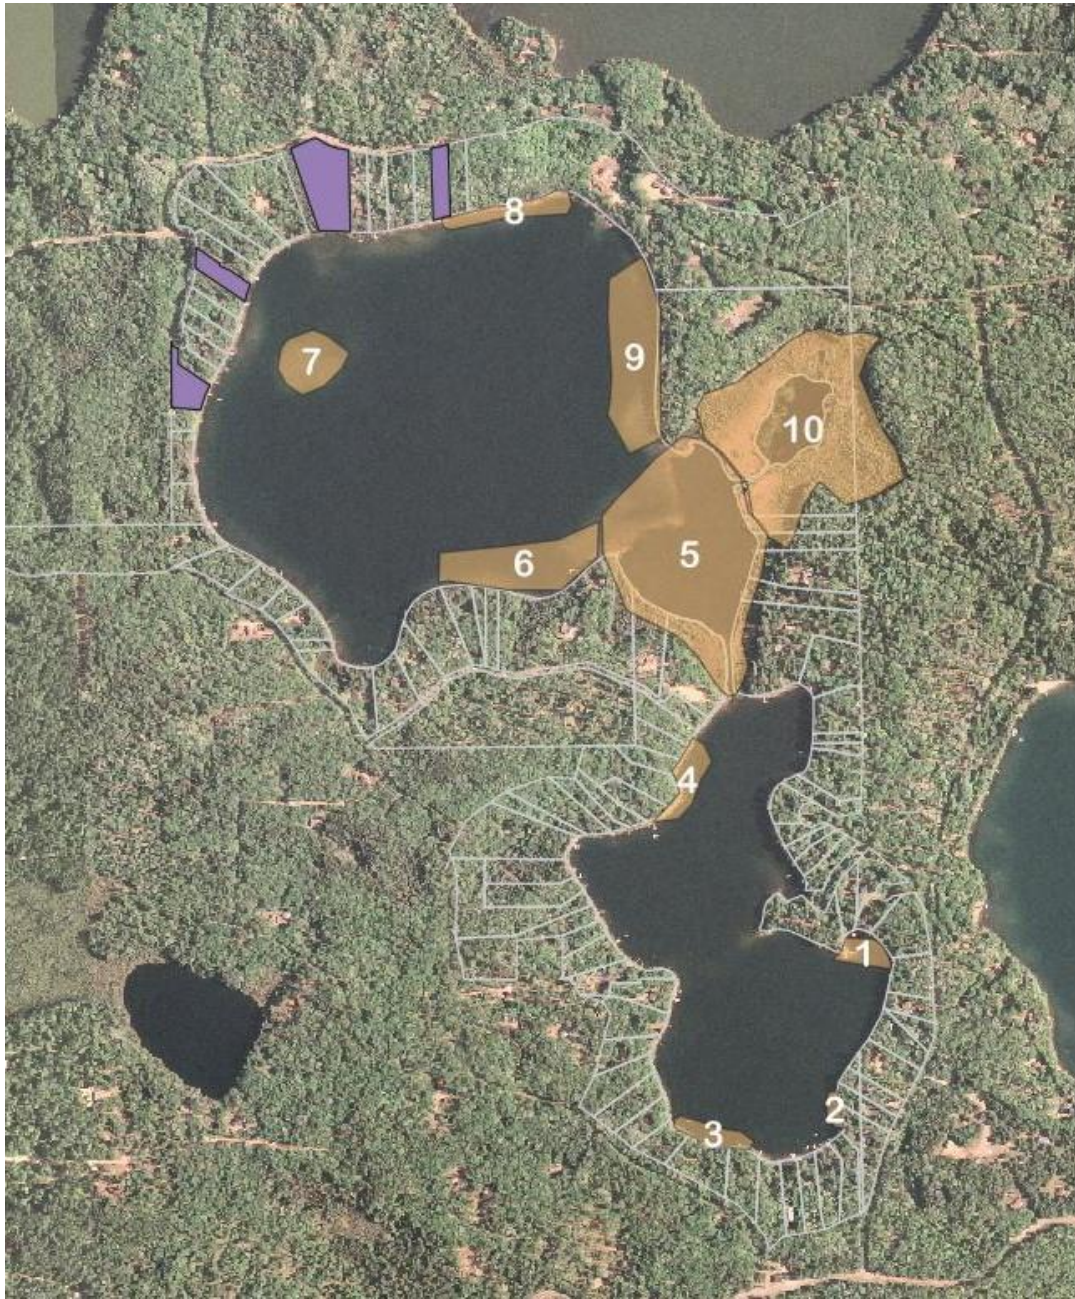
Figure 35. Critical Habitat locations on Alma and Moon Lakes (orange polygons, white numerals) and properties with bank erosion at the shoreland/lake interface.
