Comprehensive Lake Management Plan

Update 2021

Wheeler Lake

Flambeau Engineering, LLC
PO Box 273
Park Falls, WI 54552
715.965.3489
www.flambeauengineering.com

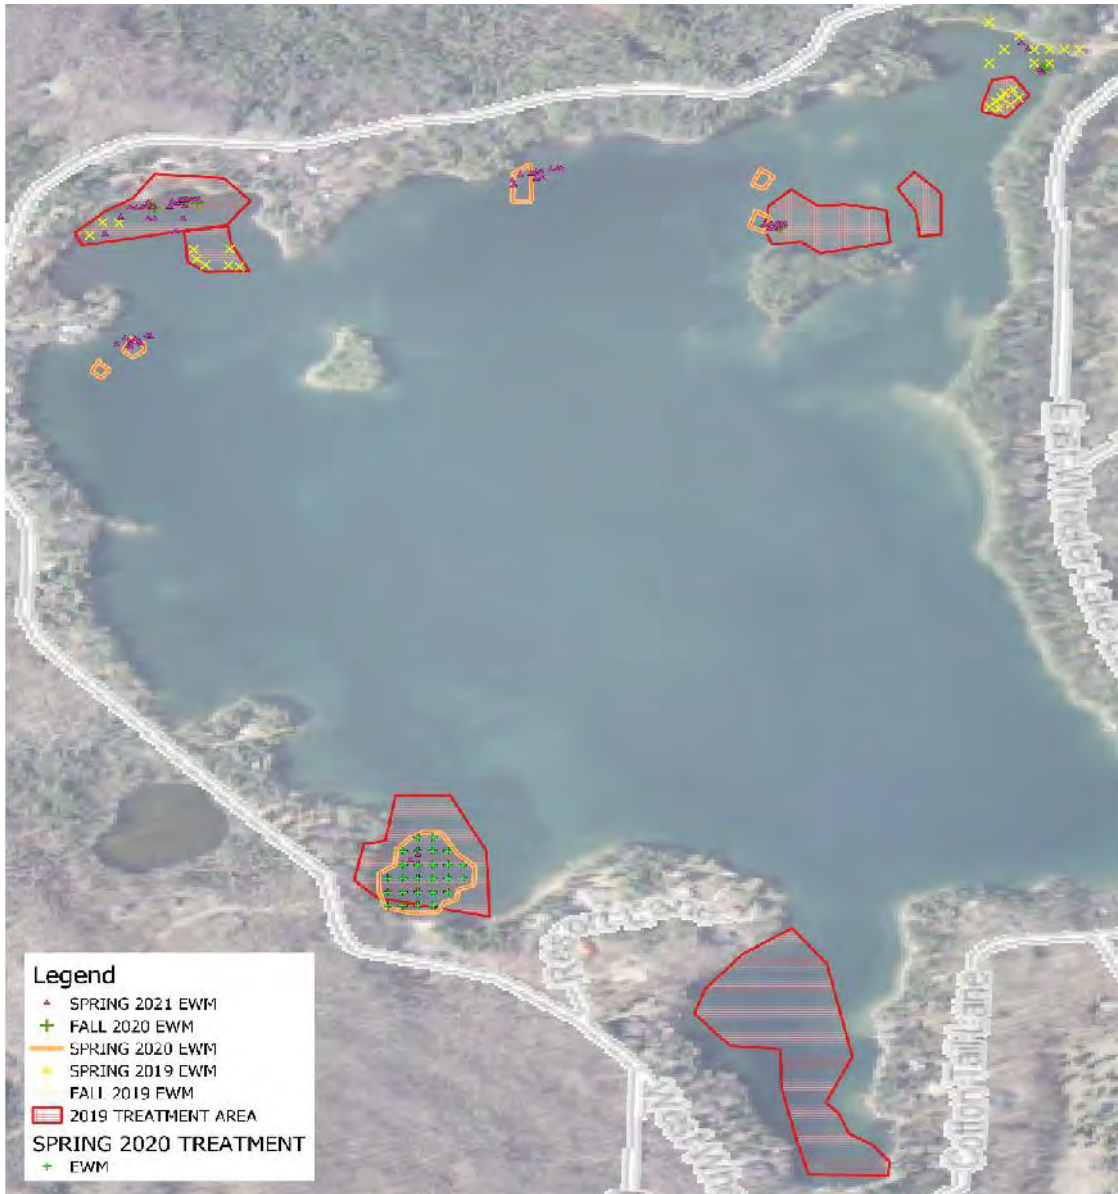
Figure 2 - EWM Location and Herbicide Treatment 2019-2021

The 2019 treatment was very effective and virtually eliminated EWM from the south bay and reduced the remaining beds to scattered, isolated plants. A follow up treatment with Procellacor was completed in the beach bay for a small, dense persistent stand. The 2021 spring EWM survey indicated small stands of scattered plants along the northern portion of the lake.

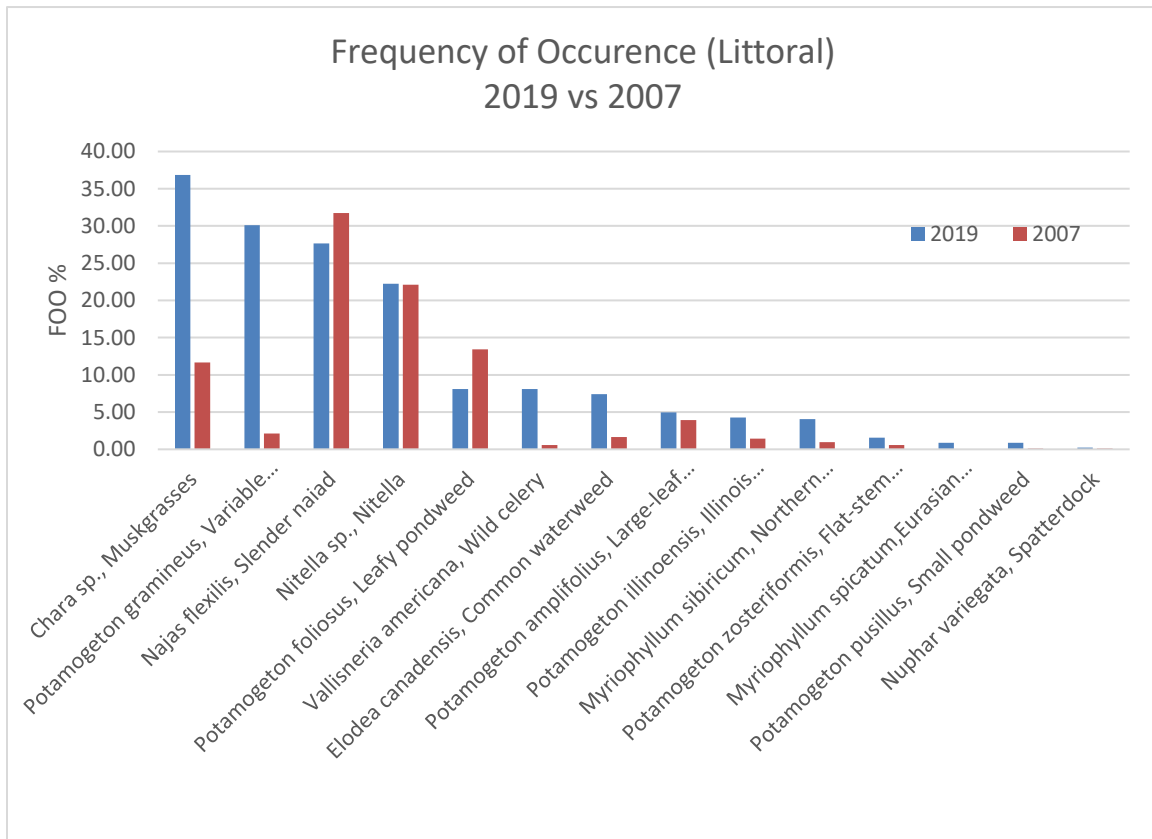
Figure 5 – Frequency of Occurrence Aquatic Plants 2019 vs 2007

The change in the plant community from 2007 to 2019 can be seen above. Several species increased by a significant amount and several decreased. The significance of observed changes is determined by the Chi-square method; this analysis was completed using WDNR provided worksheets. The following species showed a significant increase from 2007 to 2019: muskgrass, waterweed, variable pondweed and wild celery. The following species showed a significant decrease: slender naiad, nitella, leafy pondweed.

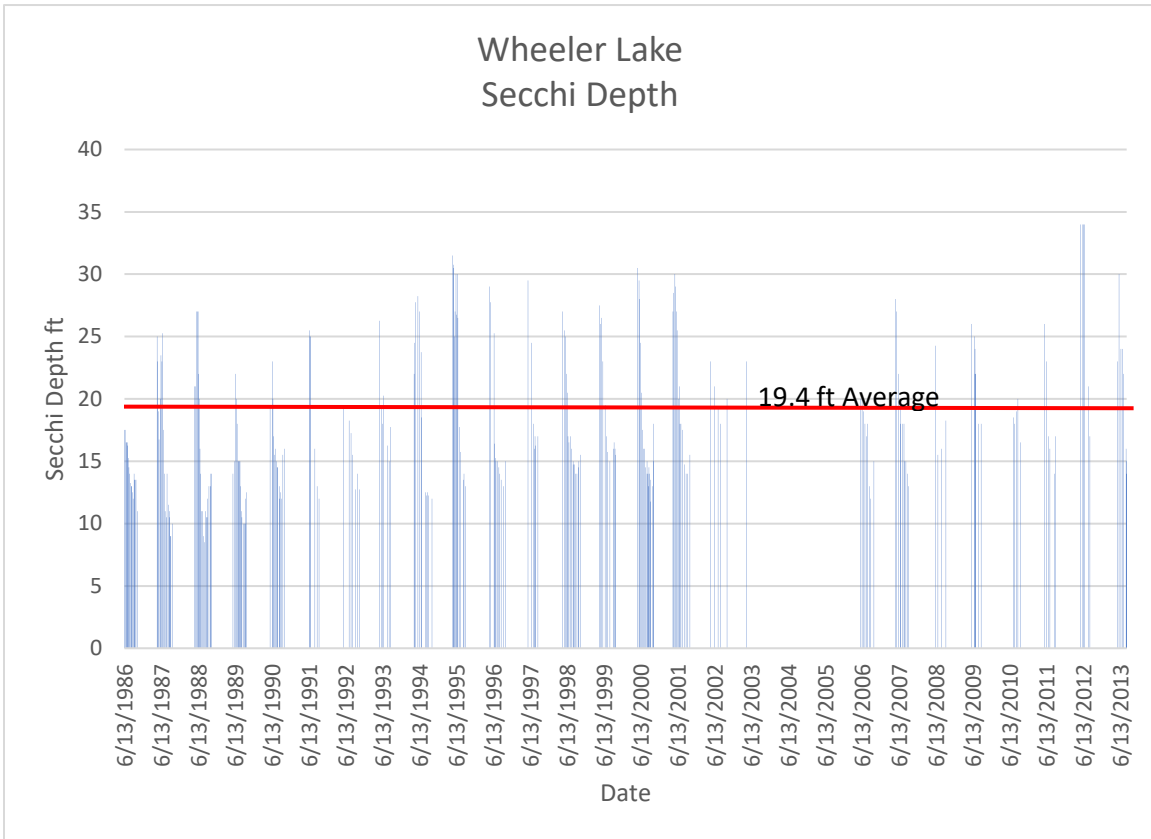
Figure 6 – Secchi Depths

The high water clarity allows for deep penetration of light allowing for plant growth at great depths. The maximum depth that plants generally grow is approximately 30 feet. In this lake plant growth was found at this maximum depth. The high clarity is due to clear, unstained water and low algae populations.

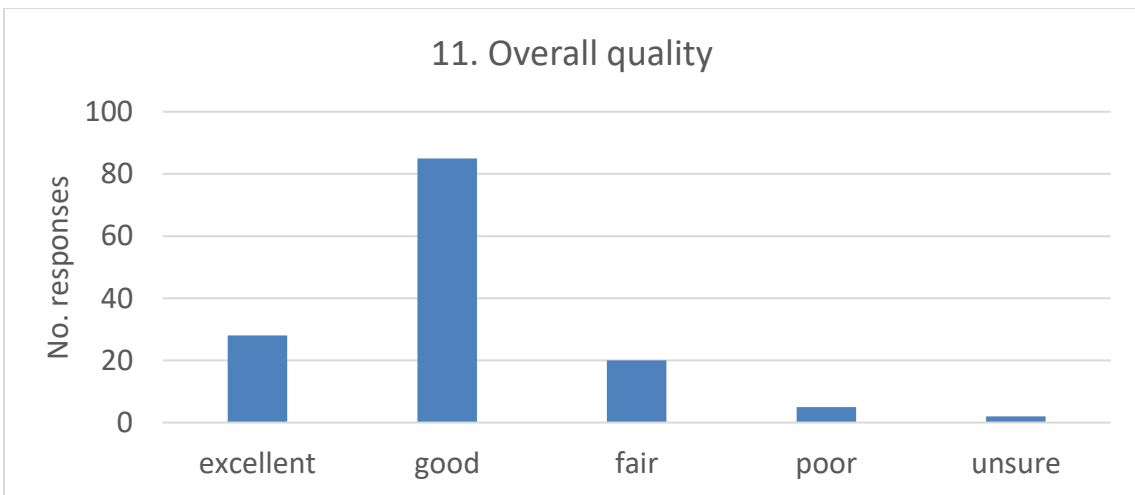
Question 11 – Personal opinion on overall quality of the lake

The vast majority feel the quality is good to excellent.

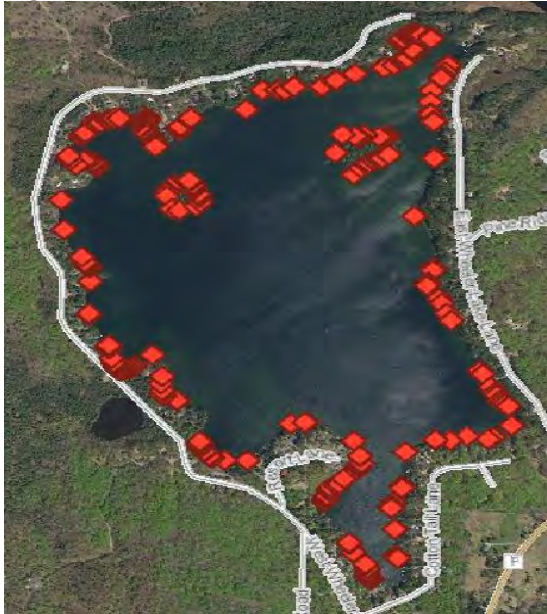
Figure 20 - Coarse Woody Habitat May 2020

In 2020, the US Forest Service completed a fish sticks projects around both of the islands in Wheeler Lake. A total of 45 trees were placed around east island and 15 trees were placed around the west island. All trees were secured with anchors to prevent them from moving and causing a navigation hazard.

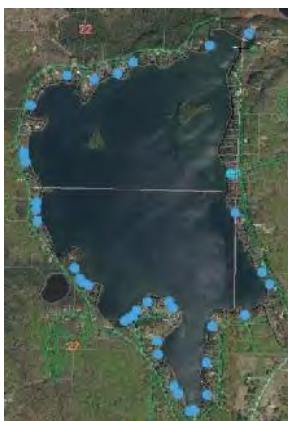
Figure 21 - Highly Developed Parcels

The figure below shows the locations that are highly developed and could benefit from shoreland improvements. The following parcels had one or more of the following: low canopy and shrub/herbaceous cover, high impervious and lawn area, numerous piers and lifts or buildings in the shoreland area.

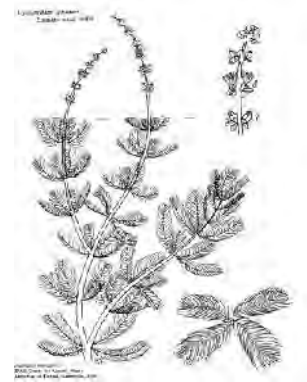
Unlike many other plants, EWM does not rely on seed for reproduction. Its seeds germinate poorly under natural conditions. It reproduces vegetatively by fragmentation, allowing it to disperse over long distances. The plant produces fragments after fruiting once or twice during the summer. These shoots may then be carried downstream by water currents or inadvertently picked up by boaters. EWM is readily dispersed by boats, motors, trailers, bilges, live wells, or bait buckets, and can stay alive for weeks if kept moist (WDNR website, 2007).

Once established in an aquatic community, EWM reproduces from shoot fragments and stolons (runners that creep along the lake bed). As an opportunistic species, EWM is adapted for rapid growth early in spring. Stolons, lower stems, and roots persist over winter and store the carbohydrates that help milfoil claim the water column early in spring, photosynthesize, divide, and form a dense leaf canopy that shades out native aquatic plants. Its ability to spread rapidly by fragmentation and effectively block out sunlight needed for native plant growth often results in monotypic stands. Monotypic stands of EWM provide only a single habitat, and threaten the integrity of aquatic communities in a number of ways; for example, dense stands disrupt predator-prey relationships by fencing out larger fish, and reducing the number of nutrient-rich native plants available for waterfowl (WDNR website, 2007).

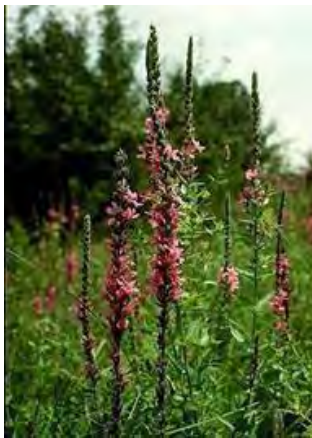
Purple Loosestrife (*Lythrum salicaria*)

Purple loosestrife is a perennial herb 3-7 feet tall with a dense bushy growth form. Showy flowers vary from purple to magenta, possess 5-6 petals aggregated into numerous long spikes, and bloom from July to September. Leaves are opposite, nearly linear, and attached to four-sided stems without stalks. It has a large, woody taproot with fibrous rhizomes that form a dense mat.

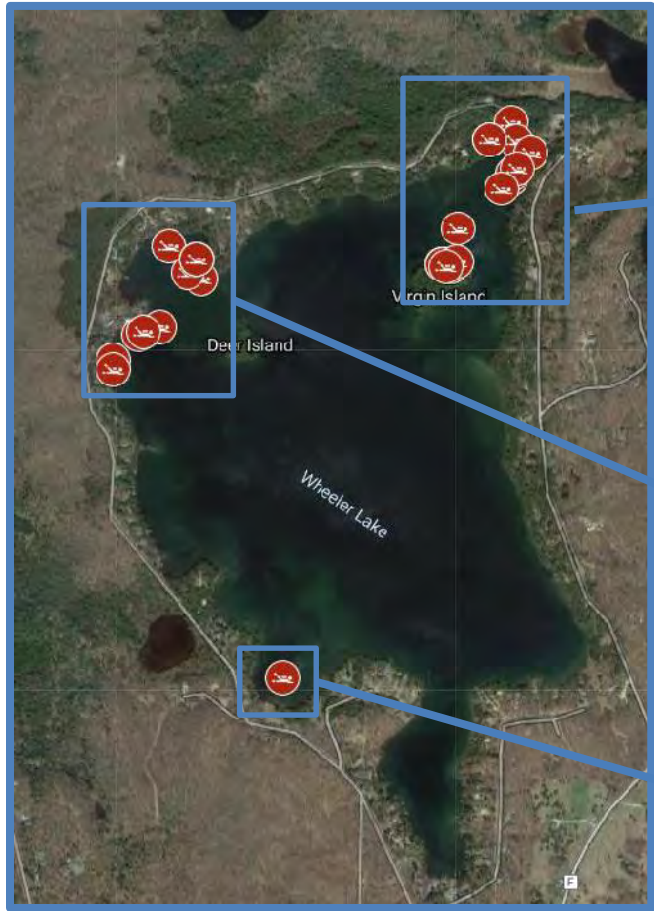
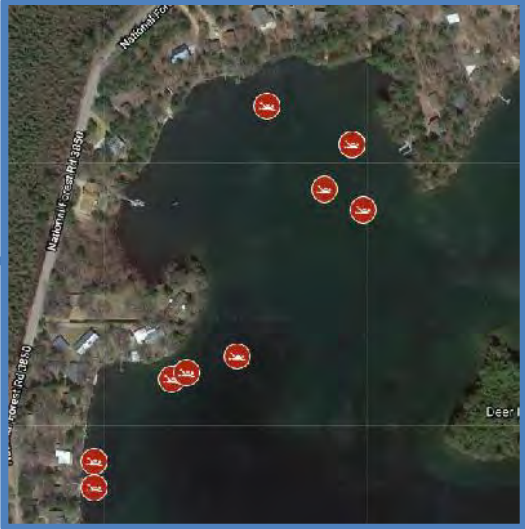
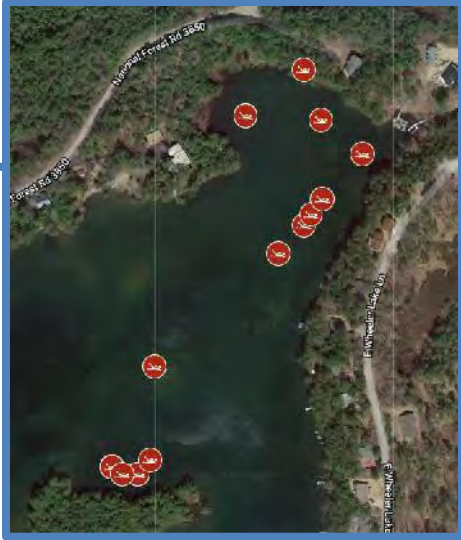
Map of Wheeler Lake Dive Sites

- beach pts.shp
- sampling point txt comma
- FALL 2019 EWM
- ▭ 2019 PROCELL AREA

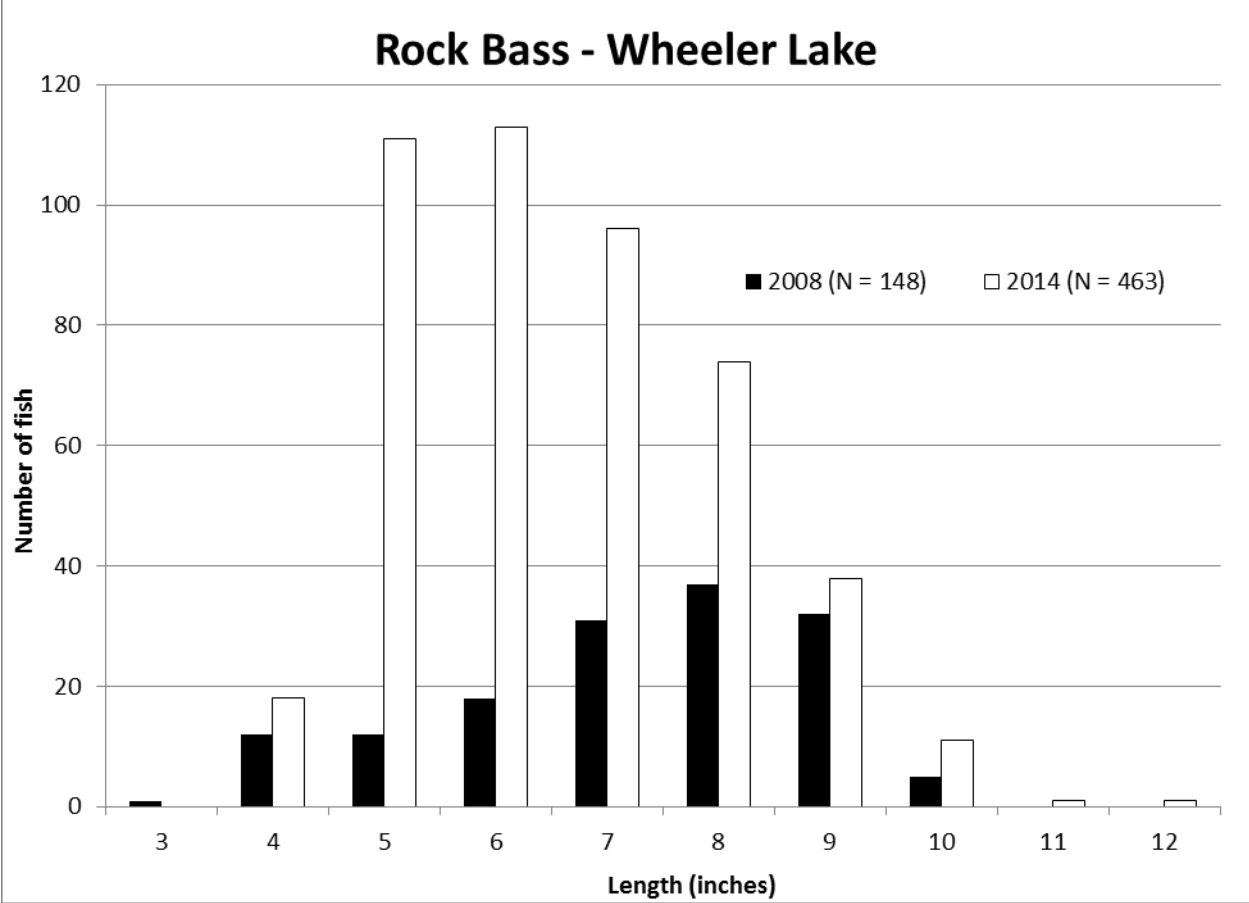
Figure 1. Rock bass length frequency from 2008 and 2014 fisheries surveys at Wheeler Lake; Oconto County, WI.

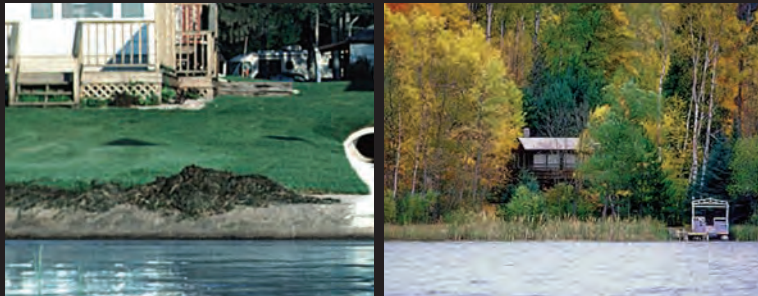
**WHICH LOTS
WILL CREATE
MORE
RUNOFF?**

When considering additions, decide whether the extra space is really needed. Perhaps you could build up instead of out. Also consider runoff from decks, sidewalks and parking areas. Gravel areas quickly become compacted and are nearly as impervious as paved surfaces. Pervious pavers are an option for areas that do not have heavy traffic.

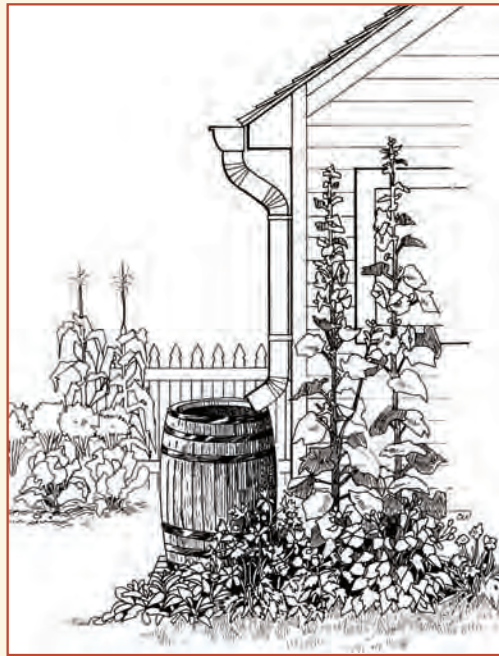
Install a rain barrel

Collect water from your rooftop to water your yard during dry periods. The barrel should be covered to keep out silt, leaves and insects.
