RED CEDAR LAKES, BARRON & WASHBURN COUNTIES

BALSAM-MUD
(2112800)
BASS (1833100)
RED CEDAR (2109600)
HEMLOCK (2109800)
MURPHY FLOWAGE
(2110900)

2024-2033 Comprehensive Lake and Watershed Management Plan

Prepared by: Dave Blumer & Megan
Mader, Lake Education and Planning
Services (LEAPS)

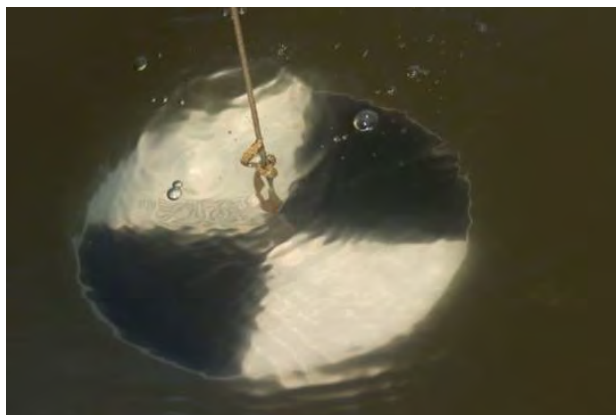
822
823 **Figure 5: Secchi disk**

812 **3.2.1 Water Clarity**
813 Water clarity is a measurement of how deep sunlight can penetrate into the waters of a lake. It can be
814 measured in a number of ways, the most common being an 8” “Secchi” disk divided into four sections, two
815 black and two white, lowered into the lake water from the surface by a rope marked in measurable increments
816 (Figure 5). The water clarity reading is the point at which the disk when lowered into the water can no longer
817 be seen from the surface of the lake. Water color (e.g. water stained by tannins from nearby bogs and
818 wetlands), particles suspended in the water column (e.g. sediment or algae), and weather conditions (clouds,
819 wind, or sunlight) can impact how far down a Secchi disk can be seen in the water. Some lakes have Secchi
820 disk readings of water clarity of just a few inches, while other lakes have conditions that allow the Secchi disk

821 to be seen for dozens of feet before it disappears from view.

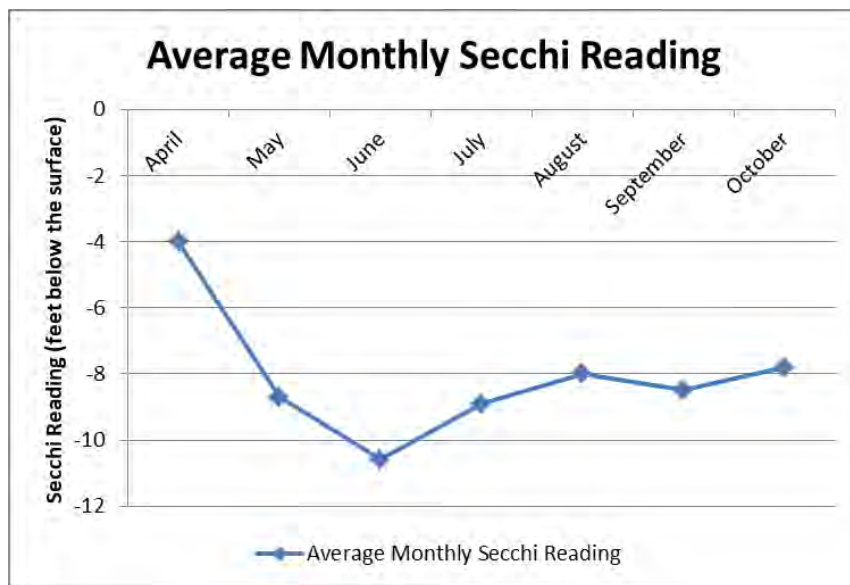
Figure 7: Balsam Lake, Deep Hole Near Birchwood (South Basin) – Secchi disk readings of water clarity (CLMN, 2005-2022)

884 Consistent water clarity monitoring using a Secchi disk began in 2005. There is Secchi data available before
885 then, but generally it only reflects one to two readings per year. Figure 7 reflects all Secchi disk data collected
886 at the Deep Hole Near Birchwood (or the south basin) between 2005 and 2022. It shows the average Secchi
887 disk reading for each year as well as the overall average of all Secchi disk readings at 9.0ft. There appears to be
888 a clear trend toward declining water clarity from 2005 to 2022. This trend has been observed by many lake
889 users who have expressed concern over how green the water gets in Balsam Lake, particularly over the last
890 few years.

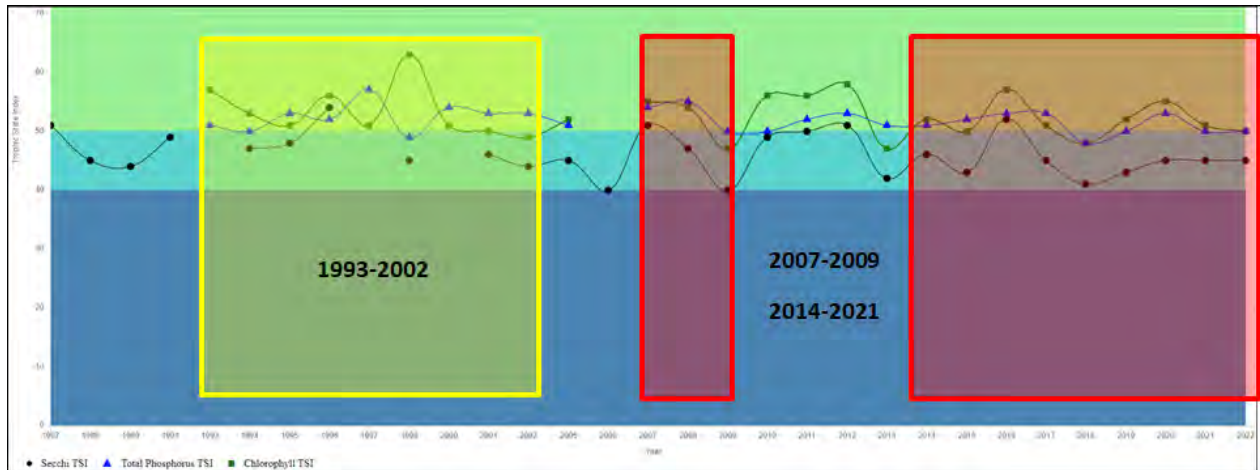
1054 In 1998, from 2010 to 2012, and again in 2016, TP and Secchi values are similar, and Chla is higher than both.
1055 This pattern is not defined by Carlson and Havens.

1056
 1057 **Figure 20: TSI values for Red Cedar Lake - North Basin Deep Hole (black circles – Secchi TSI, blue**
 1058 **triangles – TP TSI, and green squares – Chla TSI)**

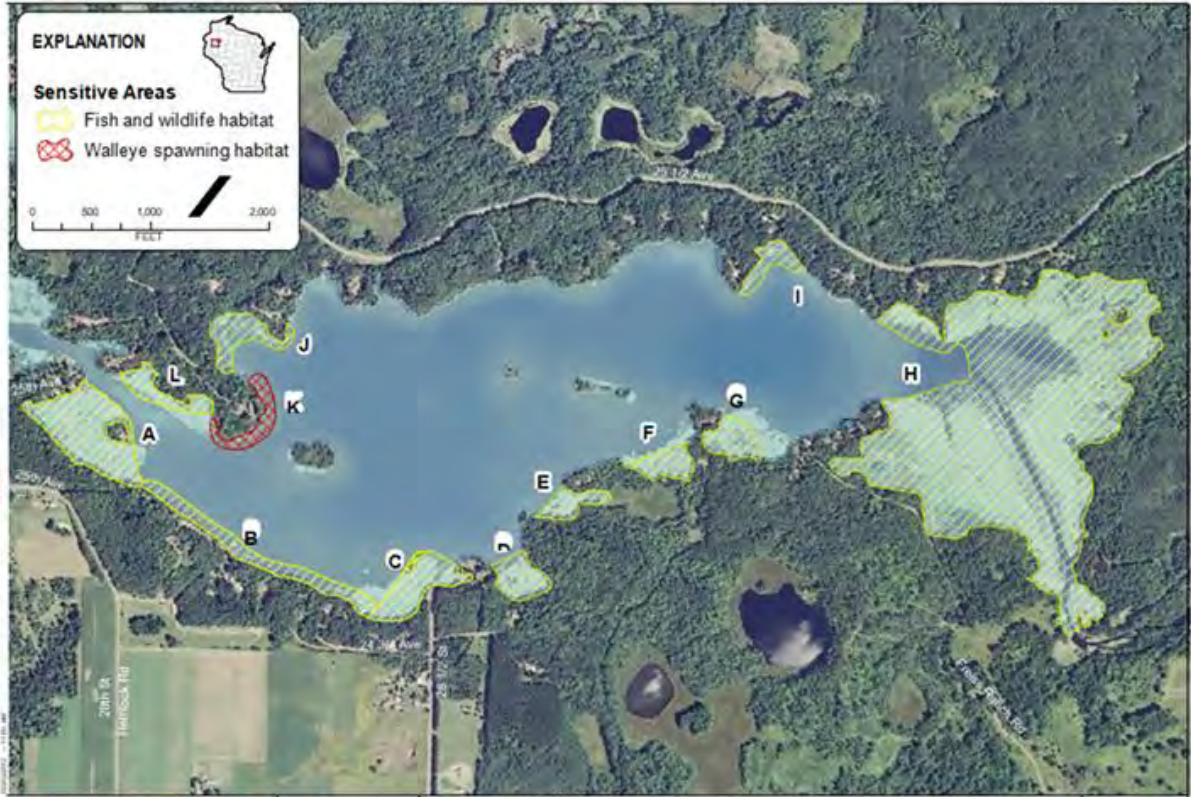
Figure 36: Sensitive areas in Balsam and Mud lakes

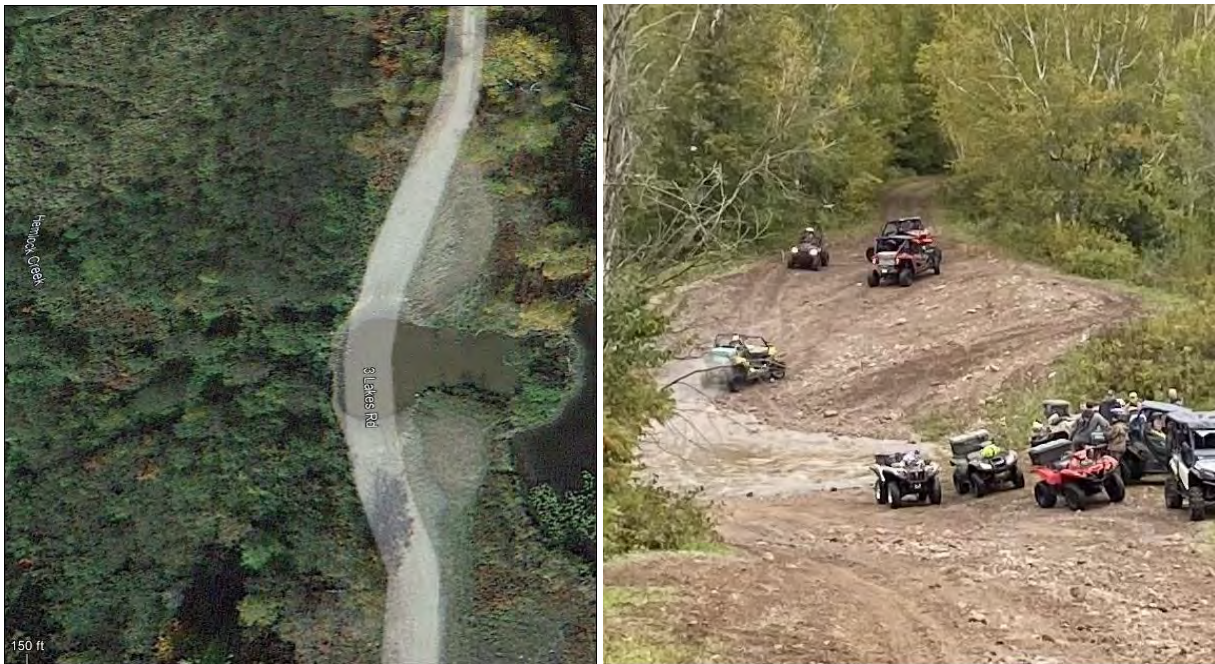
2035 There may be other ATV trail stream crossings on the Rusk County (and Barron, Sawyer, and Washburn
2036 Counties) forest ATV trail system with similar issues, but this one in particular is likely contributing to water
2037 quality issues.

2038
2039 **Figure 64: Hemlock Creek ATV Crossing on 3-Lakes Road in the Rusk County Forest. (Left - Sept.**
2040 **2012; Right – Sept. 2022)**

1701 through the pool of water created by the crossing again and again. Sediment laden water leaves the pool and
1702 continues downstream in Hemlock Creek, into Bucks Lake and on downstream. While the water may not
1703 flow 100% of the time, when it does, a large amount of sediment and phosphorus in the water can be
1704 expected.

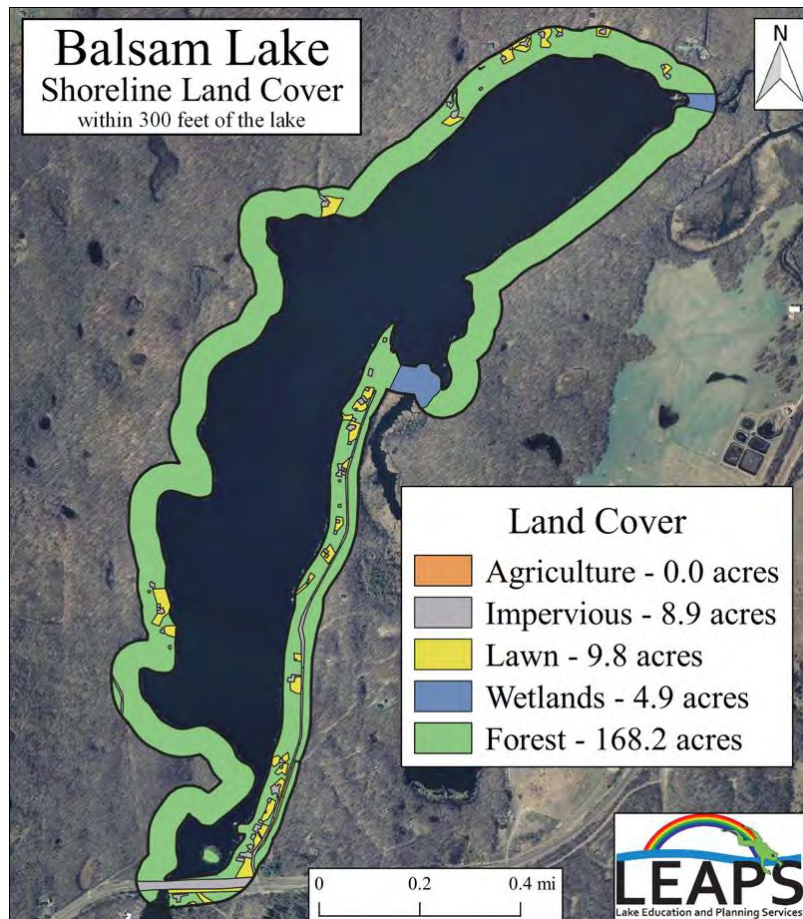
Red Cedar Lakes Land-use Digitizing (300-ft)		
Land Use	Acres	% of Total
Agriculture	6.6	0.6
Impervious	87.7	8.0
Lawn	143.1	13.1
Wetland	62.2	5.7
Forest	795.5	72.6
TOTALS	1095.1	100.00
