GILMORE LAKE, WASHBURN COUNTY

2024-2028 Aquatic Plant Management Plan
WDNR WBIC: 2695800

Prepared by: Dave Blumer, Lake Educator
December 2023

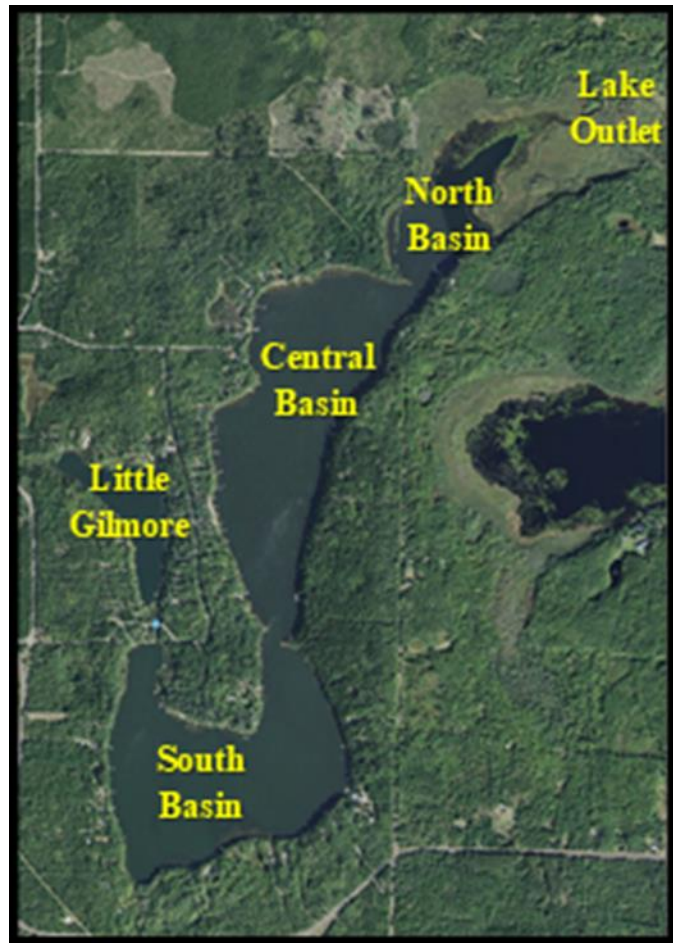
Figure 4: Gilmore Lake aerial and identification of different basins (ERS, 2022)

Gilmore Lake, including Little Gilmore Lake, is a 371 acre stratified drainage lake in north central Washburn County (Figure 4). According to the results of the 2022 whole-lake, point-intercept (PI) survey completed by Endangered Resource Services (ERS) the lake reaches 36.5 feet deep in the central basin and has a mean depth of 16.4 feet. There are no surface water tributaries to Gilmore Lake, and a single outlet at the northern end of the lake. The south basin of Gilmore Lake has the most varied underwater topography with two sunken islands and an expansive shallow flat on the south side of the lake (Figure 5). The deep central basin is characterized by sharp drop-offs; especially on the east side. The shallow north basin slopes gently towards the lake outlet moving from southwest to northeast. Little Gilmore forms a deep bowl with steep sides and a narrow littoral zone (Figure 5).

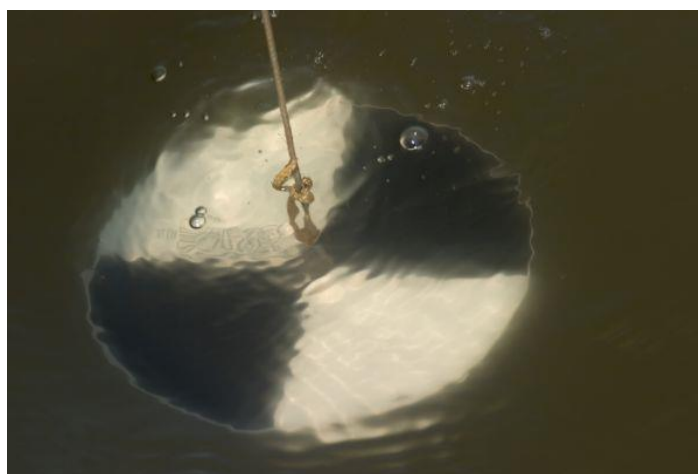
Figure 7: Black and white Secchi disk

Water clarity is a measurement of how deep sunlight can penetrate the waters of a lake. It is most often measured using an 8” disk divided into four sections, two black and two white, lowered into the lake water from the surface by a rope marked in measurable increments (Figure 7). The water clarity reading is the point at which the Secchi disk when lowered into the water can no longer be seen from the surface of the lake. Water color (like dark water stained by tannins from nearby bogs and wetlands), particles suspended in the water column (like sediment or algae), and weather conditions (cloudy, windy, or sunlight) can impact how far a Secchi disk can be seen down in the water. Some lakes have Secchi disk readings of water clarity of just a few inches, while other lakes have conditions that allow the Secchi disk to be seen for dozens of feet before it disappears.

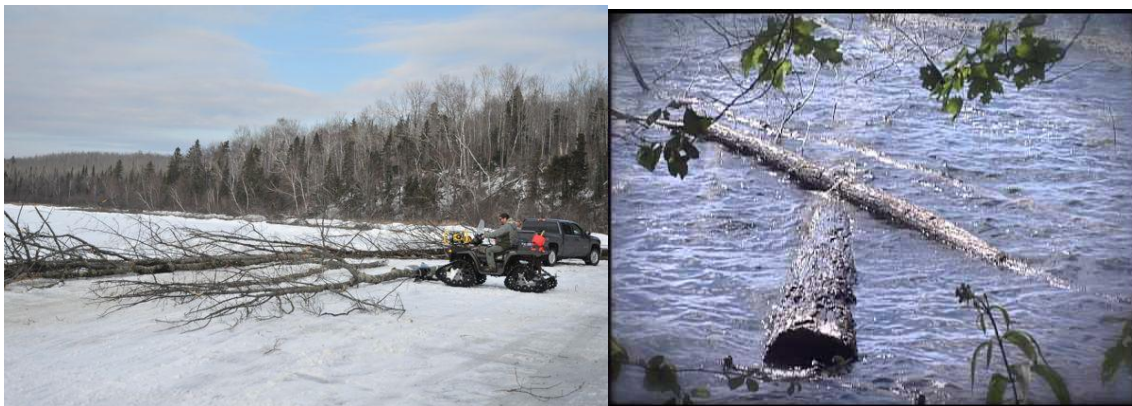
Figure 19: Coarse woody habitat-Fishsticks projects

Small-scale CWH projects, more commonly referred to as “fishsticks,” can also be done by individual property owners, and are eligible for grant assistance through the WDNR Healthy Lakes program. This program is intended to help individual property owners make a positive impact on their lake’s ecosystem through small-scale projects such as fishsticks (Figure 19).

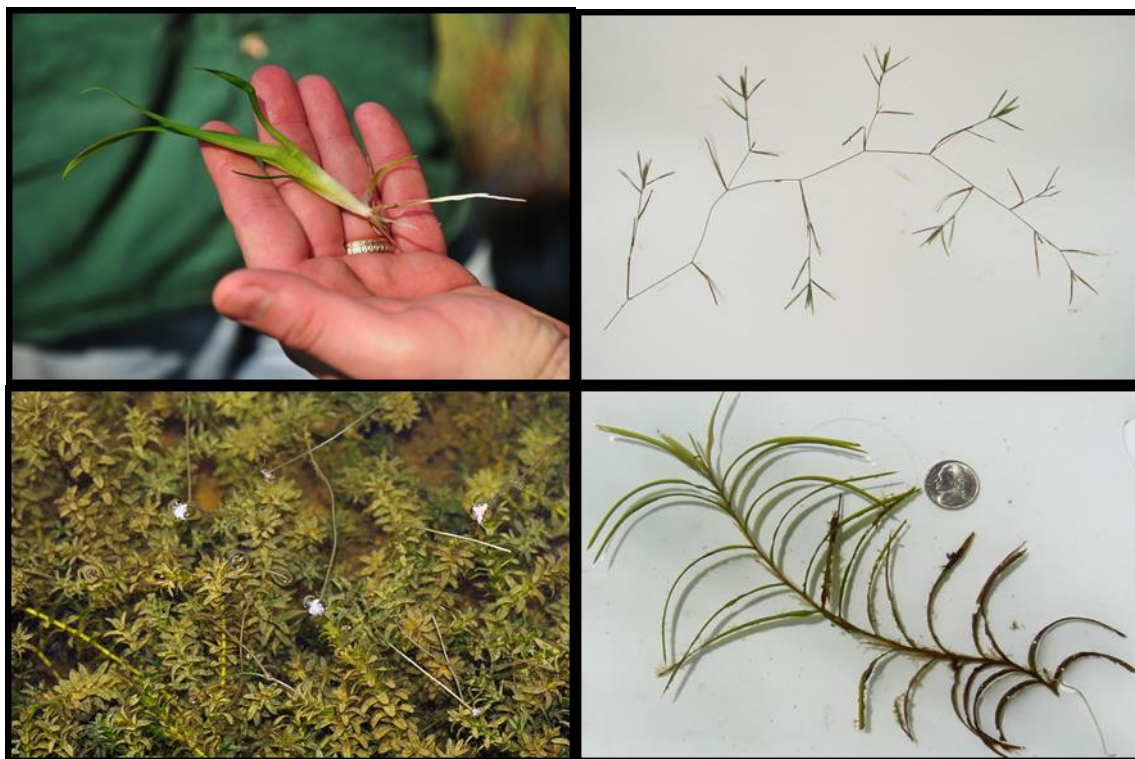
Figure 28: Wild celery, Small pondweed, Common waterweed, and Fern-leaf pondweed (ERS)

During the 2010 survey, Wild celery, Small pondweed, Fern pondweed, and Common waterweed were the most common species found at 31.68%, 29.21%, 29.21%, and 26.73% of survey points with vegetation respectively. They accounted for 29.28% of the total relative frequency in 2010 (Figure 28).

The July 2015 survey identified Slender naiad, Fern pondweed, Needle spikerush, and Wild celery as the most common species found them at 31.88%, 31.25%, 23.13%, and 21.25% of sites with vegetation. They encompassed 30.76% of the total relative frequency in 2015 (Figures 28 and 29).

The July 2022 survey identified Fern pondweed (32.08% of points with vegetation), Slender naiad (29.56%), Wild celery (22.64%), and Variable pondweed (22.01%) as the most common species with a combined relative frequency of 29.39% (Figures 28, 29, and 30).

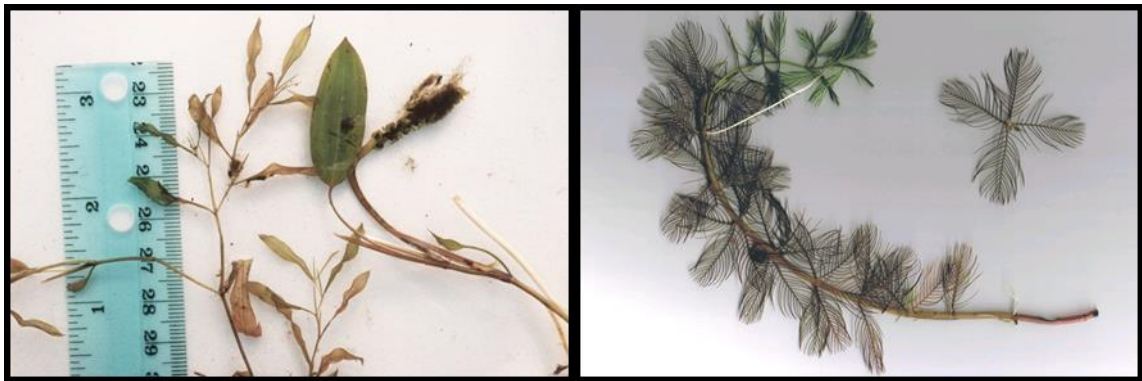
Figure 30: Variable pondweed and Eurasian watermilfoil (invasive species) (ERS)

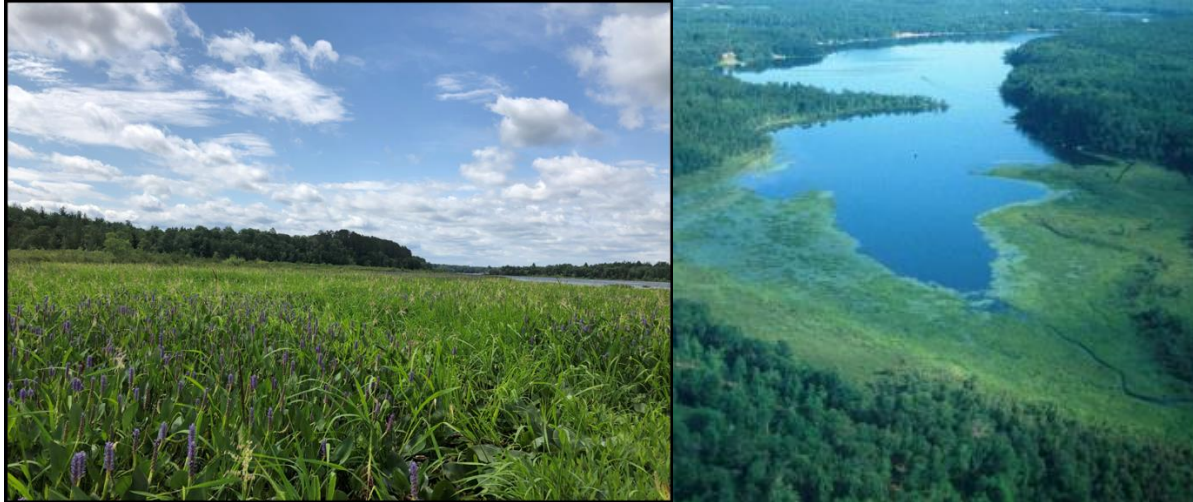
Figure 35 – July 2022 wild rice at the outlet of Gilmore Lake looking toward the lake (left, ERS); Year 2000 aerial photo of wild rice at the Gilmore Lake outlet (David, 2010)

Gilmore Lake has long supported rice, but the bed is limited to the north end of the lake, near the outlet to the Totagatic River (Figure 35). Although this bed often appears to be harvestable, and harvest at the site is date-regulated, it rarely turns up in harvest surveys, perhaps because it is a long paddle from the public access to the rice bed. Interestingly, the outlet reportedly sometimes acts as an inlet; during flood conditions on the Totagatic River, flow has reportedly reversed, causing the level of Gilmore Lake to jump. This is probably detrimental to the rice beds when it occurs. Watch status is low due to site familiarity (David, 2010).

In 2010, rice occurred at such a low density in the outlet bay that there were no true beds, and no attempt to delineate the total area with rice plants was made. The 2015 survey again found that very low-density rice was scattered among other emergents in the outlet bay. Again, a formal bed mapping survey was not completed, but the surveyor estimated that rice was present within an approximately eight-acre area. Despite this sizable coverage, the density was so low that there were no places that even approached having human harvest potential.

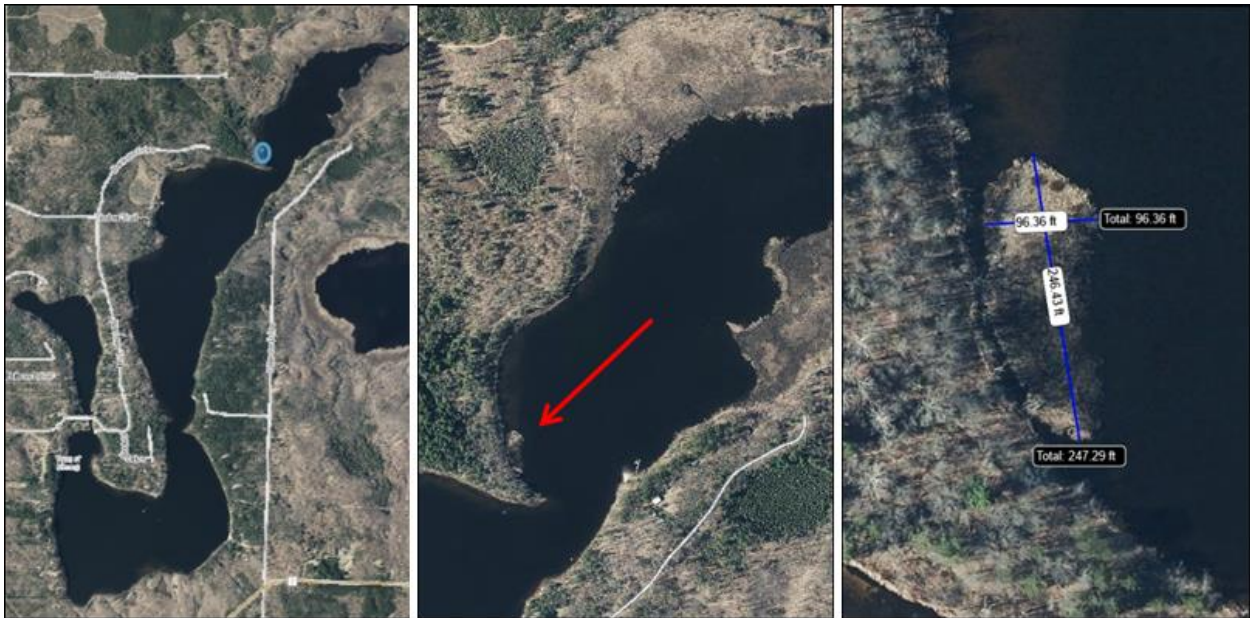
Figure 38: Location of the floating bog in Gilmore Lake

Concern has been expressed by members of the GLA related to a floating bog in the North Basin of the lake (Figure 38). The concern relates to how it moves around the North Basin when under high water conditions. The bog is currently blocking several privately owned lots and is directly in front of a newly constructed cabin. The bog moved across the lake from the Eastern shore to the Western shore in the flooding during 2018 (two floods with 5 & 7 feet over normal) and moved again in the spring flood of 2023 a few hundred yards to the north along the western shore.

The GLA board and the affected property owners would like to move the bog to undeveloped areas near the present location. GLA will explore removal options from the present location to a less intrusive area and will need assistance and advice from the WDNR and the lake consultant on appropriate management.

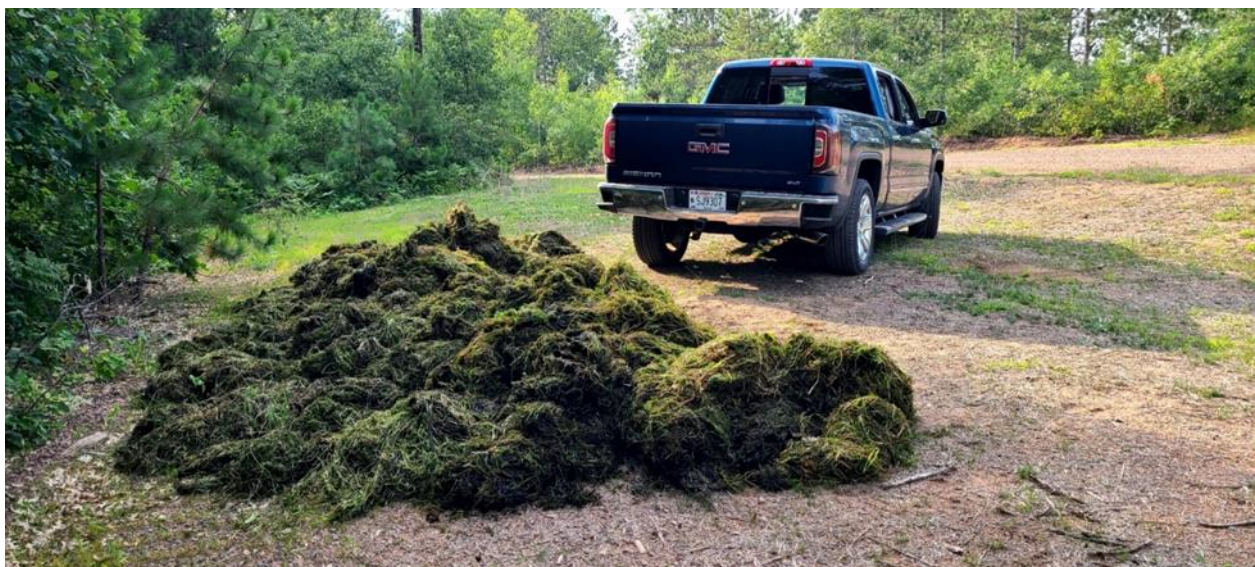
Figure 41: One day's DASH removal results (McCloskey, 2023)

In early August 2023, the GLA contracted with a company that offers DASH removal of EWM. The company was brought in for three days of DASH removal focused primarily on the southeast shoreline of the North Basin across from the larger, 8-acre bed. During their time on the water, 132 onion bags of EWM were removed (Figure 41).

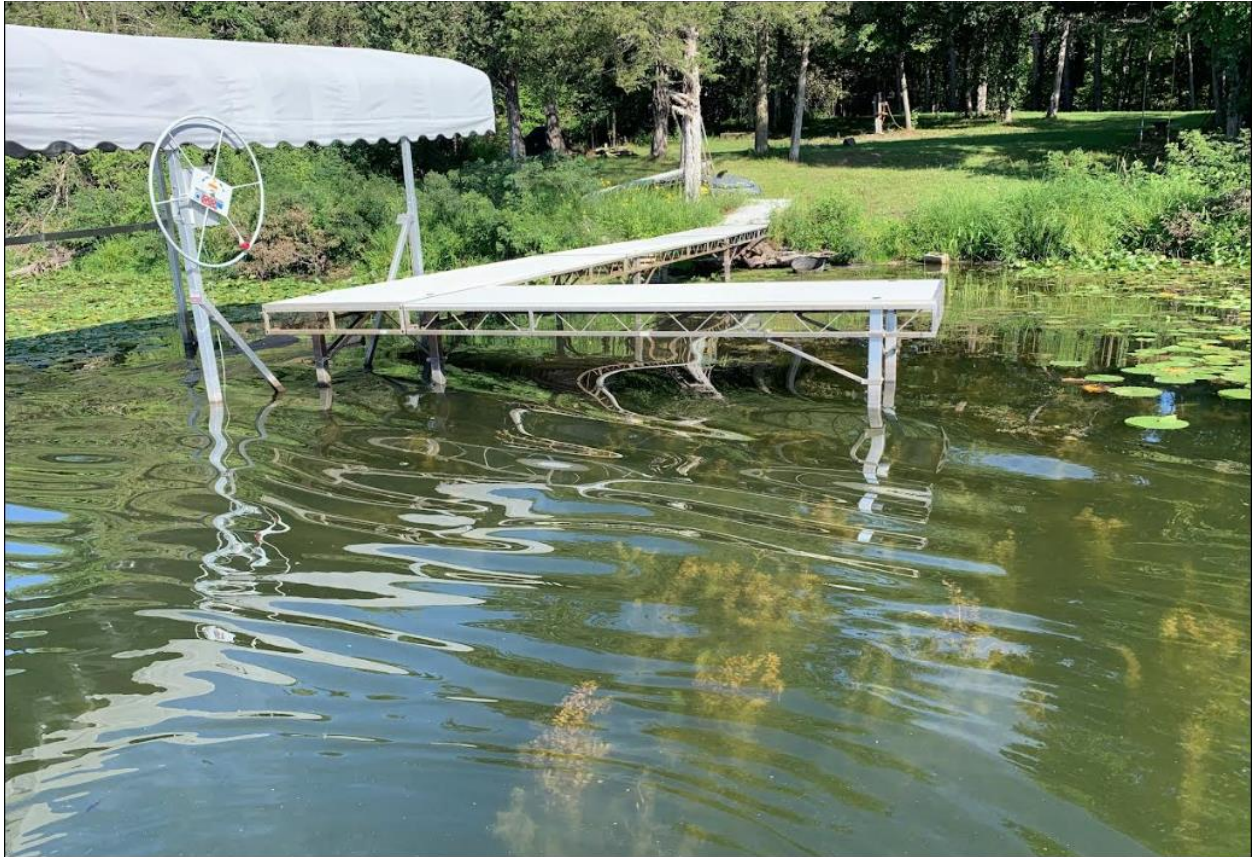
Figure 45: “Cleared” shoreline and EWM on a local lake

Although up to 30 feet of aquatic vegetation can be removed, removal should only be done to the extent necessary. Clearing large swaths of aquatic plants not only disrupts lake habits, it also creates open areas for non-native species to establish (Figure 45).

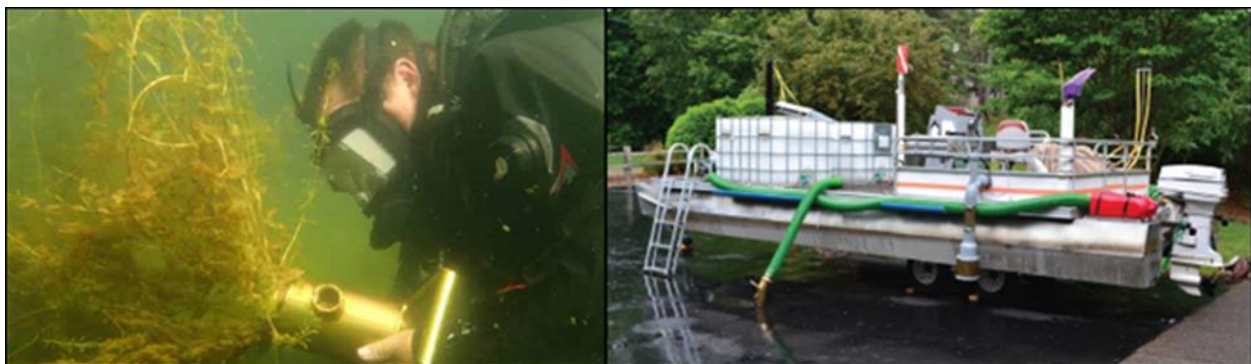
Figure 47: DASH – Feeding EWM into the underwater Suction Hose (Marinette Co.); and a sample DASH Pontoon Boat (Beaver Dam Lake Management District)

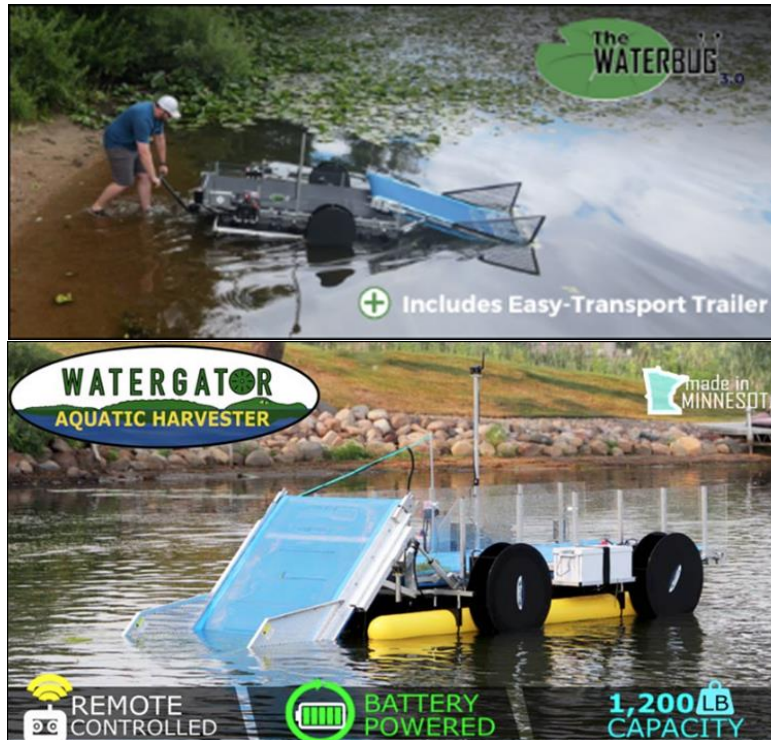
Figure 49: Waterbug and Watergator remote controlled mini aquatic plant harvesters (<https://lakeweederharvester.com/waterbug/>)

A more recent option for small-scale mechanical harvesting of aquatic plants is using a “mini” harvester that is remote-controlled. Weeders Digest currently offers two versions of a remote controlled mini mechanical harvester, the WaterBug and the WaterGator (Figure 49).

The cost of a WaterBug is estimated at around \$17,000.00. The cost of a WaterGator is about double that at \$35,000.00.

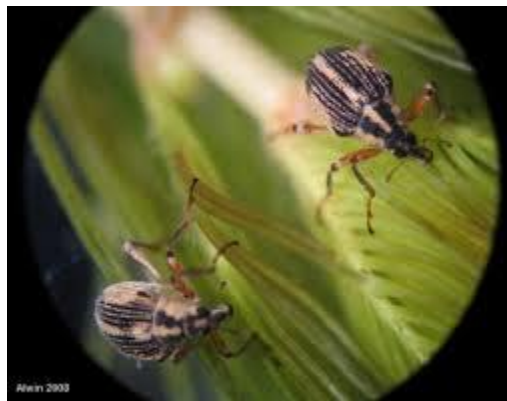
Figure 50: EWM weevil

While many biological controls have been studied, only one has proven to be effective at controlling EWM under the right circumstances. *Euhrychiopsis lecontei* is an aquatic weevil native to Wisconsin that feeds on aquatic milfoils (Figure 50). Their host plant is typically northern watermilfoil; however, they seem to prefer EWM when it is available. Milfoil weevils are typically present in low numbers wherever northern or Eurasian watermilfoil is found. They often produce several generations each year and over winter in undisturbed shorelines around the lake. All aspects of the weevil's life cycle can affect the plant. Adults feed on the plant and lay their eggs. The eggs hatch and the larva feed on the plant. As the larva mature, they eventually burrow into the stem of the plant. When they emerge as adults later, the hole left in the stem reduces buoyancy often causing the stem to collapse. The resulting interruption in the flow of carbohydrates to the root crowns reduces the plant's ability to store carbohydrates for overwintering reducing the health and vigor (Newman, Holmberg, Biesboer, & Penner, 1996).

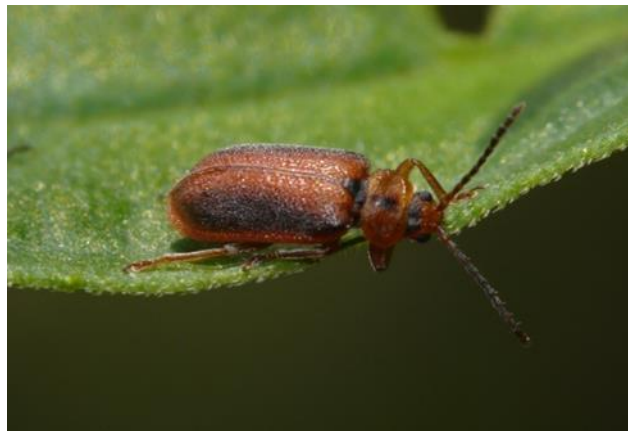
Figure 51: Galerucella beetle

Two species of Galerucella beetles are currently approved for the control of purple loosestrife in Wisconsin (Figure 51). The entire lifecycle of Galerucella beetles is dependent on purple loosestrife. In the spring, adults emerge from the leaf litter below old loosestrife plants. The adults then begin to feed on the plant for several days until they begin to reproduce. Females lay their eggs on loosestrife leaves and stems. When the larvae emerge from these eggs they begin feeding on the leaves and developing shoots. When water levels are high these larvae will burrow into the loosestrife stems to pupate into adult beetles. These new adults emerge and begin feeding on the loosestrife again (Sebolt, 1998). Galerucella beetles do not forage on any plants other than purple loosestrife. Because of this the populations, once established, are self-regulating. When the purple loosestrife population drops off, the beetle population also declines. When the loosestrife returns, the beetle numbers will usually increase.

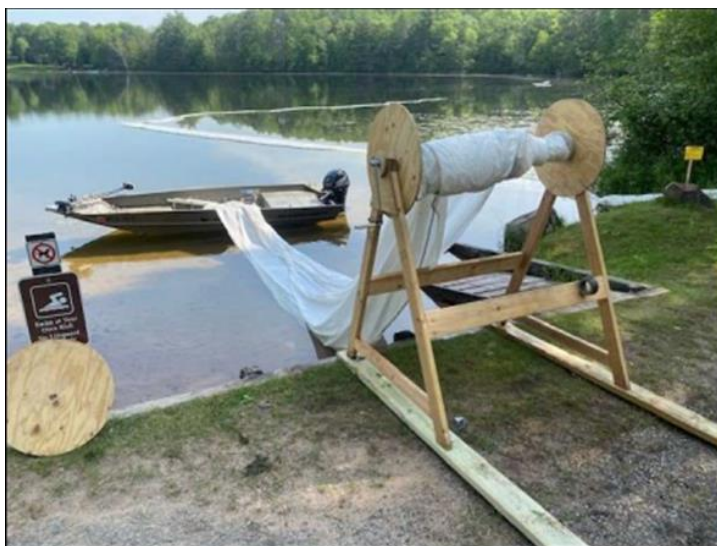
Figure 52: Limno-curtain material on a roll before installation (photo from Marinette Co. LWCD)

Small-scale herbicide applications can be made more effective by installing a limno-barrier or curtain around a treatment area to help hold the applied herbicide in place, longer. By doing so, the herbicide/target species contact time is increased. The curtain is generally a continuous sheet of plastic that extends from the surface to the bottom of the lake (Figure 52). The surface edge of the curtain is generally supported by floatation devices. The bottom of the curtain is held in place by some form of weighting. The curtain or barrier, sometimes thousands of feet of it, is installed around the proposed treatment area with the purpose of holding the herbicide in place longer by preventing dilution and drifting away from the treated area (Figure 53).

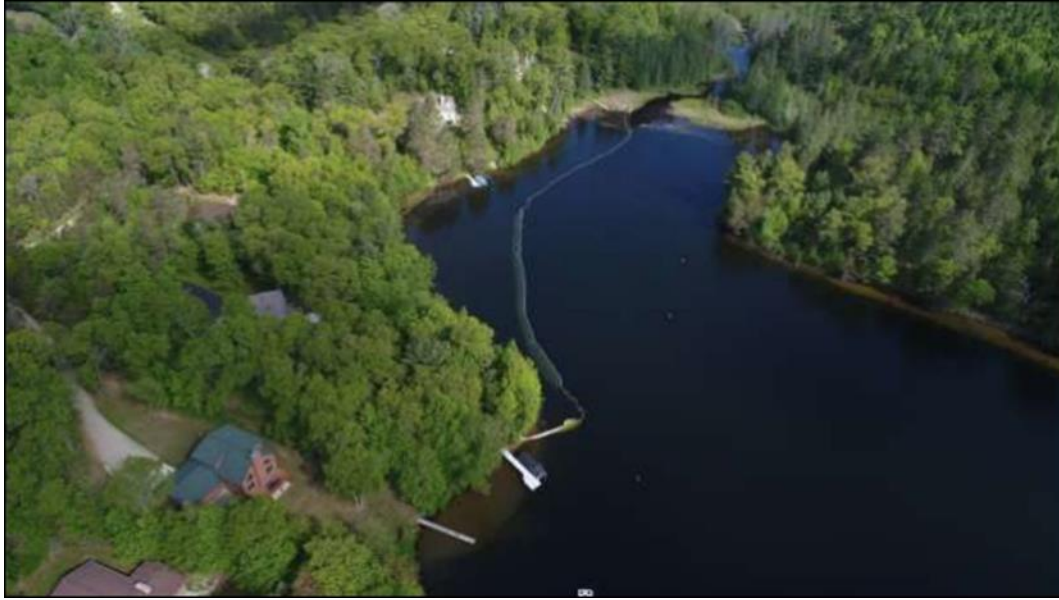
Figure 53: Limno-curtain installed on Thunder Lake (photo from Marinette Co. LWCD)

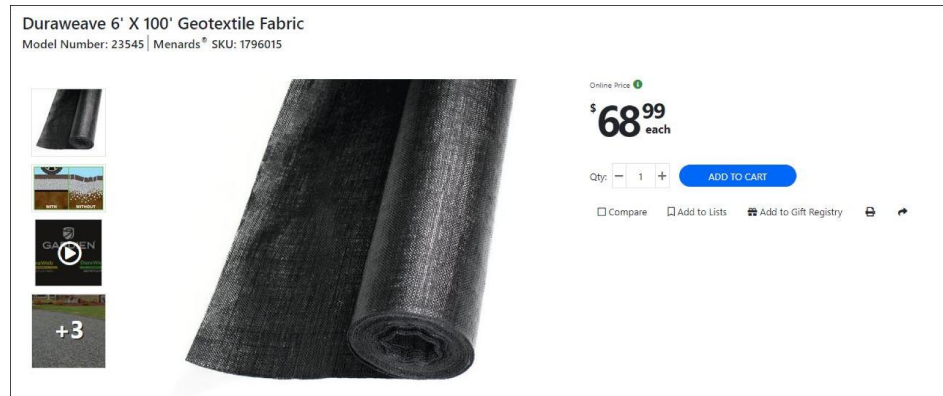
Figure 55: Limno-curtain material

The installation of a limno-curtain would likely improve the results of small-scale EWM management (<3 to 5 acres), particularly when using liquid 2,4D products. The curtain should be installed all the way around any treatment area, be constructed in such a way that there are few gaps between multiple sections of curtain (if needed), anchored on the bottom-edge of the curtain, and floats installed on the top-edge of the curtain. If posts are driven into the bottom of the lake in shallow water to support the curtain, gaps between the posts and the curtain should be minimized to the extent possible. An example of material that could be used is shown in Figure 55.
