# Lake Mallalieu Lake Management Plan

Prepared for:  
Lake Mallalieu Association

Prepared by:  
The Lake Mallalieu Association  
and  
Resource Environmental Solutions

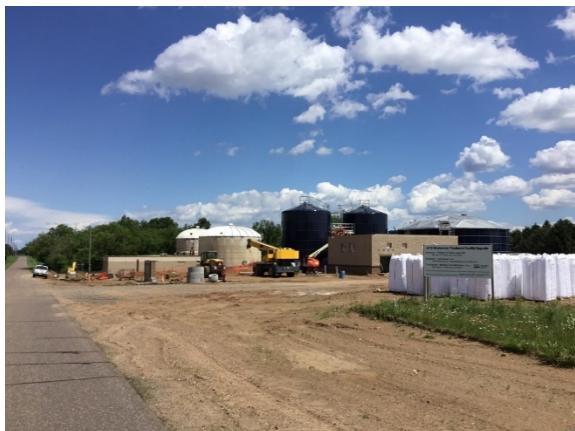
These wastewater treatment facilities are considered “point” sources or discharges, which contribute nutrients (e.g., phosphorus) to surface waters and fall under regulation by the Lake St. Croix TMDL and Wisconsin’s statewide phosphorus rule. Of the two largest dischargers, New Richmond is practicing adaptive management to manage its facility discharges, and the Clear Lake plant is currently undergoing a significant facility upgrade.

*Clear Lake wastewater treatment plant upgrade (under construction).*

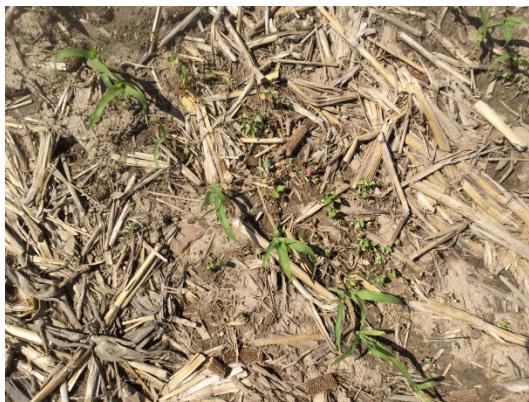
- a. No till farming appeared to be used on perhaps 5-10% of the annually cropped land in the watershed.

*No till field with 50% crop residue.*

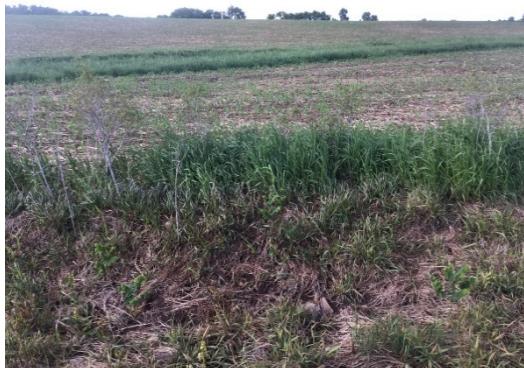
- b. Soil surface disruptions from extensive corn stover harvesting was occurring widely.
- c. Harvesting appeared to be removing 70-90% of the corn stover (possibly for farm animal bedding), and the remaining crop residue (estimated at 5-10% cover of remaining stover after harvesting at most farms, with an occasional farm having ~20-30% cover) is inadequate to control soil erosion.
- d. Few farmers used cover crops in the watershed. As a result of large acreages with soil disruptions from conservation tillage (e.g., chisel plowing) and stover harvesting, we observed significant rill soil erosion in crop fields, including fields with stressed vegetation and sediment deposits at field margins and in road ROW.

*Steep, erodible corn field.*

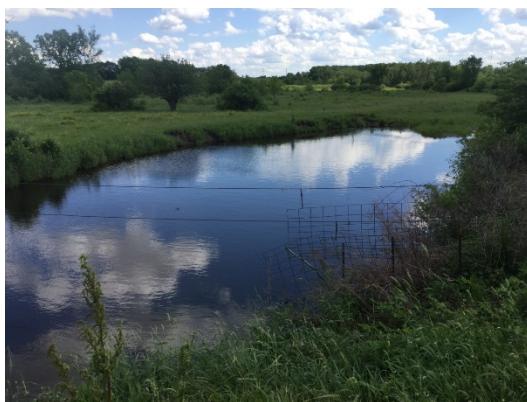
- e. Significant stream bed and bank erosion, sedimentation of fine substrates in the streams, high turbidity and suspended solid loads, very high levels of filamentous green algae (benthic growth attached to rocks and woody debris), and backwater areas had indications of excessive nutrient levels (e.g., blue-green algae (*Anabaena* sp.) and duckweed (*Lemna minor*)). These indications of nutrient enrichment are notable as they occurred already in late spring.

*Streambank erosion.*

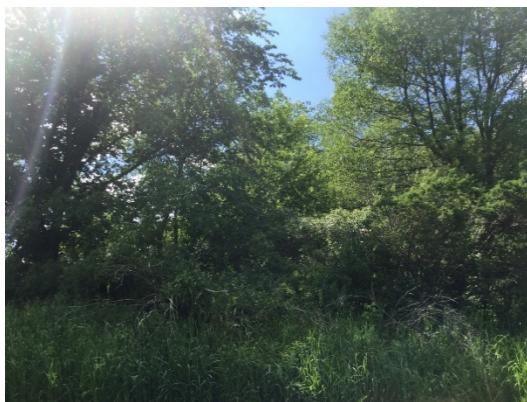
- g. Declining upland ecosystems included historical, semi-open oak savanna and forest systems that have been degraded by invasive European Buckthorn (*Rhamnus cathartica*), non-native honeysuckles (*Lonicera* spp), native (but aggressive) Boxelder (*Acer negundo*), and other non-native species. This condition now represents a large percentage of farm woodlots, but also is seen in semi-natural floodplain and riverbank environments. Where these dense non-native shrubs and Boxelder occur, dense shading results in the collapse of soil-stabilizing native grasses, sedges, and other wildflowers. This in turn contributes to the significant soil erosion observed in the watershed's riparian areas, similar to what we have documented elsewhere (e.g., see the book *Restoring Ecological Health to Your Land*, Apfelbaum and Haney 2012). This erosion contributes to degraded habitat quality and declining regional wildlife populations (e.g., native birds, insects).

Degraded, overgrown oak savanna.

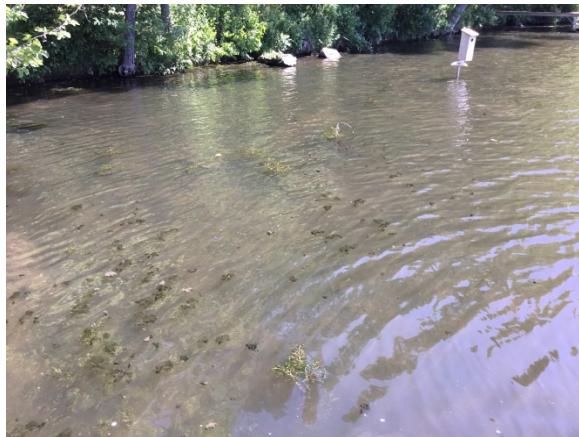
Following the upstream dam breaches between 2017 and 2019, much of the Lake bottom now consists of silts and mucks. While organic deposits are formed naturally by the accumulation and slow decomposition of plant matter in a nutrient-rich environment, much of Lake Mallalieu's organic sediments appear to have originated from the upstream dam breaches.

*Algae and shallow, turbid water.*

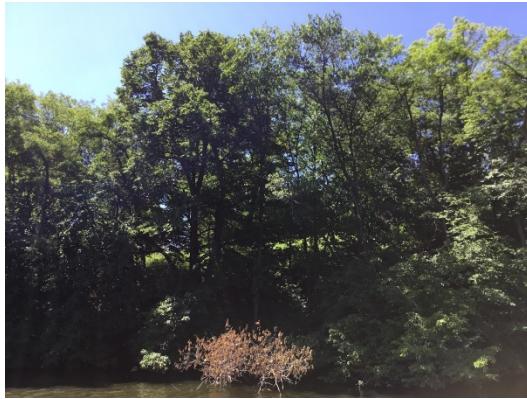
- a. Shallow conditions were confirmed in the deltaic system, in back bays, and along many of the Lake’s WDNR-identified Sensitive Area shorelines.
- b. Shallower areas tended to have fine sand sediments; deeper areas contained greater percentages of fine silts, clay, and organic deposits.
- c. Nearly all the Sensitive Areas were observed to have adjacent declining oak savanna systems that have been invaded by Common buckthorn (*Rhamnus cathartica*), non-native invasive honeysuckles (*Lonicera* spp), and Boxelder (*Acer negundo*). These forest/woodlands are rapidly

closing in, causing increasingly dense shade. *Several locations were observed where the shoreline's stabilizing native vegetation is suffering from shade suppression, leading to bare and erodible soils.*

*Historical oak savanna, currently overgrown.*

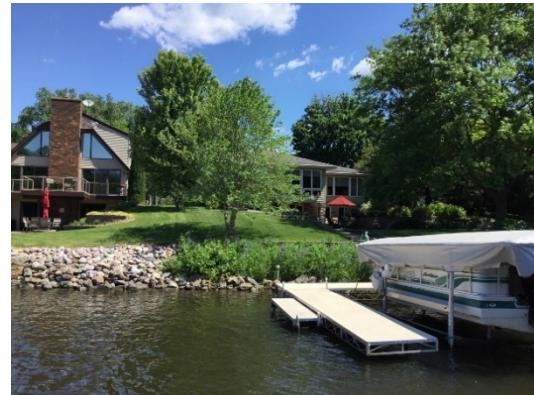
*Shorelines: rip rap (left) and natural/restored (right).*
